FIVE-YEAR REVIEW REPORT

First Five-Year Review Report

West Kingston Town Dump / URI Disposal Area
Superfund Site

South Kingstown, Rhode Island

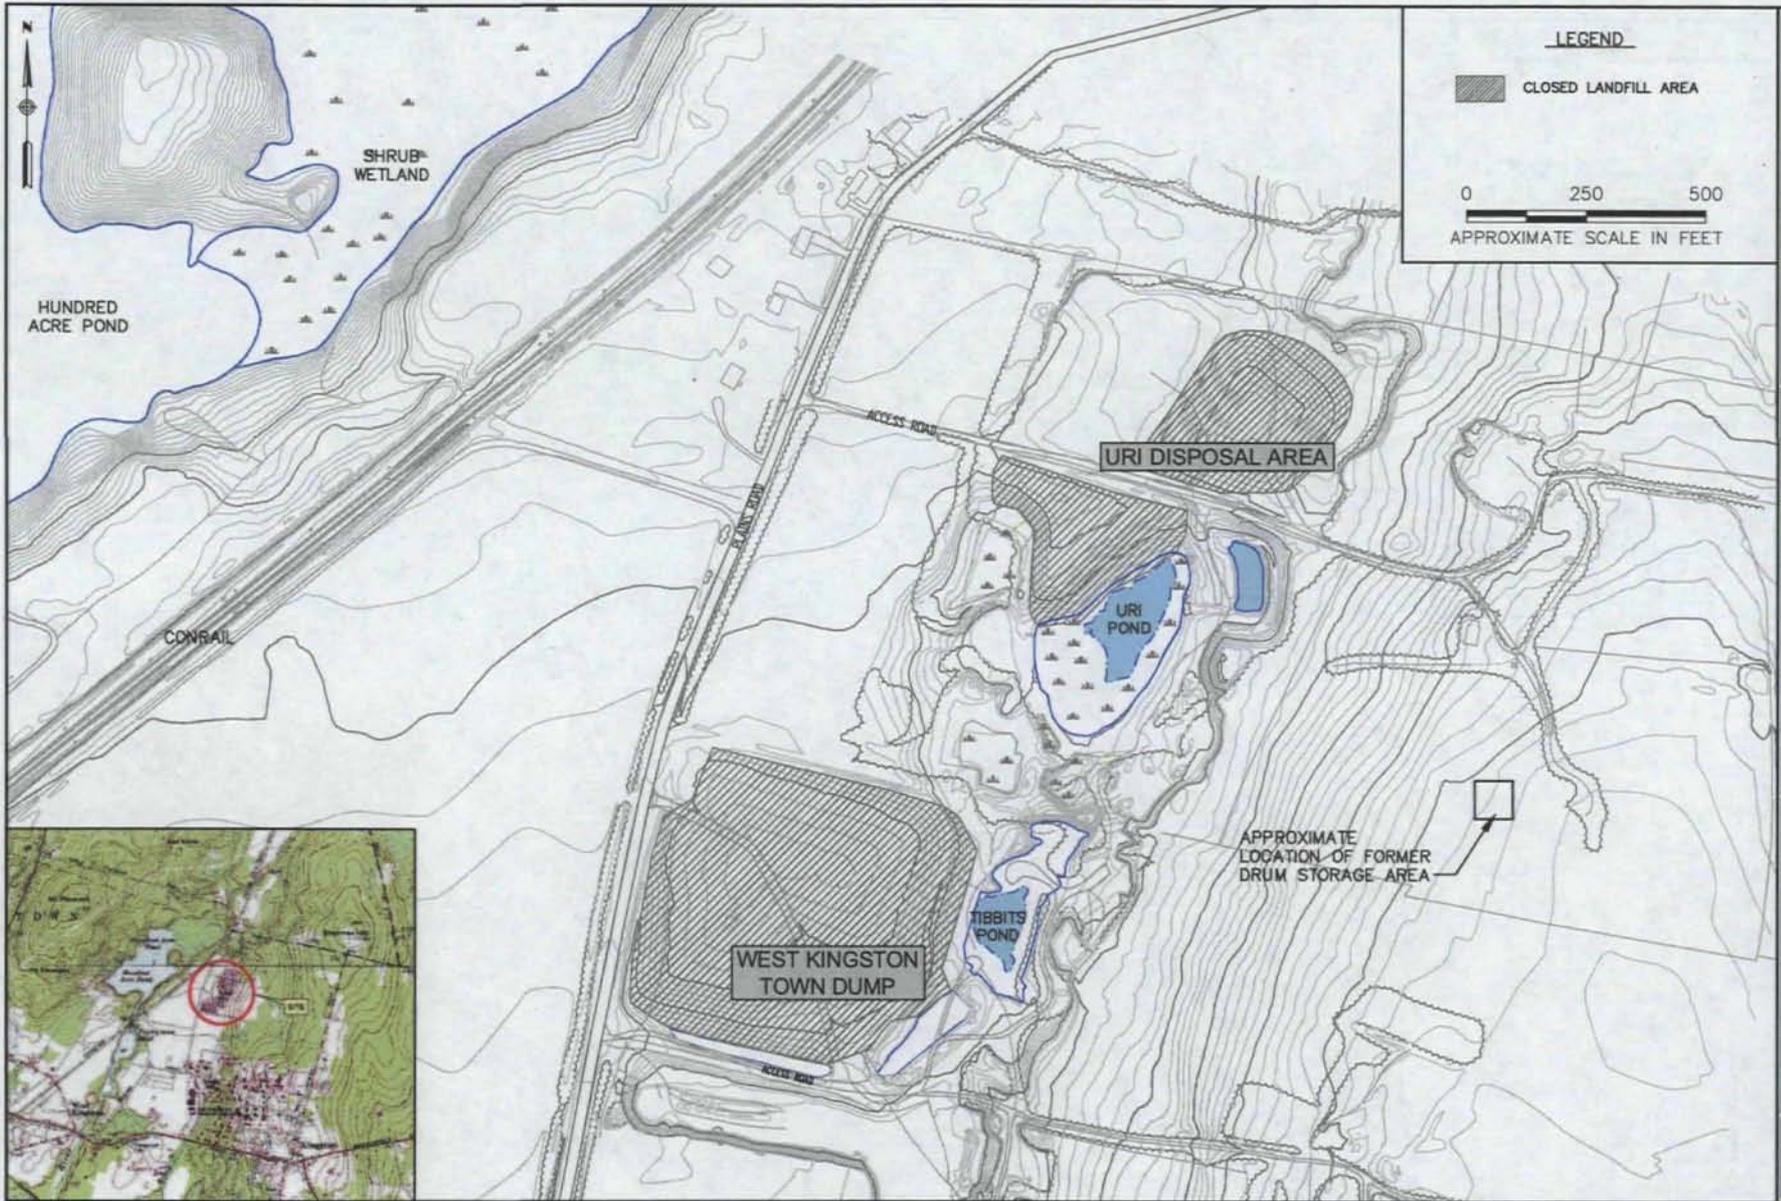
FIGURE 1

The Site is located on the eastern side of Plains Road in South Kingstown, Rhode Island as shown on the Site Plan (**Figure 1**). The Site includes two former disposal areas: the West Kingstown Town Dump and the URI Disposal Area (see Figure 1). The West Kingstown Town Dump, which comprises the southern portion of the Site, is located to the east of Plains Road, approximately 0.4 miles north of the URI campus. The Town Dump was comprised of the western 6.5 acres of a 117-acre mixed forest parcel formerly owned by Alice Tibbits of South Kingstown which has since been incorporated into a 17-acre parcel transferred to the Town of South Kingstown. The URI Disposal Area, which comprises the northern portion of the Site, is also located to the east of Plains Road, 0.5 miles north of the URI campus. The URI Disposal Area consists of approximately 12 acres (see Figure 1). The FDSA is located on the URI property to west and upgradient of the landfill areas. The URI pond lies between the FDSA and the URI landfill with a smaller Tibbits pond to the south. Hundred Acre Pond is found approximately 1,500 feet west of the landfill areas.

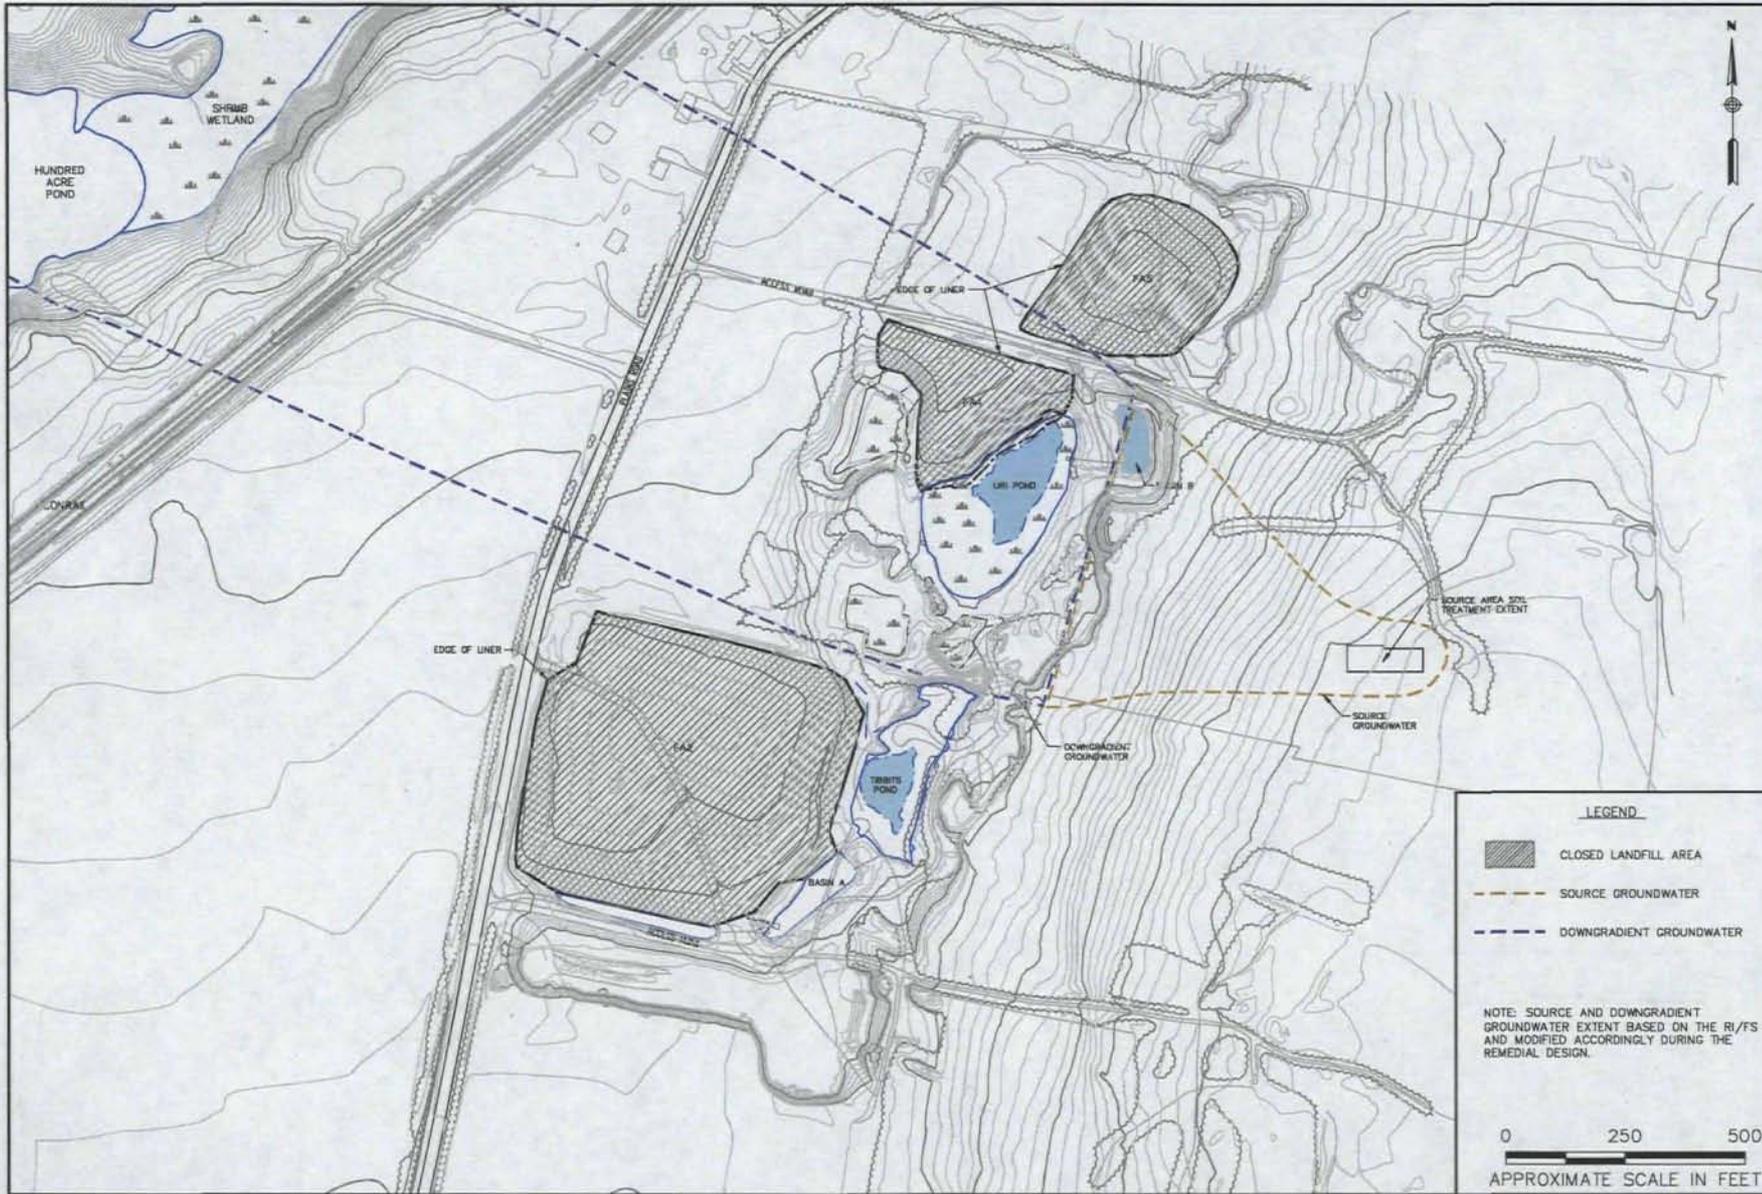
FIGURE 2

The management of migration component applies to impacted groundwater associated with the FDSA and within the two primary groundwater zones at the Site: the source groundwater and downgradient groundwater (depicted in **Figure 2**). For source groundwater, the selected remedy was designed to address the bedrock groundwater plume and residual overburden impacts. Groundwater treatment was selected to occur on an annual basis using a permanganate solution (NaMnO₄) injected through a series of injection wells.

To reduce the extent of waste disposal areas, waste from other on-site fill areas and from within the same disposal area was consolidated into three main areas: FA2, FA4, and FA5. The areas of consolidation are shown on Figure 2. The cover system cap on Landfill Areas FA2 (8.09 acres [ac]), FA4 (1.70 ac) and FA5 (2.38 ac) covers an area of about 12 acres. The cover system was designed to meet the performance requirements of RCRA Subtitle C regulations, and existing requirements of RIDEM and USEPA. The cover system consists (from top to bottom) of a 6 inch topsoil layer, a 18 inch vegetative support layer, a drainage geocomposite, a 60 mil high-density polyethylene textured geomembrane, a 12 inch low permeability soil layer, a 6 inch sand gas venting layer and a base soil layer. The cover system also includes passive gas vents and trenches, drainage channels, culverts and detention basins. Landfill Area FA2 is located on property owned by the Town of South Kingstown and Landfill Areas FA4 and FA5 are located on property owned by URI.

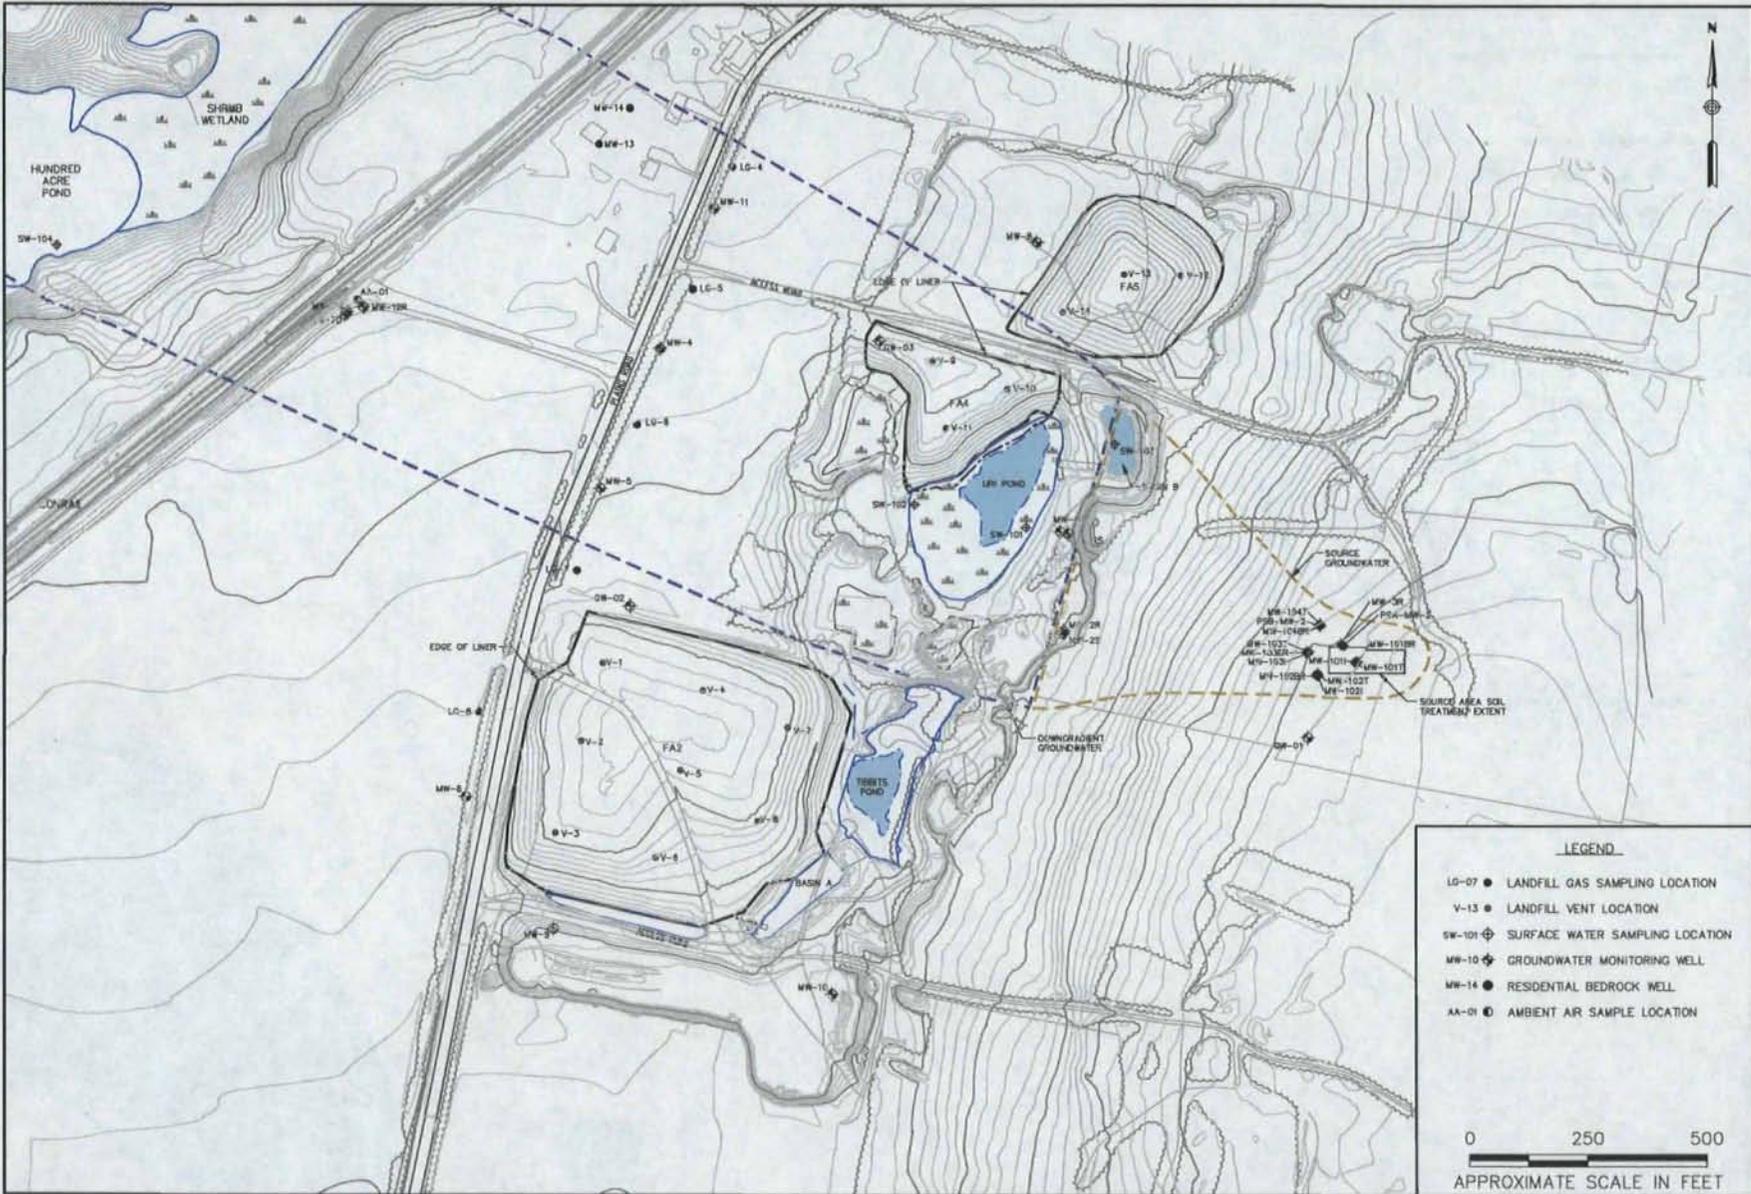
SOURCE AND DOWNGRADE MONITORING LOCATIONS

Monitoring of the downgradient groundwater plume for VOCs is also performed to assess progress of the groundwater remedy toward meeting preliminary remediation goals (PRGs). The groundwater monitoring wells associated with the downgradient groundwater zone are shown in **Figure 4**.

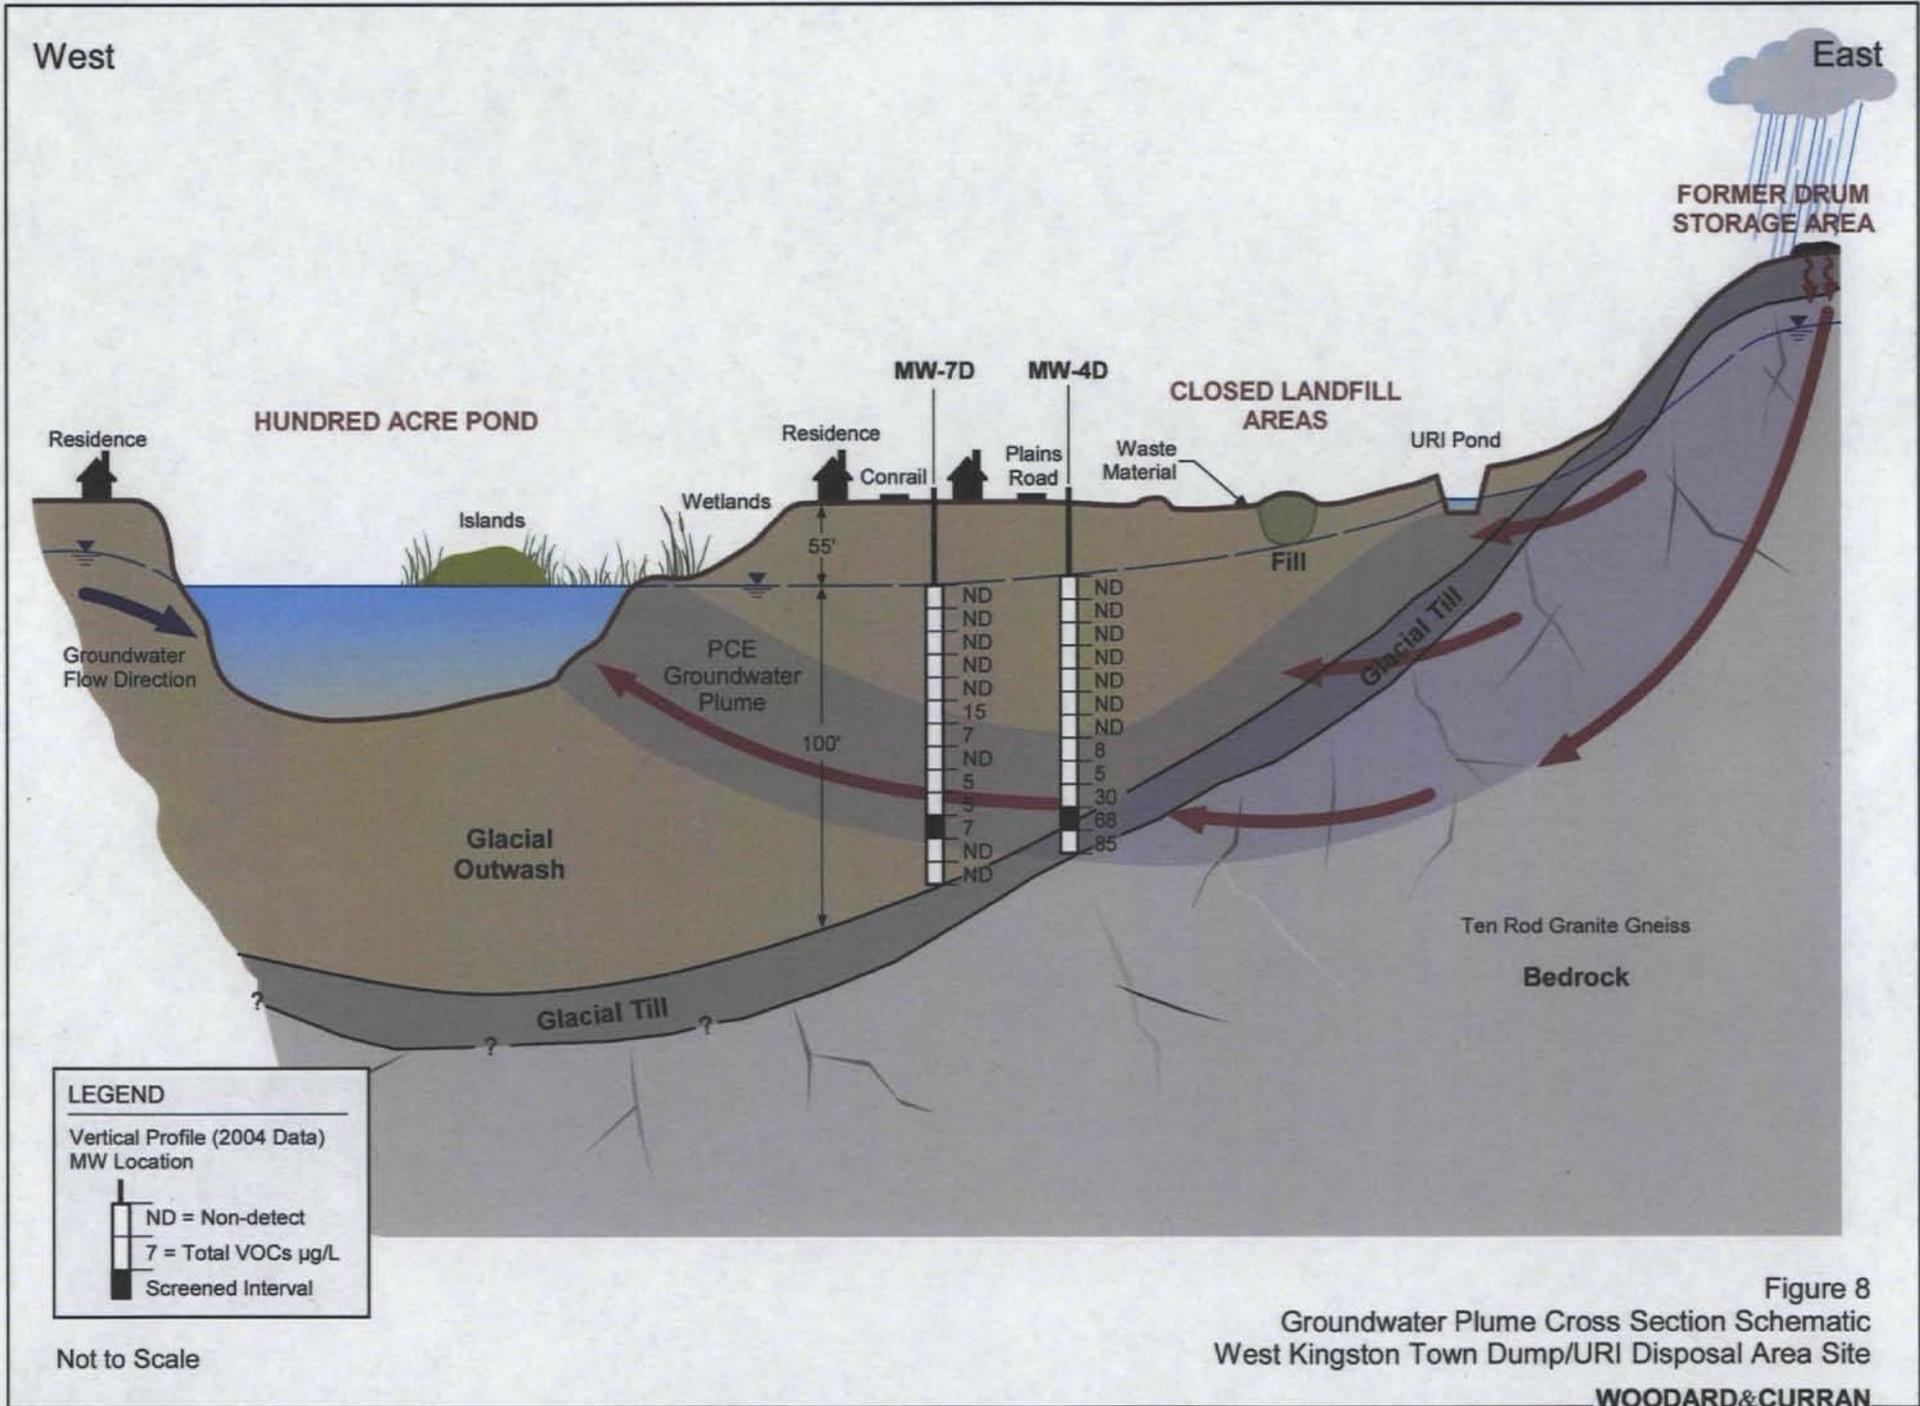
Figure 8
Groundwater Plume Cross Section Schematic
West Kingston Town Dump/URI Disposal Area Site

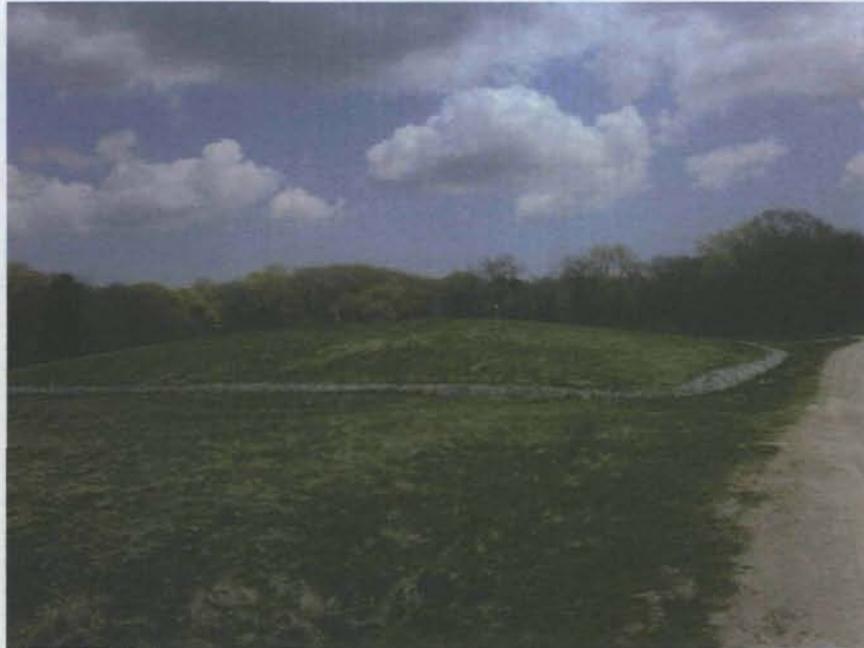
VII. LANDFILL COVERS <input type="checkbox"/> Applicable <input type="checkbox"/> N/A		
A. Landfill Surface		
1.	Settlement (Low spots) <input type="checkbox"/> Location shown on site map <input checked="" type="checkbox"/> Settlement not evident Areal extent _____ Depth _____ Remarks <u>Covers are in good condition; see Photo #3.</u>

Photo 3: FA-4 cap.

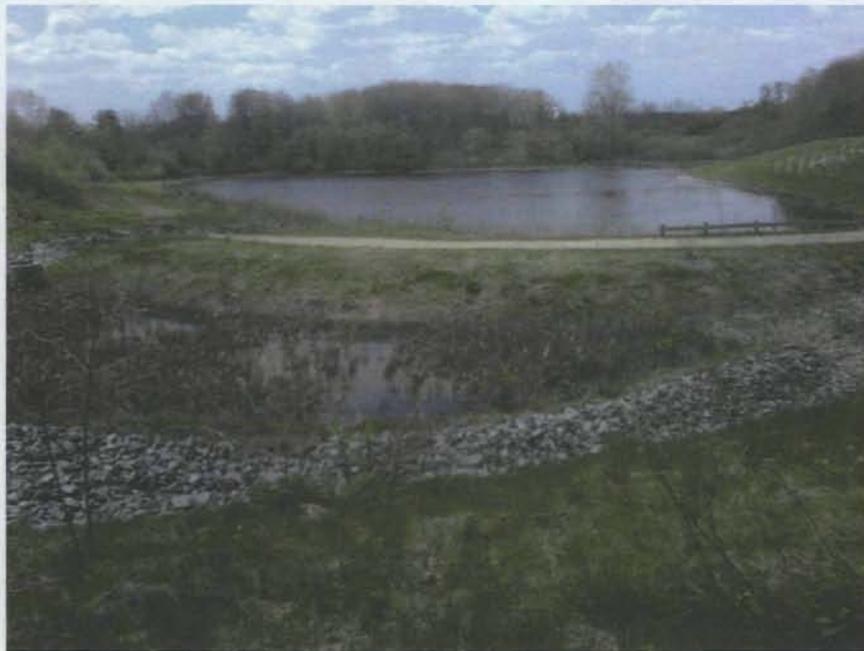
8.	Wet Areas/Water Damage	<input checked="" type="checkbox"/> Wet areas/water damage not evident	
	<input type="checkbox"/> Wet areas	<input type="checkbox"/> Location shown on site map	Areal extent _____
	<input type="checkbox"/> Ponding	<input type="checkbox"/> Location shown on site map	Areal extent _____
	<input type="checkbox"/> Seeps	<input type="checkbox"/> Location shown on site map	Areal extent _____
	<input type="checkbox"/> Soft subgrade	<input type="checkbox"/> Location shown on site map	Areal extent _____
	Remarks _____ Despite 500-year storm event, no damage to Stormwater Retention System. See _____ photo #4.

Photo 4: URI pond.

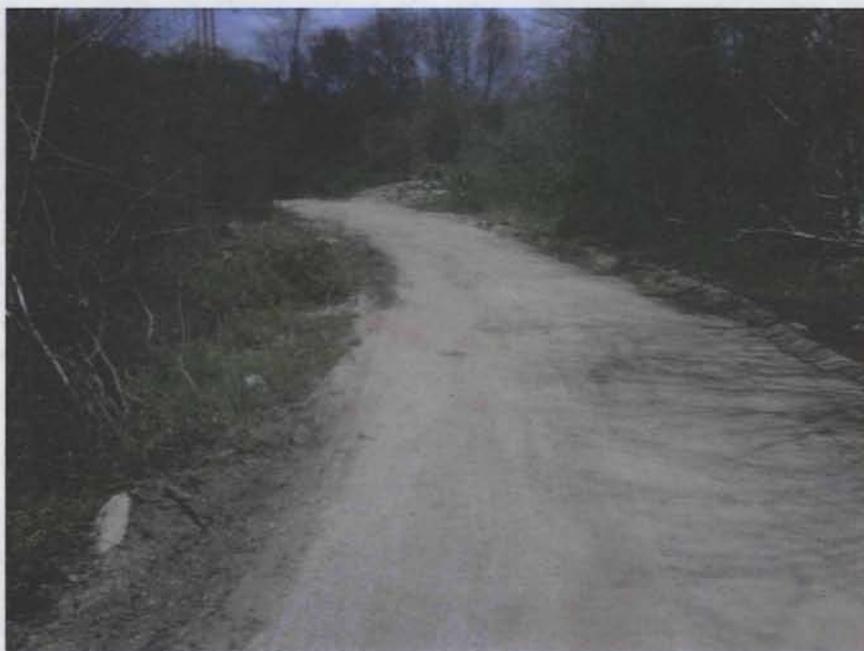
Photo 6: Repaired and regraded access road.

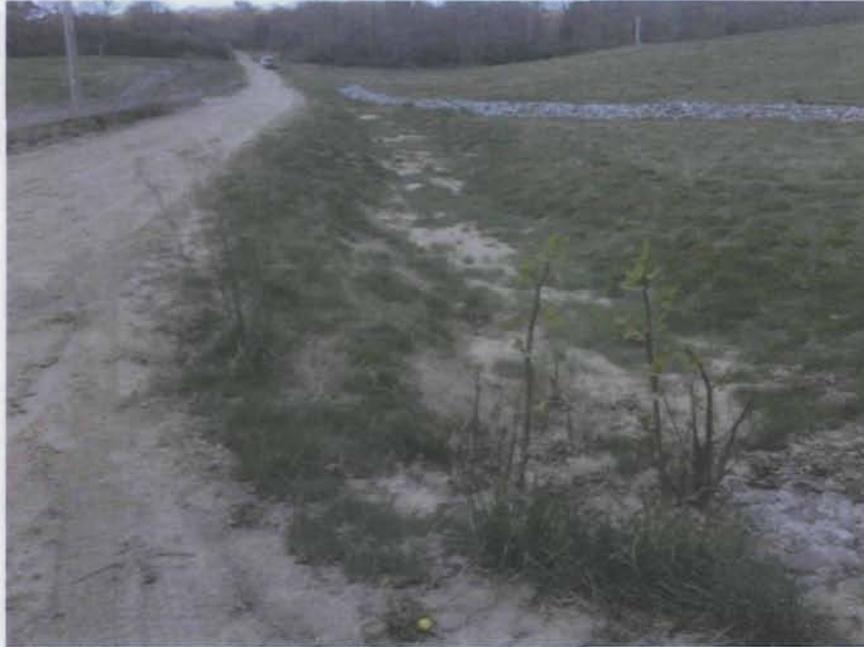
Grass Channels: Some accumulated sediment observed south of FA5 in grass channel due to minor access road erosion in that area.

Photo 7: Silt deposition within ditch.

1.	Siltation	<input checked="" type="checkbox"/> Location shown on site map	<input type="checkbox"/> Siltation not evident
	Areal extent: Approx. 20 ft ² _____	Depth: Max 6-inches _____	
	Remarks: URI is schedule to remove silt and repair as needed.		
	Remarks _____
