WHEELER BAY SHORELINE STABILIZATION SLOPE REPAIR  
FINAL CLOSURE REPORT  
TERMINAL 4 PHASE I REMOVAL ACTION  
PORT OF PORTLAND, PORTLAND, OREGON

WHEELER BAY SHORELINE STABILIZATION  
SLOPE REPAIR  
FINAL CLOSURE REPORT  
TERMINAL 4 PHASE I REMOVAL ACTION  
PORT OF PORTLAND, PORTLAND, OREGON

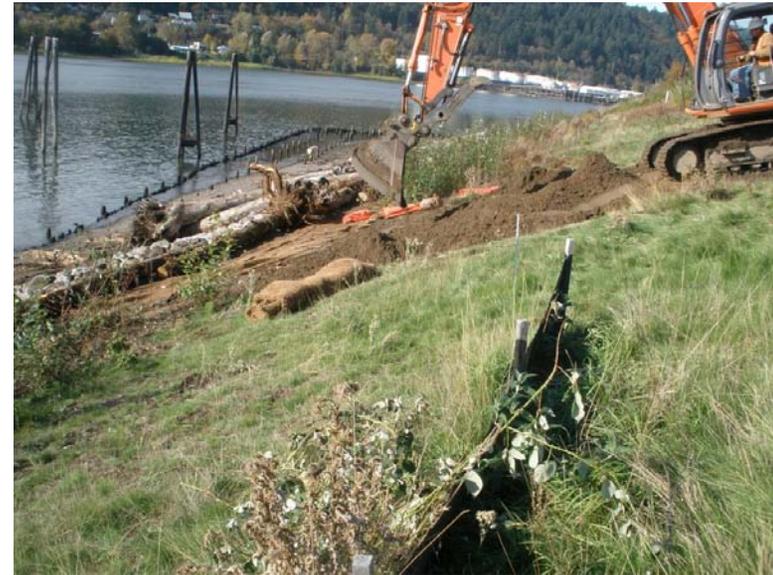
**Repairing the site access and material transfer road**

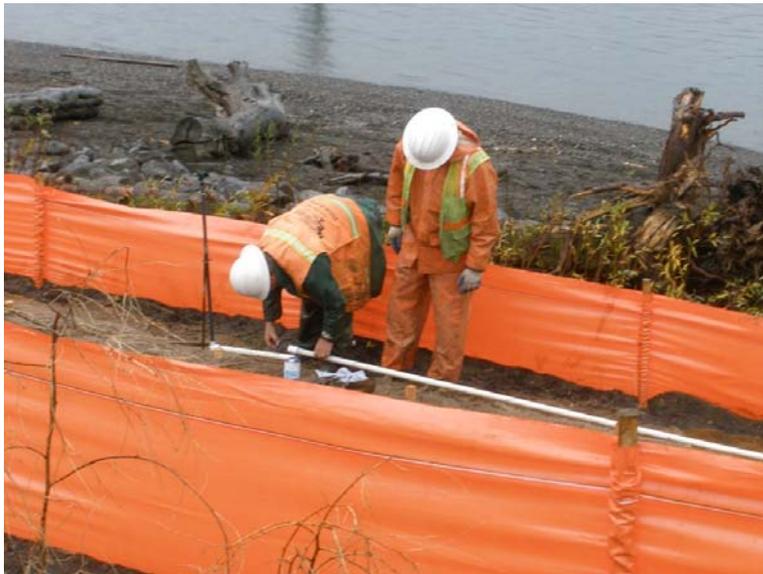
**Repairing the irrigation lines**

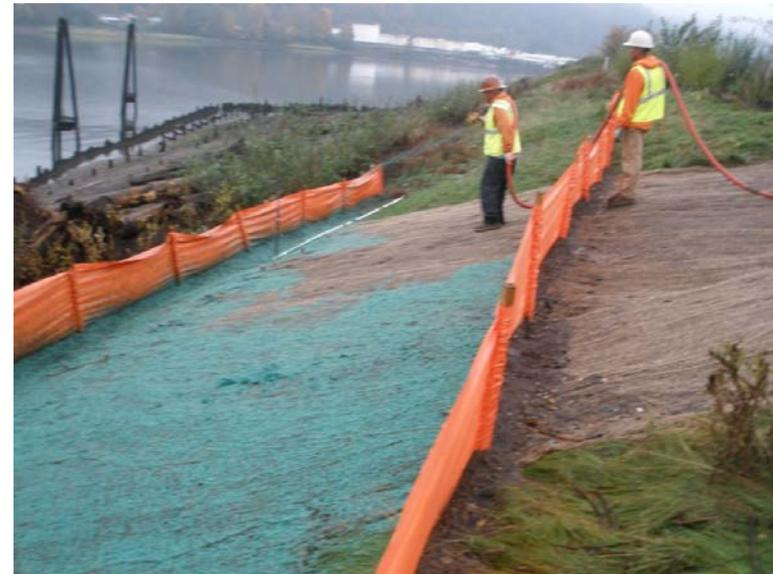
**Hydroseeding site access and material transfer road**

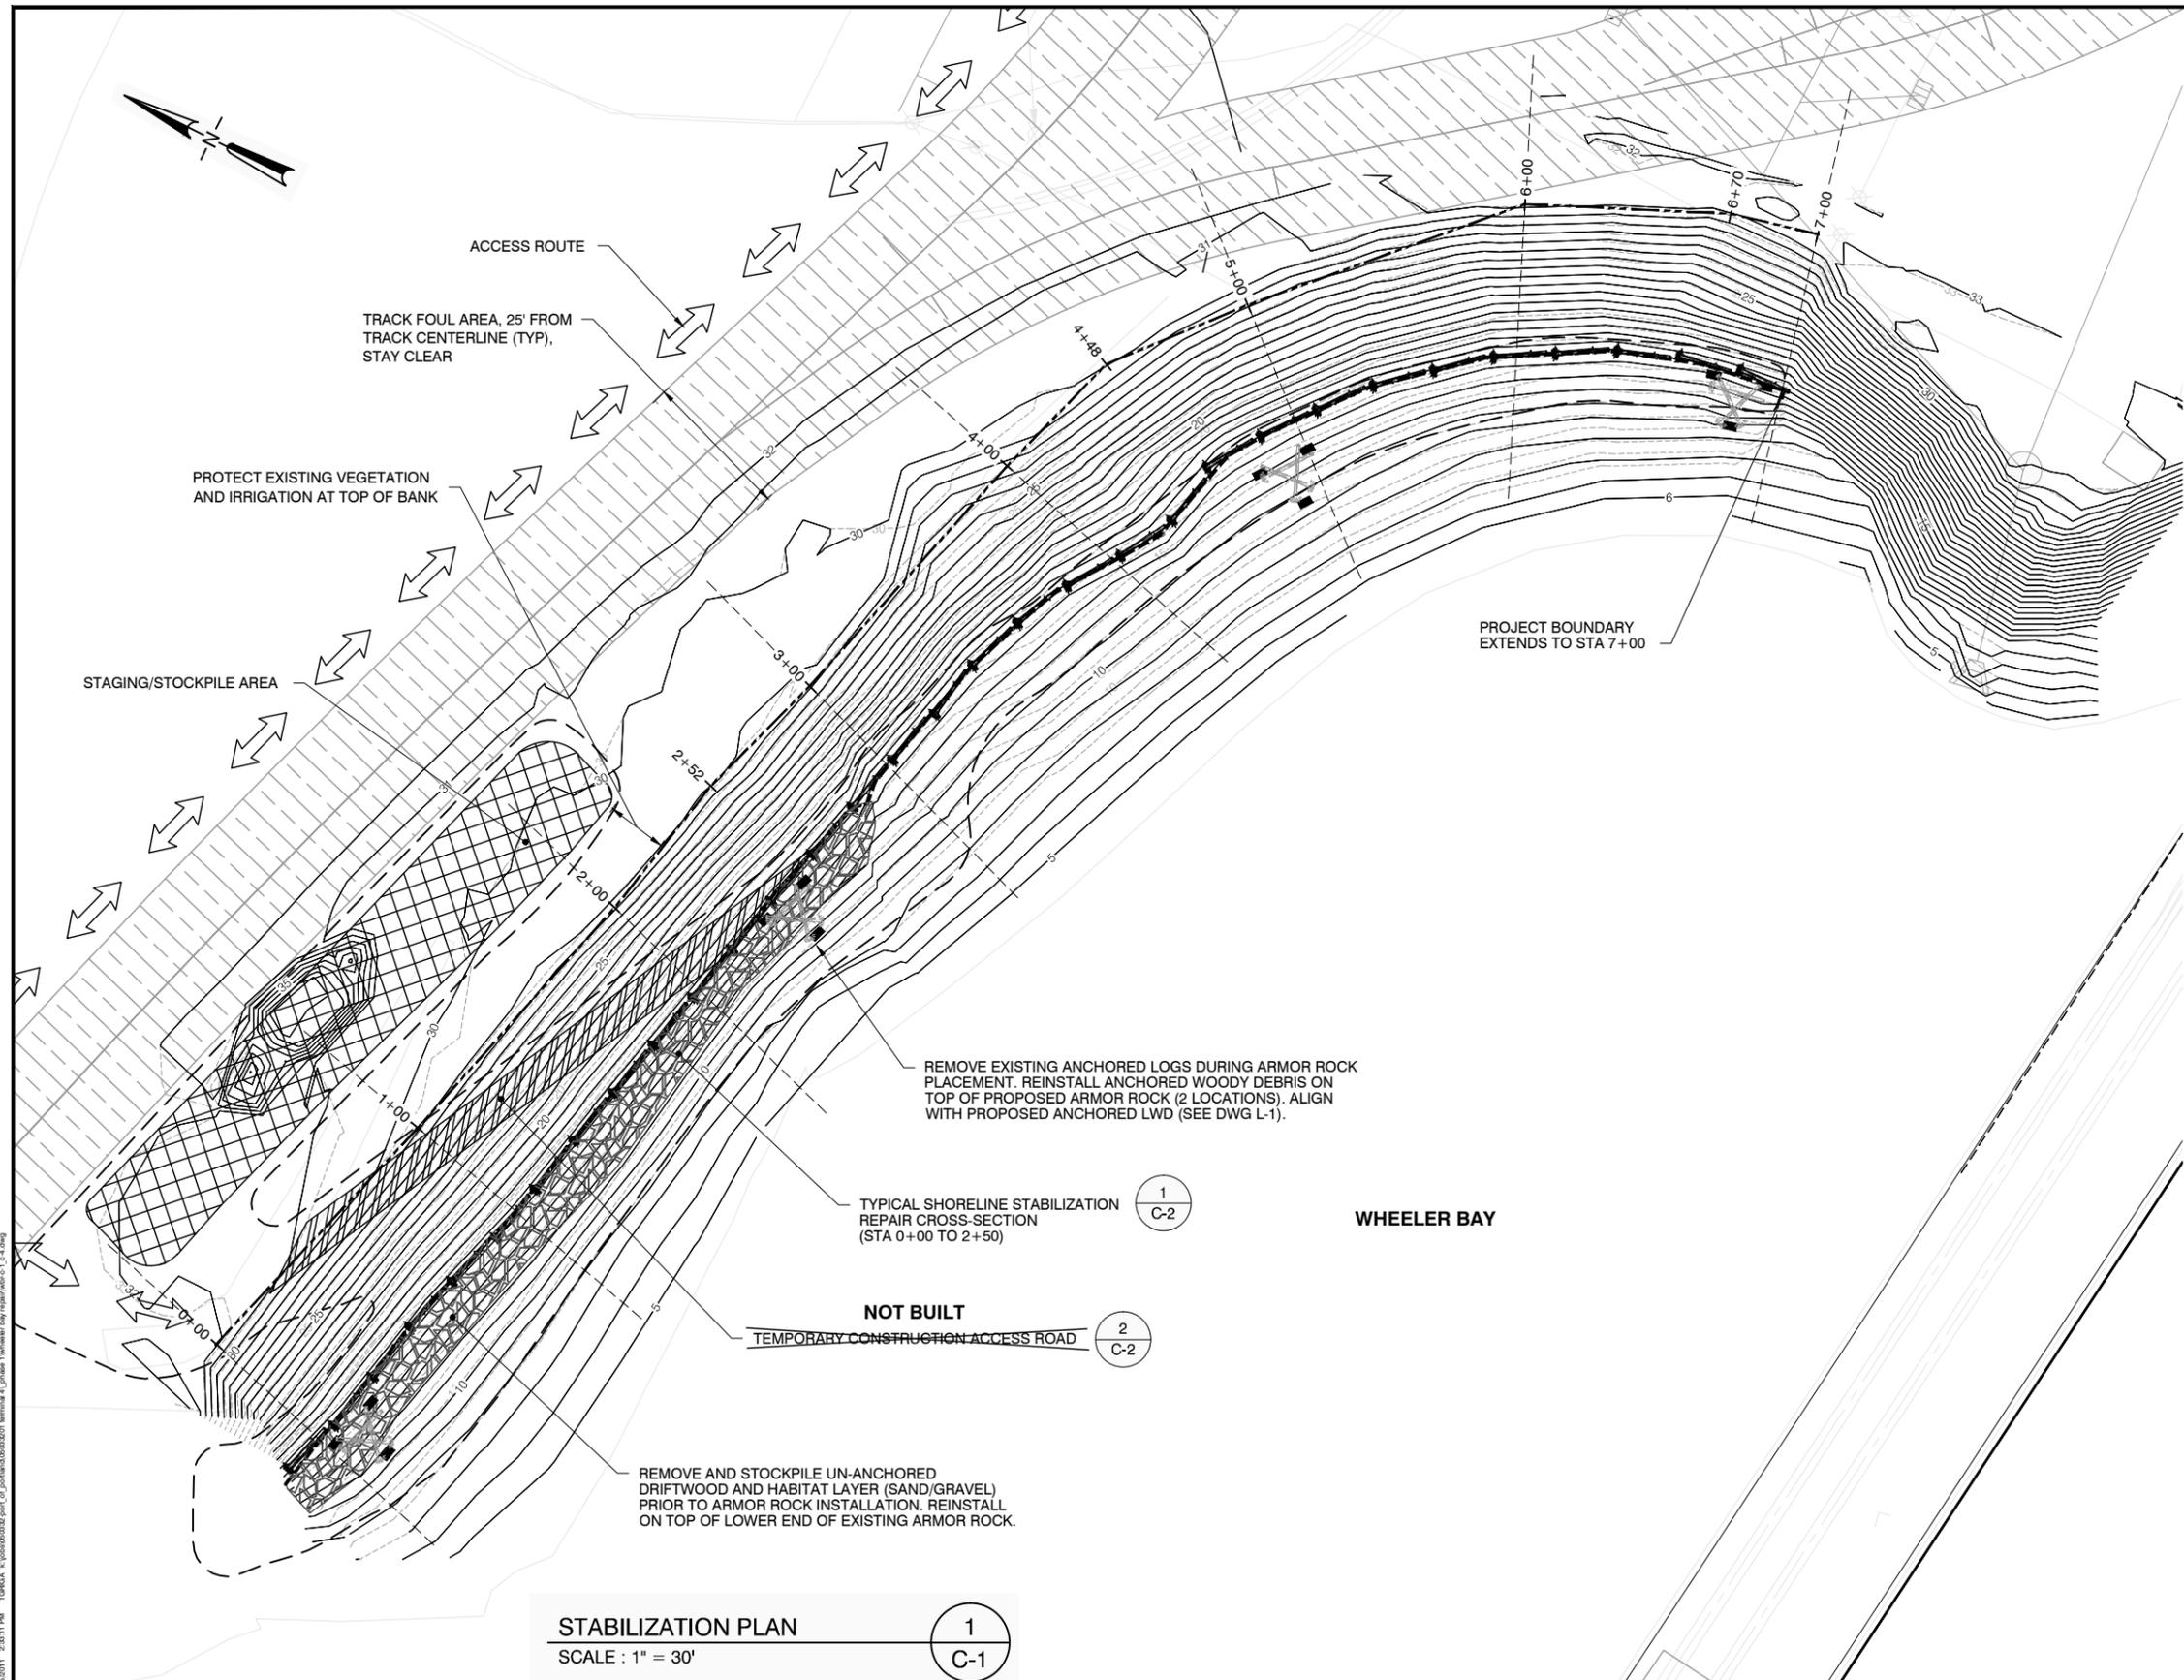
2/8 (C-1)

- LEGEND:**
- PROJECT BOUNDARY
  - SHORELINE SLOPE REPAIR ARMOR ROCK LIMITS (OCT 2010)
  - NOT BUILT** TEMPORARY CONSTRUCTION ACCESS ROAD
  - APPROXIMATE LOCATION OF NEW ANCHORED LARGE WOODY DEBRIS WITH NEW RIPARIAN PLANTING BEHIND
  - PRE-CONSTRUCTION LWD
  - PRE-CONSTRUCTION ECOLOGY BLOCK LWD ANCHORS
  - - - 25 - - - PRE-CONSTRUCTION SURVEY CONTOURS (DATE: 07/29/10)
  - 30 — POST-CONSTRUCTION SURVEY CONTOURS (DATE: 11/17/10)
  - +00 - STATION LINE
  - TRACK FOUL AREA

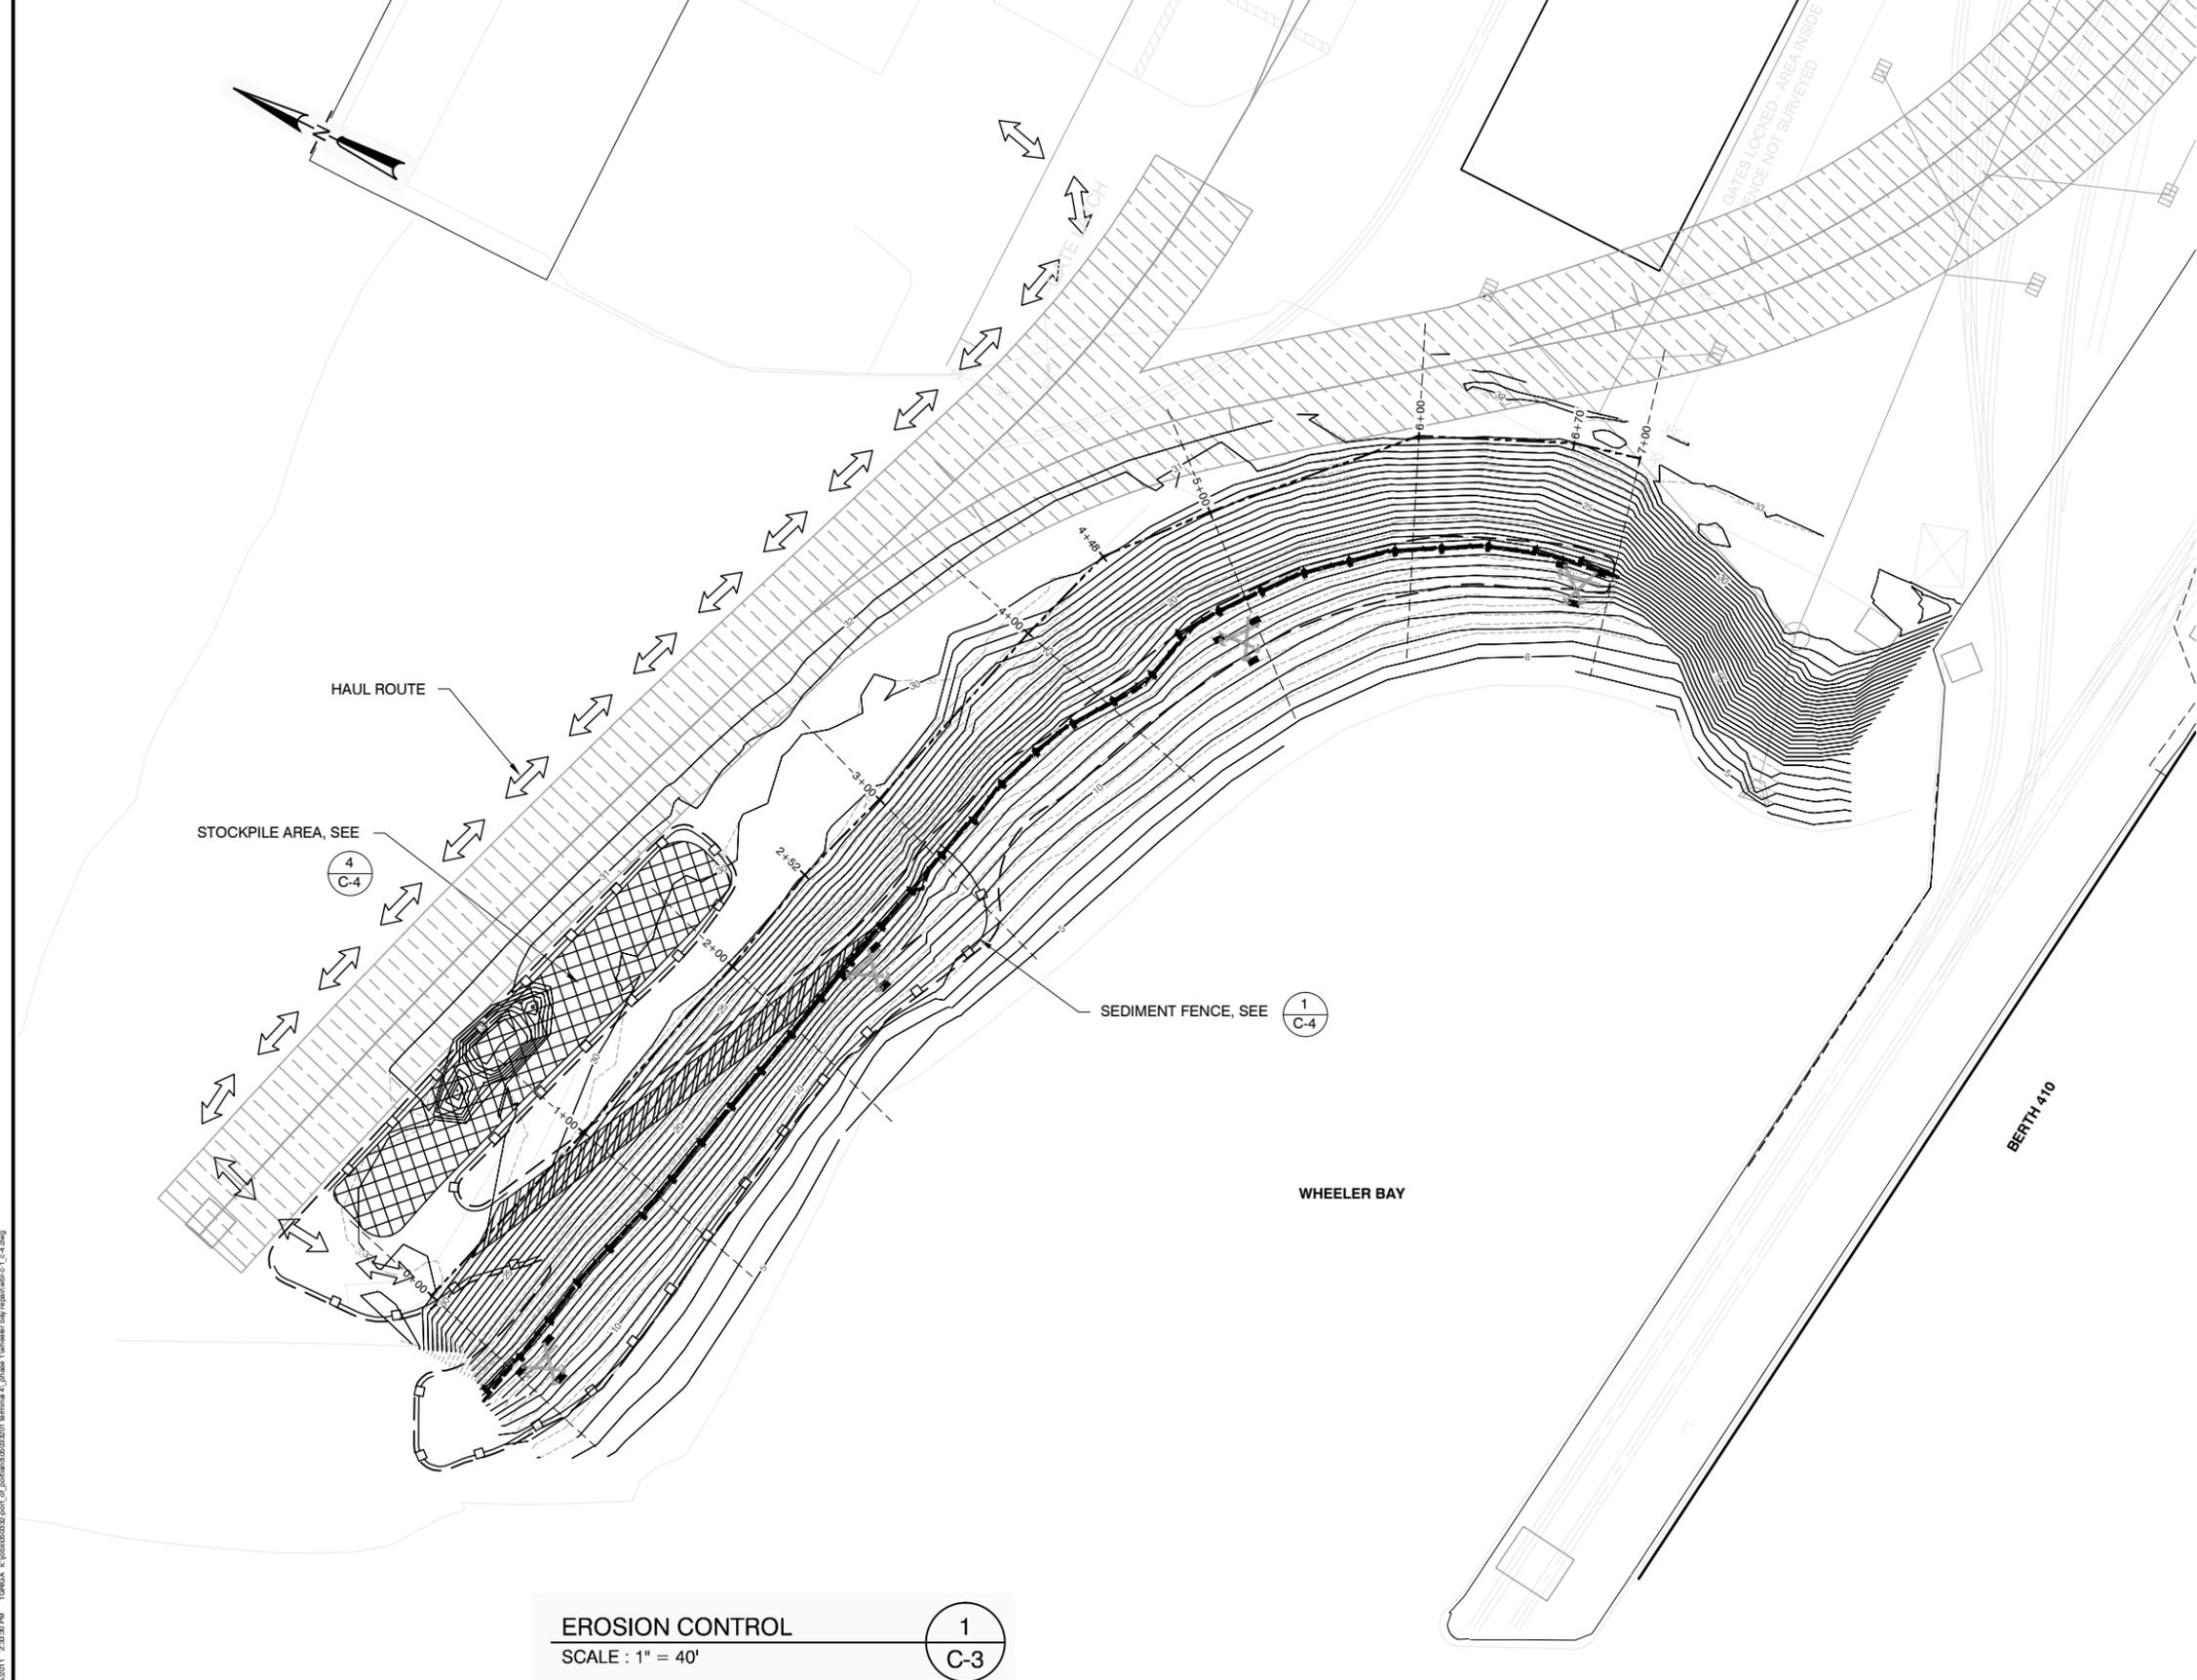
TERMINAL 4	
WHEELER BAY BANK REPAIRS EROSION CONTROL PLAN	
SUBMITTED BY ROGER ANDERSON PROJECT ENGINEER	TYPE DRAWING NO. CD T4 2010-500 4/8 (C-3)

PROJECT BOUNDARY
	TRACK FOUL AREA
	TEMPORARY CONSTRUCTION ACCESS ROAD <b>NOT BUILT</b>
	PRE-CONSTRUCTION LWD
	PRE-CONSTRUCTION ECOLOGY BLOCK LWD ANCHORS
	PRE-CONSTRUCTION SURVEY CONTOURS (DATE: 07/29/10)
	POST-CONSTRUCTION SURVEY CONTOURS (DATE: 11/17/10)
	SEDIMENT FENCE
	HAUL ROUTE

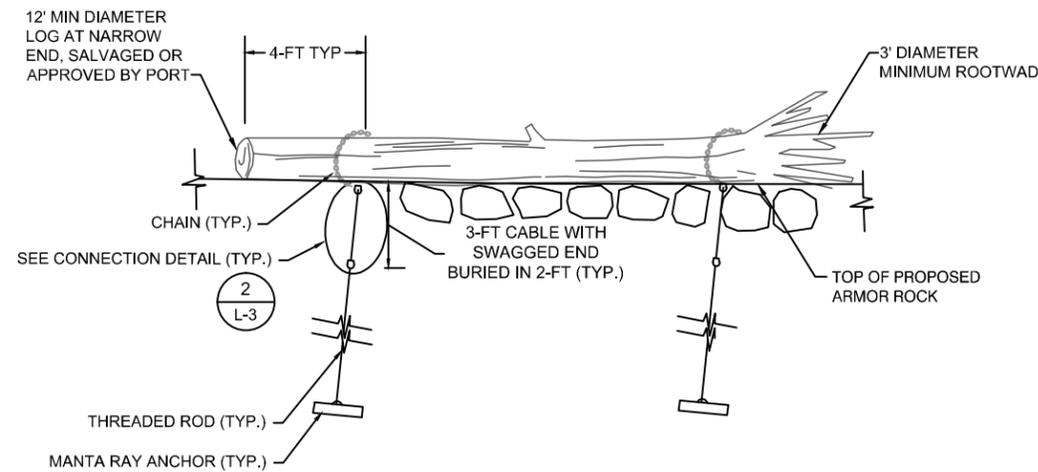
1  
ANCHORED LWD PLACEMENT  
SCALE: NTS  
L-3

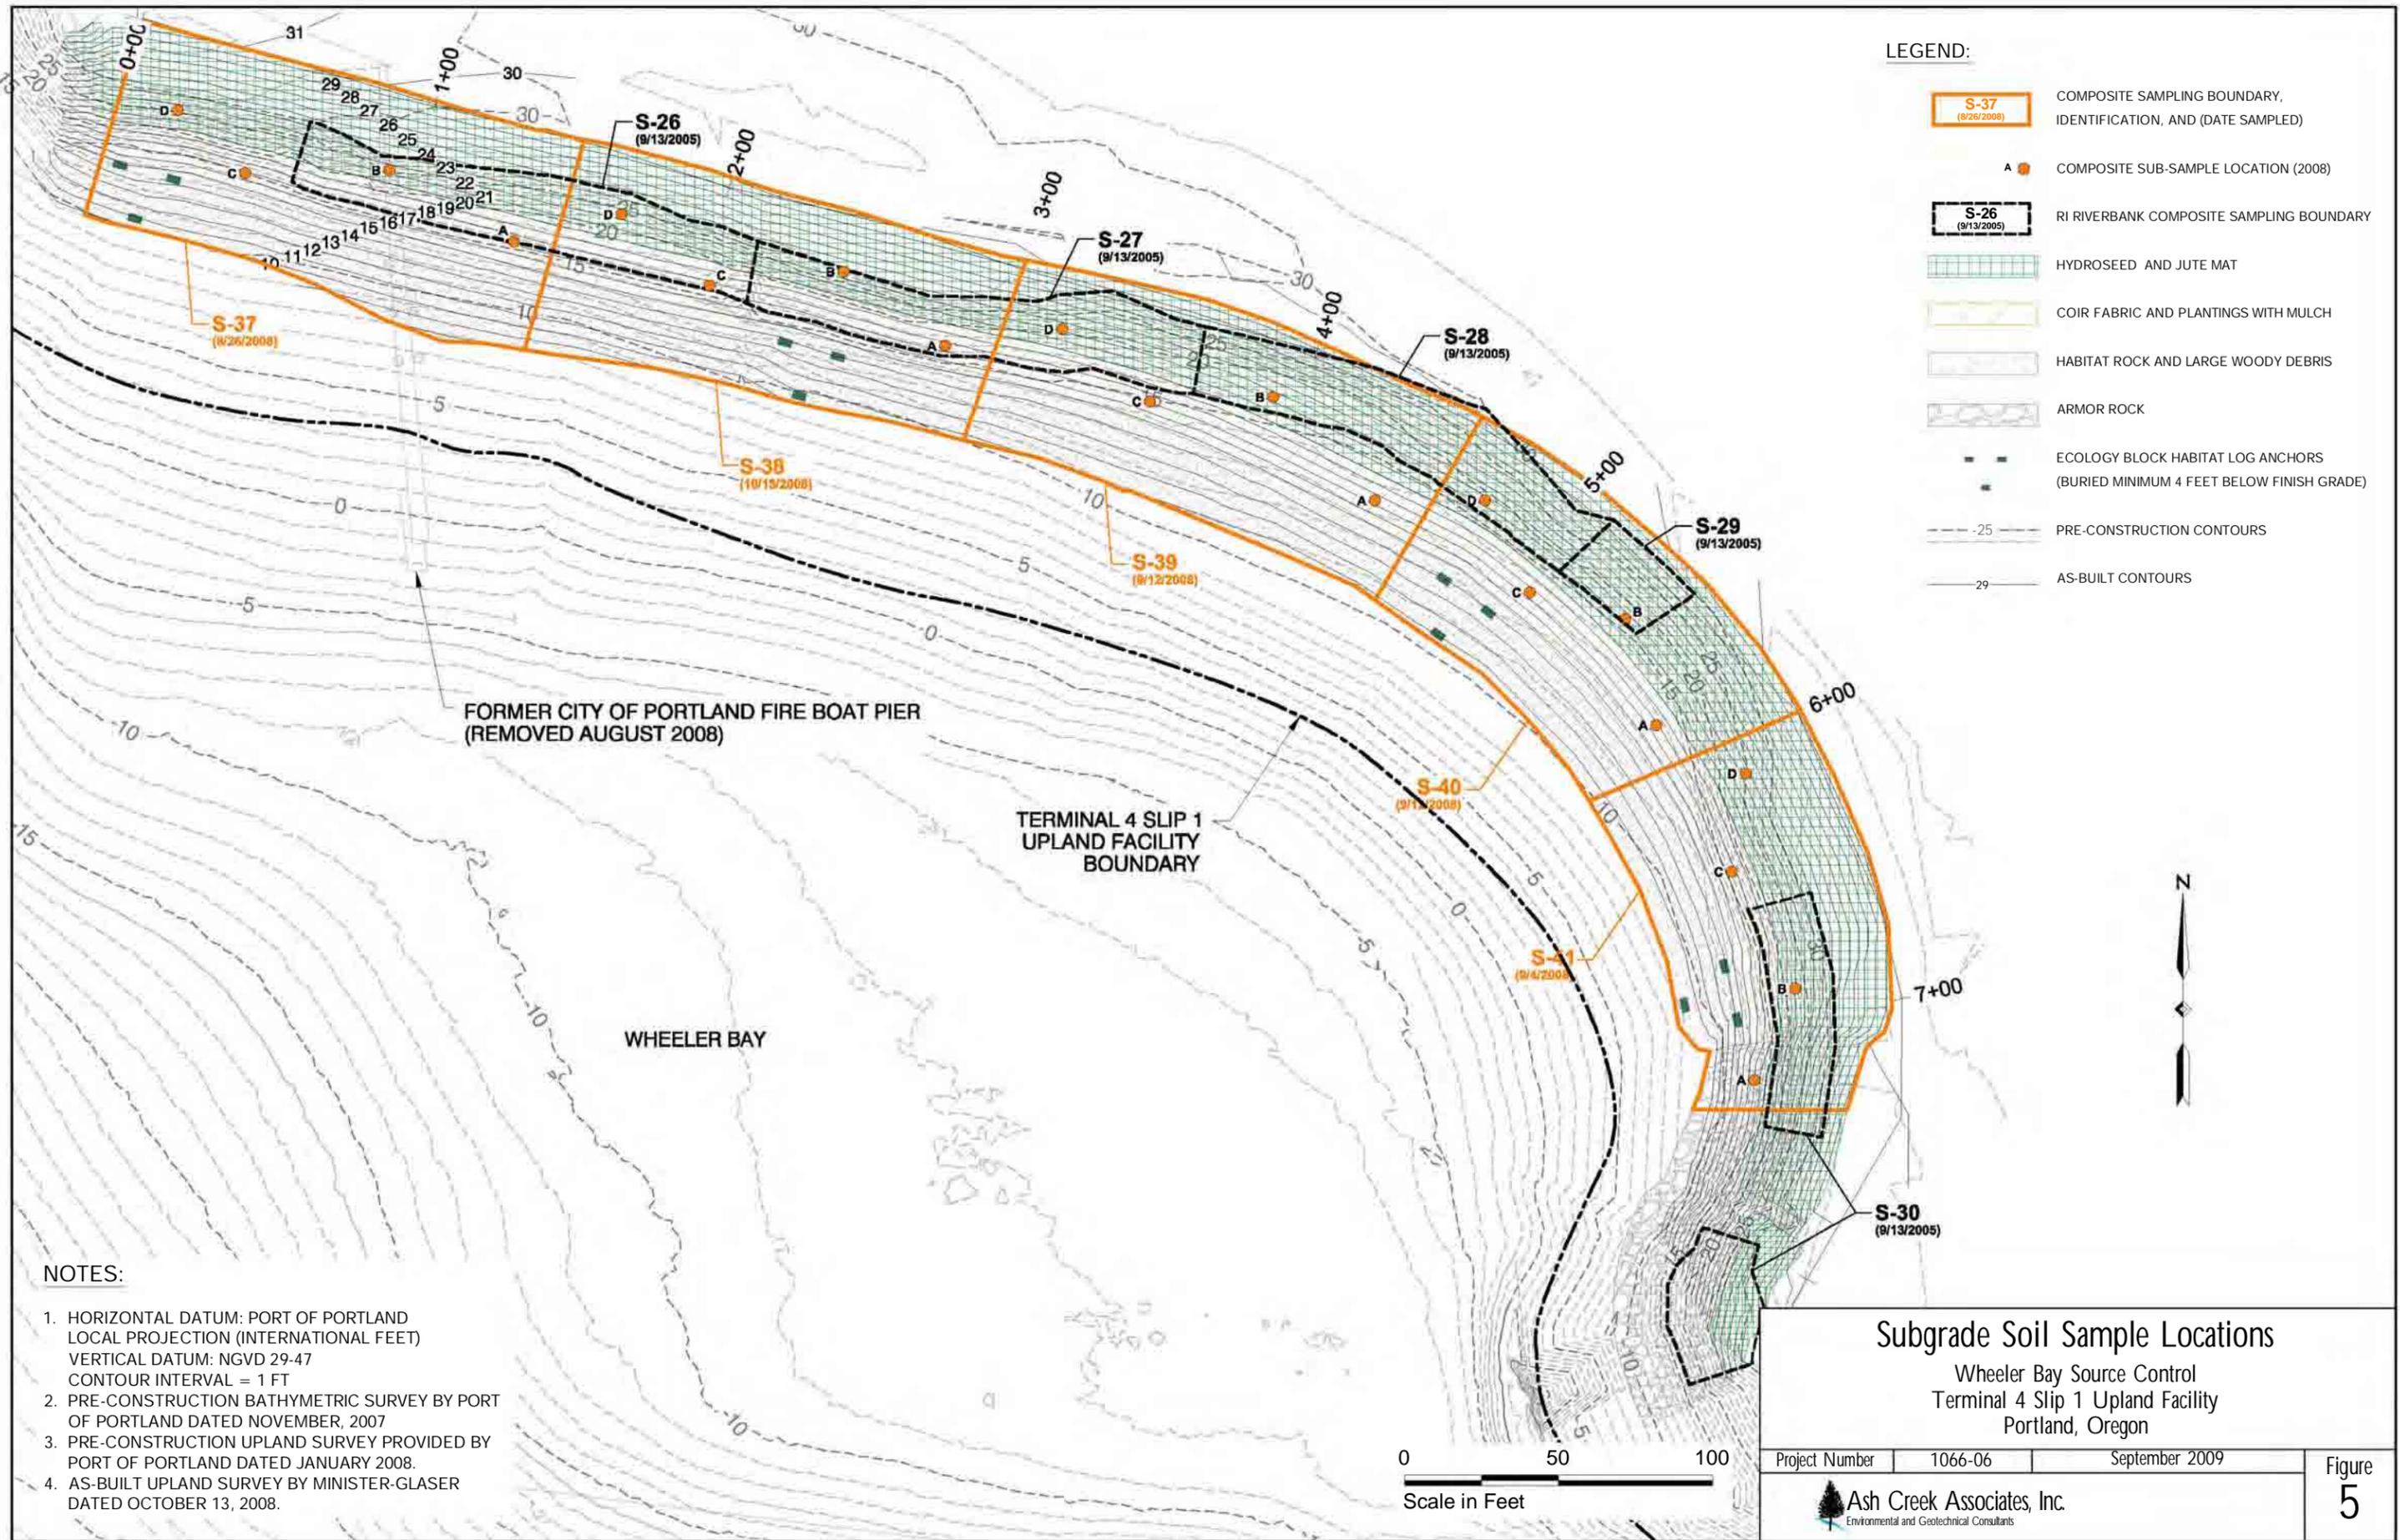
In general, the depth from finish grade to subgrade is 1 foot for two of the four composite subsamples and 2 feet for the other two composite subsamples. The surface of the subgrade is delineated by a demarcation layer consisting of orange plastic mesh.
