**Fourth Five-Year Review Report
For
American Crossarm and Conduit Superfund Site
EPA ID: WAD057311094
Lewis County, Washington**

PREPARED BY
United States Army Corps of Engineers
Seattle District
Seattle, Washington

PREPARED FOR:
United States Environmental Protection Agency
Region 10
Seattle, Washington

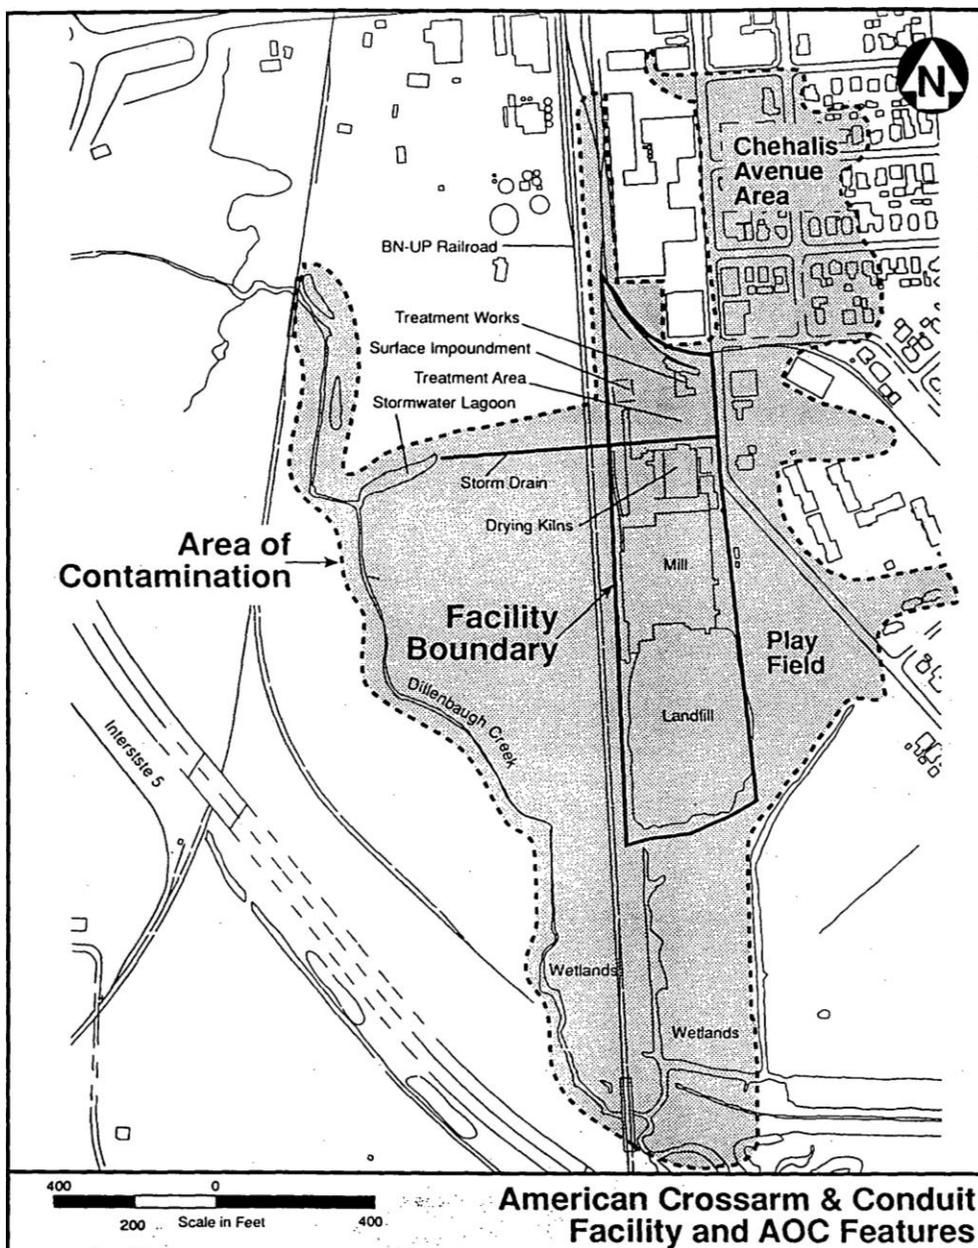
Figure 2. Former Site Building Locations and AOC (ROD 1993) area

For discussion purposes in this Fourth FYR, the ACC Site is divided into the three areas where contamination remains in place: the treatment area, the mill area, and the landfill area (Figure 2). The treatment area, which contained underground tanks, a surface impoundment, and a control room, was used to treat wood with a mixture of diesel and pentachlorophenol (PCP). This area included an elevated crane-way and eight kilns used to dry timber prior to treatment. The mill was a large wooden structure that housed wood crossarms and conduit manufacturing equipment constructed in a low-lying area on posts/pilings to elevate it to the height of the kilns. The landfill was used to dispose of wood waste and other debris from operation of the mill and treatment works.

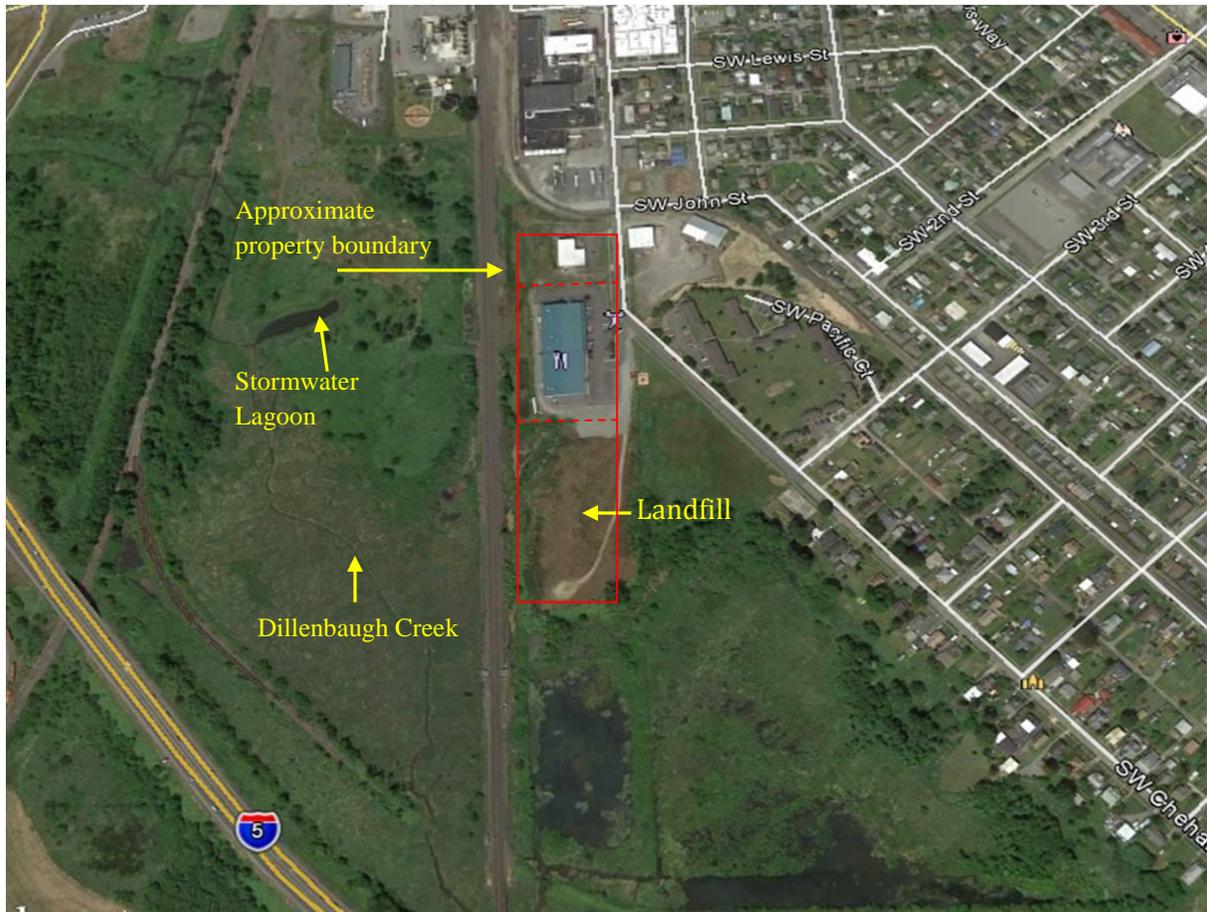
Figure 3. Current Site Layout

The current land use for the Site is commercial. One building currently houses a repair and machine shop and the second building a fitness center and a Headstart children's facility. The Head Start children's facility is attended by 80 to 85 pre-school children between the ages of 3 and 5 years old. They recreate outside the building in the concrete playground area abutting the south end of the fitness center building or the playfield to the east of the ACC Site landfill cap. The current land use for the surrounding area is residential and commercial. To the southeast of the Site are residential neighborhoods (apartments are located directly east of the Site). To the west of the Site is undeveloped land, the Burlington Northern rail line, Dillenbaugh Creek, and the Chehalis River.

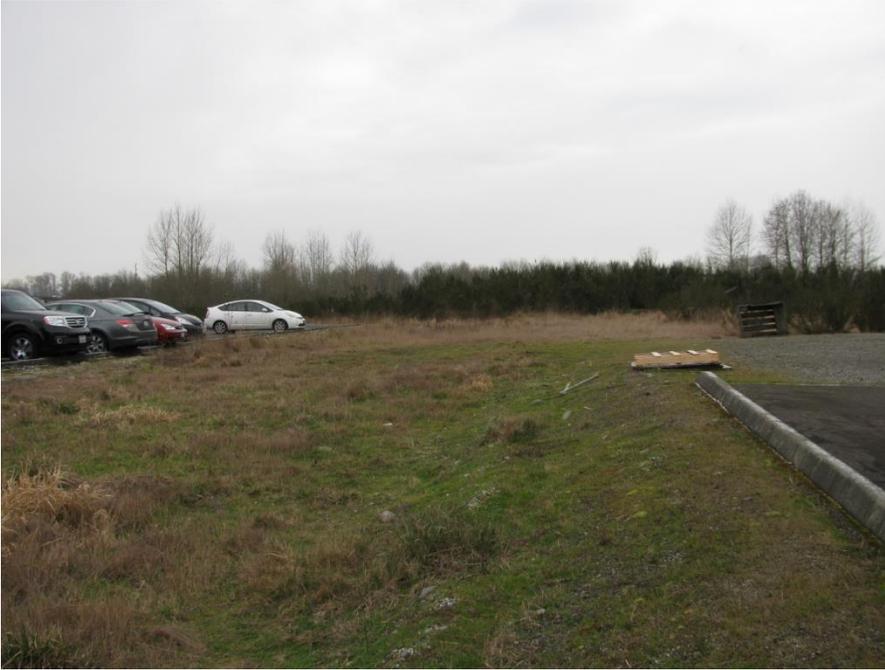
Photo 1. Drainage swale between buildings.

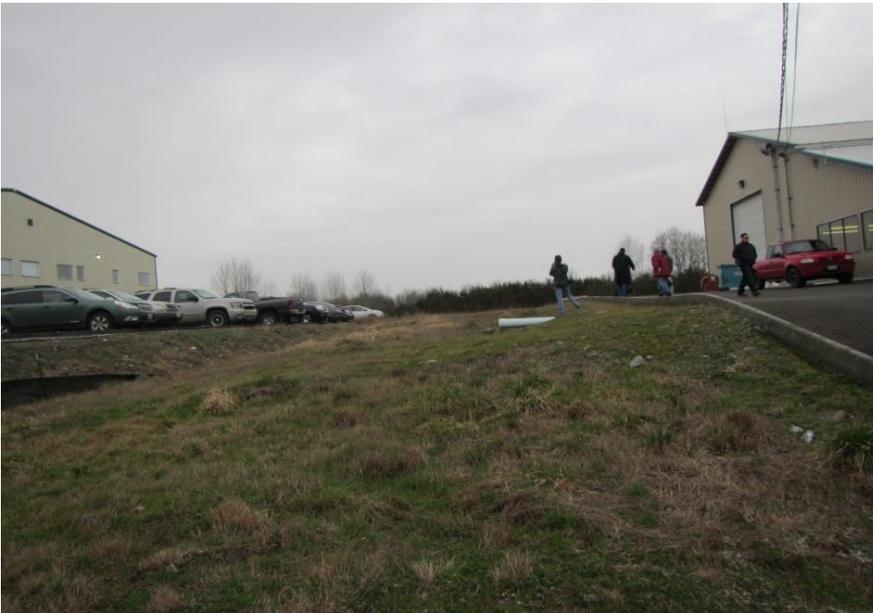
Photo 1a. Drainage swale from road noting pipe and filter fabric fencing.

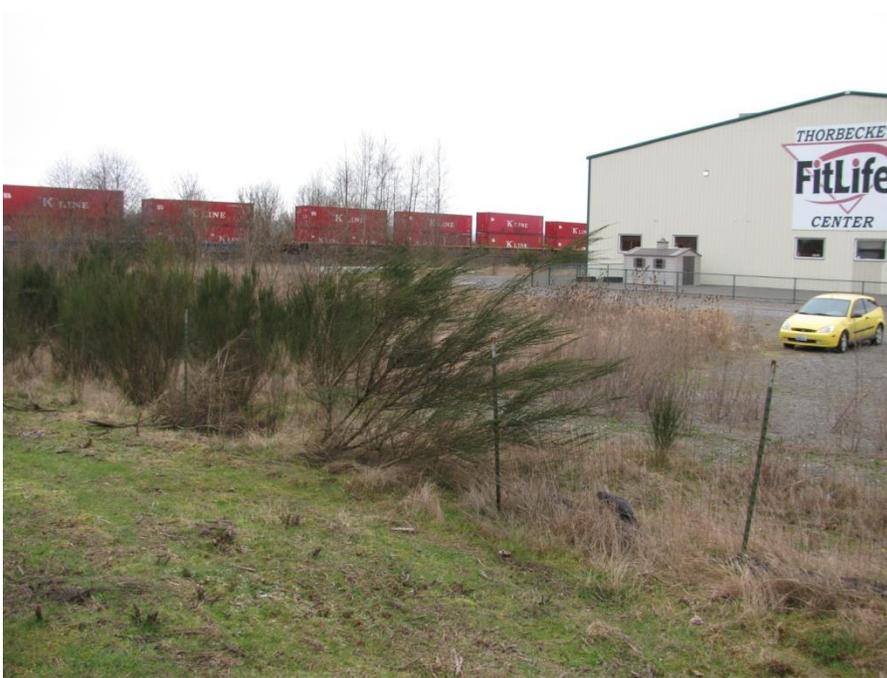
Fence missing around most of the landfill area.

Photo 2. Only remaining fence around landfill.

2.	Adequacy	<input checked="" type="checkbox"/> ICs are adequate	<input type="checkbox"/> ICs are inadequate	<input type="checkbox"/> N/A
	Remarks	Breaching was not observed at the landfill, however, access restrictions should be enforce.

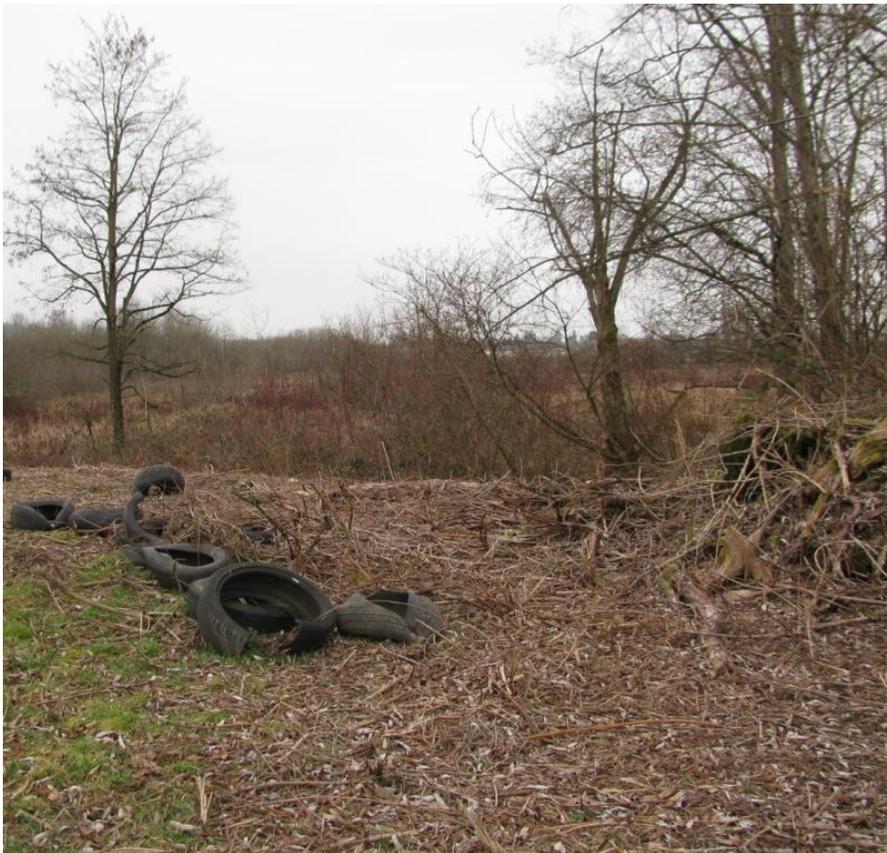
D. General				
1.	Vandalism/trespassing	<input type="checkbox"/> Location shown on site map	<input type="checkbox"/> No vandalism evident	
	Remarks	Tire tracks and garbage (e.g. tires) observed on landfill.

Photo 3. Debris around landfill perimeter.

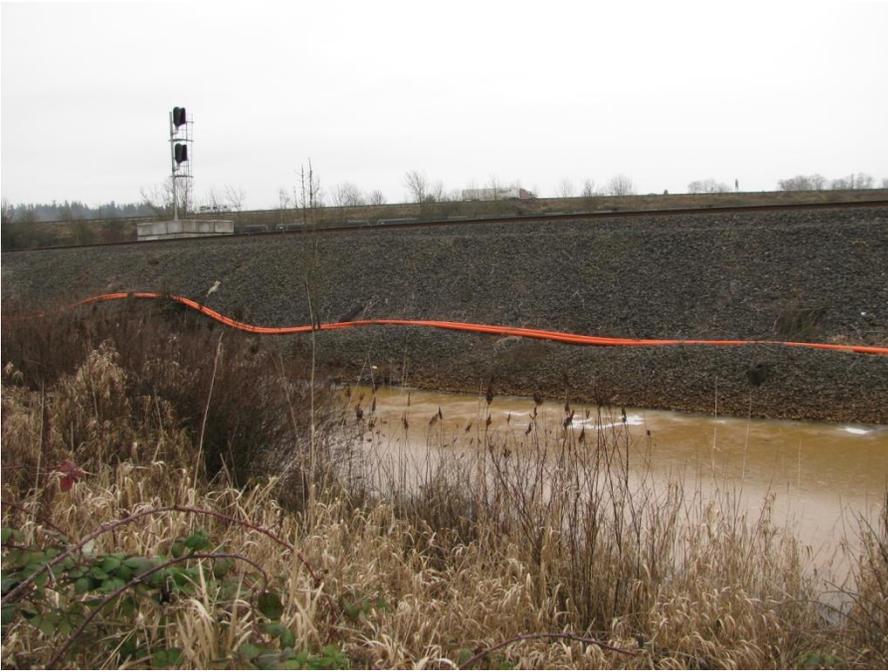
Photo4. Drainage swale to west of landfill showing railroad.

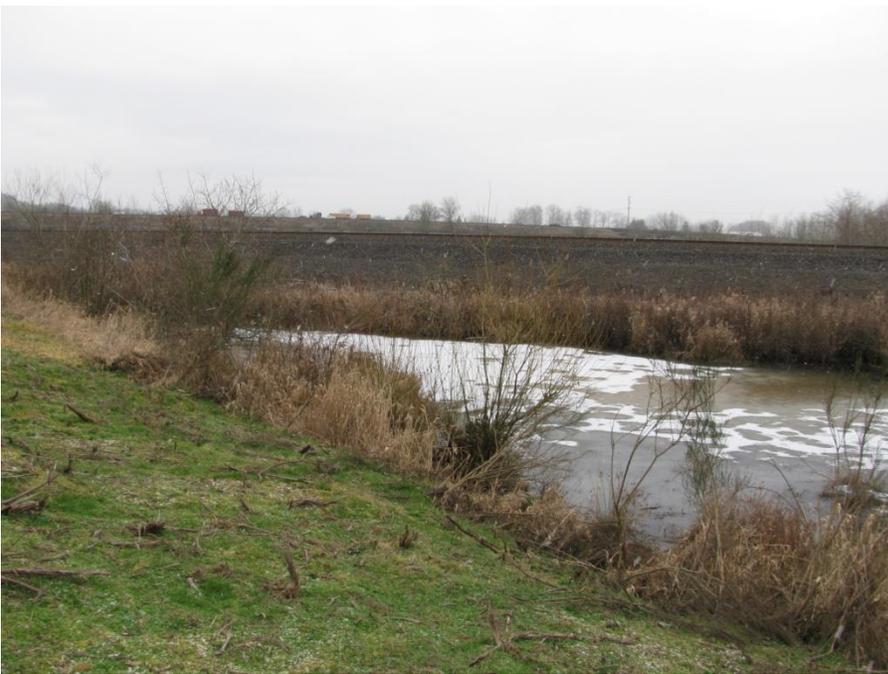
5.	Vegetative Cover	<input checked="" type="checkbox"/> Grass	<input type="checkbox"/> Cover properly established
<input type="checkbox"/> No signs of stress <input type="checkbox"/> Trees/Shrubs (indicate size and locations on a diagram)			
Remarks			
Grass contains lots of moss. Landfill appeared to be brush-cut as numerous brush stumps (Scotch Broom) were observed.

Photo 5. Roots from brush cutting and vegetation remaining at base of landfill side slope.

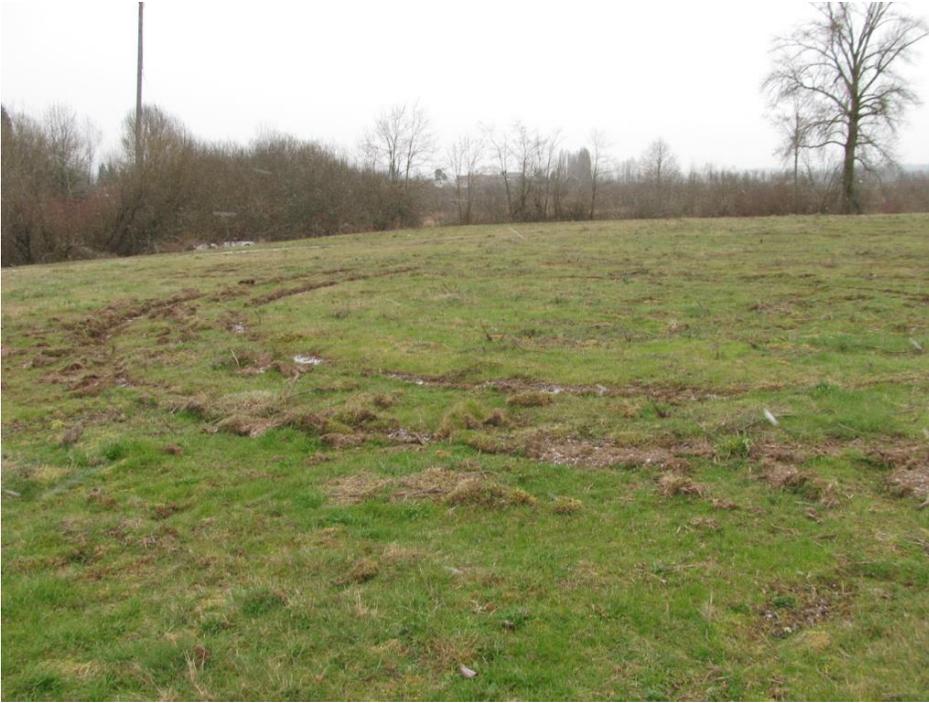
Photo 6. Tire tracks on top of landfill.

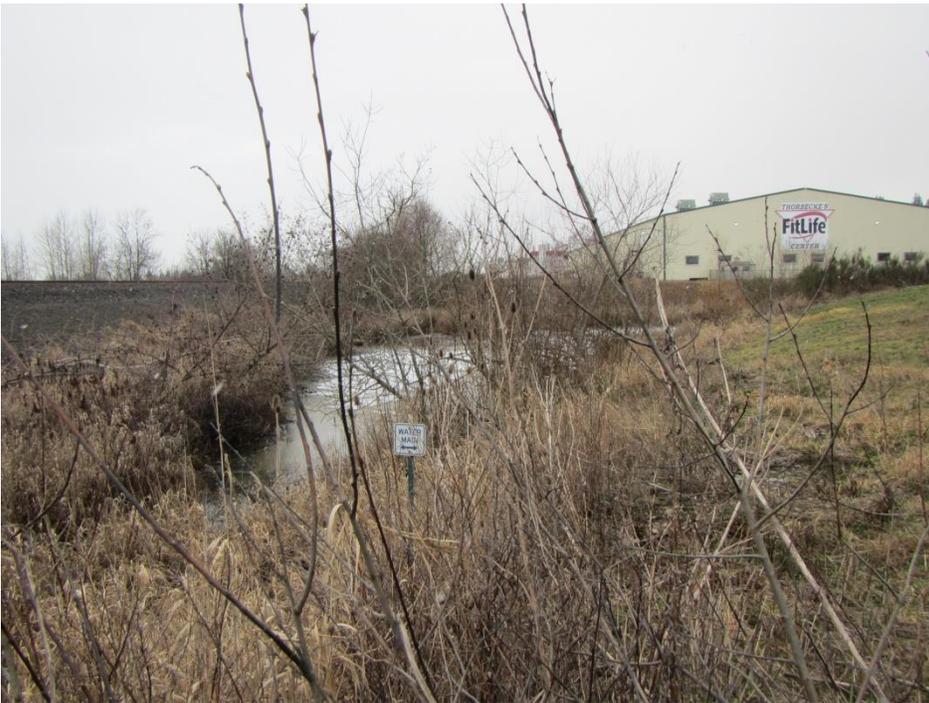
Photo 7. Sign noting location of water main on west edge of landfill.
