Subject: SUBMITTAL OF THE *FINAL FIVE-YEAR REVIEW OF  
CERCLA RESPONSE ACTIONS AT THE NAVAL REACTORS FACILITY*

**Five-Year Review of CERCLA  
Response Actions  
at the  
Naval Reactors Facility**

**February 2012**

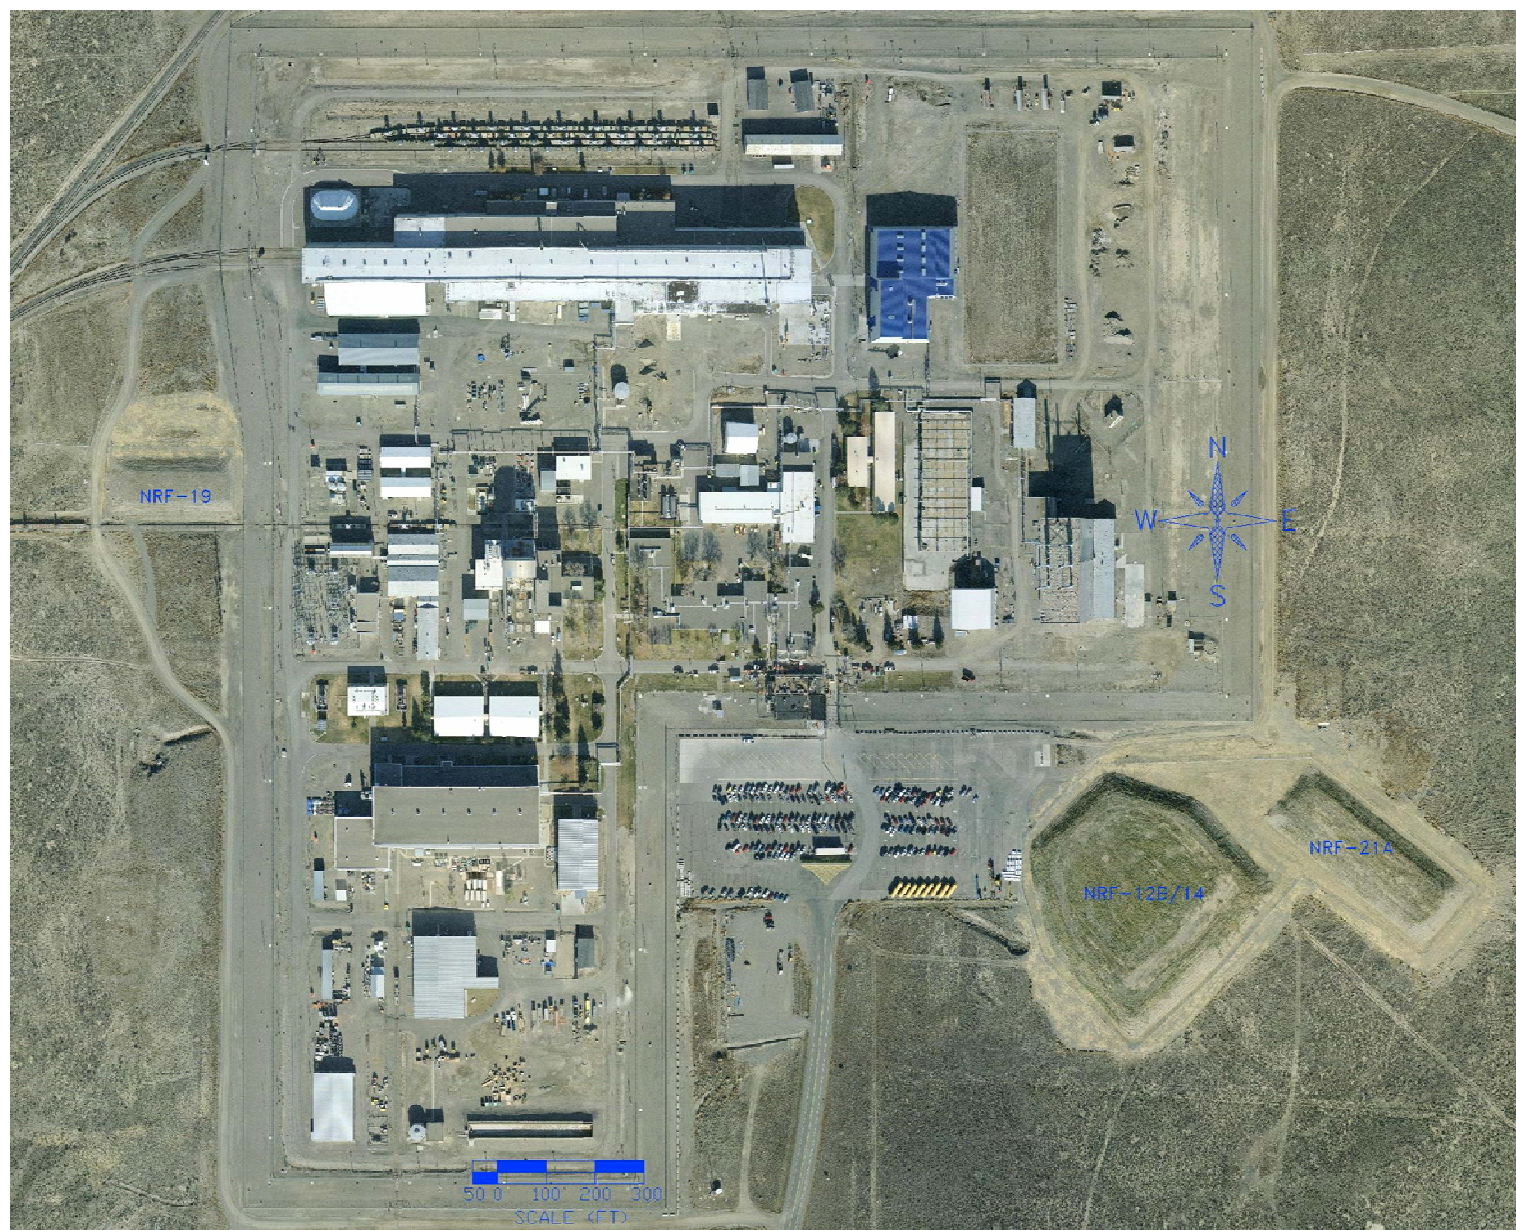
Figure 4-4 NRF-12B/14, NRF-21A, and NRF-19 OU 8-08 Engineered Cover Areas

A six to twelve inch topsoil cover layer was also constructed with soil material designed to support native vegetation, inhibit erosion, and promote drainage by placement of a three to five percent top slope. Soil material for the topsoil layer was loosely placed, with minimum compaction resulting from grading the material to the final surface grade. Construction Quality Assurance (CQA) practices were implemented to ensure construction quality. All CQA test results were within the acceptable limits (BBI, 2006). The general cross-section of the engineered covers is shown in Figure 4-3. The engineered cover top view with finished grade for each of the three areas is shown in Figure 4-4 and Figure 4-5.

4) **p.51, Figure 4-4;** Please add compass.

**6) Figure 4-4, page 51**

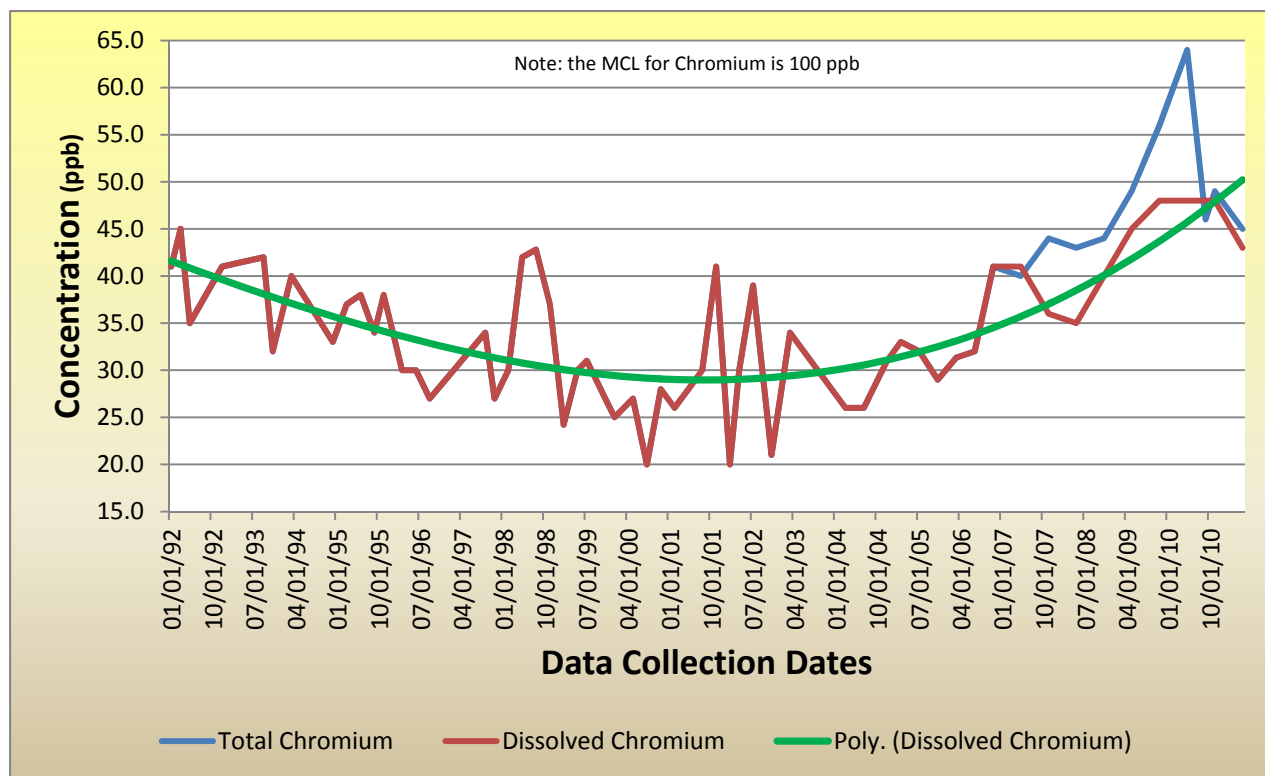
The second refurbishment occurred in 2010. Shortly after the 2004 refurbishment of NRF-6, the concentration of chromium began to rise and hit a maximum in May 2010 as shown in Figure 6-1. During this apparent upward trend in chromium concentrations, NRF began collecting a series of filtered and unfiltered samples to determine if suspended solids entrained in the water samples could account for the apparent increase. The evidence supporting corrosion or siltation as a cause for the observation was inconclusive. In July 2010, the USGS pulled the pump, motor, riser pipe and measuring line from the well again to see if a cause for the trend could be determined. An inspection revealed that all well components were generally in good shape. Although the pump and motor were covered with a thin film of sediment or precipitate, the underlying metal was not corroded. The ends of the stainless steel riser pipe, measuring line sections, and the couplers holding them together were in good shape. Although the pump and motor were generally in good condition, they were replaced.

**Figure 6-1 Comparison of Dissolved and Total Chromium in NRF-6**

The inside of the well was inspected using a video camera. The camera was inserted into the well via a wire-line to a depth of 414 feet, which is three feet above its original completion depth

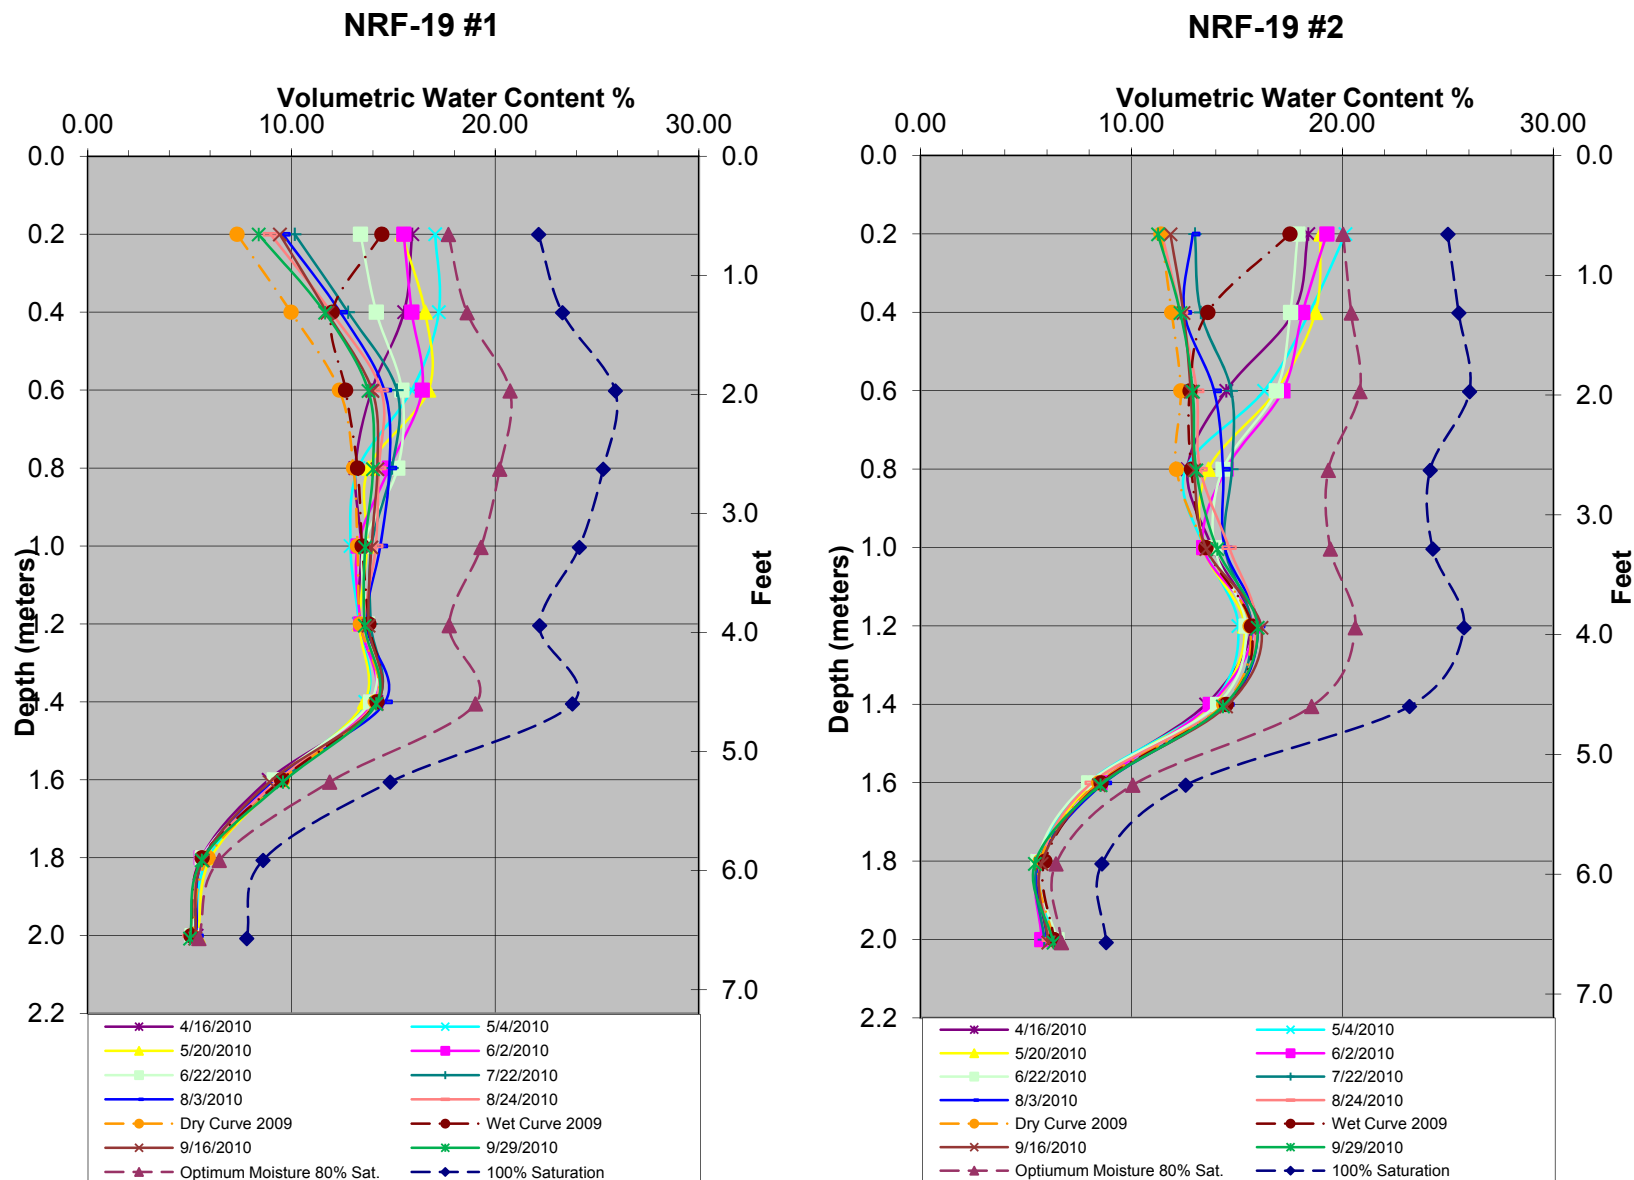
For the 2006-2010 period, soil moisture measurements were typically taken in April through October. The soil moisture data obtained during the 2006-2010 period indicate that 2006 and 2010 had the highest near surface water content. In addition, 2006, 2009, and 2010 were above normal precipitation. Water content variations (caused by percolating water through the cover from precipitation and evapotranspiration) were rapidly dampened with depth as evidenced in the graphical representation of the data. The percolating water or wetting front (represented by curve separation between April and October at shallow depths) for any given year during this period, did not reach the engineered covers' subsurface layer (as represented by relatively no separation in the curves at deeper depths, typically below 3.5 feet) and, therefore, did not migrate into the contaminant layer. Most of the soil moisture stored within the cover, from the seasonal precipitation, was removed from the soil via evapotranspiration. The graphical representation of the latest soil moisture data from 2010 are presented in Figure 6-12. Data from previous years have been documented in the annual ICMR. Data in future years will further refine any trends regarding moisture penetration.

Figure 6-12 Soil Moisture Curves for OU 8-08 Engineered Cover Sites -2010

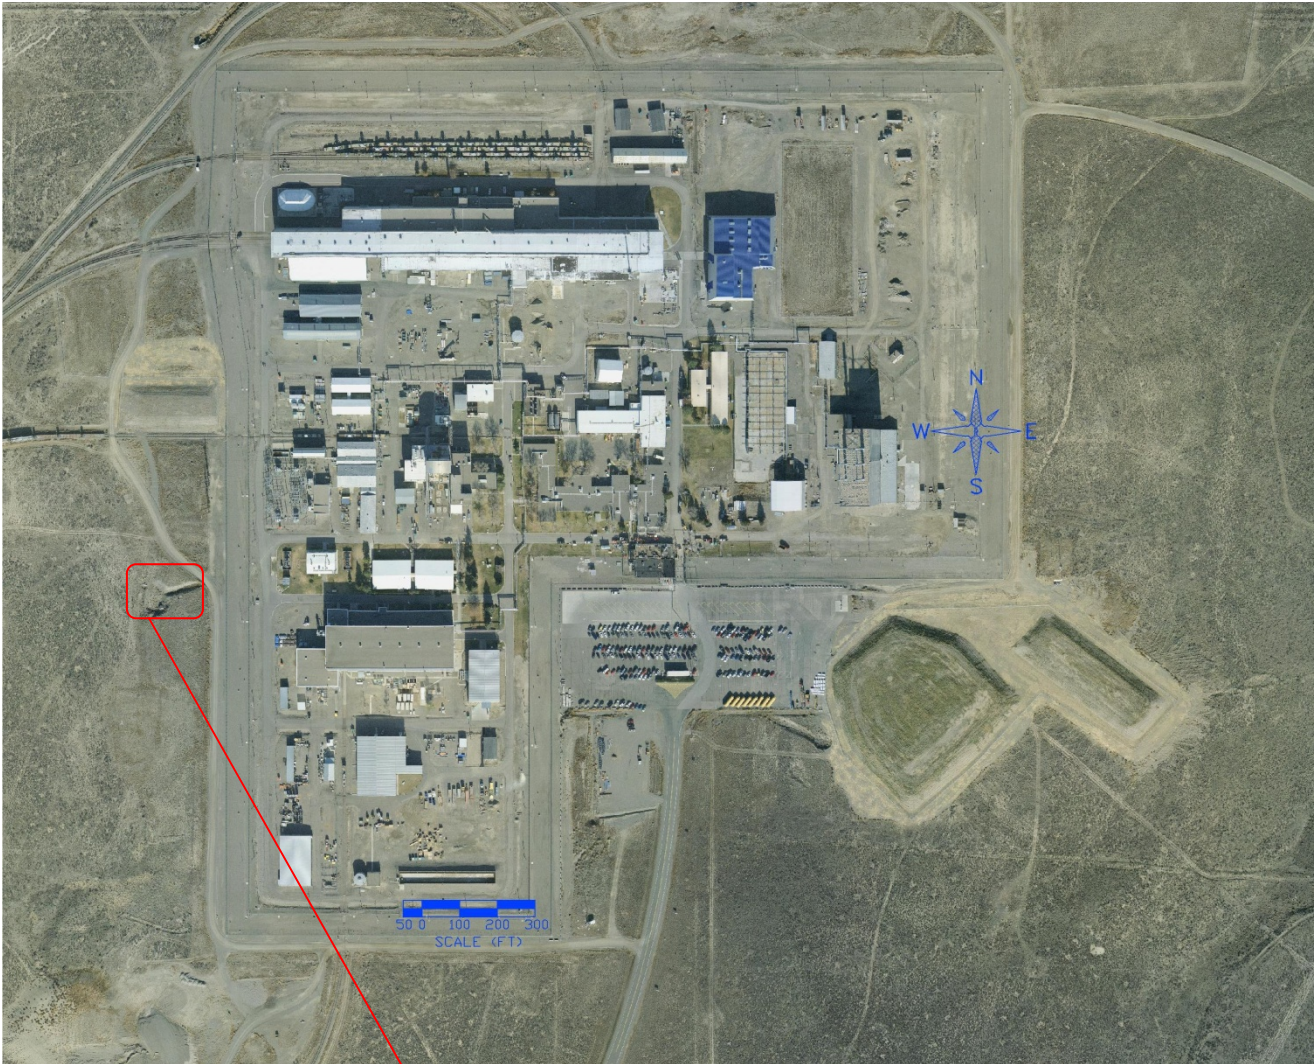
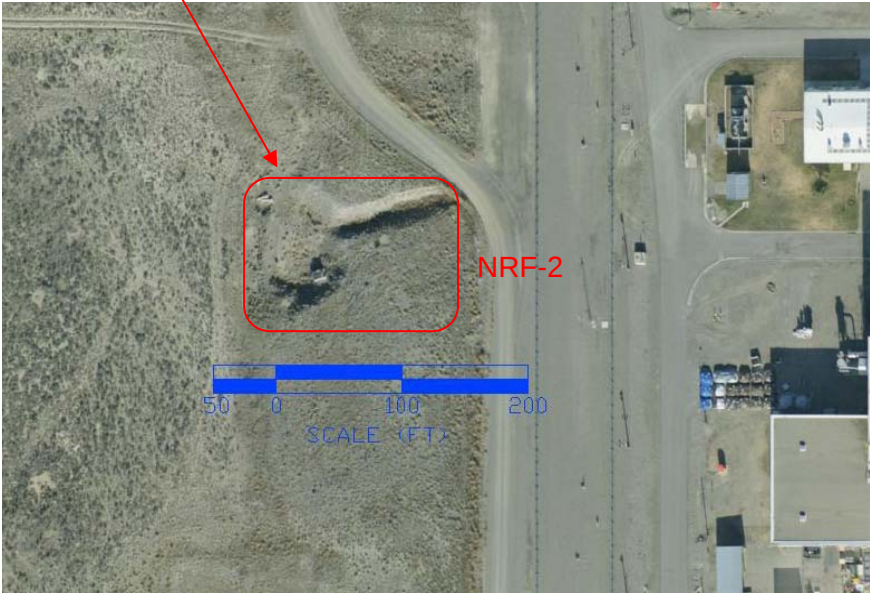
Figure A-1 NRF-2 Location

The maximum sample result (4.7 pCi/g Cs-137) from the 1992 sampling event was below the remediation goal for the 100 year residential scenario provided in the ROD (16.7 pCi/g Cs-137) but above a level that would allow the area to be released for unrestricted use. The 4.7 pCi/g Cs-137 in 1992 has decayed to a present day value of 3 pCi/g. This decay corrected value is below the revised EPA preliminary remediation goal of 6.15 pCi/g for the release of a site for unrestricted use (current residential scenario). The Co-60 activity detected at NRF-2 would have decayed to less than one pCi/g (0.81 pCi/g), which is also below the EPA preliminary remediation goal of 3.9 pCi/g for unrestricted use (based on the 2010 radionuclides table at the [epa-prgs.ornl.gov](http://epa-prgs.ornl.gov) website).

Although arsenic and chromium were detected above background levels they were not considered contaminants of concern after the risk assessment was performed in the NRF comprehensive remedial investigation and feasibility study (RI/FS). Based on the evaluation presented above, it appears that institutional controls are no longer required at NRF-2.

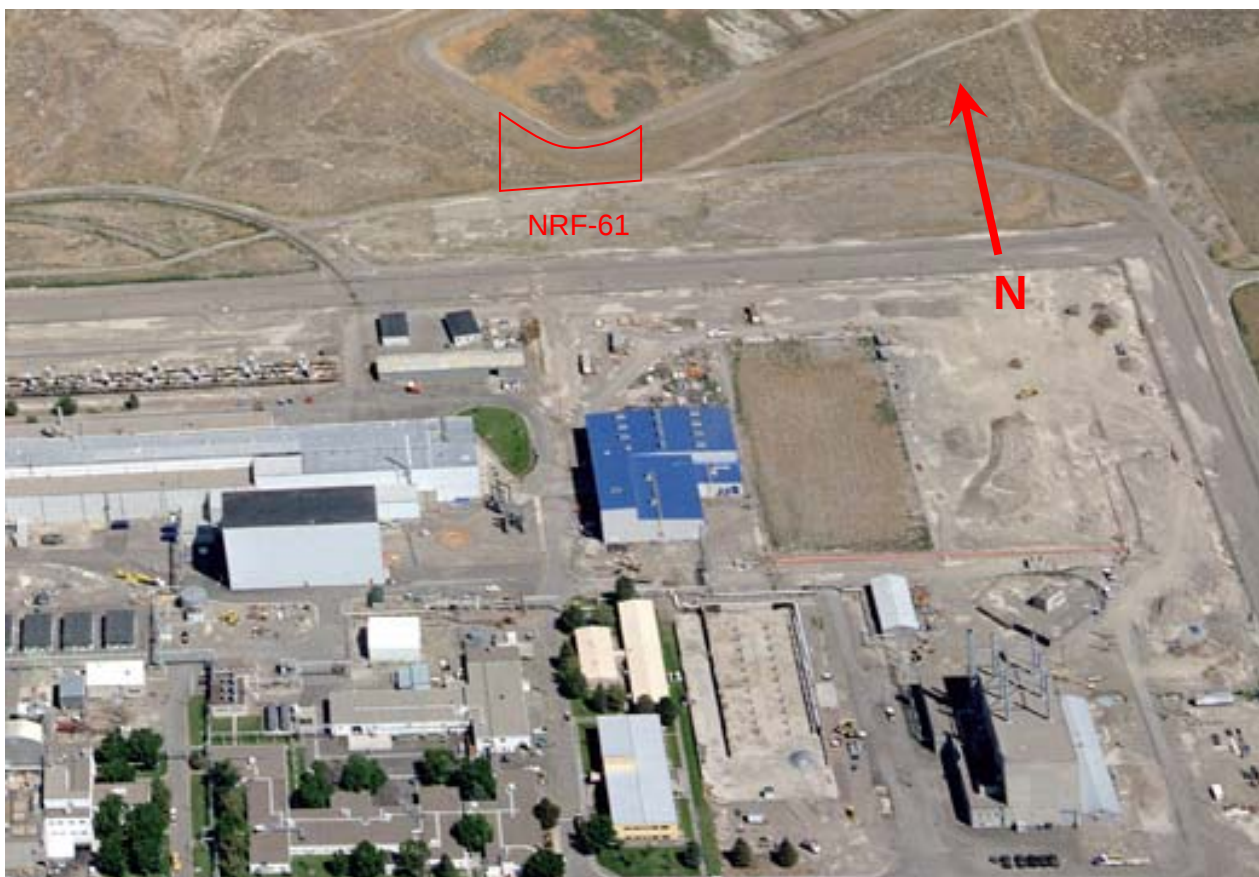
Figure A-3 NRF-61 under Present Conditions
