# LOWER DUWAMISH WATERWAY SLIP 4 EARLY ACTION AREA

## Removal Action Completion Report

July 26, 2012

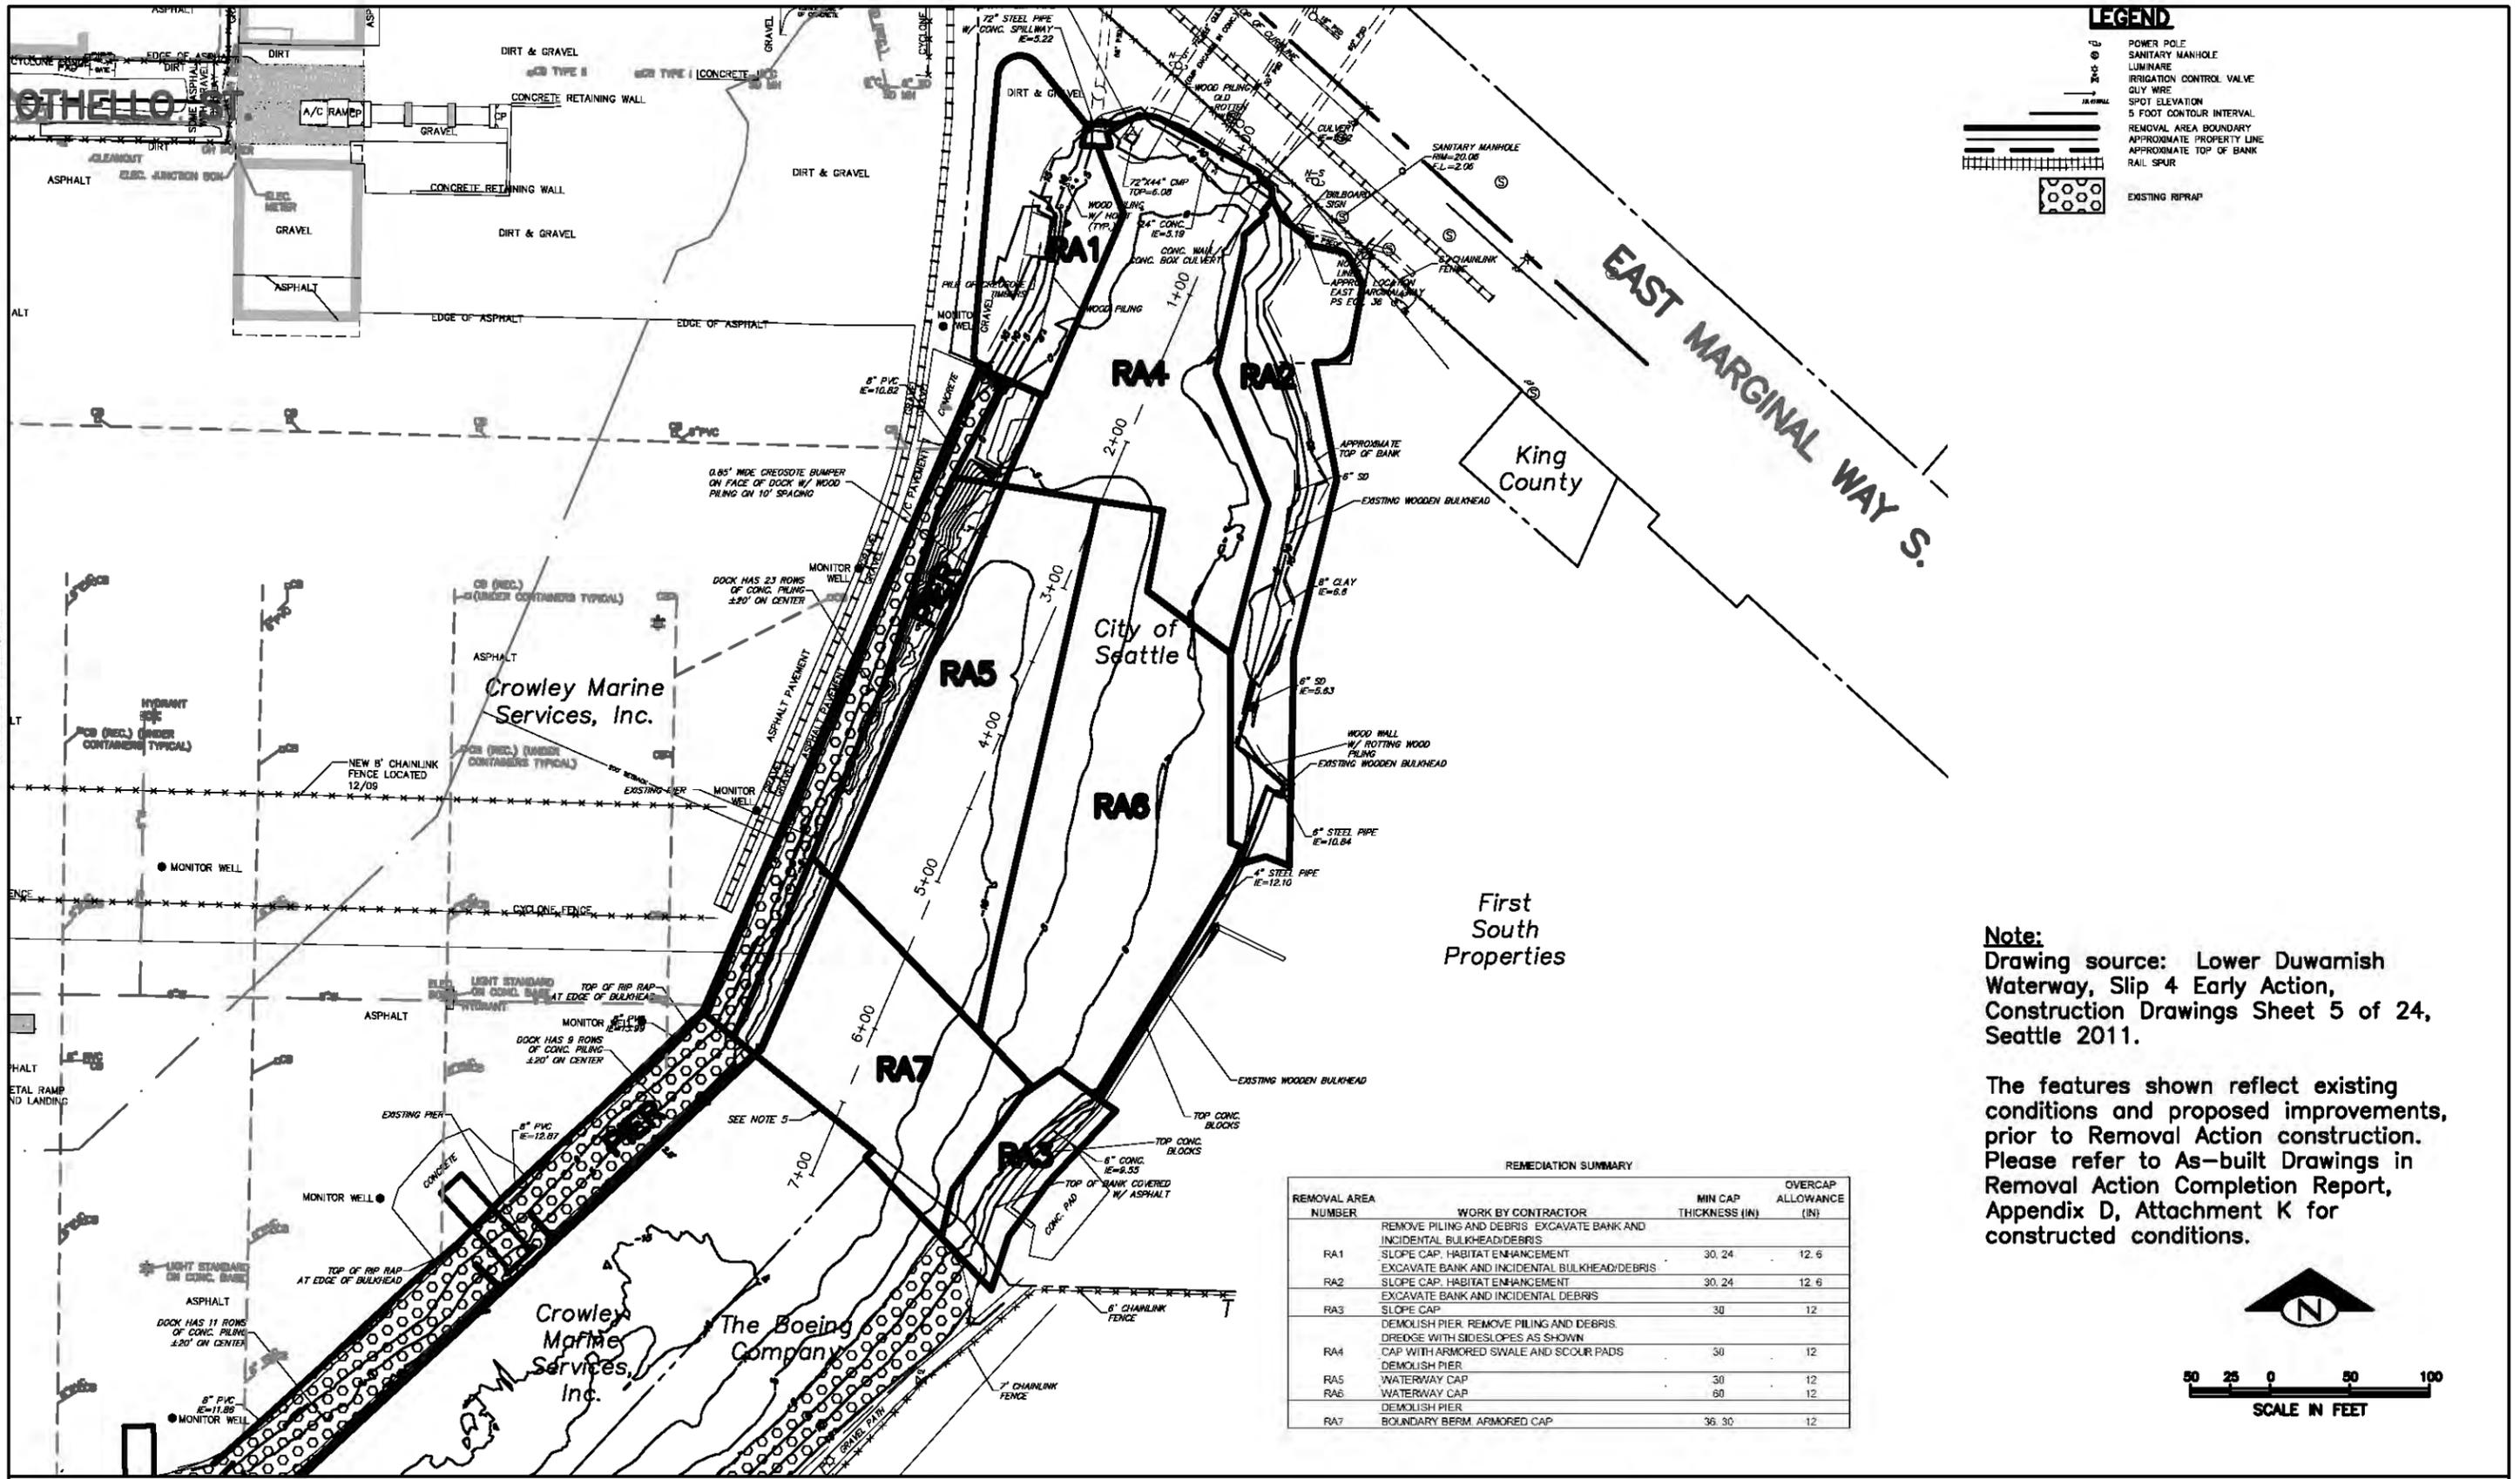
**Figure 1-3.**  
 Removal Areas  
 Slip 4 Removal Action

The features shown reflect existing conditions and proposed improvements, prior to Removal Action construction. Please refer to As-built Drawings in Removal Action Completion Report, Appendix D, Attachment K for constructed conditions.

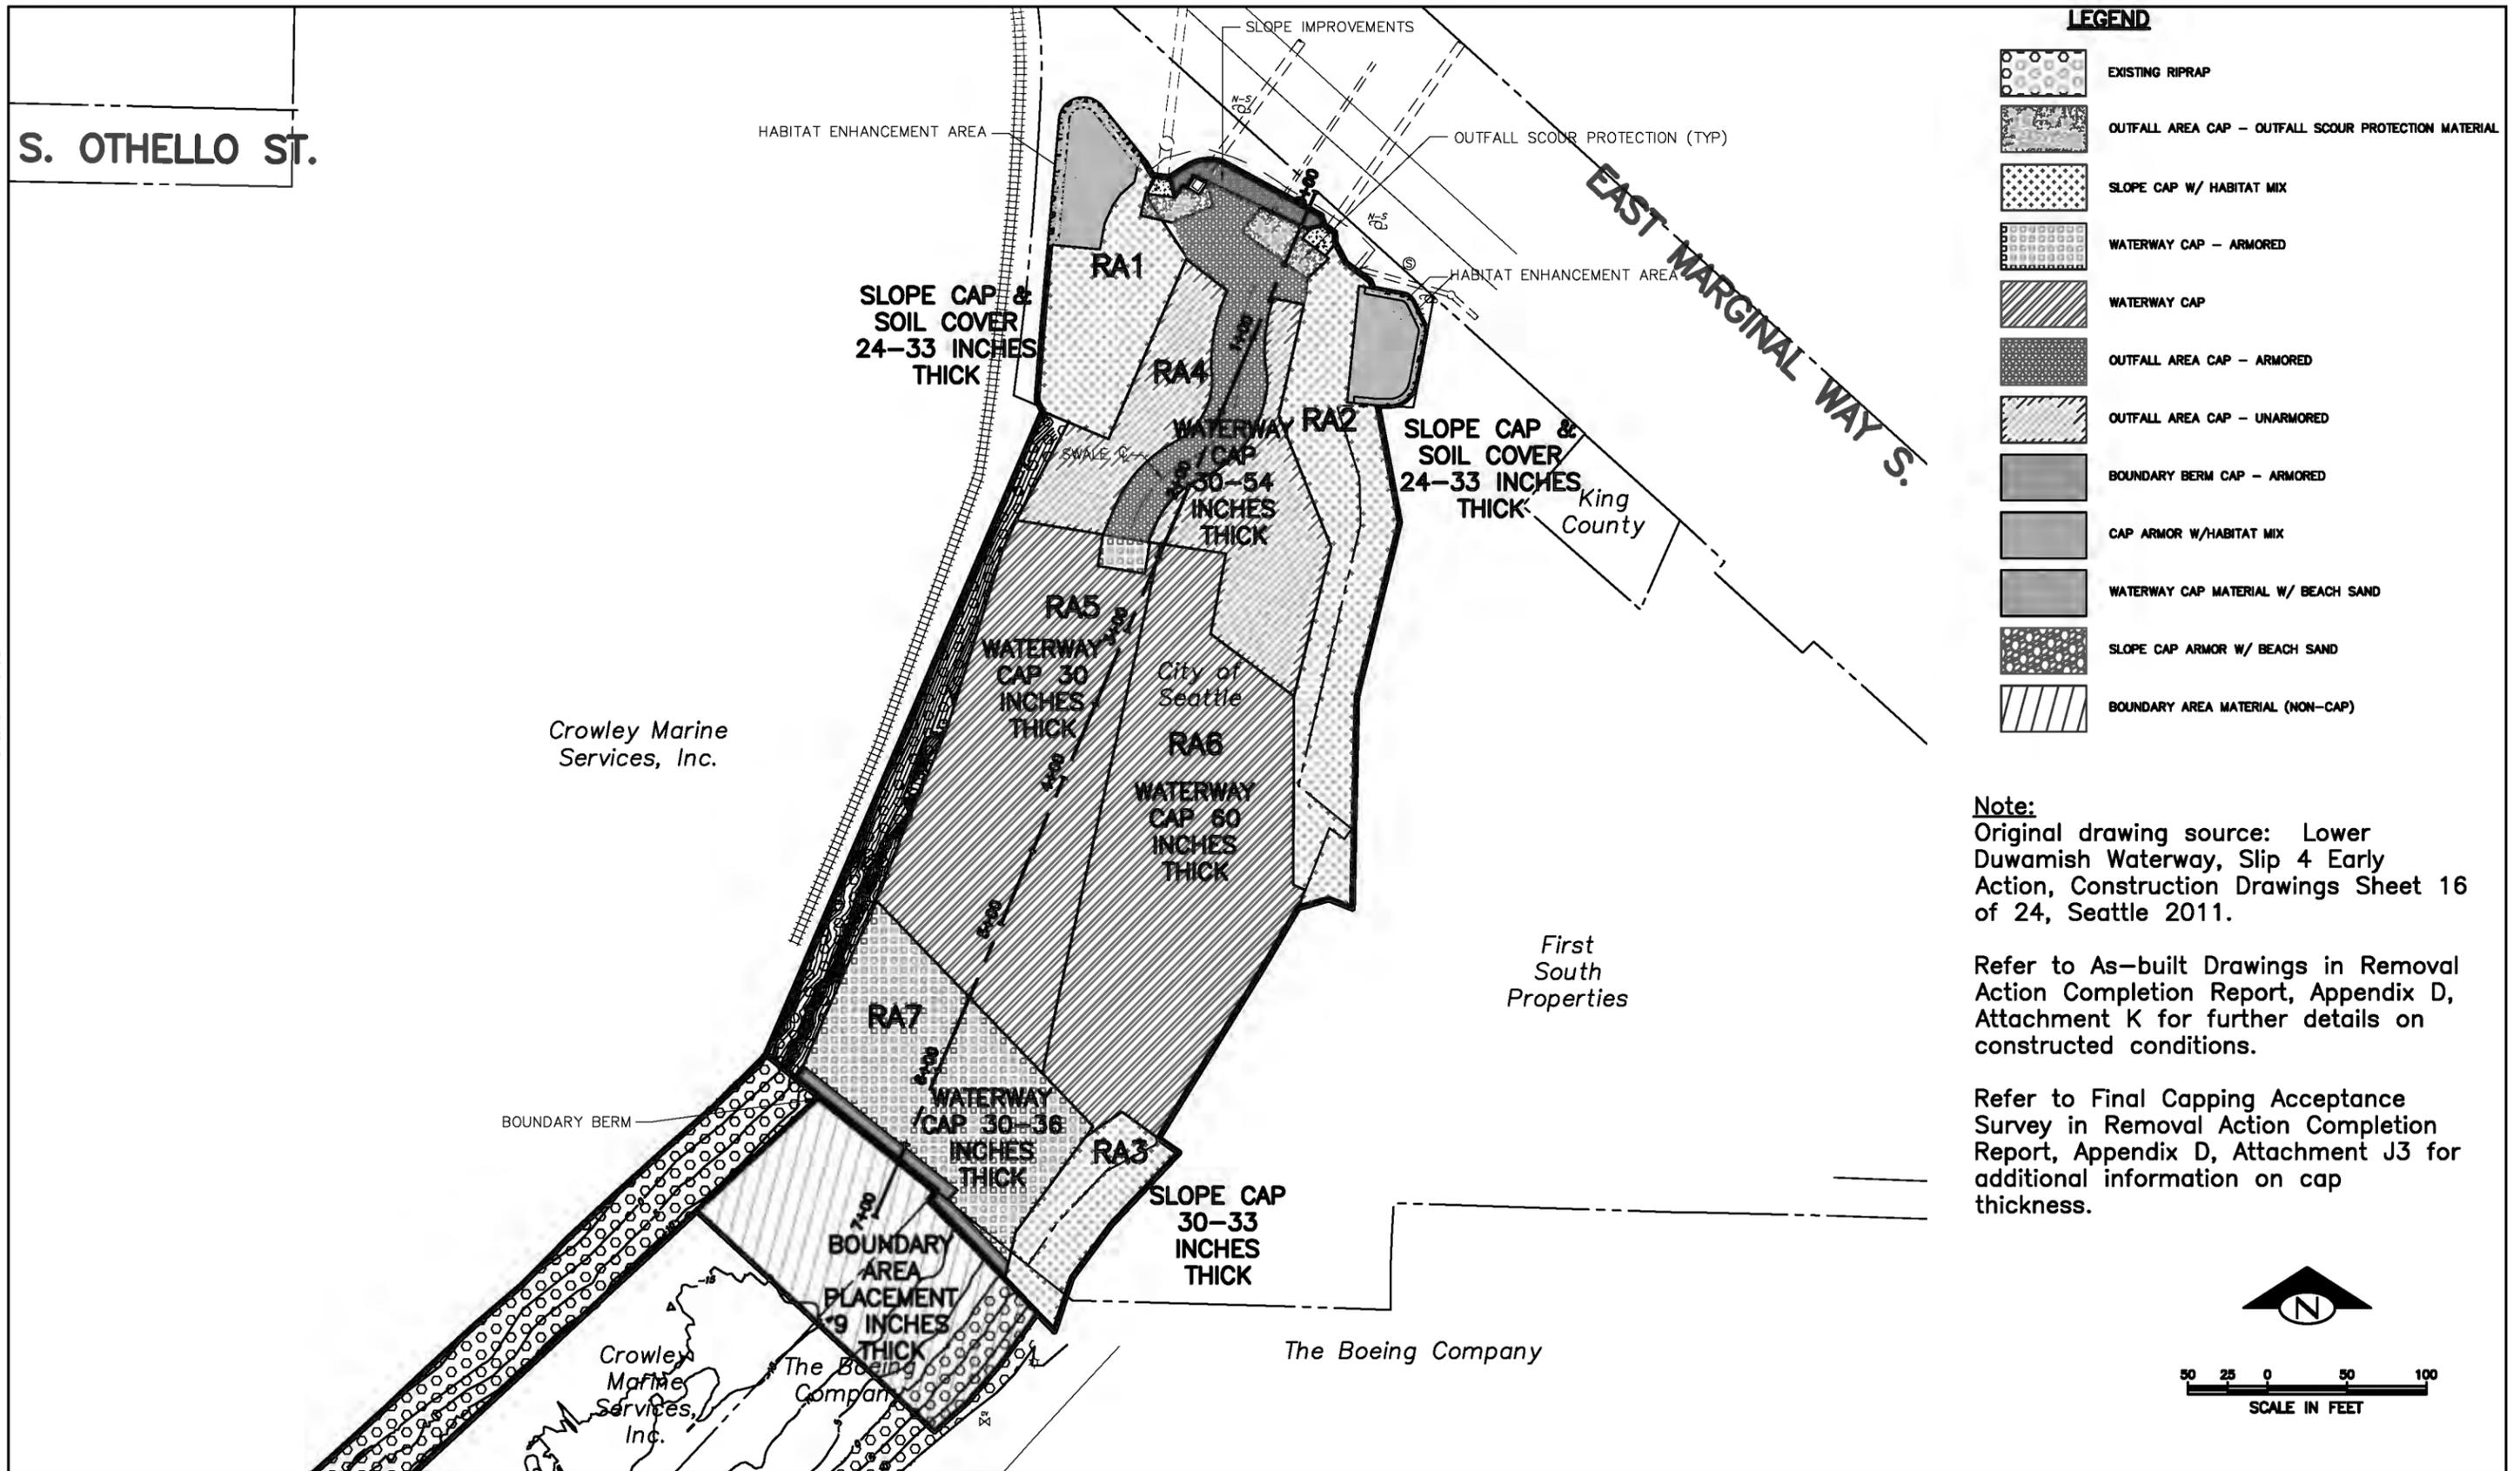
**Figure 3-2.**  
Cap Acceptance Survey Analysis  
Slip 4 Removal Action

Areas depicted in green are within the tolerance between minimum cap thickness and 1-foot allowable over-placement.

Areas depicted in light blue, dark blue, and purple have thicknesses in excess of the 1-foot allowable pay quantity for over-placement.

Areas depicted in yellow, orange, and red have thicknesses less than minimum design. These areas are described in Section 3.15 of the Removal Action Completion Report.

The City team reviewed the cap acceptance survey and noted the following:

- Additional cap material placement was required in Removal Area 7.
- Small areas of the boundary berm in Removal Area 7 and toe berm in Removal Area 6 were approximately 1 ft low. This may have been attributable to consolidation of underlying sediments and differences in survey return signals from the comparatively rough cap armor. Based on consideration of the progress surveys, bucket plots, and daily capping reports, the City recommended approval of the areas as having met design requirements.

- There was a linear area along the boundary of Removal Area 5 and 6, which was approximately 1 ft low. This reflected the transition from 30-inch to 60-inch thick capping sections and indicated that the cap material had leveled out along a natural angle of repose. This was considered normal and the City recommended approval of the area as having met design requirements.

- A 5- by 5-ft area at the south corner of Removal Area 2 was lower than design. This reflected a cut remnant of the timber bulkhead where the cap transitioned to the bulkhead as referenced on sheet 16, note 14 of the contract drawings. The City recommended approval of this area as having met design requirements.

- A 20- by 20-ft area at the northern end of Removal Area 5, adjacent to the swale outlet, was approximately 1 ft low. Review of the pre-construction and post-dredge/excavation surveys indicated that there was a small mound of existing material outside the dredge prism. The existing mound resulted in a low spot in the uniformly graded cap surface. The area was not accessible for placement of additional material from shore. Furthermore, it was determined that mobilizing the derrick barge over the completed waterway cap would have posed a disproportionate risk of cap damage due to spudding, grounding, and prop scour. Therefore, the City recommended approval of the area with no corrections made.

- Two portions of the swale and outfall area cap in Removal Area 4 and a 60- by 40-ft transitional wedge between Removal Area 4 and Removal Area 6 were lower than design. These areas were low because GCC neglected to base its target capping surface data upon the design elevations shown in the contract drawings. However, in both of these locations, the removal design intent had been met based on minimum cap thickness, and hydraulic functionality had been met based on the constructed gradient of the swale. The City recommended approval of the cap in these areas with no corrections made.

- When comparing the cap acceptance survey to target design grades, various, small, fringe areas on steep slopes and near outfalls appeared to be lower than design. These areas were considered to be artifacts due to inter-survey errors on slopes or the presence of the outfall structures themselves. These fringe areas were visually observable at low tide and appeared to be sufficient. The City recommended approval of these areas as having met design requirements.

- A 10- by 5-ft area on the west side of Removal Area 7 was approximately 1 ft lower than design. This was attributed to an error in the pre-cap placement hydrographic survey data obtained adjacent to the pier. GCC submitted Request for Information (RFI)-01014 to explain that the target design grade under the former pier was not reflective of nominal cap thickness over the actual existing grade. The City concurred with GCC's findings and recommended approval of the cap in this area based on the revised design surface.

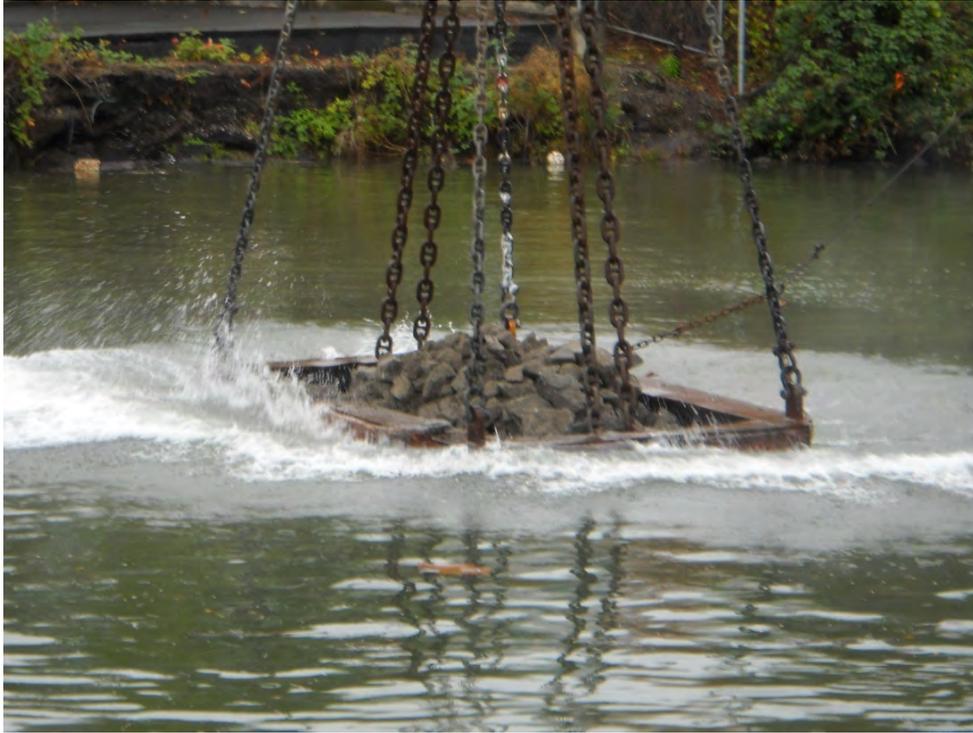
Photograph 3-1. Placement of Boundary Berm with "Bombay Box" (October 3, 2011)

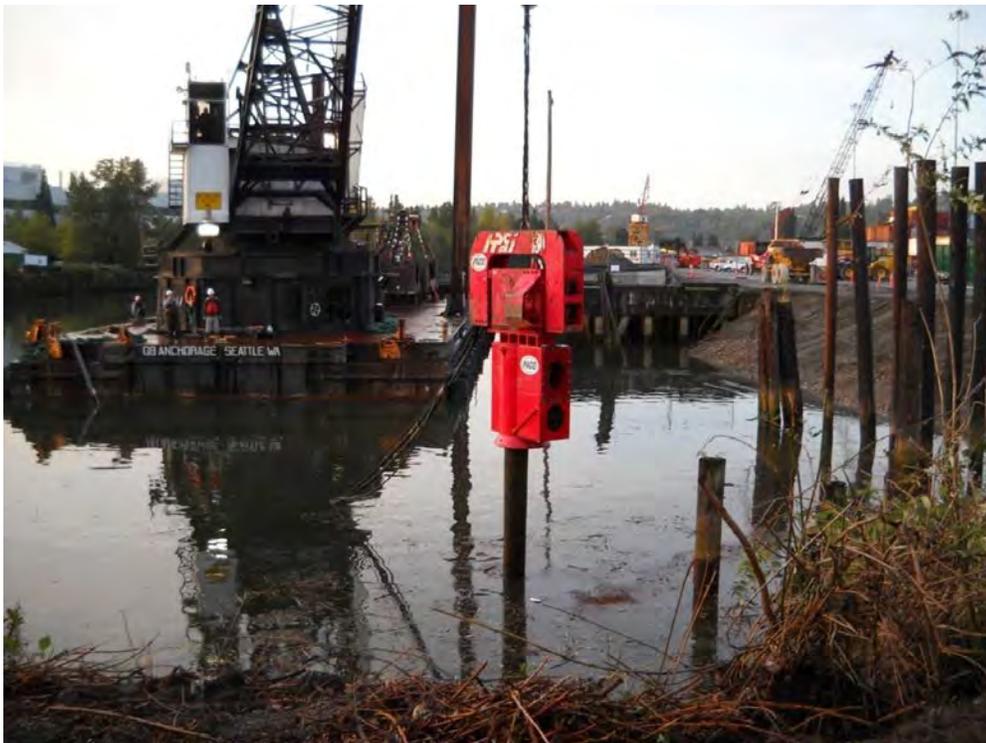
Photograph 3-2. Pile Removal with Vibratory Hammer (October 12, 2011)

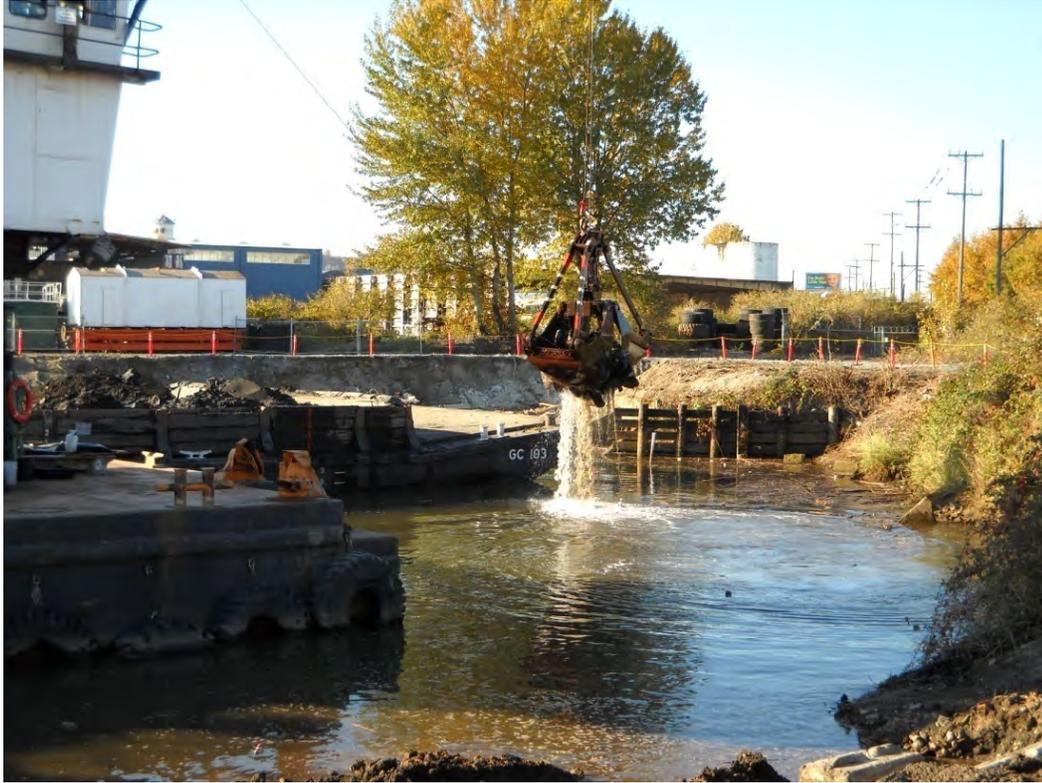
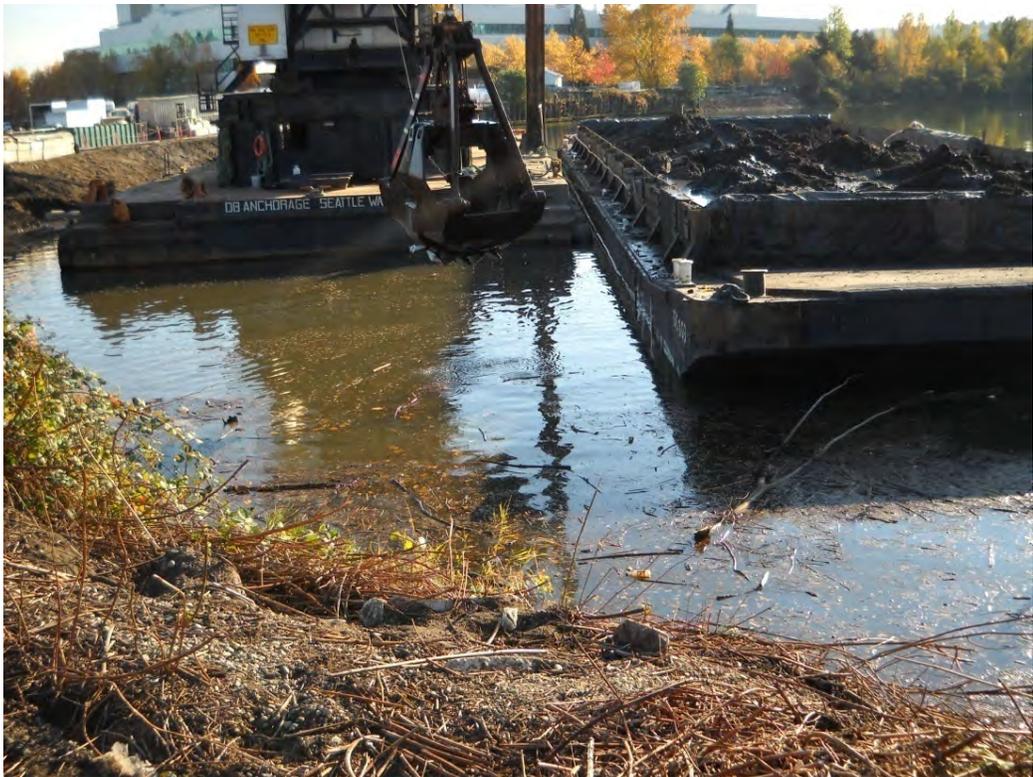
Photograph 3-3. Dredging of Sediment (November 10, 2011)

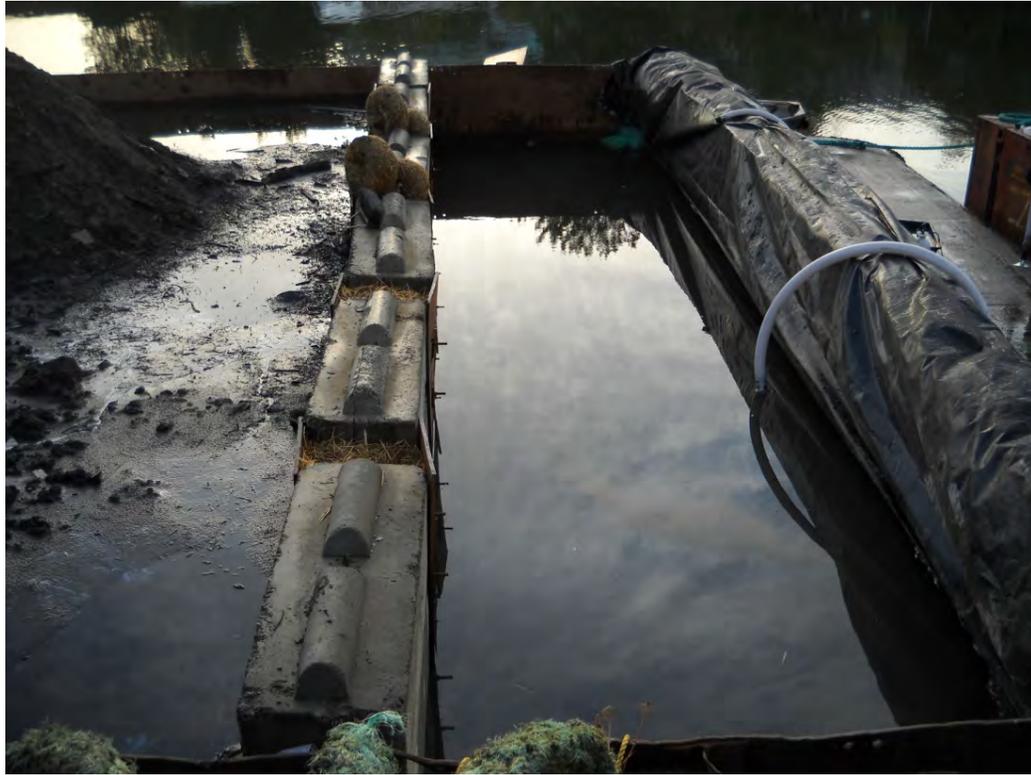
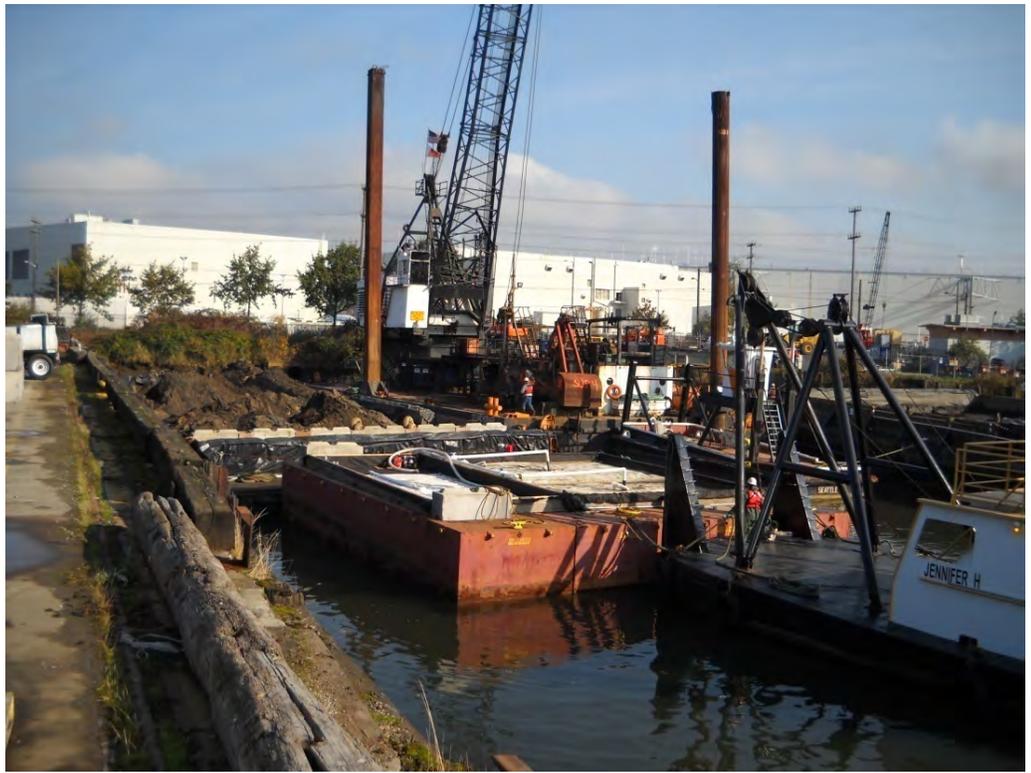
Photograph 3-4. Barge Dewatering (*top*: October 12, 2011; *bottom*: October 27, 2011)

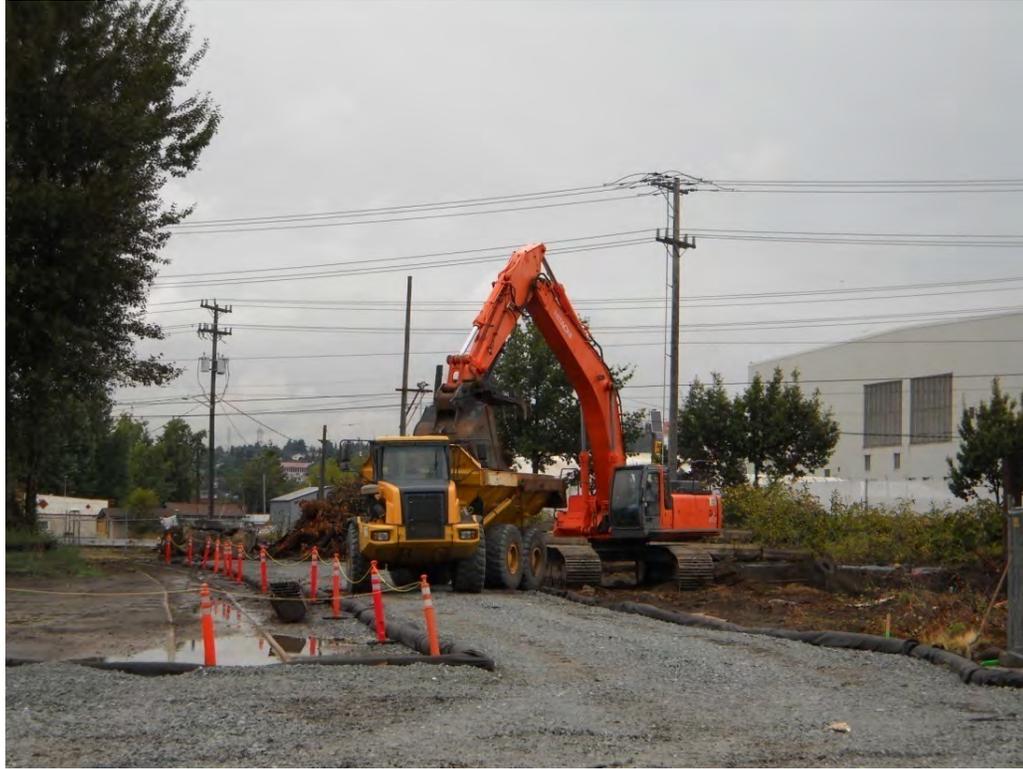
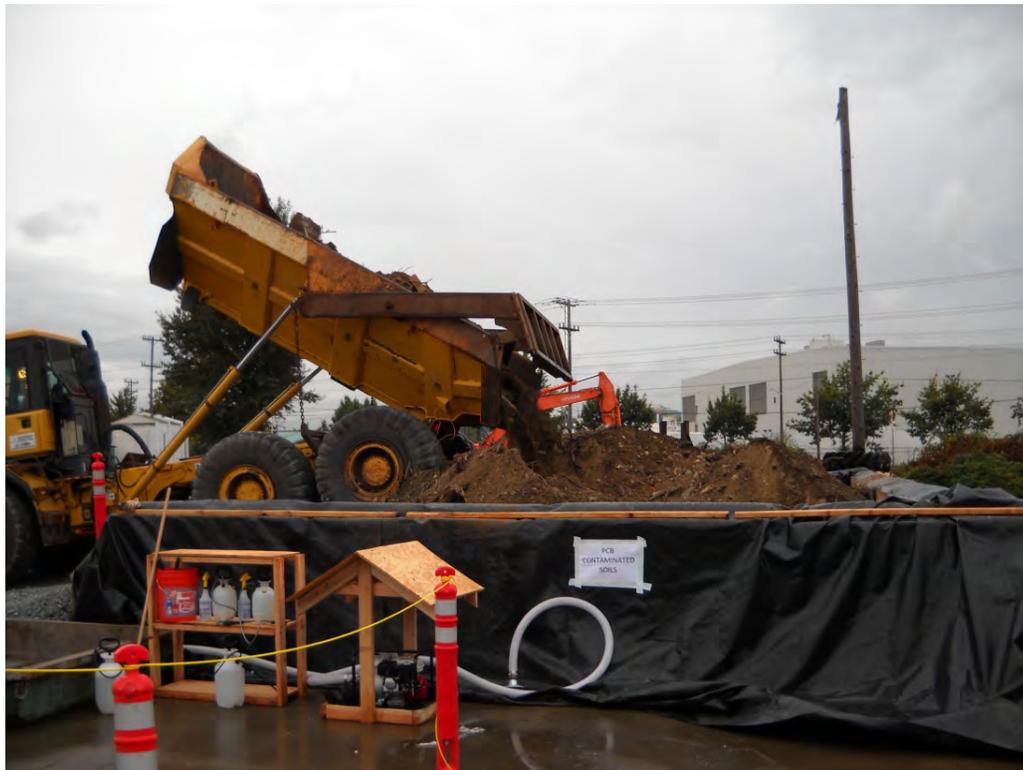
Photograph 3-5. Bank Excavation (October 5, 2011)

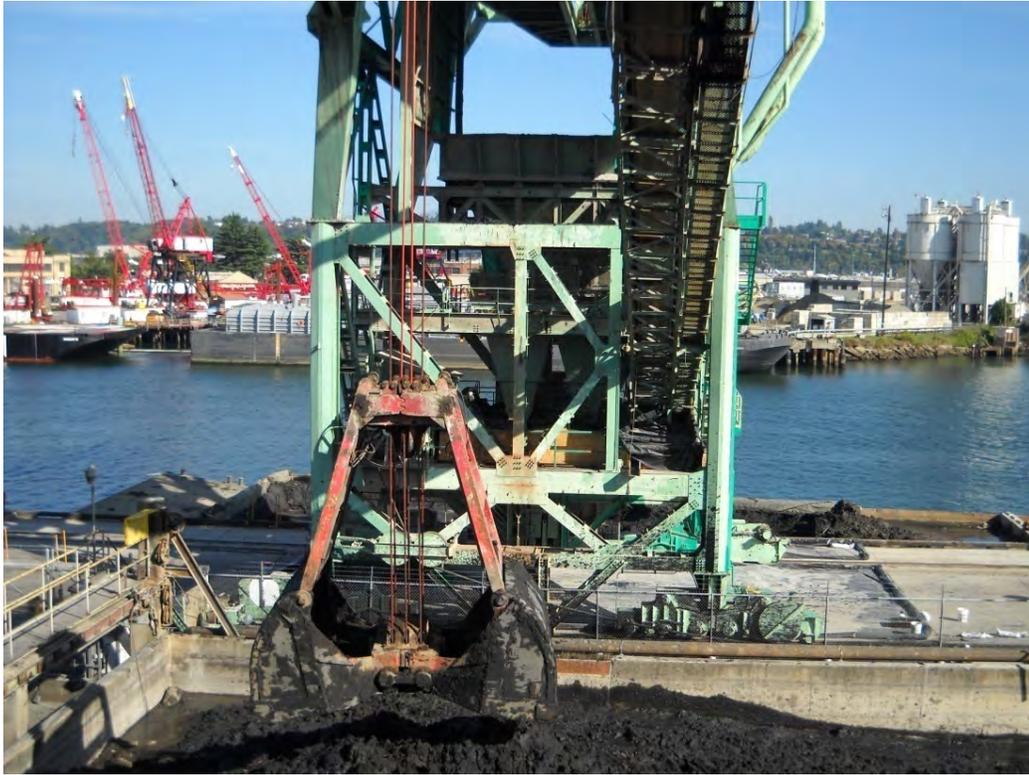
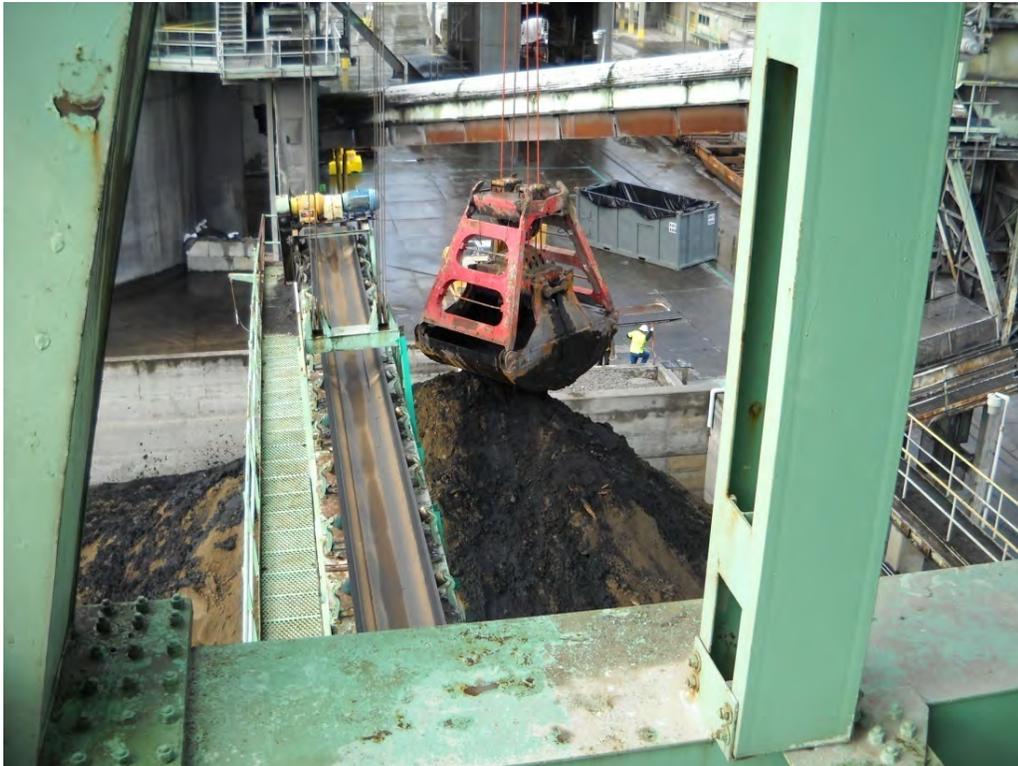
Photograph 3-6. Transloading from Barge to Vault (*top*: October 17, 2011; *bottom*: October 7, 2011)

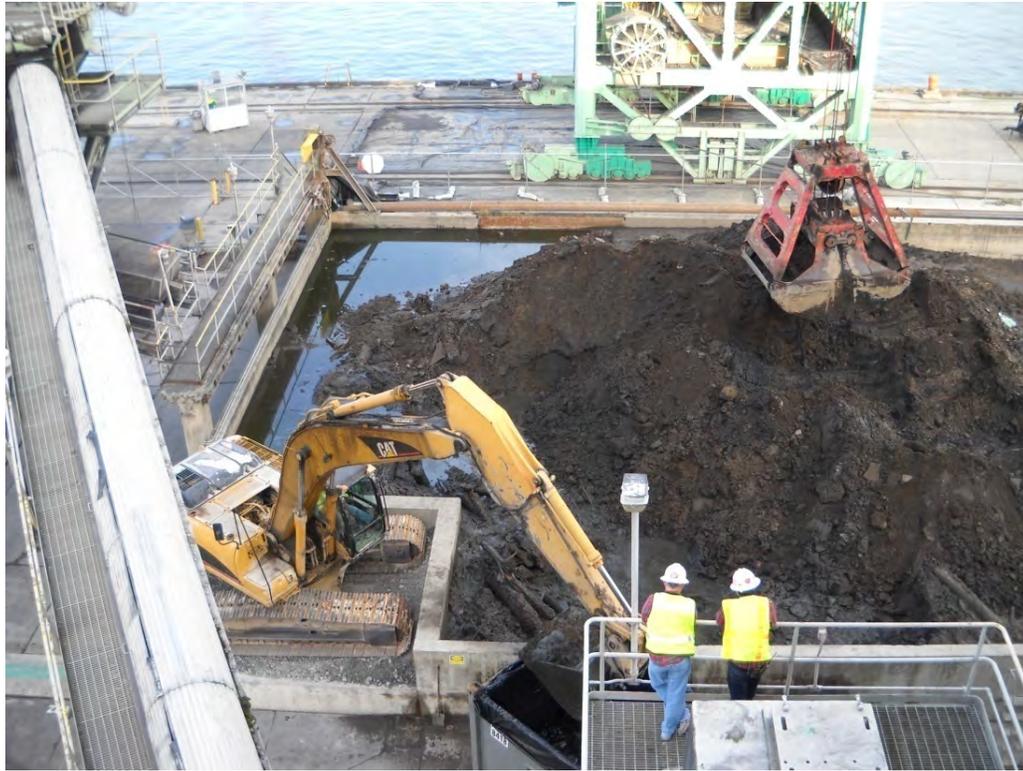
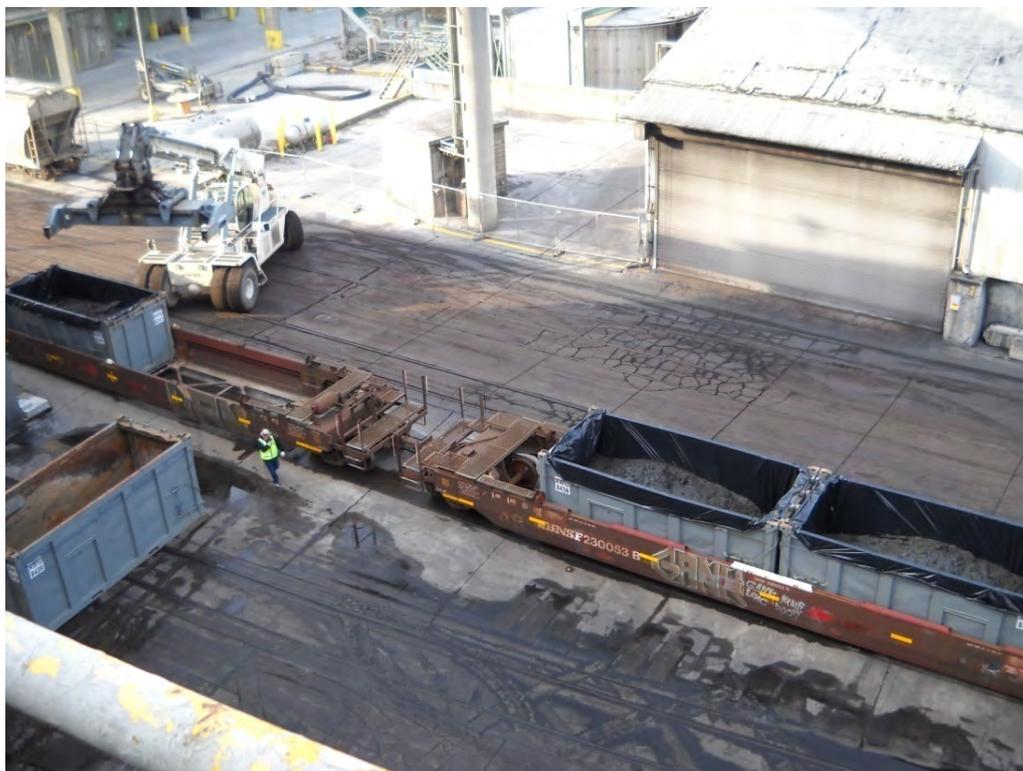
Photograph 3-7. Transloading from Vault to Containers (November 9, 2011)

Based on early observations of rail container loading, there were initial concerns regarding tears that formed at locations where the liners were affixed to the containers. These were first observed on October 14, 2011, at the tie wires near the top of each container. Photo documentation of the containers arriving at Rabanco indicated that the tears had not worsened and had not been compromised by material movement during transport. Nevertheless, Lafarge refined the liner installation process to correct the problem. Revisions to the transloading plan and standard operating procedures on liner installation and liner tears were submitted in Addendum 1 to the RAWP on November 1, 2011.

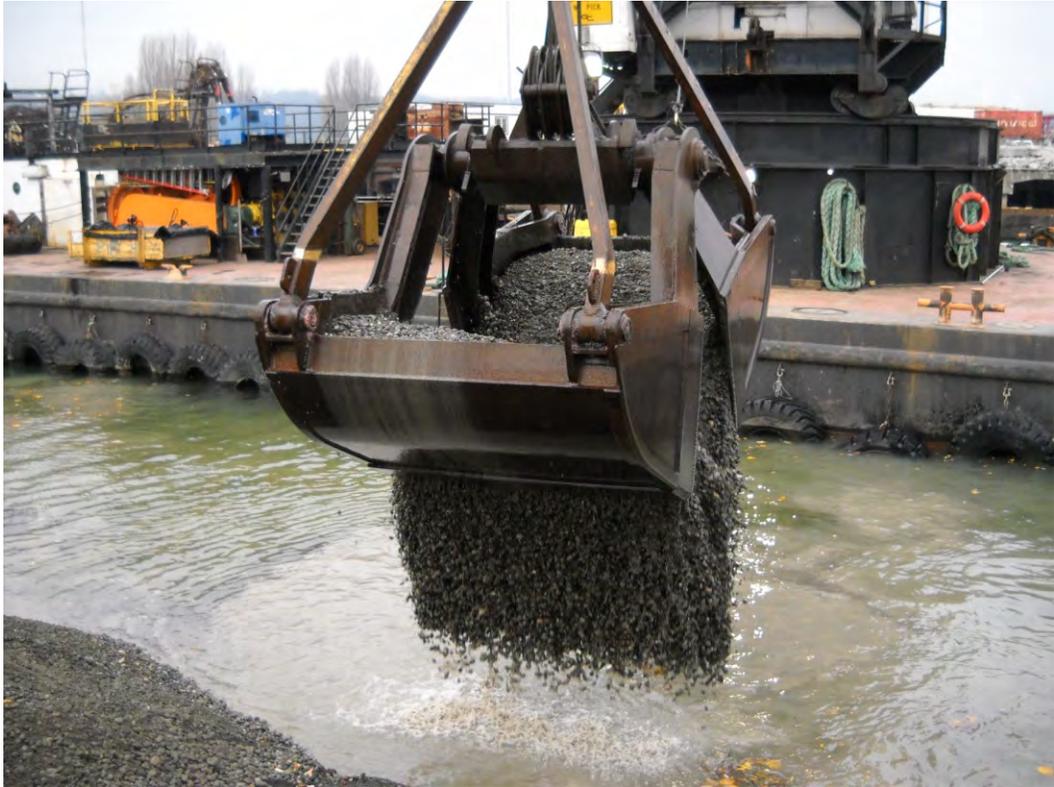
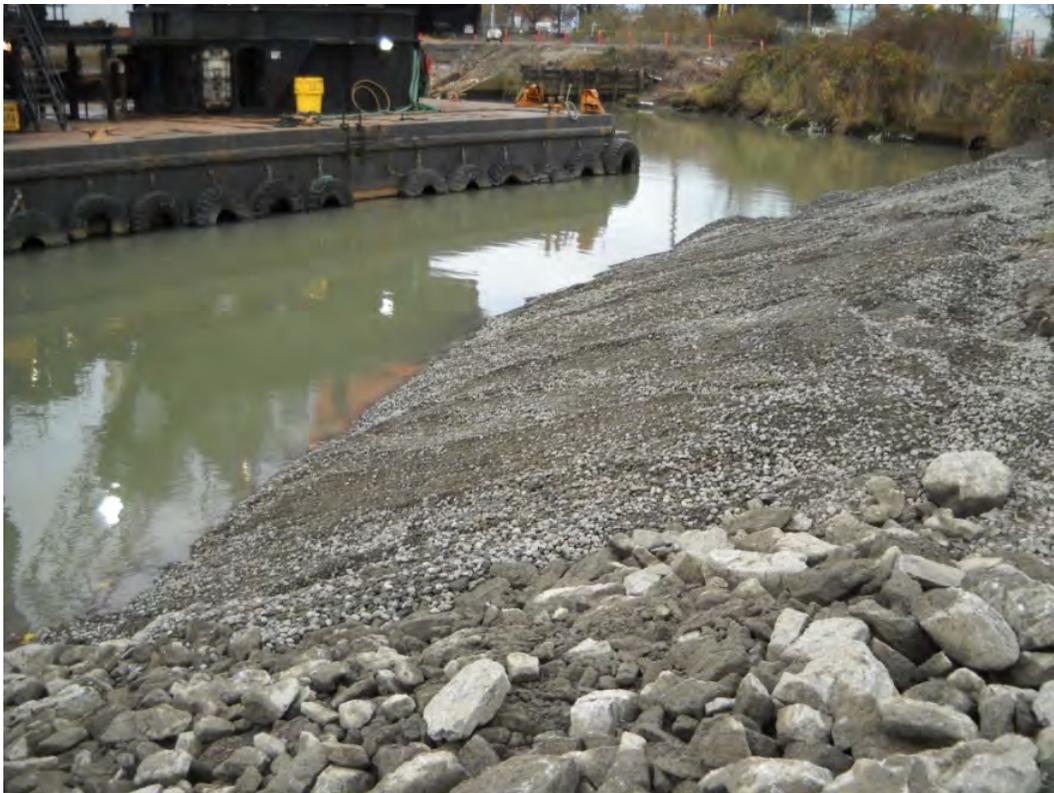
Photograph 3-8. Bank Capping—Filter Material (*top*: December 6, 2011;  
*bottom*: December 8, 2011)

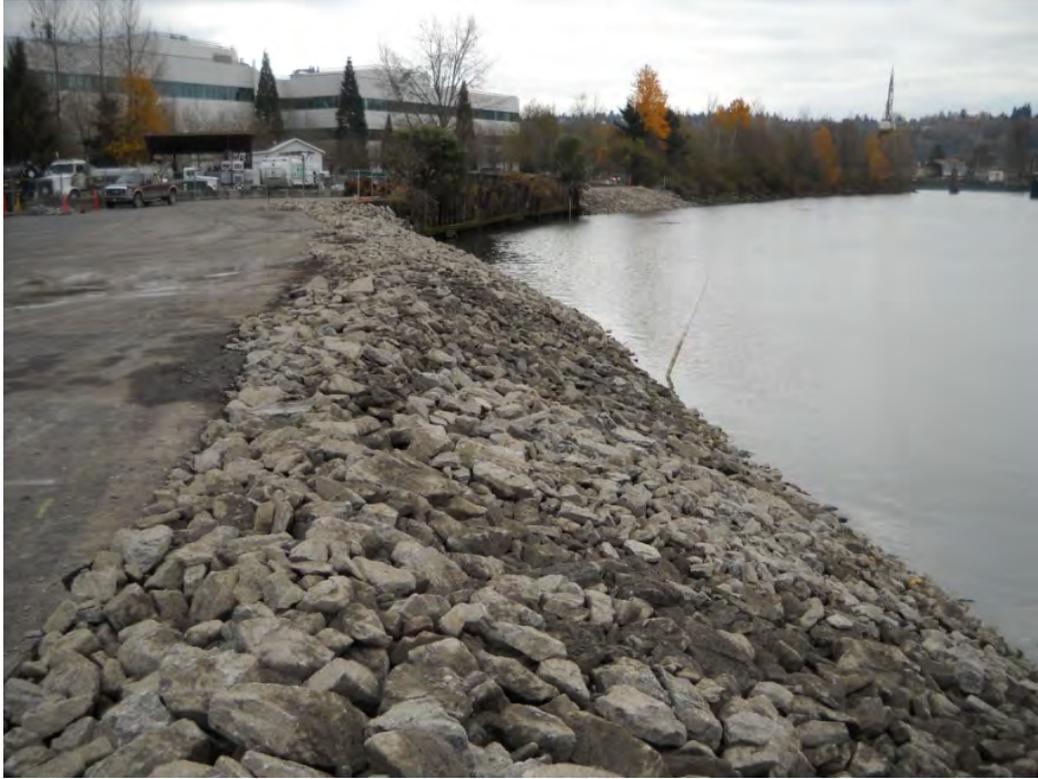
Photograph 3-9. Bank Capping—Cap Armor (December 8, 2011)

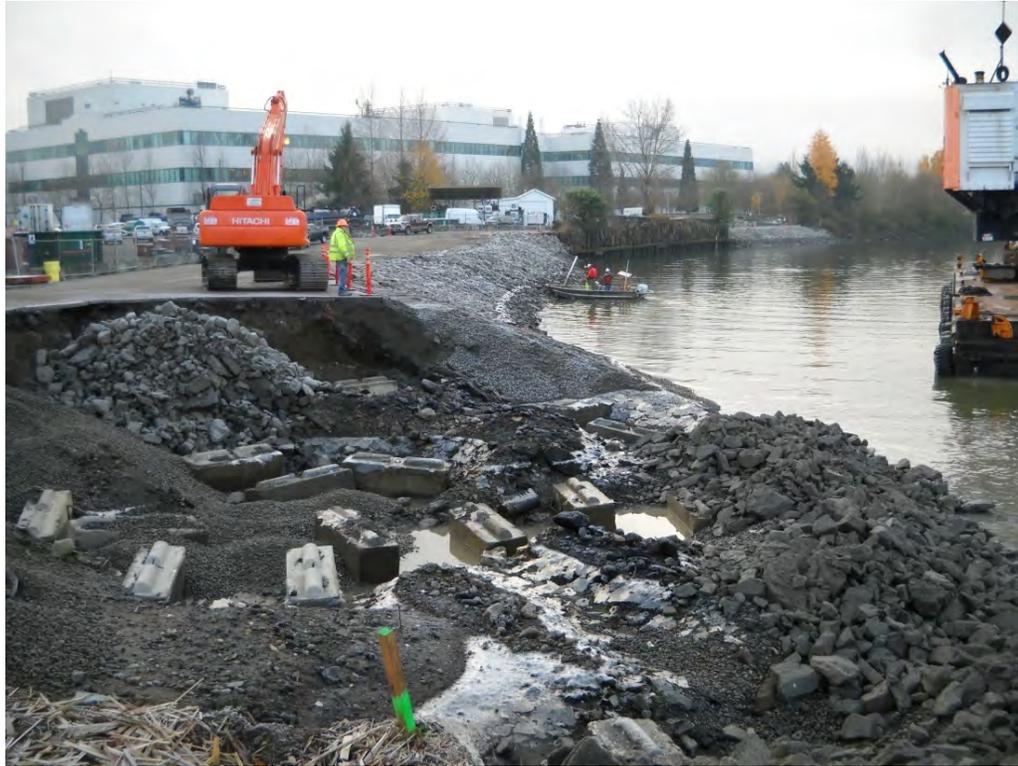
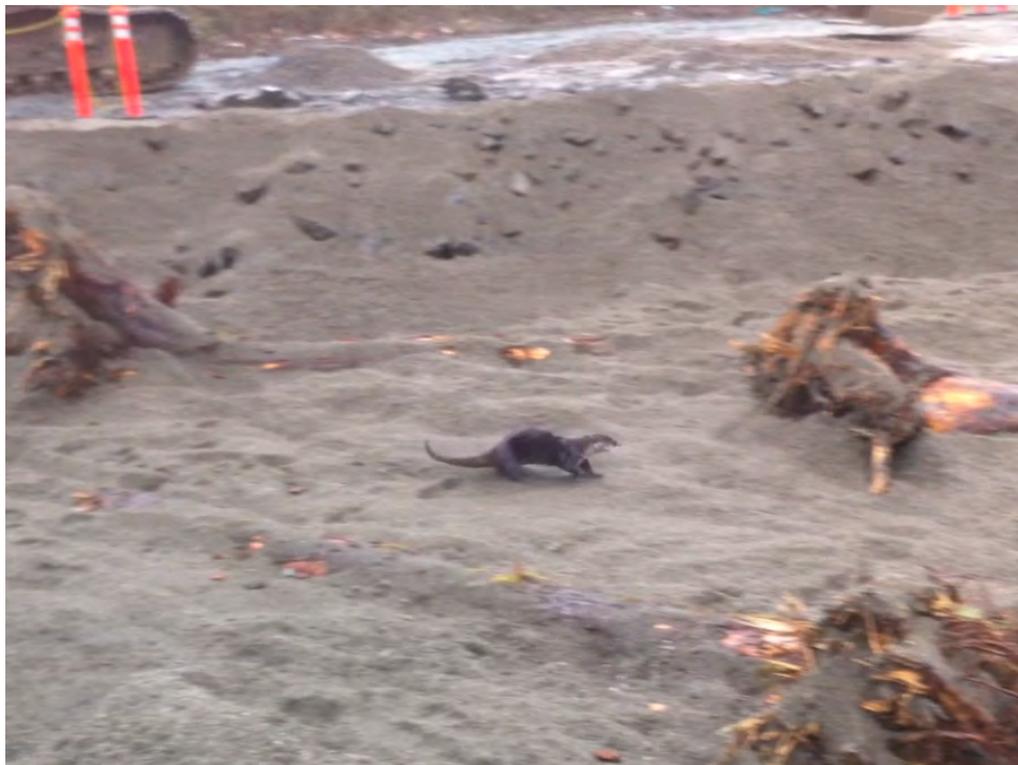
Photograph 3-10. Bank Capping—Habitat Enhancement (*top*: December 9, 2011; *bottom*: January 4, 2012)
