# LOWER DUWAMISH WATERWAY SLIP 4 EARLY ACTION AREA

## Removal Action Completion Report

July 26, 2012

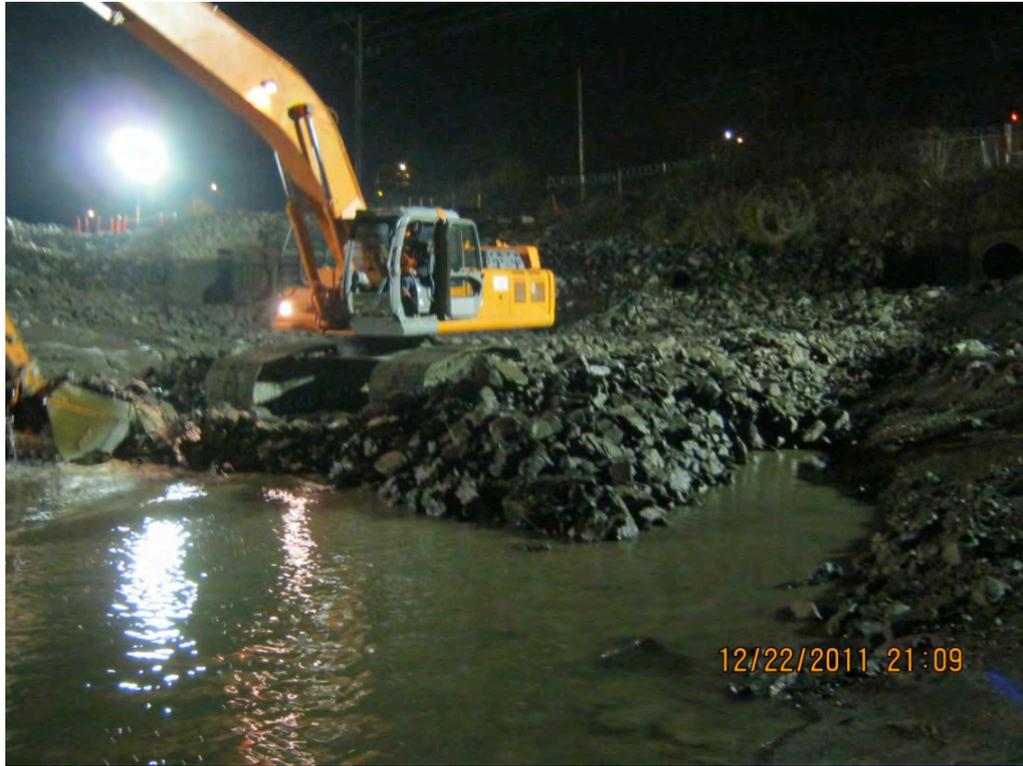
Photograph 3-11. Outfall Area Capping (December 22, 2011)

Filter material, cap armor, and heavy loose riprap were placed at the outfalls on December 12, 2011, in accordance with the contract documents. Filter material was placed using the McGinnis bucket. Cap armor and rip-rap were placed using the Bombay box.

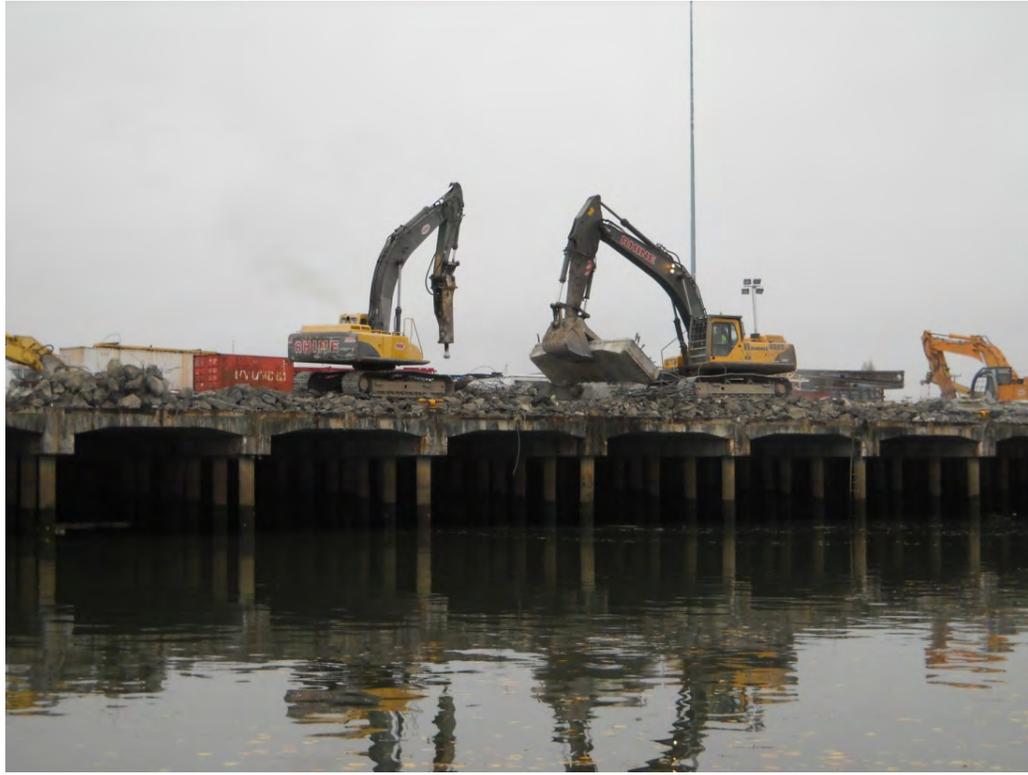
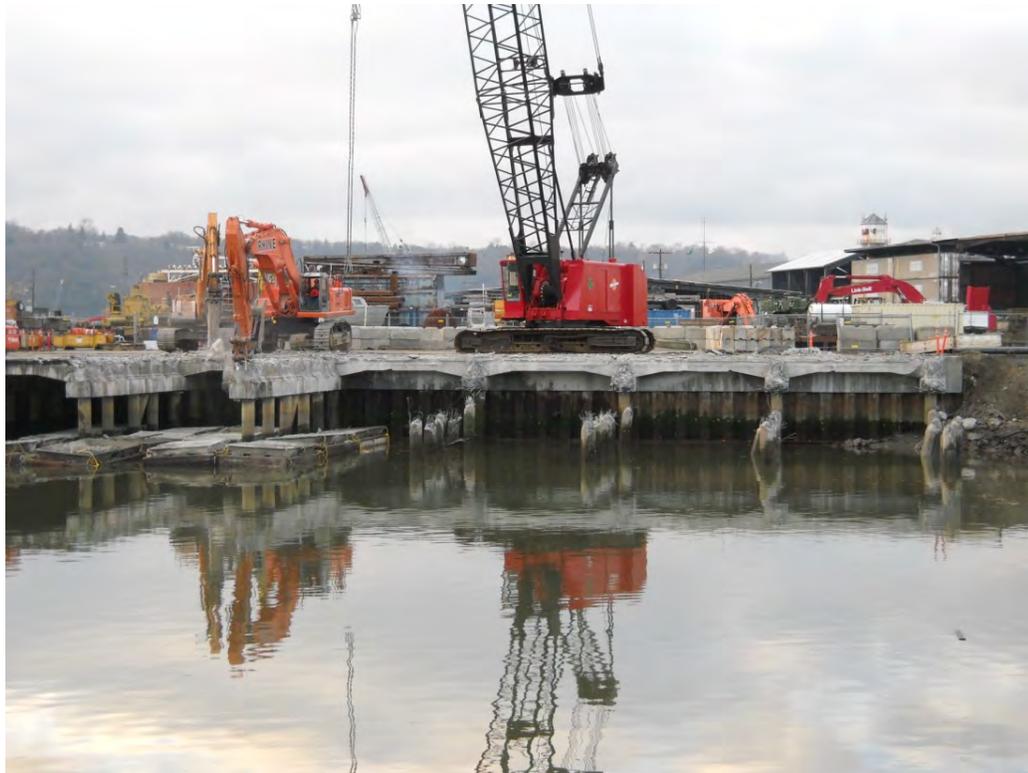
Photograph 3-12. Pier Demolition (*top*: December 7, 2011; *bottom*: December 5, 2012)

The concrete pier was demolished and removed in accordance with the contract documents and Section 4.2 of the RAWP. Concrete panels, bents, and piers were broken up on site and transported to recycling facilities by trucks, in accordance with Section 4.7 of the RAWP.

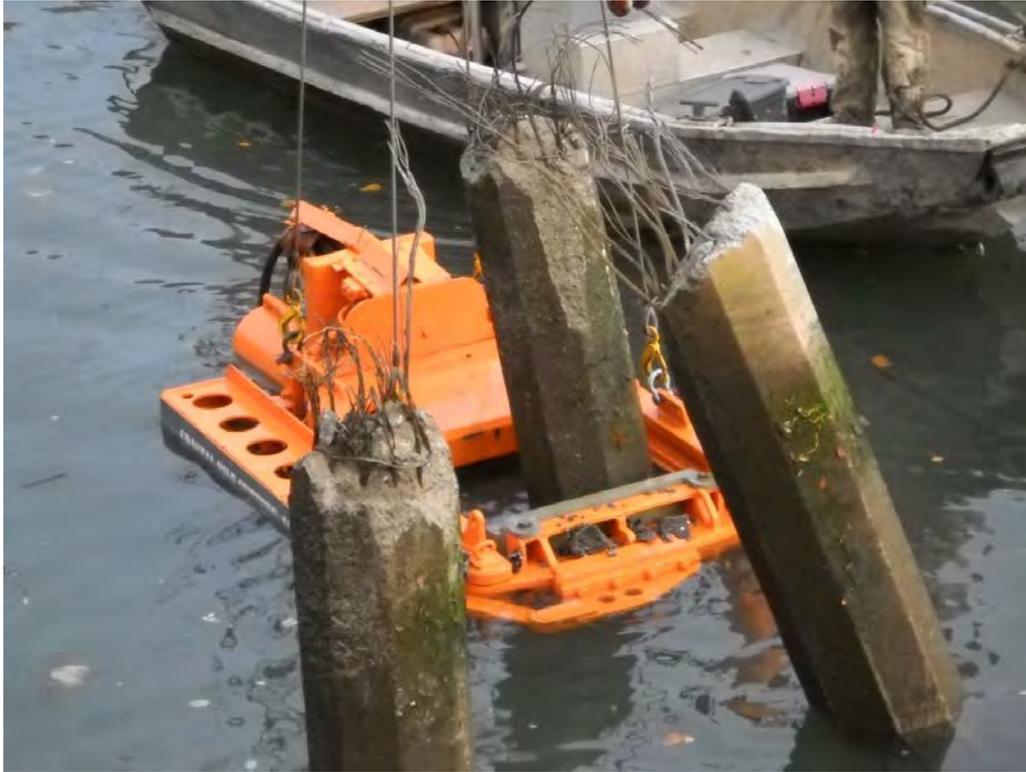
Photograph 3-13. Pier Demolition—Pile Cutting with Shear (December 16, 2011)

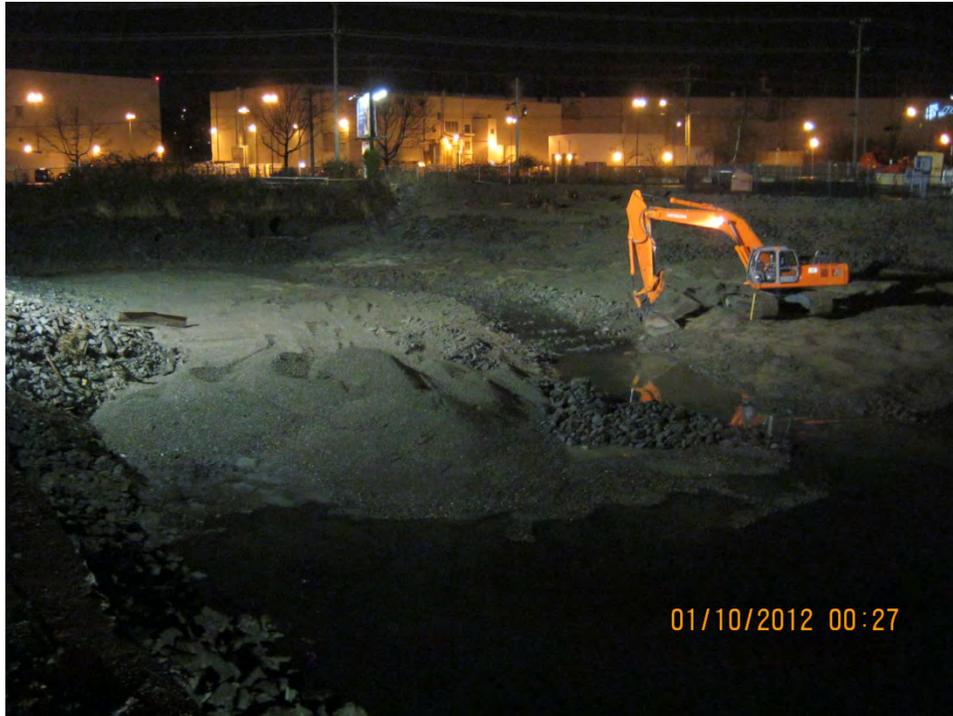
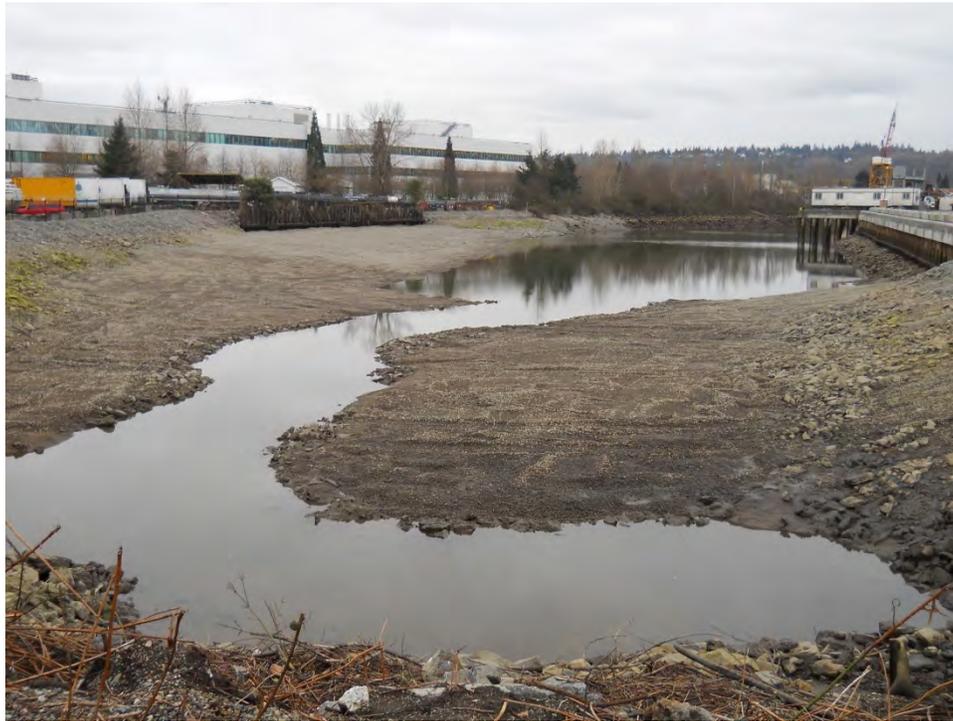
Photograph 3-14. Waterway Capping (*top*: January 10, 2012; *bottom*: February 13, 2012)

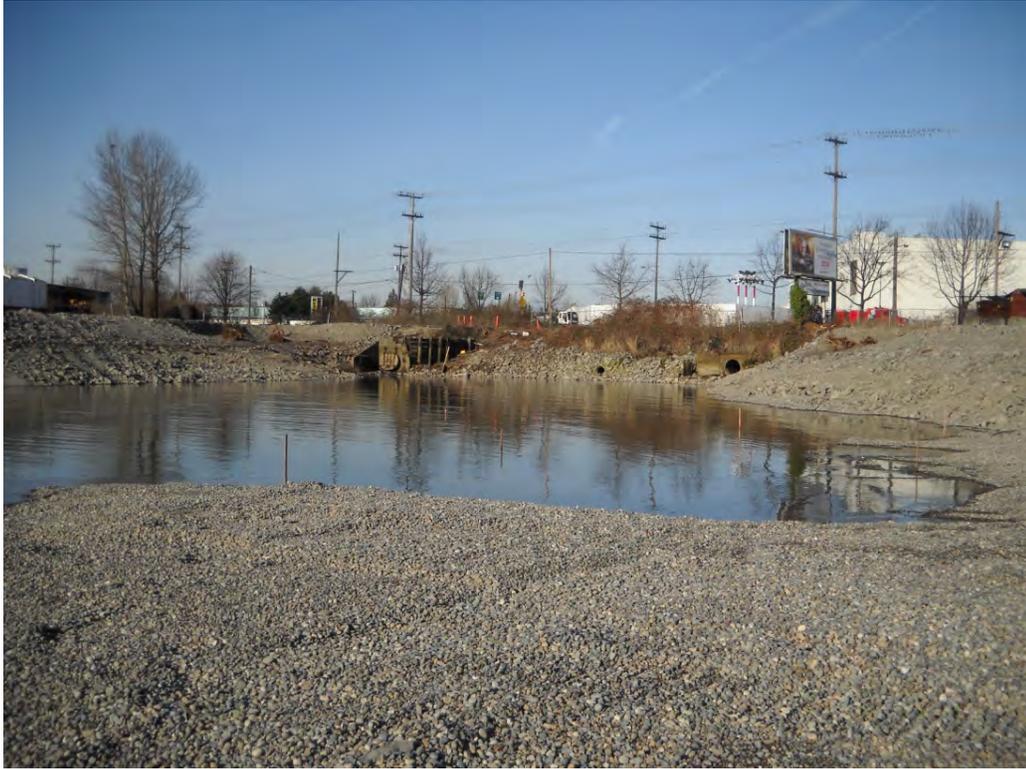
Photograph 3-15. Waterway Capping (January 27, 2012)

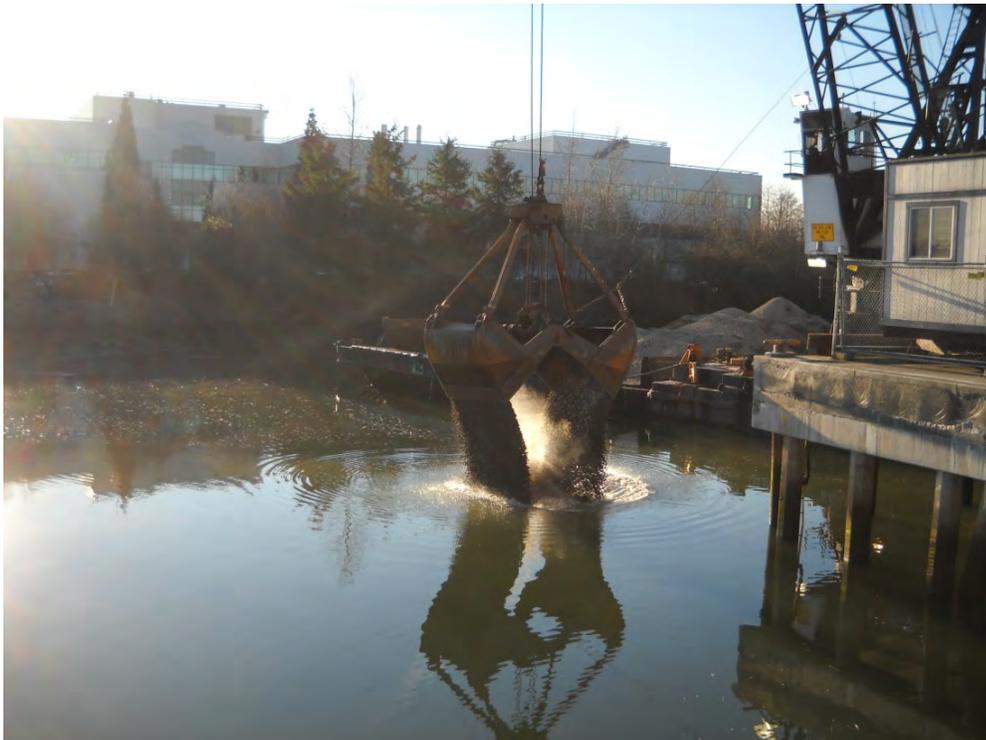
Photograph 3-16. Boundary Area Material Placement (February 7, 2012)

Subsequent boundary area sampling was performed on February 14, 2012 to document surface conditions following boundary area material placement. Review of laboratory results revealed that after boundary area material placement, sediment characteristics met the removal action objectives. The post-boundary area capping documentation sampling activities are described in Appendix A, SSAR.
