DRAFT REMEDIAL ACTION REPORT
PACIFIC SOUND RESOURCES SUPERFUND SITE
MARINE SEDIMENTS UNIT
SEATTLE, WASHINGTON

Prepared by
U.S. Army Corps of Engineers
Seattle District
4735 East Marginal Way South
Seattle, Washington 98134

Prepared for
U.S. Environmental Protection Agency
Region 10
1200 Sixth Avenue
Seattle, Washington 98101

September 9, 2005

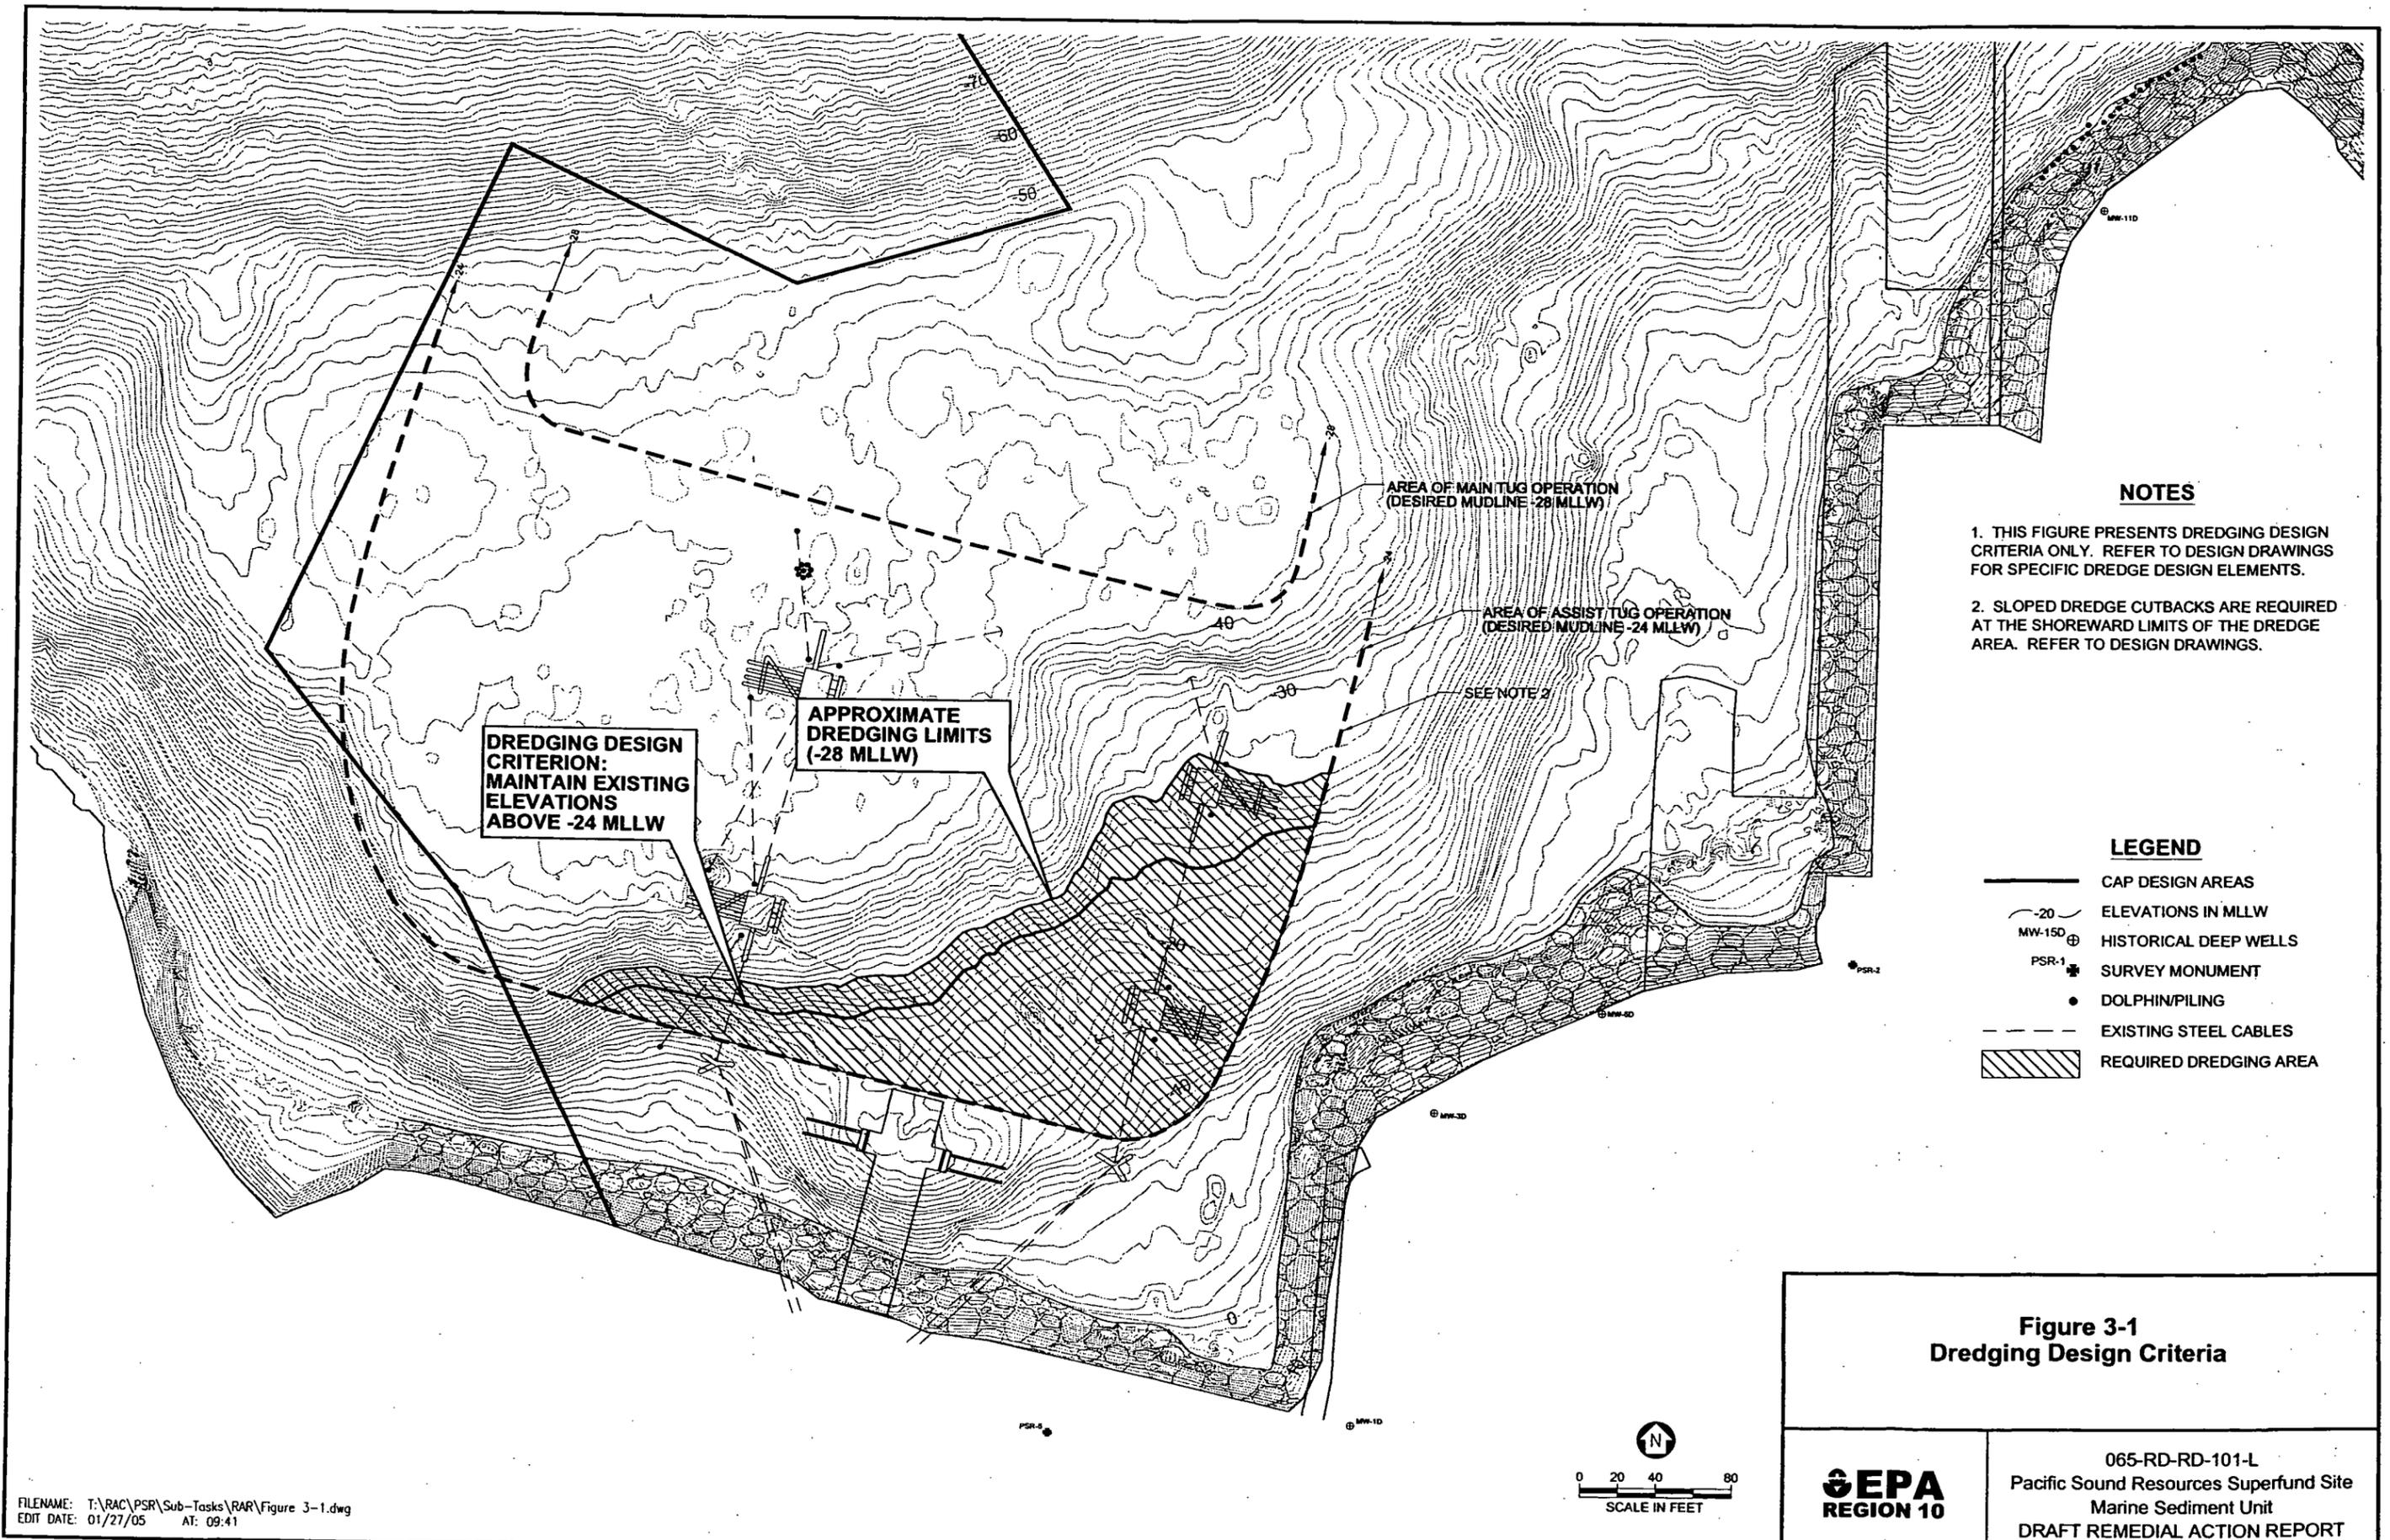
1. THIS FIGURE PRESENTS DREDGING DESIGN CRITERIA ONLY. REFER TO DESIGN DRAWINGS FOR SPECIFIC DREDGE DESIGN ELEMENTS.
2. SLOPED DREDGE CUTBACKS ARE REQUIRED AT THE SHOREWARD LIMITS OF THE DREDGE AREA. REFER TO DESIGN DRAWINGS.

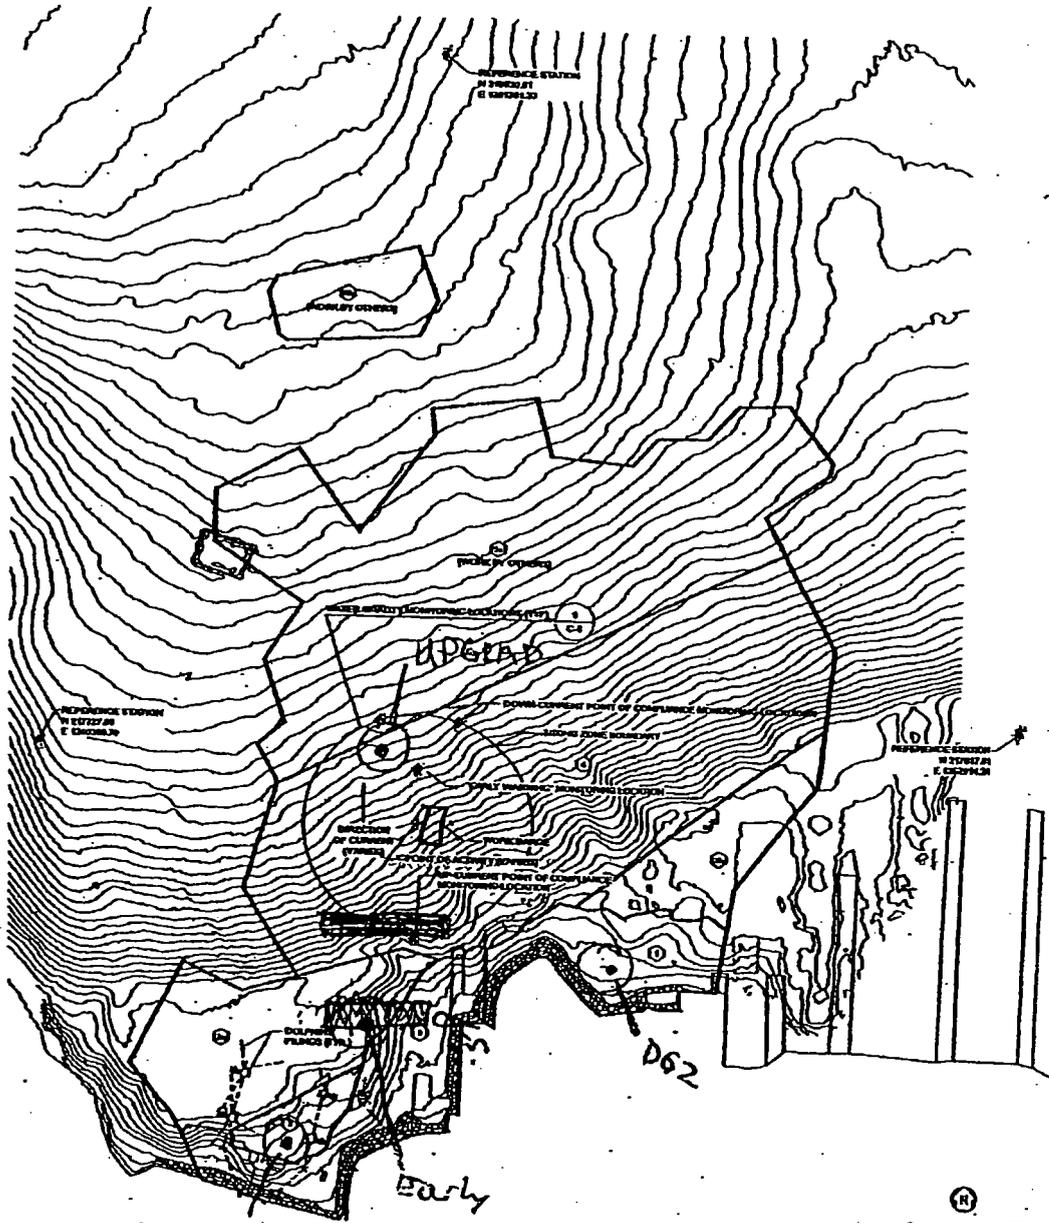
FIGURE 27
WATER QUALITY MONITORING LOCATIONS
NOVEMBER 22, 2004

Barge was ^{moving} while dumping.
 Shaded rectangle represents the
 path during the dump.

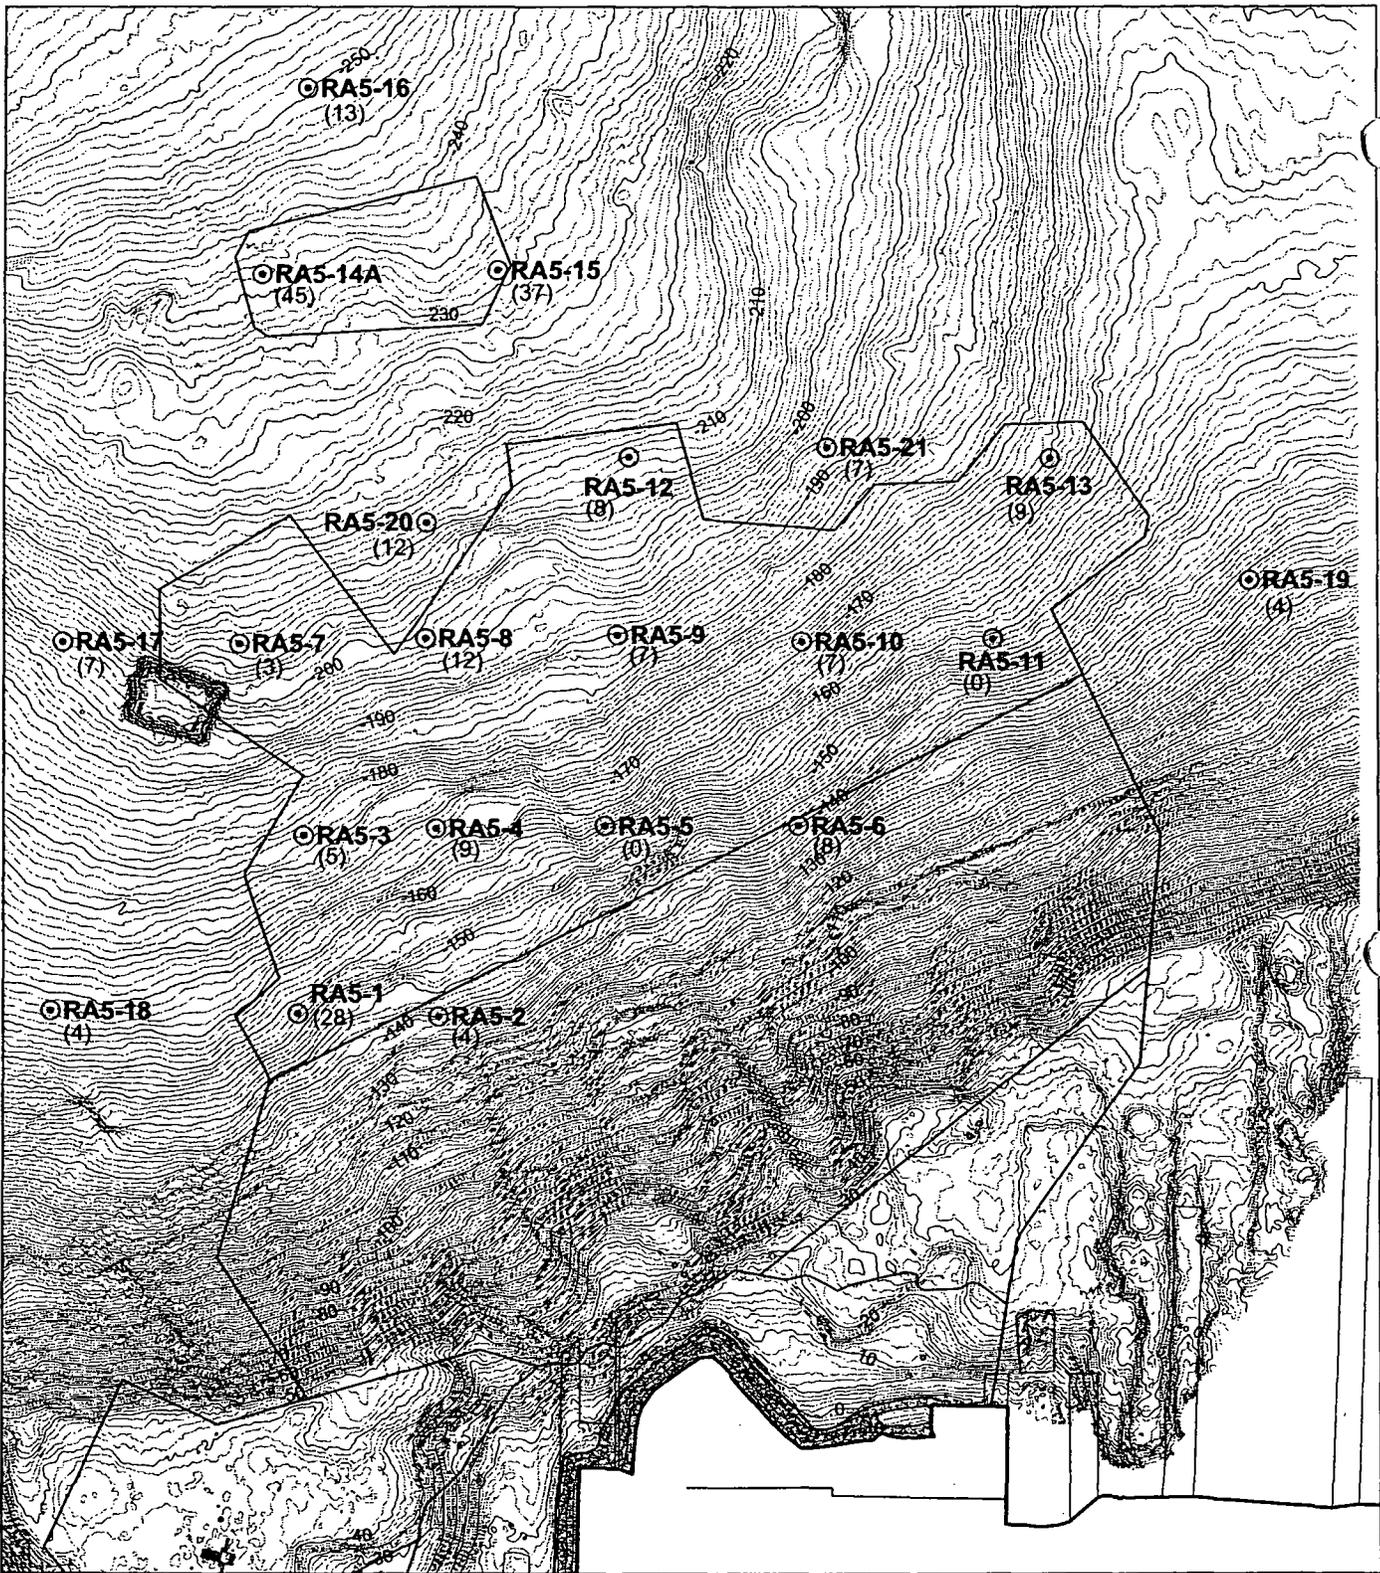
May 16, 2005 9:50am cdavidson K:\Jobs\020202-Seattle Corps\02020201\0202020126.dwg FIG 4

⊙RA5-1 Through-Cap Core
Location and Number

(12) Estimated RA5 Cap Thickness
(in inches)

The entire core (28 inches) at location RA5-01 consisted of RA5 cap material. Apparently, underlying RA4 cap material was encountered during core collection and caused refusal, although none of the RA4 material was recovered. In 9 of the 21 cores, a layer of RA4 cap fallout identified the interface between RA5 cap material and the underlying native sediment. In 2 of the 21 cores, RA5 cap material lay over RA4 cap material whose thickness could not be determined. In these cores, the thickness of RA5 cap material ranged from 3 to 12 inches. In 7 of the 21 cores, RA5 cap material was considered to lie directly in contact with the underlying native sediment, so any estimates of cap thickness rely on the ability to clearly distinguish between the two types of material. In any cases where there was uncertainty, the estimated cap thickness was limited to only that material that could clearly be identified as capping material. This constitutes a conservative approach, and the result is that these are minimum estimates of the thickness of RA5 material at these seven locations. Estimates of the minimum thickness of RA5 cap material ranged from 5 to 28 inches within and in the vicinity of RA5a, with the exception of 2 samples discussed below and from 13 to 45 inches within and in the vicinity of RA5b.

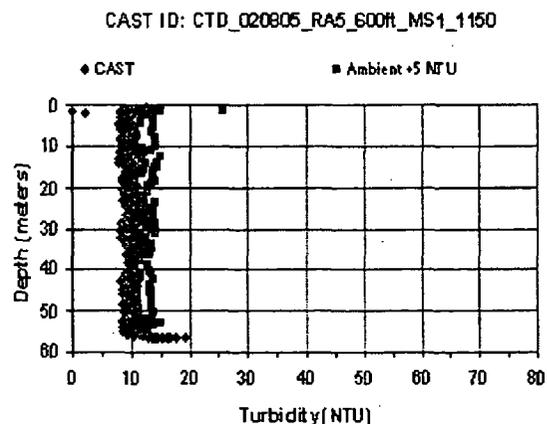
A plot of reading versus depth (X,Y plot) for each cast illustrates the range of values observed for each parameter through the water column. The example to the right, taken from Attachment 3, illustrates that although the mean value of the parameter (green points) might not exceed the permitted limit of ambient plus 5 NTU (red points), some values might fall above that limit. In this example, higher values were initially observed before the values decreased and stabilized, resulting in a reported mean value of

10.4 NTU at 55.1 meters depth. Background turbidity was usually below 10 NTU. Turbidity was the only parameter to exceed water quality standards. Detailed CTD data including X,Y plots of the parameter data are included in Attachment 3. Both the downcast and upcast of the CTD are included in the plots illustrating duplicity and consistent turbidity readings throughout the water column. In some casts, the downcast for DO appeared slightly higher than the upcast, exaggerated just below the surface. This is due to a lag time in temperature equilibration from the surface, and in these cases, the lower value of the upcast is more accurate.

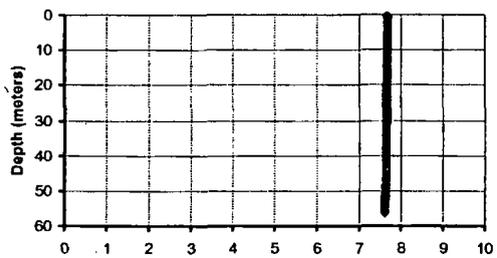
CAST ID: CTD_010605_RA5_600R_MS2_1645

Start Time: 16:34:22
 Duration(min): 6.05
 Samples: 363
 Tide: EBB

Depth	Turbidity	Dissolved	Salinity	pH	Temperature
Meters (Feet)	(NTU)	Oxygen (mg/l)	(ppt)		(°C)
1 (3.3)	7.7	7.50	32.0	7.68	8.44
26 (85.3)	6.2	6.82	32.8	7.67	9.06
55.2 (181.1)	102.1	6.27	33.1	7.63	9.44

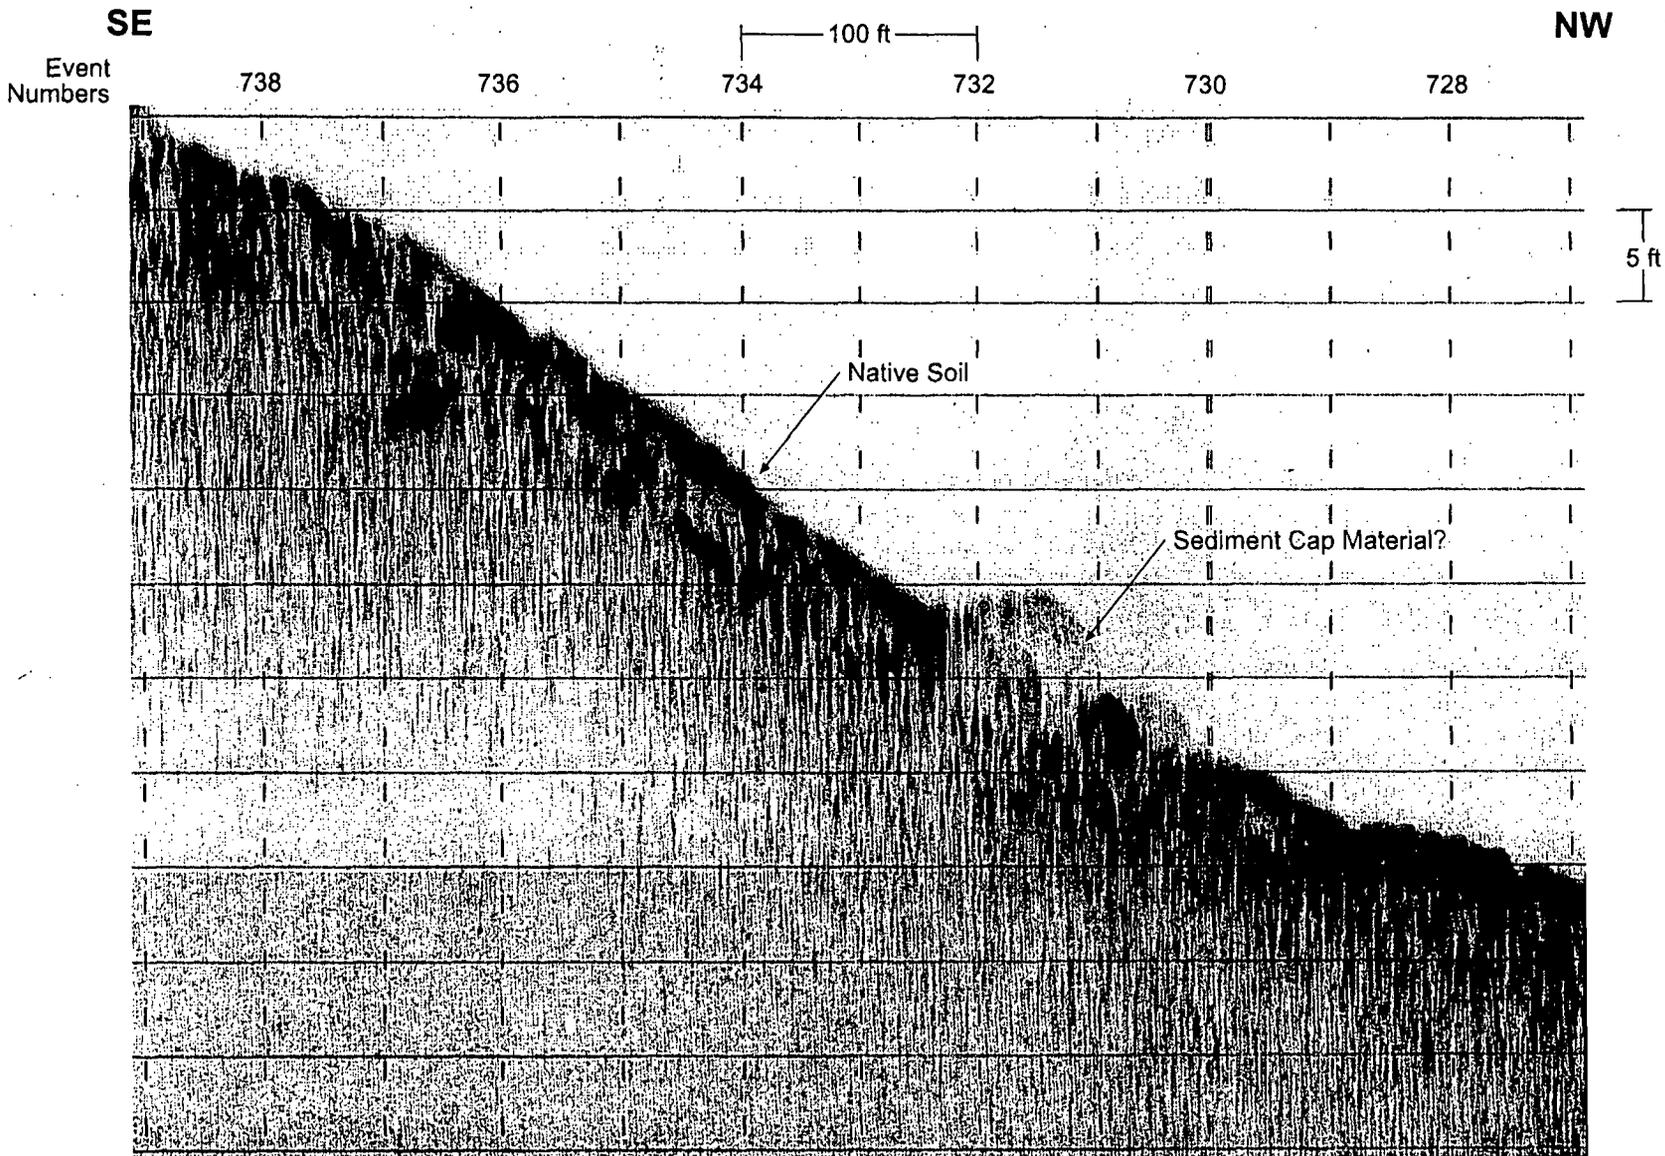
FIGURE 2
SUBBOTTOM PROFILE OVER
INTERPRETED CAP MATERIAL
 ANCHOR/PSR RA5 GEOPHYSICS/WA

See Map 3 for location.

The SBP data were analyzed by determining what subsurface reflectors, or reflection characteristic would most likely represent cap material. SBP data from other projects, such as the data shown below, were used as reference for interpretation. Cap material is generally acoustically transparent (light colored image, no internal reflectors) and usually uniformly distributed as shown in the image below. In addition, data from the through-core samples were correlated, where possible, with the interpreted SBP data.

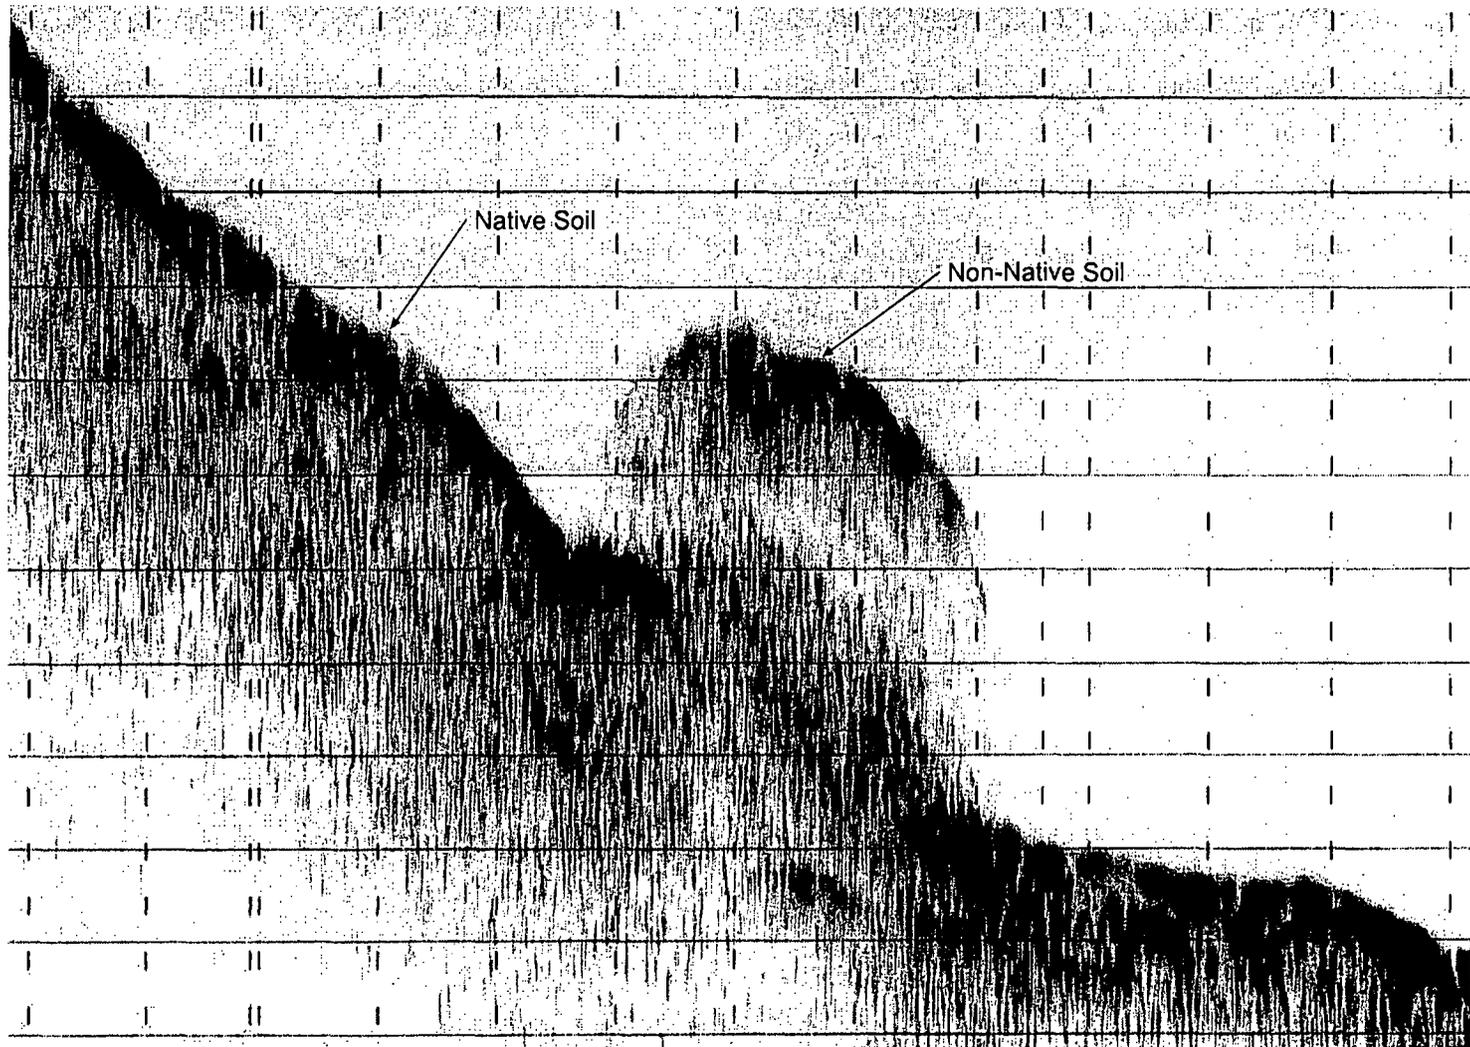
FIGURE 3
SUBBOTTOM PROFILE OVER
LARGE MOUND OF NON-NATIVE SOIL
ANCHOR/PSR RA5 GEOPHYSICS/WA

See Map 3 for location.
