**Treatability Study to
Stabilize Intertidal Tailings Deposits**

**Salt Chuck Mine Remedial Investigation
Tongass National Forest, Alaska**

Prepared for
US Environmental Protection Agency
Region 10

May 23, 2013

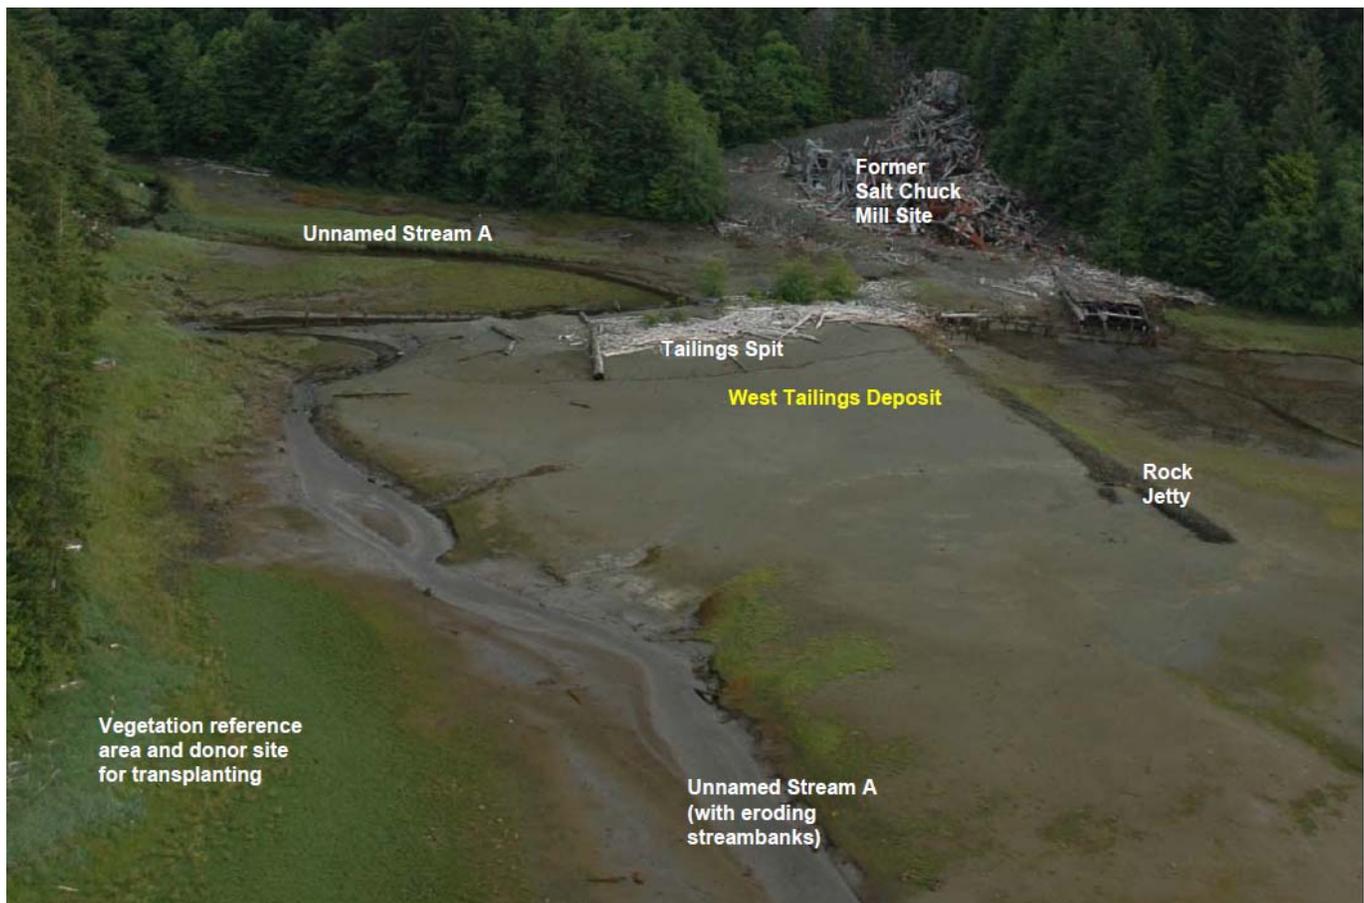
Figure 2-2. Overview of the Project Site and Intertidal Area

The **Rock Jetty** was constructed in the early 1900s (as evidenced in the 1929 photo shown in Figure 3-9). This feature is approximately 230 feet long by 15 feet wide and was constructed using uniform 4 to 8-inch quarry spalls (see Photo 3-6). This feature is presumed to have been constructed to contain the tailings from migrating into the access channel used to barge materials to and from the former mill site.

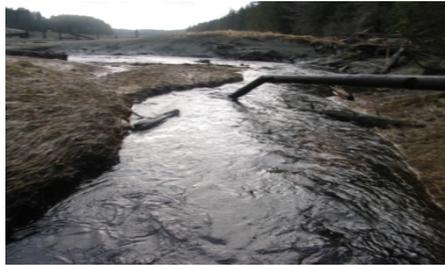
Photo 3-1. Streambank location of high velocity where erosion is likely occurring, between Station 1+50 and 2+00. Note exposed bank in background.

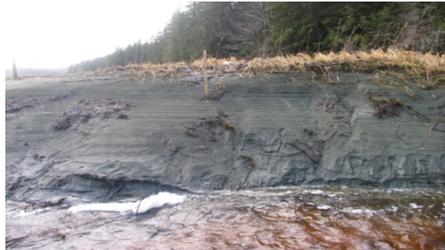
Photo 3-2. Close up view of streambank location of high velocity where erosion is likely occurring, between Station 1+50 and 2+00. The 5- to 6-foot high bank is at risk of episodic erosion and transport during high streamflow event.

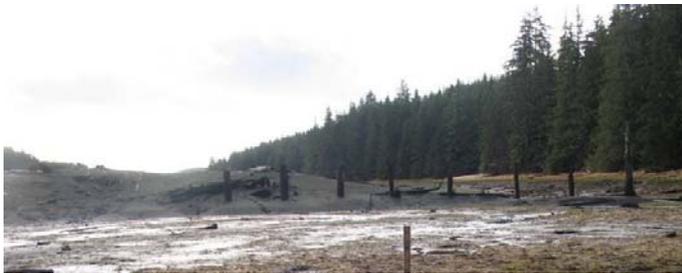
Photo 3-3. Location of high velocity where erosion is likely occurring, between Station 5+00 and 6+00.

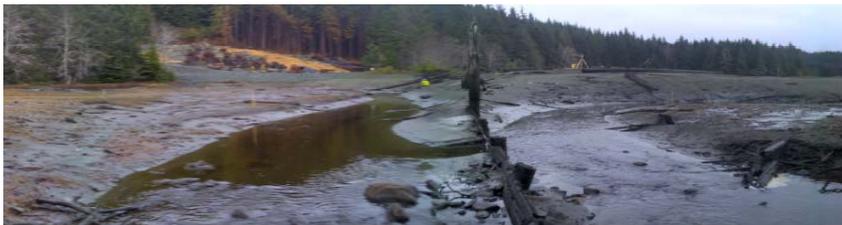
Photo 3-4. Location of high velocity where erosion is likely occurring, between Station 5+00 and 6+00.

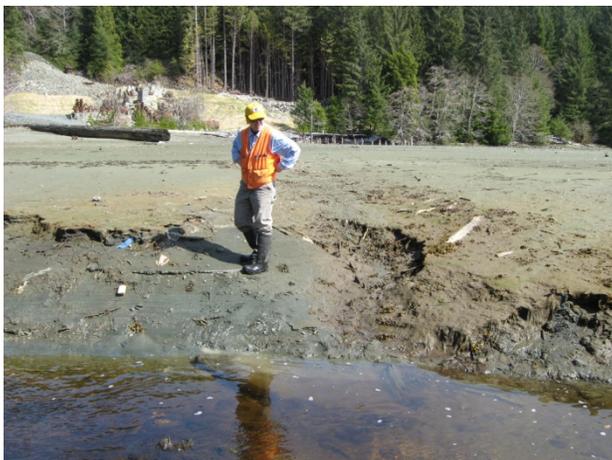
Photo 3-5. Location of head-cutting gully near Station 8+80.

A small head-cutting gully appears to be forming along the west side of the West Tailings Deposit (see Photo 3-5) near Station 8+80. Gully formation can be rapid and result in considerable erosion and transport of sediment. Stabilizing such an area early to minimize additional erosion may be warranted.

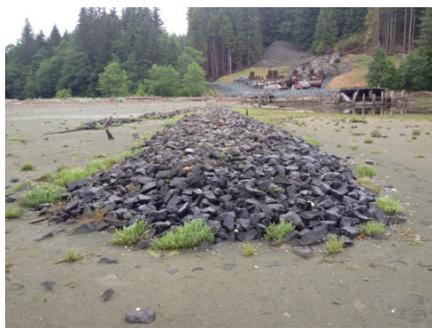
Photo 3-6. Sea asparagus establishment among and around the rocks at the south end of the rock jetty.

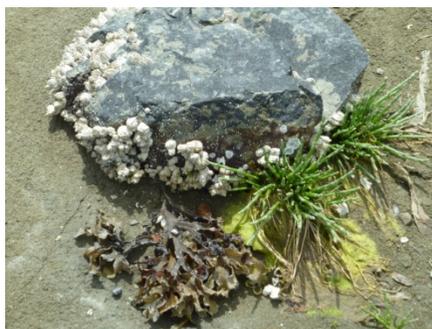
Photo 3-7. Sea asparagus establishment at base of rock on tailings deposit.

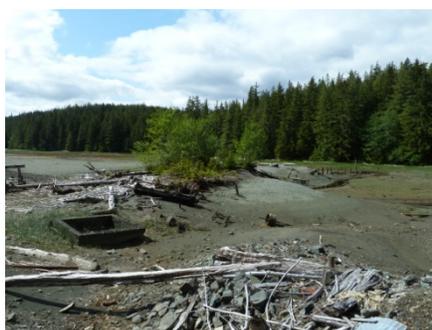
Photo 3-8. Red alder establishment on the Tailings Spit.

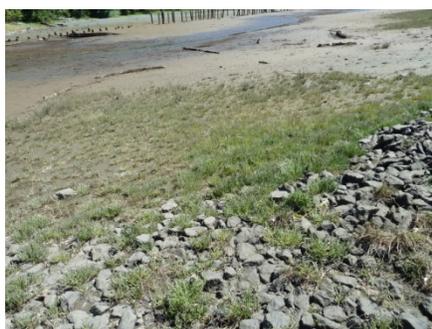
Photo 3-9. Sea asparagus establishment near drainage channel immediately east of the rock jetty.

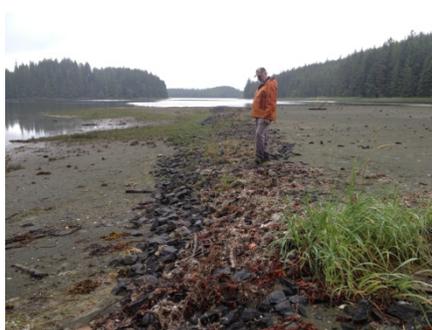
Photo 3-10. Patch of beach wildrye (*Leymus mollis*)—in the lower right corner—establishing in the protection of the north end of the rock jetty near the tailings spit.

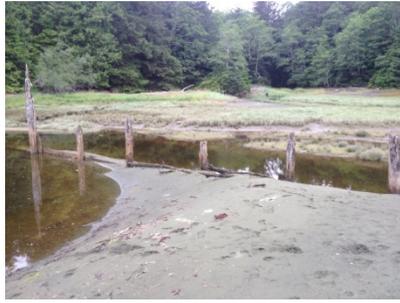
Photo 3-11. Vegetation dominated by Lyngbye's sedge (*Carex lyngbyei*) on floodplain areas upstream of the tailings spit in area of historical mine tailings pond.

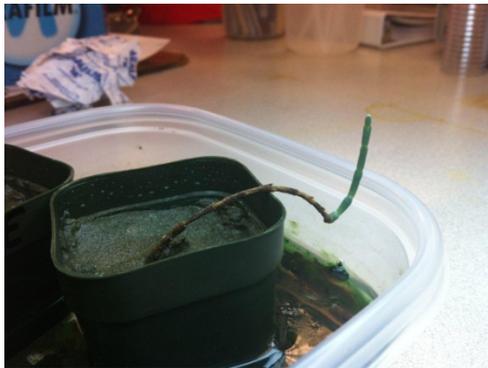
Photo 3-12. Shoot elongation of a sea asparagus live cutting fragment after several months in Salt Chuck Mine tailings (sample SCSD-304).

Photos 3-12 and 3-13 show elongation of roots and shoots of sea asparagus grown in Salt Chuck Mine tailings from sample SCSD-304, which contained 1,100 mg/kg copper. However, sea asparagus planted in tailings from sample SCSD-301 (containing 2,530 mg/kg copper) had essentially no root growth. These preliminary results suggest a possible phytotoxic threshold that could be somewhere between 1,100 and 2,530 mg/kg. Sediment/tailings samples that were collected within the 8- to 10-foot elevation zone where sea asparagus will be transplanted appear to be relatively similar in copper concentration as sample 304 that was tested, which offers potential for using live cutting fragments of sea asparagus to colonize the intertidal areas of that elevation zone onsite.

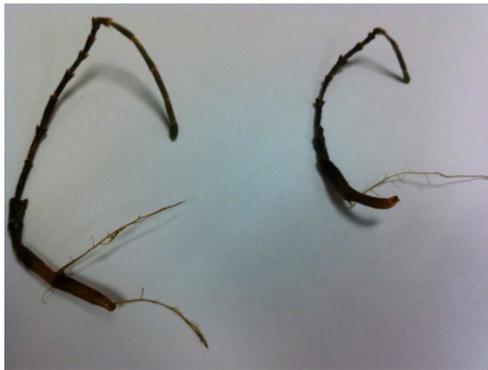
Photo 3-13. Root development of sea asparagus live cutting fragments after several months in Salt Chuck Mine tailings (sample SCSD-304).

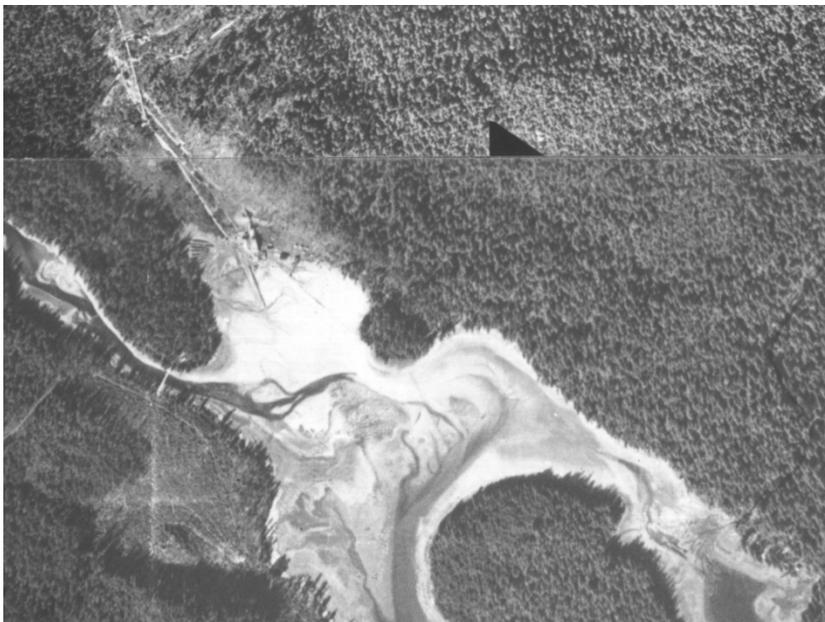
Figure 3-9. Aerial Photo of the Project Area during Operation of the Salt Chuck Mill in 1929.

Figure 3-9 shows an aerial photo from 1929. By that time, the rock jetty, and piles with whaling are visible. In addition, there is a signature of what appears to be a braided low flow channel of Unnamed Stream A flowing around the south end of the rock jetty. There are other signatures of potential channel threads extending southward that may be overflow channels of Unnamed Stream A from higher flow events or may depict the tailrace or outflow from the mill site. This seems to indicate that the channel alignment for Unnamed Stream A was substantially altered during operation of the mill, compared to its current location, as well as its location before mining began.

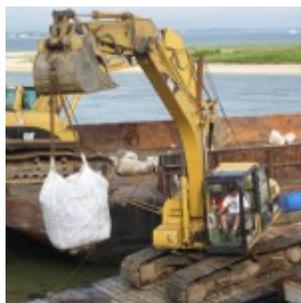
Photo 4-1. Example of how an excavator could be used to transport rock in super sacks to remote areas where excavation will occur (use of a barge is not anticipated).

Because access roads will not be constructed, the contractor will need a method to transport rock that will be needed for limited bank armoring at both excavation locations. One method being considered is to use bulk transport bag (e.g., super sacks) to transport the rock. A typical one-ton bag can hold one cubic yard of dry material, or approximately 2,500 pounds.

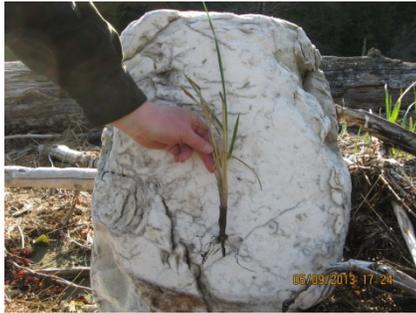
Photo 5-2. Sprigs will be individual plants (with or without soil attached) that will be transplanted. A sprig of beach wildrye is shown

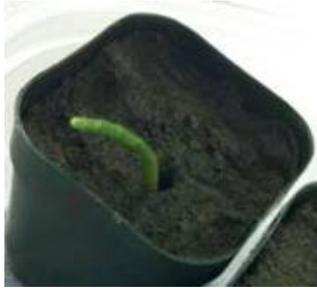
Photo 5-3. Live cuttings will be used only with sea asparagus, which can propagate vegetatively from cuttings (as was demonstrated during the bench test with sea asparagus from coastal Oregon).

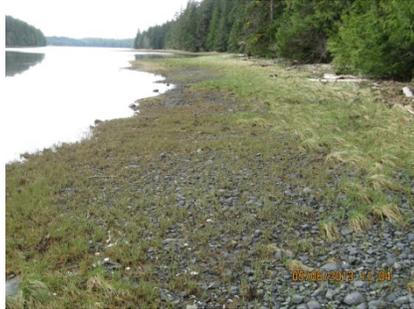
Photo 5-4. Rock with interspersed vegetation provides a natural armoring of the shoreline near Salt Chuck Mine.

Therefore, several test plots will include rocks alone and in combination with transplanted vegetation.

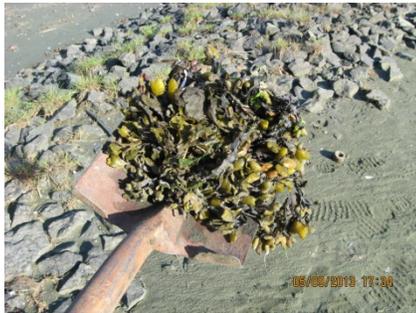
Photo 5-5. Local sources of marine-derived organic matter (such as, rock weed or popper weed [*Fucus* sp.]) that drifts to the site will be collected and used in several test plots.

Organic matter in the tailings sediments is low compared to native sediments. Using native local marine-derived seaweed (such as, rock weed) to amend soils has been a traditional way of increasing soil organic matter in gardens and cultivated soil in Alaska. Seaweed that has floated and/or deposited at the site will be collected.

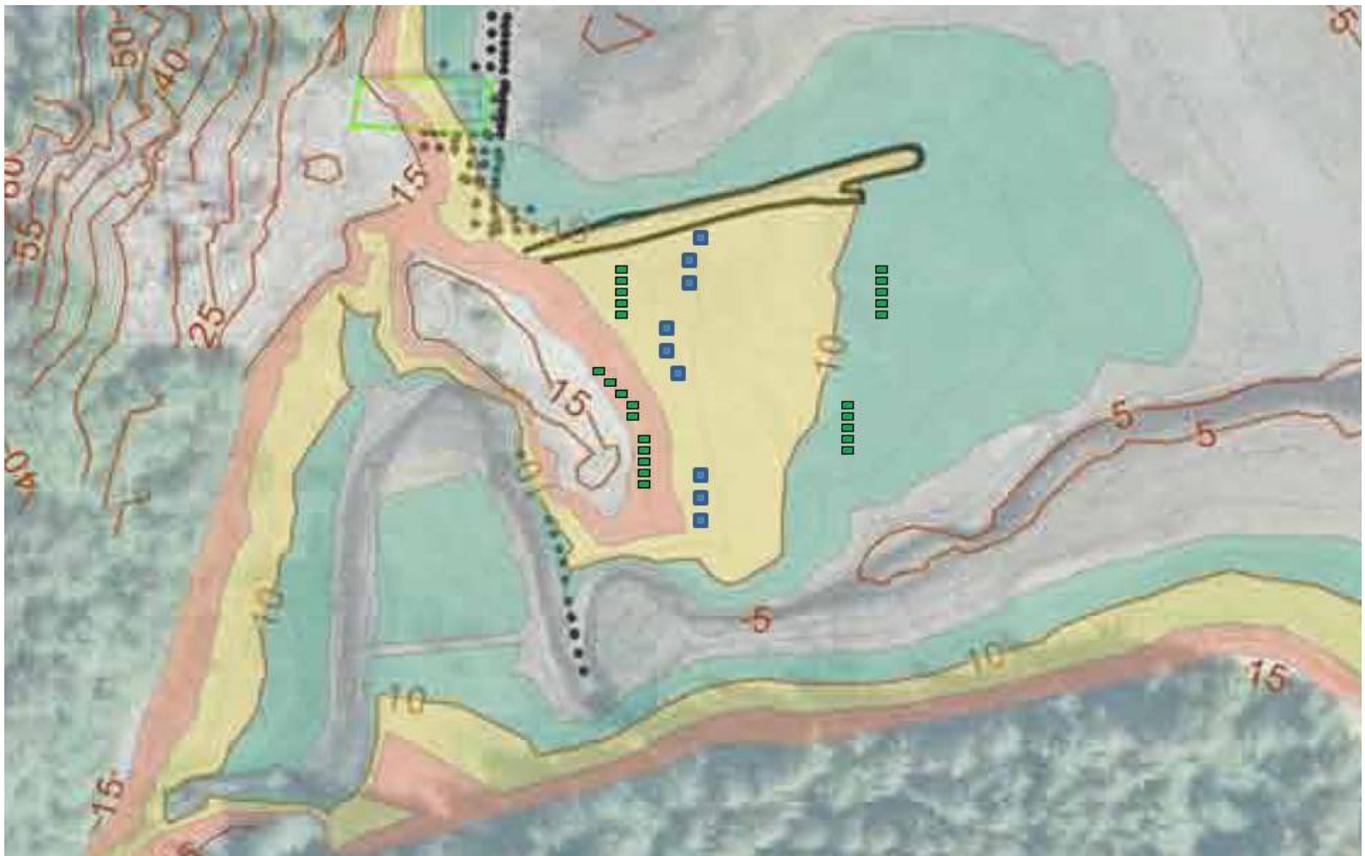
Figure 5-1. Preliminary Layout of Vegetation Plots. (Small green rectangles represent preliminary layout of 5x10-foot vegetation transplanting plots; small blue boxes represent 10x10-foot seed plots. Actual plot locations will be adjusted in the field).

^a Plot size is 5 feet by 10 feet, with plant spaced 2.5 feet on center.

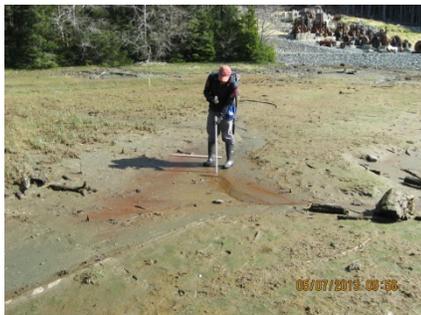
Photo 7-1. Installation of an erosion monitoring pin (white PVC) in a rill network on the floodplain upstream of the tailings spit in early May 2013.

A simple erosion monitoring network will be established to try to gain a better understanding of the relative and absolute amounts of erosion in different locations onsite where different processes are being studied.

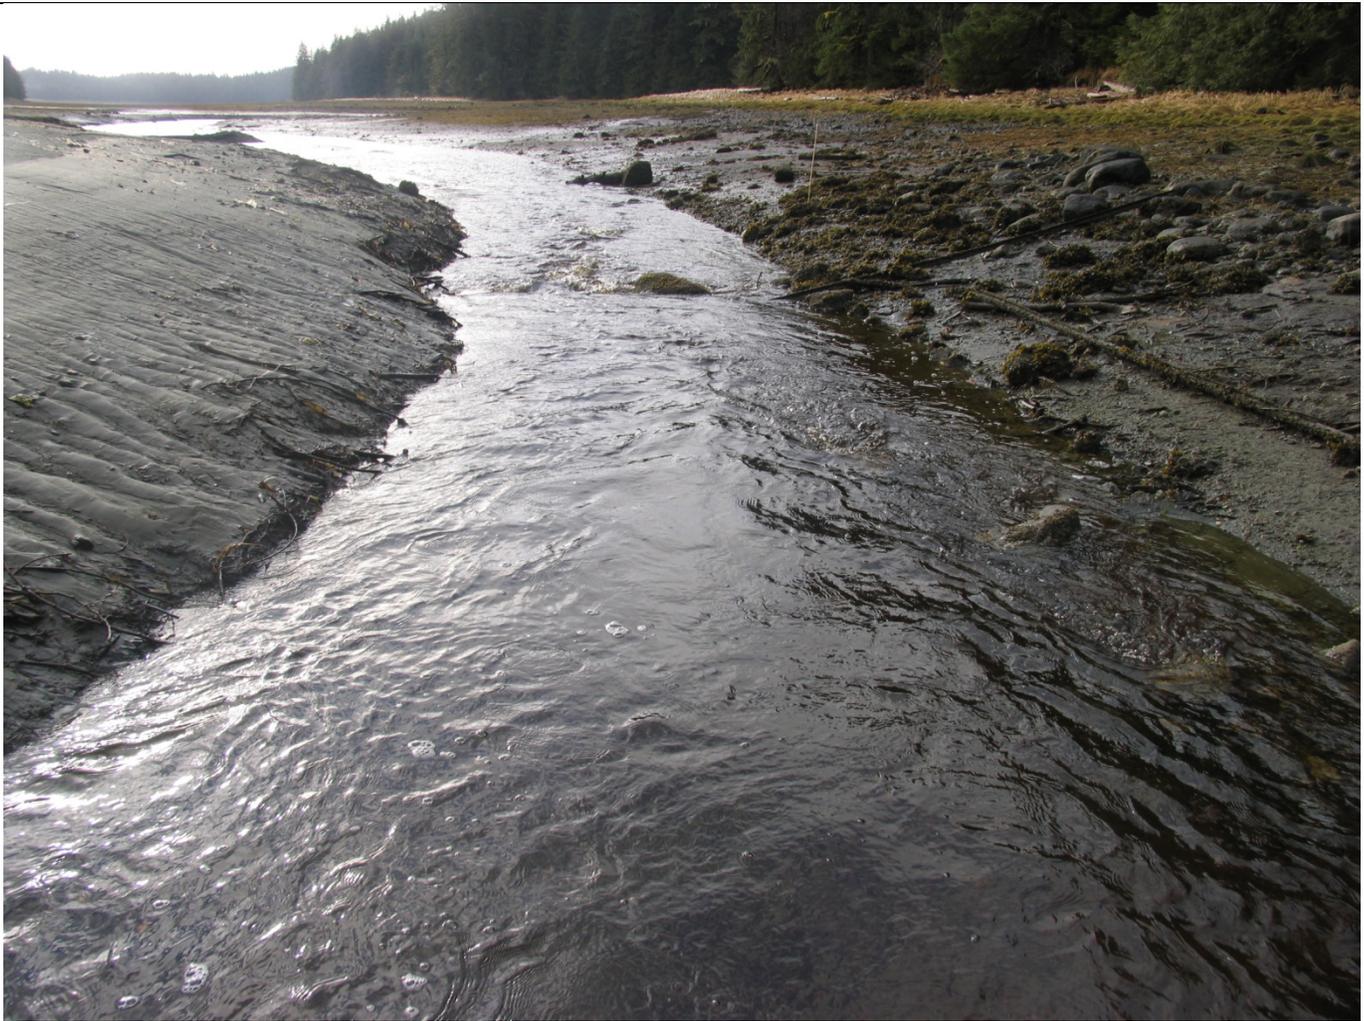
Figure 12. Downstream view of Unnamed Creek A at Station 7+50, February 16, 2013

During storm inflows and tidal water levels below approximately 8 feet NAVD88, stream velocities may be sufficient to cause erosion despite the proposed regrading. With predicted velocities near 2 feet per second, it is advisable to employ some means of streambank protection to reduce the likelihood of continued erosion of the tailings during heavy rainfall events. Quarry stone 3 to 6 inches in diameter, which is available at quarries onsite, is sufficient to armor the streambanks against predicted velocities during storm events. Rock placed on the regraded streambank to an elevation of 10 feet at the West Excavation Area and the western end of the tailings spit would protect against the highest predicted velocities. The model also predicts elevated velocities at Station 7+75 on Unnamed Stream A, but photographic survey documentation does not indicate that this area is undergoing substantial erosion (Figure 12); therefore, streambank protection at this location may not be necessary.

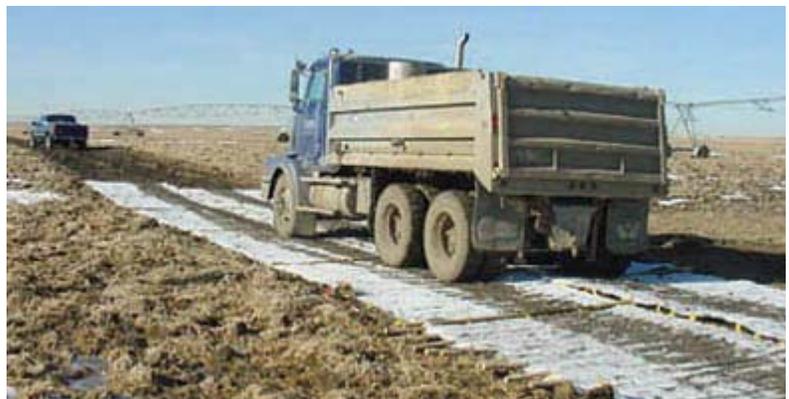
Mud Mats consist of pocketed, double-wall, high-strength fabric with high tensile reinforcing ribs confined within each sleeve
