**Reference: Contract No. EP-S7-06-03
Technical Direction Document No. 09-10-0010
Makah Warmhouse Beach Dump
Final Preliminary Assessment Report**

**Preliminary Assessment Report, Final
Makah Reservation
Warmhouse Beach Open Dump
Neah Bay, Clallam County, Washington
TDD: 09-10-0010**

**TechLaw, Inc.
Contract EP-S07-06-03**

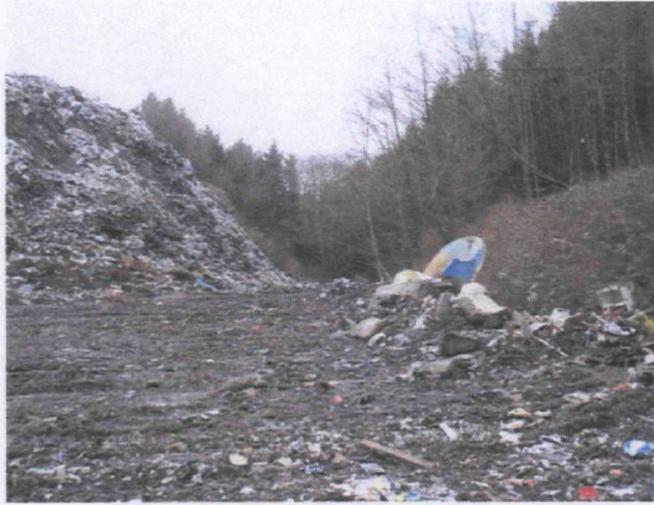
PHOTOGRAPH #1

Description: Northeast boundary of open dump. East creek headwaters are located in back left corner.

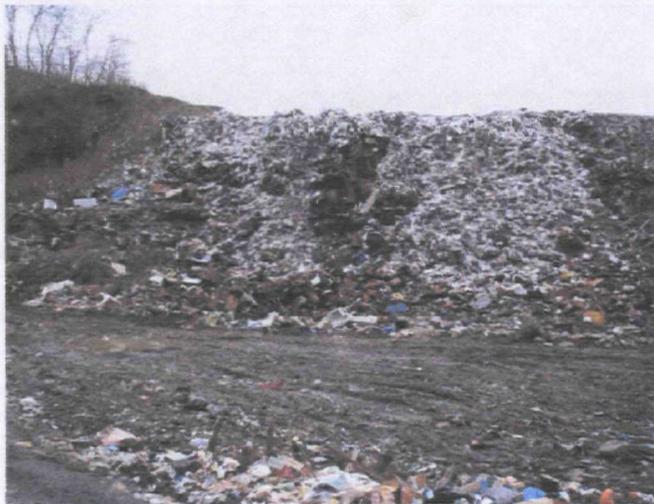
PHOTOGRAPH #2

Description: Open dump; upper level has metal debris exposed on the hillside.

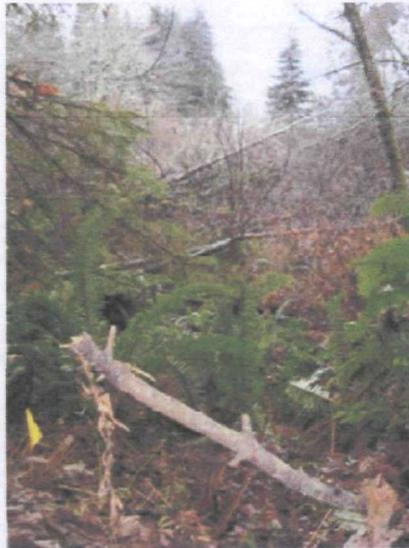
PHOTOGRAPH #5

Description: View of surface water and sediment samples WBE-09-SW/SD and their duplicates WBE-12-SW/SD, located 300' downstream of east creek headwaters.

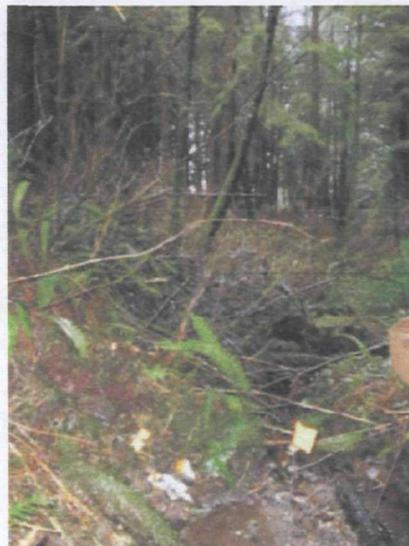
PHOTOGRAPH #6

Description: View of surface water and sediment samples WBE-11-SW/SD, located 50' south of the junction between the east and west creek.

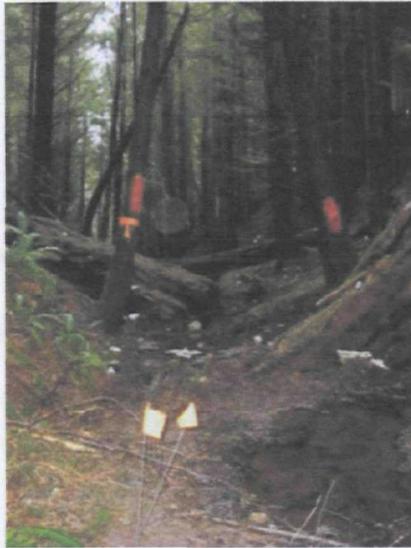
PHOTOGRAPH #7

Description: View of surface water and sediment samples WBW-03-SW/SD and their duplicates WBW-07-SW/SD, located 550' downstream from west creek headwaters.

1115 sample # WBW-03-SD & duplicate sample WBW-07-SD, collected by AD. separates are clay w/ iron staining. small gravel sits on top. clay 2-4" deep. 03, 07 collected 550' down stream of head water.

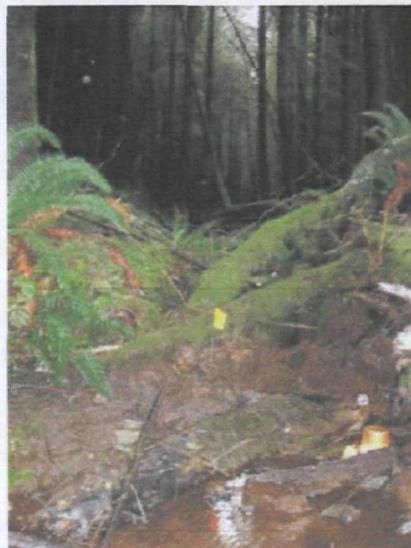
PHOTOGRAPH #8

Description: View of surface water and sediment samples WBW-01-SW/SD, located 105' downstream from west creek headwaters.

1410 sample # WBW-01-SW collected from 105' down stream of head water
the sample is 25' near (horizontally) W from GPS N48.38829
W124.65789.

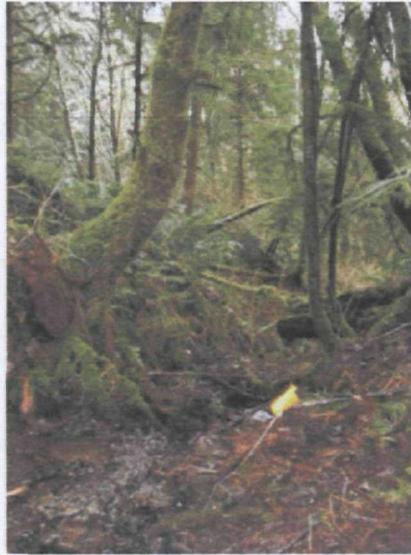
PHOTOGRAPH #9

Description: View of surface water and sediment samples WBE-10-SW/SD, located 440' downstream from east creek headwaters.

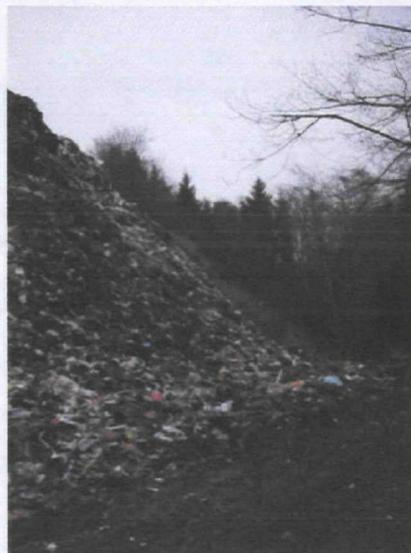
PHOTOGRAPH #10

Description: View of surface soil sample WB-17-SS and its duplicate WB-18-SS.

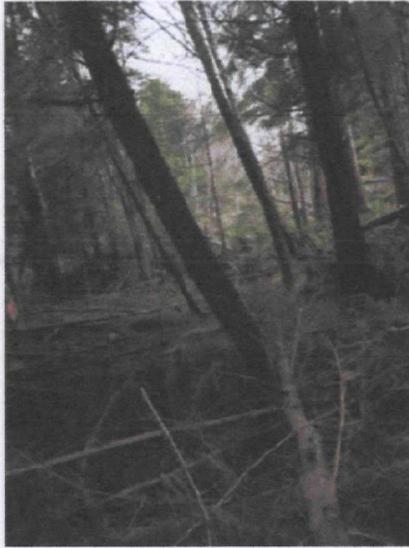
PHOTOGRAPH #11

Description: View of surface soil sample WBB-06-SS, located 12' up the bank of the small stream used for the background surface water sample.

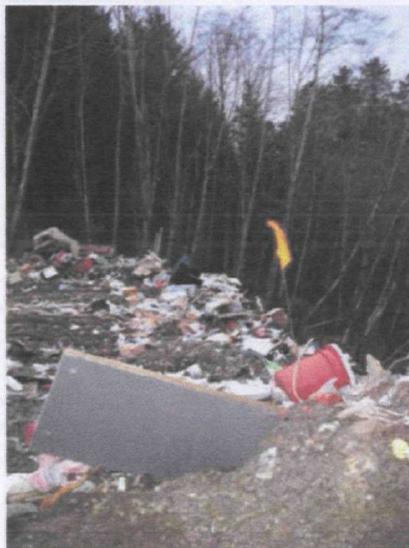
PHOTOGRAPH #12

Description: View of surface soil sample WB-14-SS, from a pushed soils pile.

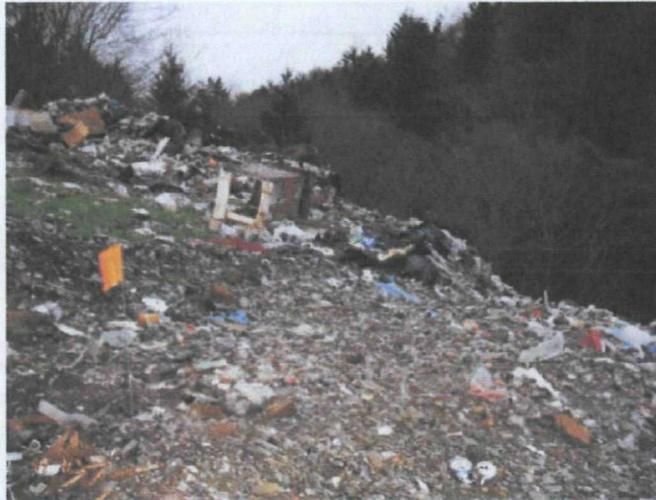
PHOTOGRAPH #13

Description: View of surface soil sample WB-15-SS, located on the southeast edge of upper dump area.

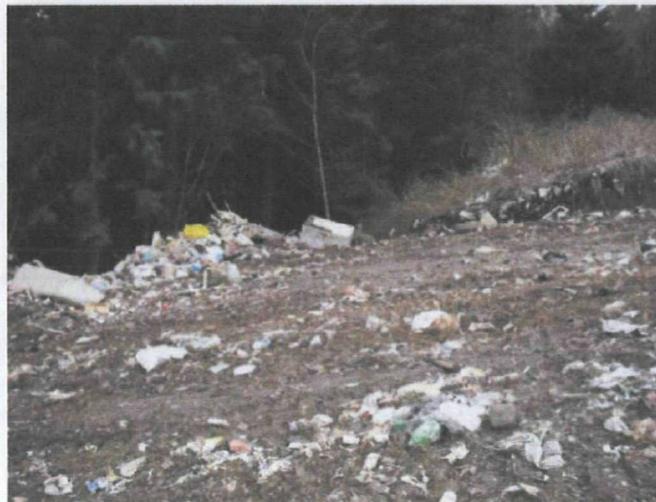
PHOTOGRAPH #14

Description: View of surface soil sample WB-16-SS, located 50' from the edge of the pushed dump.

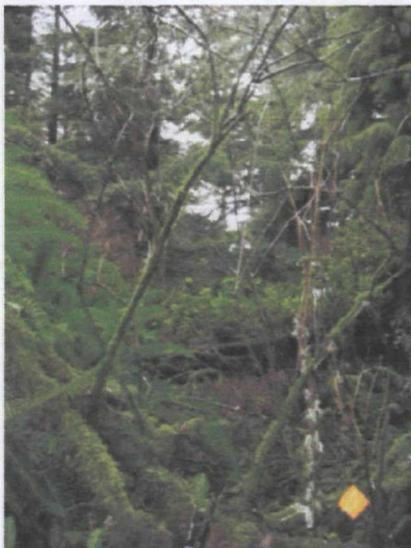
PHOTOGRAPH #15

Description: View of surface water and sediment samples WBW-04-SW/SD, located 800' downstream from west creek headwater.

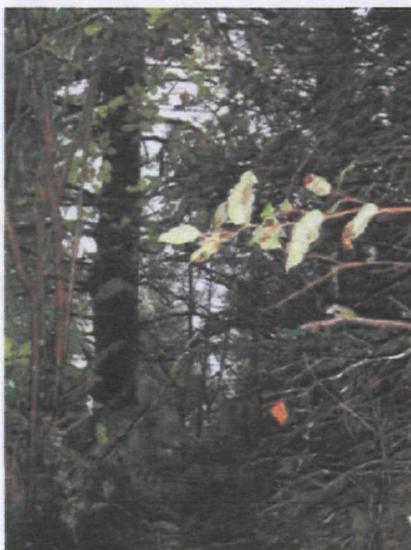
PHOTOGRAPH #16

Description: View of surface water and sediment samples WBW-05-SW/SD, located 18' upstream of waterfall that drops roughly 125' to beach access.
