**ASSESSMENT REPORT
FOR
BAY HARBOR LAKE
BAY HARBOR RESORT
RESORT TOWNSHIP, EMMET COUNTY, MICHIGAN**

BAY HARBOR LAKE ASSESSMENT TEAM

WESTON SOLUTIONS, INC.
2501 Jolly Road, Suite 100
Okemos, Michigan 48864

JUNE 2007

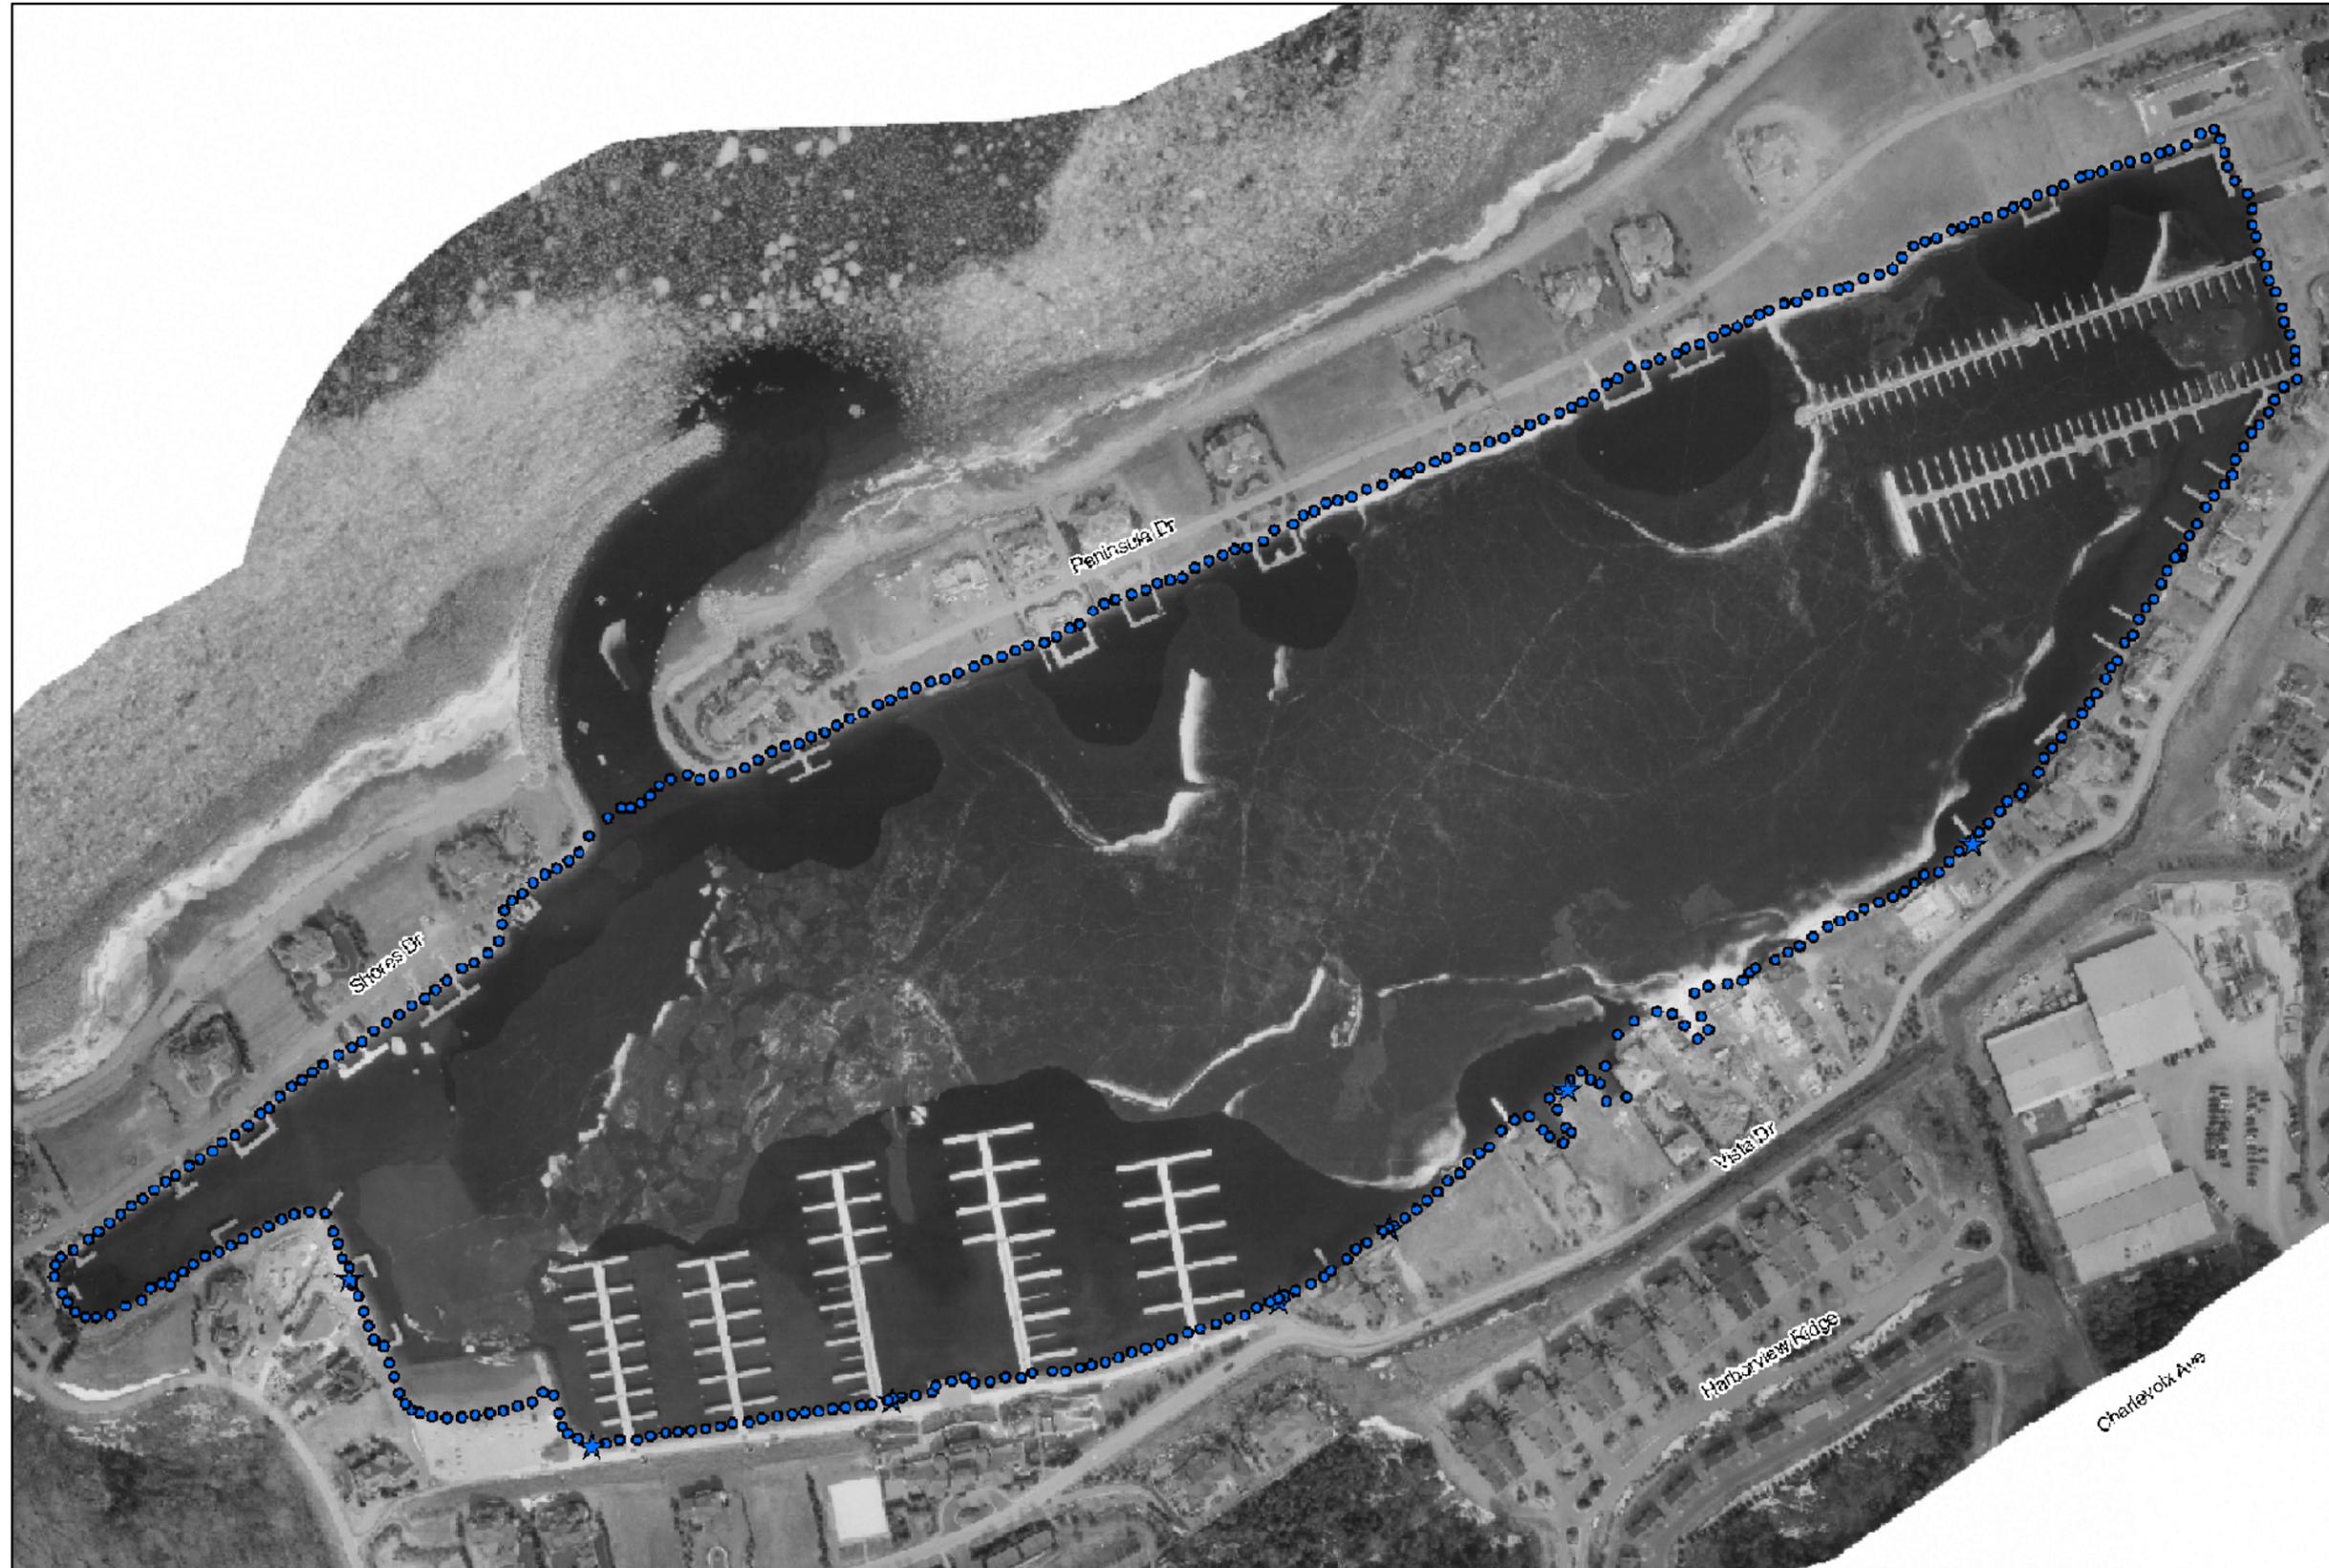
Figure:
2

Shoreline Survey
Bay Harbor Lake
May, 2006
Little Traverse Bay CKD Site
Petoskey, Michigan

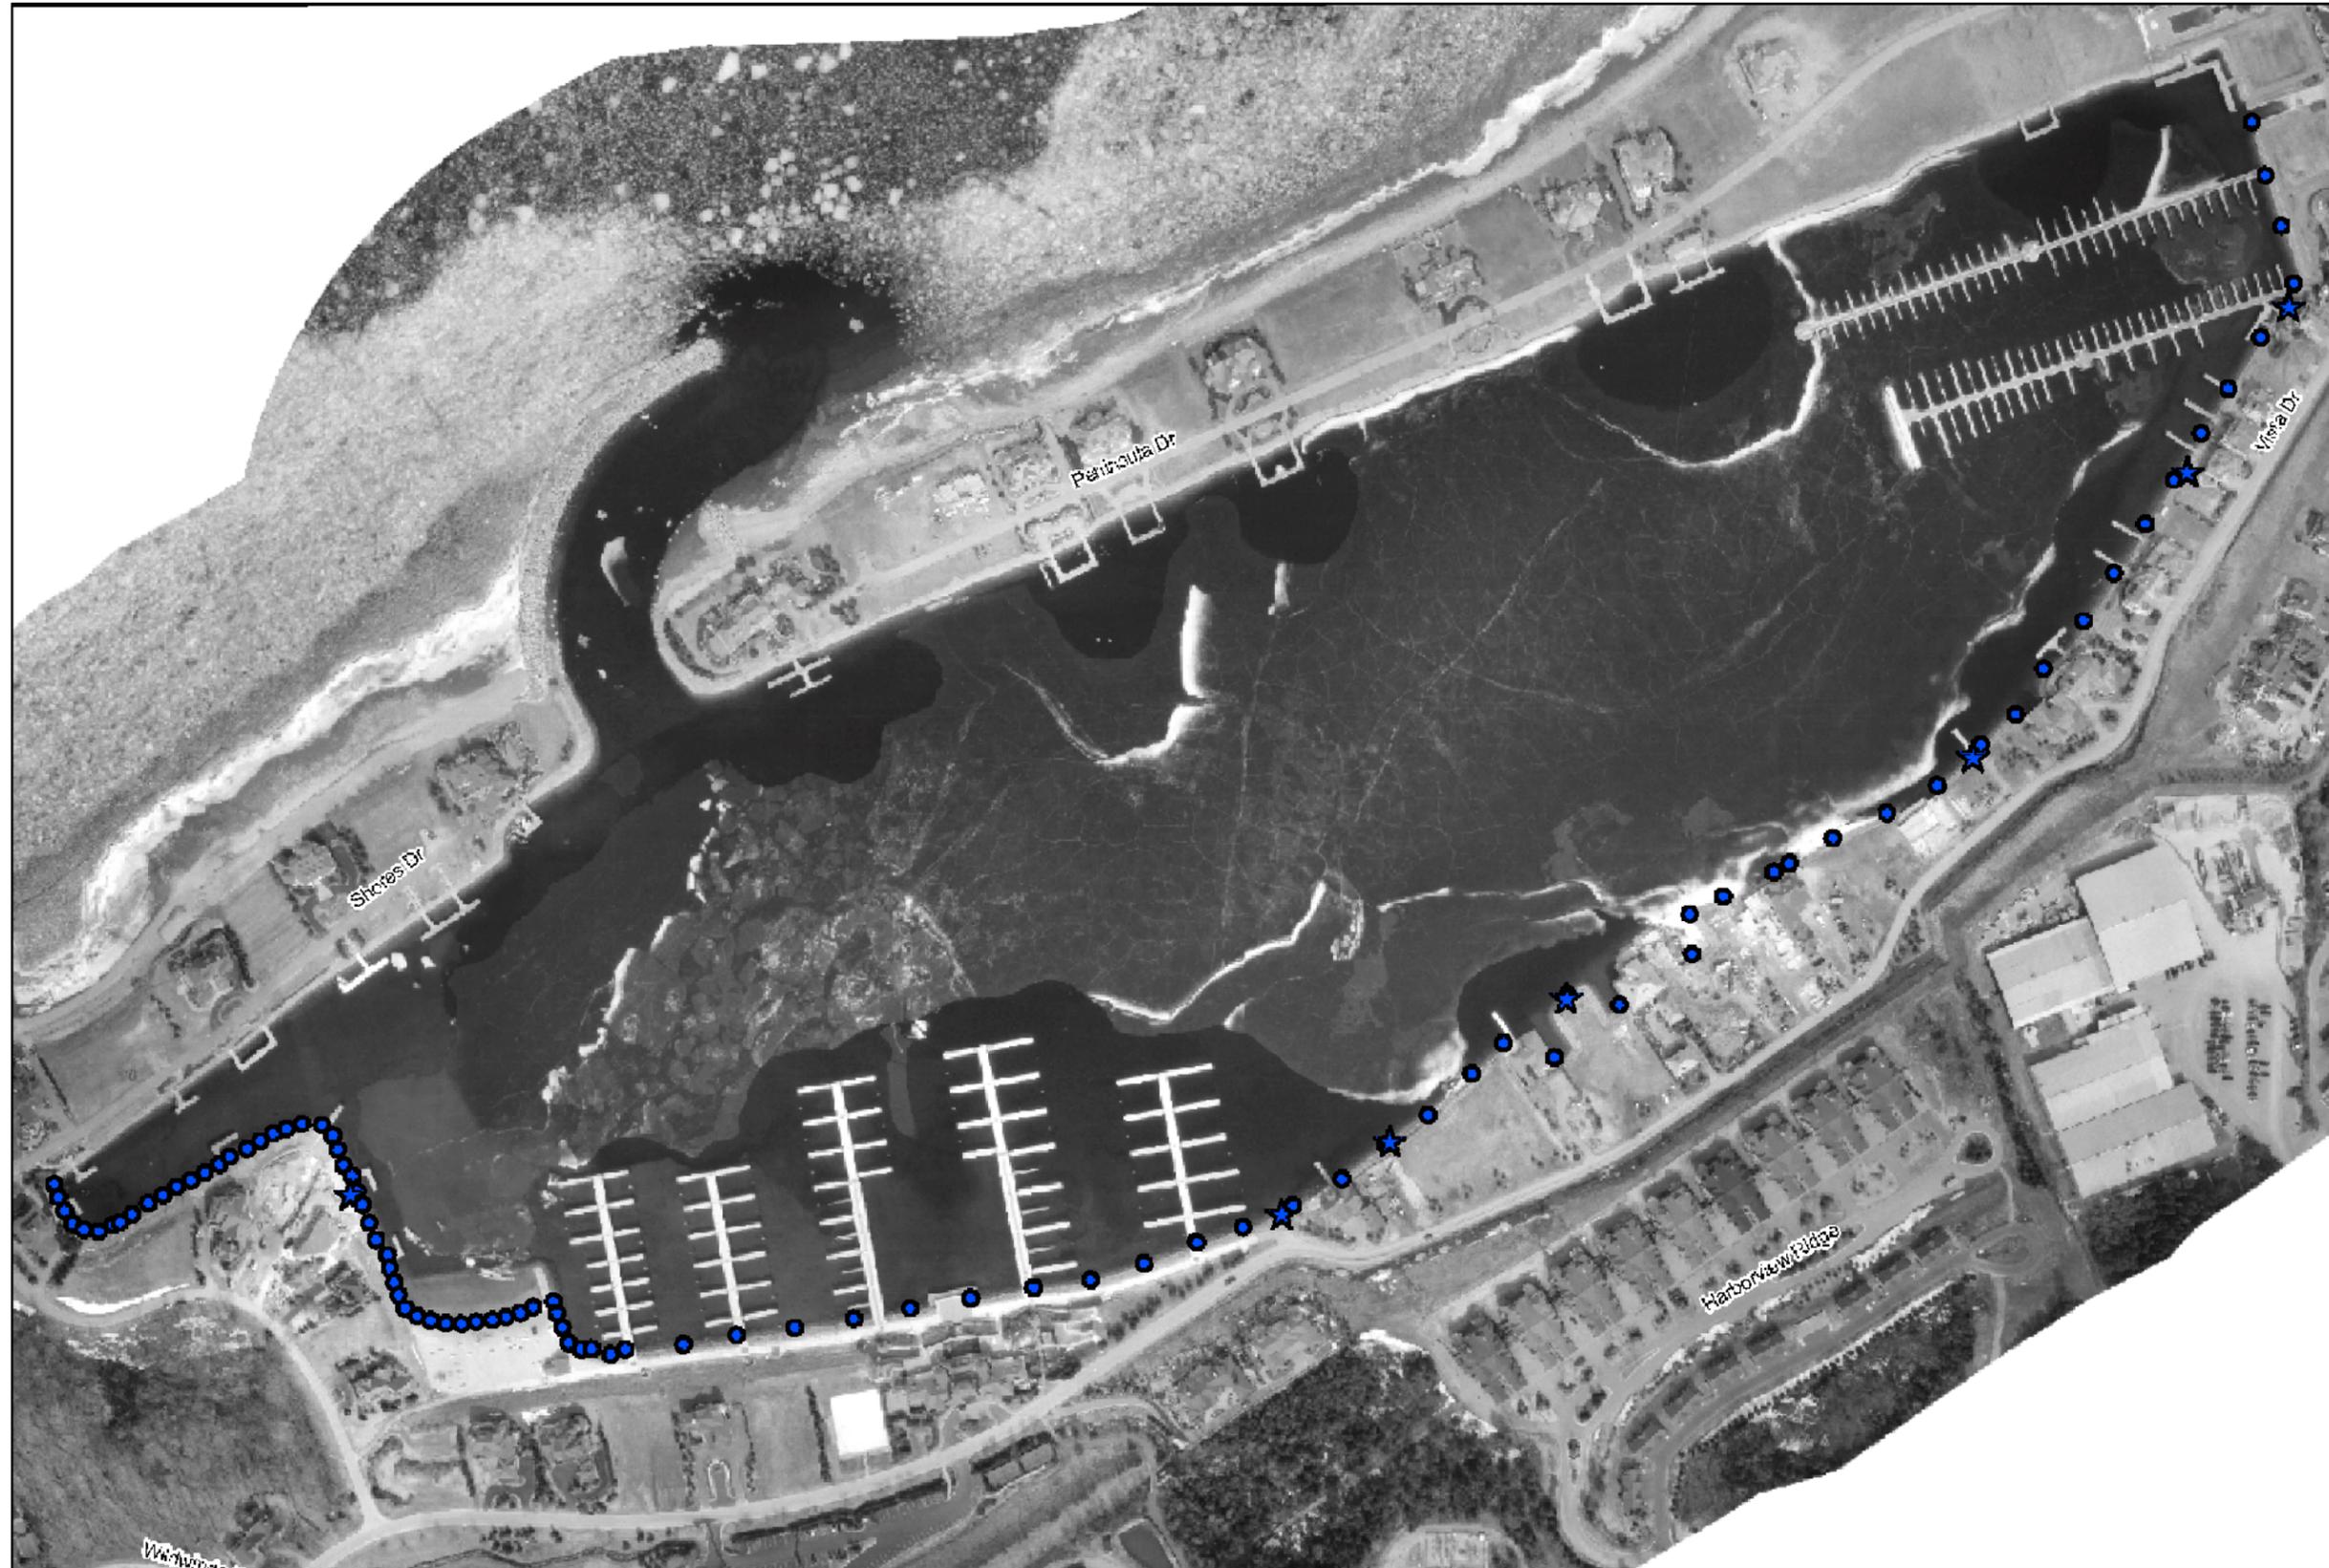
Figure:
3

Shoreline Survey
Bay Harbor Lake
October, 2006
Little Traverse Bay CKD Site
Petoskey, Michigan

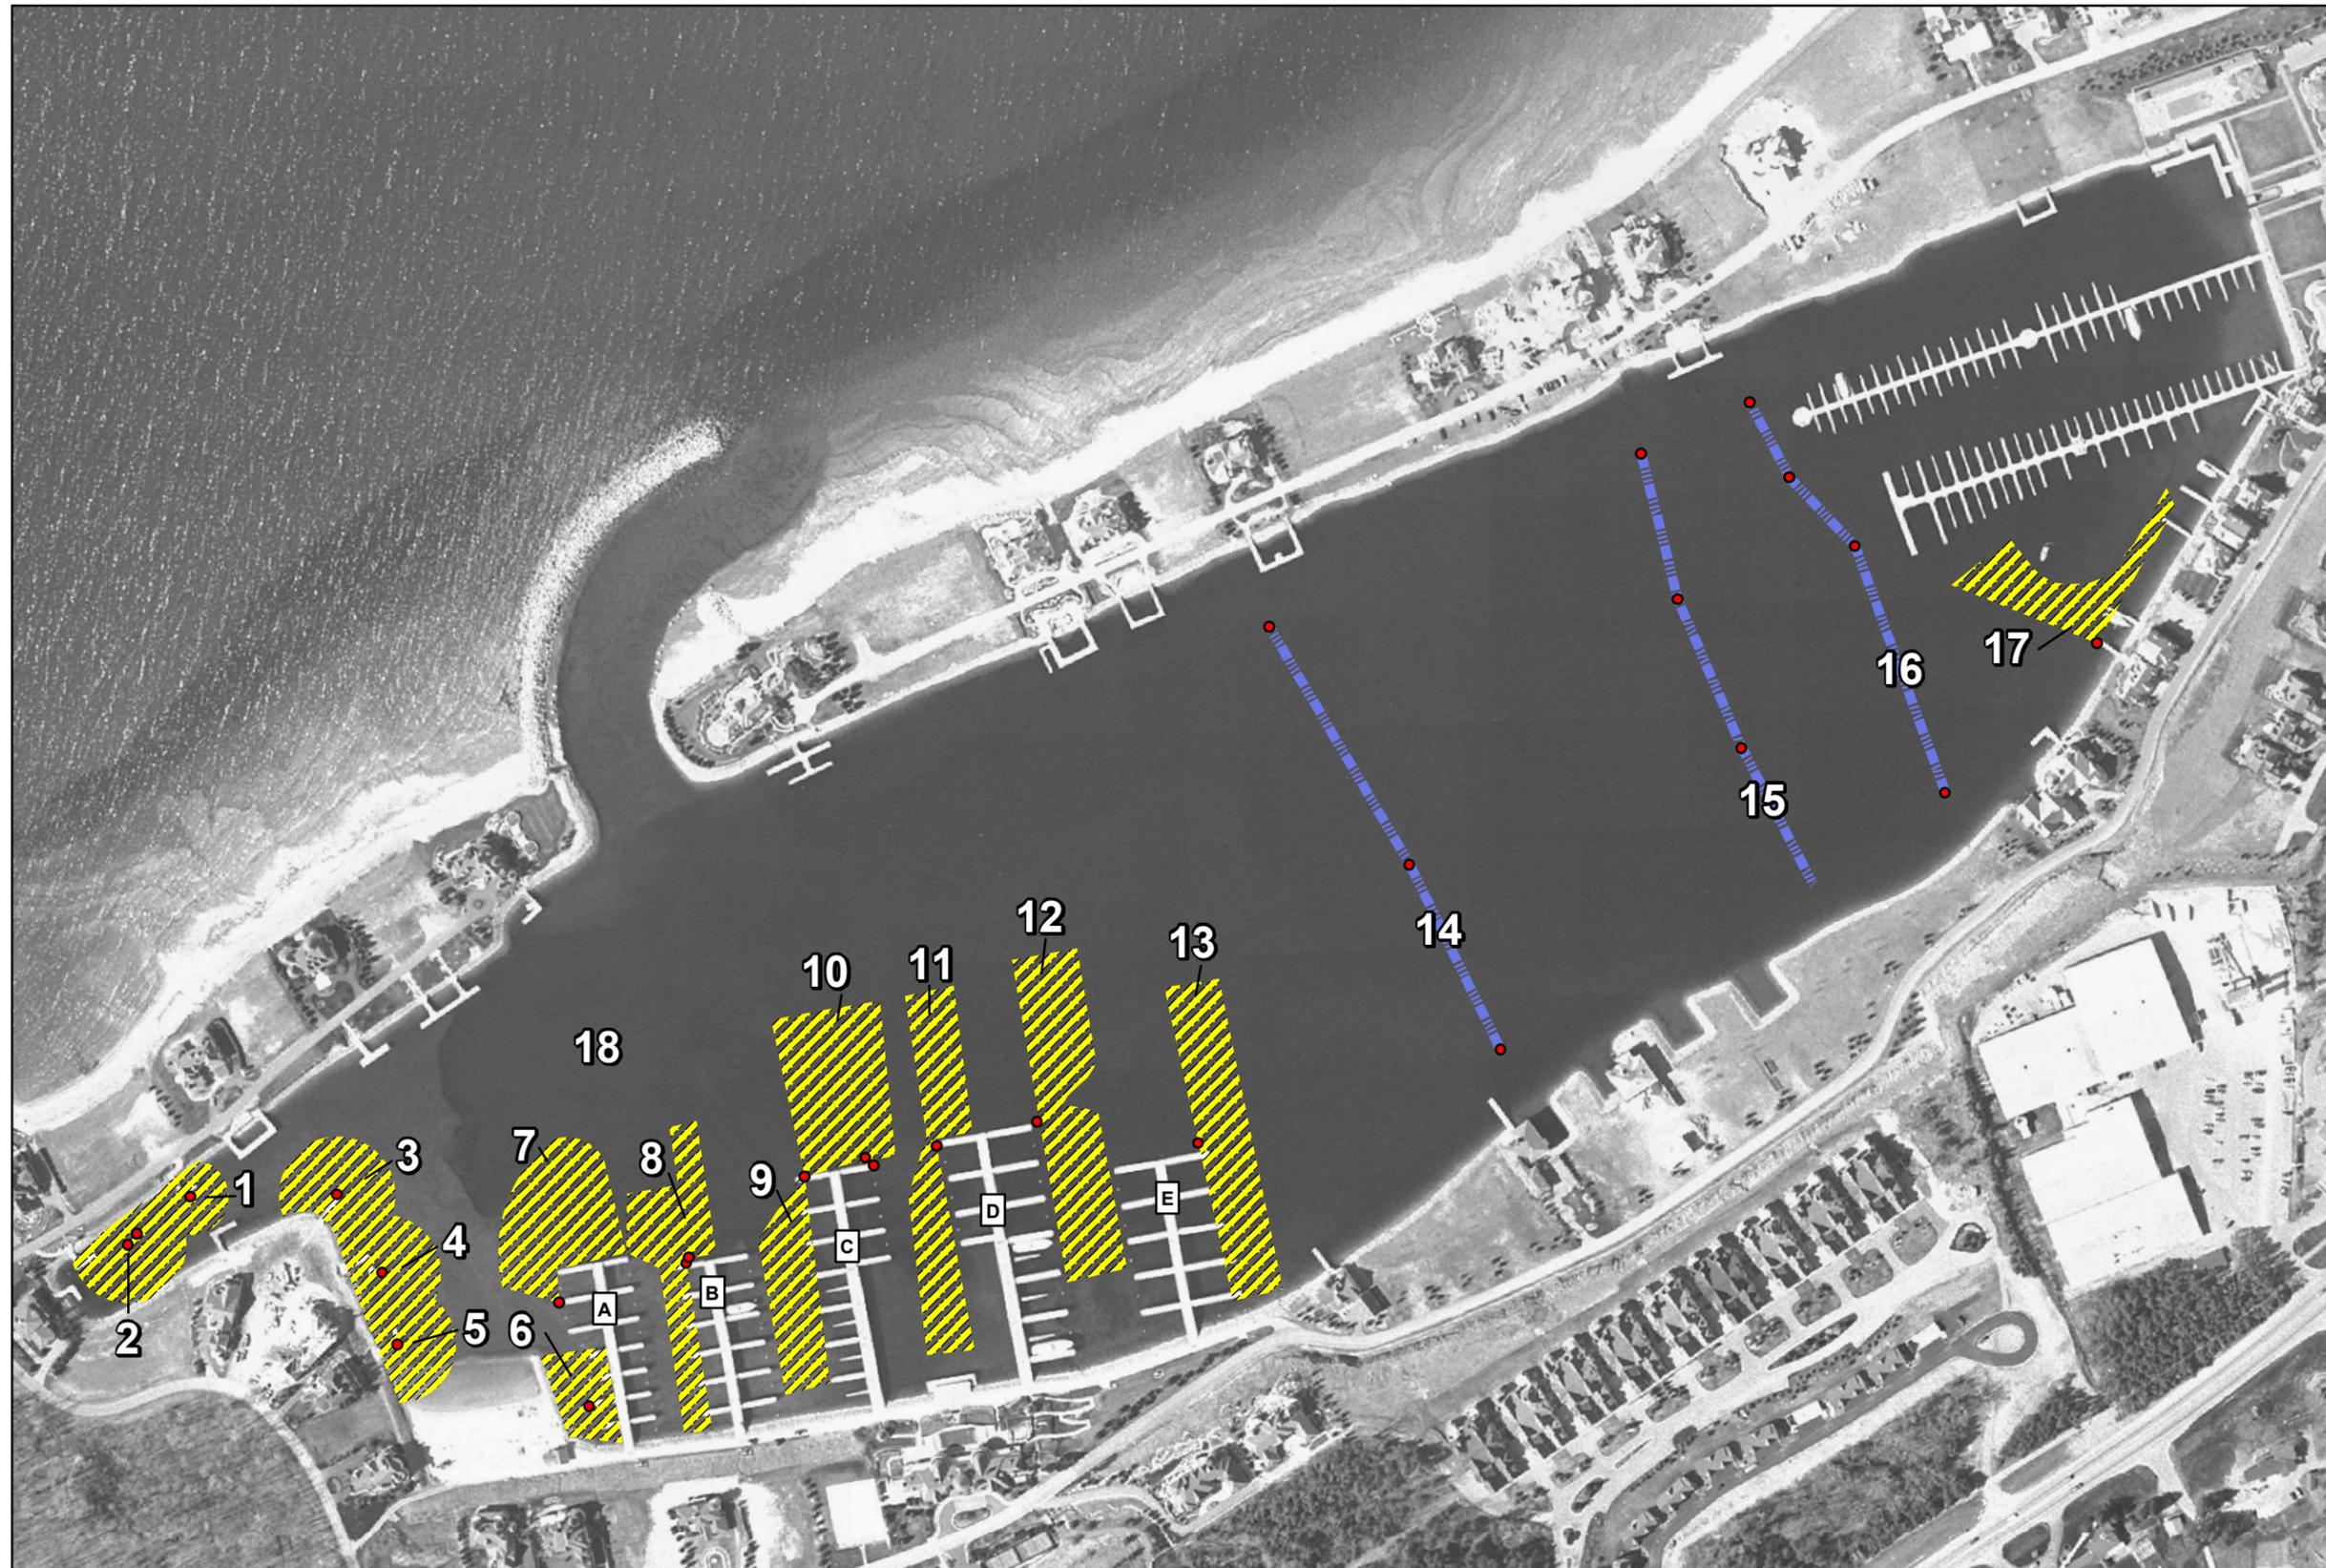
Figure:
4

Dive Survey
Bay Harbor Lake
June, 2006
Little Traverse Bay CKD Site
Petoskey, Michigan

Fourteen dives totaling 482 minutes were conducted in the vicinity of the Bay Harbor Yacht Club piers (Figure 4 and Table 3, Dives 6-13 and Dive 18; Figure 5 and Table 4, Dives 5-8). The depth in this area ranged from 10 to 41 feet and the visibility was typically greater than 25 feet. The area between the piers is relatively flat with a uniform bottom, and the deeper areas were found near the central and eastern piers (Piers C, D, and E). The bottom consists of a 2- to 6-inch layer of silty sand over a hard packed gravel and rock substrate with an occasional gravel to softball-sized piece of rock or construction debris. As observed in the western area, small patches of disturbed and discolored sediment caused by the feeding activity of fish were noted throughout this area. In the central portion of the pier area, a forested patch remains and remnants of rooted trees rise 20 feet or more above the lake bottom.

In June, one dive totaling 36 minutes (Figure 4 and Table 3, Dive 17) was conducted around the floating dock area in the western portion of Bay Harbor Lake. This area was not surveyed during the October deployment. Although the maximum depth noted was 66 feet, the typical lake depth in the dock area was 30 feet or less. The bottom in this area was flat with little relief. The visibility was less than 25 feet because the sky was heavily overcast with light rain so there was less available light than during other dives. The sediment consisted of a ½- to 1-inch layer of silty sand over a hard packed gravel and rock substrate. The color of the sediment was light tan to brown and the bottom was flat and featureless. The rock and other structures throughout the area were covered with a thick biofilm and inorganic sediment.

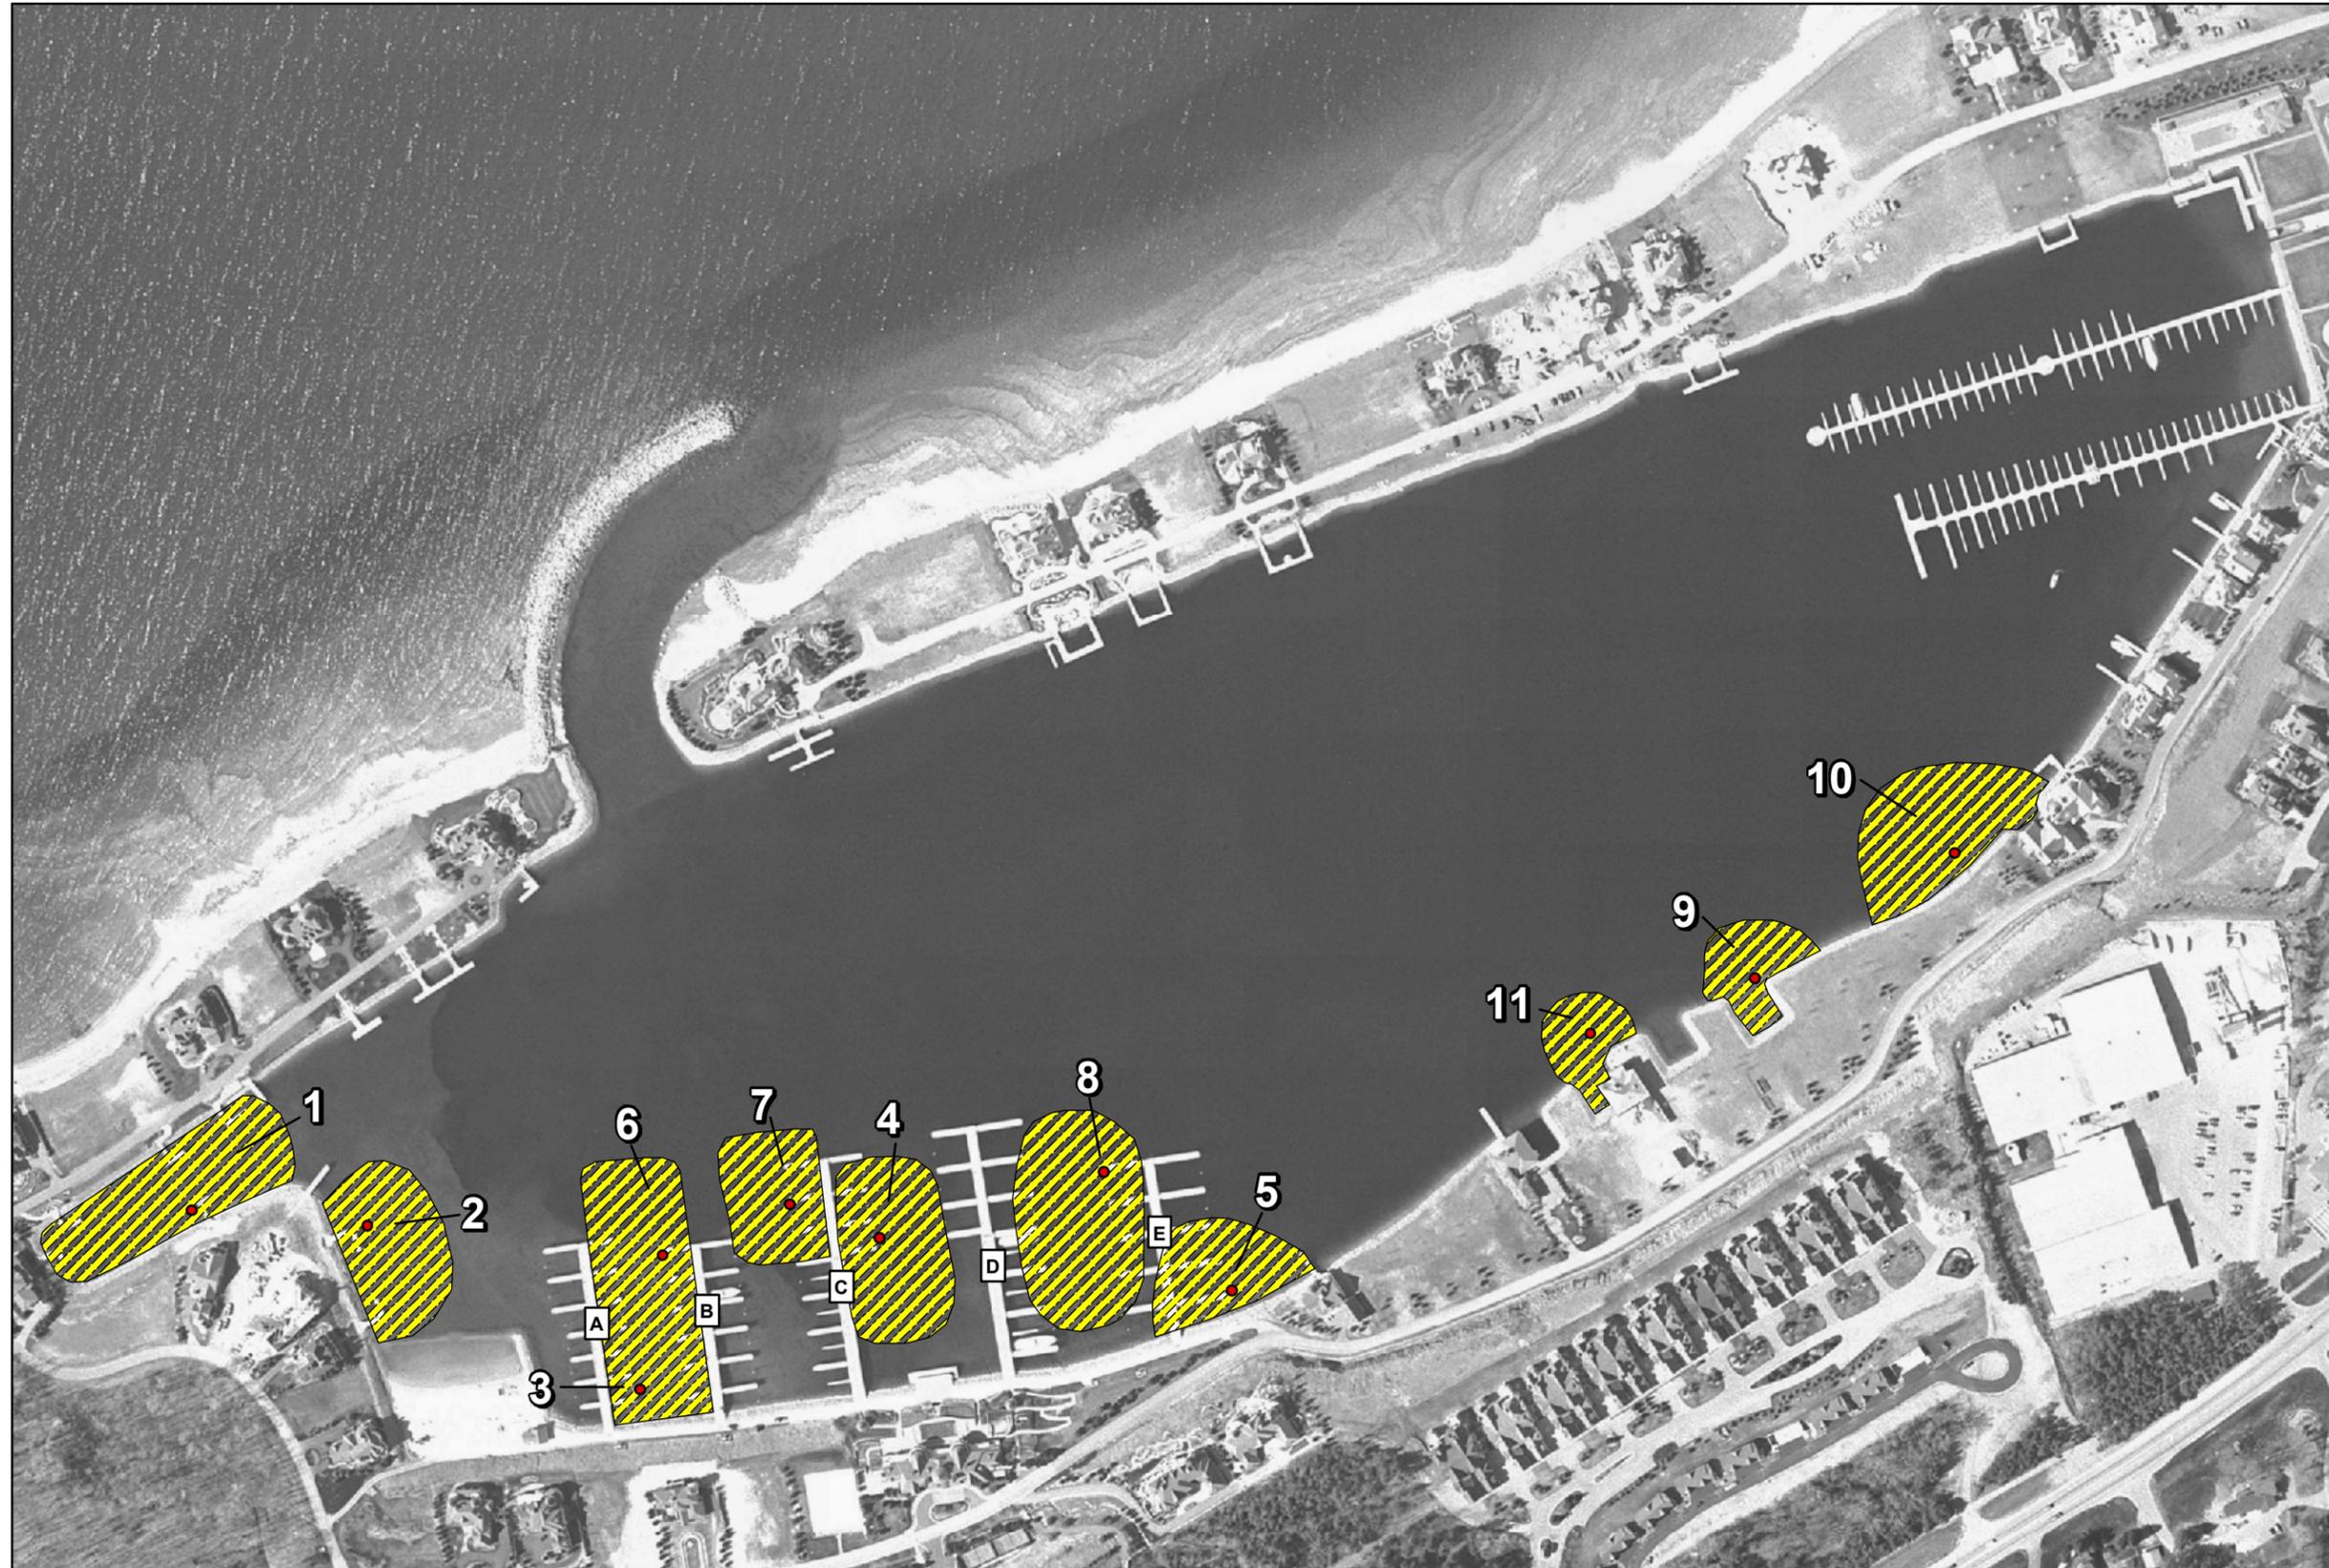
Dive Survey
Bay Harbor Lake
October, 2006
Little Traverse Bay CKD Site
Petoskey, Michigan

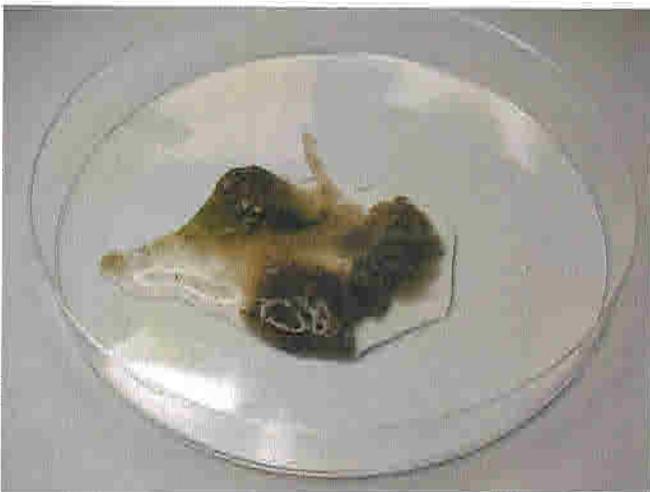
Figures 1 and 2 identify the appearance of the greenish-brown slimy material in the base of the petri dish. In comparison, Figure 3 presents an image of the same material recovered from bottom debris at Bay Harbor Lake immediately following sample collection. As an environmental microbiologist, it is my opinion that the sample received at the laboratory is very similar in color and structure to that shown on Figure 3. Digital images of the sample taken at the laboratory were obtained with a Nikon Coolpix 4500 camera.

Figure 1. Macroscopic image of gelatinous, slimy material in petri plate (Bay Harbor Lake sample, March 2006).

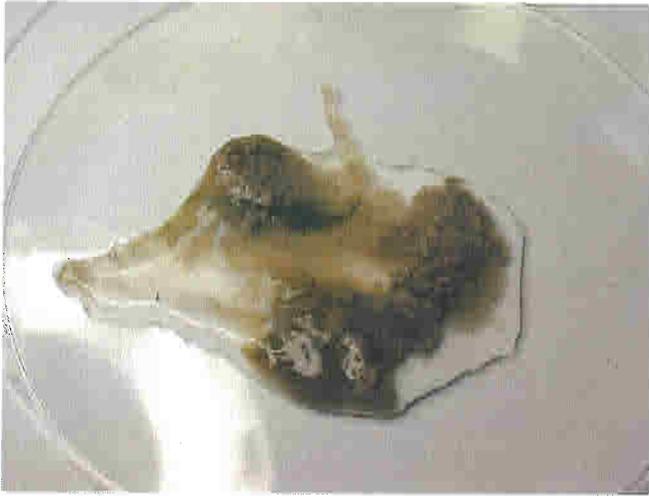
Figure 2. Macroscopic image of gelatinous, slimy material, close up (Bay Harbor Lake sample, March 2006).

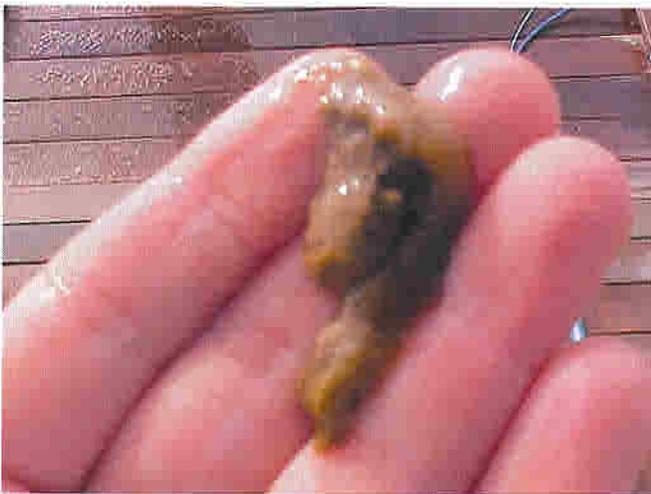
Figure 3. Macroscopic image of gelatinous, slimy material as observed immediately following sampling (Bay Harbor Lake sample, March 2006).

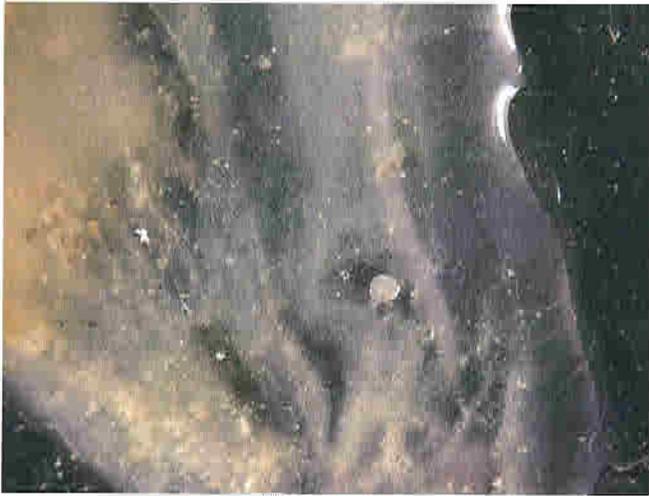
Following initial observation of the sample in the petri plate, the digital camera was fitted to a Nikon SMZ-1B stereomicroscope for examination at 8 to 35 × magnifications. Figure 4 shows the gelatinous, slimy material as it separates from the algal growth. Figure 5 shows that the gelatinous, slimy material is composed of a water mold. The large opaque spherical object to the right of the image is the sexual form of the mold. *Allomyces* can produce gametangia (sex cells) that appear very similar to what is observed in the sample.

Figure 4. Image of sample as observed with the stereomicroscope and black background at 8 × magnification (Bay Harbor Lake sample, March 2006)

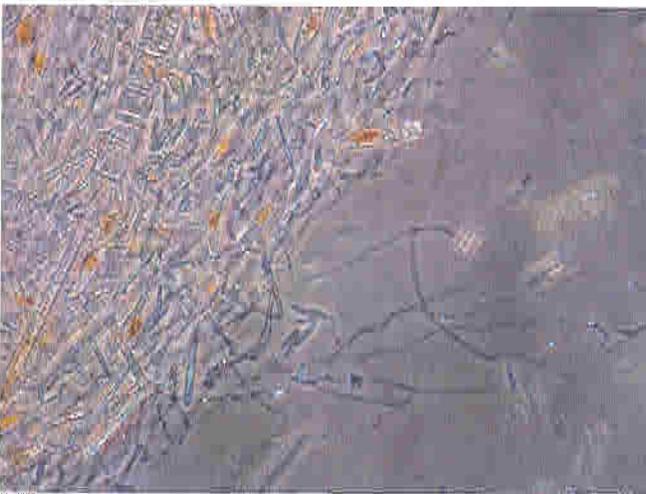
Figures 6, 7, and 8 show the hyphae of the water mold with the green algae filaments and the diatoms amongst the gelatinous material at a magnification of 400 ×. Further examination at 1000 × magnification shows the water mold hyphae.

Figure 6. Microscopic image using phase contrast microscopy at 400 × magnification (Bay Harbor Lake sample, March 2006).

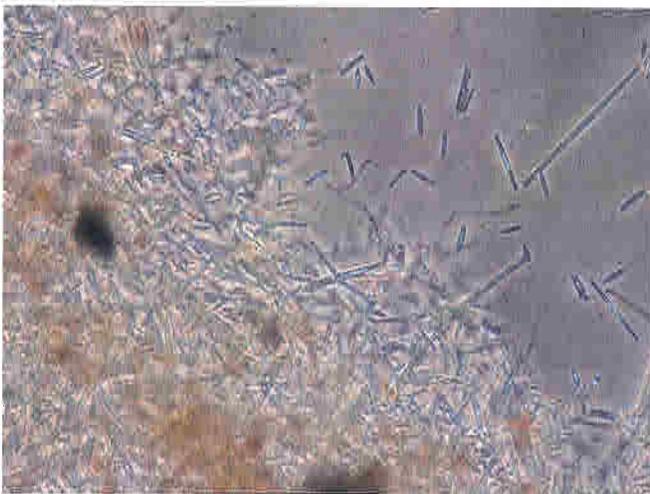
Figure 7. Microscopic image of diatoms using phase contrast microscopy at 400 × magnification (Bay Harbor Lake sample, March 2006).

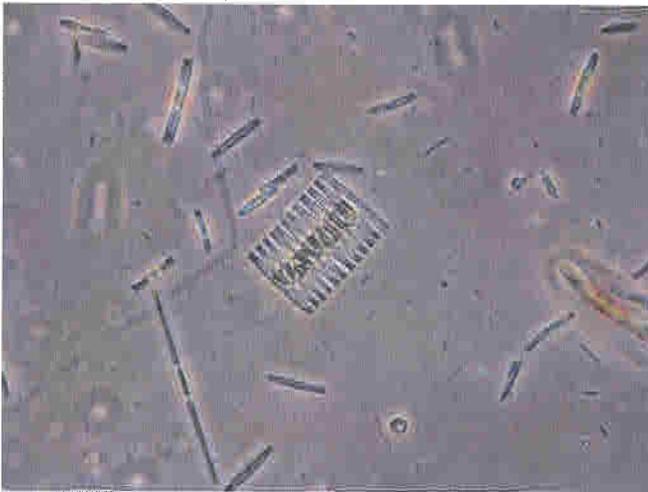
Figure 9 shows the predominant diatoms in the sample at 1000 × magnification. Figure 10 again shows the gelatinous, slimy mass of hyphae of the water mold observed growing on the stones, pebbles, etc. on the bottom of Bay Harbor Lake.

Figure 9. Microscopic image of diatoms as observed at 1000 × magnification (Bay Harbor Lake sample, March 2006).

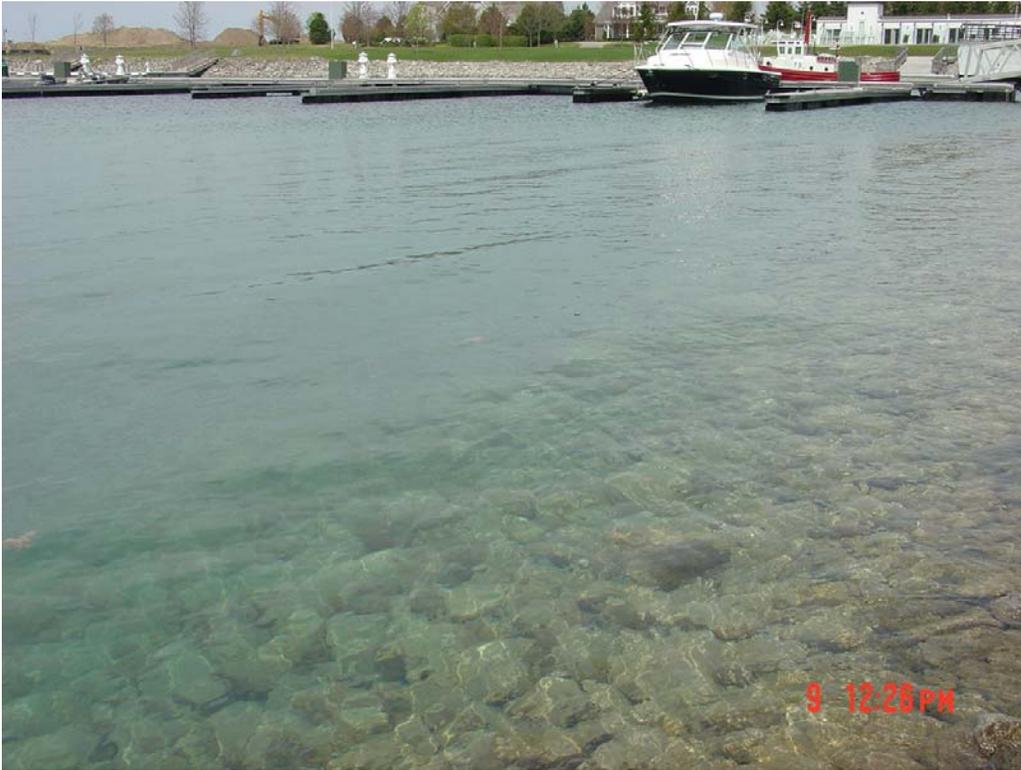
Photo Description: Shoreline conditions observed during May 2006 Shoreline Survey.

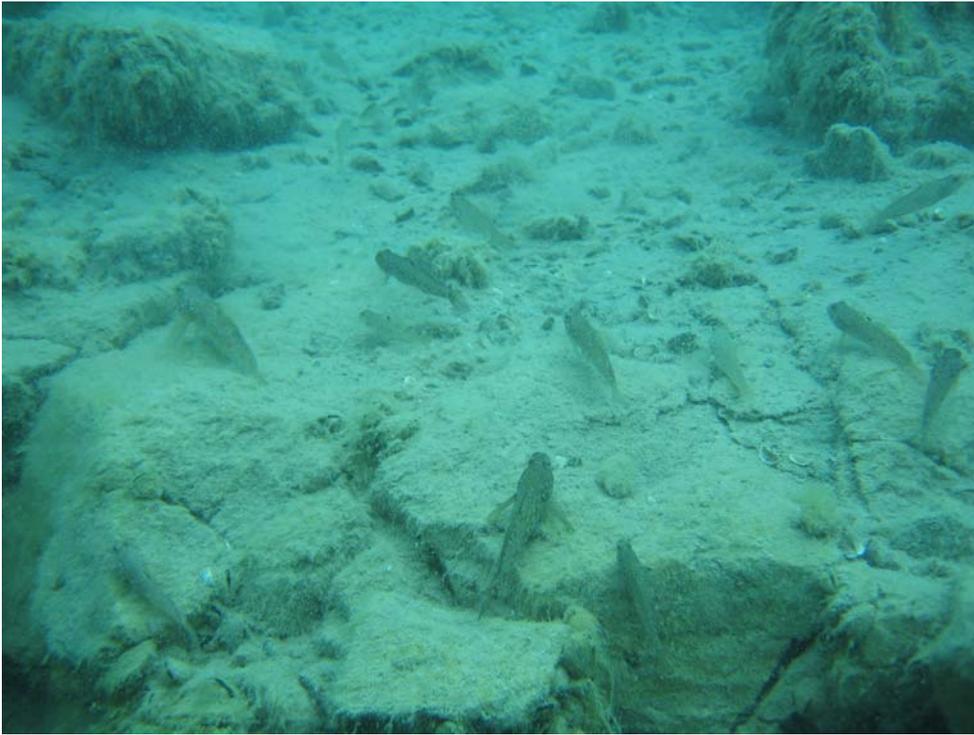
Photo Description: Observation along bottom of Bay Harbor Lake – June 2006.
