Reference: EPA Contract No. EP-W-07-074; TechLaw Task Order No. R05033; EPA Task Order No. EP-G10S-00032; Final Field Sampling Activity Report; Carboline Company, Xenia, Ohio; Task 06 Deliverable

**FINAL FIELD SAMPLING ACTIVITY REPORT
FOR
CARBOLINE COMPANY
XENIA, OHIO**

Carboline Draft Field Sampling Activity Report

125 Fairground Road, Xenia, Ohio

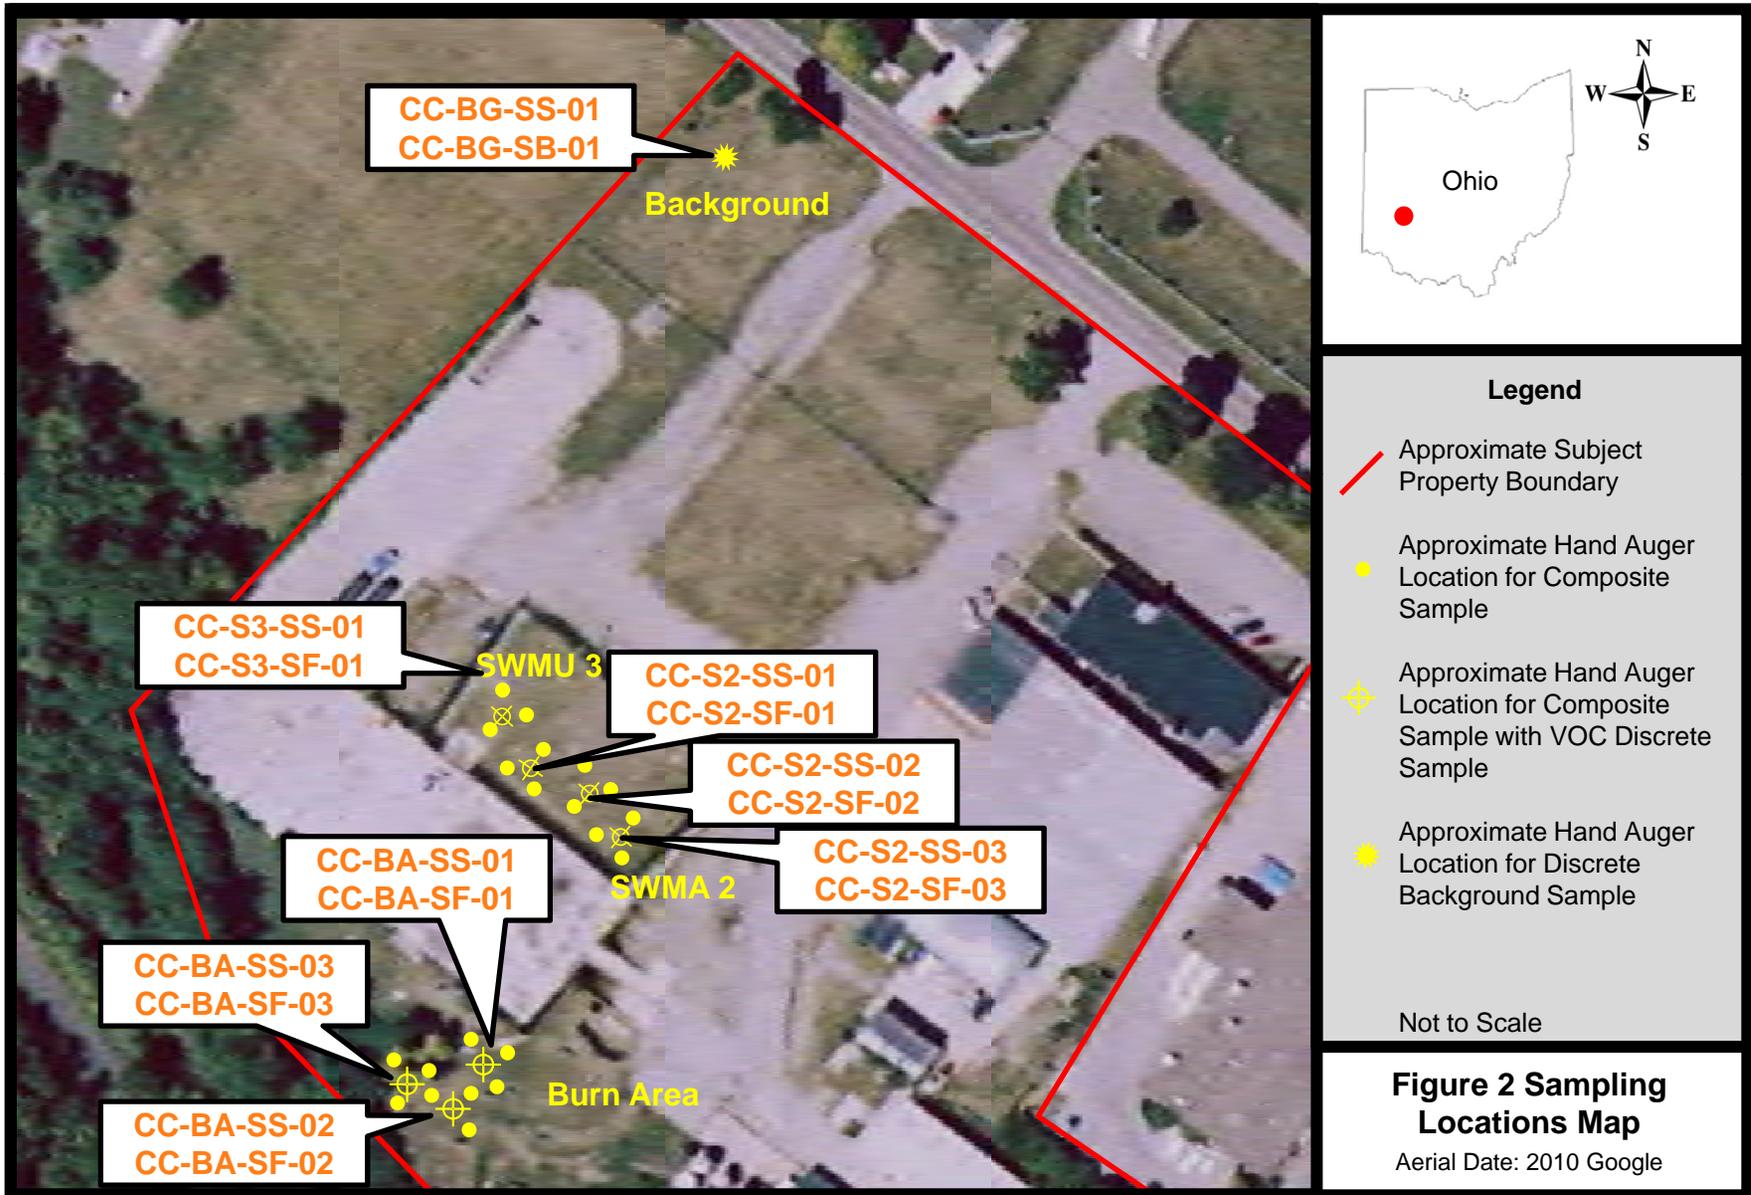
In total, TechLaw collected 18 soil samples at the Carboline Company facility; see Figure 2, Sampling Locations Map. TechLaw collected surface soils with a hand auger from approximately 0 to 12 inches below ground surface (bgs) and subsurface soils from approximately 2 to 3 feet bgs using a hand auger. Composite samples for non-VOC analytes consisted of four aliquots per sample. For each composite, four hand auger locations were advanced to a total depth of approximately three feet bgs in a triangular pattern, with one location at the approximate center of the triangle. A discrete VOC soil sample was collected from the center location. Samples were collected to evaluate if releases to environmental media occurred as a result of historical operations at the Carboline site, and whether contaminants of concern were present at concentrations which exceed applicable EPA Regional Screening Levels (RSLs), see Table 1, Soil Analytical Results. Global Positioning System (GPS) Coordinates were also collected at each hand auger location; see Table 2, Hand Auger GPS Coordinates. A copy of the Field Log Book for the sampling event is presented in Attachment 1. A Photograph Log depicting the sampling activities is provided in Attachment 2. Chain of custody (COC) forms are provided in Attachment 3.

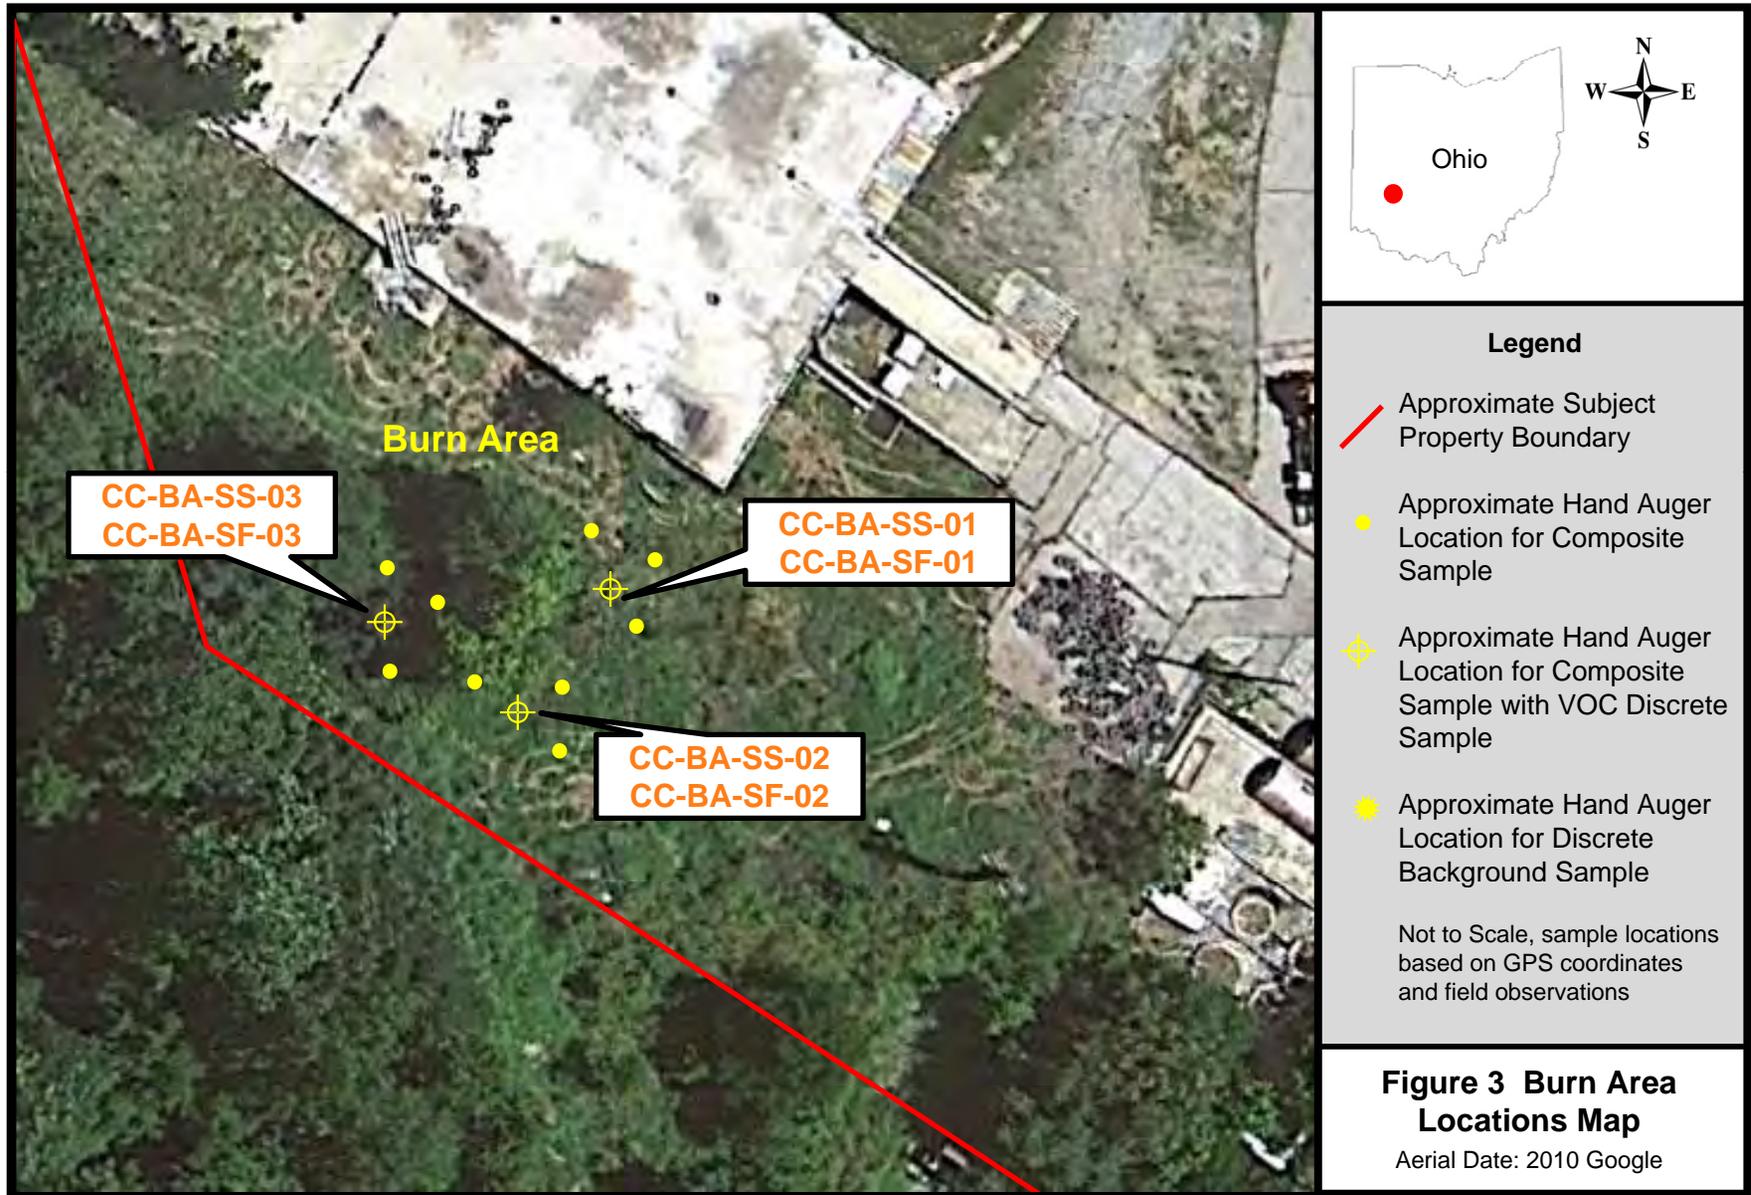
- three surface and three subsurface soil samples at the Burn Pit Area for a total of 6 samples, see Figure 3;
- three surface and three subsurface soil samples at SWMA 2 (drum area) for a total of 6 samples;
- one surface and one subsurface soil sample at SWMU 3 (tank area) for a total of 2 samples;
- a background surface and subsurface soil sample for a total of 2 samples,
- a duplicate surface and subsurface soil sample for a total of 2 samples; and,
- a rinsate sample.

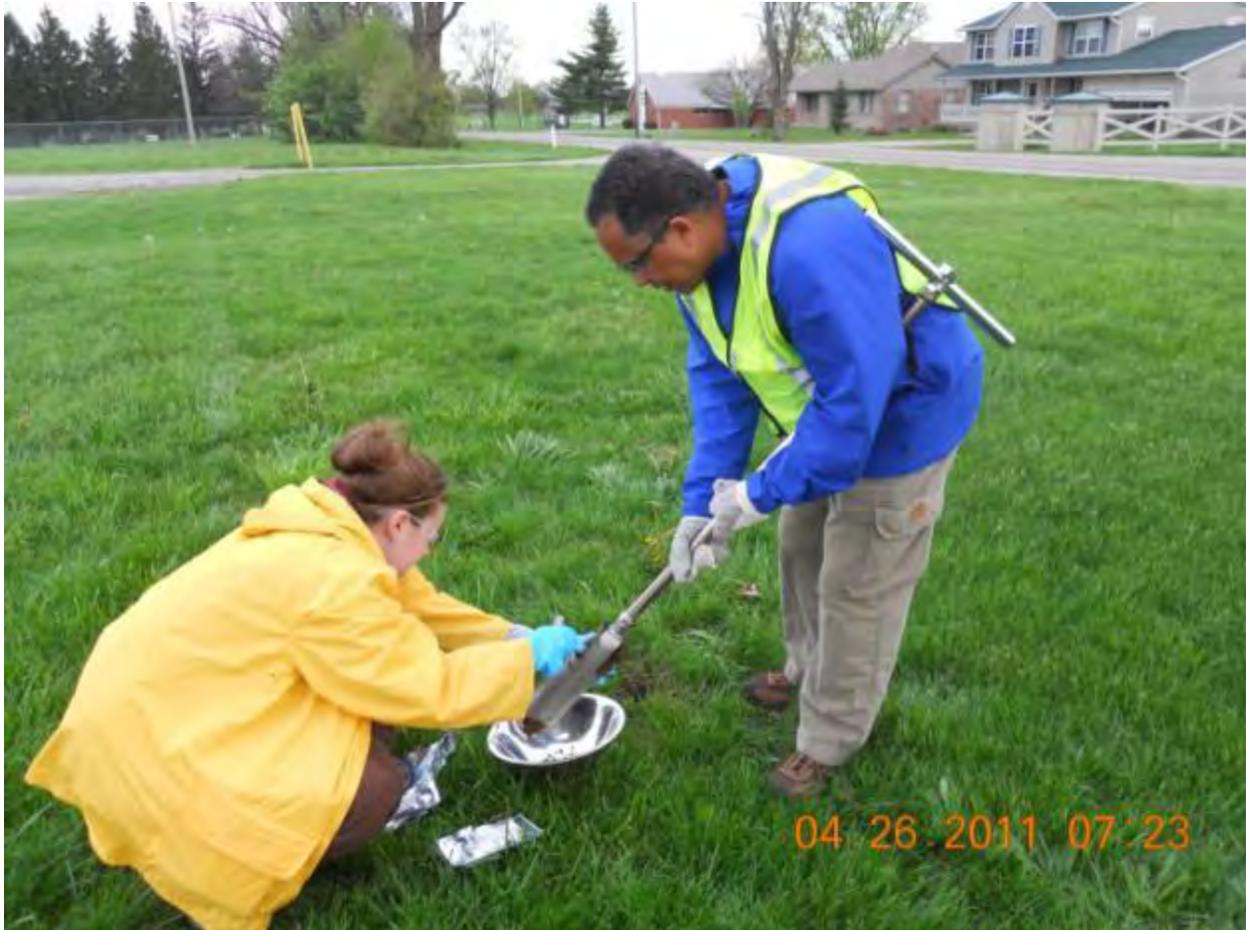
Photograph No. 1
Date: 04/26/11

View of En Core® sample being collected from hand auger at background sample location BG-01.

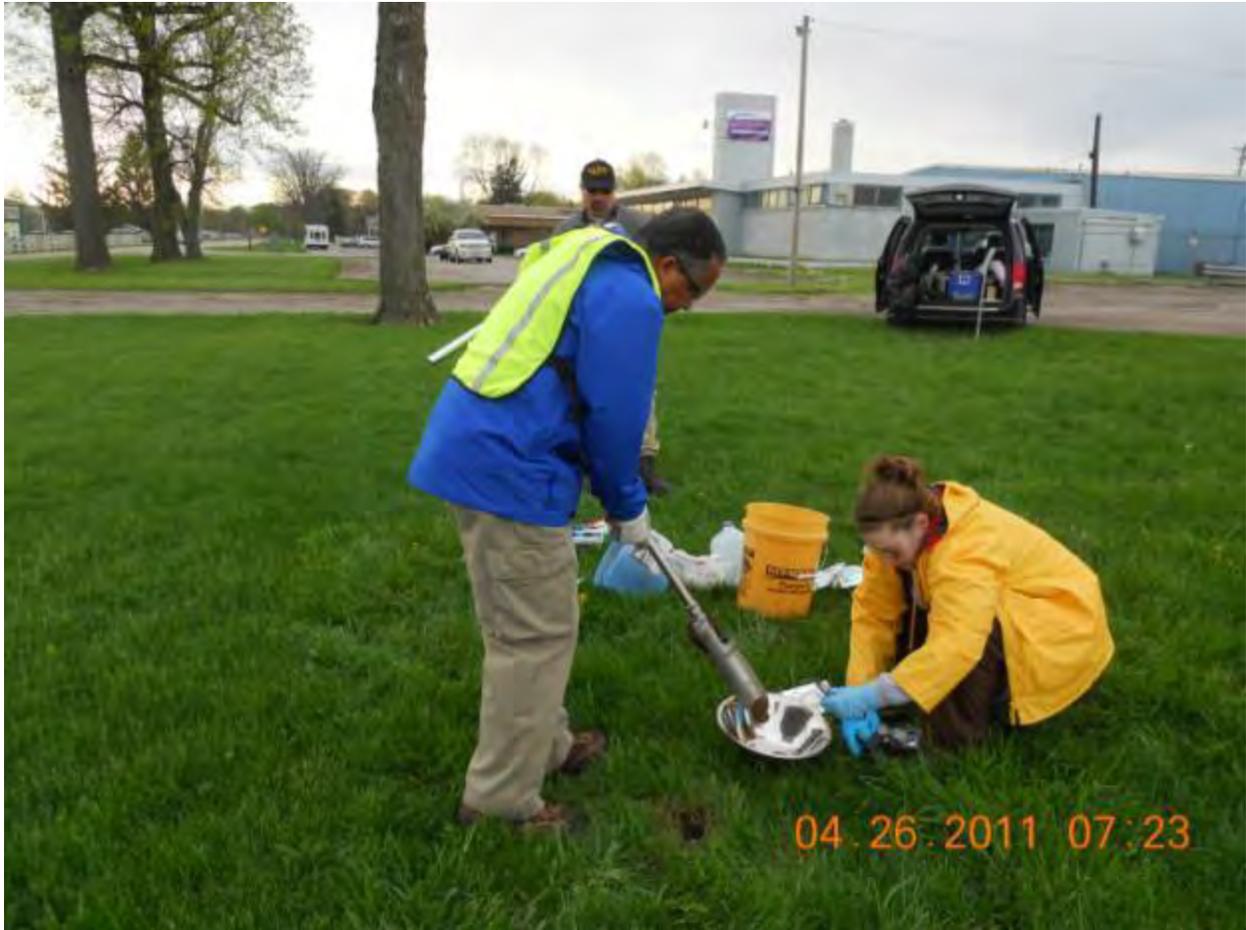
Photograph No. 2
Date: 04/26/11

View of En Core® sample being collected from hand auger at background sample location BG-01.

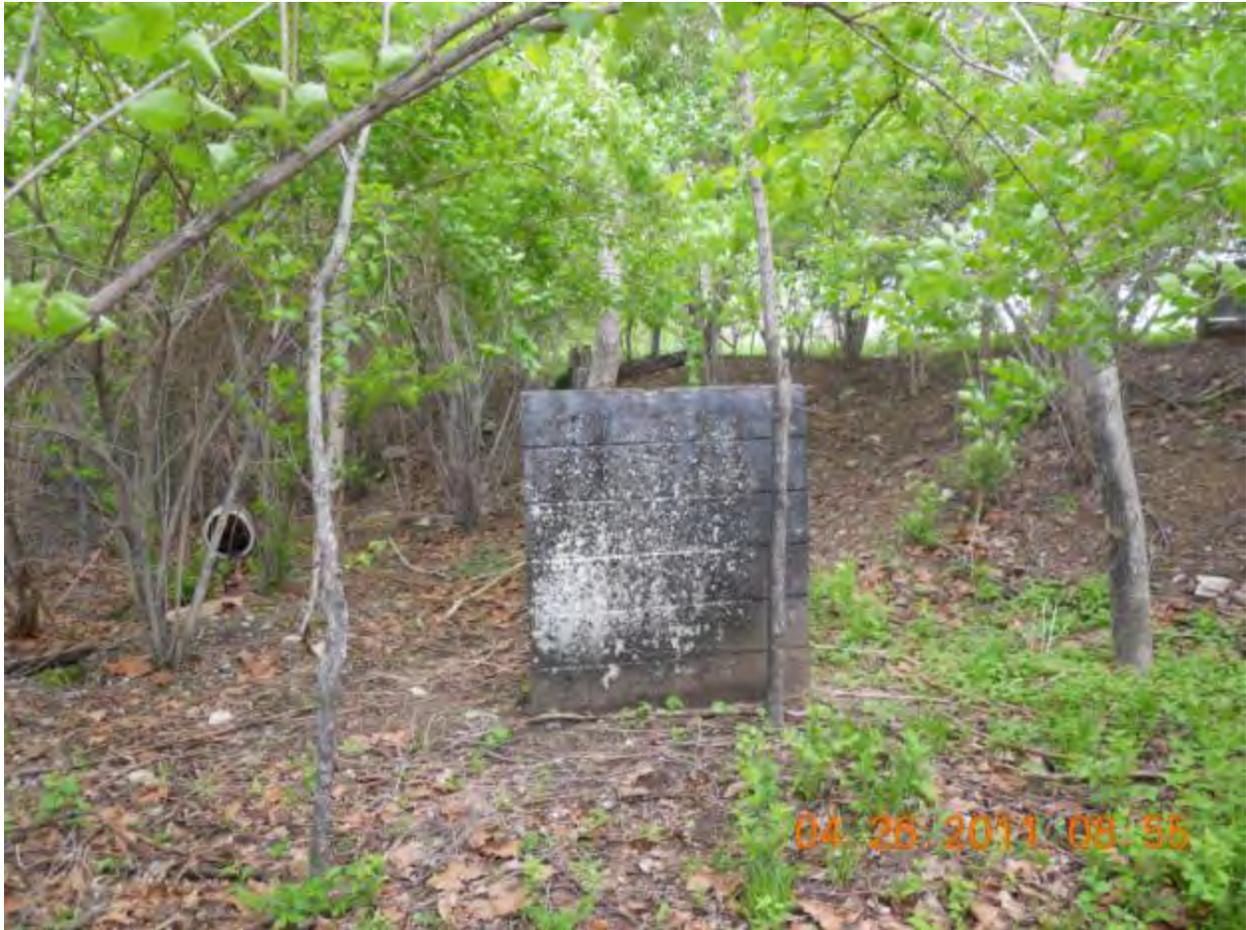
Photograph No. 3
Date: 04/26/11

View toward board near the burn area and fence at southwestern portion of property, which is likely used for paintball activities onsite.

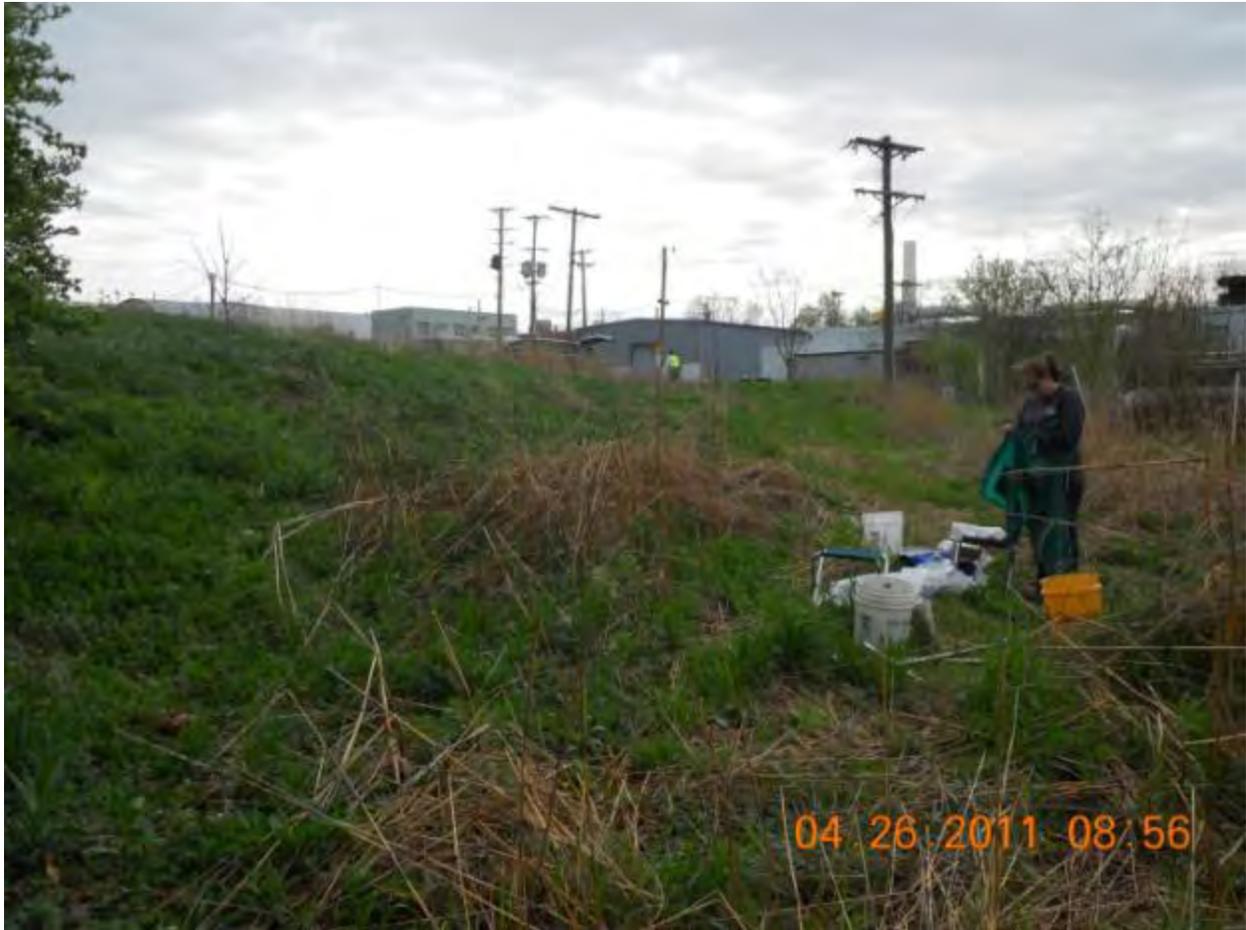
Photograph No. 4
Date: 04/26/11

View toward burn area at southwest portion of site near sample locations BA-01 and BA-02.

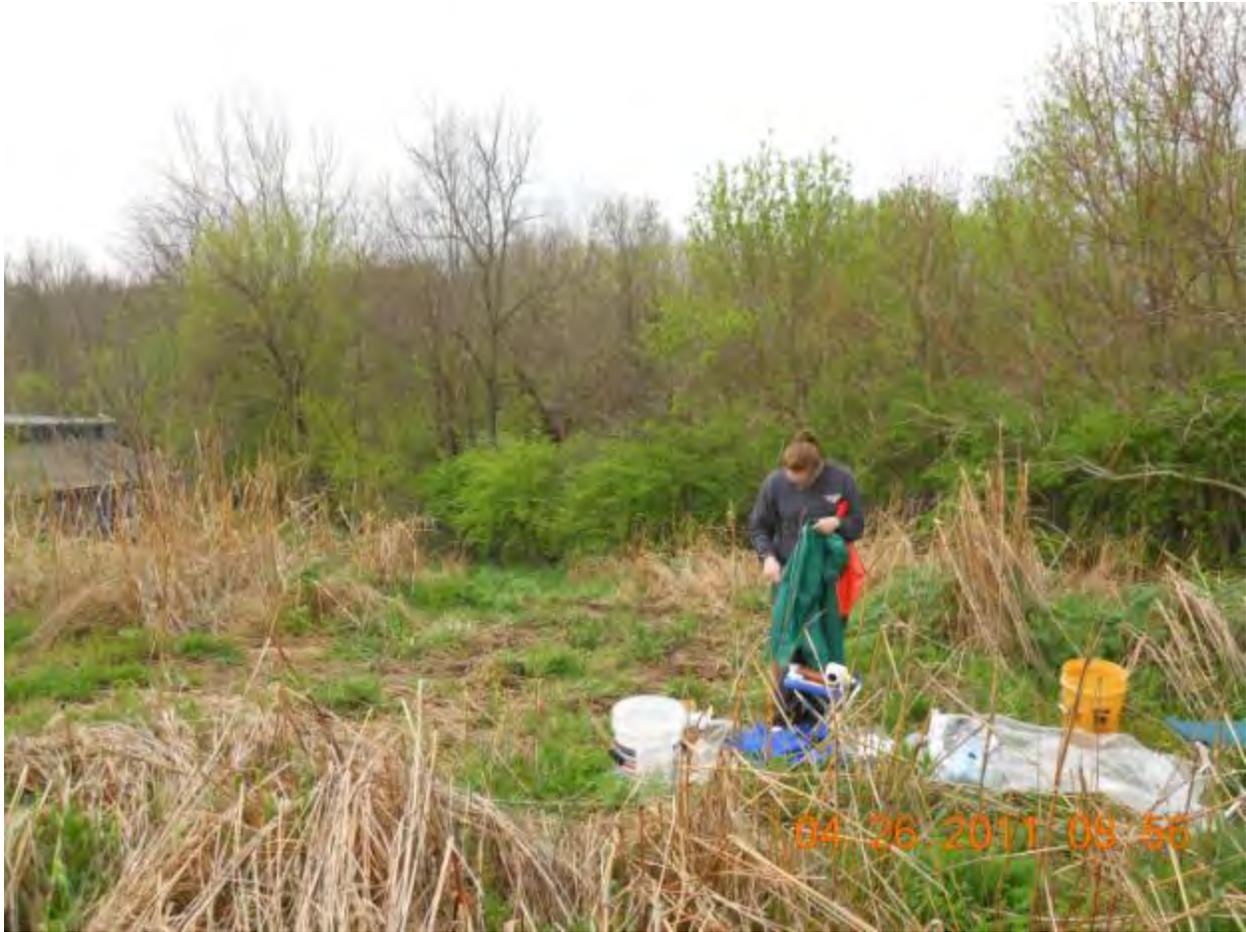
Photograph No. 5
Date: 04/26/11

View toward burn area at southwest portion of site near sample locations BA-01 and BA-02.

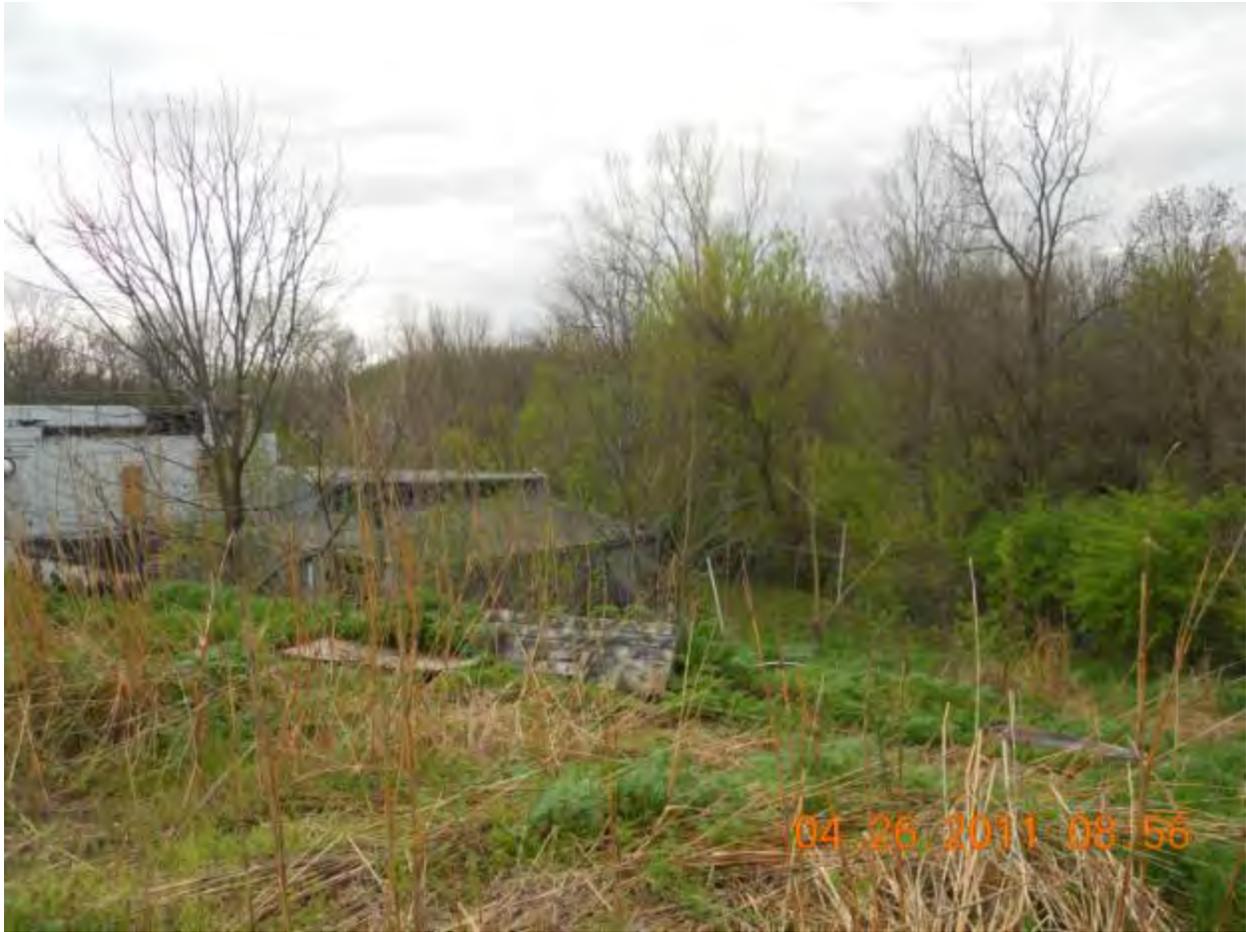
Photograph No. 6
Date: 04/26/11

View toward burn area at southwest portion of site near sample locations BA-01 and BA-02.

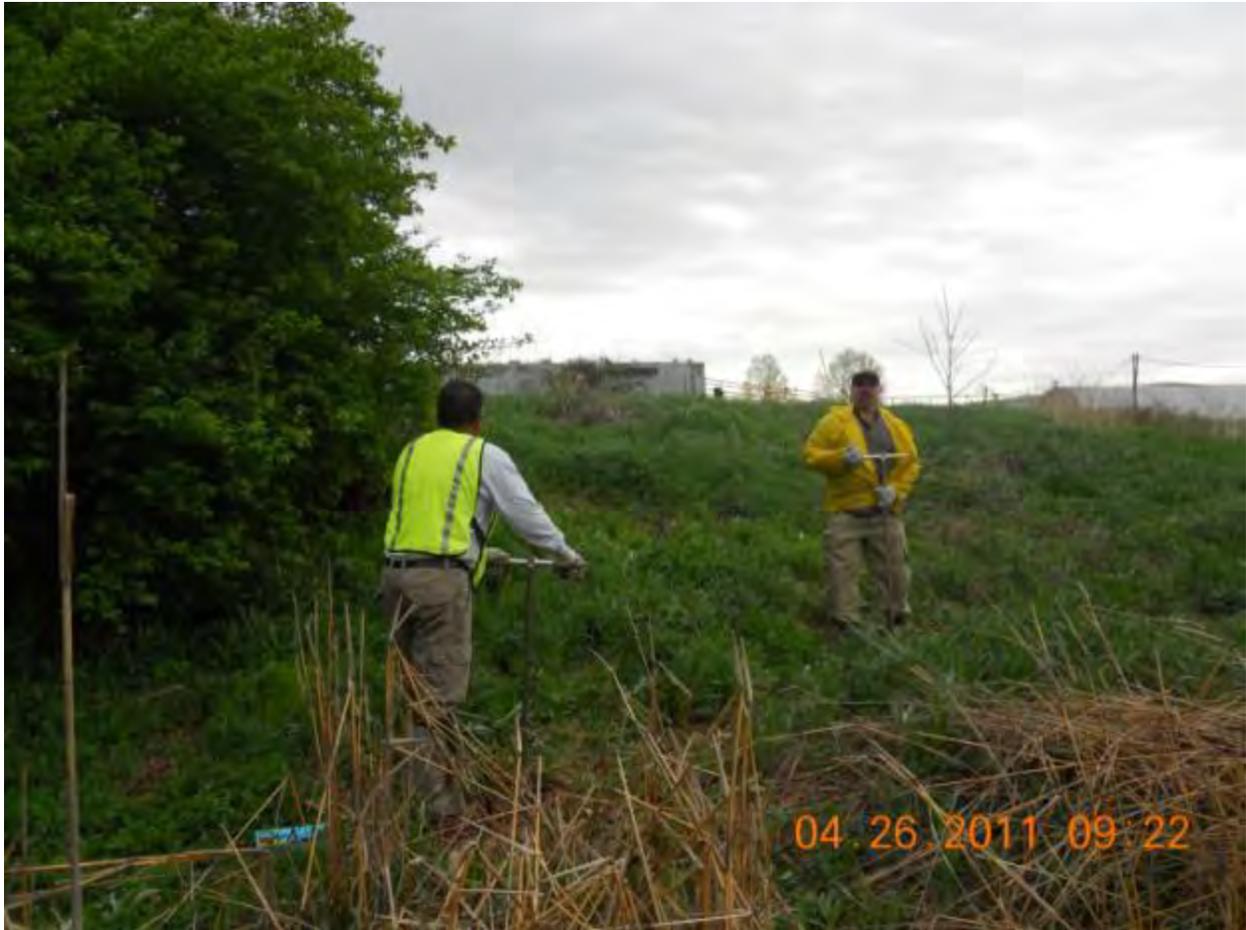
Photograph No. 7
Date: 04/26/11

View toward hand auger locations for composite sample BA-01 in burn area.

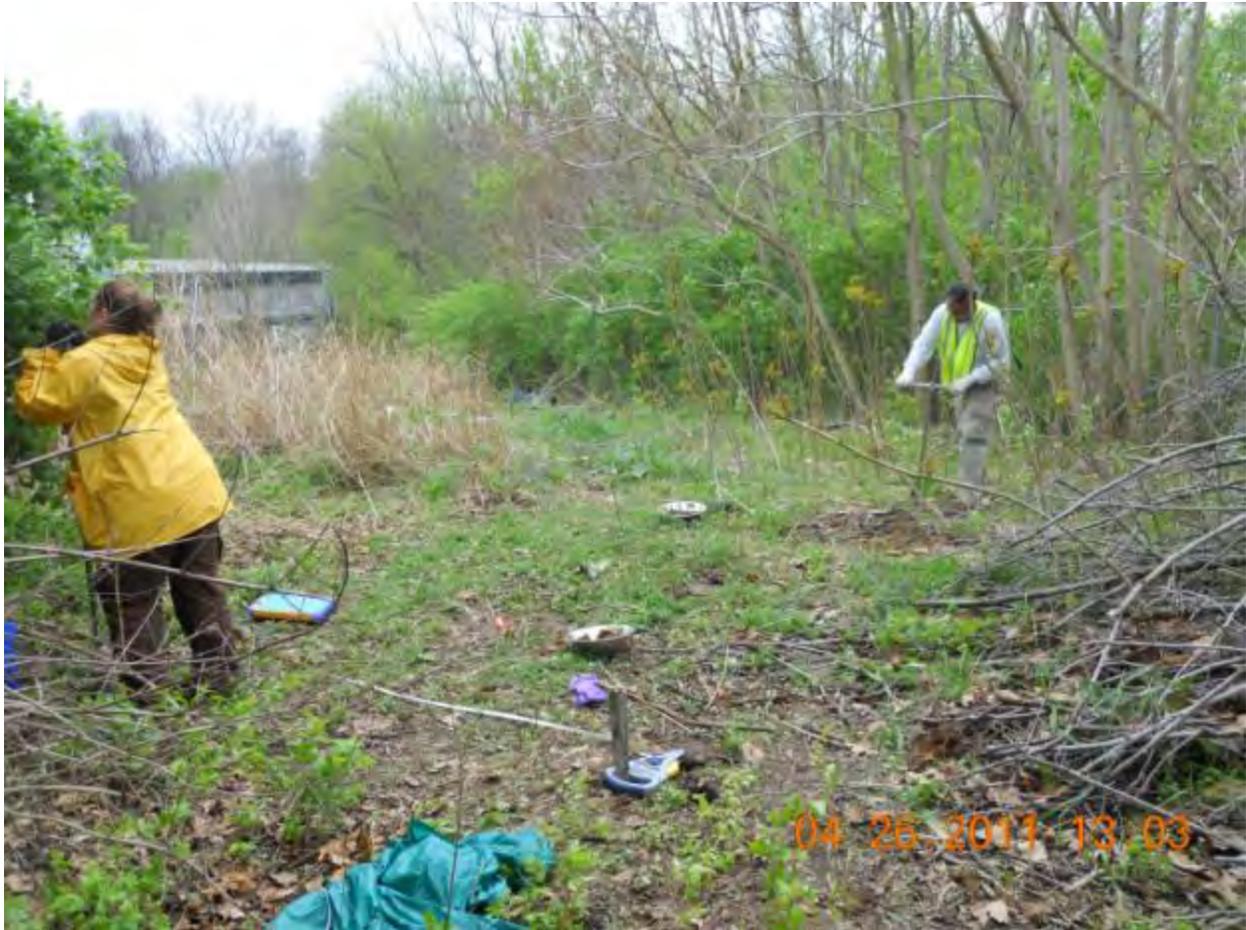
Photograph No. 8
Date: 04/26/11

View toward hand auger locations for composite sample BA-02 in burn area.

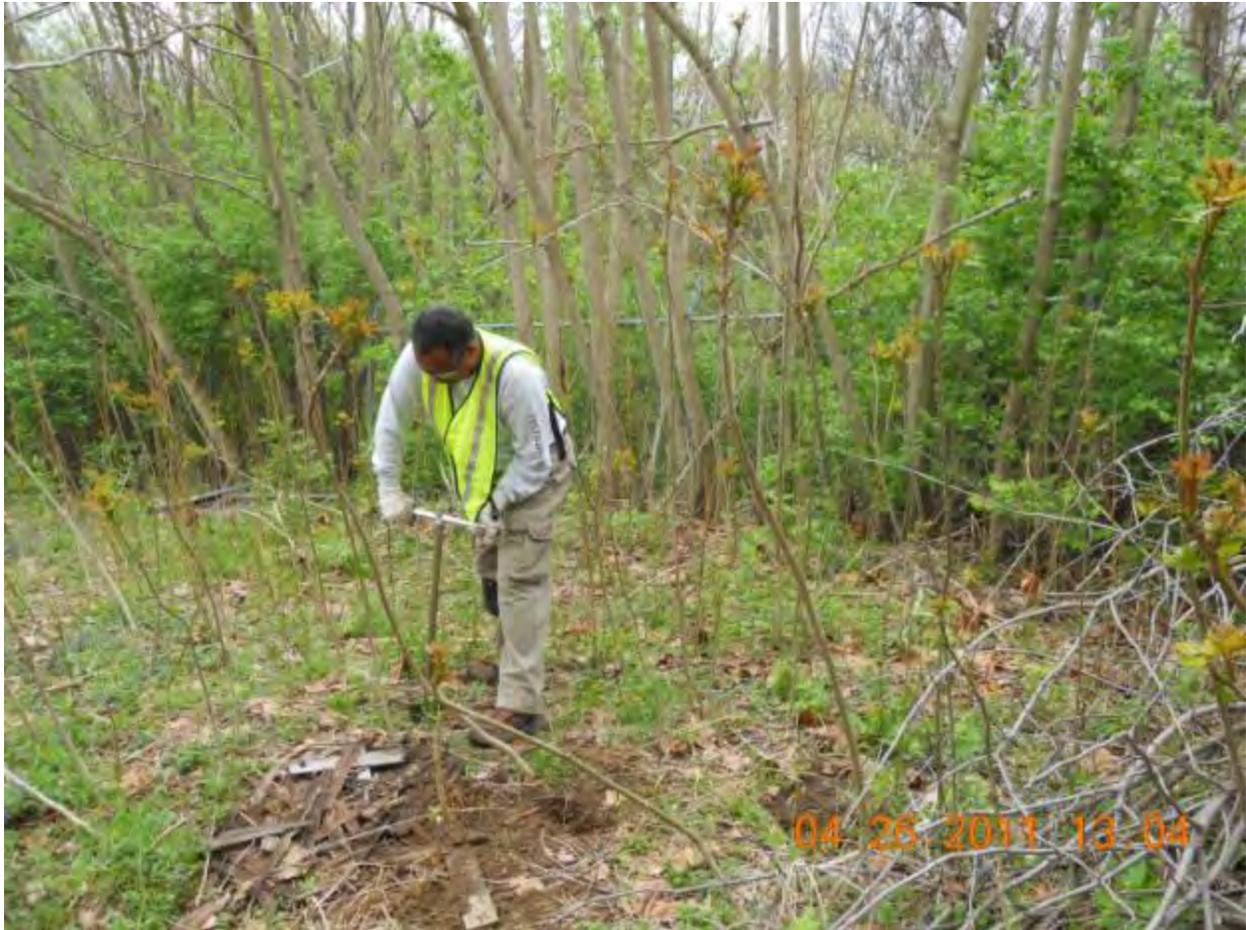
Photograph No. 9
Date: 04/26/11

View toward hand auger locations for composite sample BA-02 in burn area.

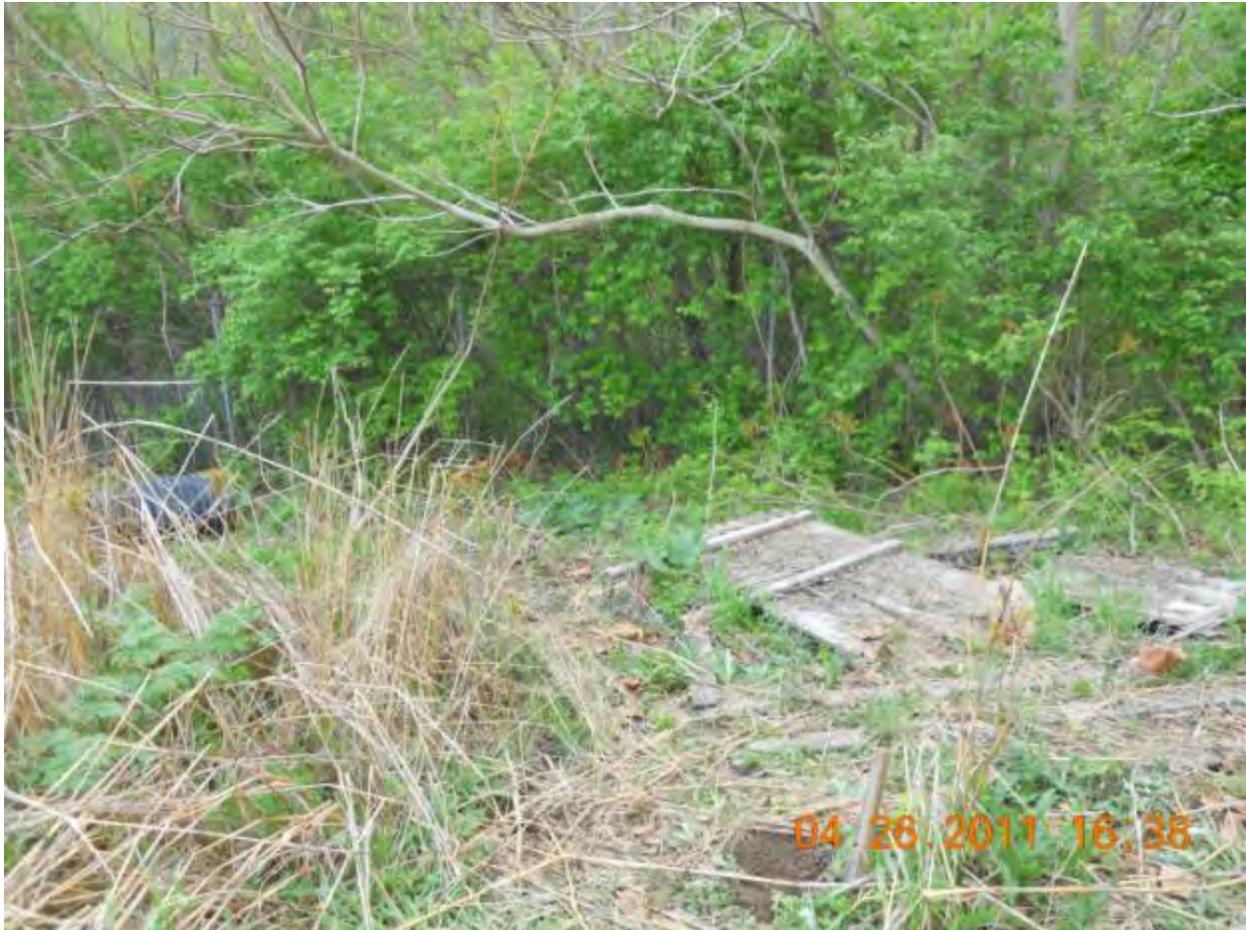
Photograph No. 10
Date: 04/26/11

View toward hand auger locations for composite sample BA-03 in burn area and wood debris.

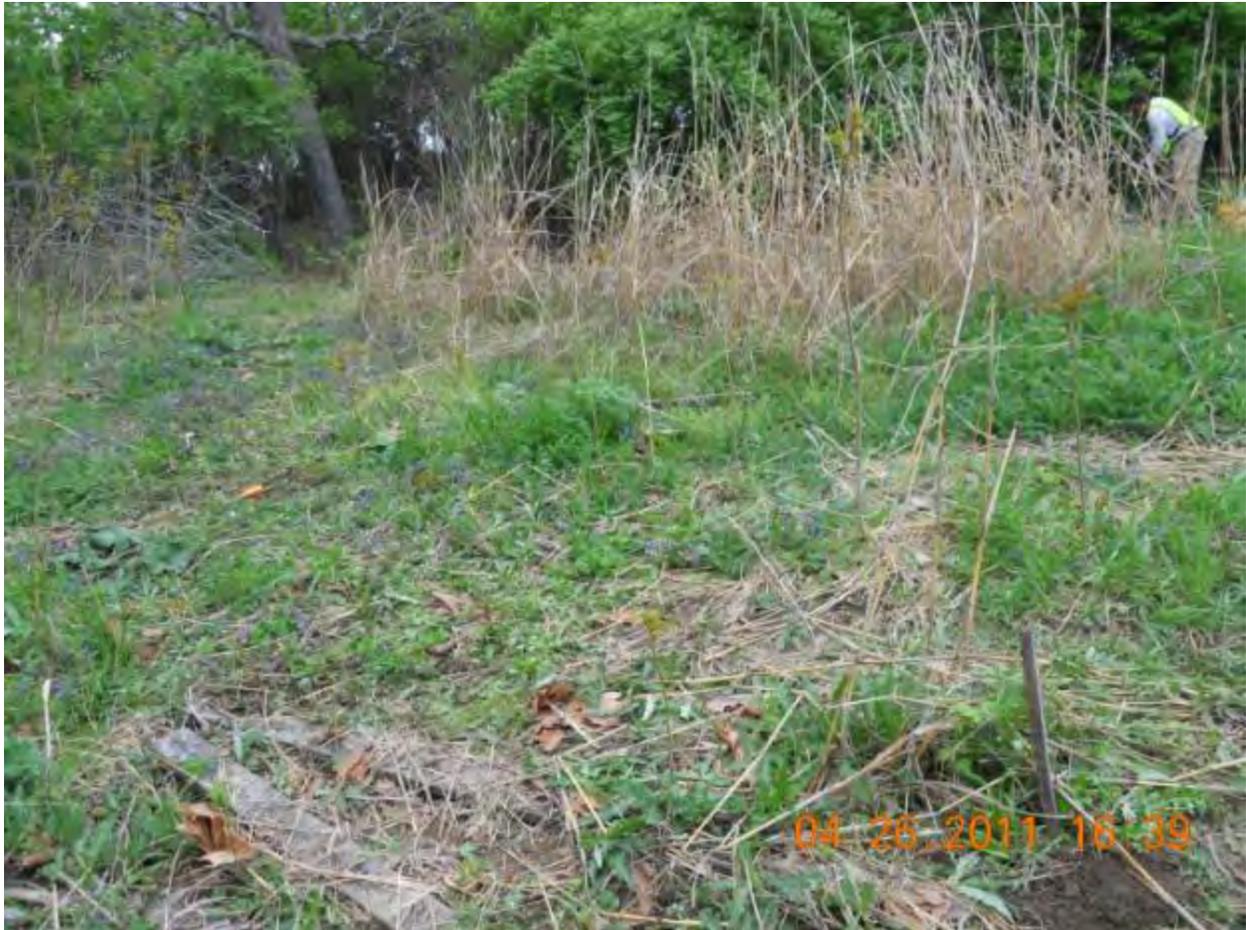
Photograph No. 11
Date: 04/26/11

View toward hand auger locations for composite sample BA-03 in burn area.

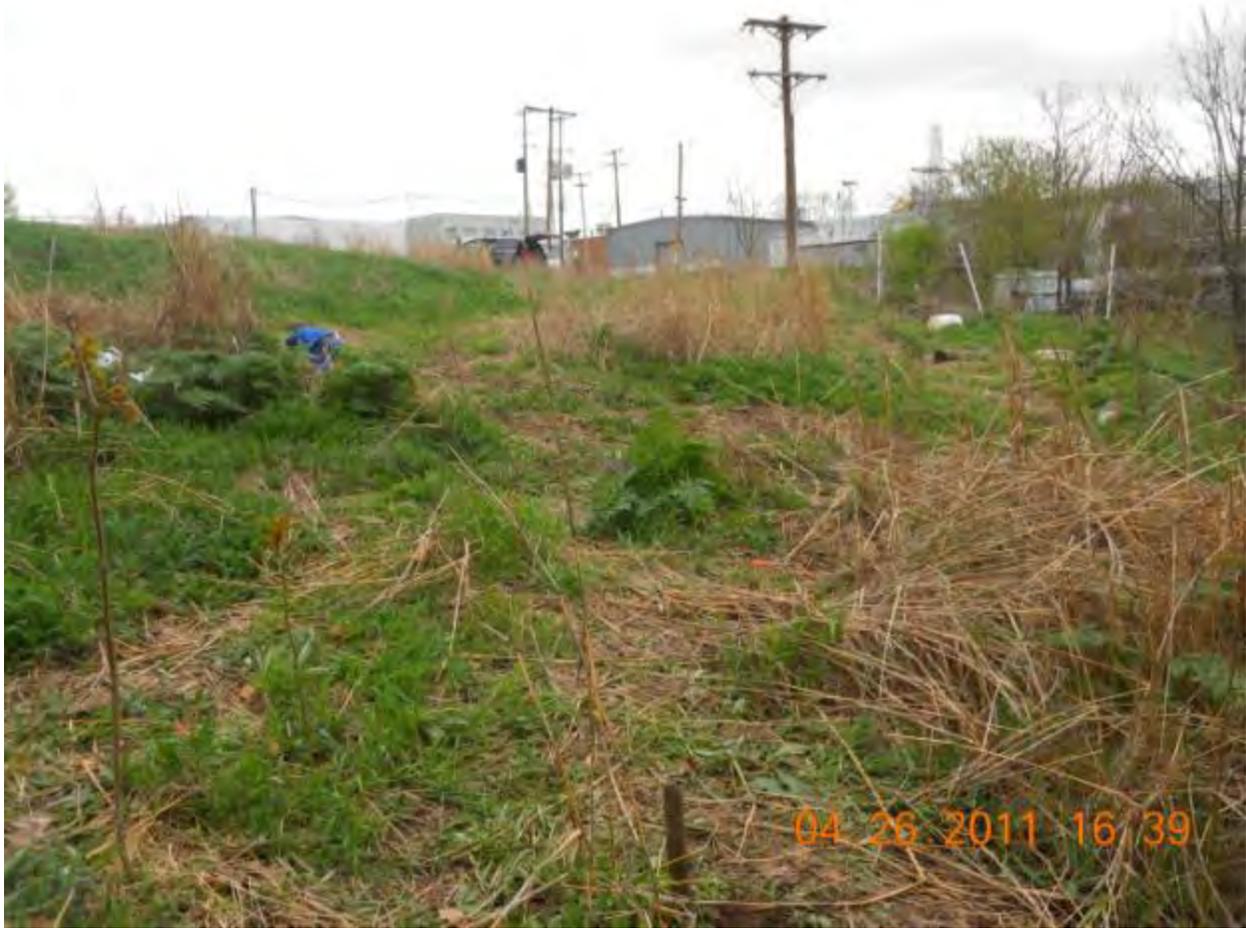
Photograph No. 12
Date: 04/26/11

View toward hand auger locations for composite samples BA-01 and BA-02 in burn area.

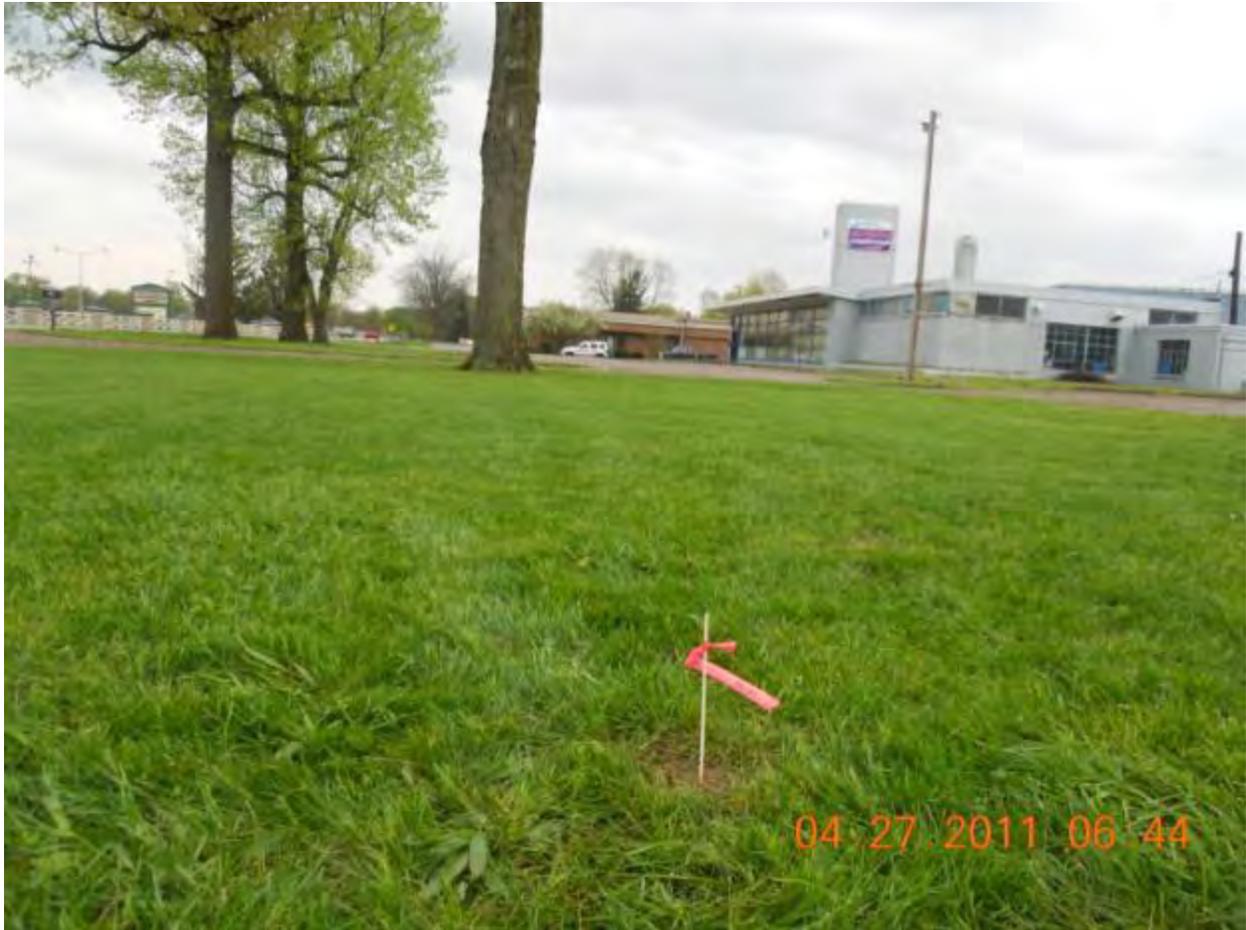
Photograph No. 13
Date: 04/27/11

View toward background sample location BG-01 and along Fairgrounds Road.

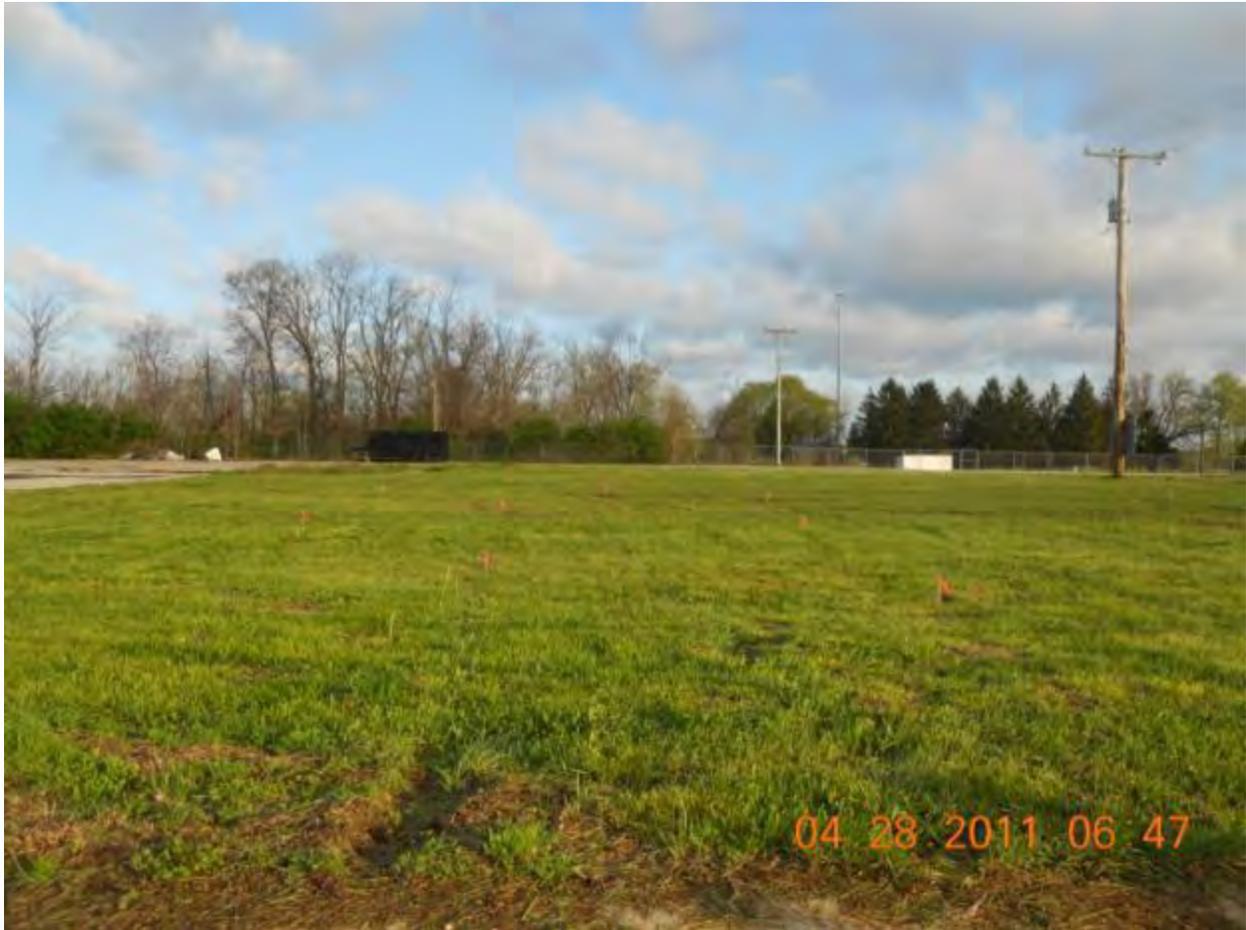
Photograph No. 15
Date: 04/28/11

View toward SWMA 2 and SWMU 3 area showing hand auger locations marked with orange flags.

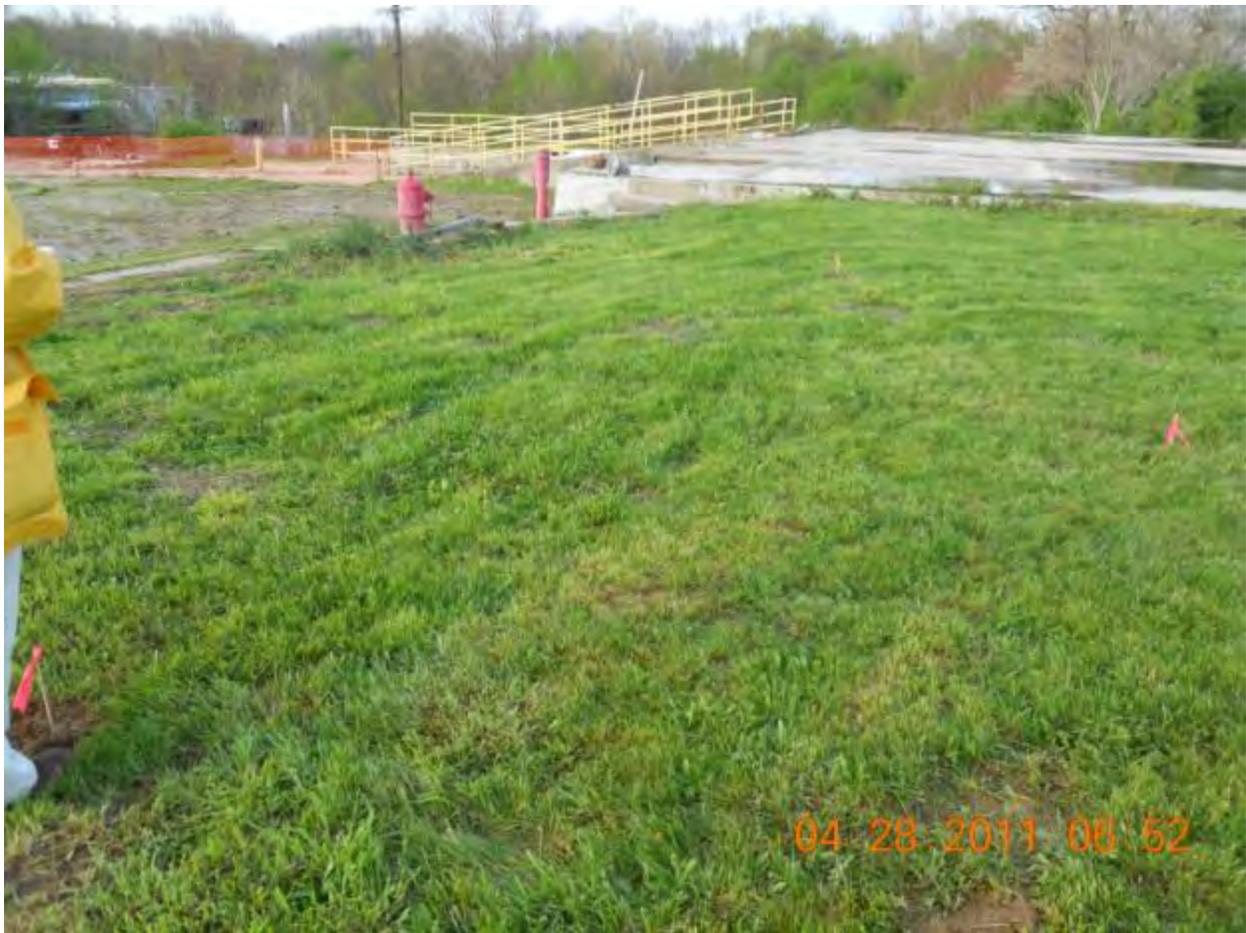
Photograph No. 16
Date: 04/28/11

View toward the east side of the building foundation adjacent to SWMA 2 area sample location S2-03.
