Reference: EPA Contract No. EP-W-07-074; TechLaw Task Order No. R05033; EPA Task Order No. EP-G10S-00032; Final Field Sampling Activity Report; Carboline Company, Xenia, Ohio; Task 06 Deliverable

**FINAL FIELD SAMPLING ACTIVITY REPORT
FOR
CARBOLINE COMPANY
XENIA, OHIO**

Carboline Draft Field Sampling Activity Report

125 Fairground Road, Xenia, Ohio

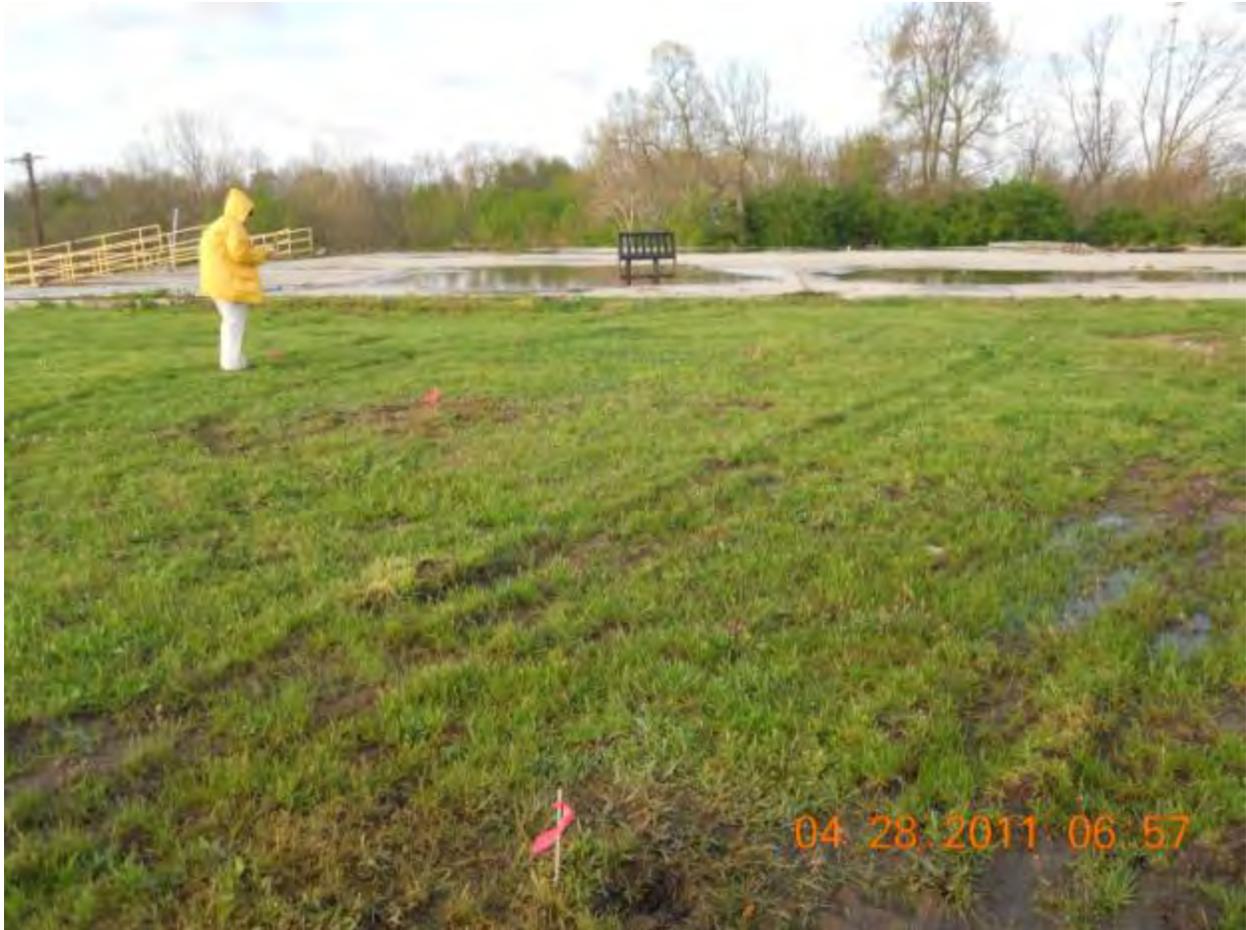
Photograph No. 17
Date: 04/28/11

View toward the east side of the building foundation adjacent to SWMA 2 sample location S2-02 area showing hand auger locations marked with orange flags.

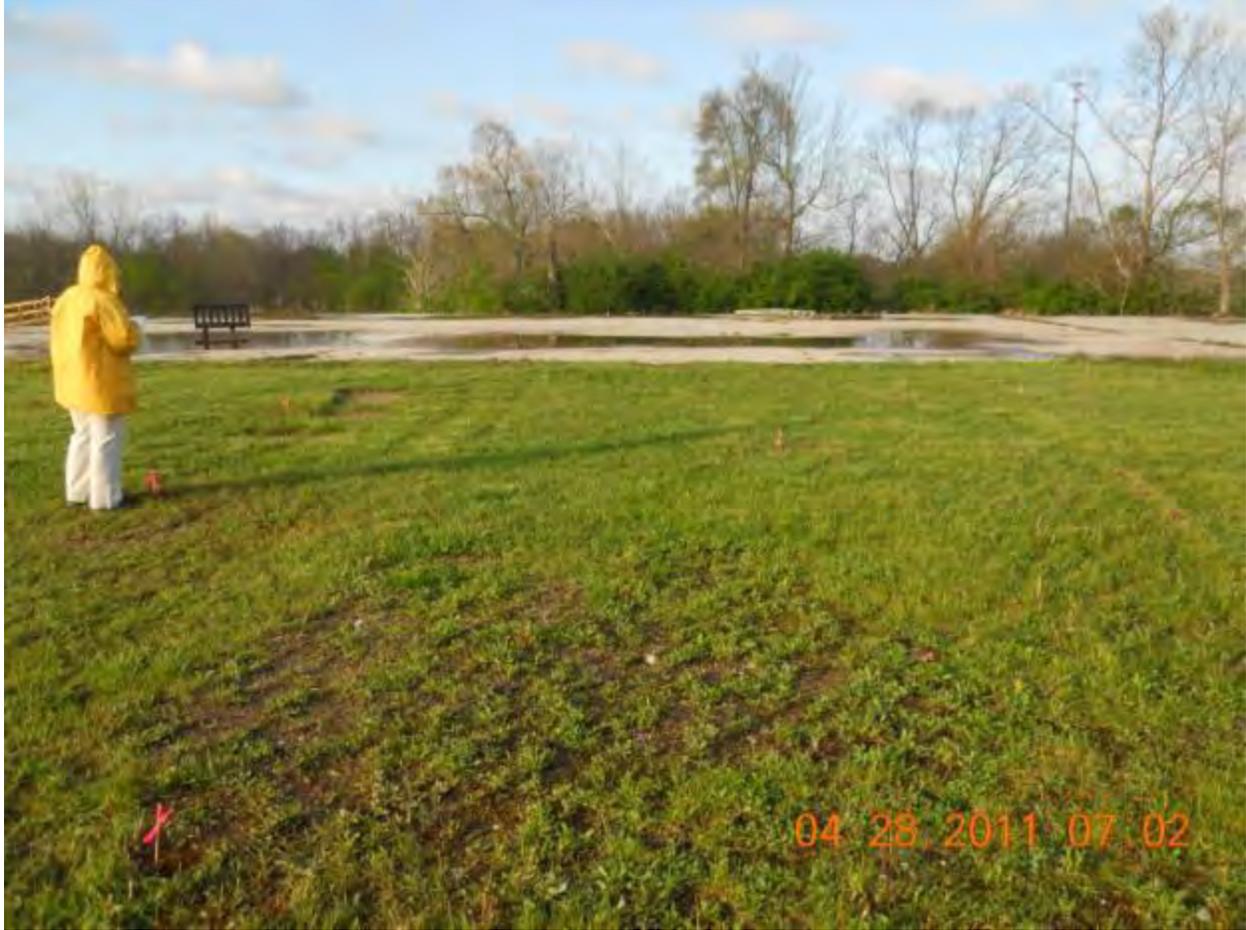
Photograph No. 18
Date: 04/28/11

View toward the building foundation adjacent to SWMA 2 sample location S2-01 area showing hand auger locations marked with orange flags.

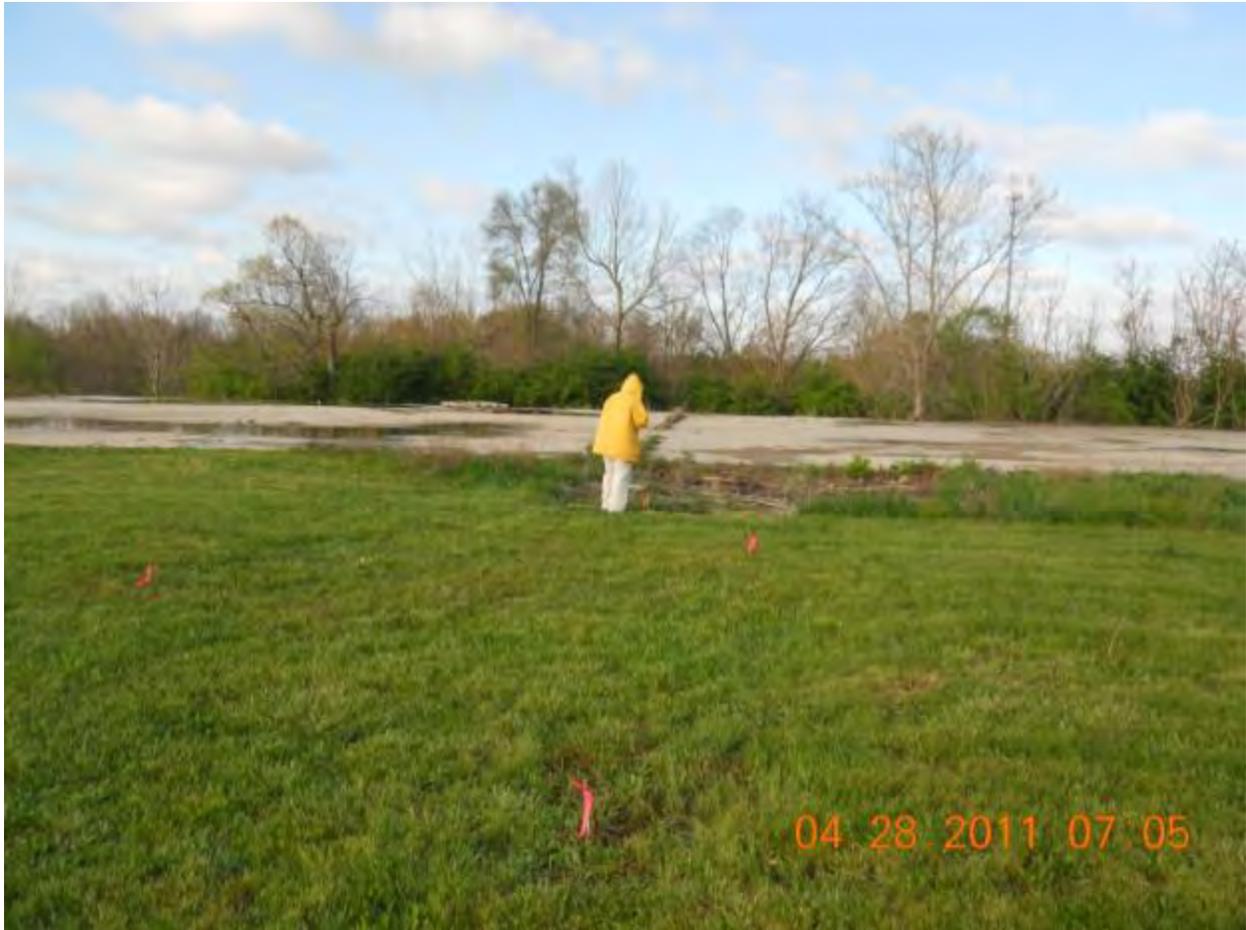
Photograph No. 19
Date: 04/28/11

View toward the building foundation adjacent to SWMU 3 sample location S3-01 area showing hand auger locations marked with orange flags.

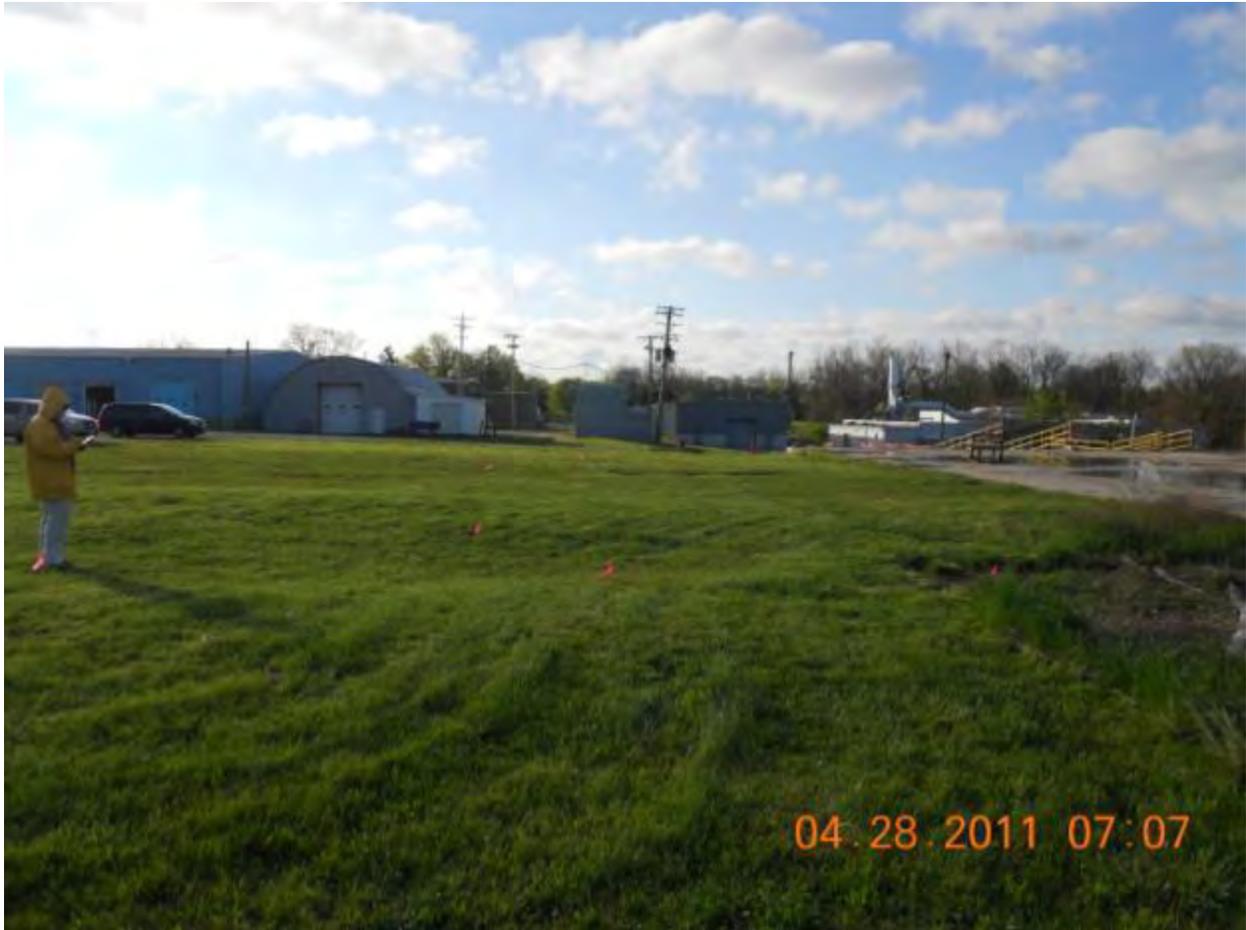
Photograph No. 20
Date: 04/28/11

View toward SWMA 2 and SWMU 3 with building foundation to right and other onsite buildings in background and hand auger locations marked with orange flags.

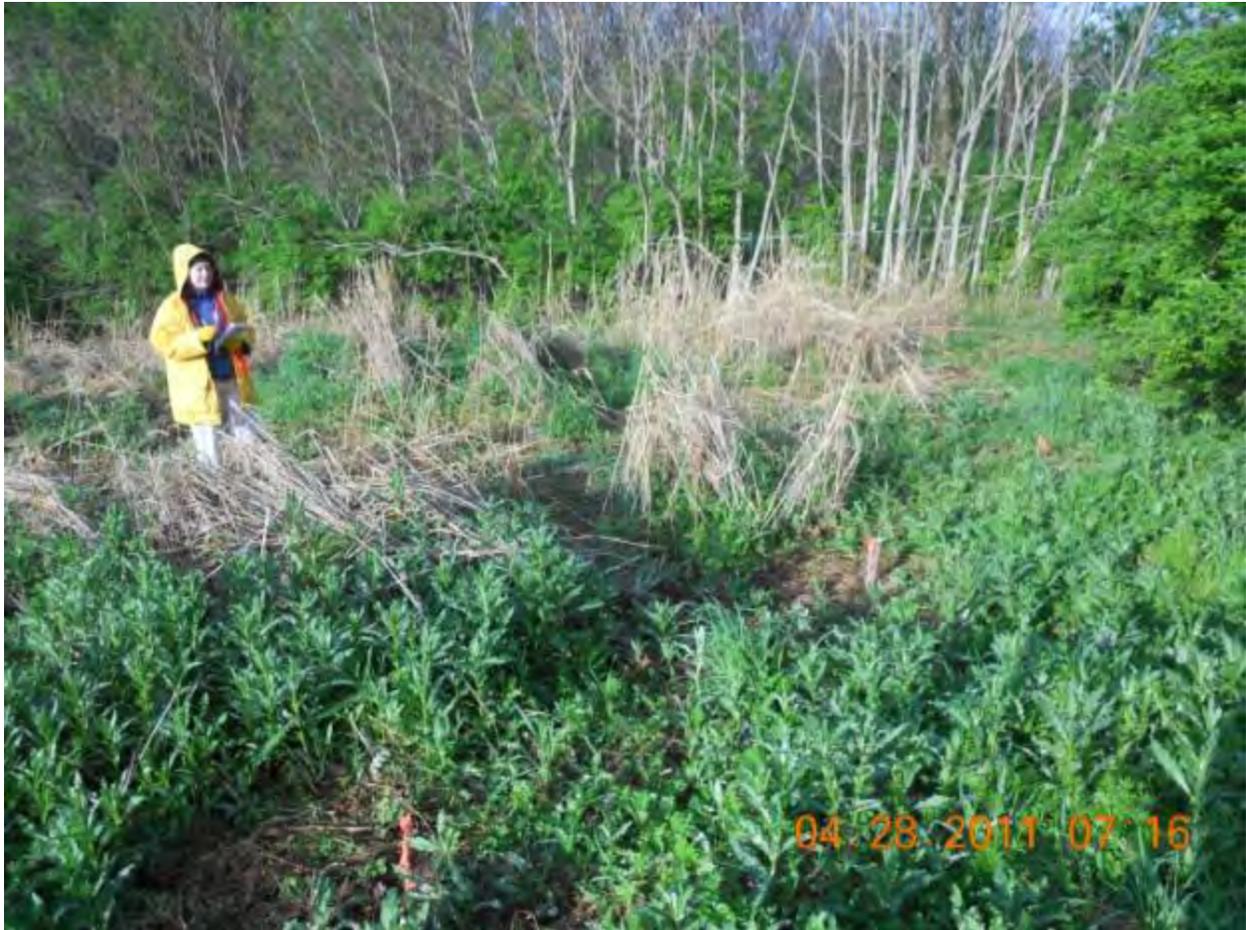
Photograph No. 21
Date: 04/28/11

View toward BA-01 area showing hand auger locations marked with orange flags.

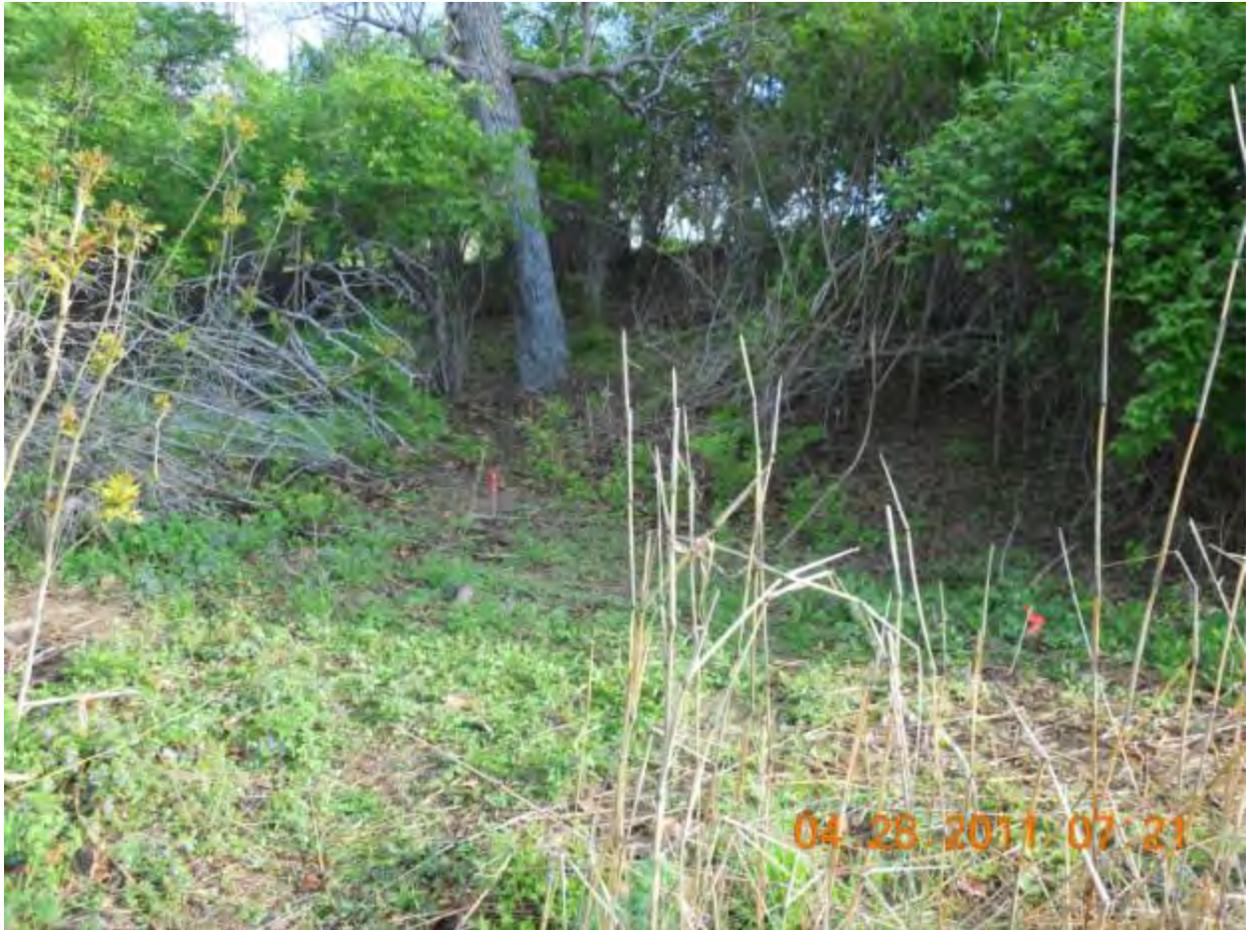
Photograph No. 22
Date: 04/28/11

View toward BA-02 area showing hand auger locations marked with orange flags.

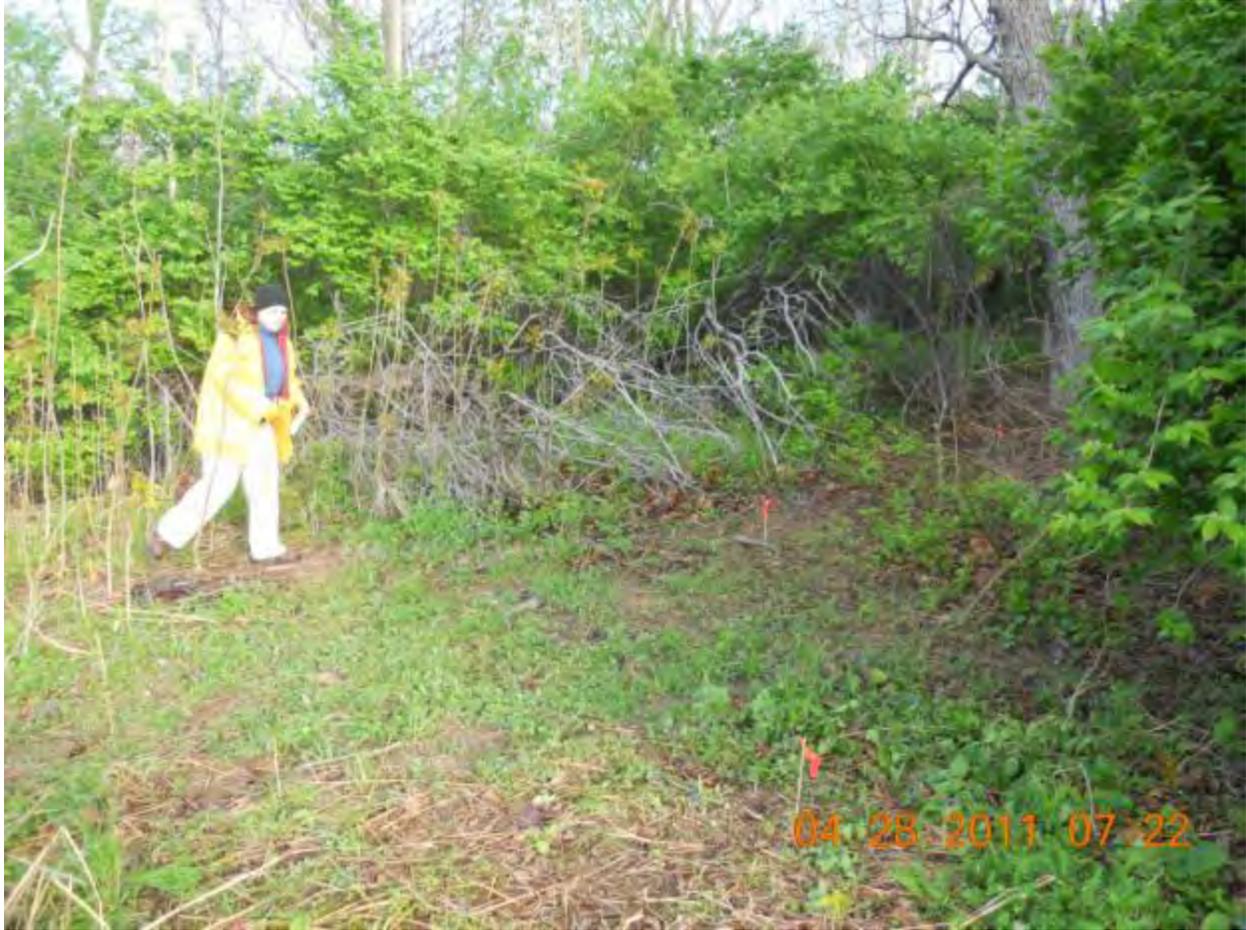
Photograph No. 23
Date: 04/28/11

View toward BA-02 area showing hand auger locations marked with orange flags.

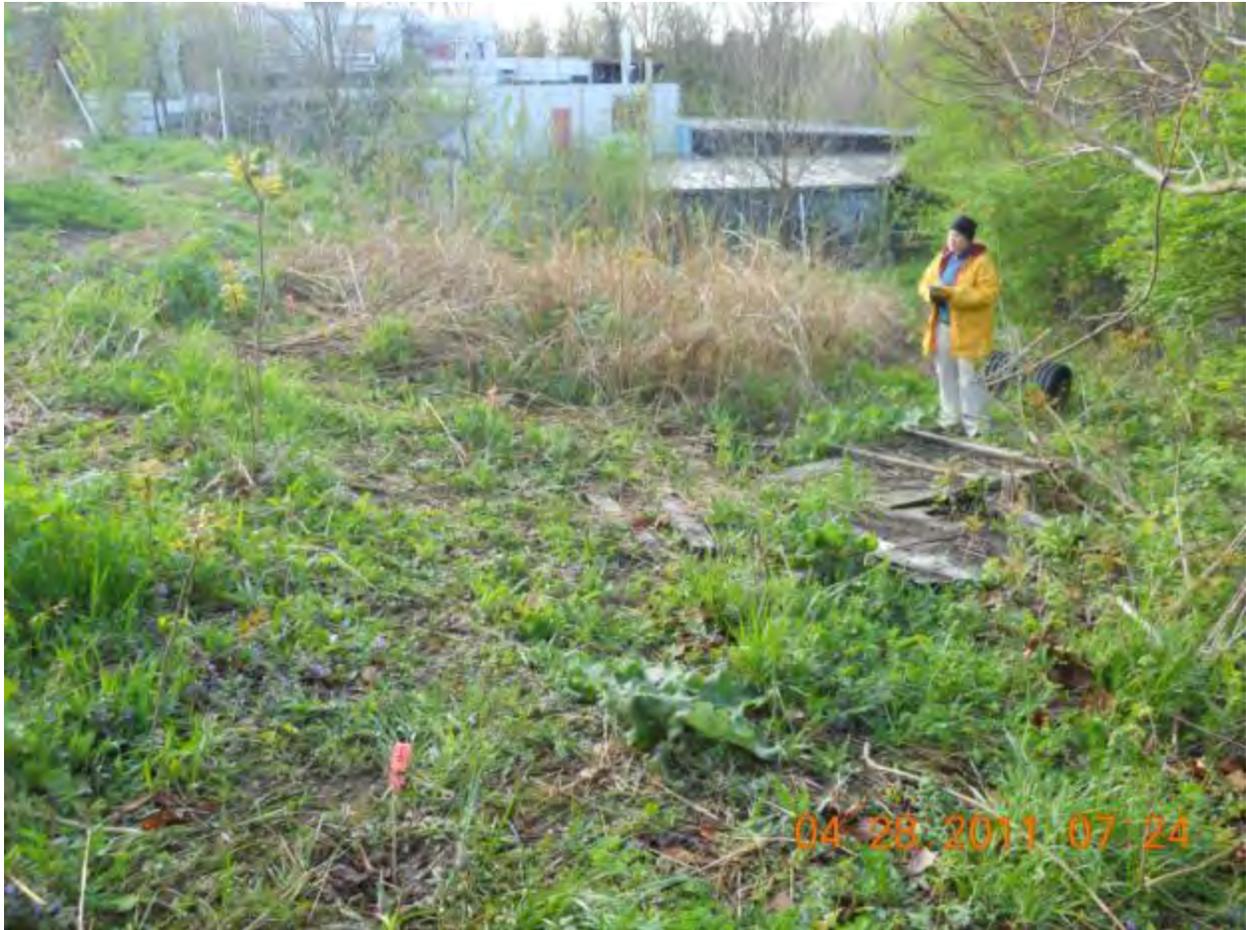
Photograph No. 24
Date: 04/28/11

View toward BA-03 area showing hand auger locations marked with orange flags.

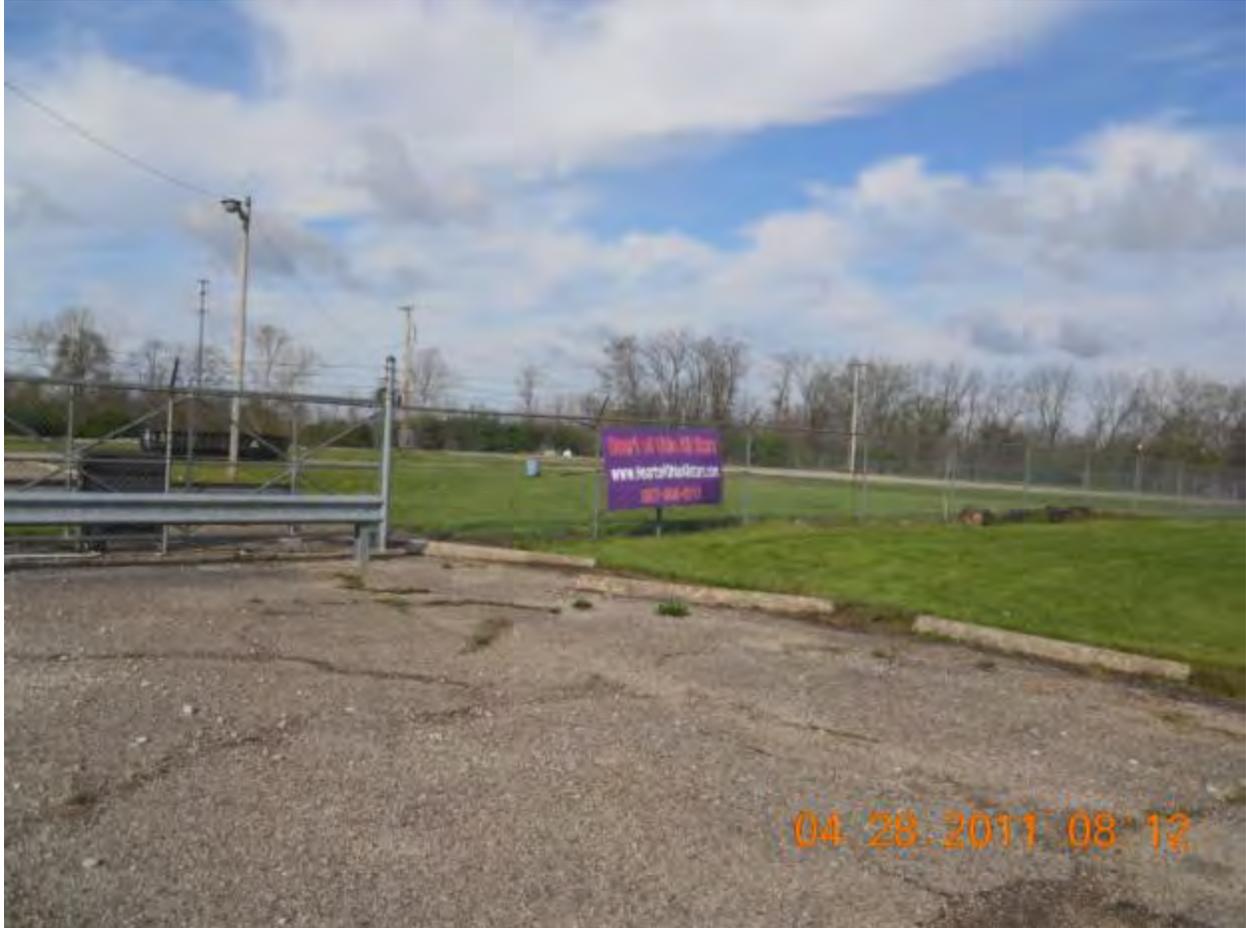
Photograph No. 25
Date: 04/28/11

View toward fence and sign of "Heart of Ohio All Stars," which is the current property owner.
