Koppers Open House - July 16, 2013 and Protective Clean-up Overview

Former Koppers Wood Treating Site

Carbondale, Illinois

July 2013

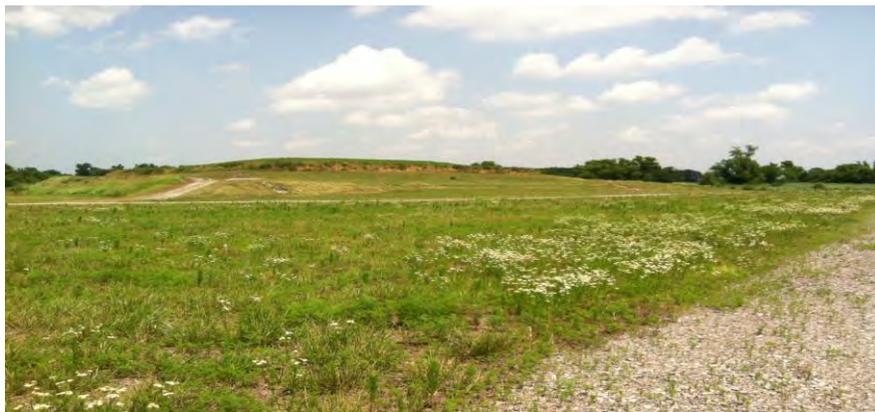
The three-acre CAMU in the background, looking north from the western soil cover. The CAMU contains contaminated materials dug up at the site and has a leak monitoring and collection system.

CAMU: An engineered containment unit called a Corrective Action Management Unit ("CAMU") was constructed on top of an area of already contaminated soil. The CAMU holds 30,000 cubic yards of materials from around the site. The CAMU design includes a double liner and liquid collection system that is routinely monitored and maintained to prevent buildup of liquids. It also includes a soil cover system to reduce rainwater infiltration and to prevent people and wildlife from coming into contact with materials in the CAMU. Regular inspections ensure that the cover system remains in place.

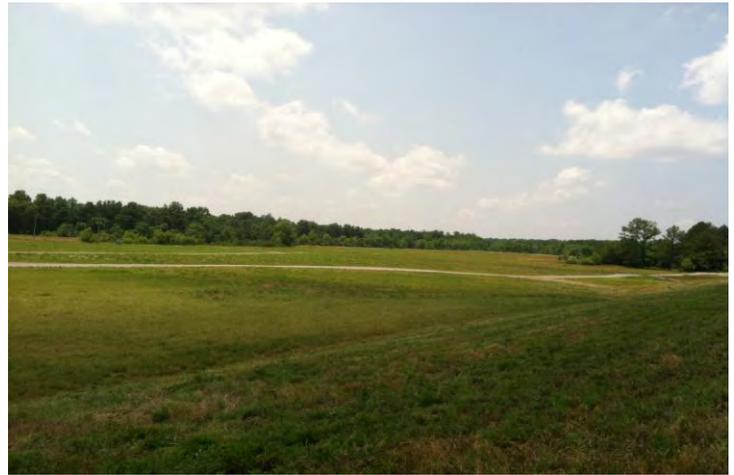
Western soil cover, looking southwest from the CAMU. The adjacent neighborhood is on the other side of the tree-line.

Soils: Soils stained with creosote were removed and placed in the CAMU. Also, about 37 acres of contaminated soils are contained beneath a low-permeability cover. Some of the cover areas include a high-density polyethylene liner for additional isolation. All of the covers have one foot of soil, and grass or roadway surfaces. Covers do not destroy or remove contaminants. Instead, they isolate them, keep the soil in place, and prevent people and wildlife from coming into contact with contaminants.

A cover is effective as long as it does not erode, develop holes or cracks, and stays in place. Regular inspections will continue to be required at Koppers to make sure that weather, plant roots, wildlife or humans have not damaged the soil cover. Also, groundwater monitoring wells are placed around the cover areas and the site itself. The wells are sampled to ensure that contamination does not spread beyond the site boundaries.
