Re: May 21, 2008 Clean Water Act Inspection

**U.S. Environmental Protection Agency
Region 9
Clean Water Act Compliance Office**

NPDES Compliance Evaluation Inspection Report

Industrial User: Maxton Manufacturing Company
Industrial User Address: 1728 Orbit Way, Minden, NV 89423
Inspection Date: May 21, 2008

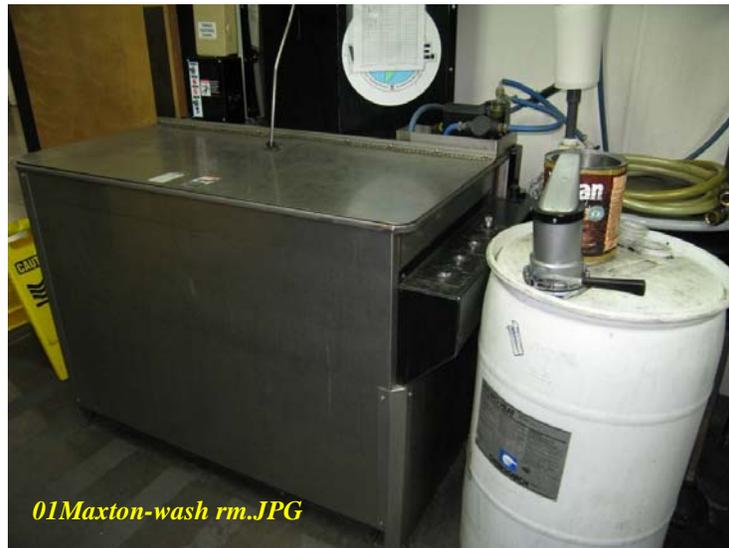
1. **Hot tank** (*see Photo 1 in the Appendix*) – The tank is full of a heated soapy water solution. The parts are submerged in the solution. The tank contains approximately 60 gallons of solution, which is made up of a cleaning compound diluted with water. The cleaning compound contains tallow fatty amine ethoxylate and sodium tripolyphosphate. Oil is skimmed off the surface of the solution and sent to the storage bins of the evaporative unit. Once per month, the used solution is changed out for new solution. The used solution is transferred to the storage bins of the evaporative cooler via the vacuum drum.
2. **Wash sink** (*see Photos 2 and 3*) – The parts are washed off by hose with the same type of soap solution as in #1 above. The used solution circulates in a closed loop,

Hot tank in wash room – Step #1 of the parts-washing process
Taken by Anna Yen on May 21, 2008

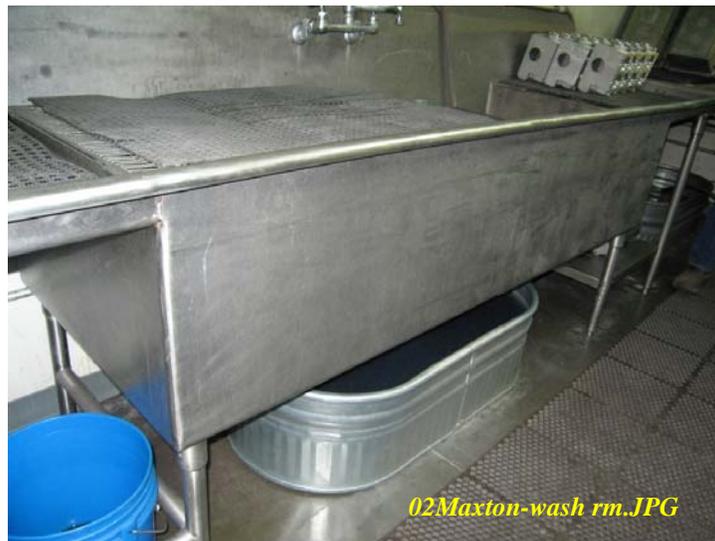
Photo 2

Wash sink in wash room – Step #2 of the parts-washing process
Taken by Anna Yen on May 21, 2008

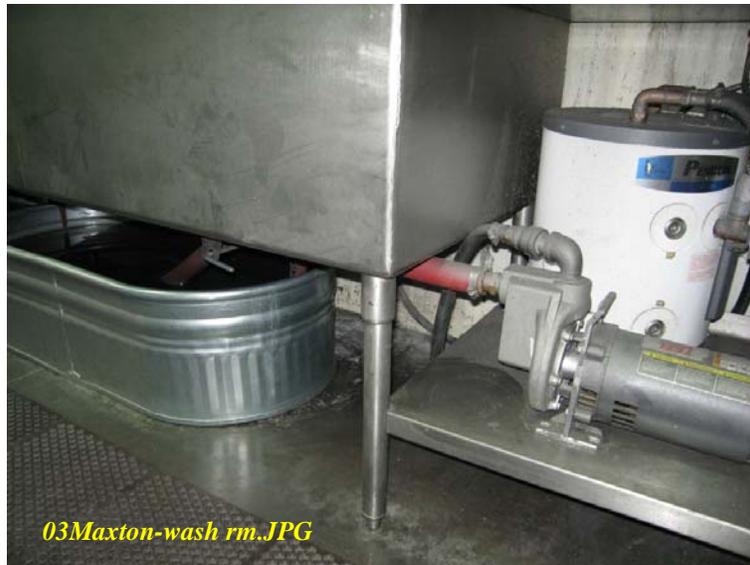
Photo 3

from the sink to a container under the sink. The cleaning compound, with water, is originally added to this container. The solution is then pumped to a hot water heater and sent through the hose to the sink.

Wash sink, with hot water heater and pump, in wash room
– Step #2 of the parts-washing process
Taken by Anna Yen on May 21, 2008

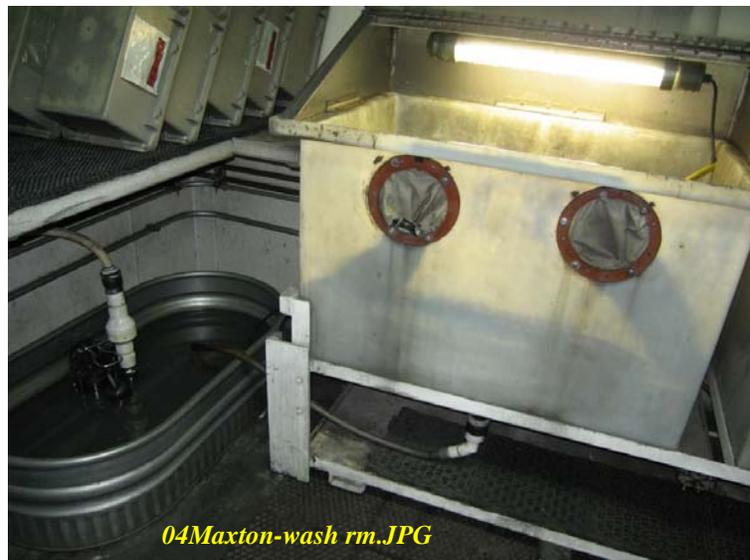
Photo 4

3. **High-pressure washer** (*see Photos 4 - 6*) – The parts are rinsed off with a high-pressure washer which uses tap water. The dirty water travels from the sink to a container under the counter. This wastewater is then pumped out of the container through a pipe that leads to the janitor room next door, finally discharging out of the pipe through a nylon sock filter to a floor drain leading to the local sewer system.

High-pressure washer in wash room – Step #3 of the parts-washing process
Taken by Anna Yen on May 21, 2008

Since the facility has only one low-volume wastewater stream discharging to the sewer system, EPA suggests that the facility consider also sending its high-pressure wash water to its evaporative unit instead of discharging into the floor drain of the janitor room. Among other considerations, the facility would need to determine if soapy residue on the parts were minimal enough to avoid inhibiting the evaporation process at the evaporative unit. By becoming a zero-discharger, the facility would be subject to fewer pretreatment regulatory requirements since its wastewater streams would not be flowing through the sewer system or ending up at a POTW.

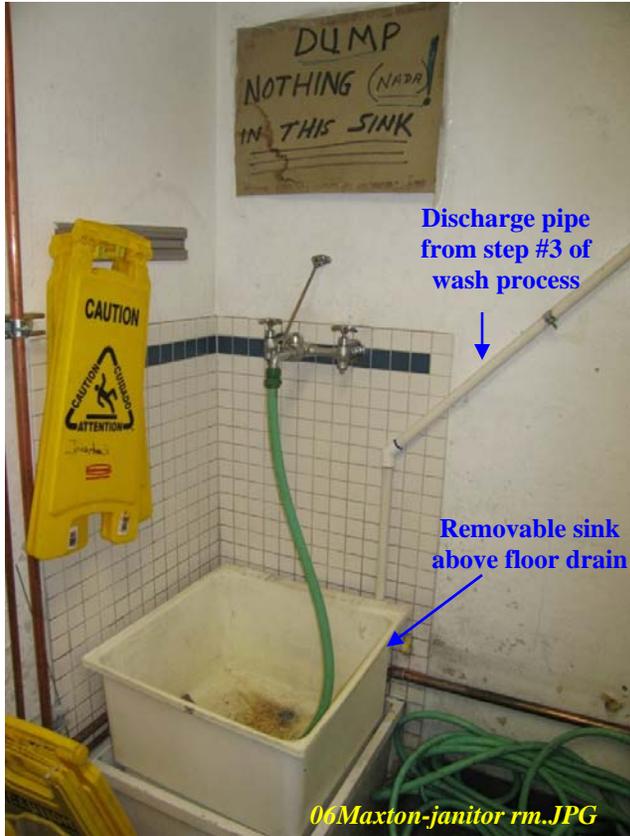
Photo 5

Two wastewater streams originate from the first source above. One is from changeout of the used soap solution in the hot tank. The used solution is sent to the storage bins of the evaporative cooler. The other wastewater stream is from the high-pressure washer. The dirty rinse water drains out of the sink. This wastewater is conveyed via hard piping to the janitor room floor drain which discharges to the local sewer system.

Floor drain in janitor room
– Discharge from Step #3 of the parts-washing process
Taken by Anna Yen on May 21, 2008

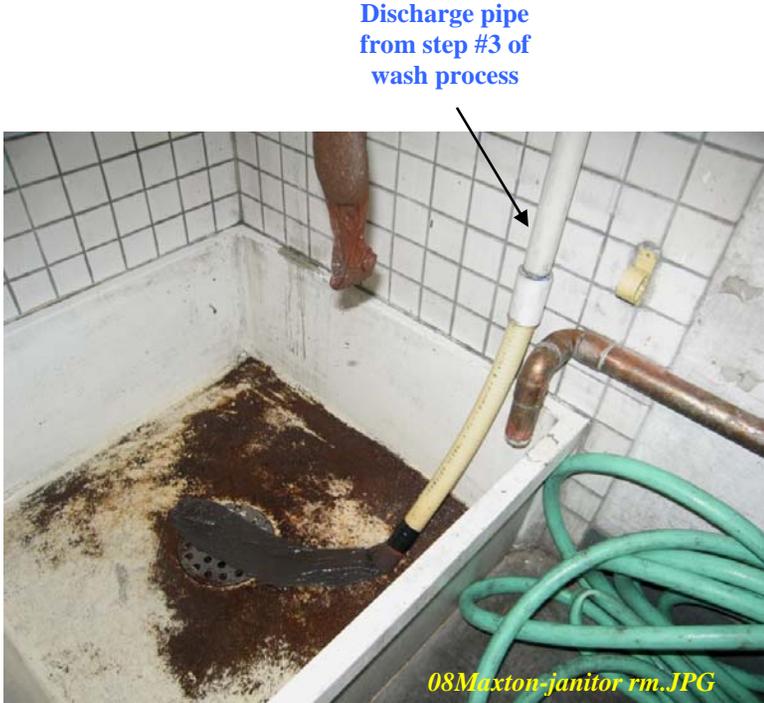
Photo 6

Floor drain in janitor room, without sink above floor drain
– Discharge from Step #3 of the parts-washing process
Taken by Anna Yen on May 21, 2008
