Re: May 21, 2008 Clean Water Act Inspection

NPDES Compliance Evaluation Inspection Report

Industrial User: Maxton Manufacturing Company
Industrial User Address: 1728 Orbit Way, Minden, NV 89423
Inspection Date: May 21, 2008

Maxton Manufacturing Company (“Maxton”) began operations at this facility in 1995. This facility manufactures elevator hydraulic control valves.

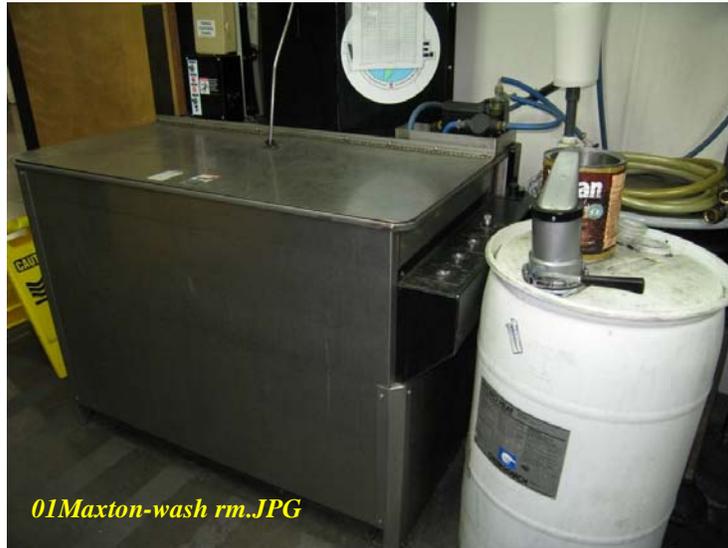
1. **Hot tank** (*see Photo 1 in the Appendix*) – The tank is full of a heated soapy water solution. The parts are submerged in the solution. The tank contains approximately 60 gallons of solution, which is made up of a cleaning compound diluted with water. The cleaning compound contains tallow fatty amine ethoxylate and sodium tripolyphosphate. Oil is skimmed off the surface of the solution and sent to the storage bins of the evaporative unit. Once per month, the used solution is changed out for new solution. The used solution is transferred to the storage bins of the evaporative cooler via the vacuum drum.
2. **Wash sink** (*see Photos 2 and 3*) – The parts are washed off by hose with the same type of soap solution as in #1 above. The used solution circulates in a closed loop,

Hot tank in wash room – Step #1 of the parts-washing process
Taken by Anna Yen on May 21, 2008

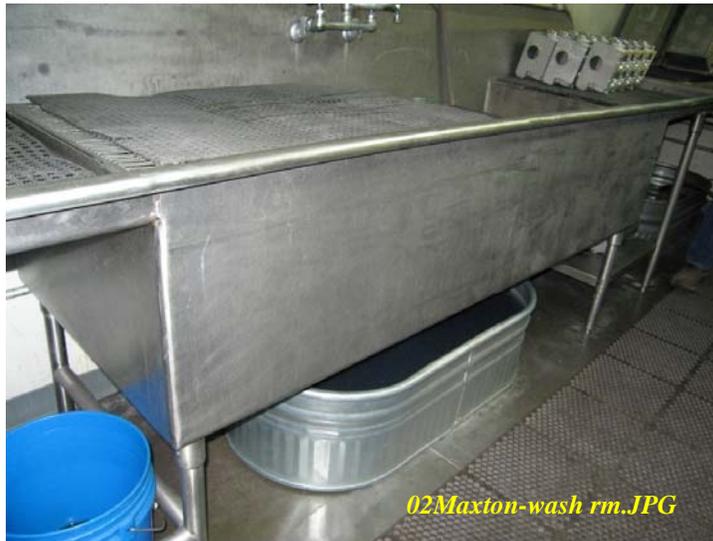
Photo 2

from the sink to a container under the sink. The cleaning compound, with water, is originally added to this container. The solution is then pumped to a hot water heater and sent through the hose to the sink.

Wash sink in wash room – Step #2 of the parts-washing process
Taken by Anna Yen on May 21, 2008

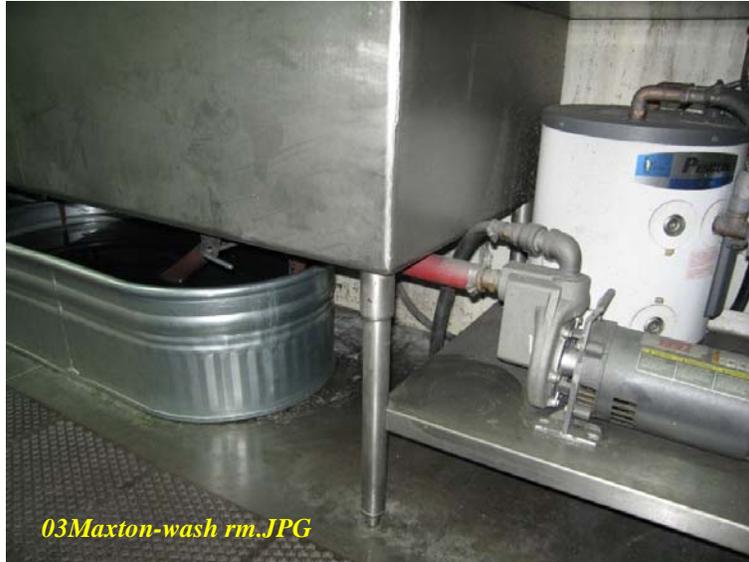
Photo 3

Wash sink, with hot water heater and pump, in wash room
– Step #2 of the parts-washing process
Taken by Anna Yen on May 21, 2008

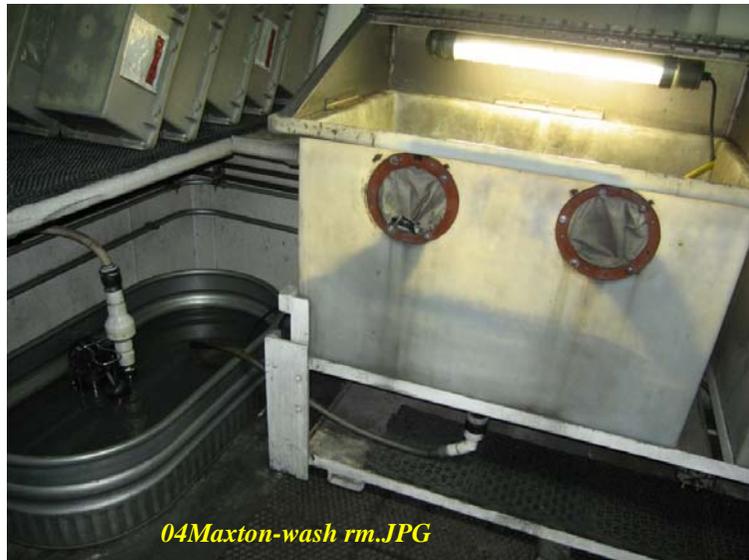
Photo 4

3. **High-pressure washer** (*see Photos 4 - 6*) – The parts are rinsed off with a high-pressure washer which uses tap water. The dirty water travels from the sink to a container under the counter. This wastewater is then pumped out of the container through a pipe that leads to the janitor room next door, finally discharging out of the pipe through a nylon sock filter to a floor drain leading to the local sewer system.

High-pressure washer in wash room – Step #3 of the parts-washing process
Taken by Anna Yen on May 21, 2008

Since the facility has only one low-volume wastewater stream discharging to the sewer system, EPA suggests that the facility consider also sending its high-pressure wash water to its evaporative unit instead of discharging into the floor drain of the janitor room. Among other considerations, the facility would need to determine if soapy residue on the parts were minimal enough to avoid inhibiting the evaporation process at the evaporative unit. By becoming a zero-discharger, the facility would be subject to fewer pretreatment regulatory requirements since its wastewater streams would not be flowing through the sewer system or ending up at a POTW.

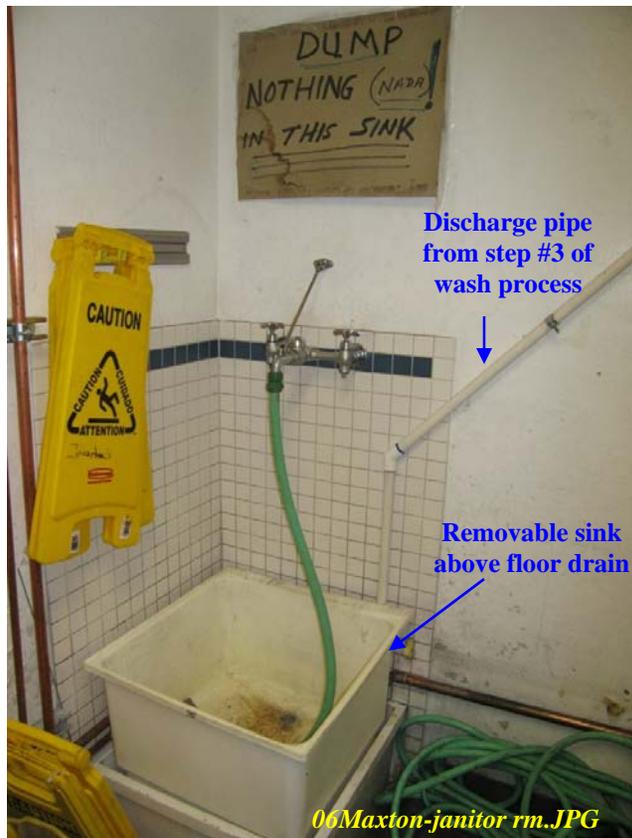
Photo 5

Two wastewater streams originate from the first source above. One is from changeout of the used soap solution in the hot tank. The used solution is sent to the storage bins of the evaporative cooler. The other wastewater stream is from the high-pressure washer. The dirty rinse water drains out of the sink. This wastewater is conveyed via hard piping to the janitor room floor drain which discharges to the local sewer system.

Floor drain in janitor room
– Discharge from Step #3 of the parts-washing process
Taken by Anna Yen on May 21, 2008

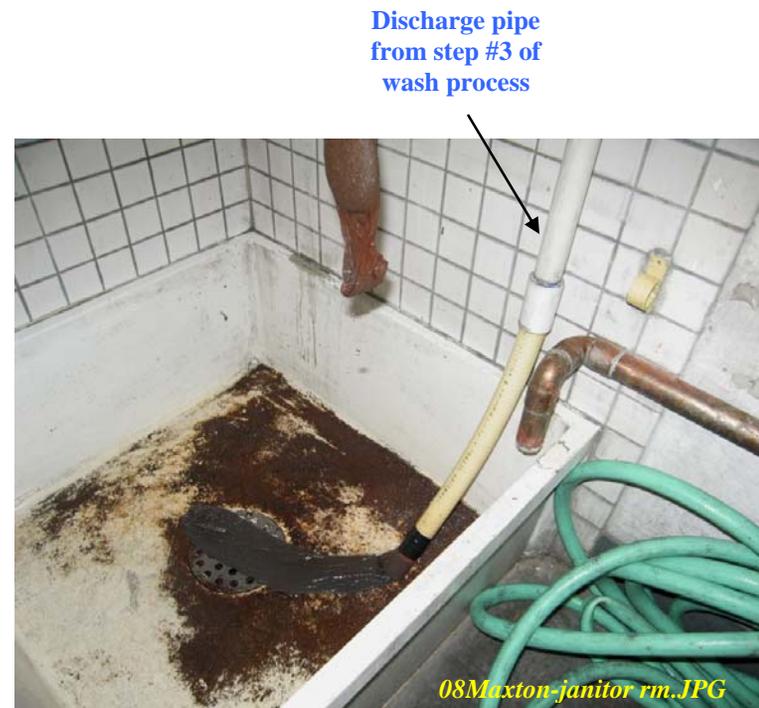
Photo 6

Floor drain in janitor room, without sink above floor drain
– Discharge from Step #3 of the parts-washing process
Taken by Anna Yen on May 21, 2008
