**U.S. Environmental Protection Agency
Region 9
Clean Water Act Compliance Office**

NPDES Compliance Evaluation Inspection Report

Industrial User: American AVK Company
Industrial User Address: 2155 Meridian Blvd., Minden, NV 89423
Inspection Date: November 26, 2007

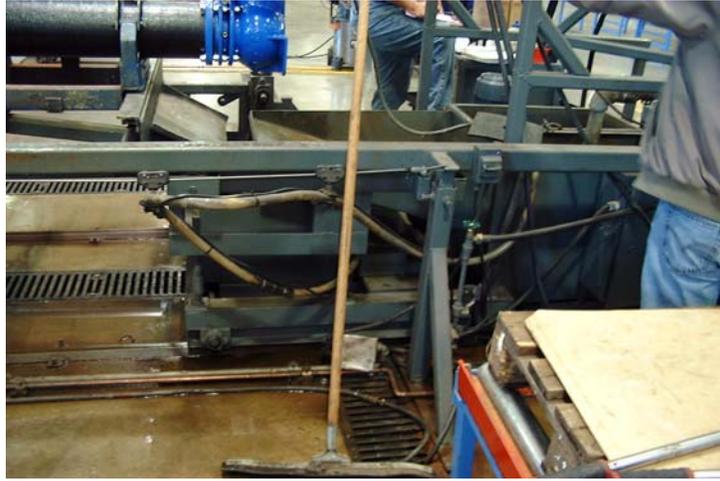
Fire hydrant hydrotesting is performed to ensure that, when installed and operating under pressure, no leaks occur. Testing is conducted by running water into the fire hydrant at pressures up to 500 psi. The pressure test water recirculates. The used water – approximately 30 gallons per day - runs into a floor trench in this testing area of the facility. *See Photo 1 in the Appendix.* A filter located in the trench catches large solids (mostly wood debris) before the wastewater flows to the sewer system.

Photo #1: Floor trench at fire hydrant hydrotesting station
Taken by Greg Arthur on November 26, 2007

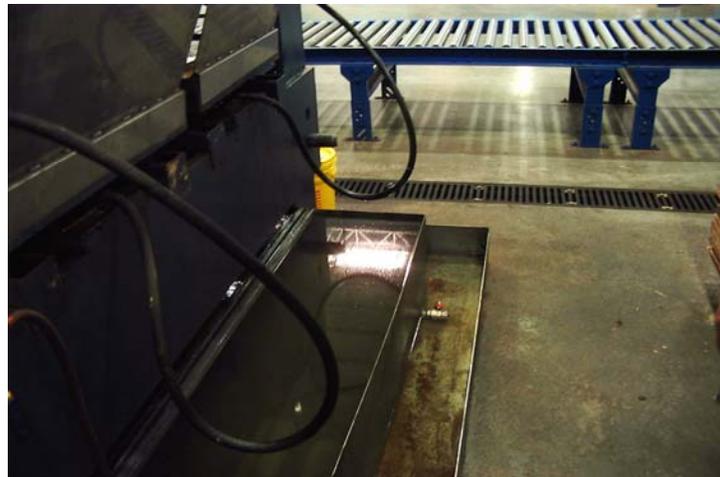
Hydrotesting of valves is similar to testing of fire hydrants. Water is run into the valve up to a certain pressure to ensure that no leakage occurs. The pressure test water recirculates. The used water runs into a trough which ultimately drains to a floor trench in this testing area of the facility. There are five testing stations, but the facility operates a maximum of three at one time. A total of approximately 100 gallons of wastewater flows to the floor trench per day. *See Photo 2 in the Appendix.* The same filter as described for the testing of fire hydrants catches large debris before the wastewater continues on to the sewer system.

Photo #2: Trough and floor trench at a valve hydrotesting station
Taken by Greg Arthur on November 26, 2007
