**NPDES COMPLIANCE EVALUATION INSPECTION**

NPDES Permittee: MYD Samoa, Inc.

Facility: Satala Shipyard  
P.O. Box 7684, Pago Pago, Tutuila Island, American Samoa  
(NPDES Permit No. AS0020026)

Date of Inspection: April 1, 2008

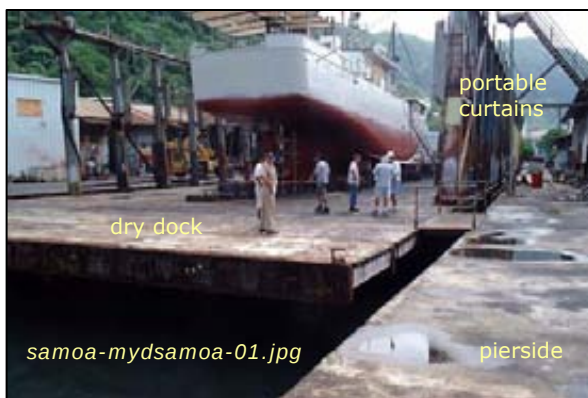
- Dry dock rainfall run-off is expected to drain through the gaps in the dry dock decking or directly to into the open gap over the harbor between the uncurbed dry dock and the pier. The 3000-ton dry dock was observed during this inspection to have one notable pollutant source, spent blasting grit on the dry dock decking, exposed to contact with storm water run-off. See Photos #1 through #4 in Section 1.6 on page 8.

Photo #1: 3000-Ton Dry Dock - Leading Edge  
Taken By: Greg V. Arthur  
Date: 04/01/08

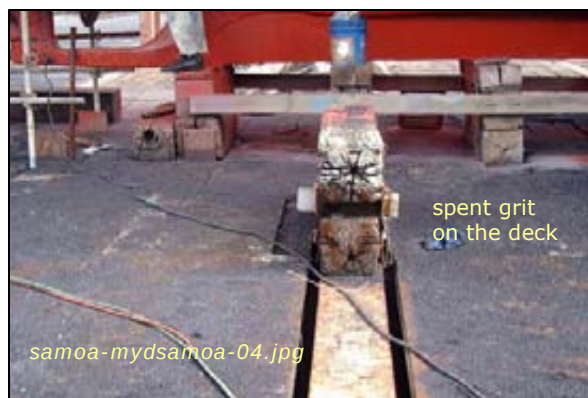
Hydroblast Tail Waters – Hydroblasting involves the high-pressure water spray removal of sea growth and slime from ship hulls, and possibly as well from ship internals such as heat exchangers, and ballast tanks. Hydroblast tail water at the Satala Shipyard cannot be collected because the dry dock decks are not curbed and sealed and there are no controlled methods of wastewater disposal. MYD Samoa indicated that hydroblasting is performed on ship hulls. As a result, although the process itself was not observed during this inspection, hydroblasting can be expected to generate an uncontrolled discharge of process-related wastewater that drains through the gaps in the deck to the harbor.

Photo #2: 3000-Ton Dry Dock - Gaps in Decking  
Taken By: Greg V. Arthur  
Date: 04/01/08

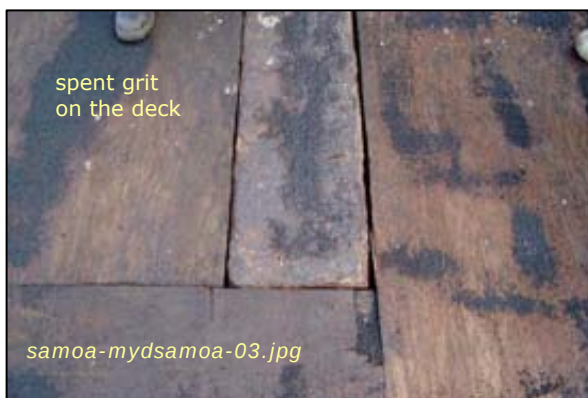
Photo #3: 3000-Ton Dry Dock - Gaps Between Boards  
Taken By: Greg V. Arthur  
Date: 04/01/08

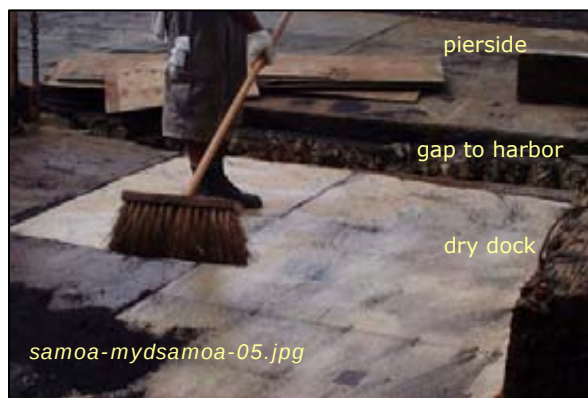
- 3 Blasting grit and paint chip debris were deposited on the dry dock and piers, exposed to contact with storm water drainage. Temporary planking, curtains, and sweeping captured debris but do not prevent significant losses through gaps in the deck and past uncurbed piers.

Photo #4: 3000-Ton Dry Dock - Sweeping / No Curbs  
Taken By: Greg V. Arthur  
Date: 04/01/08

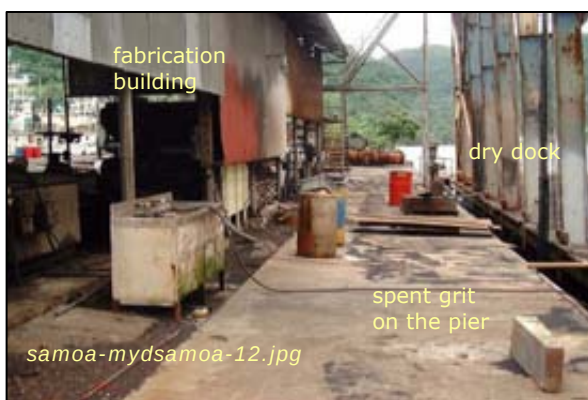
Depainting and Grinding Grit - Depainting involves both hand grinding and high-pressure blast abrasion of paint using copper slag grit. MYD Samoa employs a number of BMPs to control and capture spent grit and grinding residuals. These BMPs involve laying down plywood planking on the dry dock decking during sandblasting, broom deck sweeping of spent grit and residuals into piles, vacuum cyclone cleaning of piled-up spent grit to remove paint chips, and unfurling of portable curtains to keep the grit on the dry dock deck. Vacuum cyclone cleaned grit is disposed by truck to a landfill under ASEPA approval. Removed paint chips are incinerated on-island. On the day of this inspection, these BMPs were observed to be of limited effectiveness in keeping the spent grit out of the harbor. In particular, there were innumerable gaps found throughout in the dry dock decking, spent grit spread over the entire deck and on the surrounding piers, and wet grit residue left on the deck after sweeping. In addition, the frequency of rains and the wet condition of the spent grit indicate that it was likely exposed to rainfall over the course of the previous days. See Photos #1 through #5 in Section 1.6 on page 8.

- Catch Basin #3 includes the South Dock and the pier side landings between the fabrication and machining buildings and the 3000-ton dry dock. Catch Basin #3 was observed during this inspection to have many pollutant sources exposed to contact with storm water run-off, in particular spent blasting grit on the landings south of the dry dock, zinc anodes stacked near the fabrication building, and light boat repair work performed by the ship crews on the South Dock. Most of the drainage collects to a sump outfitted with siphon overflows to a short canal leading to the harbor, and designated as NPDES discharge point 003. There was curbing along the South Dock but on the pier around the 3000-ton dry dock. However, around the dry dock, the landing appeared to slant toward the open gap over the harbor between the uncurbed pier and the dry dock. See Photos #5 through #8 in Section 1.6 on pages 8 and 9.

Photo #5: Catch Basin #3 - Fab Bldg / Dry Dock  
Taken By: Greg V. Arthur  
Date: 04/01/08

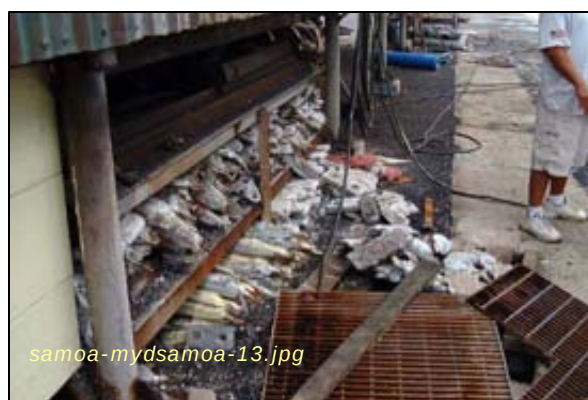
Photo #6: Catch Basin #3 - Zinc Anodes Exposed  
Taken By: Greg V. Arthur  
Date: 04/01/08

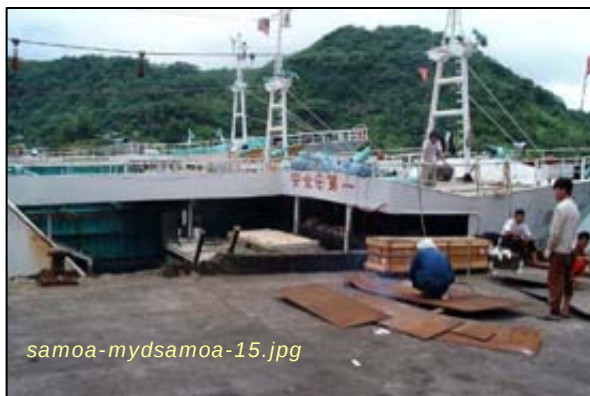
South Dock - Ships berthing takes place next to the shipyard in an area called the South Dock extending south of the 3000-ton Dry Dock and the harbor, within the storm water drainage watershed referred to as Catch Basin #3. Crews from the berthed ships were observed performing light maintenance on the pier.

Photo #7: Catch Basin #3 - South Dock Crew Work  
Taken By: Greg V. Arthur  
Date: 04/01/08

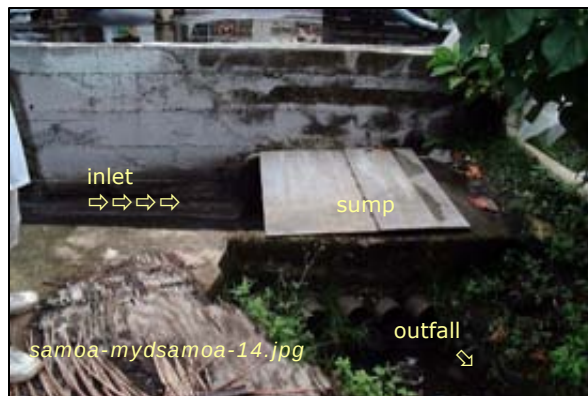
Photo #8: Catch Basin #3 - Discharge Sump 003  
Taken By: Greg V. Arthur  
Date: 04/01/08

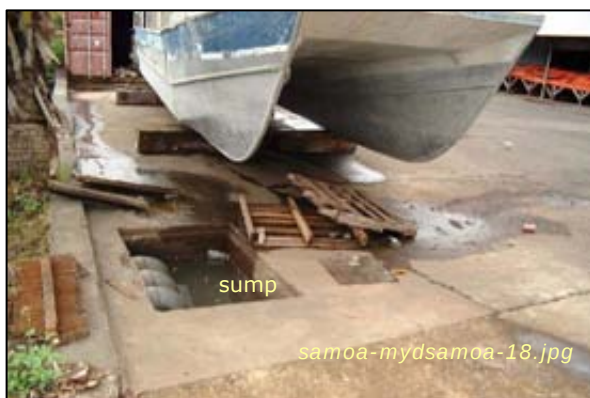
- Catch Basin #2 encompasses buildings and pier side landings north and east of the 3000-ton dry dock. Catch Basin #2 was observed during this inspection to have one notable pollutant source, spent blasting grit on the landings north of the dry dock, exposed to contact with storm water run-off. The warehouses and the winch engine room were not found to have exposed pollutant sources. There curbing along the open harbor but not on the pier around the 3000-ton dry dock. The drainage collects to a sump outfitted with siphon overflows to the harbor. See Photo #9 in Section 1.6 on page 9.

Photo #9: Catch Basin #2 - Discharge Sump 002  
Taken By: Greg V. Arthur  
Date: 04/01/08

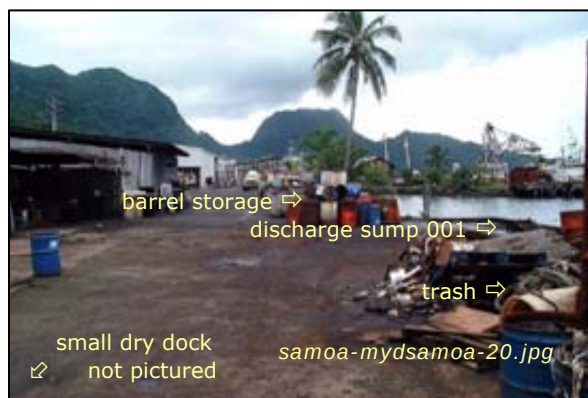
- Catch Basin #1 includes the piers and landings around the 800-ton dry dock and two buildings. The compressor building houses both a diesel fueling tank and battery storage areas under roofing and behind secondary containment. There was curbing along the open harbor but not around the 800-ton dry dock. The drainage collects to a sump outfitted with siphon overflows to the harbor. On the day of this inspection, numerous pollutant sources were observed exposed to contact with storm water run-off. In particular, the ground between the dry dock and harbor was heavily contaminated with spilled oil and there were piles of trash, barrels, spent materials and equipment on the landing along the open harbor. On the day of this inspection, oily drainage from the contaminated ground and the trash and barrels was observed draining into and through the discharge sump to form an oily sheen on the harbor. See Photos #10 through #12 in Section 1.6 on page 9.

Photo #10: Catch Basin #1 - Trash and Oily Ground  
Taken By: Greg V. Arthur  
Date: 04/01/08

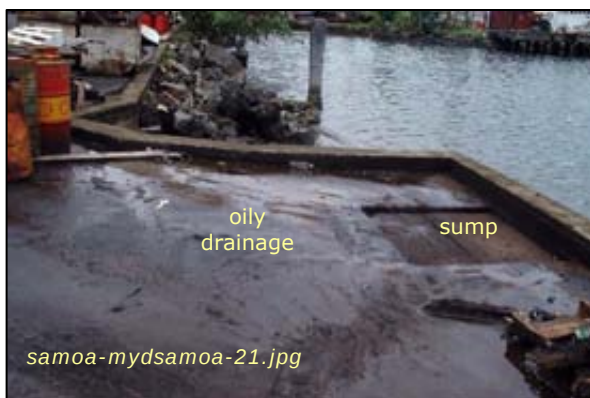
Photo #11: Catch Basin #1 - Discharge Sump 001  
Taken By: Greg V. Arthur  
Date: 04/01/08

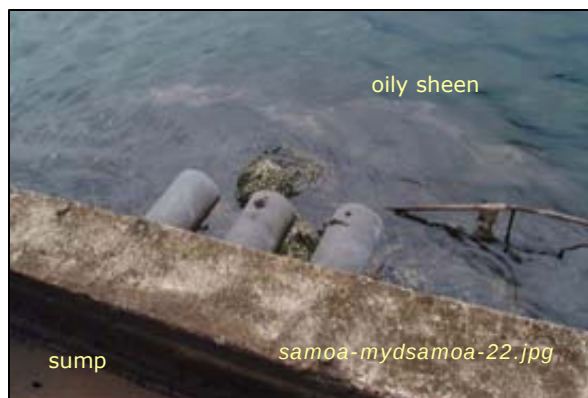
- 4 Numerous shipyard sources of contamination were exposed to contact with storm water drainage. Consequently, oily drainage into and out of one of the catch basin sumps resulted in an oily sheen on the harbor around the sump outfall.

Photo #12: Catch Basin #1 - Oily Sheen in Harbor  
Taken By: Greg V. Arthur  
Date: 04/01/08

**Compliance Status** - The shoreside shipyard areas are not designed to successfully achieve full compliance with the requirements of the NPDES permit. There are areas around the dry docks in particular that are not curbed and from which runoff appeared to drain into the harbor. See Photo #5 on page 7 of this report. There are also numerous potential sources of storm water contamination from the observed exposure to rainfall or runoff of materials, wastes, or equipment. See Photos #6, #7, and #10. Also while the three sumps each discharge through inverted siphons to capture floating solids, during this inspection, the EPA inspector found oily drainage into and from the sump serving as the NPDES discharge point for Catch Basin #1. See Photos #11 and #12. These findings constitute a violation of the
