**Re: April 27 and April 30, 2009 Clean Water Act Inspection**

**NPDES COMPLIANCE EVALUATION INSPECTION**

NPDES Permittee: MYD Samoa, Inc.

Facility: Satala Shipyard  
P.O. Box 7684, Pago Pago, Tutuila Island, American Samoa  
(NPDES Permit No. AS0020026)

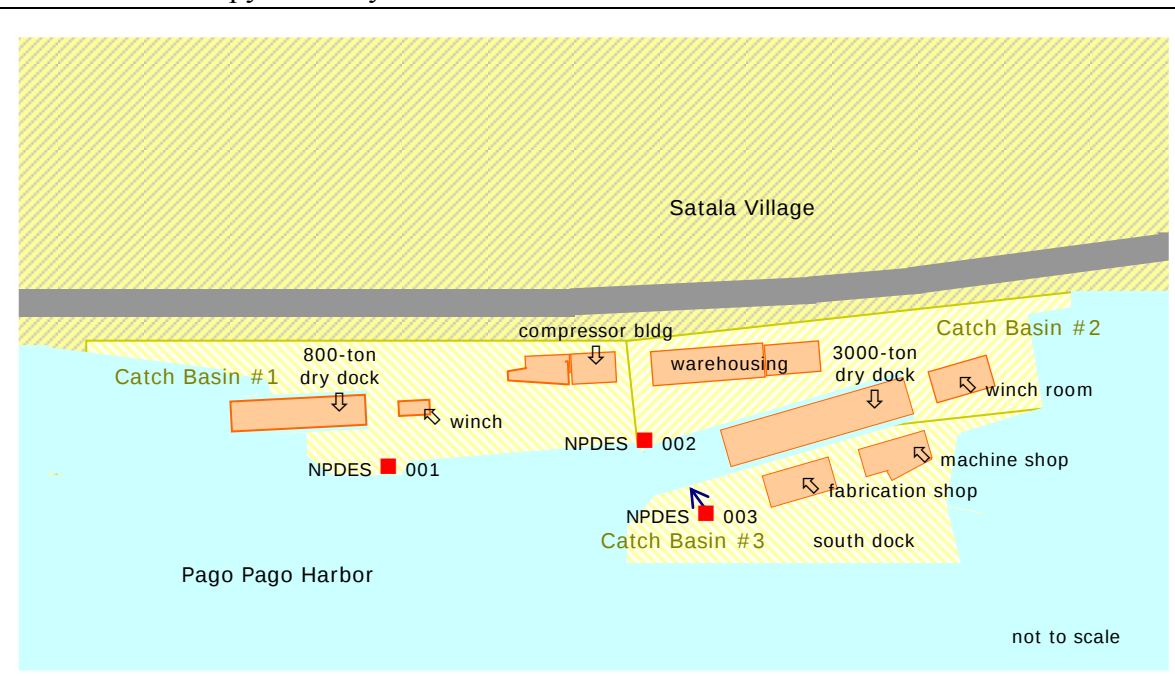
**Figure 1.3**  
MYD Samoa Shipyard – Layout

3000-Ton Cradle Dry Dock - The larger of two cradle dry docks was found on this inspection to be functioning and in order. The cradle dry dock consists of a bifurcated 50x300-foot platform mounted on rolling stock. The dry dock rolls down a marine railway that extends into and is submerged under the harbor. Ships are positioned over and fixed on hauling blocks to the cradle which is then winched up the railway out and over of the water. An electric winch engine and gearing is housed at the head of the dry dock. The gearing travels through a basin pit filled with lubricating oil. The ship repair work in the dry docks involves hydroblasting, repainting, painting, fitting, repair work, and fabrication. Vessels under repair have hulls made of fiberglass, aluminum, or steel. Sand-blast repainting uses copper-slag grit.

The deck consists of removable plywood and planking without perimeter curbing. Roofing felt now is added under new plywood to better fill in the gaps between the planking on the deck directly over harbor water. The dry dock has framing and rigging that allows the unfurling of portable curtains around and over the dry dock to capture painting overspray and windborne blasting debris. On the date of this inspection, MYD Samoa indicated that new curtains with grommet kits have been procured but not yet delivered to the shipyard. See Photos #1 and #2 in Section 1.6 of this report on page 9.

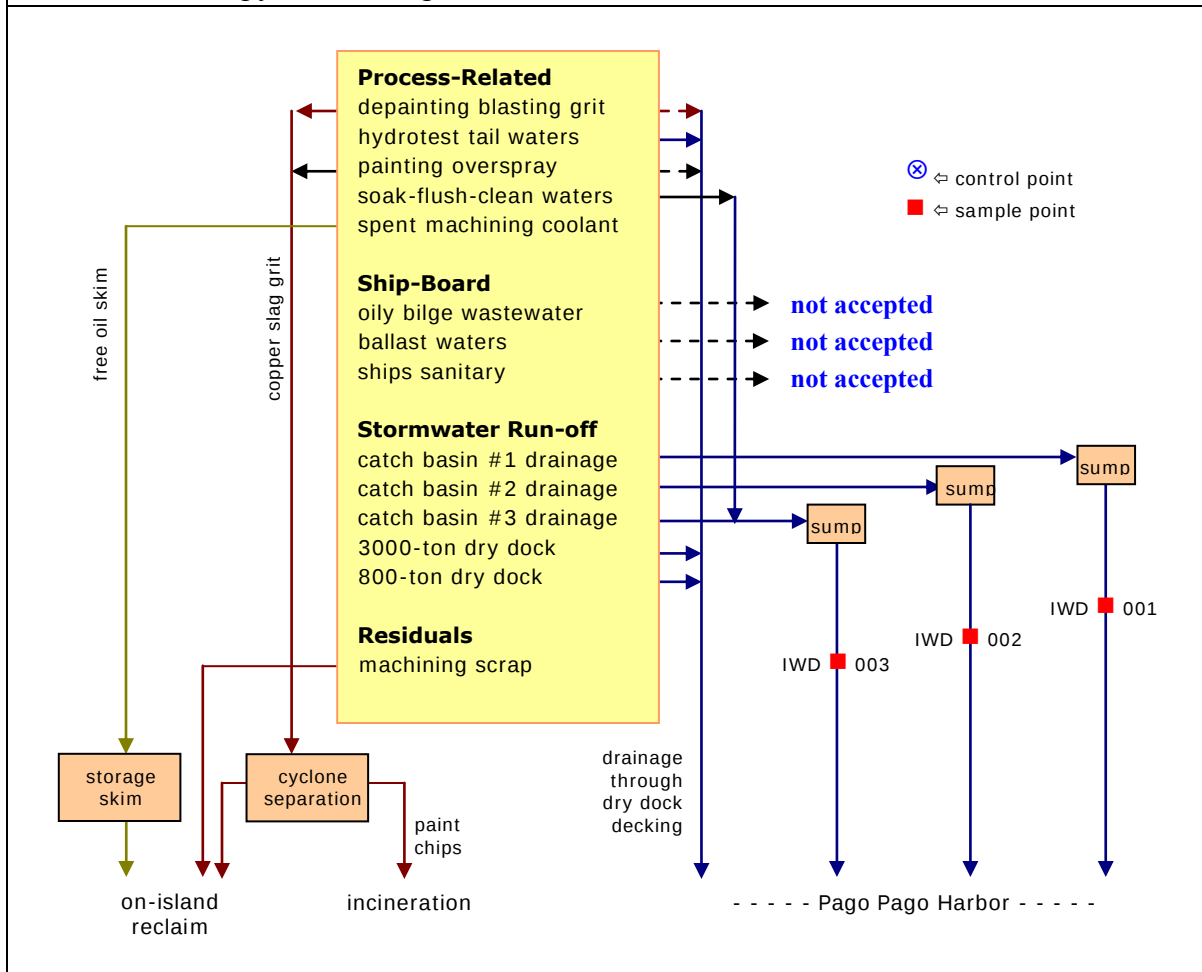
**Figure 1.4**  
MYD Samoa Shipyard – Configuration

Storm water run-off would be expected from the dry docks, and the three drainage areas referred to as Catch Basins #1, #2 and #3. All of the shipyard sources and the drainage areas have the potential either to produce contaminated contact wastewaters or to discharge pollutants into the harbor. MYD Samoa is not designed and does not have the capability to provide any wastewater treatment beyond make-shift oil interception. MYD Samoa also does not have non-domestic connections into the domestic ASPA sewers. As a result, the wastewater controls can only be through operational best management practices ("BMPs").

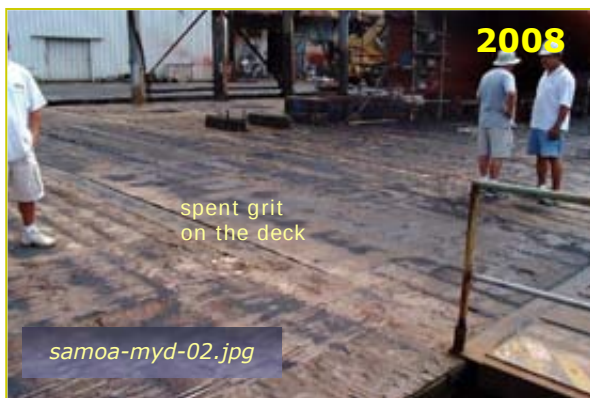
Photo #1: 3000-Ton Dry Dock Decking – April 2008  
Taken By: Greg V. Arthur  
Date: 04/01/08

Dry dock Drainage – Rainfall runoff is expected to drain through the gaps in the dry dock decking (although there are now fewer gaps) or directly to into the open gap over the harbor between the uncurbed dry dock and the pier. The 3000-ton dry dock was observed during this inspection to have no significant pollutant sources exposed to contact with rainfall run-off. See Photos #1 and #2 in Section 1.6 on page 9.

Corrective Actions - A few remaining shortcomings have been identified following the EPA Order. First, there were no curtains available to capture drifting solids within the dry dock for removal, although MYD Samoa had them on order. Second, process-related wastewaters (*hydroblast, hose cleaning, hydrotesting*) discharge uncontrolled from the dry dock deck to the harbor beneath. Additional BMPs to correct these shortcomings and to ensure the shipyard and dry dock remain swept, clean, and in order are listed in Table 3.1 on page 17.

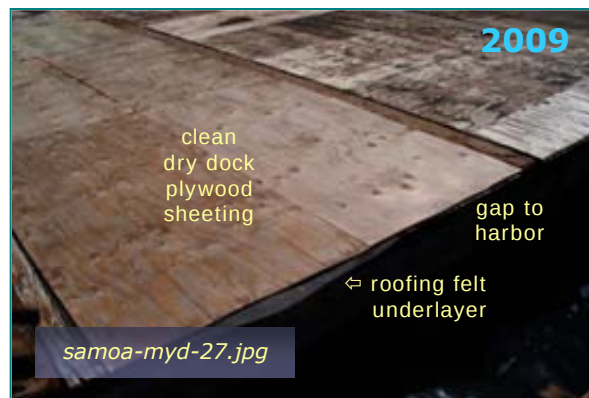
Photo #2: 3000-Ton Dry Dock Decking – April 2009  
Taken By: Greg V. Arthur  
Date: 04/27/09

On the day of this inspection, these BMPs were observed have been effective in keeping much of the spent grit out of the harbor. In particular, (1) many of the gaps in the decking were underlain with roofing felt; (2) there was little spent grit on the deck and none on the surrounding piers; (3) there was no wet grit residue left on the deck after sweeping; and (4) the stockpile of spent grit stored next to the 800-ton dry dock was removed. However, spent grit blown to the dry dock edges would not be captured until MYD Samoa installs the new curtains. See Photos #1, #2, #4, #5, and #6 in Section 1.6 on page 9.

Compliance Status - The dry dock was found with the gaps better sealed and the deck swept, clean, and in order. In particular, there was no blasting grit, paint debris, or overspray found on the dry dock deck or alongside on the piers. The design of the dry dock, with a split down the middle and crisscrossed with chain ways, forestalls the corrective actions advanced in the EPA Order to entirely seal the deck and direct all dry dock drainage for discharge through a controlled sample point. Nevertheless, continuous capture and removal of the solids from a curtain-shrouded and gap-sealed deck (roofing felt underlayer and temporary plastic sheeting) should prevent the loss of solids through deck gaps, over the deck edge, or entrained in storm water run-off and drainage. The EPA Order is expected to be modified to rescind the corrective actions related to controlled deck drainage. See Photos #1 and #2 on page 8.

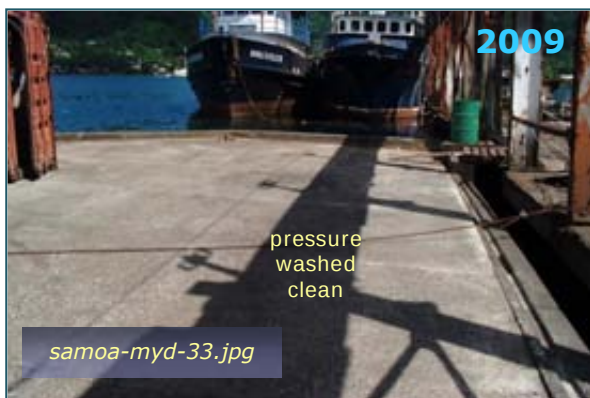
Photo #3: End of the Pier – April 2009  
Taken By: Greg V. Arthur  
Date: 04/27/09

Catch Basin #1 Drainage – Catch Basin #1 includes the piers and landings around the 800-ton dry dock and two buildings. Catch Basin #1 was observed to be swept, in order, cleaned, and pressure washed, with no significant pollutant sources left exposed to contact with storm water run-off. The numerous pollutant sources observed last year were no longer found. In particular, the open storage of spent blasting grit and material debris adjacent to the 800-ton dry dock and the winch room was entirely removed. The trash piles, oily barrels, spent materials, and equipment on the landing were also removed. The pavement between the dry dock and harbor was pressure washed clean. There was curbing along the open harbor but not around the 800-ton dry dock. Catch Basin #1 drainage collects to a sump outfitted with siphon overflows to the harbor, designated as discharge point NPDES-001. No oily drainage was observed flowing into and through the discharge sump and no sheen was observed in the harbor around NPDES-001. See Photos #3, #4, #7, #8, #9, and #10 in Section 1.6 on page 10.

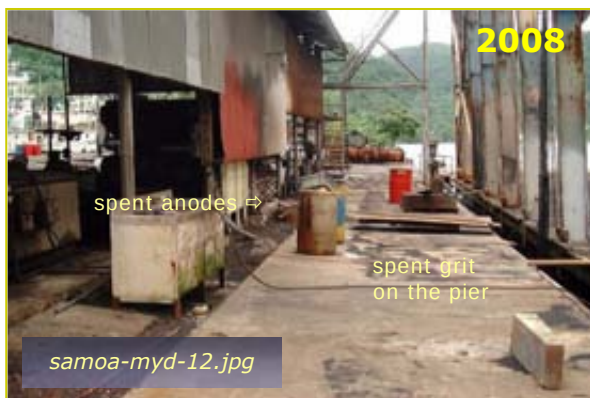
Photo #5: Catch Basin #3 – April 2008  
Taken By: Greg V. Arthur  
Date: 04/01/08

Fabrication Shop - Sheet metal fabrication and welding work is performed in an open but roofed building located near the South Dock just south of the 3000-ton dry dock within the storm drainage watershed referred to as Catch Basin #3. The metal fabrication work includes sheet metal shearing, welding, rolling, and bending. The EPA inspector observed that scrap and materials, such as spare zinc anodes, were no longer stored exposed to the rain along the outside of the building. The cement driveway between the shops and the dry dock appeared to slope from the shops toward the dry dock and the gap that opens to the harbor waters below. See Photos #5 and #6 in Section 1.6 of this report on page 9.

Catch Basin #3 Drainage – Catch Basin #3 includes the South Dock and the pier side landings between the fabrication and machining buildings and the 3000-ton dry dock. Catch Basin #3 was observed to be swept, in order, and cleaned, with no significant pollutant sources exposed to contact with rainfall run-off. Spent blasting grit was not found on the landings south of the dry dock. Zinc anodes, barrels, materials, scrap, and debris were no longer stored outside and around the fabrication and machining buildings. No boat repair work was being done by the ship crews on the South Dock. Most of the drainage collects to a sump outfitted with siphon overflows to a short canal leading to the harbor, and designated as discharge point NPDES-003. No sheen was observed in the canal and harbor around NPDES-003. There is curbing along the South Dock but not on the pier around the 3000-ton dry dock. Around the dry dock, the landing slants toward the open gap over the harbor between the uncurbed pier and the dry dock. See Photos #5, #6, and #12 in Section 1.6 on pages 9 and 10.

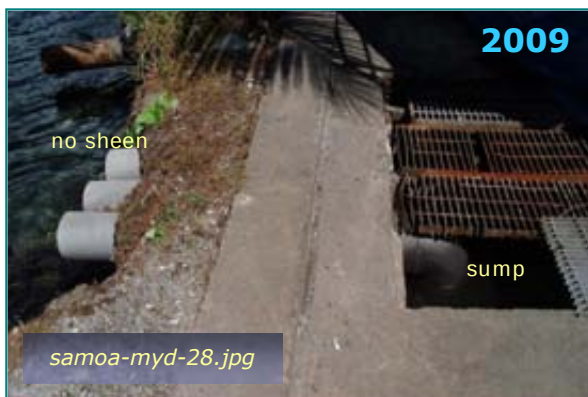
Photo #11: Discharge Sump 002 – April 2009  
Taken By: Greg V. Arthur  
Date: 04/27/09

Catch Basin #2 Drainage – Catch Basin #2 encompasses buildings and pier side landings north and east of the 3000-ton dry dock. Catch Basin #2 was observed to be swept, in order, and cleaned, with no significant pollutant sources exposed to contact with rainfall run-off. Spent blasting grit was not found on the landings north of the dry dock. There is curbing along the open harbor but not on the pier around the 3000-ton dry dock. The drainage collects to a sump outfitted with siphon overflows to the harbor, designated as discharge point NPDES-002. No sheen was observed in the harbor around NPDES-002. See Photo #11 in Section 1.6 on page 10.

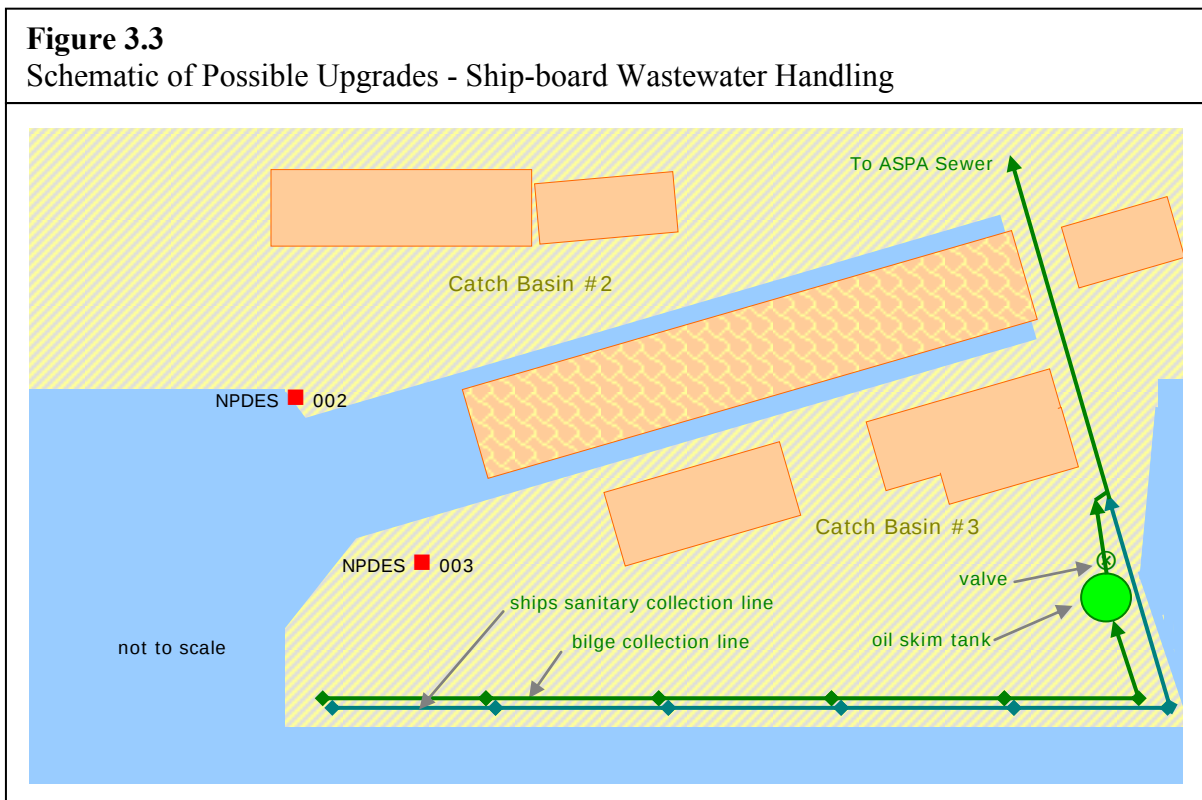
- MYD Samoa should consider providing a connection for ships sanitary wastewaters to the ASPA domestic sewer system. See Figure 3.3 on page 16 of this report.
