**U.S. Environmental Protection Agency
Region 9
Clean Water Act Compliance Office**

Industrial User Inspection Report

Industrial User: Kion Technology, Inc.
Industrial User Address: 2190 Oakland Rd., San Jose, CA 95131

Inspection Date: August 17, 2011

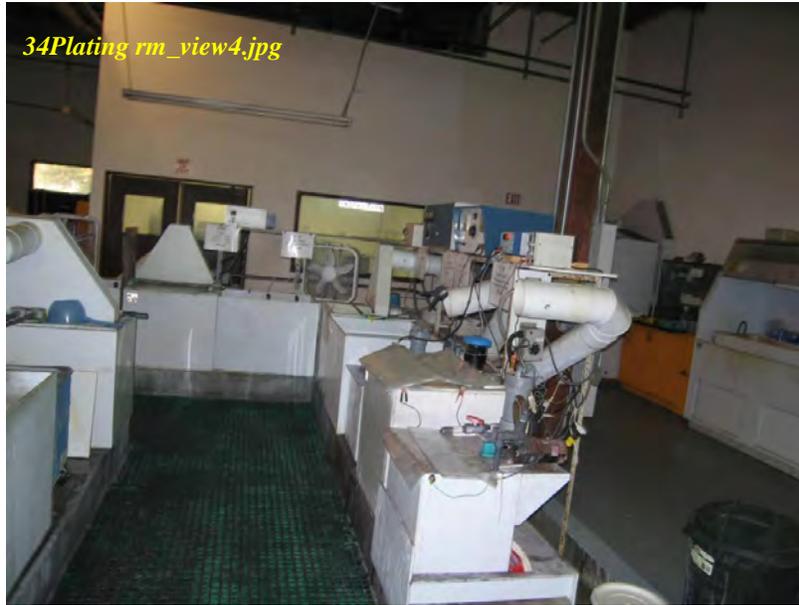
All tanks except the rinse tanks are dual-contained tanks. In addition, all of the metal finishing tanks sit on top of floor grating, below which is the secondary containment. *See Photo 1 in Attachment 1.* During the inspection, the secondary containment was dry with no standing liquid. Kion stated that, if any liquid were to collect in the secondary containment area, Kion would vacuum it out and send the liquid to the onsite wastewater treatment system.

Metal finishing room

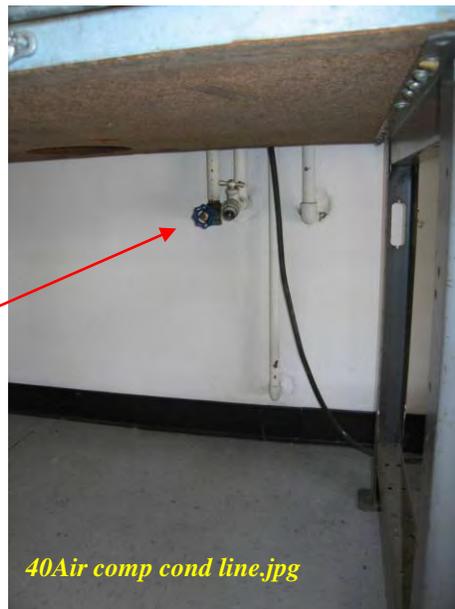
The treated wastewater is sent in a 300-gallon batch to a holding tank. The contents, once released, flow through a sample box and on to the local sanitary sewer system. Kion discharges a 300-gallon batch per day. Kion stated that the air compressor condensate is collected in two locations and then manually transferred to the onsite wastewater treatment system, approximately two gallons every week. One of the locations is simply a pipe with the valve closed. No container for collecting the condensate was observed. *See Photo 2 in Attachment 1.* Kion stated that it would double-check that staff were collecting the condensate on a weekly basis.

Air compressor condensate line

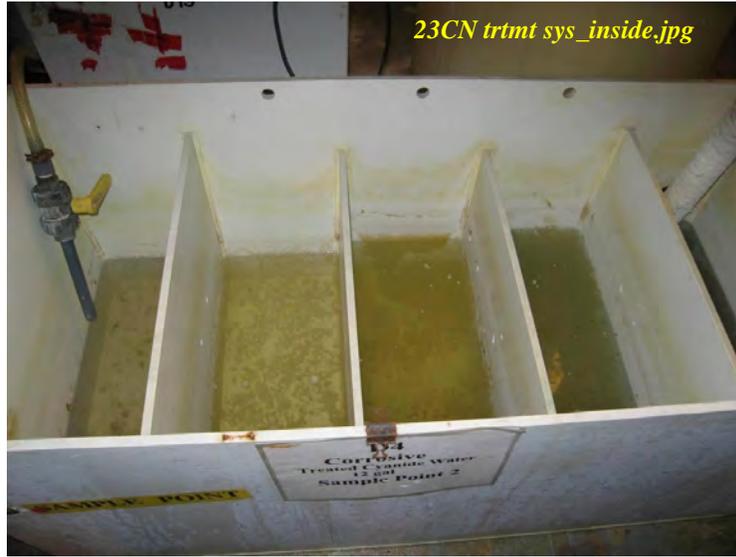
After Kion's cyanide violations in late 2010, Kion decided not to use its cyanide treatment system and instead have the cyanide-contaminated wastewaters hauled offsite for hazardous waste disposal. The cyanide treatment system is no longer connected to the process lines or to the rest of the wastewater treatment system. The City of San Jose required that Kion empty the contents of the cyanide treatment tank. Kion did so, sending the contents offsite as hazardous waste. However, Kion subsequently refilled the tank with water, stating that the tank, which is of non-metal construction, would crack at the joints if not filled with liquid. During the inspection, the tank was full of an opaque liquid. It did not appear to be clean water. *See Photo 3 in Attachment 1.*

Cyanide treatment system –
currently not in operation
Taken by Anna Yen on August 17, 2011

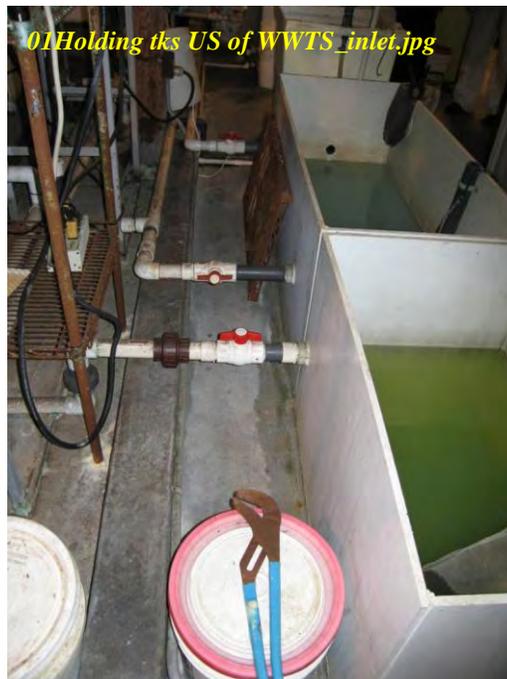
Photo 4

Wastewater from the process area gravity flows to a two-compartment holding tank: one compartment for cyanide-contaminated wastewater and the other compartment for wastewater without cyanide. The compartment containing cyanide-contaminated wastewater used to be pumped to the cyanide treatment system. However, now that Kion is not using its cyanide treatment system, it pumps out the compartment containing cyanide wastewater and has the contents hauled offsite for hazardous waste disposal. Kion pumps the contents of the other compartment to a treatment tank equipped with a mixer. The pH is adjusted automatically with the addition of sodium hydroxide. During the inspection, Kion's pH meter read 10.6. Ferrous sulfate is added for coagulation/flocculation. After some time for precipitation, the contents are sent to one of two filter presses. The filter cake is hauled away for offsite disposal, and the filtrate is sent to a 2000-gallon clarifier. Approximately 300 gallons of effluent from the clarifier are allowed to flow to a final holding tank for each batch discharge. Once released, the contents of the holding tank flow through a sample box and ultimately to the local sanitary sewer system. *See Photos 4-13 in Attachment 1.*

Holding tanks immediately prior to treatment
Taken by Anna Yen on August 17, 2011

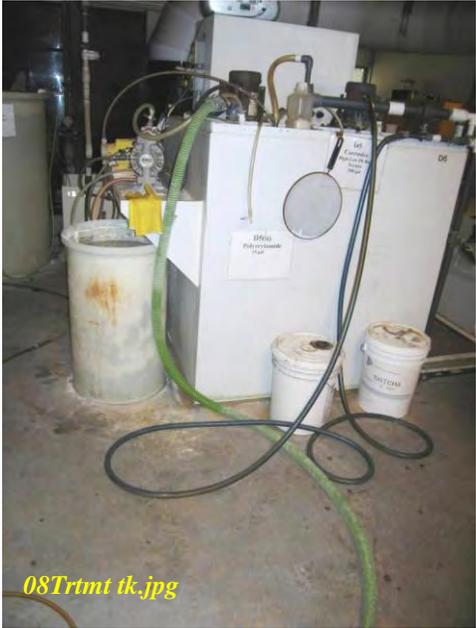
Photo 5

EPA noted that Kion was leaving open drums of chemicals out on the floor: drums of chemicals for addition to the wastewater treatment system as well as the 5-gallon containers used for batch treatment. *See Photos 5 and 16 in Attachment 1.* Though these drums and containers are all located in the bermed area of the wastewater treatment system, these open containers pose a safety hazard to employees working in this area.

Treatment tank

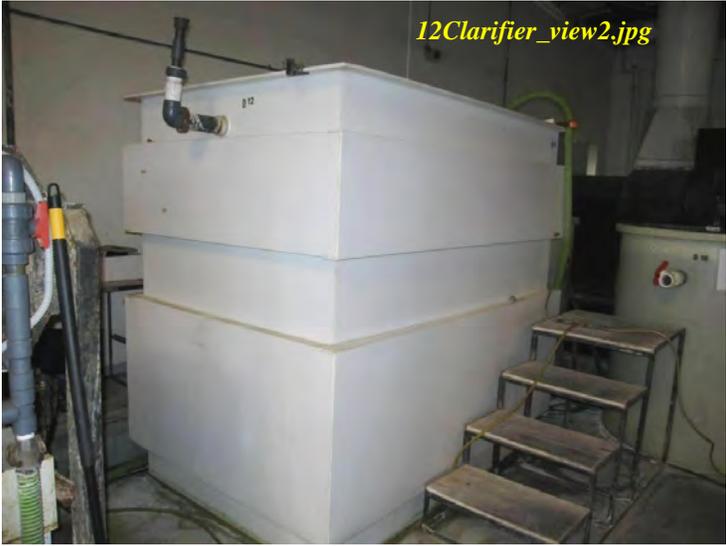
Photo 6

Clarifier

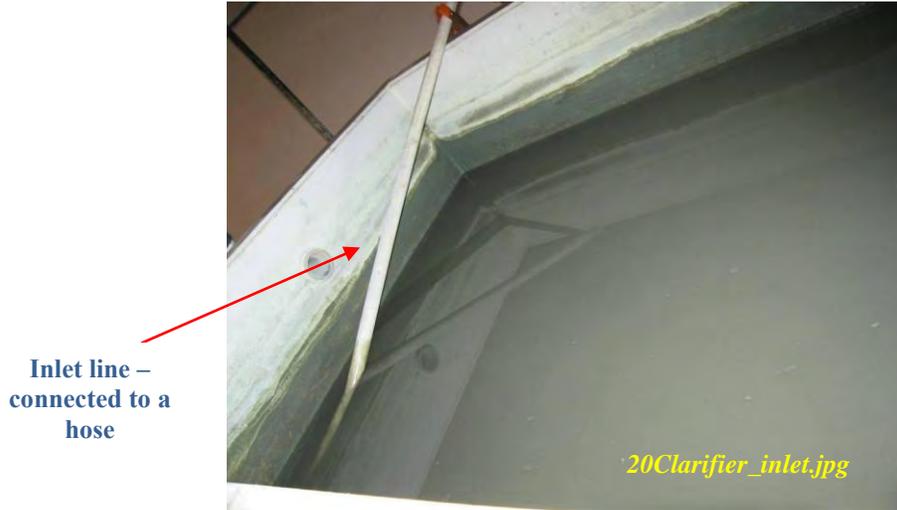
Photo 7

Inside of clarifier – view from top
Taken by Anna Yen on August 17, 2011

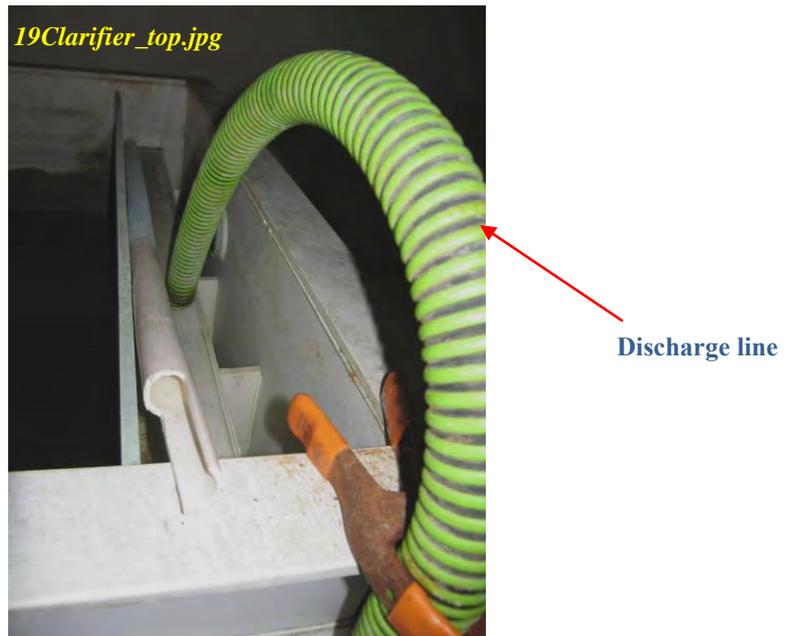
Photo 8

Top of clarifier
Taken by Anna Yen on August 17, 2011

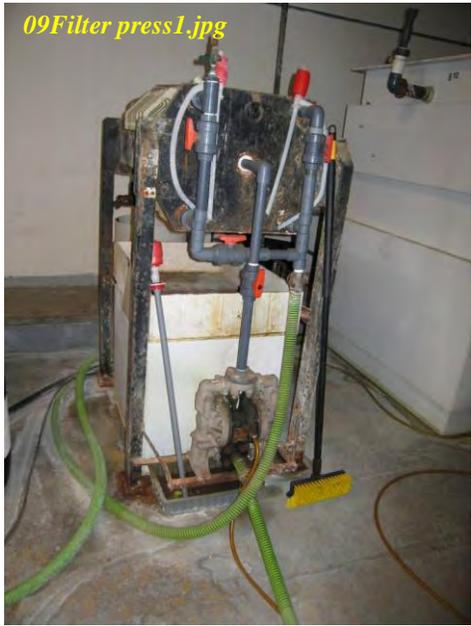
Photo 9

Filter press

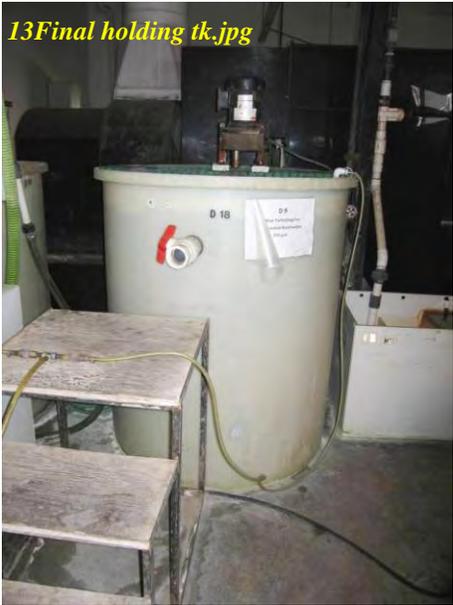
Photo 10

Final holding tank/batch tank
Taken by Anna Yen on August 17, 2011

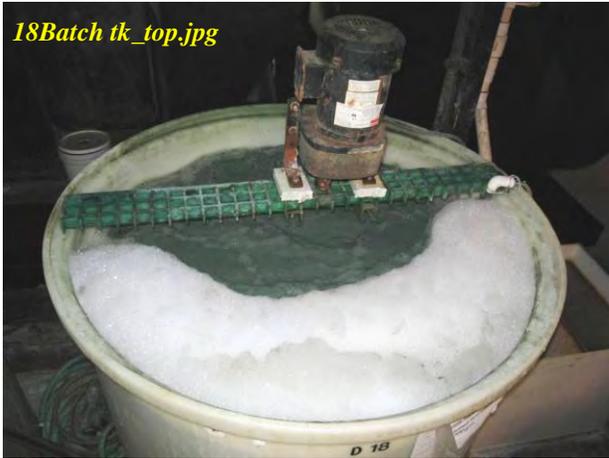
Photo 11

Top of final holding tank
Taken by Anna Yen on August 17, 2011

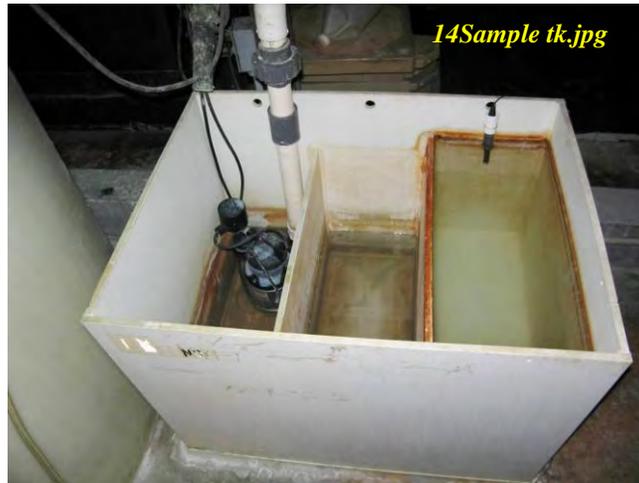
Photo 12

Sample box – view of inside
Taken by Anna Yen on August 17, 2011

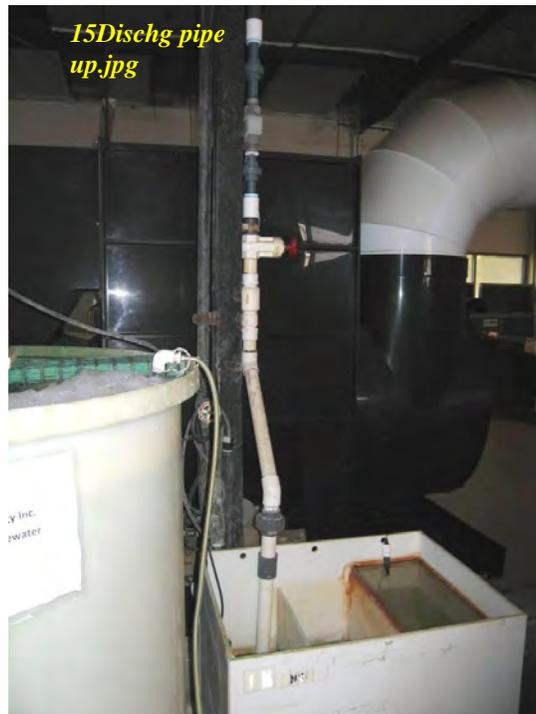
Photo 13

Discharge pipe – extending up from sample box
Taken by Anna Yen on August 17, 2011

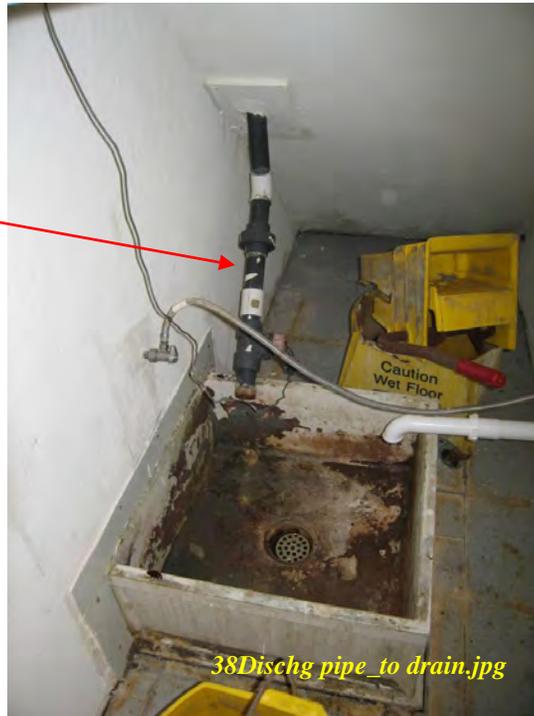
Photo 14

The effluent pipe from the sample box, however, first conveys the treated wastewater to a room outside the process area. The treated wastewater exits the pipe into a floor drain which leads to the local sewer system. A nearby sink which is also outside of the process area drains to this same floor drain. *See Photos 14-15 in Attachment 1.*

Treated effluent
from wastewater
treatment system

Drain line from
sink on other
side of wall (see
Photo 15)

Discharge pipe from wastewater treatment system –
to floor drain to sewer system
Taken by Anna Yen on August 17, 2011

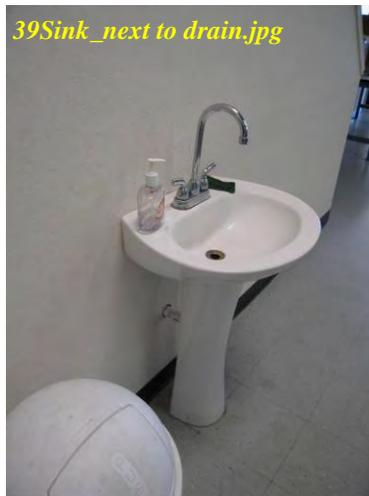
Photo 15

Sink – outside of metal finishing process area
- on other side of wall from discharge pipe end point
Taken by Anna Yen on August 17, 2011

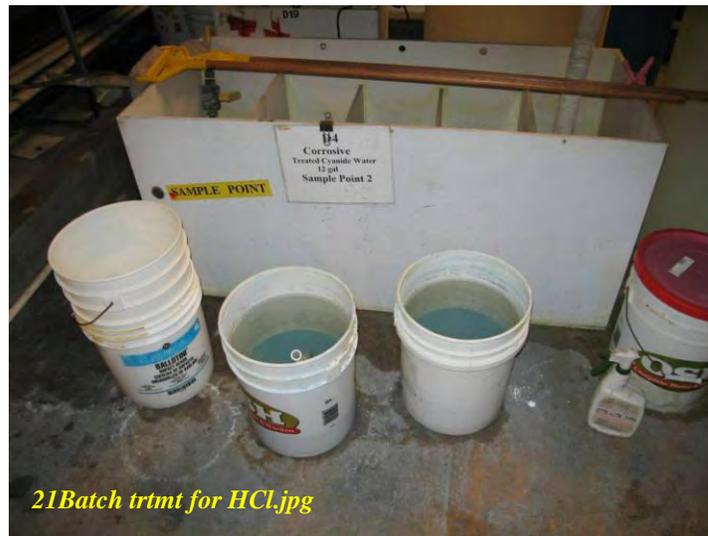
Two 5-gallon containers sitting on the floor are used for batch treatment of spent hydrochloric acid. *See Photo 16 in Attachment 1.* Lime, for pH adjustment, and metabisulfite are added to the containers of hydrochloric acid. After a few hours, the contents are pumped through one of two filter presses for solids removal. The filtrate is sent to a 2000-gallon clarifier, while the filter cake is hauled away for offsite disposal.

Batch treatment of hydrochloric acid –
in 5-gallon containers
Taken by Anna Yen on August 17, 2011
