UNITED STATES ENVIRONMENTAL PROTECTION AGENCY
REGION IX
75 Hawthorne Street
San Francisco, CA 94105

NPDES COMPLIANCE EVALUATION INSPECTION

NPDES Permittee: MYD Samoa, Inc.
Facility: Satala Shipyard
P.O. Box 7684, Pago Pago, Tutuila Island, American Samoa
(NPDES Permit No. AS0020026)
Receiving Water: Pago Pago Harbor
Date of Inspection: April 1, 2008

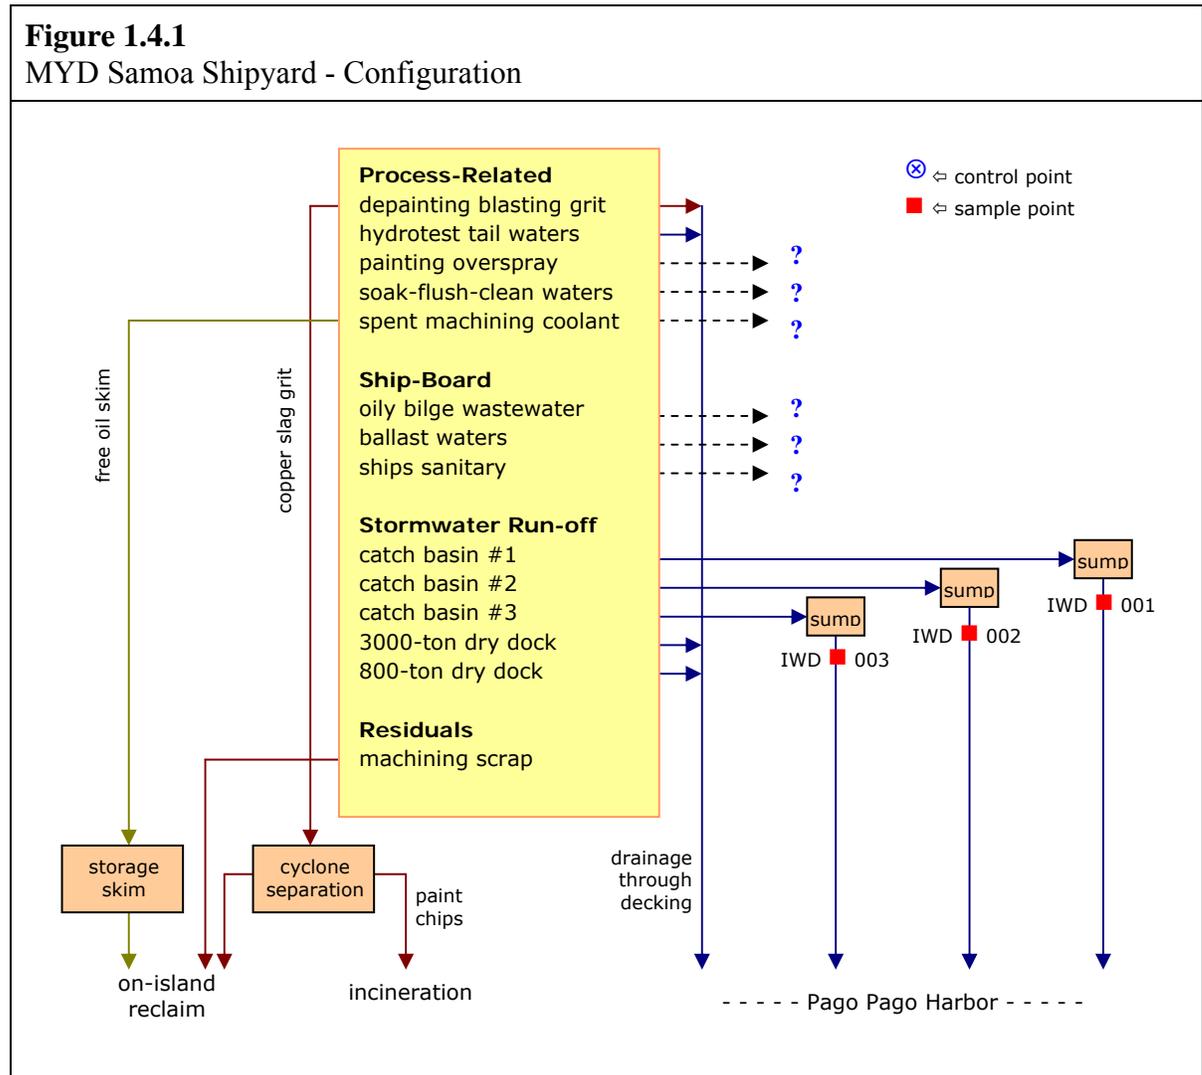
Figure 1.4.2
MYD Samoa Shipyard - Layout

Rainwater Runoff – The Satala Shipyard, minus the two dry docks, is partitioned into three run-off basins, referred to as Catch Basins #1 through #3. See Figure 1.4.2 on page 5 for a layout of the facility.

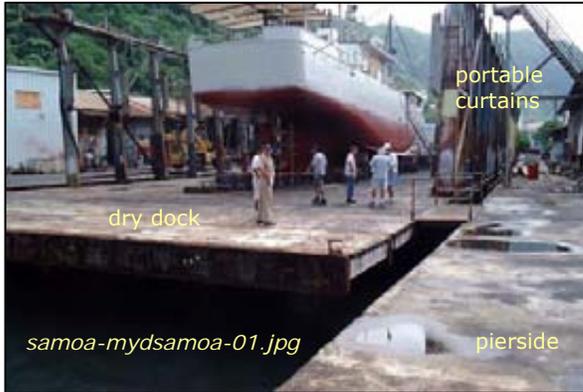
- Dry dock rainfall run-off is expected to drain through the gaps in the dry dock decking or directly to into the open gap over the harbor between the uncurbed dry dock and the pier. The 3000-ton dry dock was observed during this inspection to have one notable pollutant source, spent blasting grit on the dry dock decking, exposed to contact with storm water run-off. See Photos #1 through #4 in Section 1.6 on page 8.

Photo #1: 3000-Ton Dry Dock - Leading Edge
Taken By: Greg V. Arthur
Date: 04/01/08

- MYD Samoa must seal and curb the dry dock deck in order to capture and control all discharges of process wastewaters, wastes, and storm water drainage to the harbor.
- MYD Samoa must establish both a method to segregate contaminated wastewaters from uncontaminated storm water drainage and an alternative to harbor discharge.
- MYD Samoa must curb the piers surrounding the dry docks and along the harbor.
- MYD Samoa must implement BMPs to minimize storm water contact with all process equipment, materials, debris, and wastes.
- MYD Samoa must install dry dock drainage controls to allow the settling of solids, the skimming of oils and floating solids, visual inspection prior to discharge, and controlled discharge through a sample point or points.
- MYD Samoa must establish a sample point or set of points through which all dry dock wastewaters and drainage can discharge to the harbor.

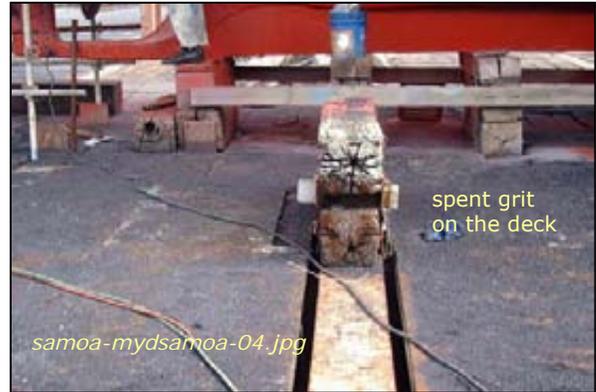
Photo #2: 3000-Ton Dry Dock - Gaps in Decking
Taken By: Greg V. Arthur
Date: 04/01/08

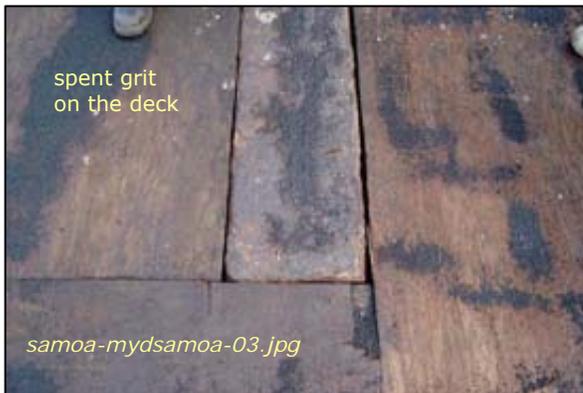
Photo #3: 3000-Ton Dry Dock - Gaps Between Boards
Taken By: Greg V. Arthur
Date: 04/01/08

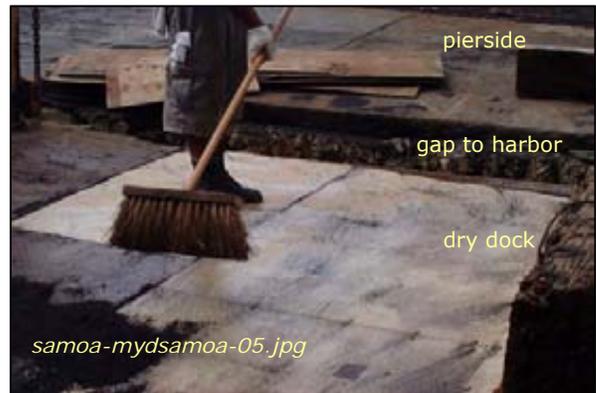
Photo #4: 3000-Ton Dry Dock - Sweeping / No Curbs
Taken By: Greg V. Arthur
Date: 04/01/08

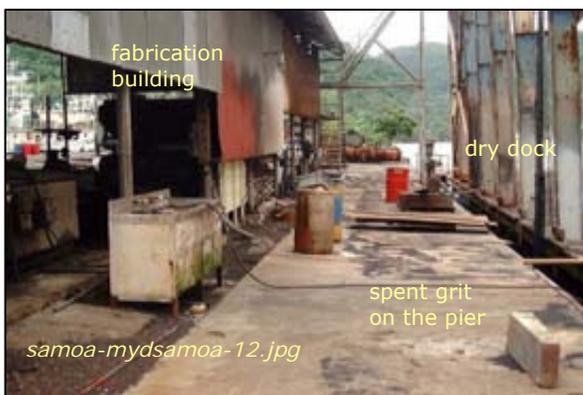
- Catch Basin #3 includes the South Dock and the pier side landings between the fabrication and machining buildings and the 3000-ton dry dock. Catch Basin #3 was observed during this inspection to have many pollutant sources exposed to contact with storm water run-off, in particular spent blasting grit on the landings south of the dry dock, zinc anodes stacked near the fabrication building, and light boat repair work performed by the ship crews on the South Dock. Most of the drainage collects to a sump outfitted with siphon overflows to a short canal leading to the harbor, and designated as NPDES discharge point 003. There was curbing along the South Dock but on the pier around the 3000-ton dry dock. However, around the dry dock, the landing appeared to slant toward the open gap over the harbor between the uncurbed pier and the dry dock. See Photos #5 through #8 in Section 1.6 on pages 8 and 9.

Photo #5: Catch Basin #3 - Fab Bldg / Dry Dock
Taken By: Greg V. Arthur
Date: 04/01/08

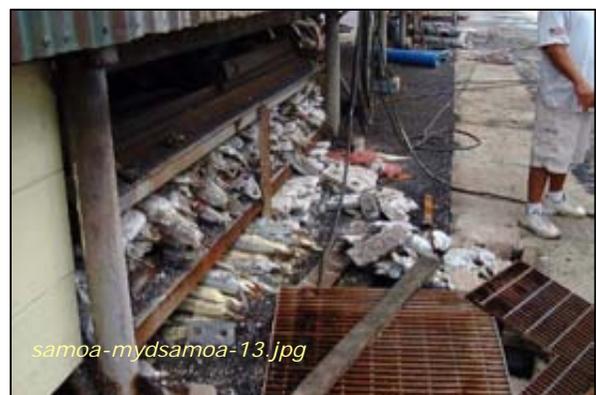
Photo #6: Catch Basin #3 - Zinc Anodes Exposed
Taken By: Greg V. Arthur
Date: 04/01/08

Figure 3.2 Correction Actions for Shipyard Operations	
3.2.1	Secondary containment always shall be deployed around all materials, paints, fuel, containers, drums, trash heaps, hazardous materials storage, tooling and mechanized equipment exposed to rainfall on the dry docks or on shore.
3.2.2	New zinc or aluminum anodes and lead ballast shall be covered or wrapped in plastic to prevent contact with rain and storm water runoff, and spent anodes and ballast shall be contained within drums or sealed crates.
3.2.3	Collected spent blasting grit shall be stored in a way that prevents contact with rainfall or storm water run-off.
3.2.4	All captured runoff from contact with contamination sources shall be disposed either through settling and oil skimming or to the ASPA sewers.
3.2.5	Pierside curbs surrounding the dry docks and along the harbor shall be constructed.

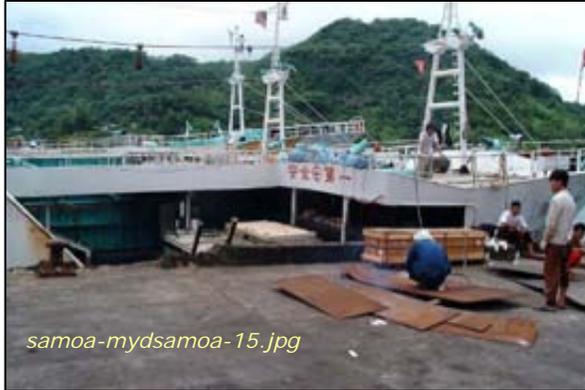
Photo #7: Catch Basin #3 - South Dock Crew Work
Taken By: Greg V. Arthur
Date: 04/01/08

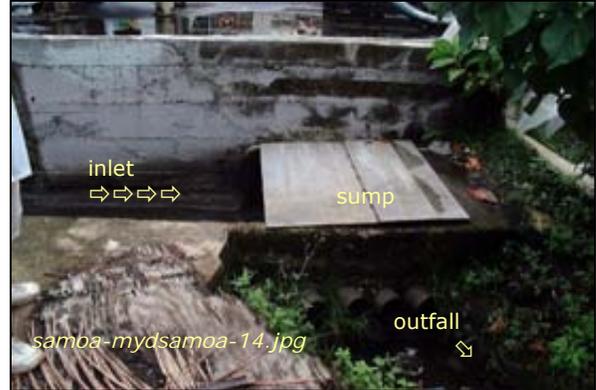
Photo #8: Catch Basin #3 - Discharge Sump 003
Taken By: Greg V. Arthur
Date: 04/01/08

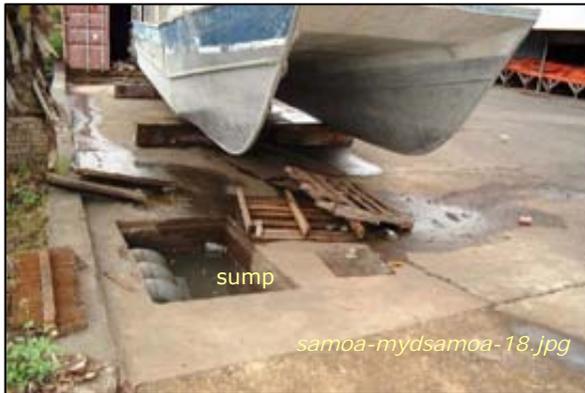
- Catch Basin #2 encompasses buildings and pier side landings north and east of the 3000-ton dry dock. Catch Basin #2 was observed during this inspection to have one notable pollutant source, spent blasting grit on the landings north of the dry dock, exposed to contact with storm water run-off. The warehouses and the winch engine room were not found to have exposed pollutant sources. There curbing along the open harbor but not on the pier around the 3000-ton dry dock. The drainage collects to a sump outfitted with siphon overflows to the harbor. See Photo #9 in Section 1.6 on page 9.

Photo #9: Catch Basin #2 - Discharge Sump 002
Taken By: Greg V. Arthur
Date: 04/01/08

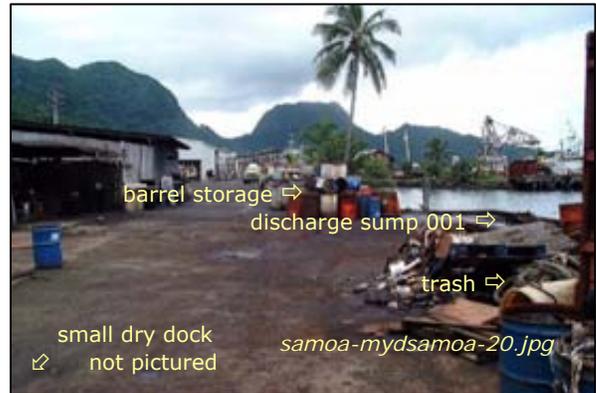
- Catch Basin #1 includes the piers and landings around the 800-ton dry dock and two buildings. The compressor building houses both a diesel fueling tank and battery storage areas under roofing and behind secondary containment. There was curbing along the open harbor but not around the 800-ton dry dock. The drainage collects to a sump outfitted with siphon overflows to the harbor. On the day of this inspection, numerous pollutant sources were observed exposed to contact with storm water run-off. In particular, the ground between the dry dock and harbor was heavily contaminated with spilled oil and there were piles of trash, barrels, spent materials and equipment on the landing along the open harbor. On the day of this inspection, oily drainage from the contaminated ground and the trash and barrels was observed draining into and through the discharge sump to form an oily sheen on the harbor. See Photos #10 through #12 in Section 1.6 on page 9.

Photo #10: Catch Basin #1 - Trash and Oily Ground
Taken By: Greg V. Arthur
Date: 04/01/08

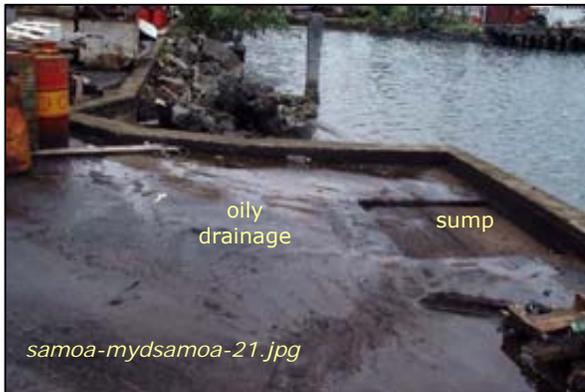
Photo #11: Catch Basin #1 - Discharge Sump 001
Taken By: Greg V. Arthur
Date: 04/01/08

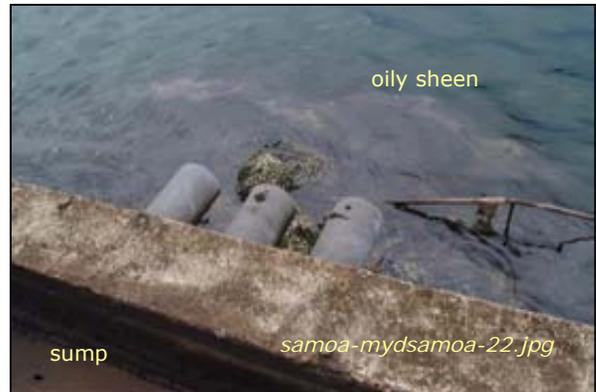
- 4 Numerous shipyard sources of contamination were exposed to contact with storm water drainage. Consequently, oily drainage into and out of one of the catch basin sumps resulted in an oily sheen on the harbor around the sump outfall.

Photo #12: Catch Basin #1 - Oily Sheen in Harbor
Taken By: Greg V. Arthur
Date: 04/01/08

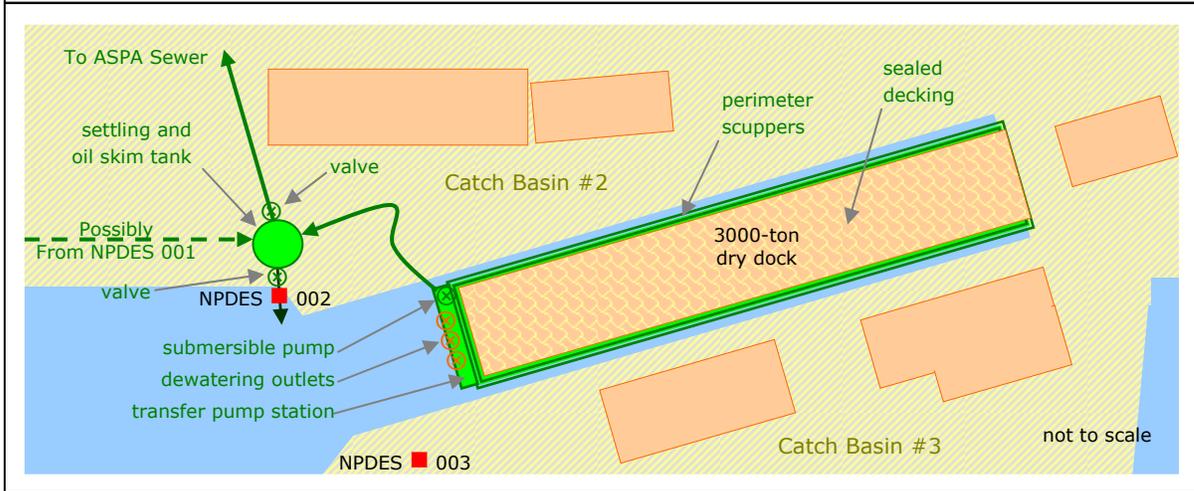
Figure 3.1.2
Schematic of Possible Upgrades - Option 1 Settling Tank Treatment

Dewatering outlets on the dry dock fantail would be locked in the open position when the dry dock is winched into and out of the harbor to allow the free flow of water, but returned to the closed position during ship repair. The outfall(s) from the drainage controls would be established as new NPDES permit sampling point(s).
