## **Additional methods of maintenance beyond those prescribed by the manual for the Andersen RAAS-300 Sequential Air Sampler.**

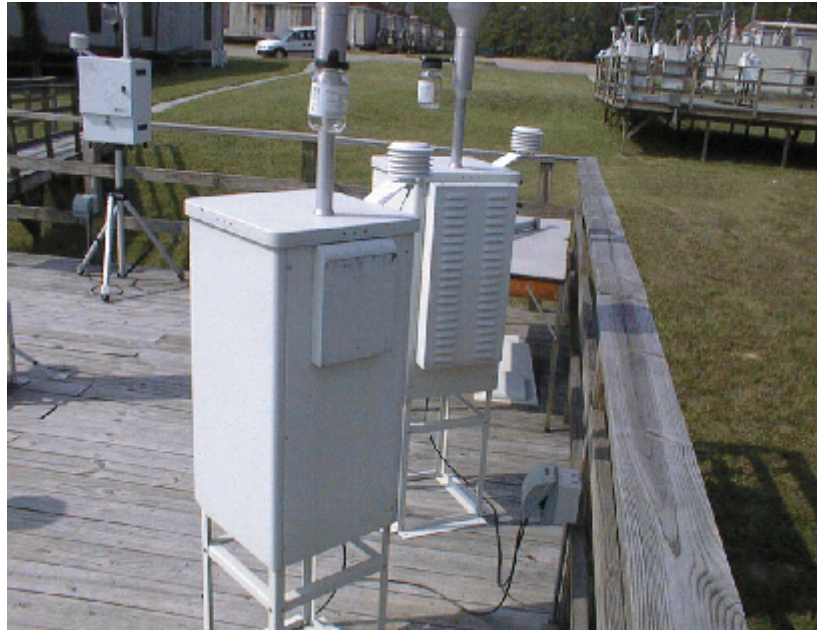
**Figure 1.** Showing the difference between the Andersen sequential's old back (on left) and the newer louvered back (on right) .

**Passive deposition:** There is a question of the potential for passive deposition on filters sitting in the filter carousel. Since the lid that covers the filter tray/carousel does not entirely cover the filter cassettes (there is a gap from the lid to the top of the cassettes), the opening could allow access for fugitive particles to contaminate filters. The main defense for passive deposition is to keep the inside of the sampler clean, wiping away dust or pollen whenever necessary so that a build up does not occur that may enhance that chance of contamination. Also, it is wise to make sure that the cooling fan is working properly and that the filter for the fan is relatively clean and properly in place. Andersen has updated the back of the sampler where the cooling fan and filter are located. Note the difference in the

backs in Figure1, where the old back is a small shield covering the fan and the filter with an opening on the bottom. The new back is a louvered back with multiple openings on the back surface and contains a larger filter inside.

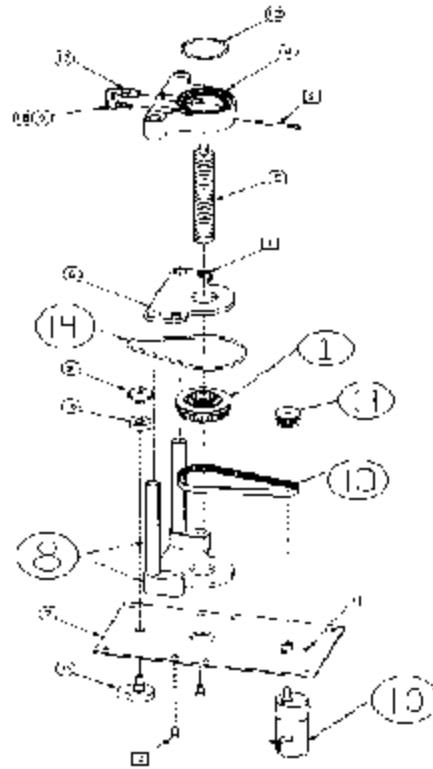
**Figure 2.**  
Diagram of  
Andersen sequential  
filter cassette  
elevator or vertical  
mechanism.

One problem is with the timing pulley (part #3 , Figure 2) which is attached to and rotated by the electric motor (part #10, Figure 2). The timing pulley is fastened to the motor by two half-moon brackets (highlighted in Figure 3) which if not tightened enough, will allow the cam from the motor to spin freely without rotating the timing pulley. The operator wants to make sure the brackets are in good condition, i.e, not warped or rusted, and that it is fitted properly onto the electric motor cam-shaft. The operator also wants to make sure that the toothed belt (part #13, Figure 2) is also in good shape and is taunt around the timing pulley and the drive wheel (part #1, Figure 2).

The operator may also want to periodically check all the parts of the cassette elevator mechanism such as the larger O-ring (part #14, Figure 2) and the status of the drive shaft (part #5, Figure 2) and vertical mounting rods on the mount bottom (part #8, Figure 2) for any rust, excess wear, or other deficiency.

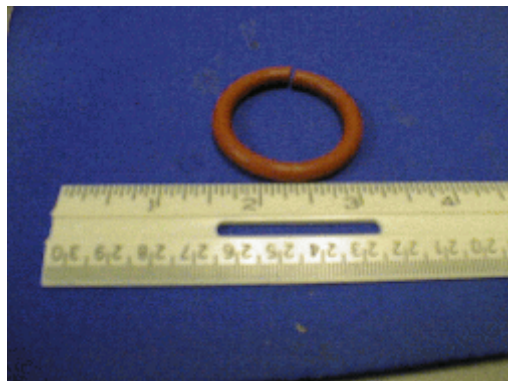
**Figure 3.** Showing a used red, rubber o-ring that was cut off of one of the main rotator wheels.

**Filter tray/carousel rotator system:** The filter tray/carousel holds up to eight filter cassettes which are rotated in series to be used for sampling. Each filter position is recognized by the sampler software by magnets adjacent to each filter. The filter tray is held in place by three adjacent rotating wheels. The two main wheels that turn the tray are towards the back of the sampler, and the third wheel is a free spinning wheel on the front of the tray enclosure (see Figure 4). On the back, main wheels are red, rubber o-rings (see Figure 3) which over time may wear down or shred. As these o-rings are used shavings may eventually come off and get loose inside the main compartment. Additionally, when these o-rings wear out, the filter tray may not rotate properly, if at all. The operator needs to keep a check on the wear of the red o-rings so that they do not fail, possibly creating a mess of shavings in the main compartment, or preventing a programmed sample event to fail to run.

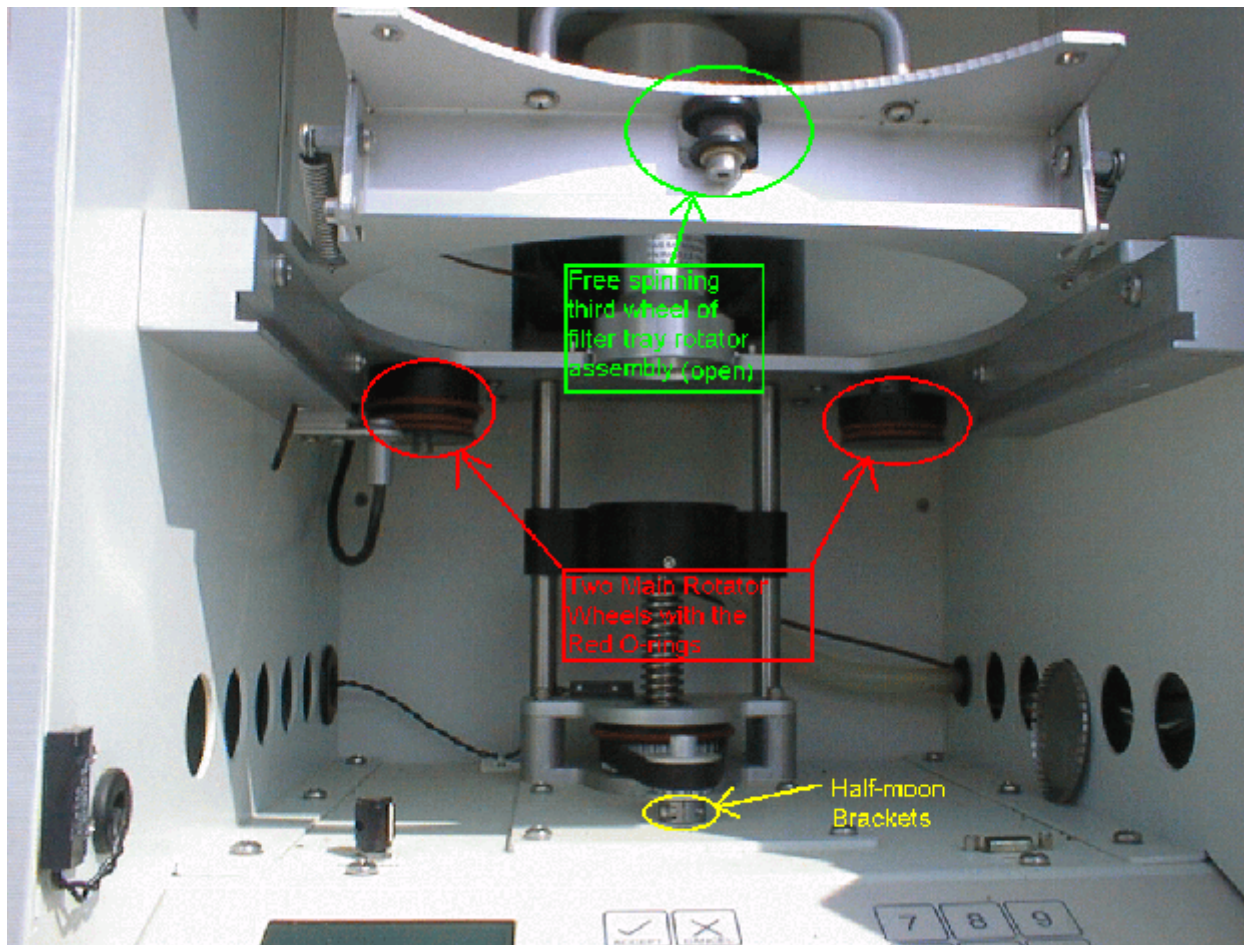
**Figure 4.** Showing an open filter tray rotator assembly, pointing out several parts of interest.
