Coal Combustion Residue Impoundment
Round 11 - Dam Assessment Report

Watts Bar Fossil Plant (Site #12)
Old Ash Pond and Stilling Basin
Tennessee Valley Authority
Spring City, TN

Dewberry Consultants LLC
Fairfax, Virginia

Under Contract Number: EP-09W001727
January 2013(Revised April 2013)

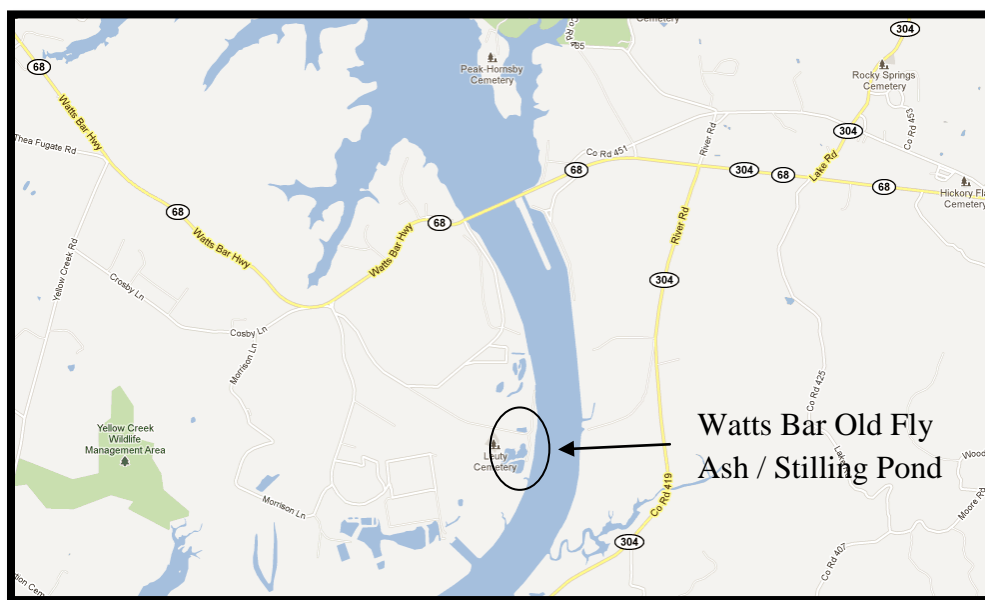
EPA Comment 6: Figure 2.1-2: Aerial Photograph is inadequate. The scale of the photo is not detailed enough. This becomes an issue when attempting to determine the perimeter of the CCR unit. Additionally, the call out in the Figure states "Dry Flay Ash…" – Please correct the typo.

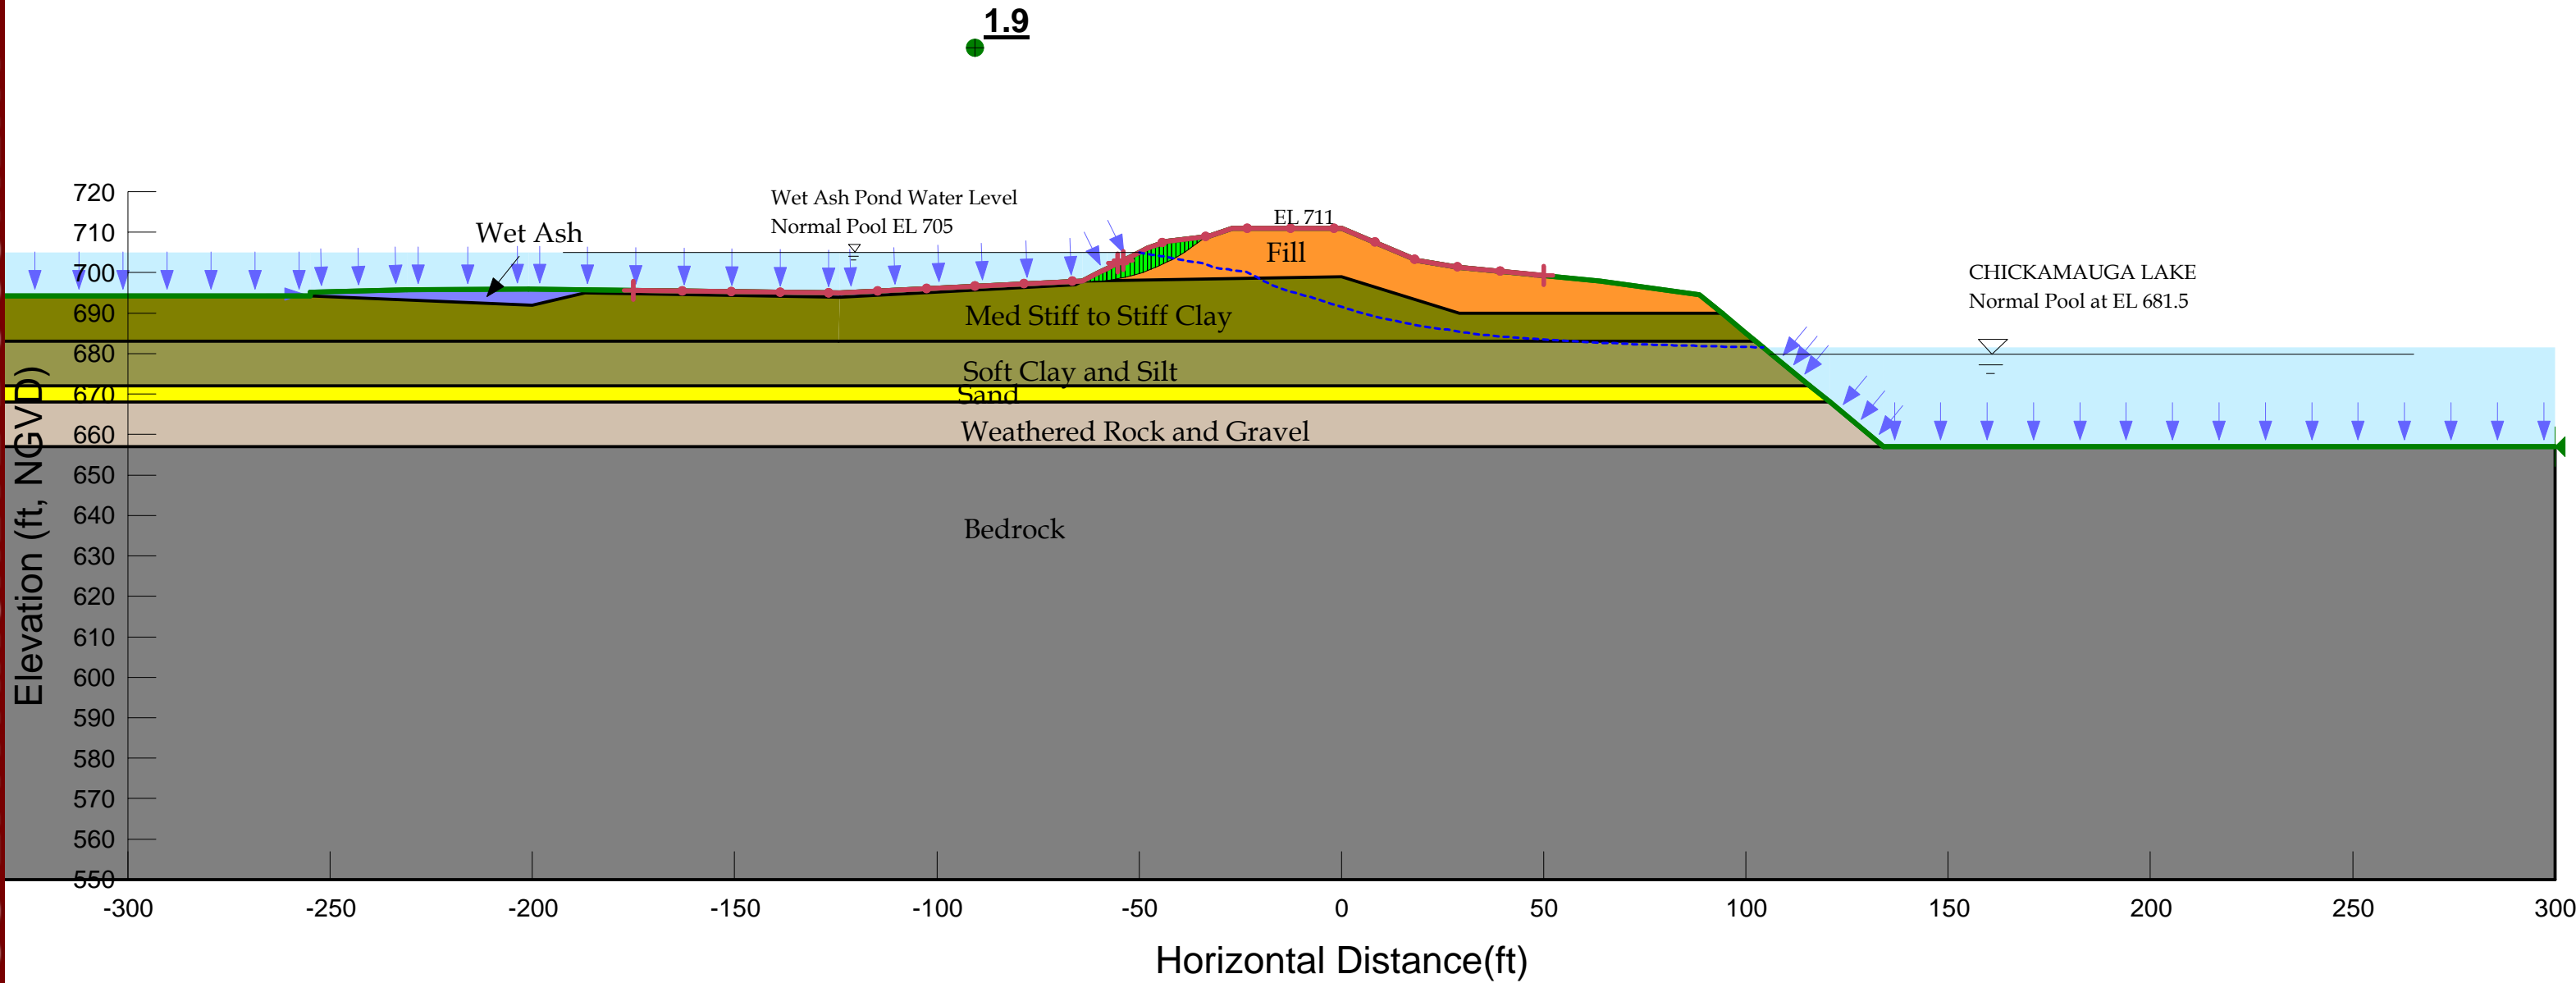
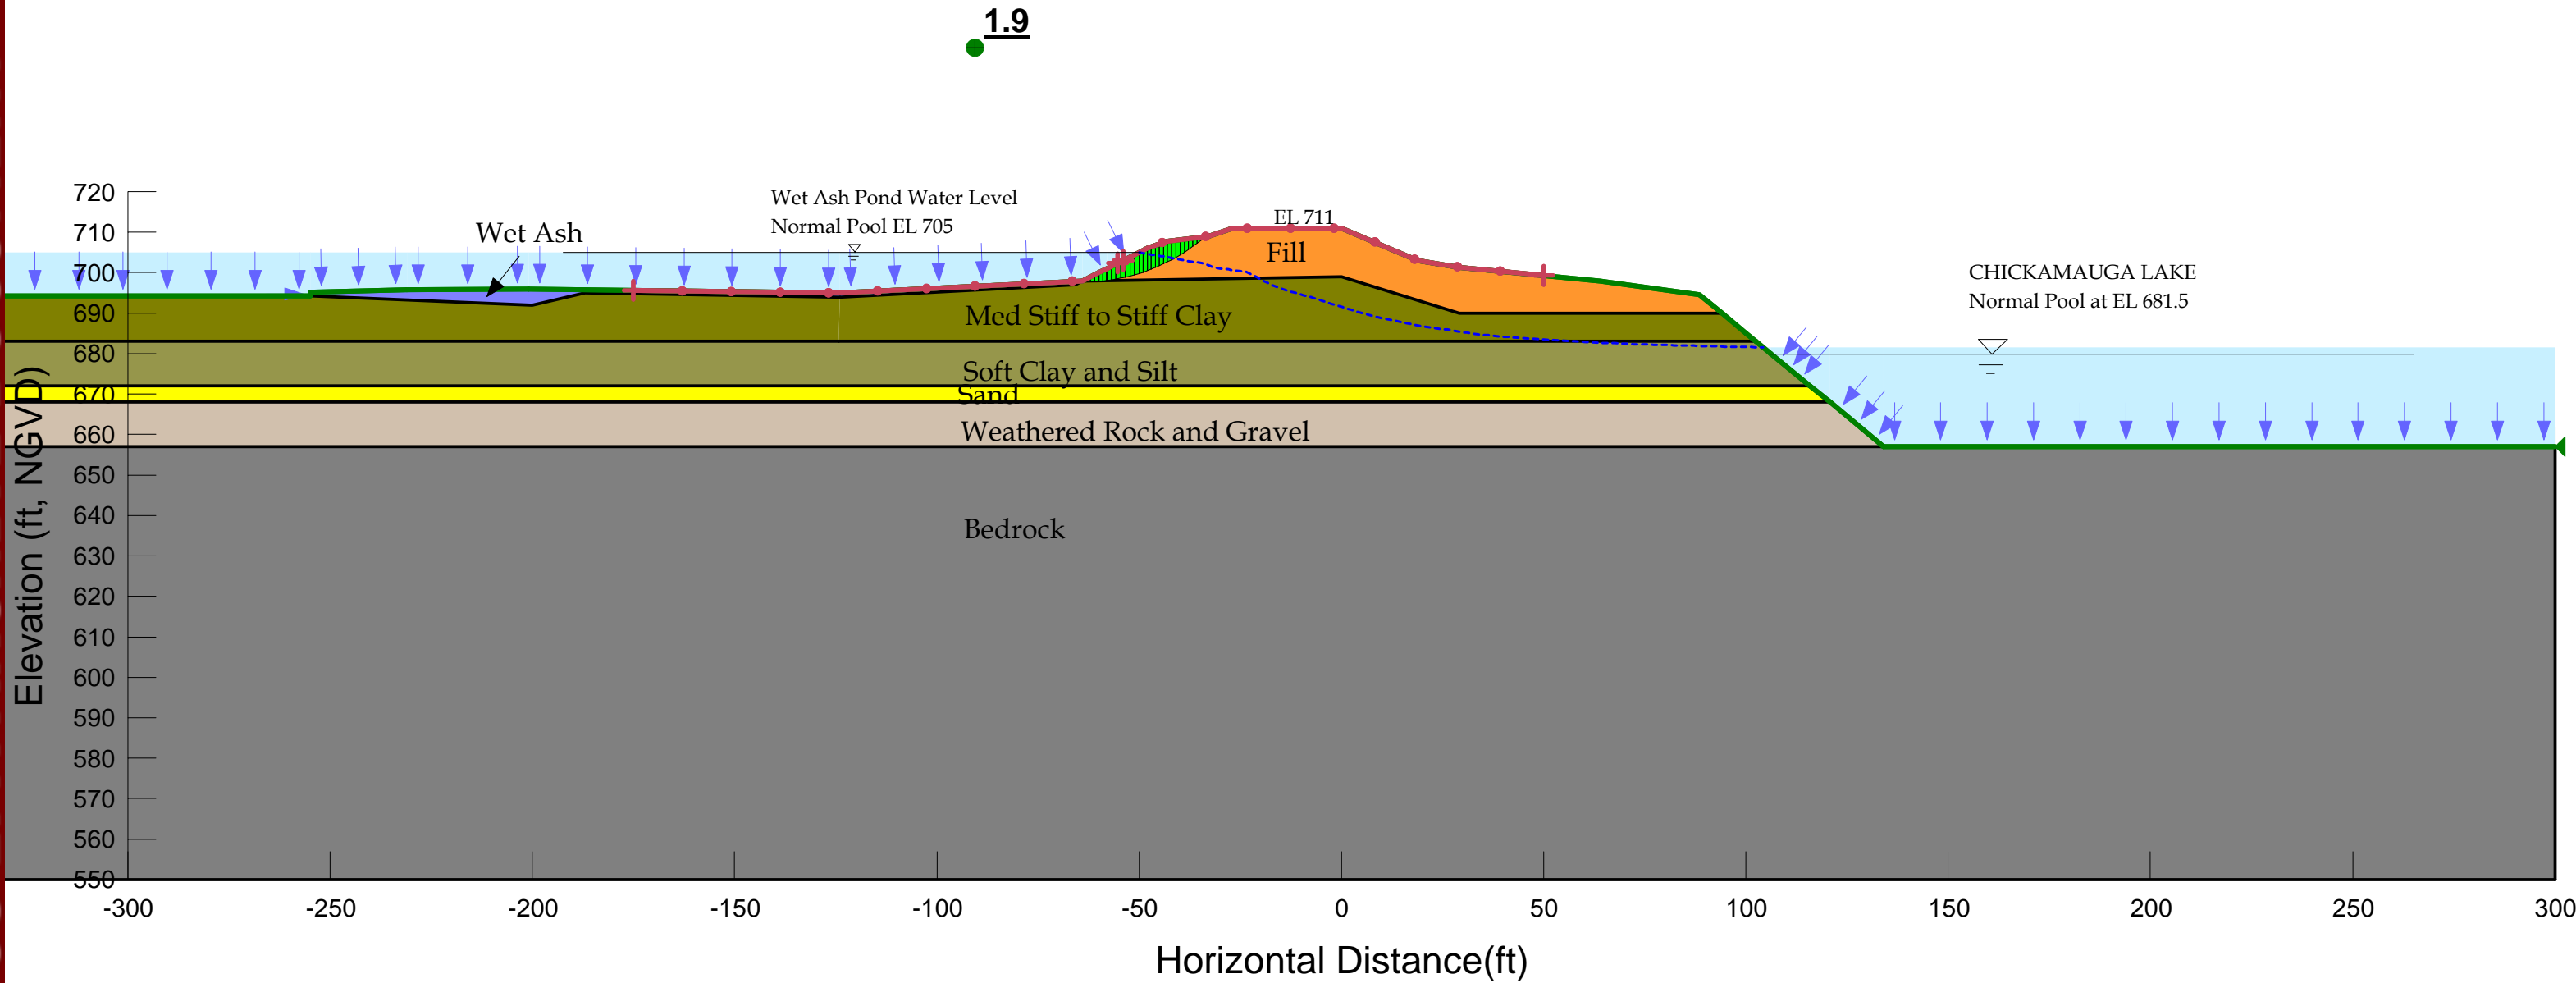
**Seepage and Slope Stability Analyses**
Cross-Section A-A' at Wet Ash Pond Area

Section	Calculated Static Loading Safety Factor per Failure Mode		Required Safety Factor (US Army Corp of Engineers)	Calculated Seismic Loading Safety Factor per Failure Mode		Required Safety Factor (US Army Corp of Engineers)
	Exterior Slope Global Failure	Exterior Slope Non-Global Failure		Exterior Slope Global Failure	Exterior Slope Non-Global Failure	
A-A' (Wet Area)	1.8	1.9	1.5	1.1	1.4	>1.0
B-B' (Dry Ash Area)	1.5	2.4	1.5	1.0	1.3	>1.0

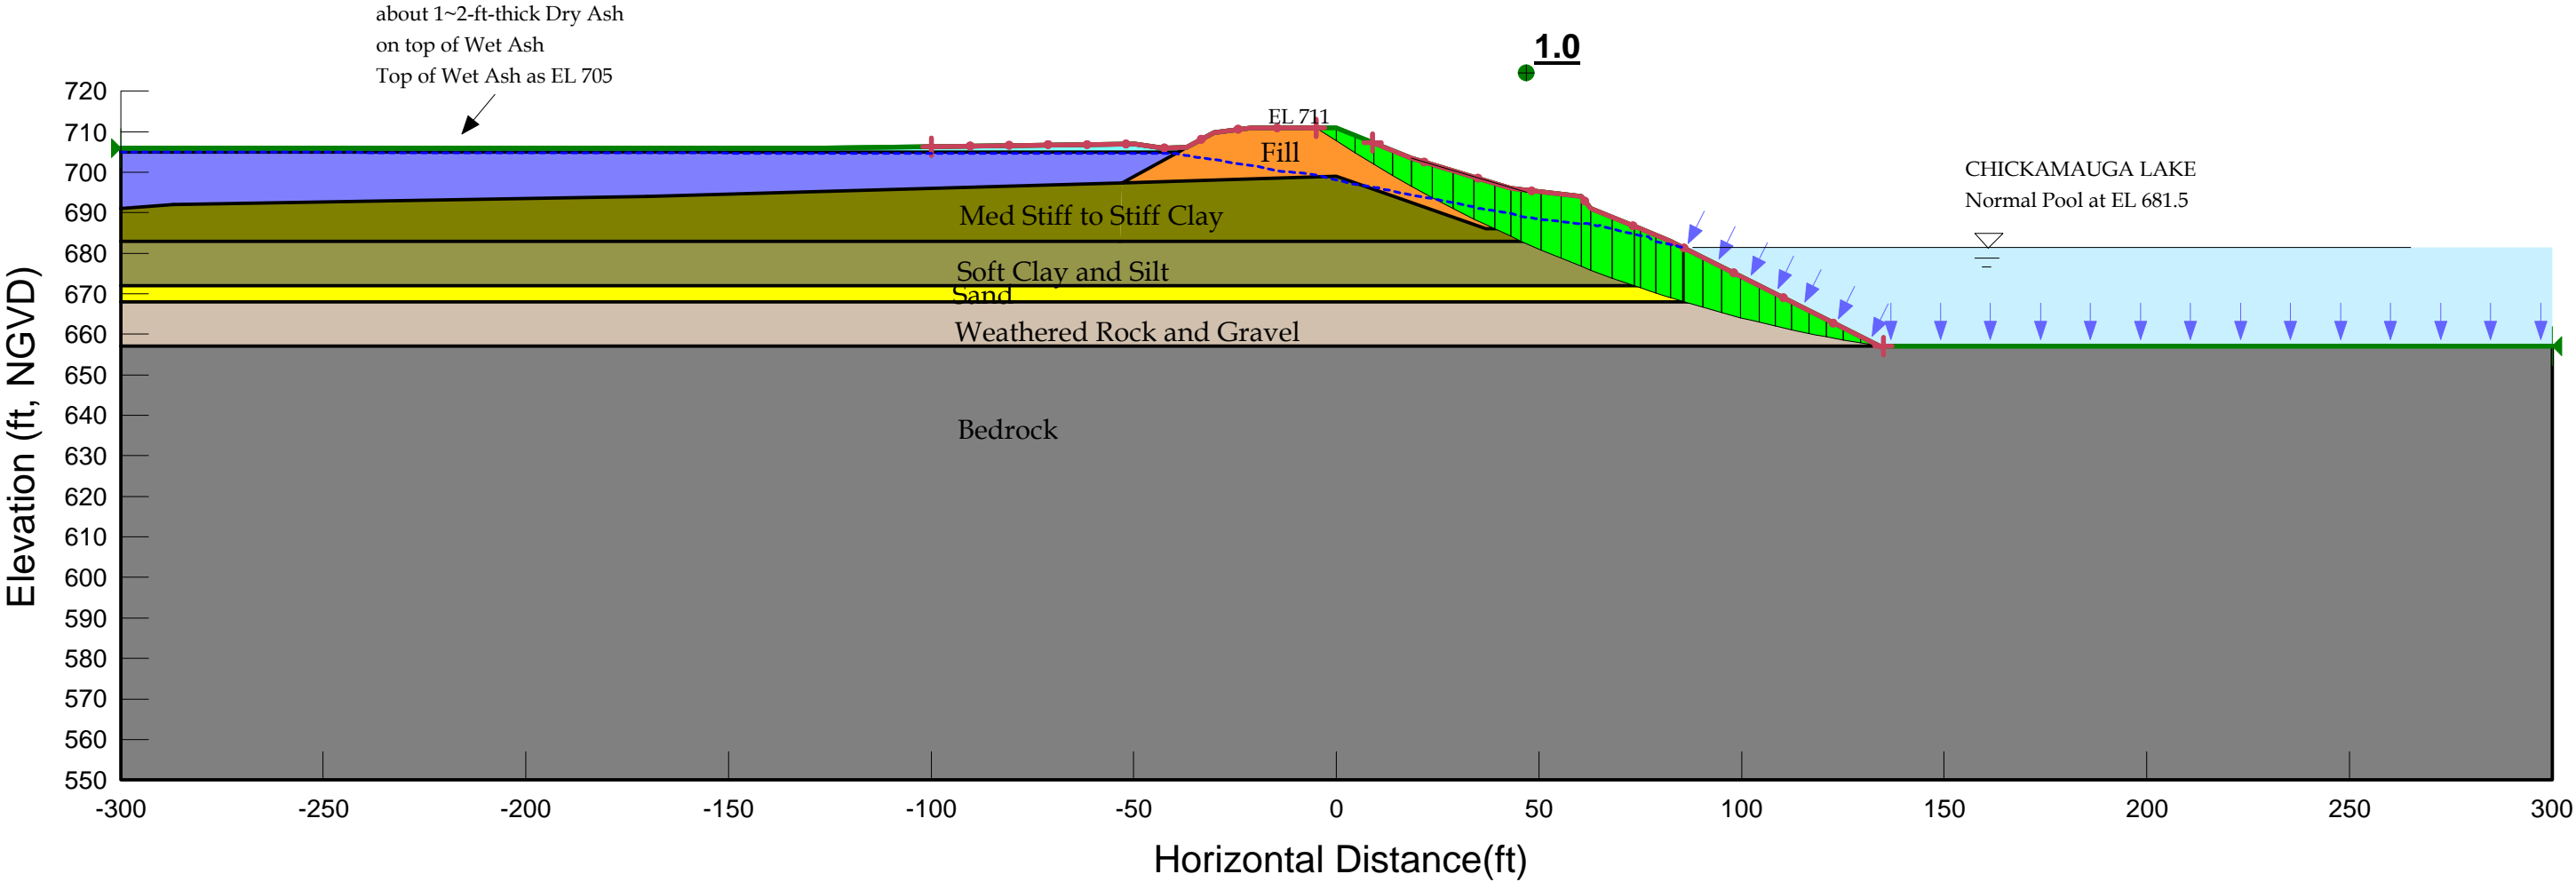
Model Scenario:
Existing Conditon at Wet Ash Pond
Seismic Analysis PHA=0.116g

1.1

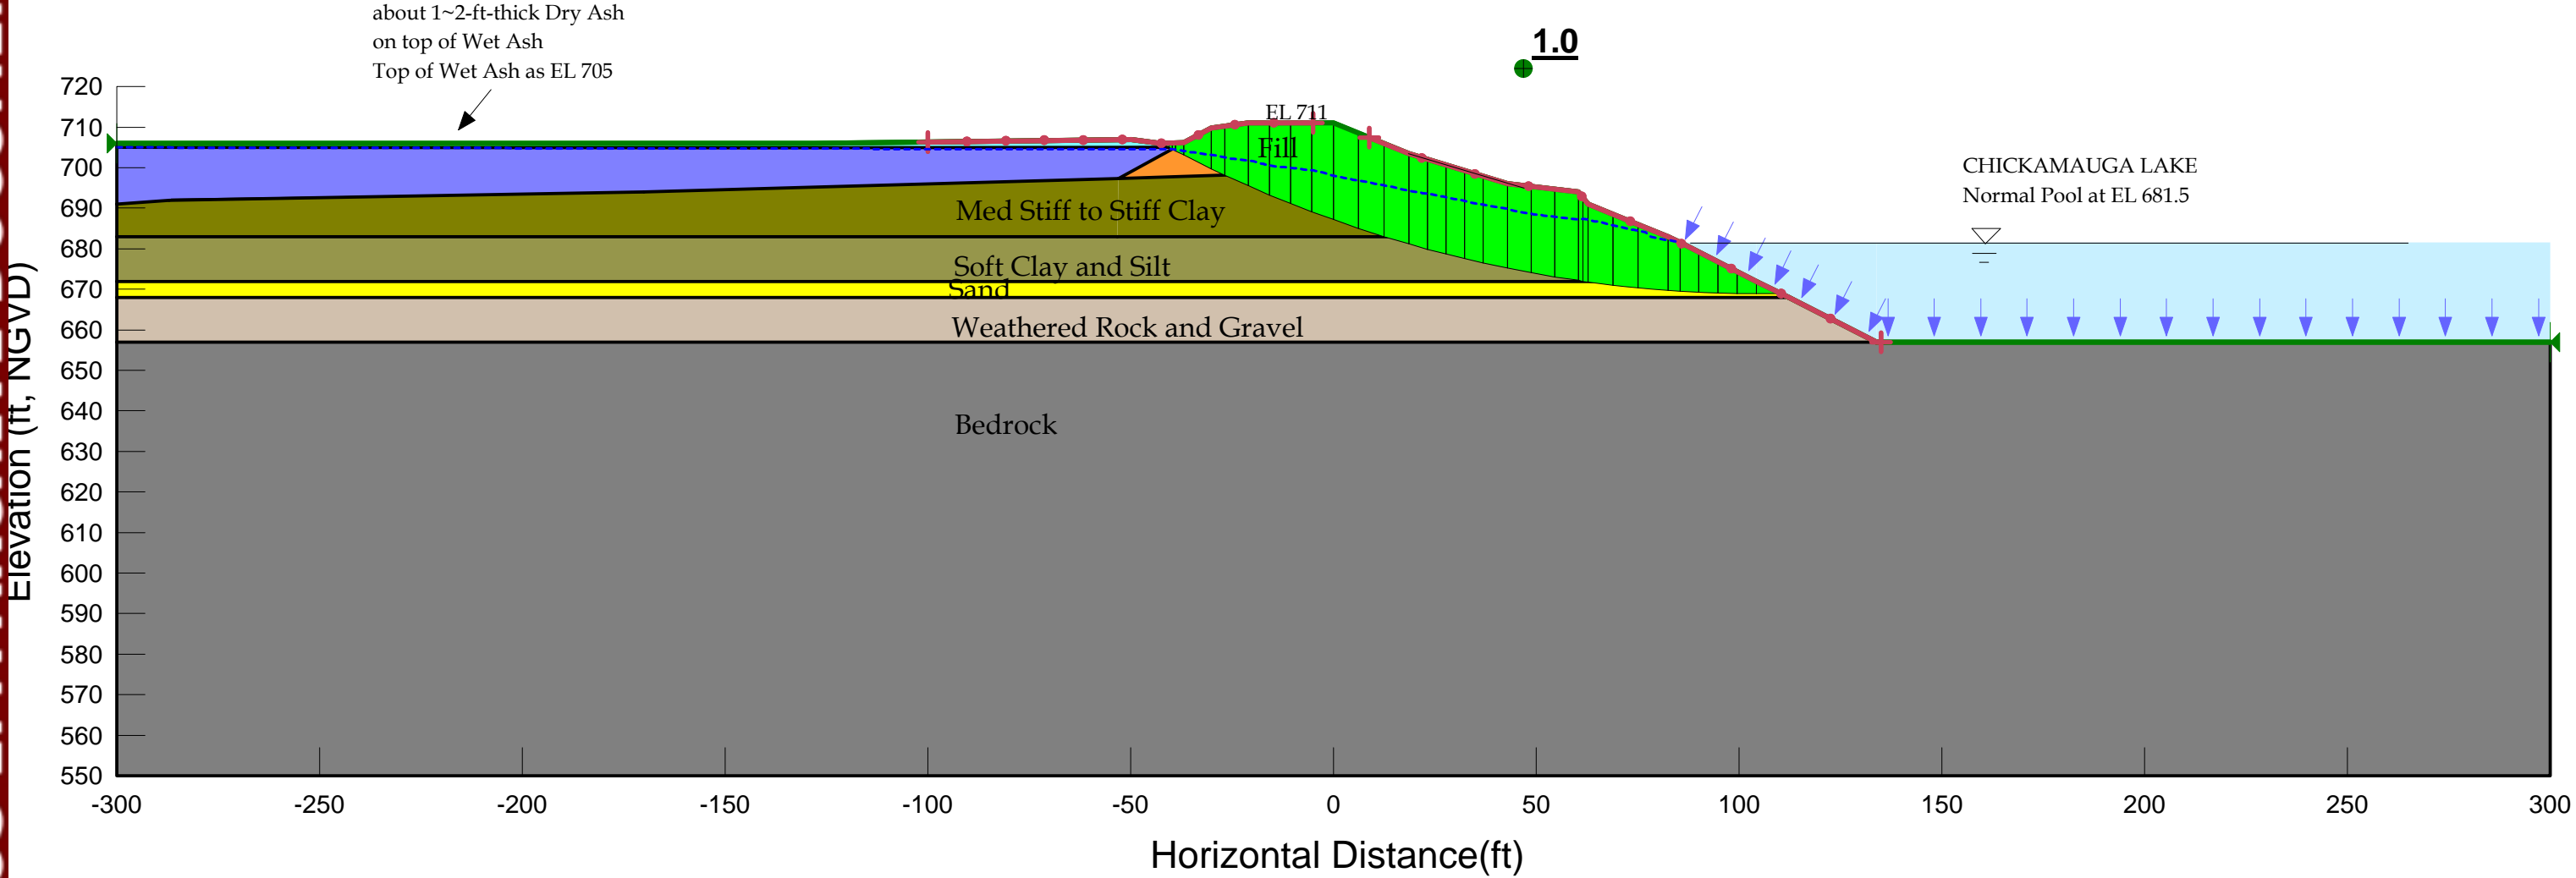
Model Scenario:
Existing Conditon at Dry Ash Area.
Seismic Analsyes, PHA=0.116g

1.3
