Records Center
Covitch / ATF
17.4
557635

ATF Davidson
Northbridge MA
4/24/85

(8) AIT Davidson, Northbridge MA - 4/24/85 site inspection

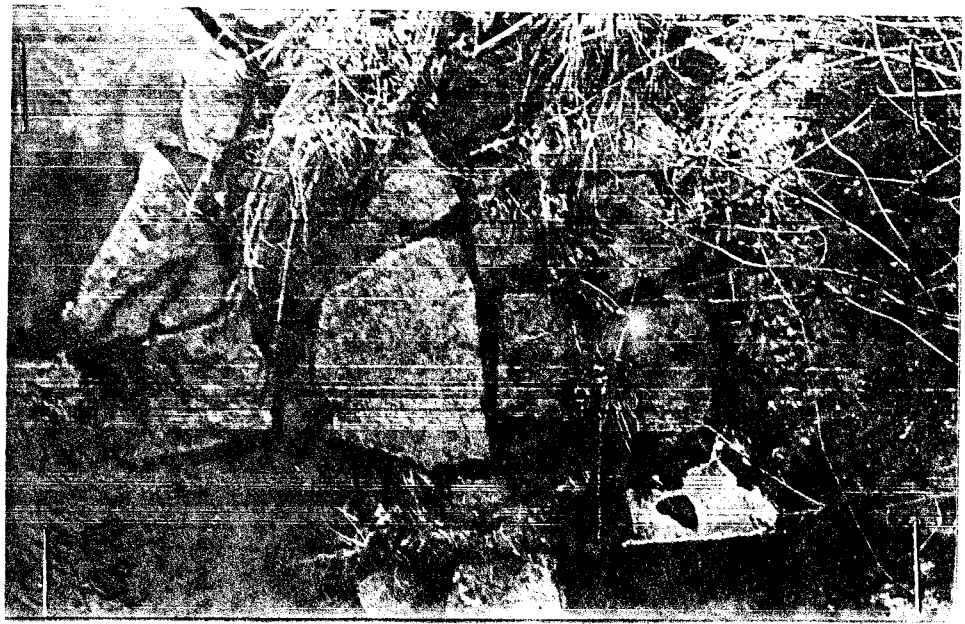
(4)

Oil Sheen flowing on Mumford River (north side near bridge next to power house, bldg 9)

Oil Sheen on water next to rocks; photo taken from above (bridge

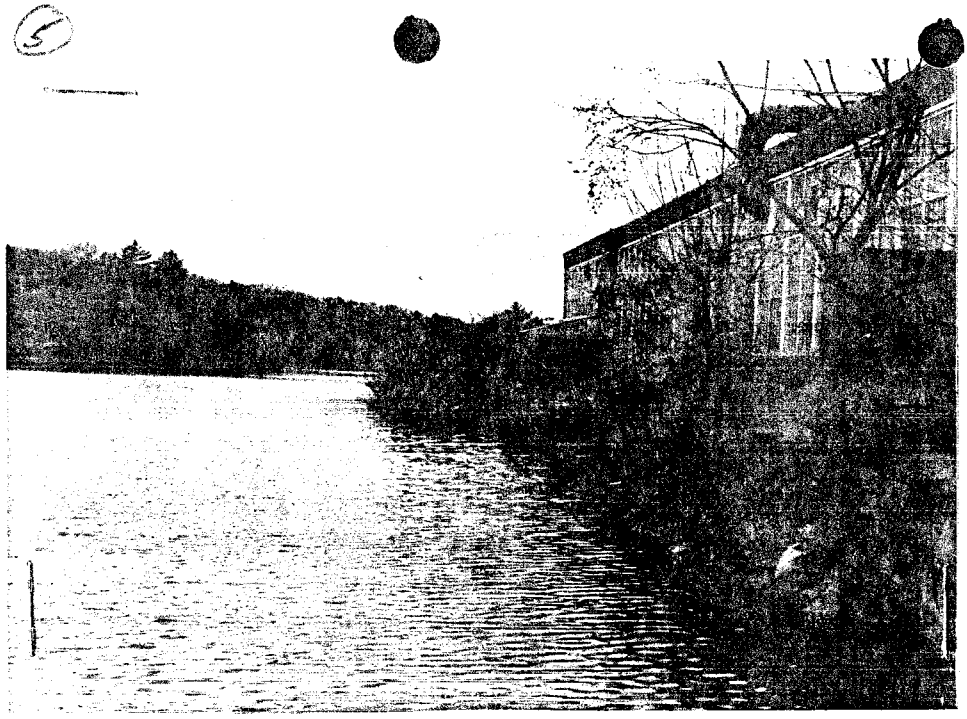
(5)

Inlet of raceway which runs under the old factory area - near bldg. 23 "Blacksmith Shop"

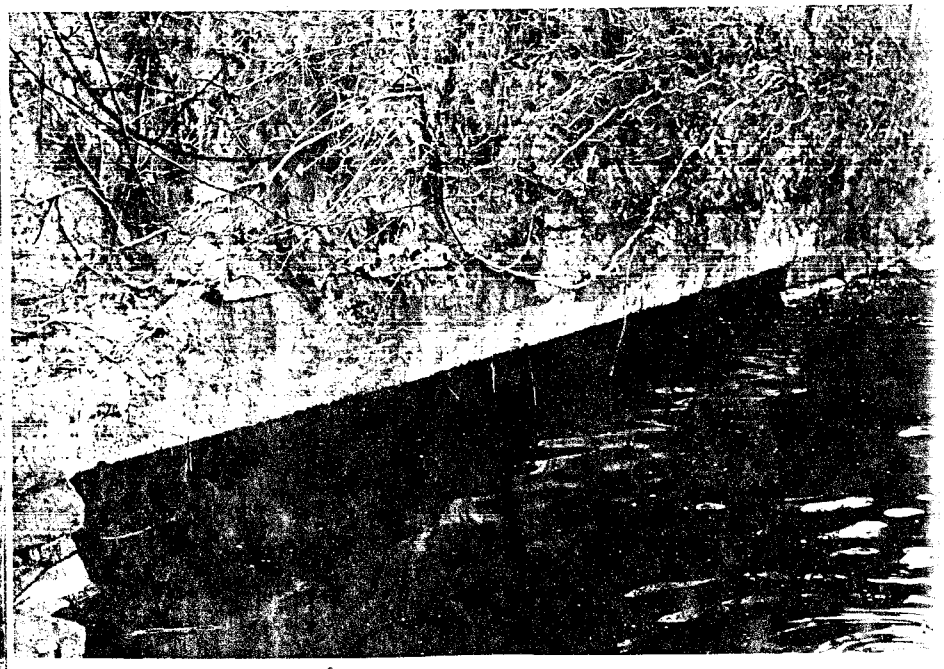
(7)

Outlet of raceway to river downstream

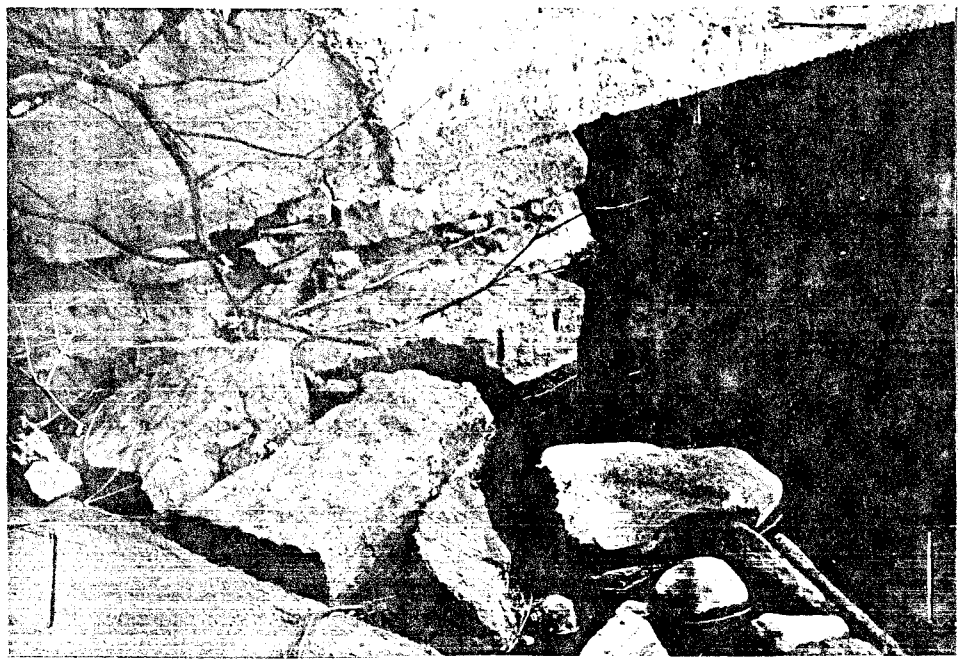
Outlet of raceway to river

Oil Sheen on river near bridge same location as picture (4)

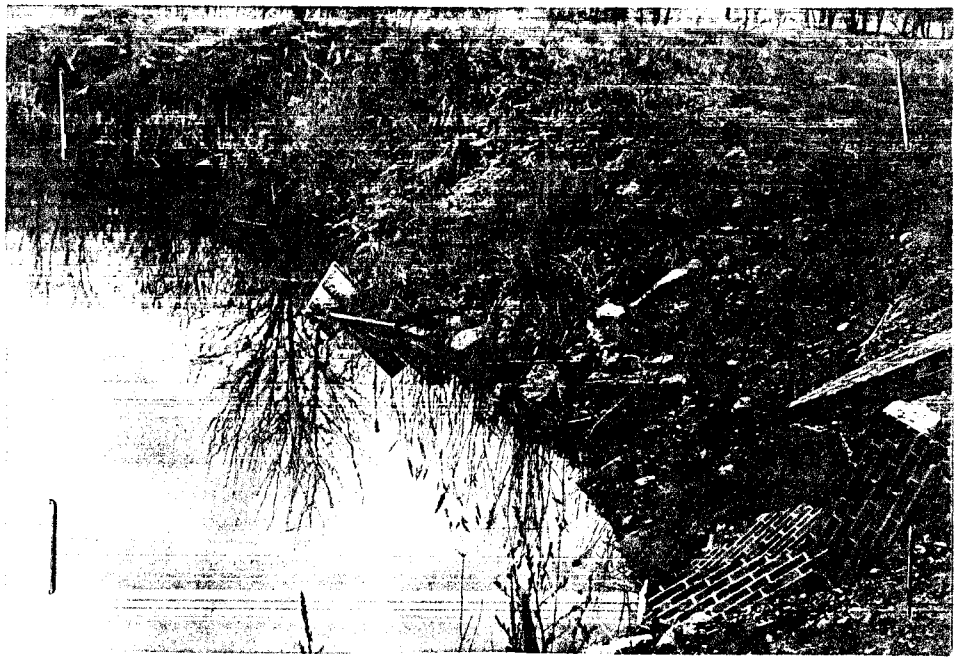
Edge of wetlands not filled in by landfill; ~~east~~ west end near Mumford River

Edge of wetlands as above

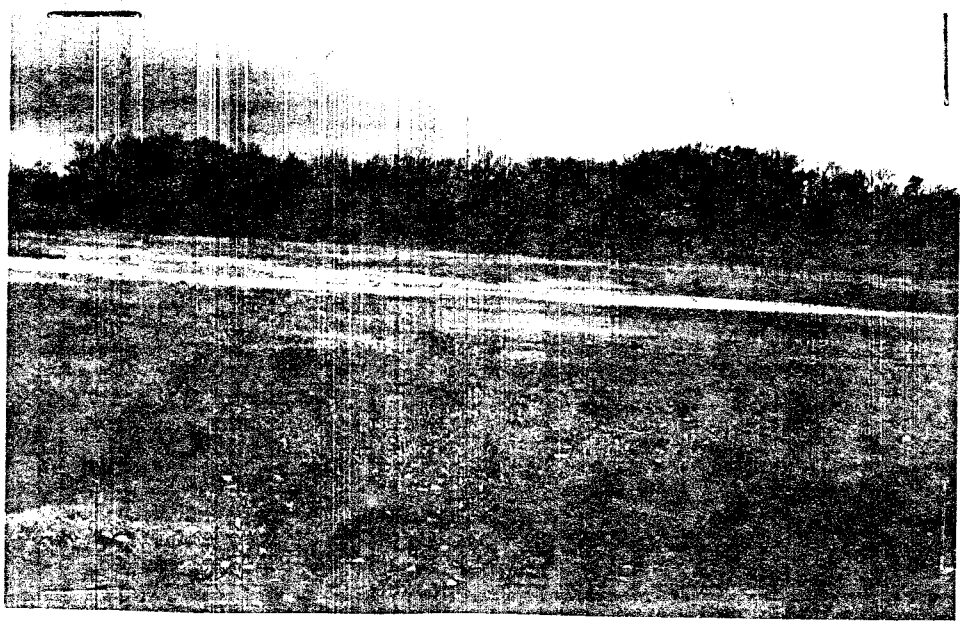
(9)

Landfill, facing northwest with back to building 38

Landfill area between bldg 12 and

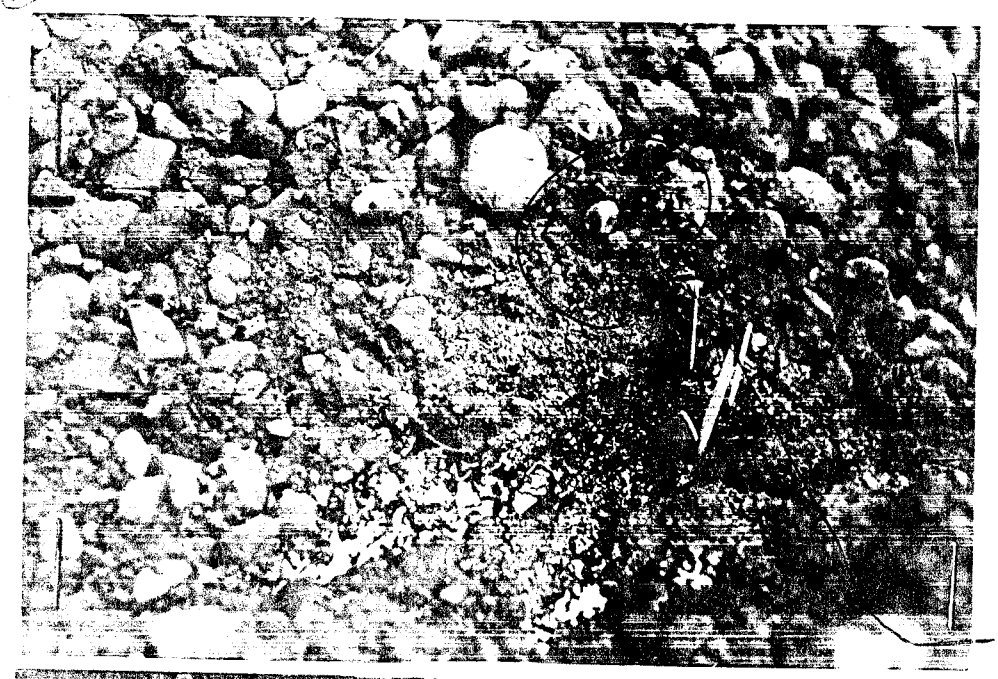
(2)

Test pit with oil breakout (marked by 4 sticks) next to building 9, "Machine Shop"

Close-up of breakout
Mercury droplets visible

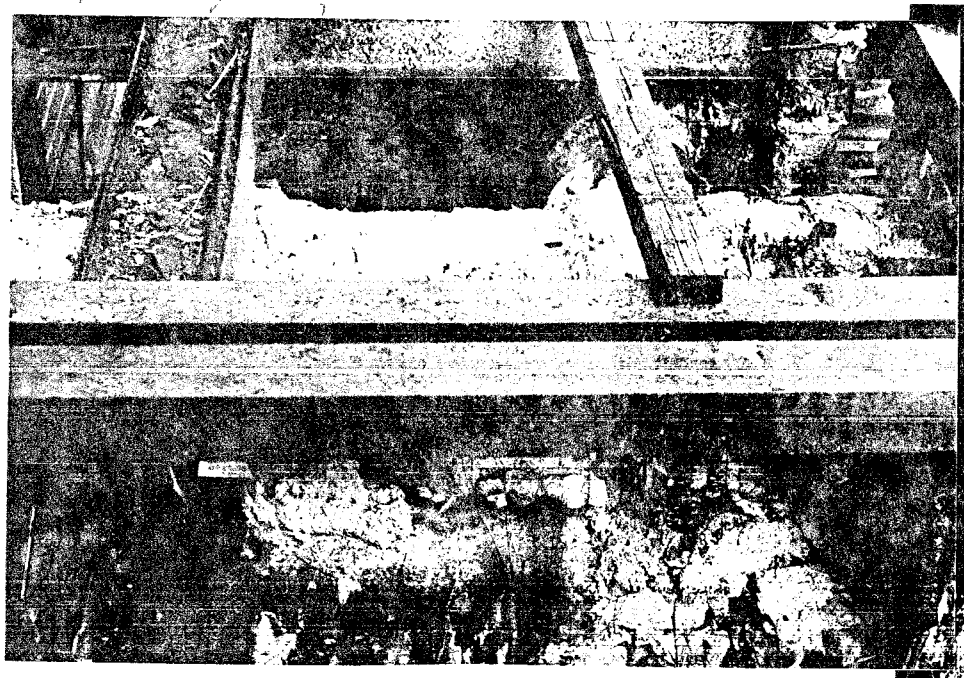
(4) [illegible] of power plant east side

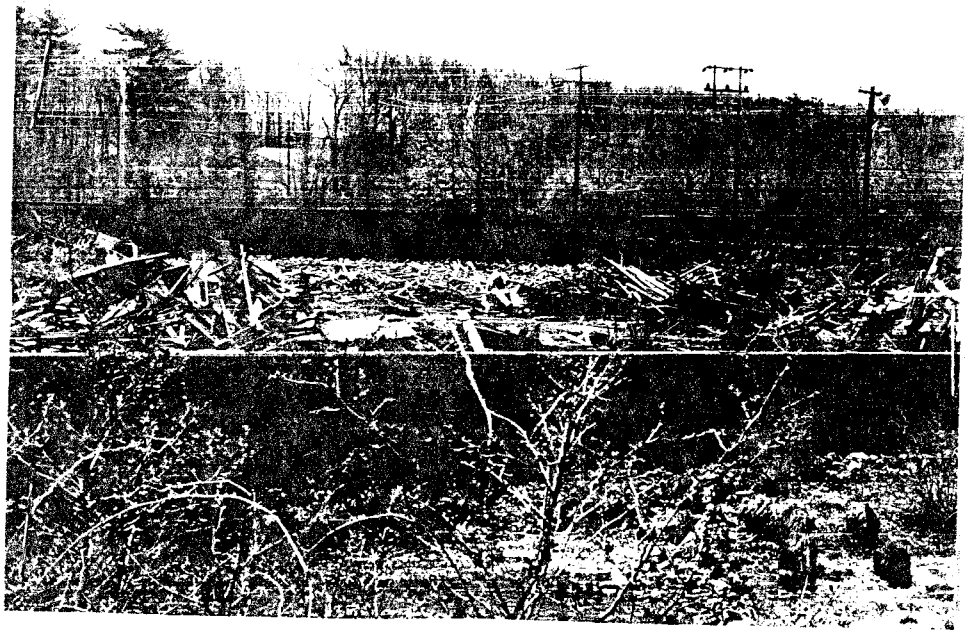
(6) Brush, Demo pile; south of Power Plant, south side of river behind dam

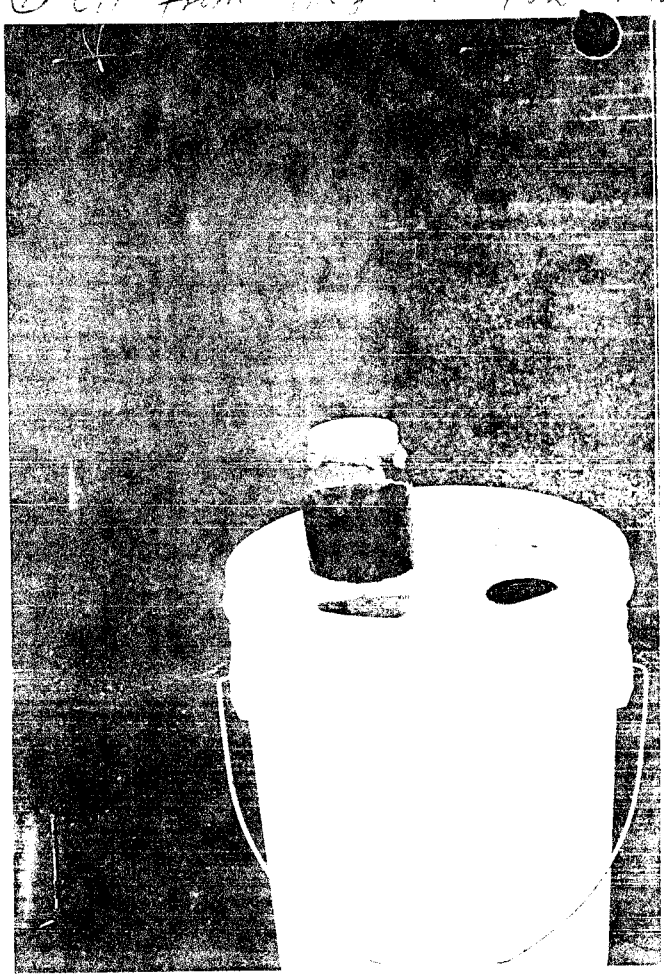
① Oil from Bldg 19 - Power Plant

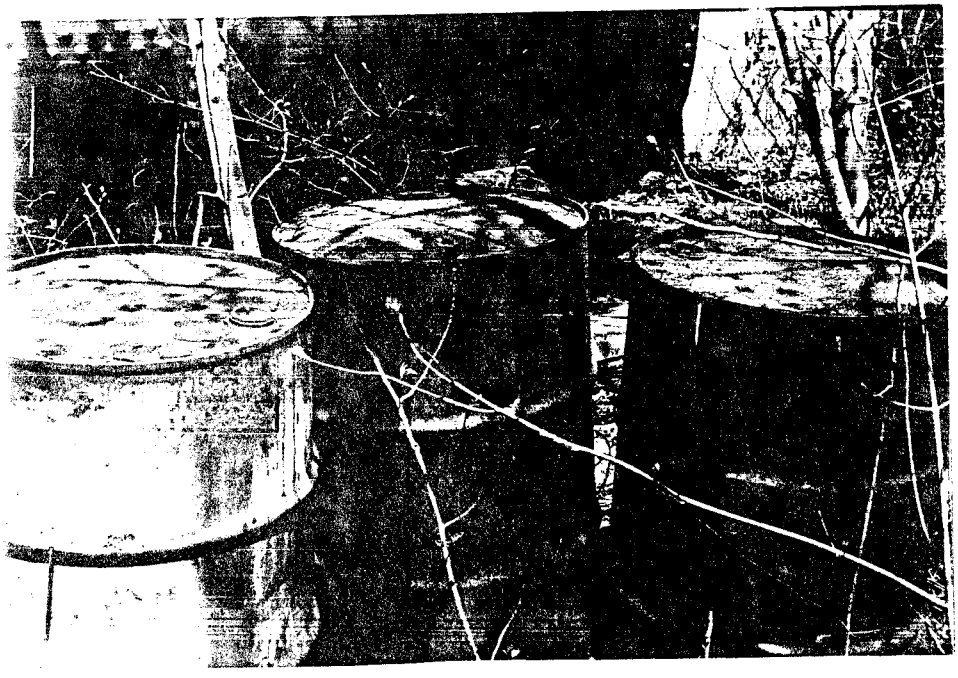
③ Fuel drums next to Bldg 19 East Side Power House Contents unknown

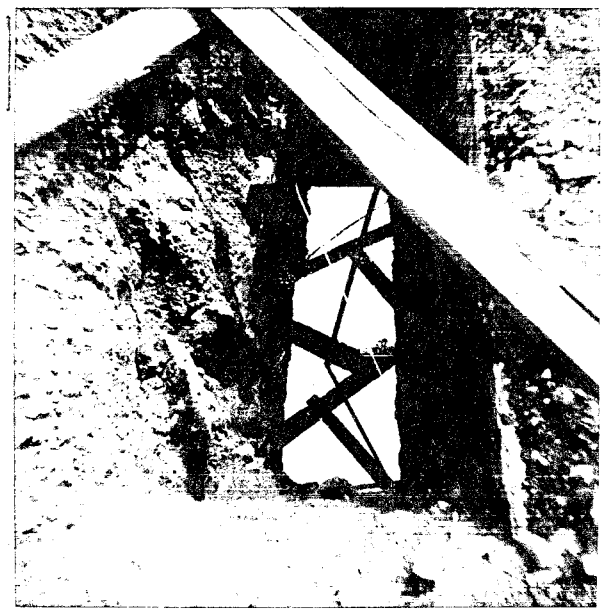
7/12/85 Man hole
to Tail race, w/

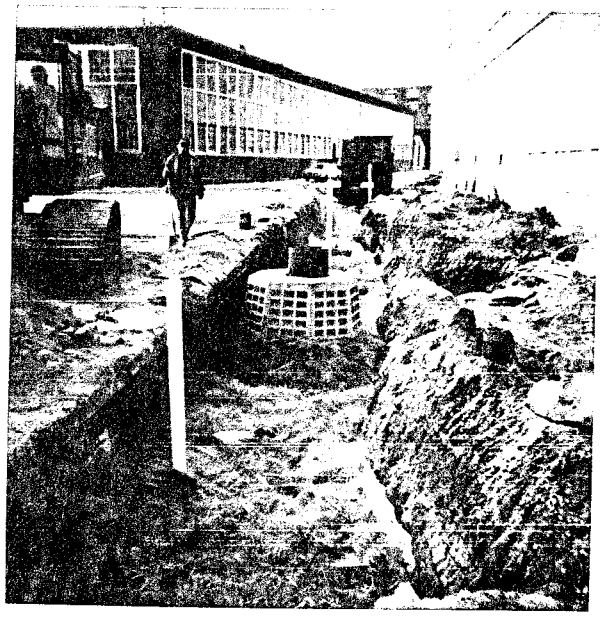
7/12/85 ATF. -Trench
w/ oil & water

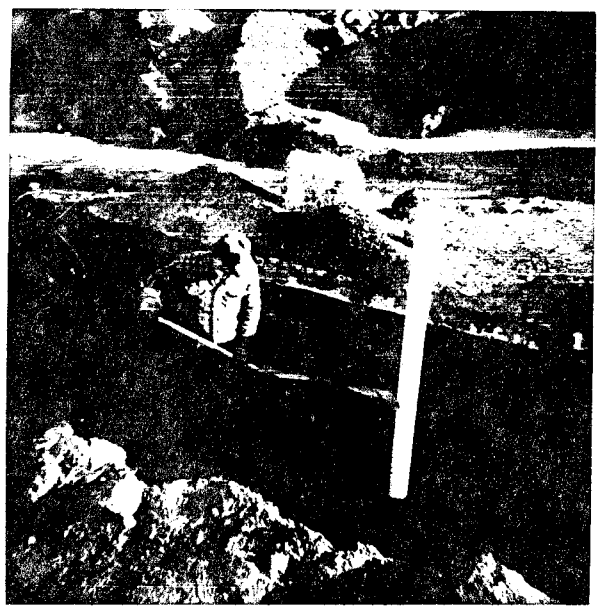
1/7/86 WORKER LAYING PEASTONE

UP AGAINST TOP OF LINER AND AROUND

MONITORING WELL. G.C

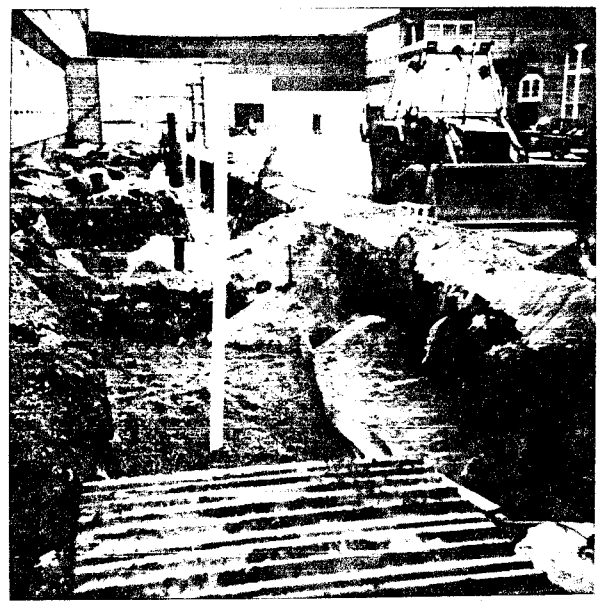
1/10/86 TO RIGHT OF LINER IS CLEAN FILL. TO LEFT IS PLASTIQUE
