Five-Year Review Report

Third Five-Year Review
for
Barkhamsted-New Hartford Landfill
Barkhamsted, New Hartford, Connecticut

September 2013

The United States Environmental Protection Agency
Region 1, New England
Boston, Massachusetts

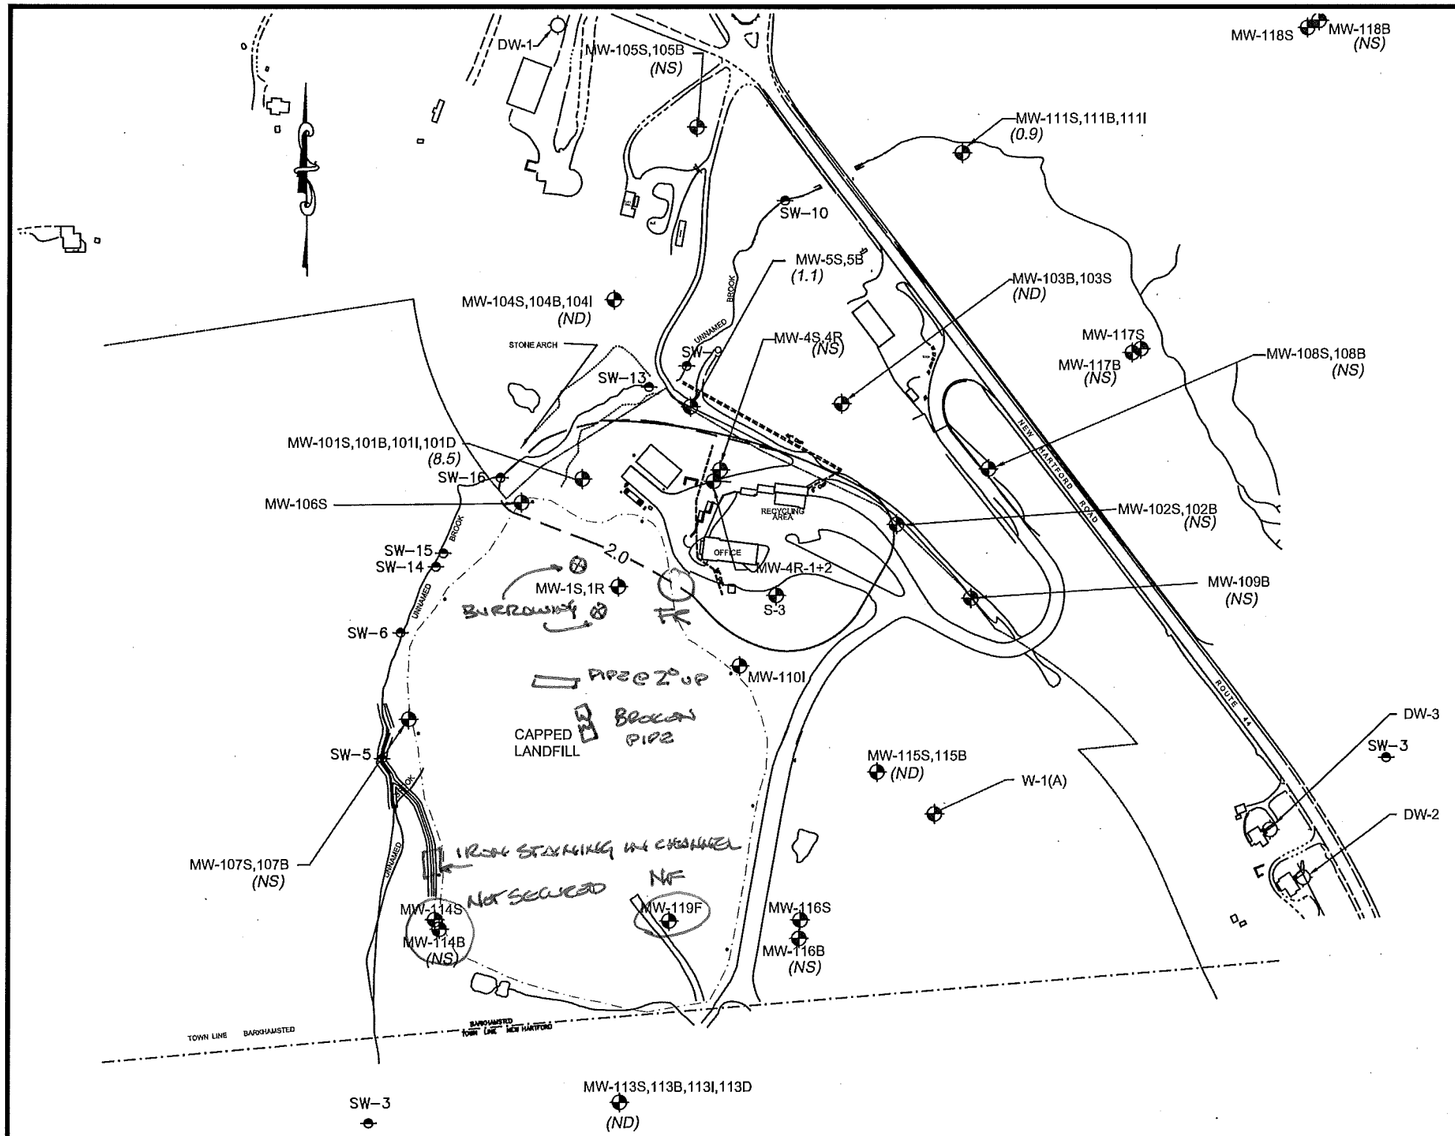
- An area of fencing along the northeastern landfill perimeter was damaged, but is not breached. No repair to the fence has been made;
- Monitoring well casings within the landfill cap were not locked;
- In December 2011 the landfill inspector stated that portions of the landfill cap had been rutted and de-vegetated by the machines used to mow the cap. After experimenting with several modifications to the mowing method, a track-mounted skid-type loader with mower attachment was selected for the work. This revision to the mowing operation has resulted in no further problems; and
- Recommended vegetation removal from a variety of areas, all of which occurred within a reasonable timeframe.

NF = NOT FOUND
FR = FENCE REPAIR NEEDED

OU(s): 01	Issue Category: Site Access/Security			
	Issue: The northeastern portion of the landfill perimeter fence was damaged			
	Recommendation: Repair the damaged fence			
Affect Current Protectiveness	**Affect Future Protectiveness**	**Implementing Party**	**Oversight Party**	**Milestone Date**
No	Yes	PRP	EPA/State	September 2014
