REMOVAL PROGRAM
PRELIMINARY ASSESSMENT/
SITE INVESTIGATION REPORT
FOR THE
MERINO PARK SITE
PROVIDENCE, PROVIDENCE COUNTY, RHODE ISLAND
18 AUGUST 2010

Weston Solutions, Inc.
Region I
Superfund Technical Assessment and Response Team (START)
3 Riverside Drive
Andover, MA 01810

January 2011

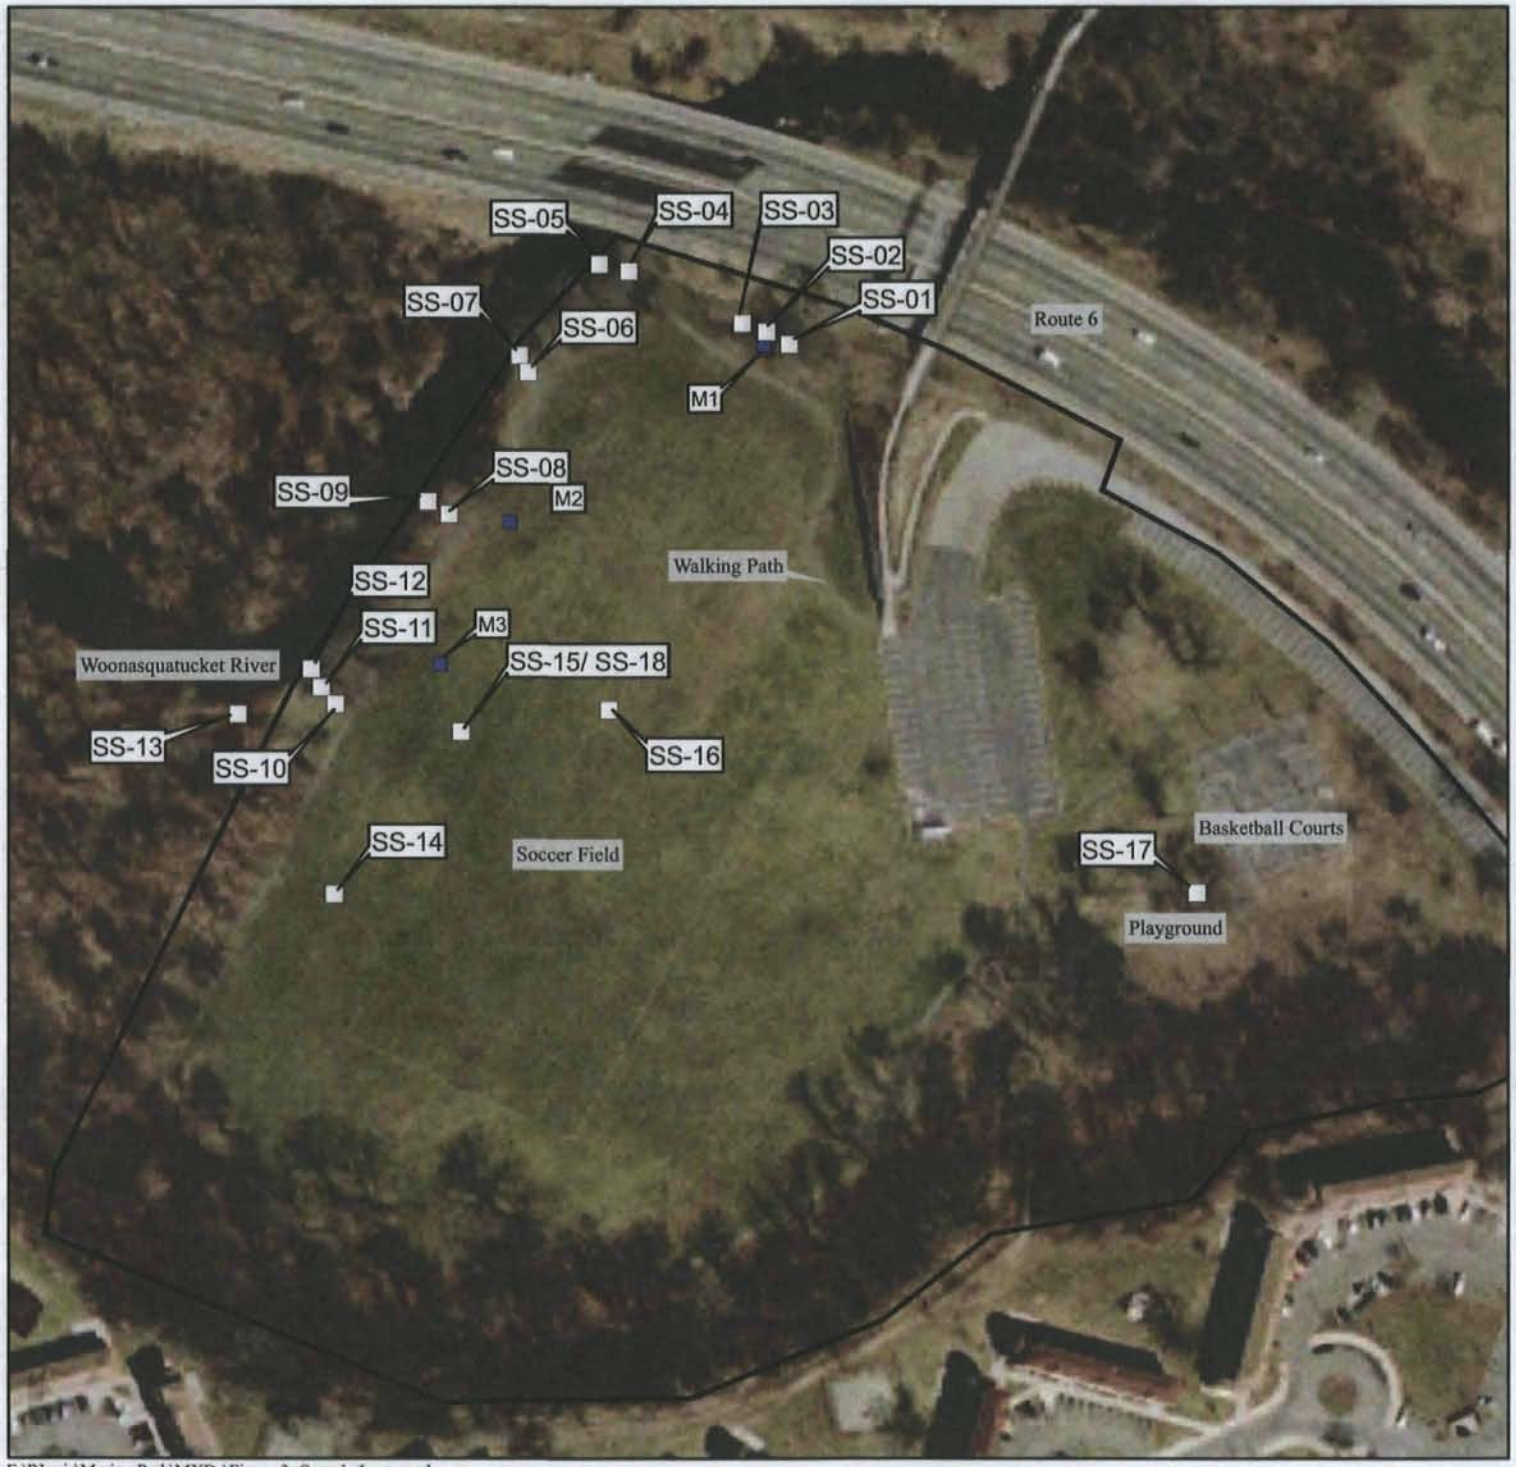
Figure 3

START personnel and OSC Bazenas marked sample locations on the riverbank; in the vegetated area near M1; on the soccer field; and between the basketball court and playground (see Appendix A, Figure 3). Air monitoring was conducted during sample location selection. No readings about background levels were observed.

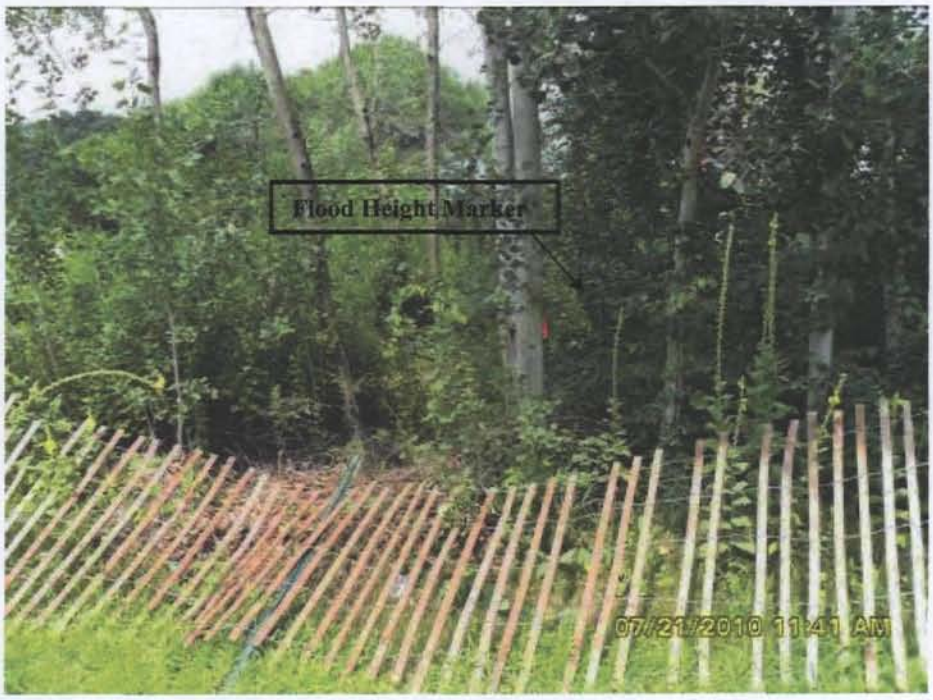
SCENE: View of sample location M1, collected by the City of Providence, and high water level (flagging tape) from spring 2010 floods. Photograph taken facing west.
DATE: 21 July 2010 **TIME:** 1141 hours
PHOTOGRAPHER: C. Dupree **CAMERA:** Samsung SL605

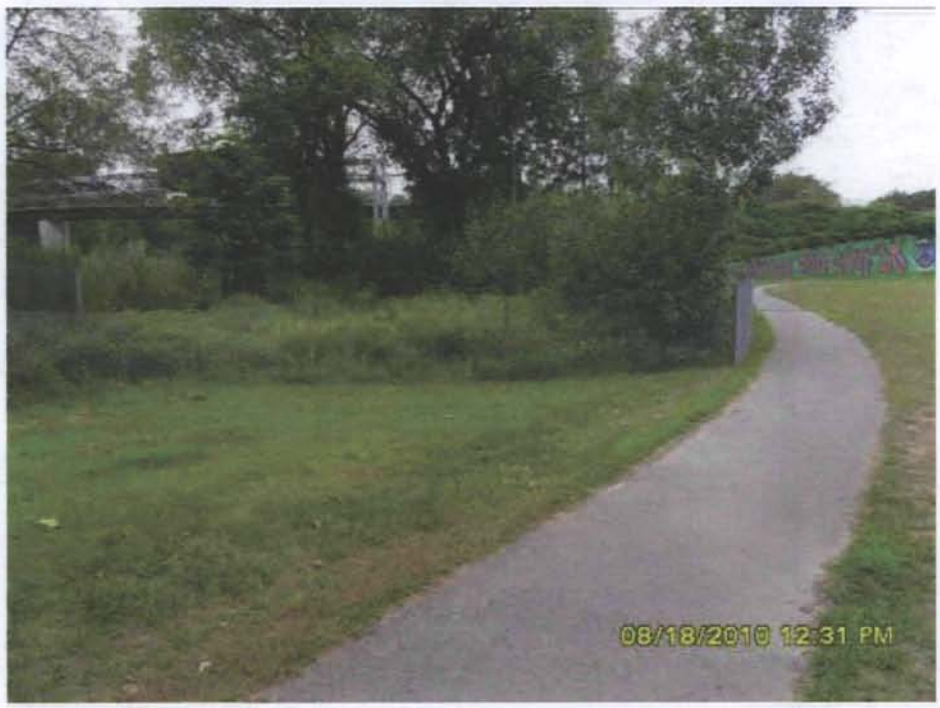
SCENE: View of the west side of the fenced area. Photograph taken facing east.
