CENWS-HH-HE-CU 12 APR 2013

MEMORANDUM FOR RECORD

SUBJECT: Pacific Sound Resources (PSR) Superfund Site Marine Sediment Unit RA5 Cap Placement Monitoring.

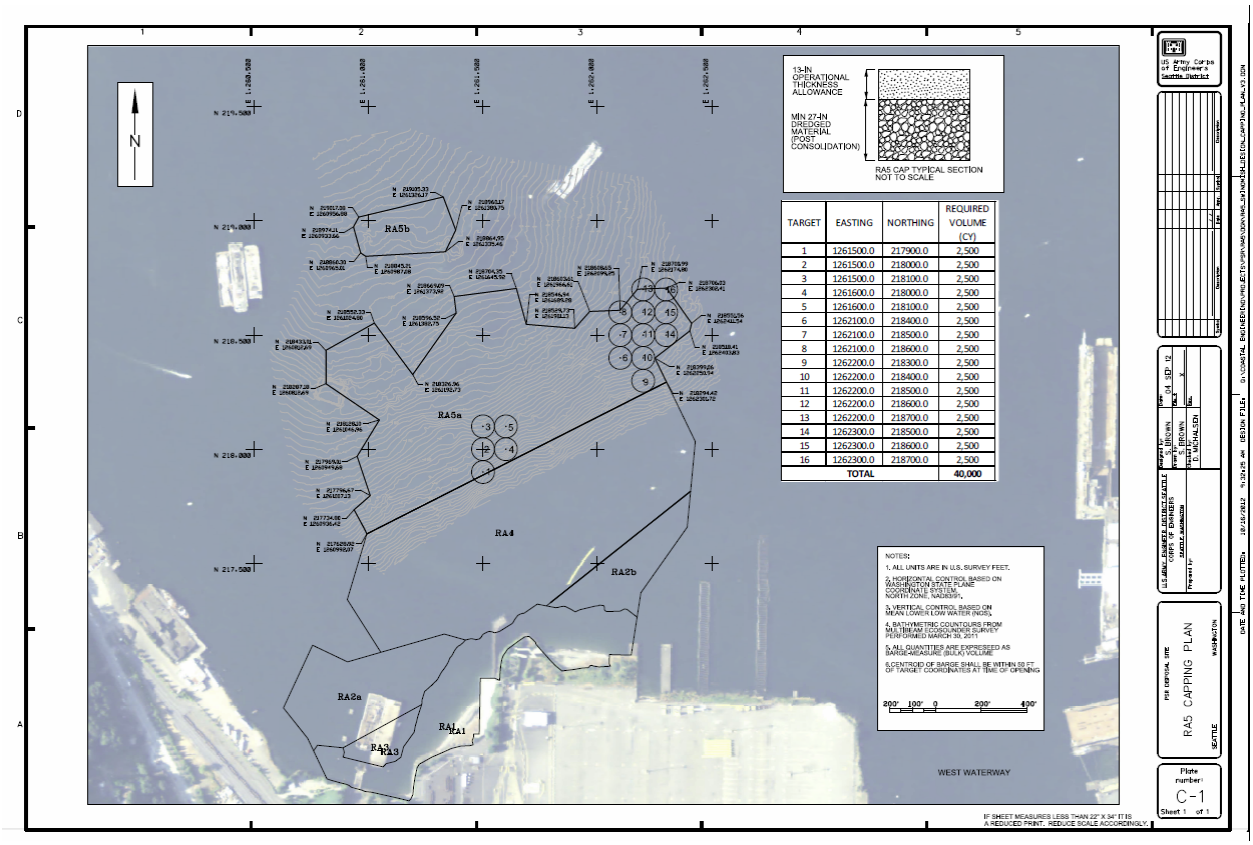
The original sediment cap design for marine sediment unit RA5 called for a minimum thickness of 27 inches of sandy dredged material, with an operational allowance of 13 inches for a maximum cap thickness of 40 inches. Sandy Swinomish Channel dredged material was identified as the preferred material for cap augmentation. Based on the characteristics of the Swinomish Channel dredged material, and the navigation dredging equipment employed, it was determined that between 2,500 and 3,000 cubic yards (cy) of material, placed by bottom dump barge, at 16 target locations on 100 foot spacing intervals, would achieve the required cap thickness (Figure 1). The 16 target locations were identified to address the cap thickness issues in the vicinity of monitoring stations RA5-05 (1.95 inches thick) and RA5-13 (3.9 inches thick) on the RA5a cap.

Figure 1: FY 2012 RA5 Sediment Capping Plan.

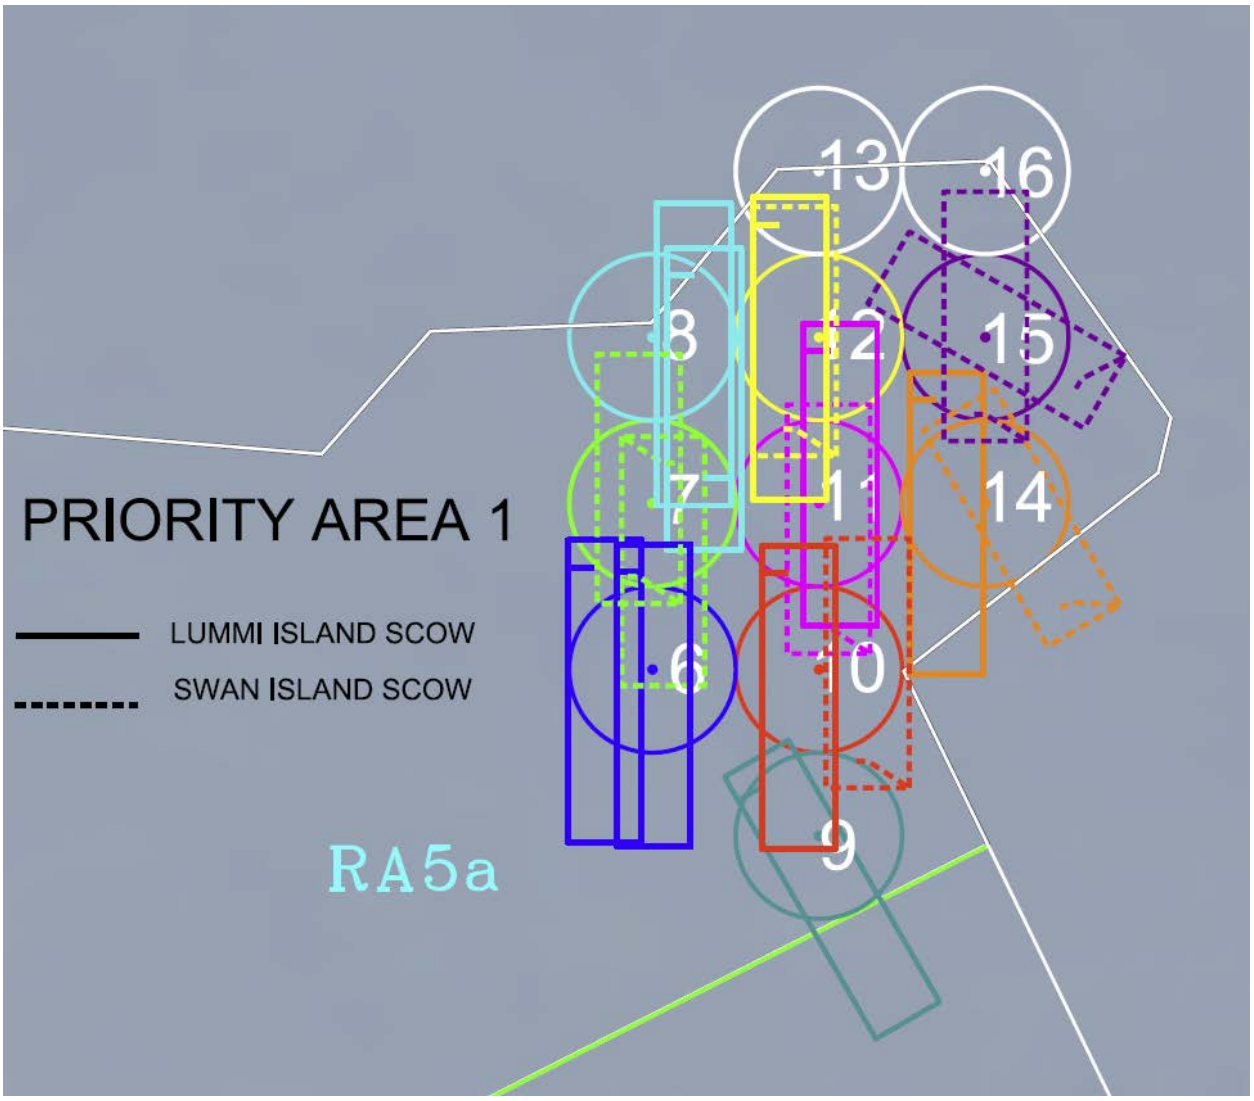
One of the issues identified with the 2005 capping project was the lack of accuracy in barge positioning during placement. In order to address this issue the Dredge Quality Management tool (DQM) was used to monitor the barge positioning during placements. The DQM records the position, heading, speed, draft and displacement of the scows during both dredging and disposal activities. The design called for the centroid of the barges to remain within a 50 ft radius of the target during placement. Figures 2 and 3 show the target areas along with the color coded outline of the barge position during placement. While there was some drift in the barge position during the duration of placement (approximately 2-3 minutes) the barges remained within the designated target areas while material was being released.

Figure 2: Priority Area 1 Placements.
