RE: Visual Site Inspection -- Carboline Company
Xenia, Ohio
OHD 030 963 615

I have enclosed a corrected facility layout diagram, which was Figure 2 on page 5 of the Report. In the diagram that is currently in the Report, the spent solvent tank and the NPDES outfall were incorrectly located. On the enclosed diagram, I have indicated the actual locations of the tank and outfall. I have also added the location of the new containments and some other changes that have occurred at the facility since EPA's visual site inspection (see discussion below).

CARBOLINE COMPANY
XENIA, OHIO

FACILITY LAYOUT

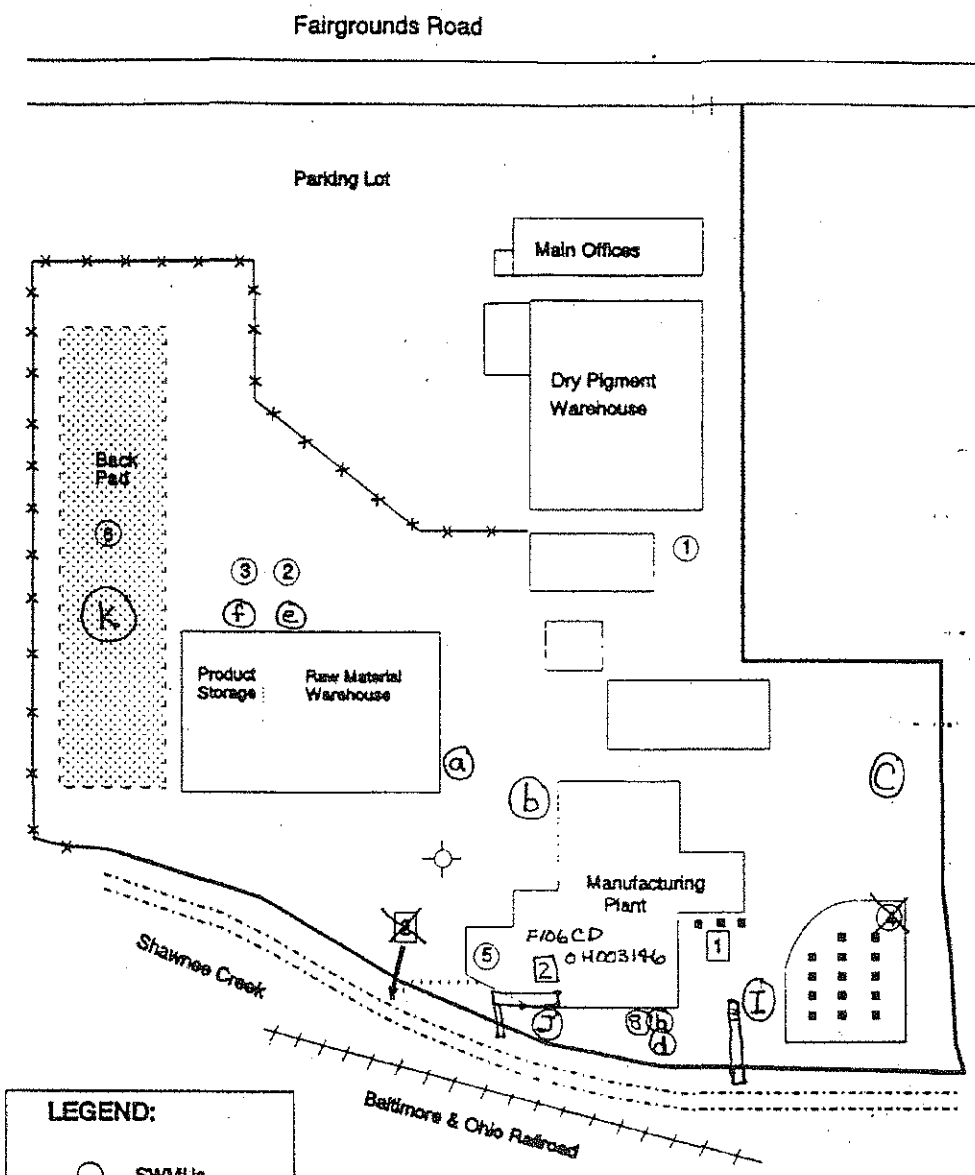
FIGURE 2

The first few lines of paragraph 3 on page 7 of the Report are inaccurate. As the thinners become spent, they are pumped into the F-Waste Storage Tank (shown as #4 on the enclosed diagram) and sent off-site to be burned as a supplemental fuel. These spent thinners are ***not*** placed in 55-gallon drums. However, the sludge from the Kettle Washer is transferred to 55-gallon drums which are then emptied into the F-Waste Storage Tank in the Hazardous Waste Storage Area (#4 on the enclosed diagram).

In addition, the outfall covered in Carboline's NPDES permit is non-contact cooling water that is pumped from the well indicated as the "Production Well" in the facility layout diagram (i.e. Figure 2 of the Report) and emitted from a series of settling pits that are part of NPDES permit no. F106*CD-OH0031461.

changes are reflected on the enclosed, corrected facility layout diagram. First containment has been added at several locations at the facility:

- Tote tank unloading and pumping station,
- Resin tank unloading,
- Solvent tank unloading, and
- Spent solvent and paint waste loading.

Second, the facility decommissioned SWMU #2, the hazardous waste storage area, and disposed of SWMU #3, the D-waste storage tank. A contained hazardous waste storage area and a contained D-waste storage tank have been added.

Third, the old storm drain has been closed and a new storm drain with a shutoff valve has been installed.

Fourth, the back pad has been cleared of all finished goods storage.
