Guam Waterworks Authority (VP0989)

SDWA Sanitary Survey

Tumon, Guam
Southern System
NEIC Field Investigation Photographs
April 26 and May 2, 2012

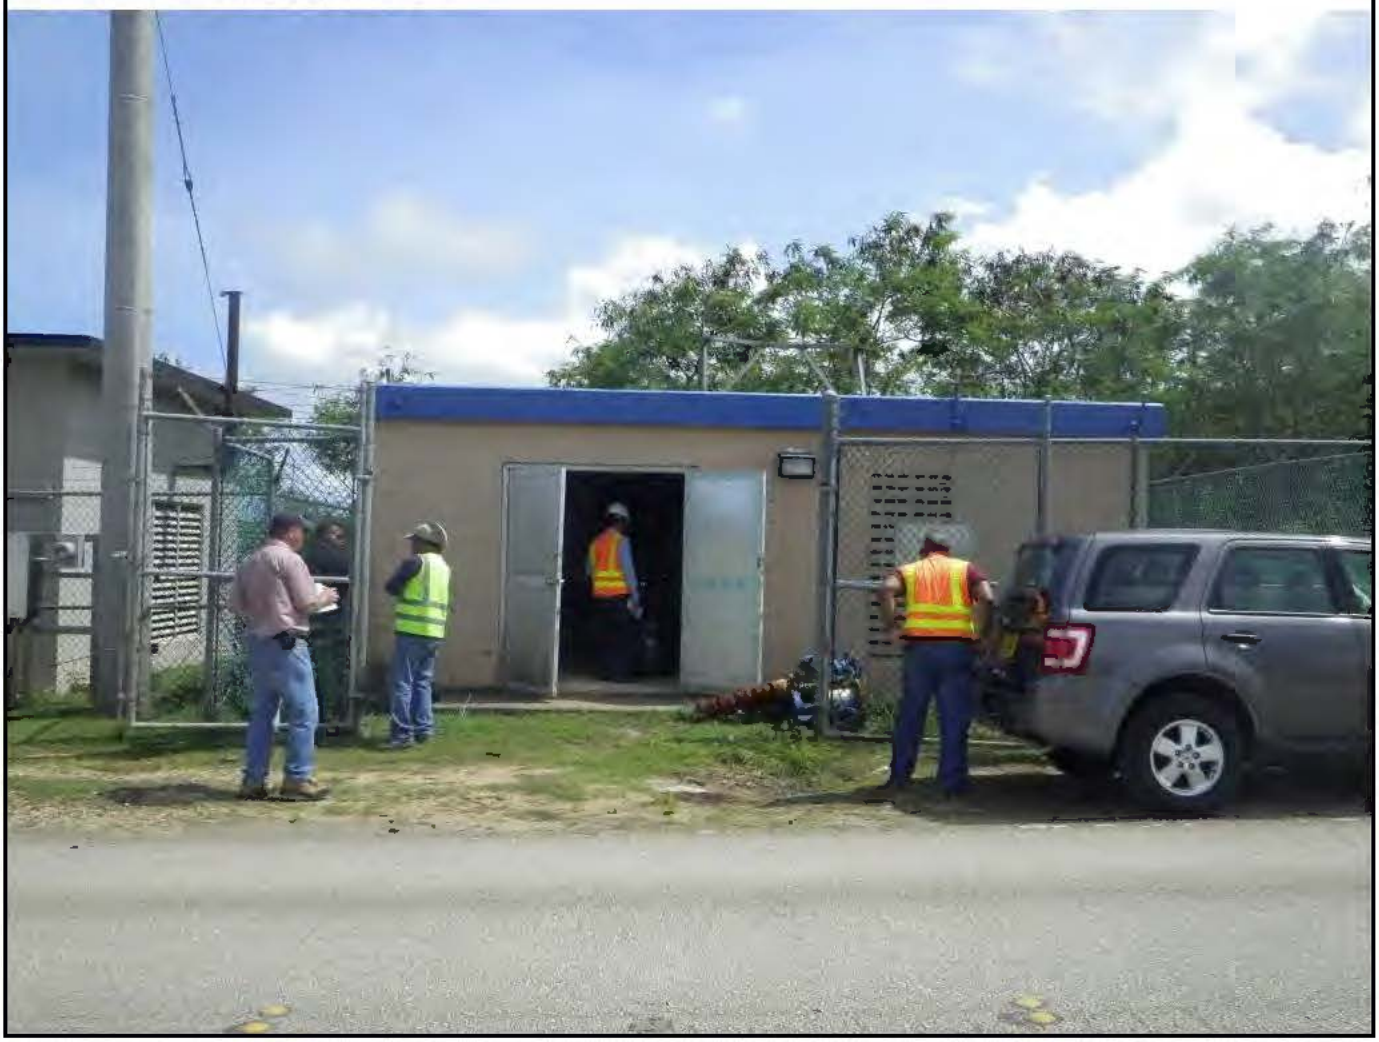
File Name: RIMG0087.JPG

Attributes	
Title	Guam Waterworks Authority (VP0989)
Subject	Southern System
Latitude	[redacted]
Longitude	[redacted]
Photo Direction	[redacted]
Elevation	[redacted]
Date Time Stamp	4/26/2012 2:21:45 PM
Photographer	K. Sable
Comment	Windward Hills Pump Station
Description	Pump station building

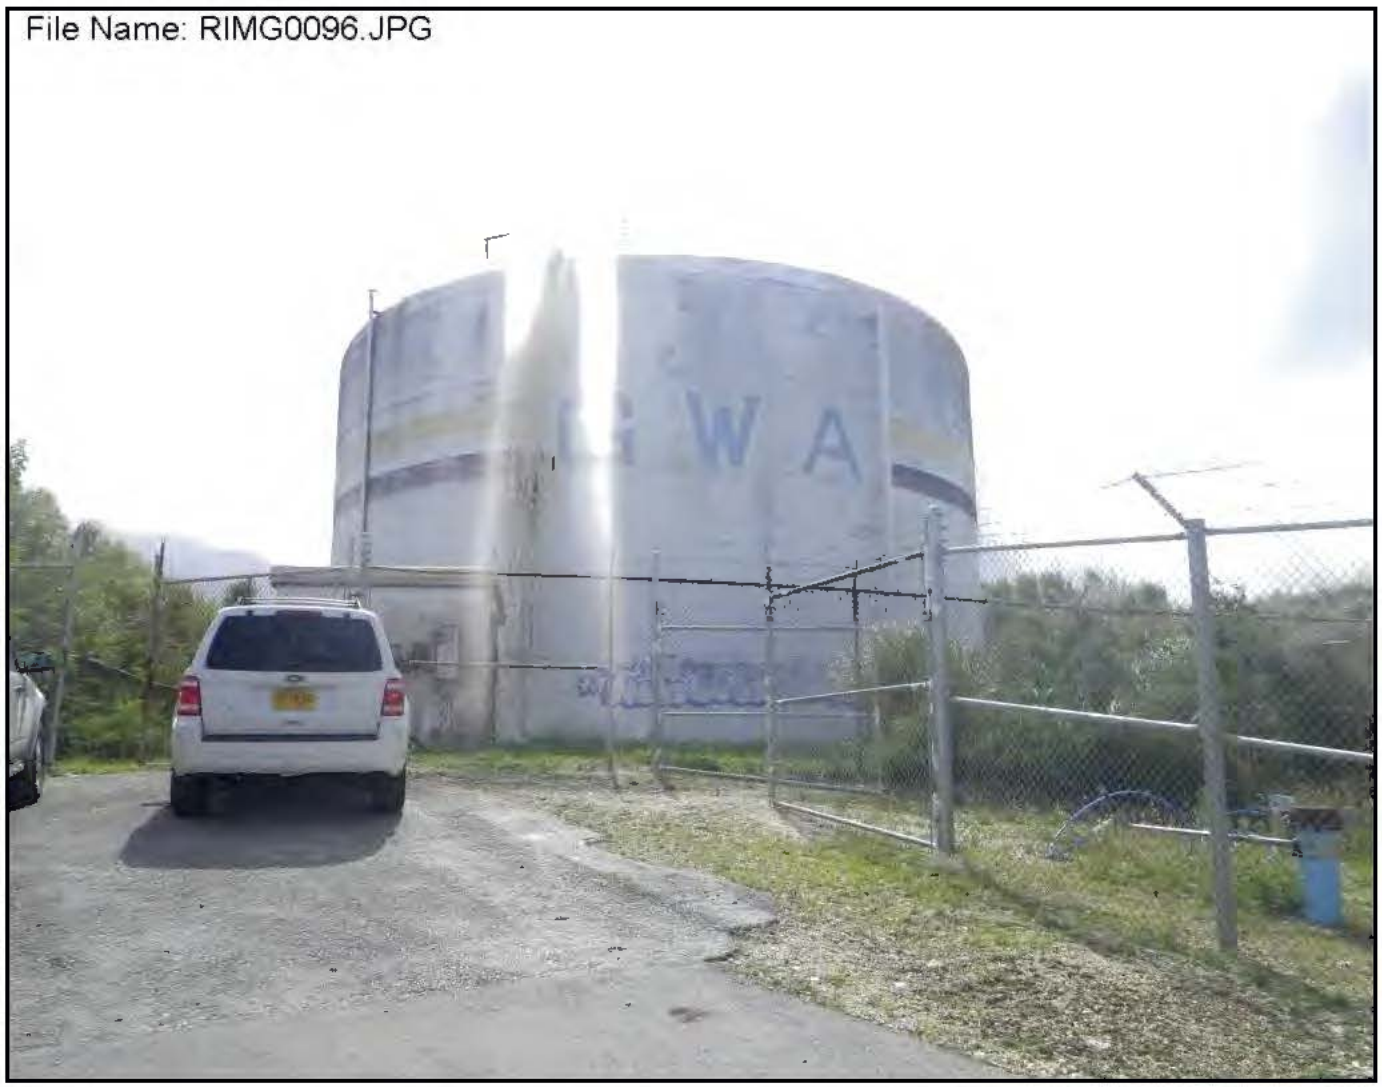
File Name: RIMG0096.JPG

Attributes	
Title	Guam Waterworks Authority (VP0989)
Subject	Southern System
Latitude	[redacted]
Longitude	[redacted]
Photo Direction	[redacted]
Elevation	[redacted]
Date Time Stamp	4/26/2012 2:59:48 PM
Photographer	K. Sable
Comment	Sinifa Tank
Description	Overview of tank

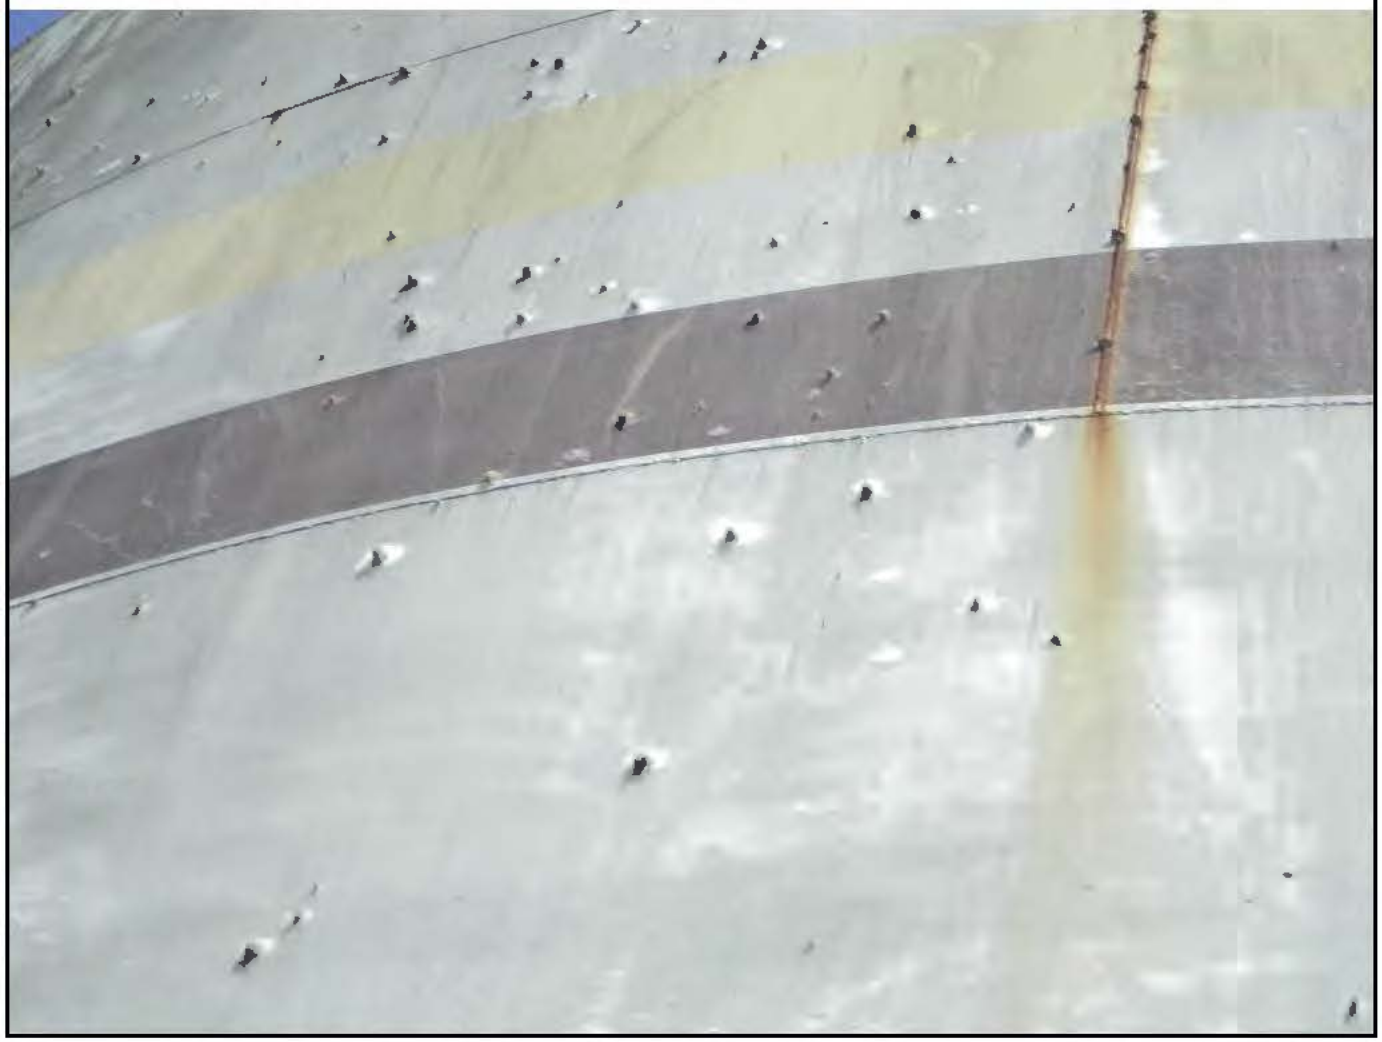
File Name: RIMG0099.JPG

Attributes	
Title	Guam Waterworks Authority (VP0989)
Subject	Southern System
Latitude	[redacted]
Longitude	[redacted]
Photo Direction	[redacted]
Elevation	[redacted]
Date Time Stamp	4/26/2012 3:06:38 PM
Photographer	K. Sable
Comment	Sinifa Tank
Description	Moss clumps on side of tank
