# Assessment of Dam Safety

## Coal Combustion Surface Impoundments (Task 3)

Pleasants Power Station

McElroys Run Dam

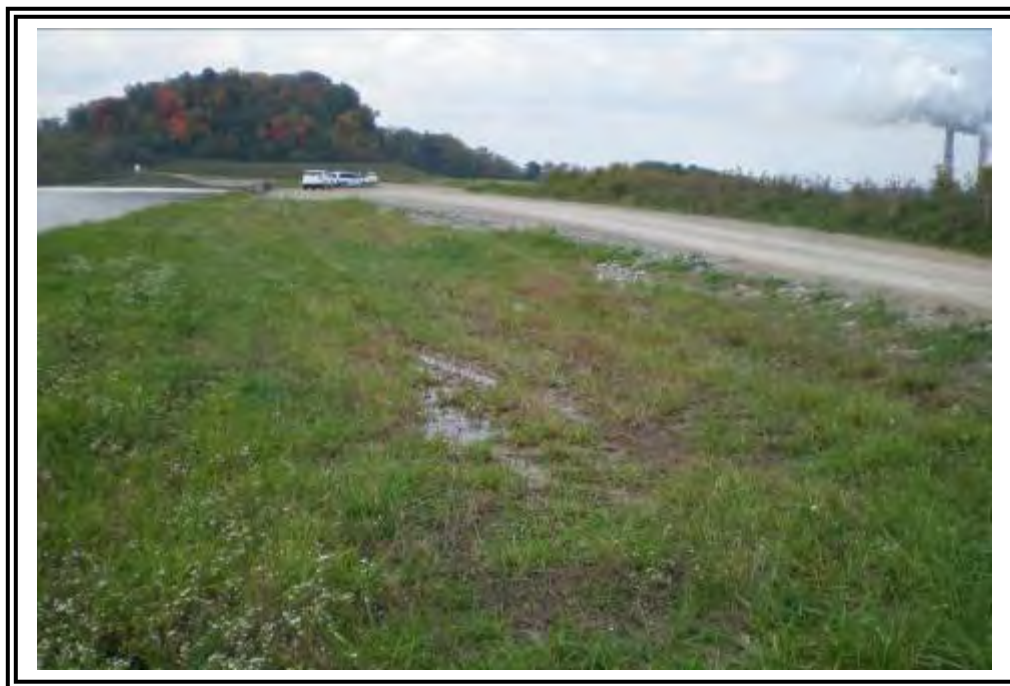
17

Downstream slope face, looking west, showing part of crest and access drive.

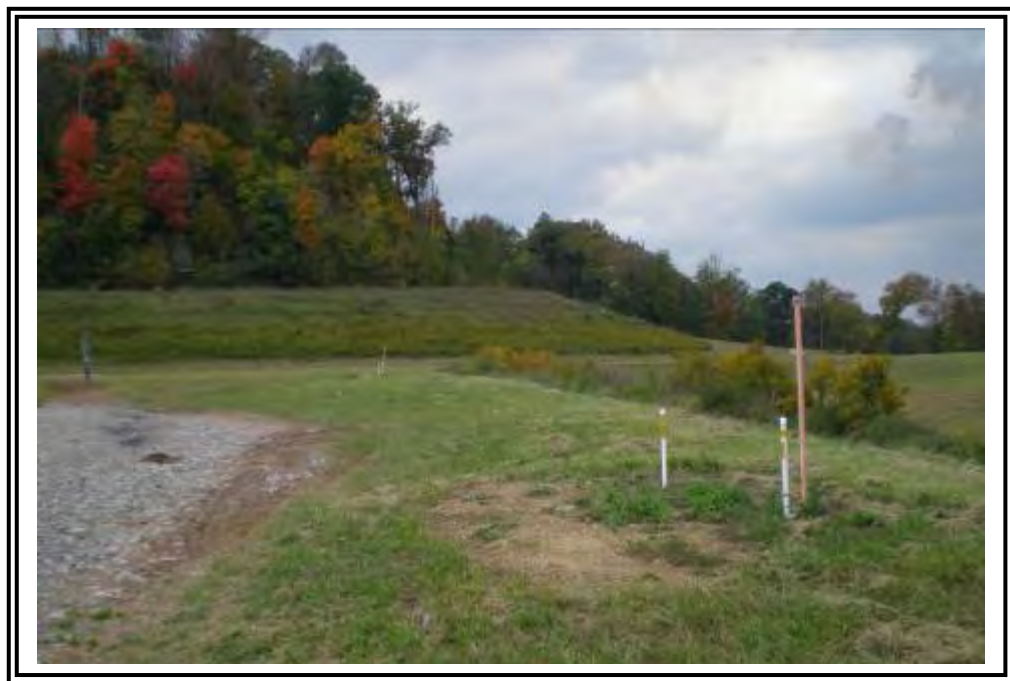
18

Instrumentation on the dam crest, looking west.

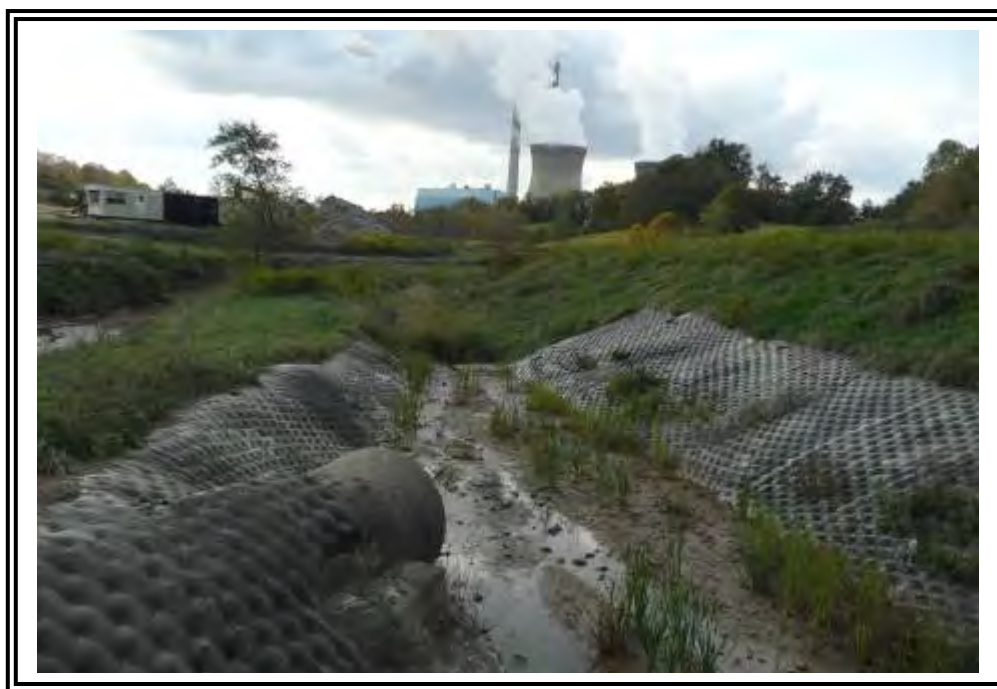
59

Looking downstream at spillway outlet basin.

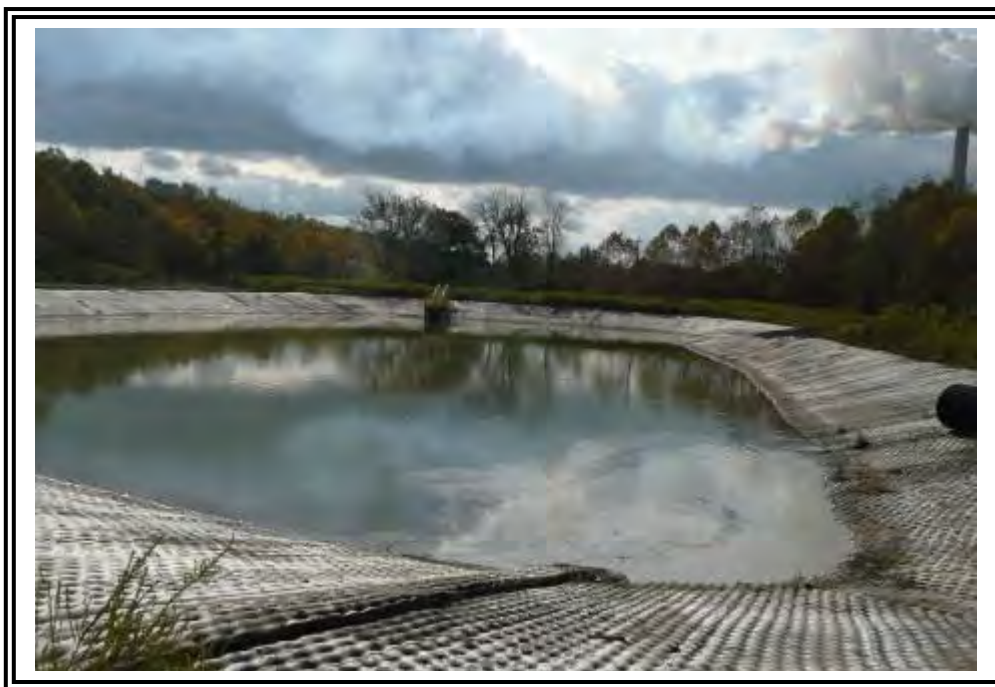
63

Sedimentation Basin No. 2 for general site runoff and outfall from Sedimentation Basin No.1.
