# Assessment of Dam Safety Coal Combustion Surface Impoundments (Task 3) Draft Report

American Electric Power

Cardinal Power Plant

Brilliant, Ohio

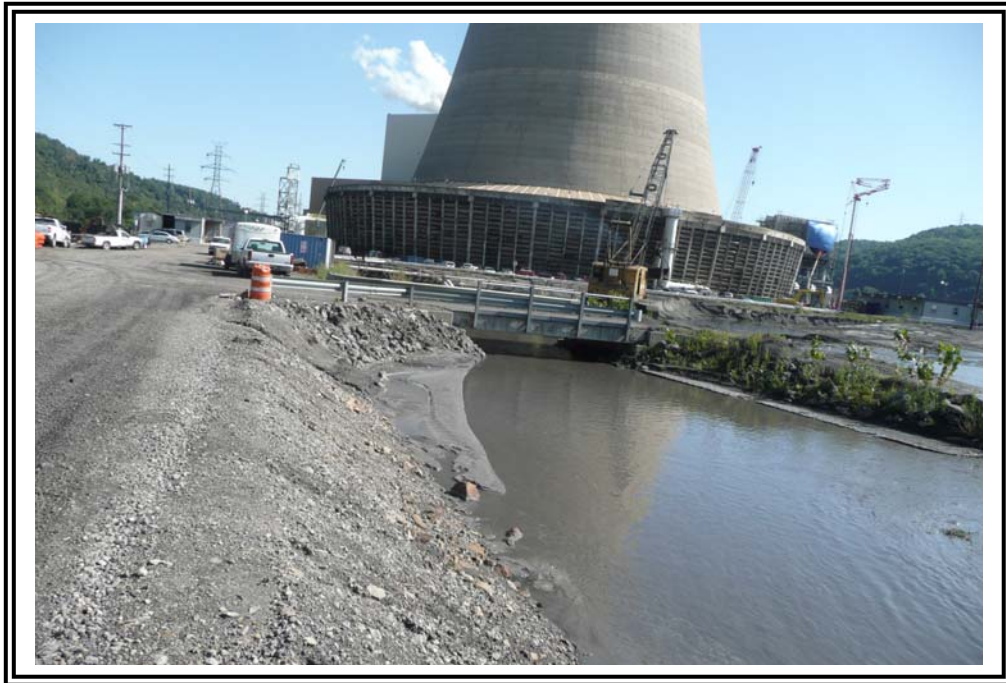
7

Upstream slope of west dike looking north.

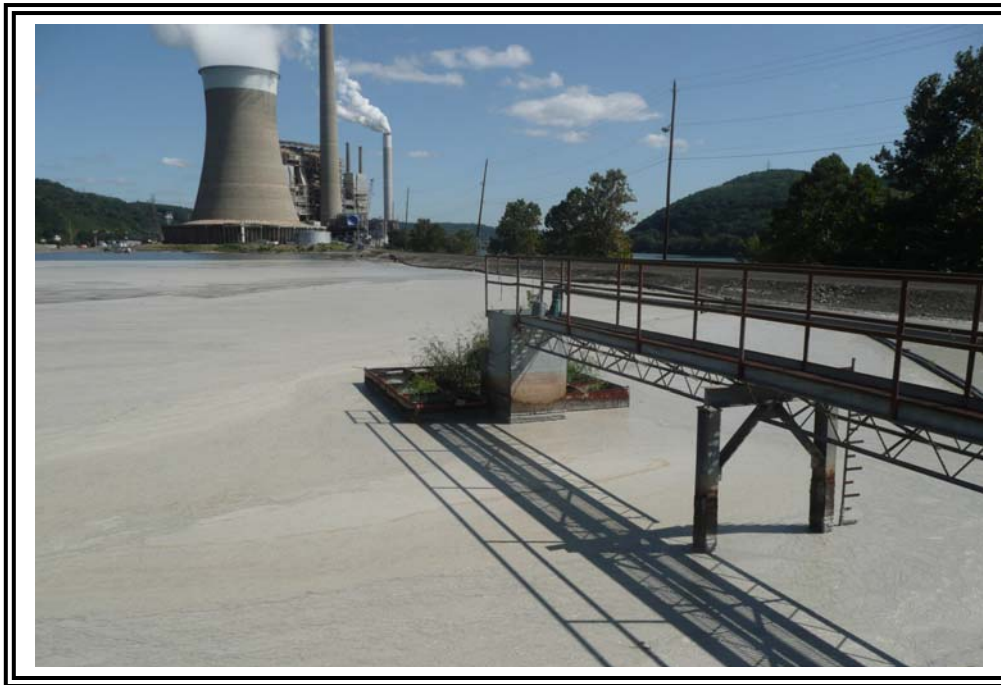
17

Pond spillway tower looking north.

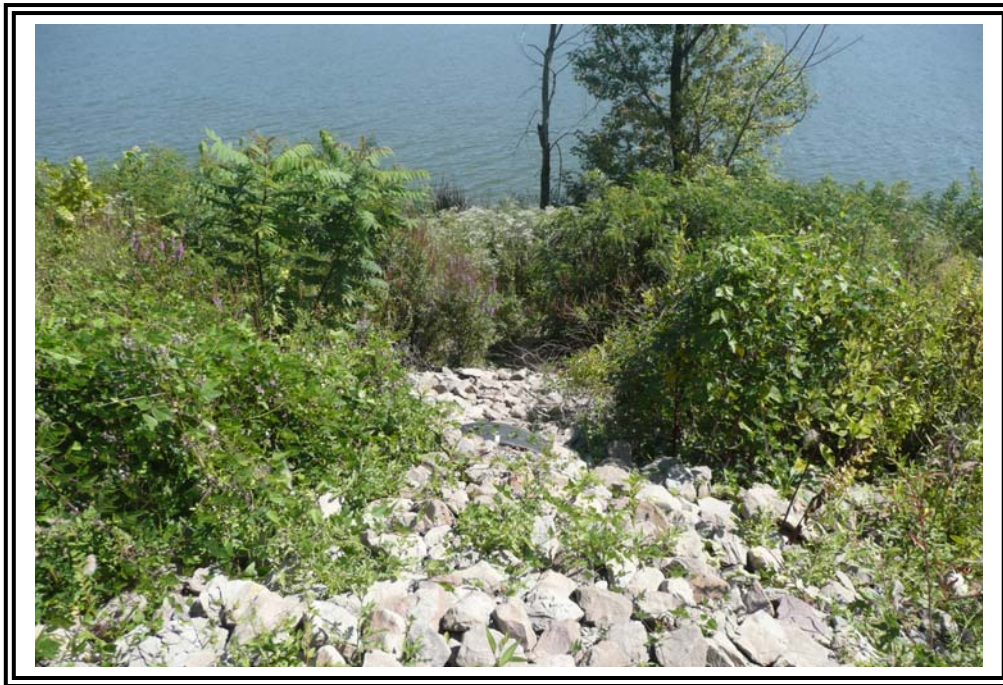
45

Slope protection below recirculation pond outfall.

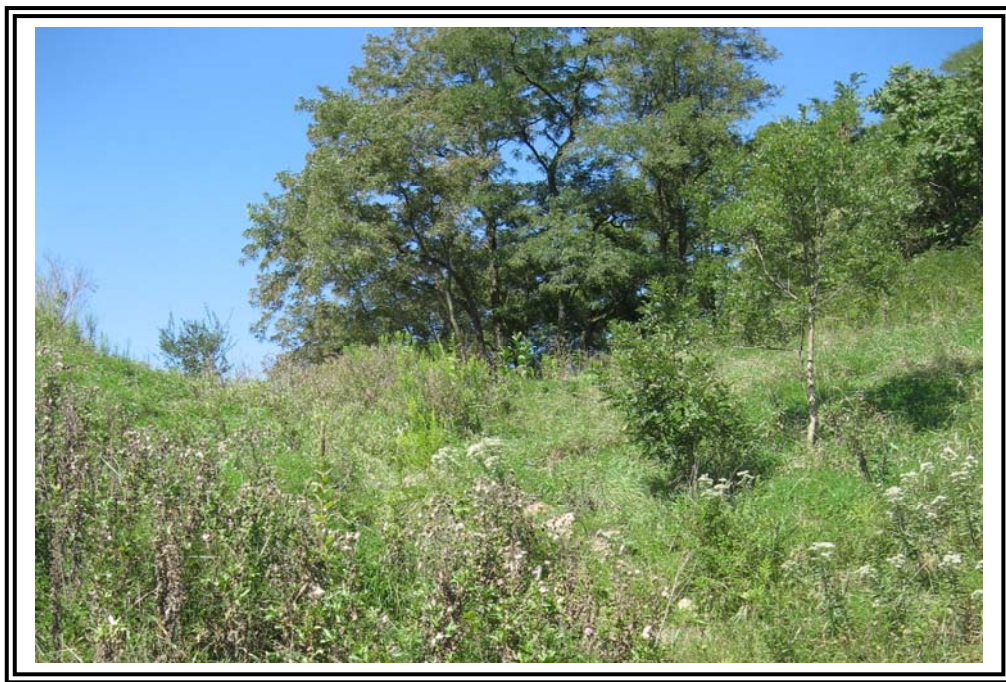
58

Left (north) abutment rock groin; heavily vegetated.

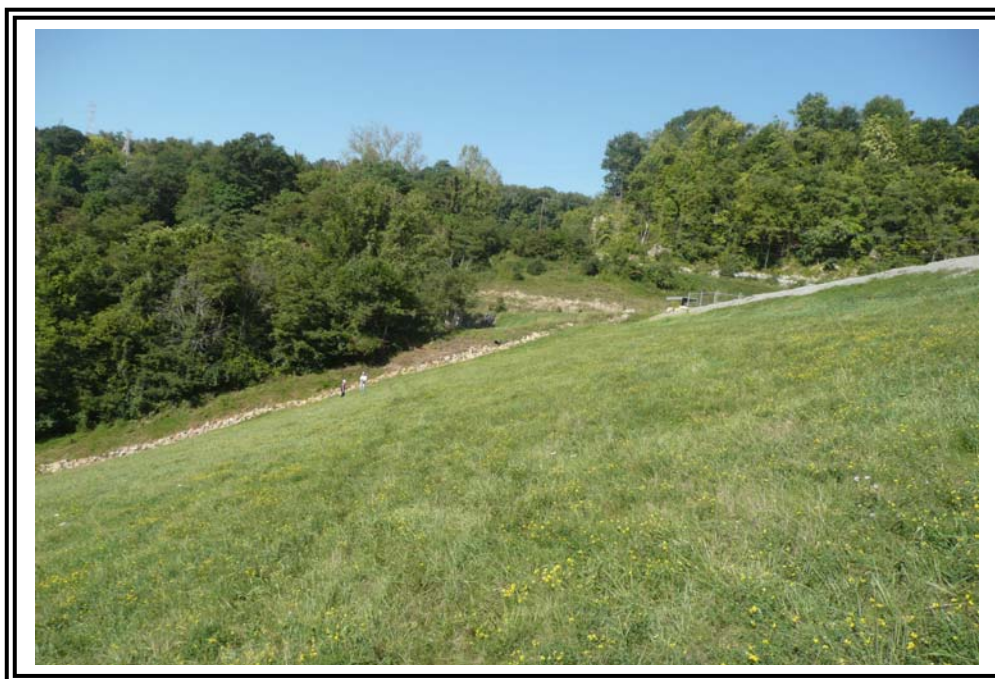
64

The downstream slope areas generally appeared to be well maintained and vegetated with an adequate grass cover as noted in Photos 64, 99, 101, and 105. Much of this cover has grown on the portion of the dam above elevation 925 which is the RCC portion. Isolated grass cover losses were observed in some areas, such as the ones on the upper bench shown in Photos 102 and 103, but these were considered minor. The erosion observed between the upper bench and the west groin is more prominent however, as shown in Photo 100.

Downstream slope below crest at looking west toward right abutment. Note rock groin at abutment contact.

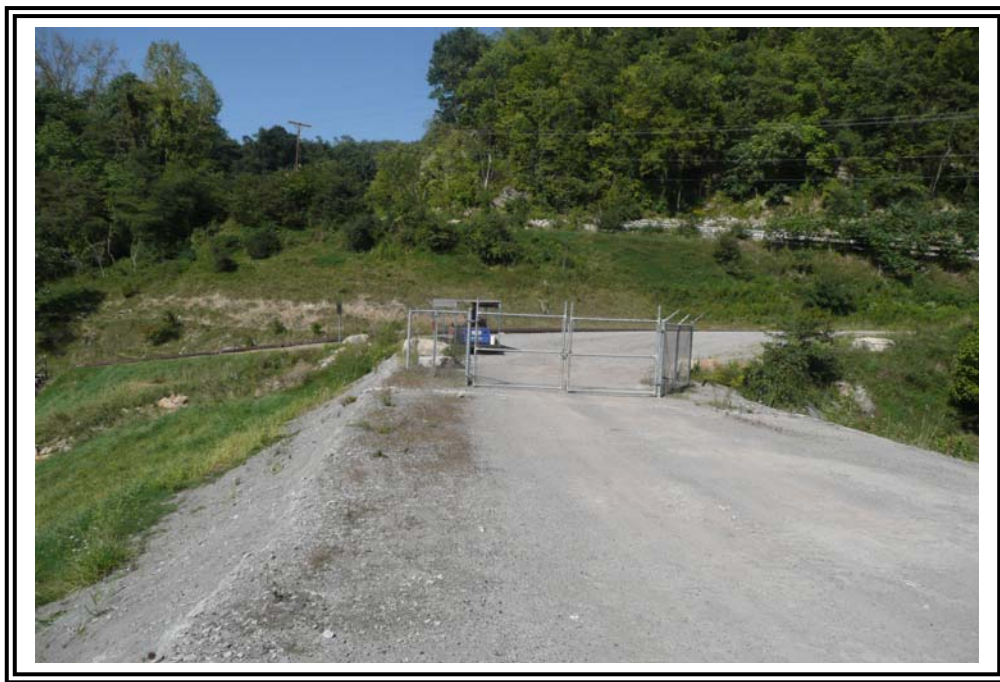
66

On crest looking at right (west) abutment

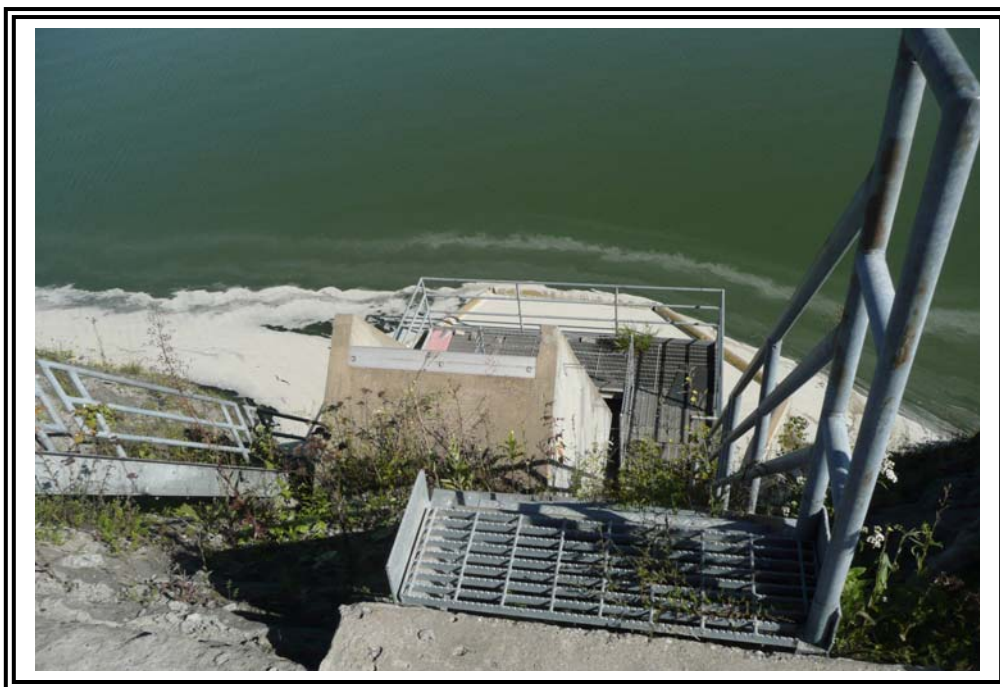
73

Inclined spillway from crest

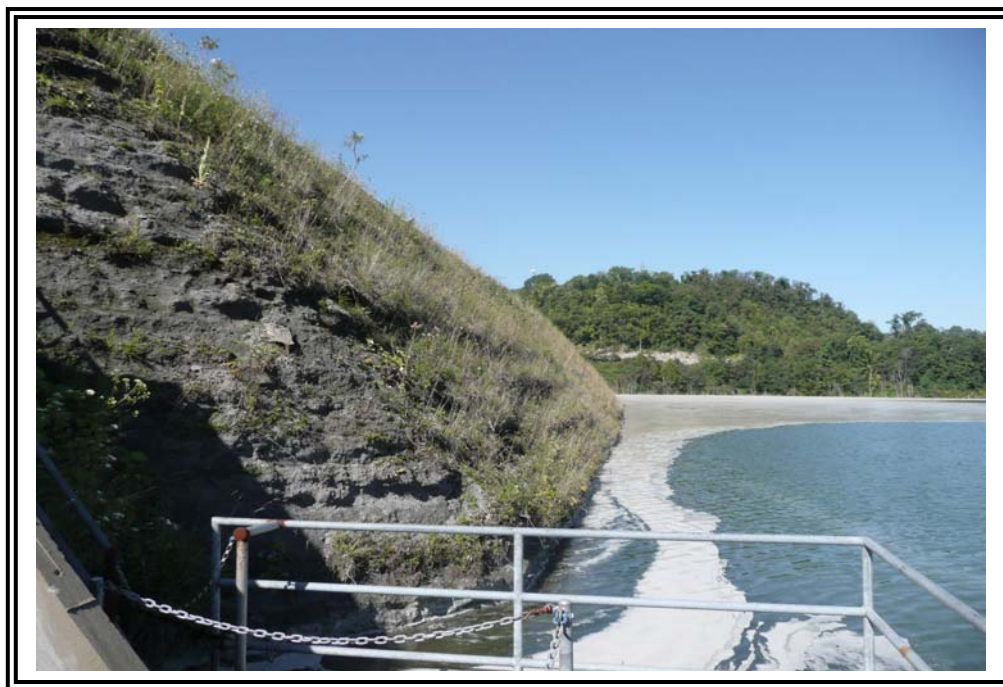
77

The upstream slope of the roller compacted concrete (RCC) crest is fairly steep and generally appears to be in good condition. Sparse vegetation has slowly started to establish itself (Photos 76 and 77). Due to the nature of the upstream slope, only a limited portion could be directly viewed during the site visit.

Upstream slope looking west from spillway.

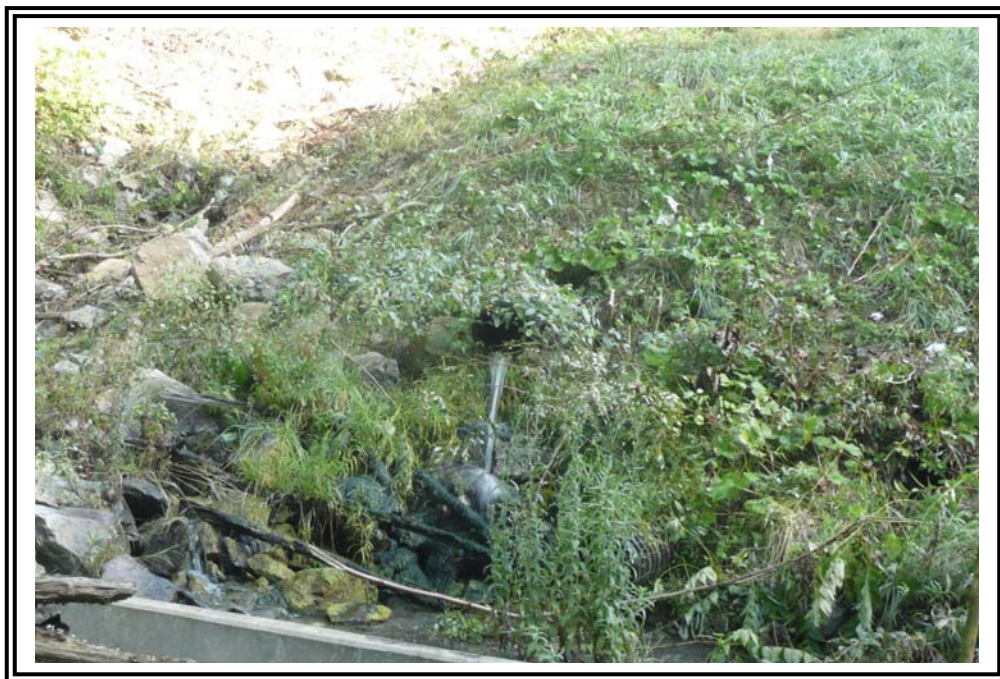
94

Closer view of seepage discharge.

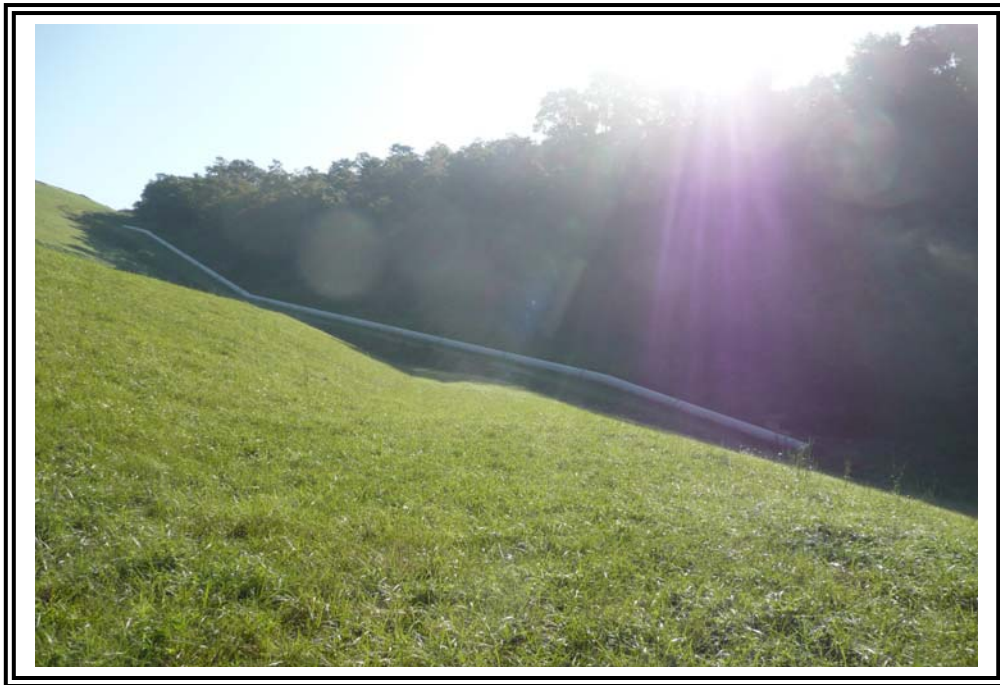
99

Downstream slope looking east on lower bench.

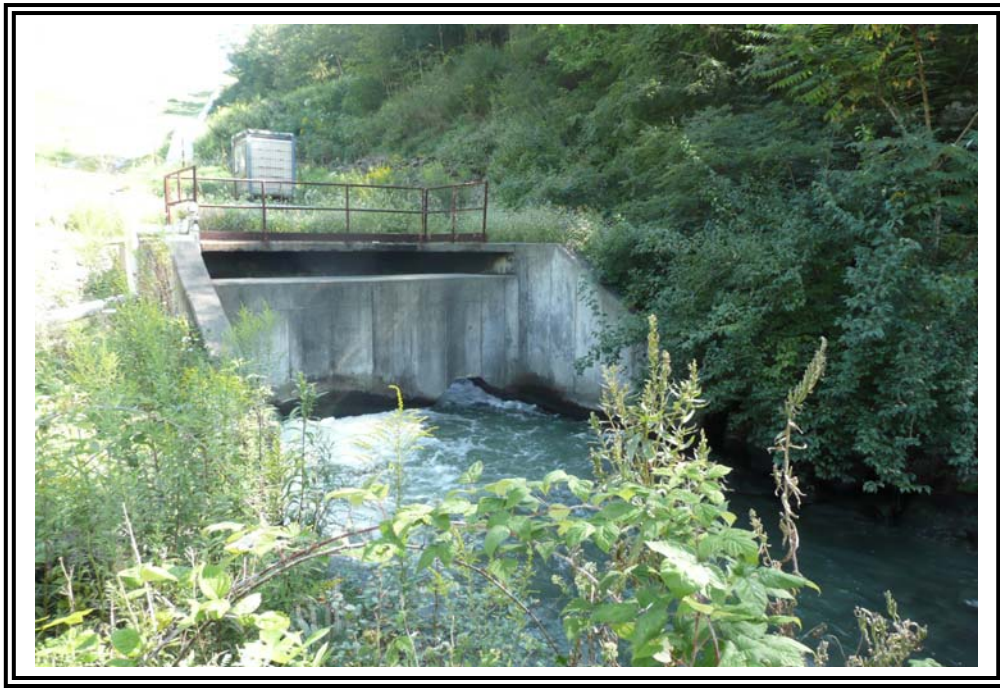
107

Spillway outfall and energy dissipation structure.

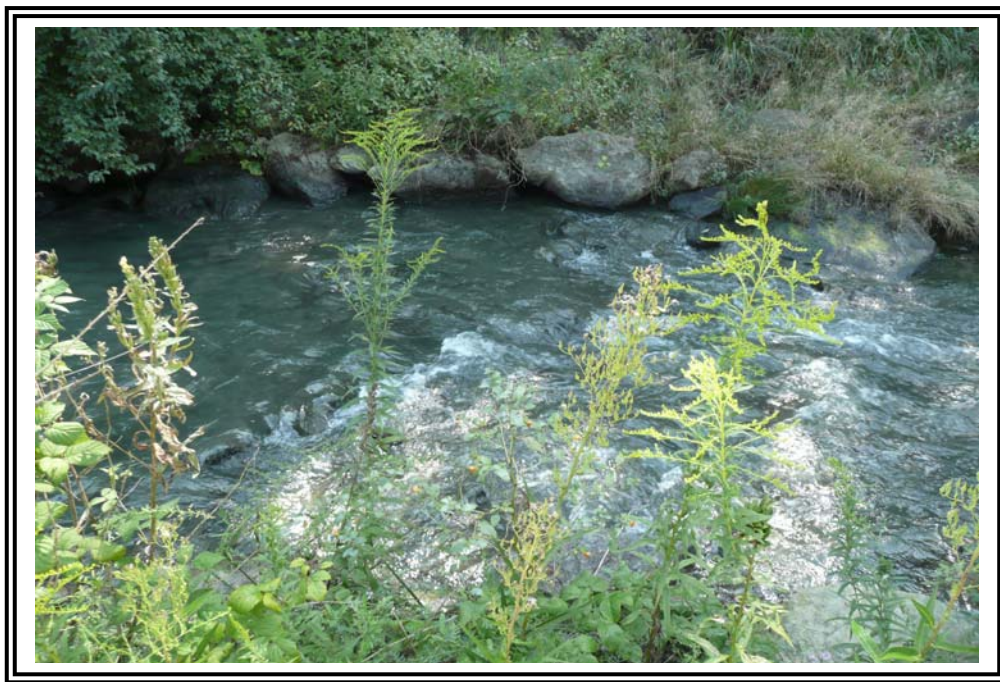
108

Downstream outfall creek channel.
