**Coal Combustion Residue Impoundment  
Round 9 - Dam Assessment Report**

*Clinch River Power Plant*  
*Ash Pond Management Units*  
*Appalachian Power*  
*d/b/a American Electric Power*  
**Carbo, VA**

Dewberry & Davis, LLC  
Fairfax, Virginia

**April 2011**

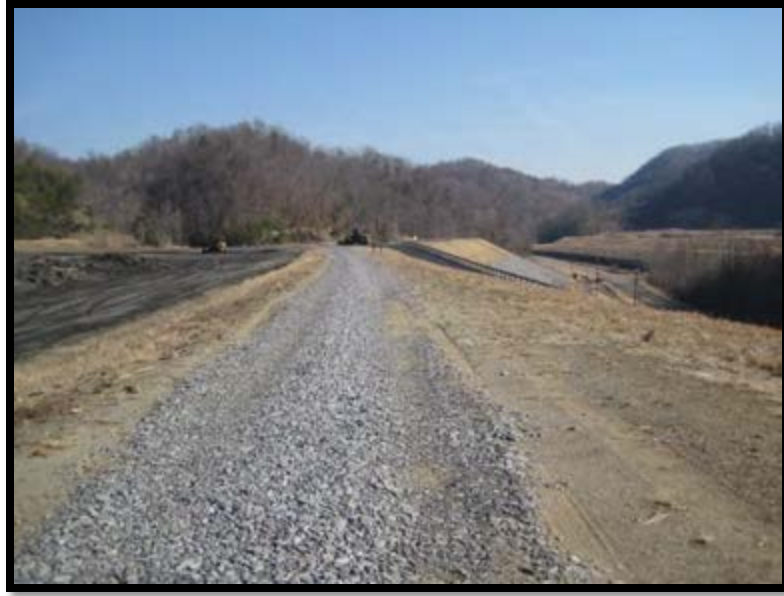
The crest of the perimeter dike had no significant signs of depressions, tension cracks or other indications of settlement or shear failure. Figure 5.2.1-1 and Figure 5.2.1-2 shows the typical crest conditions along the perimeter dike.

**Figure 5.2.1-2:** Crest, Northeast. Route 616 and railroad to right.

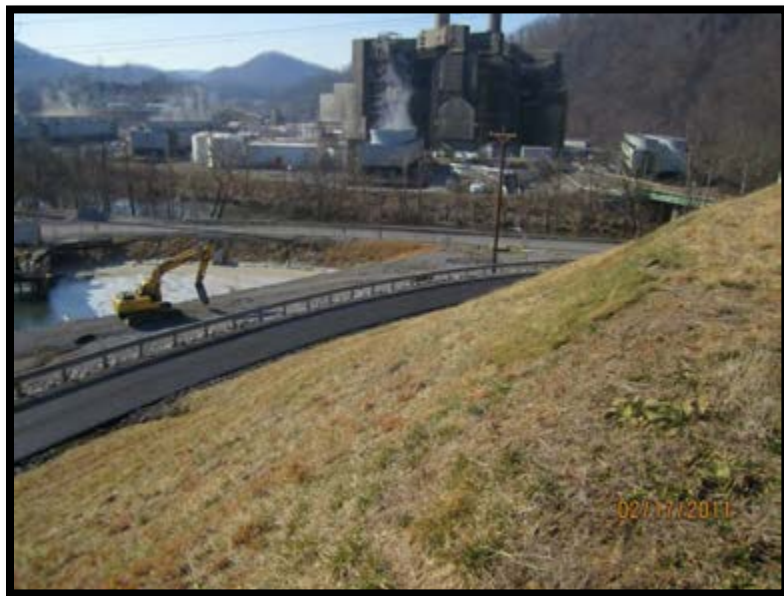
The visible downstream slope of the perimeter dike had adequate and well maintained cover of grasses/weeds as well as rip-rap armoring and inverted filter. A paved access road from Route 665 runs up the downstream slope of the perimeter dike to its crest. An animal burrow was observed along the downstream slope of the perimeter dike. The burrow hole was small in size and near the crest. No scarps, sloughs, bulging, cracks, depressions or other indications of slope instability were observed along the downstream slope. Figures 5.2.3-1 thru 5.2.3-3 show representative downstream slope sections of the perimeter dike.

**Figure 5.2.3-2:** Downstream slope along paved access road, Southwest. Note reclaim beyond the toe of the perimeter dike.

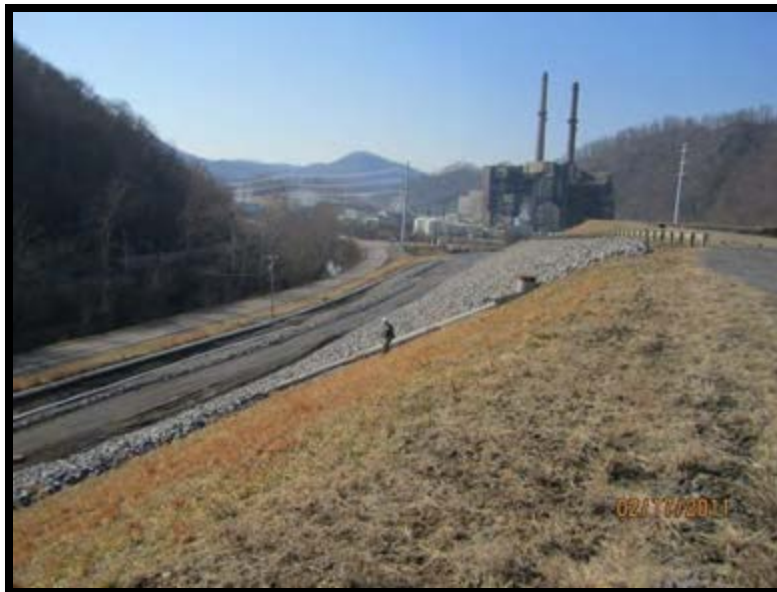
**Figure 5.2.3-3:** Downstream slope, Southwest. The embankment runs parallel to Route 616. Note transit pipes along edge of riprap. Transit pipes carry offsite runoff through the ponds splitter dike and out to Dumps Creek.

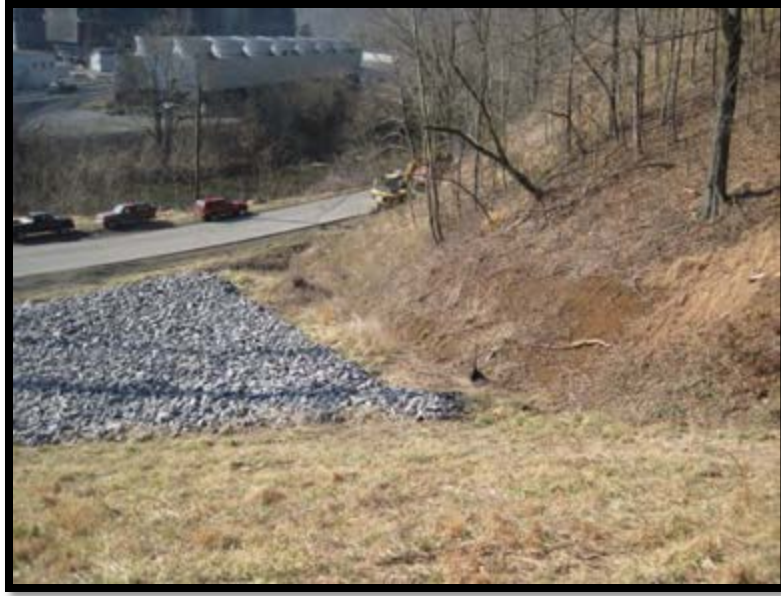
The perimeter dike has two abutments; the south and north abutments. Both abutment contacts consist of a drainage ditch. The south ditch shows some signs of erosion due to wet weather flow runoff from the adjacent hillside. The north ditch appeared in better condition with some stone and a v-notch weir that is used to monitor seepage, which was present on the day of the assessment. Apart from some minor erosion along the south abutment ditch, both abutments were well maintained. There were no observed scarps, sloughs, bulging, cracks, depressions or other indications of slope instability. Figures 5.2.4-1 and 5.2.4-2 show south and north abutment contacts.

**Figure 5.2.4-2:** South abutment ditch. Note downstream slope rip-rap used for seepage control and abutment ditch used to convey hillside drainage.

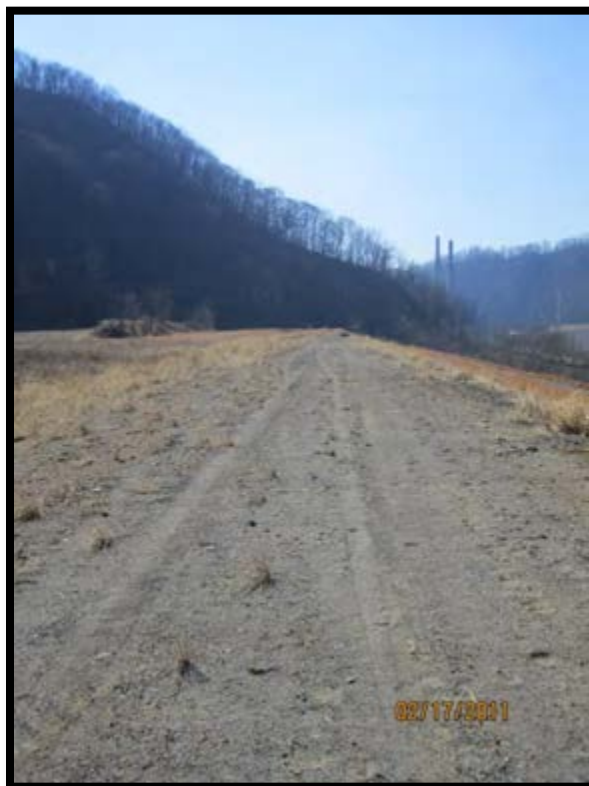
Portions of the upper dike have been removed and some re-grading has been completed near the crest of the middle dike. A small sized animal burrow was observed along the crest of the middle dike. No depressions, tension cracks or other indications of settlement or shear failure were observed on the crest of the middle or lower dike. Figure 5.3.1-1 and Figure 5.3.1-2 show typical crest conditions along the dike.

**Figure 5.3.1-2:** Middle dike crest, South.  
Note removed portions of upper dike and re-grading near crest of the middle dike.

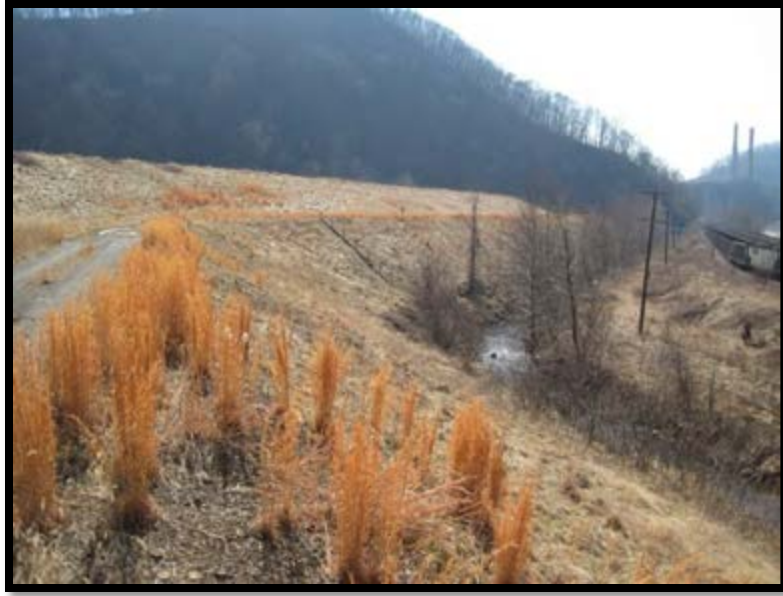
The downstream slopes of the dikes are covered in high grass/weeds. The upper dike had some areas of tree growth. Significant tree growth between the toe of the lower dike and Dumps Creek made visual observations difficult. Based on what could be observed there were no scarps, sloughs, bulging, cracks, depressions or other indications of slope instability along any portion of the dikes. Figures 5.3.3-1 thru 5.3.3-3 show representative sections of the downstream slopes and toe.

**Figure 5.3.3-2:** Downstream slope of lower dike, Southeast. Note significant tree growth along Dumps Creeks.

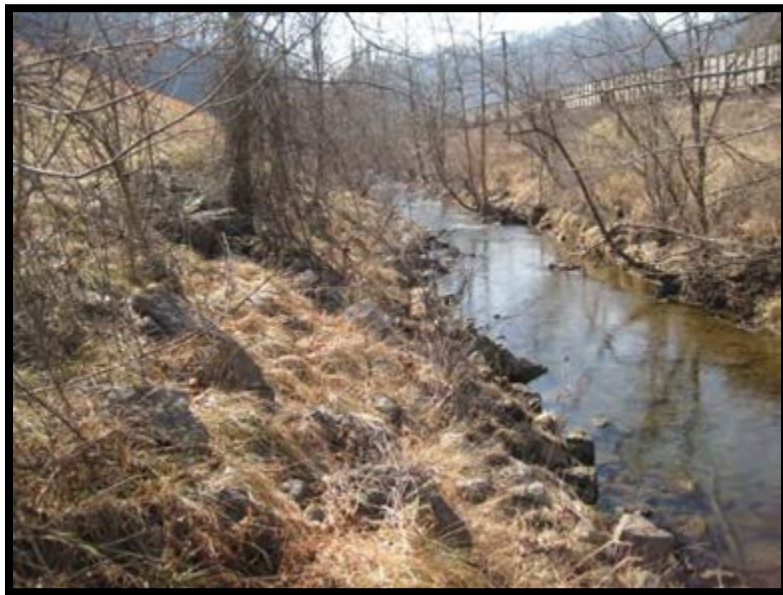
**Figure 5.3.3-3:** Downstream toe of lower dike. Note significant tree growth and rip-rap adjacent Dumps Creek.

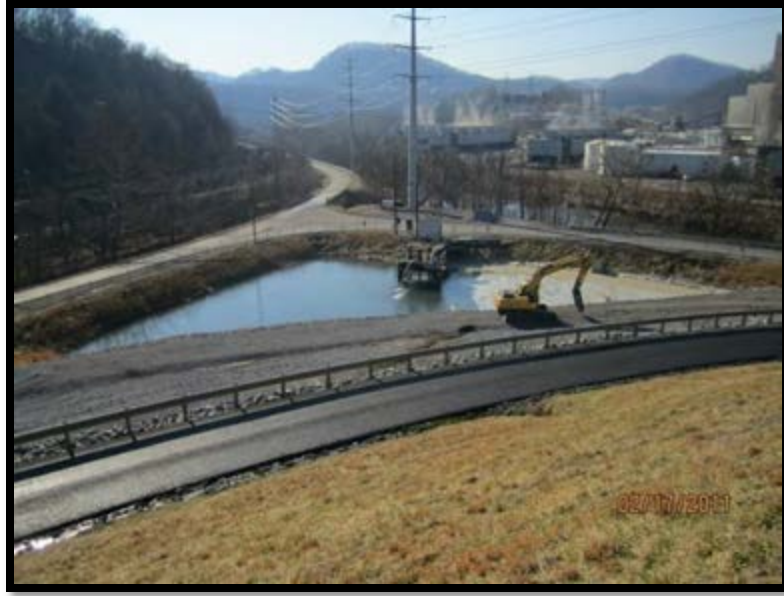
The spillway outlet conduit for Ash Pond 1 consists of a 36-inch reinforced concrete pipe leading to a catch basin that subsequently outfalls to a 30-inch reinforced concrete pipe that drains to the existing reclaim pond. The 30-inch outfall was not visible as it is completely submerged below the permanent pool of the reclaim pond (Figure 5.4.2-1).

**Figure 5.4.2-1:** Outlet conduit outfall, reclaim pond at intersection of Route 616 and 665.

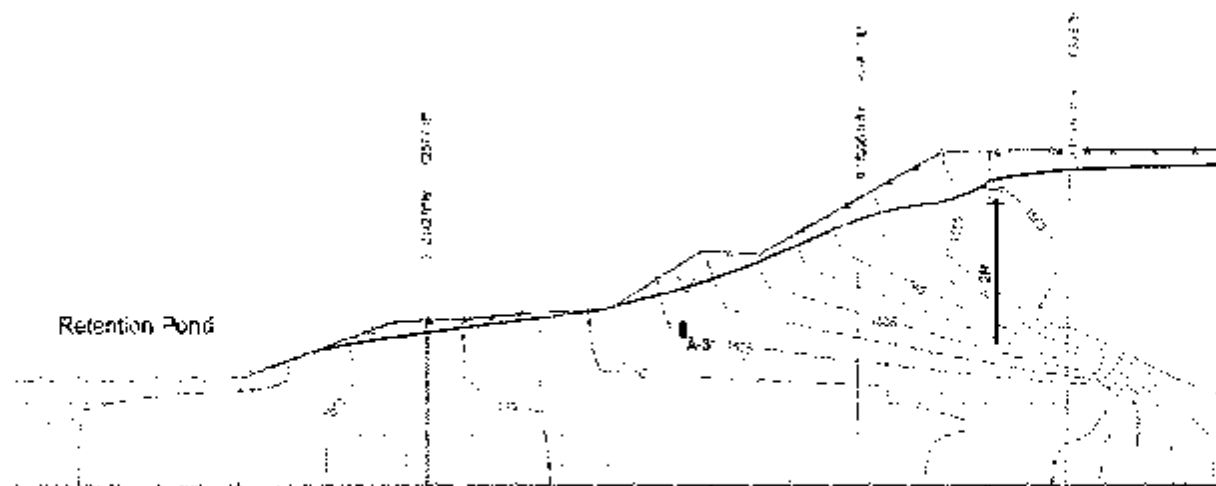
Each analysis was performed in two stages. In stage one the pool levels were raised from the bottom of each pond to the operational pool levels without the cut-off wall, and in stage 2 the cut-off wall was activated by changing the material type of the elements that defined the wall. Figure 4 presents the computed total head distribution across Section A together with the seepage flow rates per unit length of the dike before the installation of the cut-off wall. The predicted phreatic surface can be seen to be in a reasonable agreement with the historical records of piezometer A-2 and A-3. To achieve such agreement the hydraulic conductivity of the outer shell was adjusted to 0.05 ft/hr. Depicted in Figure 5 are plots of historical readings of all the piezometers that are at or near Section A, including the piezometers installed in 2009. More information on the locations and screening depths of the piezometers has been included Appendix 3. The model predicts seepage at the toe that is confirmed by history of seepage and boils at this area of the dike. In general the model predictions are in reasonable agreement with the field observations and piezometric readings, indicating that the values of hydraulic conductivities and the boundary conditions used in the analysis were well selected.

Figure 4. Computed total head distribution in Section A before construction of the cut-off wall.

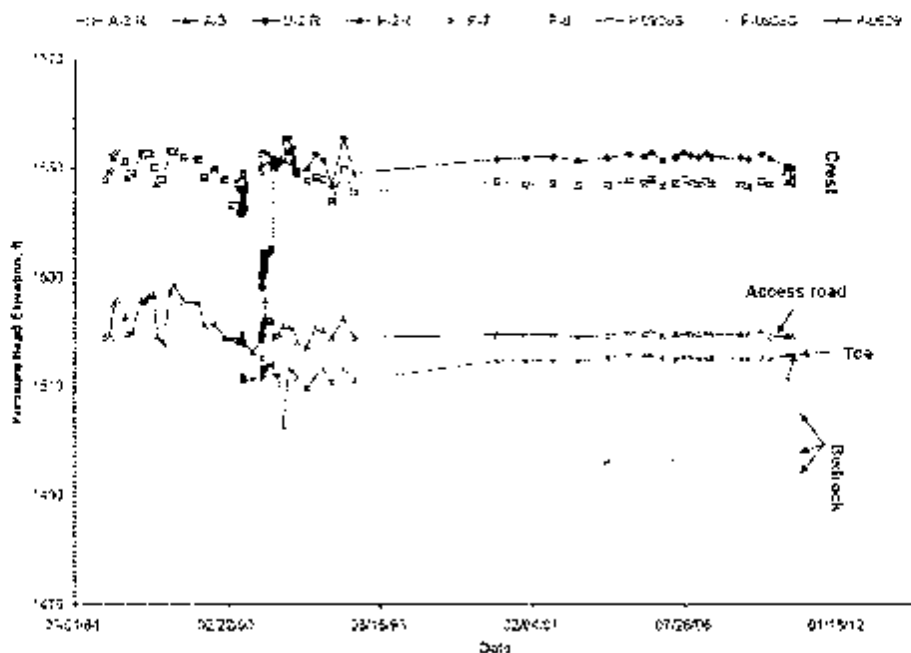
Figure 5. Historical piezometer records near Section A together with readings from newly installed piezometers P-0908S, P-0908D, and P-0909.

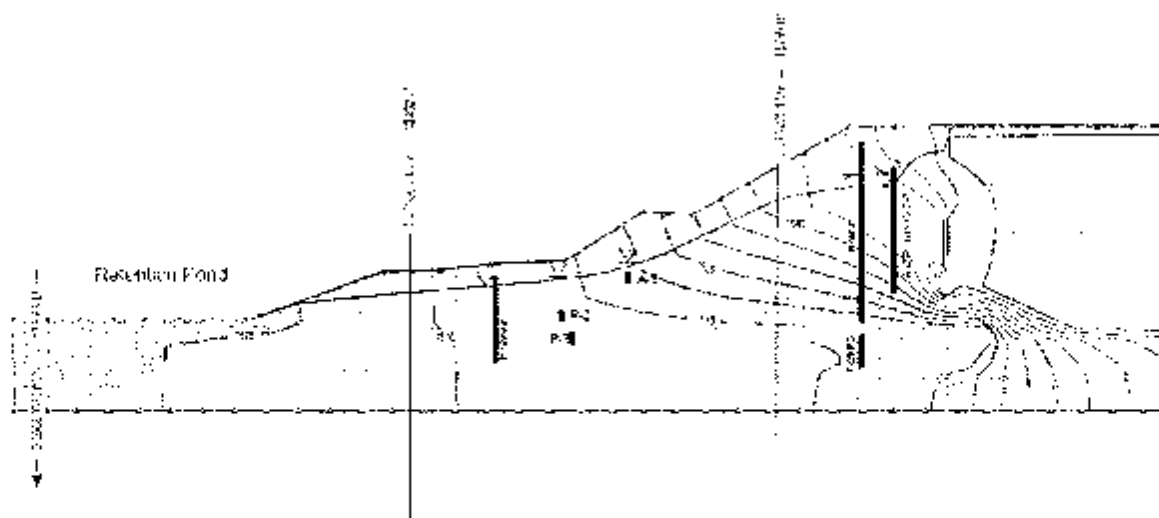
Figure 6 shows similar results for the second stage of the analysis after the cut-off wall was activated. It can be seen that the computed phreatic surface is in reasonable agreement with the recorded piezometric water levels in piezometers P-0908S, P-0908D, and A-2R. Figure 7 shows the predicted hydraulic gradients (xy-gradient) at the toe and the retention pond. The maximum predicted gradient on the ground surface is about 0.3 that is within the acceptable range for this type of structure. The analysis showed that installation of the cut-off wall can lower the phreatic water levels and significantly decrease seepage flow rates through the embankment. These outcomes were expected and are consistent with field observations and monitoring data. The seepage analysis did not conclude any adverse condition that could be considered as a potential hazard to the safety and stability of the structure. The seepage areas that exist on the toe of the structure are, thereby, believed to be through permeable layers of the foundation soil, a normal phenomenon that occurs in majority of earthen structures and does not pose a threat on the stability. It has to be emphasized that this analysis is not a substitute for the regular inspections and monitoring program that is performed by the plant on quarterly basis. The inspection and monitoring program has to be continued and any unusual condition should be immediately reported to AEP Geotechnical Engineering.

Figure 6. Computed total head distribution in Section A after construction of the cut-off wall.

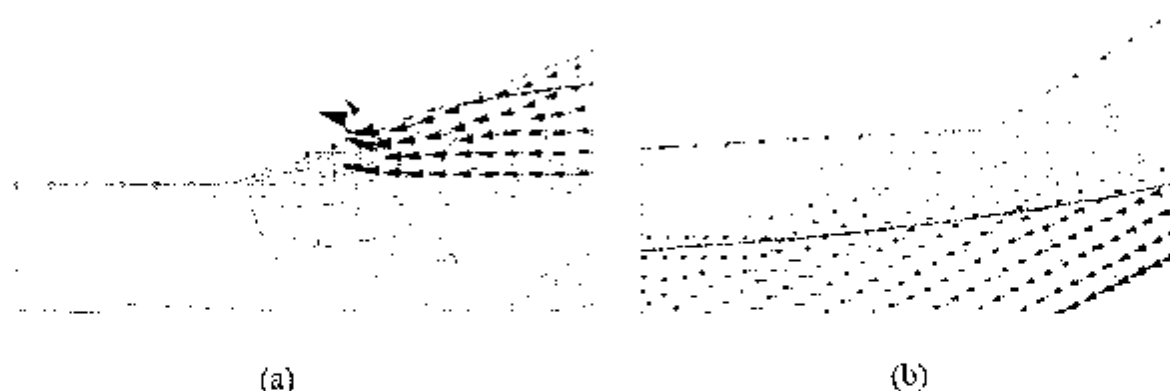
Figure 7. Computed hydraulic gradients for Section A after construction of the cut-off wall (a) at retention pond, and (b) at the embankment toe.

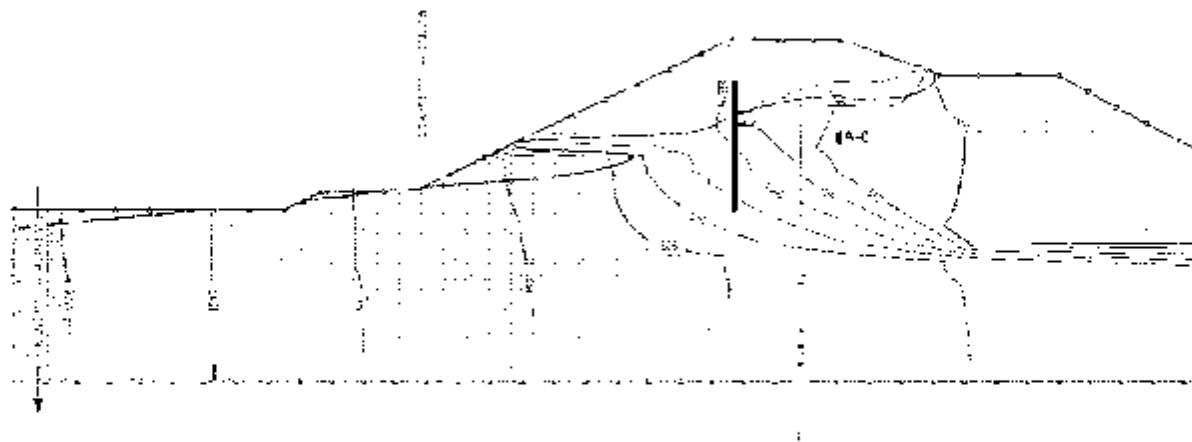
For the portion of the dike that is represented by Section B, the reported seepage at elevation 1533 ft continued even after construction of the cut-off wall. Furthermore, the observed piezometric level on the downstream side of the wall from piezometer A-7R has been at about the same elevation (1533 ft) since the construction of the wall. Water elevations in the piezometer B-4R and P-0904 have been at (approximately) elevation 1542 ft and 1546 ft, respectively. These observations suggest that a relatively permeable horizontal layer exists at about elevation 1533 ft, which acts as a conduit to transfer water to the slope face. Such a structure could have been formed by segregation of fine and coarse portions of the shale rockfill during placement. A high permeable layer over a low permeable layer within the outer shell is incorporated into the analytical model of Section B, as depicted in Figure 2. Figure 8 shows the computed total head distribution across the cross-section of the dike along with the seepage flow rates per unit length of the dike. A saturated hydraulic conductivity of 0.05 ft/hr was used for the outer shell at this section. The computed water levels for piezometers A-6 and A-7R are in agreement with the recorded water levels that are marked on this figure and also presented in Figure 9. The readings from the piezometers varied with the pool level, however, the maximum water levels (Figure 9), most likely corresponding to the maximum experienced pool level, were used to back-calculate the hydraulic conductivity. The computed levels are within few feet of field observations.

Figure 8. Computed total head distribution in Section B before installation of the cut-off wall.

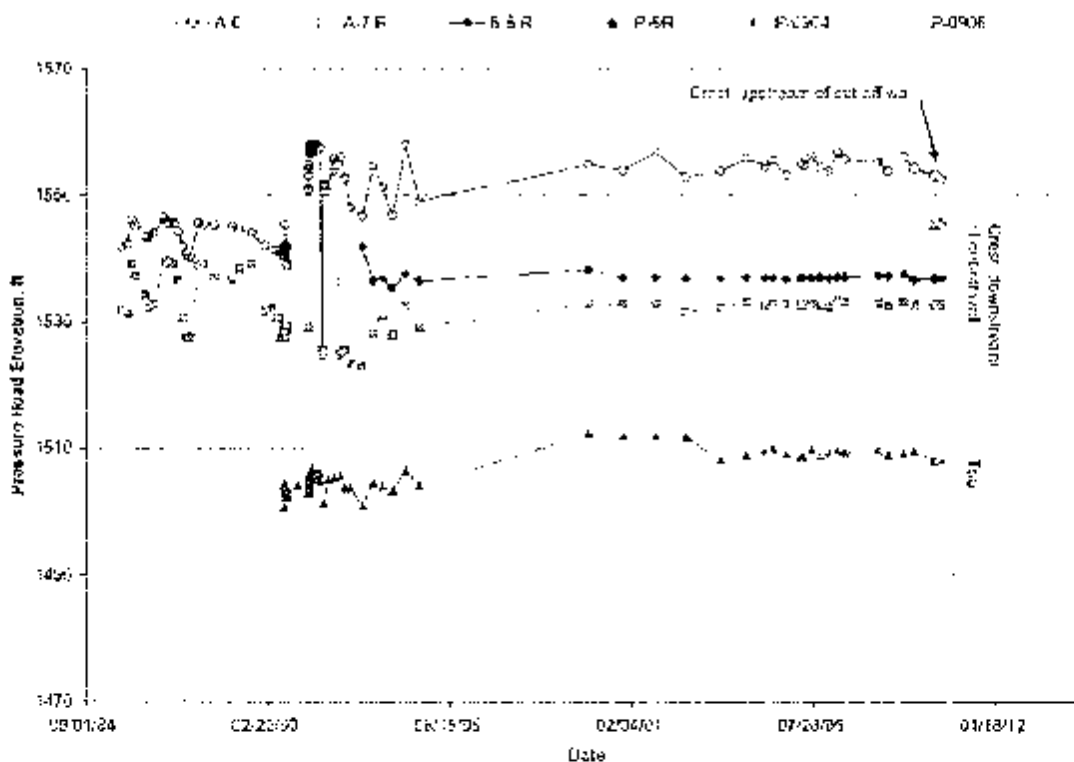
Figure 9. Historical piezometer records near Section B along with the readings from newly installed piezometers P-0904 and P-0905.

Figure 10 illustrates computed total head distribution across the section after construction of the cut-off wall. The model predicted a 5 ft raise in the piezometric levels on the upstream side of the wall and a 5 ft drop on the downstream side, presenting consistency with the readings from piezometers A-6 and A-7R. Furthermore, the computed phreatic water level is in agreement with the readings from piezometers P-0906, P-5 and P-0904. Piezometer B-5R, located in the crest of Pond 1B between Section B and Section C, have a water level of about 1537 ft since 1992 (Figure 9), that is within the predicted levels on the downstream side of the cut-off wall.

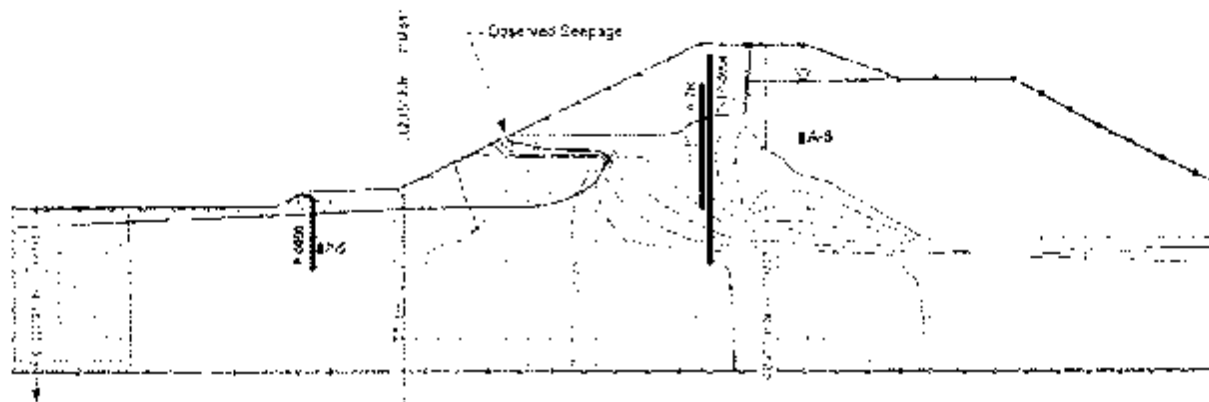
Figure 10. Computed total head distribution in Section B after installation of the cut-off wall.

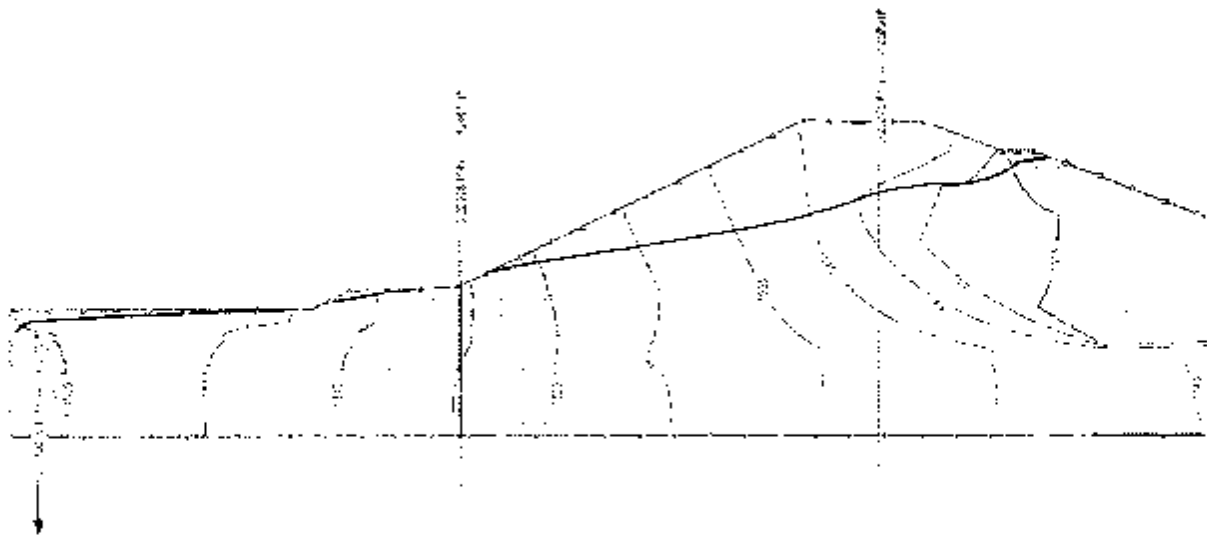
A thin layer of ash on the slope of the original dike was not included in the seepage model for Section C, as analysis of Section A and B suggested a hydraulic conductivity of 0.05 ft/day for the outer shell that is very close to that of the compacted ash layer (0.08 ft/hr). Figure 12 shows the computed total head distribution across Section C before the construction of the cut-off wall. All the existing piezometers near this section were installed after the construction of the cut-off wall, thus no piezometric data are available to confirm the predicted phreatic surface. A hydraulic conductivity of 0.05 ft/hr back-calculated from analysis of Sections A and B was used for this section. The analysis predicts some seepage at the toe of the embankment before the construction of the cut-off wall, in agreement with the field observations made before 1991.

Figure 12. Computed total head distribution in Section C before installation of the cut-off wall.

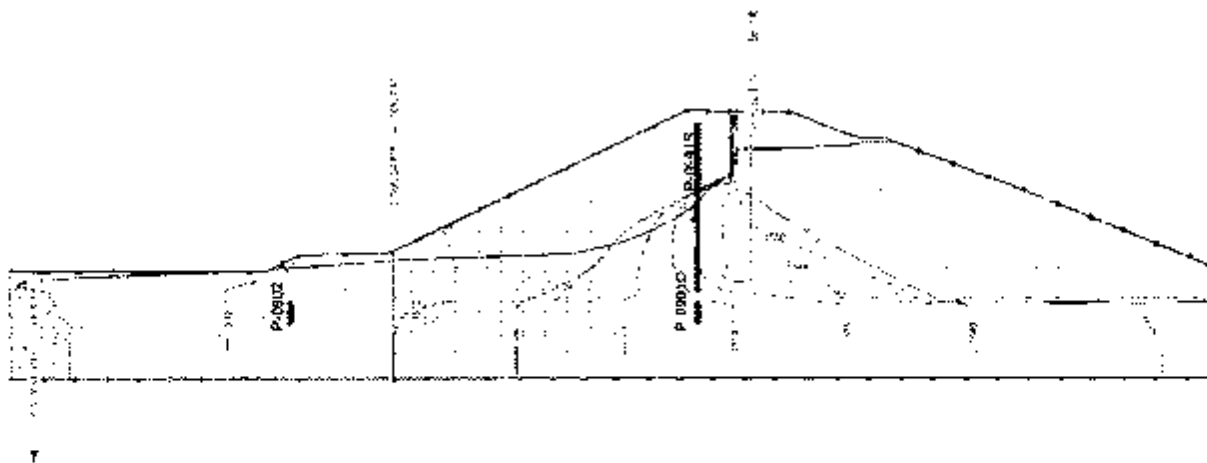
Figure 13. computed total head distribution in Section C after installation of the cut-off wall.

Figure 13 shows similar results for Section C after the construction of the cut-off wall. The predicted phreatic water levels are in agreement with the data from piezometers P-0901 and P-0902. Water level in Piezometer B-6 has not been shown on this figure because the screening depth of this piezometer is unknown. Figure 14 presents plots of recorded piezometric water levels for B-6, P-0901S, P-0901D, and P-0902. Figure 15 presents predicted hydraulic gradients at the toe of the section after construction of the cut-off wall. The maximum predicted gradient at the ground surface is about 0.2. No potential for piping failure due to internal erosion is believed to exist.

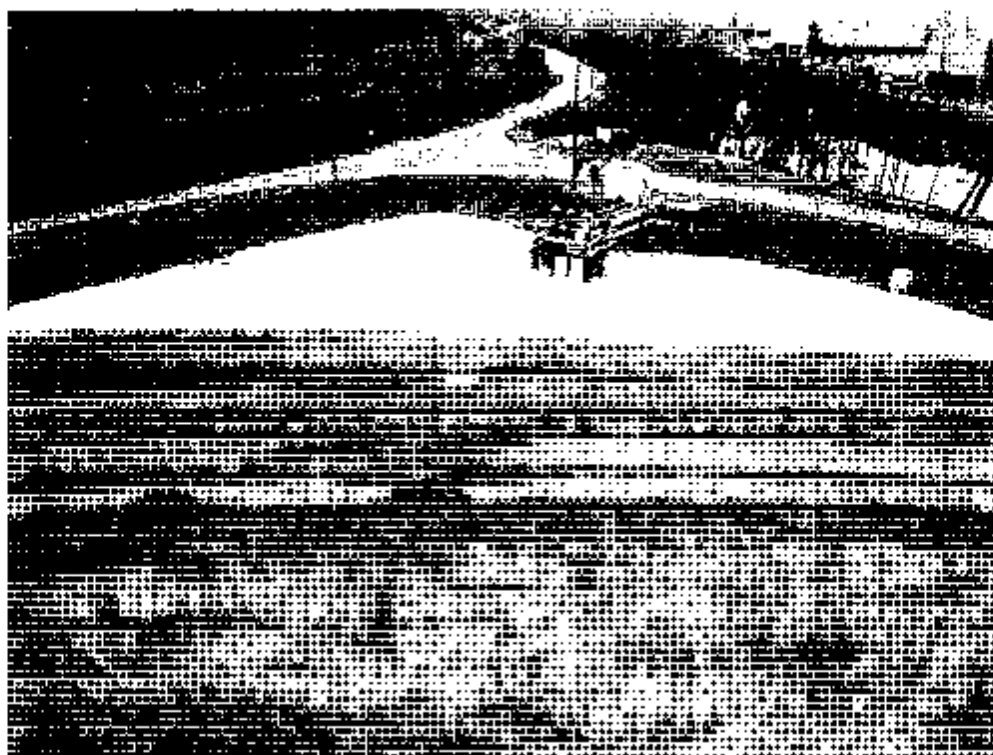
2. The V notch weir boxes referenced as Nos. 2, 3, and 5 were in fair condition. Clear water flow was discharging from all the weirs. Gray precipitate was observed on the downstream of weir box No. 3 (Photo 2), and at the bottom of all the weir boxes.
3. The surface of the Reclaim Pond was entirely covered with ctenospheres (Photo 3).

Photo 3. Reclaim Pond viewed from the crest of West LA dike

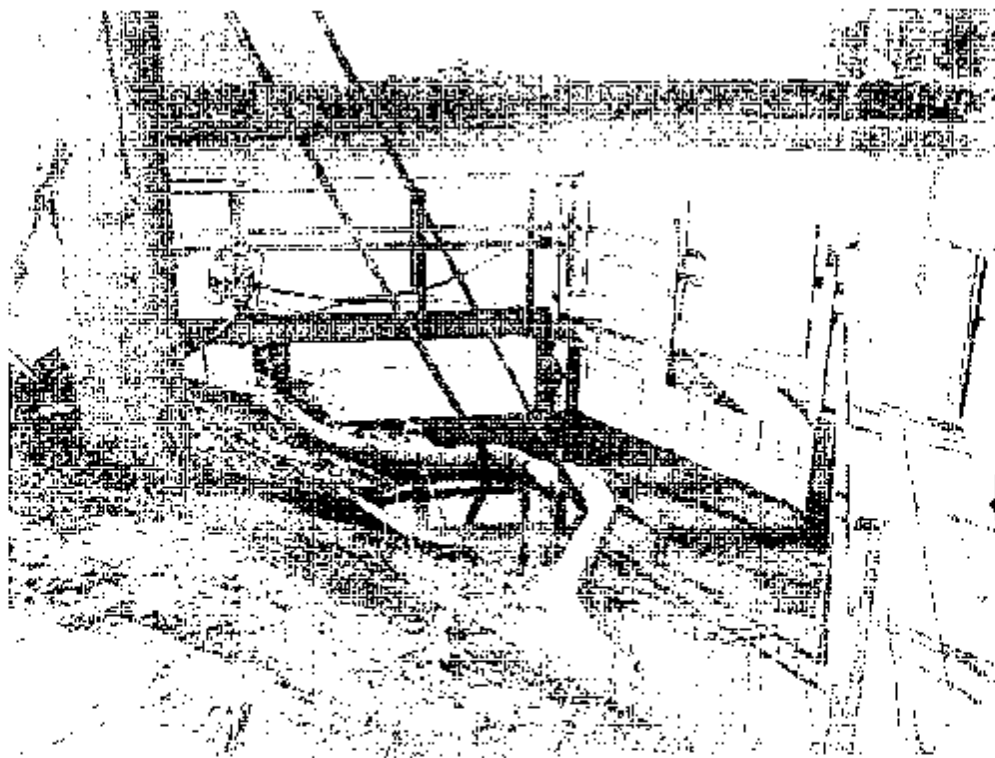
9. Reddish to light gray precipitate were present in most of the toe drain pipes (e.g. Photo 8).
10. The overflow tower from 1A to 1B ponds was in satisfactory conditions (Photo 9). There was no protective railing on the splitter dike around the overflow structure from 1A Pond to 1B Pond. The hand rail around the overflow structure was loose.

Photo 9. The overflow structure that discharges from IA to IB Ponds

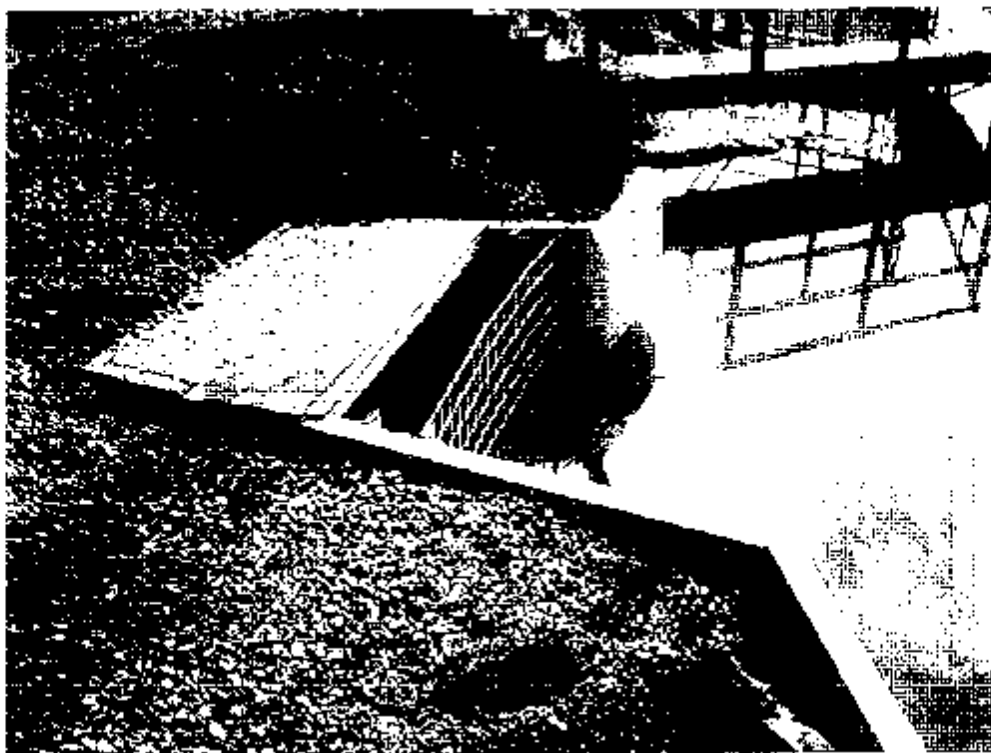
11. Two temporary spillway shafts have been installed to discharge the flow from 1A to 1B ponds to facilitate maintenance of the main spillway shaft. Photo 10 shows one of the new spillway shafts to the north of the overflow tower. The second shaft, located to the south of the overflow tower, has a higher invert elevation to pass discharge water from 1A to 1B ponds if the pool level increases to higher than normal levels during a storm event.

Photo 10. Inlet of the new spillway shaft from 1A to 1B ponds
