**Coal Combustion Residue Impoundment  
Round 9 - Dam Assessment Report**

*Glen Lyn Power Plant  
Ash Pond Management Units  
Appalachian Power  
d/b/a American Electric Power  
Glen Lyn, VA*

Dewberry & Davis, LLC  
Fairfax, Virginia

Under Contract Number: EP-09W001727  
**April 2011**

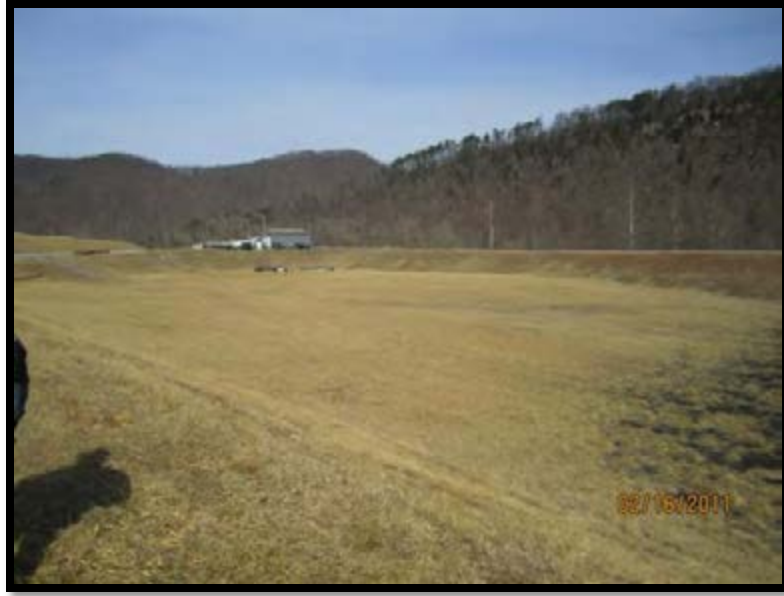
The upstream slope of the perimeter dike, including all groins, had adequate and well maintained cover of grasses/weeds. There were no obvious signs of scarps, bulging cracks, depressions or other indications of slope instability. Some woody vegetation was noted growing on the northwest upstream slope of the pond. Figures 5.2.2-1 and 5.2.2-2 show representative upstream slope sections of the perimeter dike.

**Figure 5.2.2-2:** Upstream slope, North.

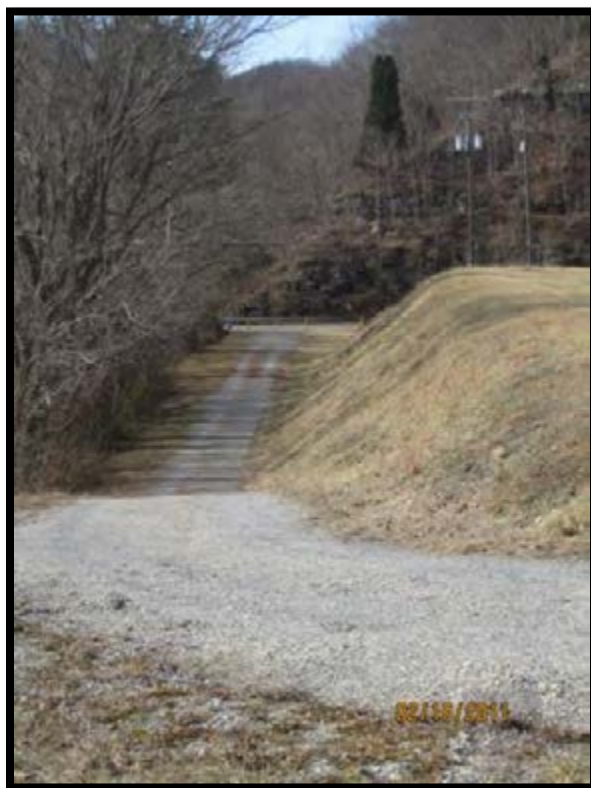
The downstream slope of the perimeter dike is vegetated with various species of maintained grasses and weeds. Significant woody vegetation and underbrush was noted growing at and beyond the toe of the north dike towards the New River. Based on what could be visually assessed, there were no scarps, sloughs, bulging, cracks, depressions or other indications of slope instability. Figures 5.2.3-1 thru 5.2.3-3 show representative downstream slope sections of the perimeter dike.

**Figure 5.2.3-2:** Downstream slope, Southwest.

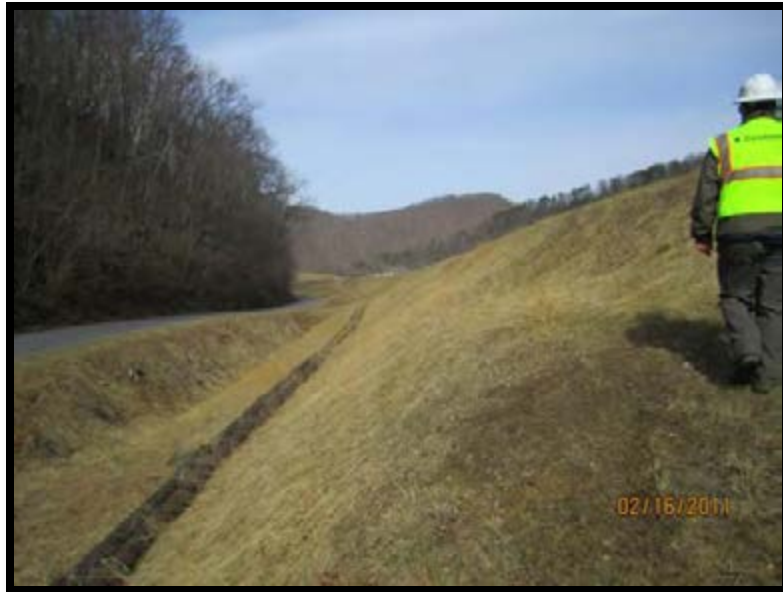
**Figure 5.2.3-3:** Downstream slope, Northwest.

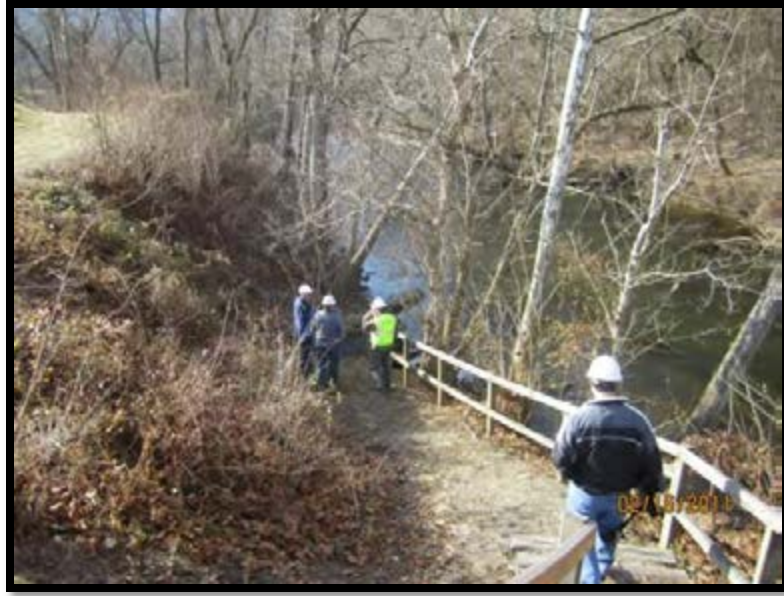
The downstream slope of the perimeter dike is vegetated with various species of maintained grasses and weeds. Significant woody vegetation and underbrush was noted growing on the slope of the dike adjacent to East River. Lower section of the dike adjacent to New River is protected with rip-rap armoring. Based on what could be visually assessed, there were no scarps, sloughs, bulging, cracks, depressions or other indications of slope instability. Figures 5.3.3-1 thru 5.3.3-2 show representative downstream slope sections of the perimeter dike.

**Figure 5.3.3-2:** Downstream slope, East. East River to the right. Note woody vegetation and trees growing on dike.
