**DRAFT REPORT
ROUND 10 DAM ASSESSMENT
AMERICAN ELECTRIC POWER
PICWAY GENERATING STATION
ASH POND**

November 21, 2011
File No. 01.0170142.30

Re: Round 10 Dam Assessment - Draft Report
EPA Contract No. EP10W001313
American Electric Power – Picway Generating Station
Ash Pond
Lockbourne, Ohio

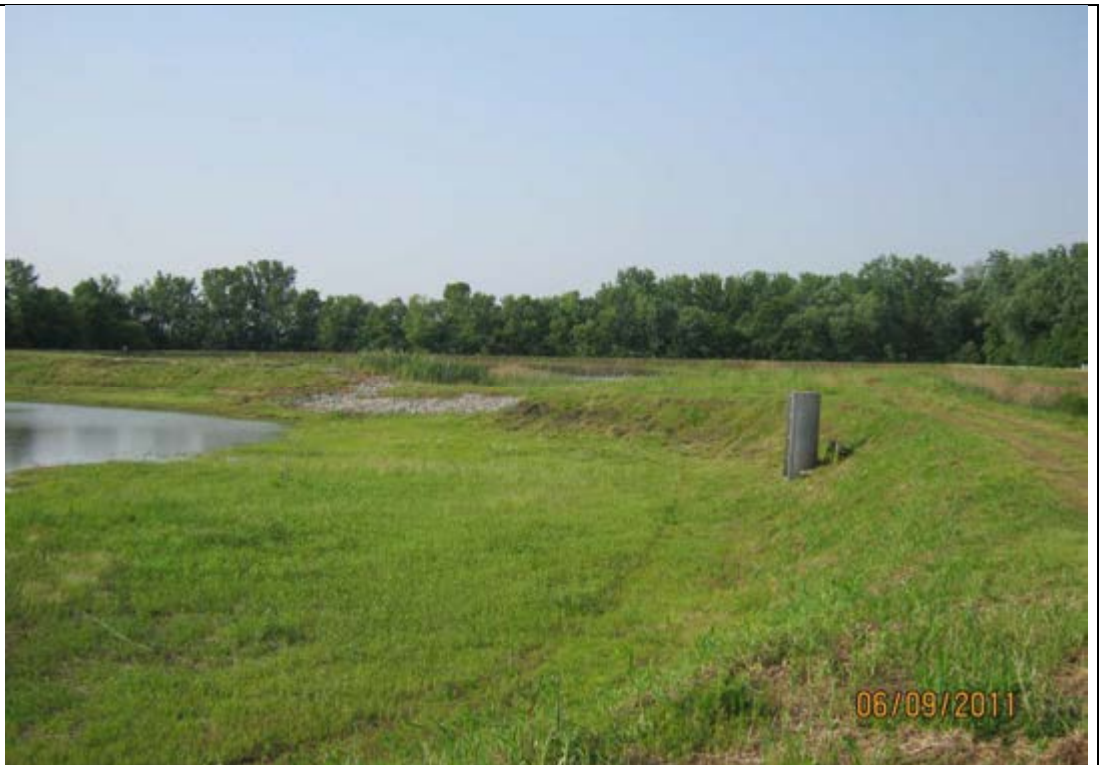
Outlet structure located in Cell S3 of south pond.

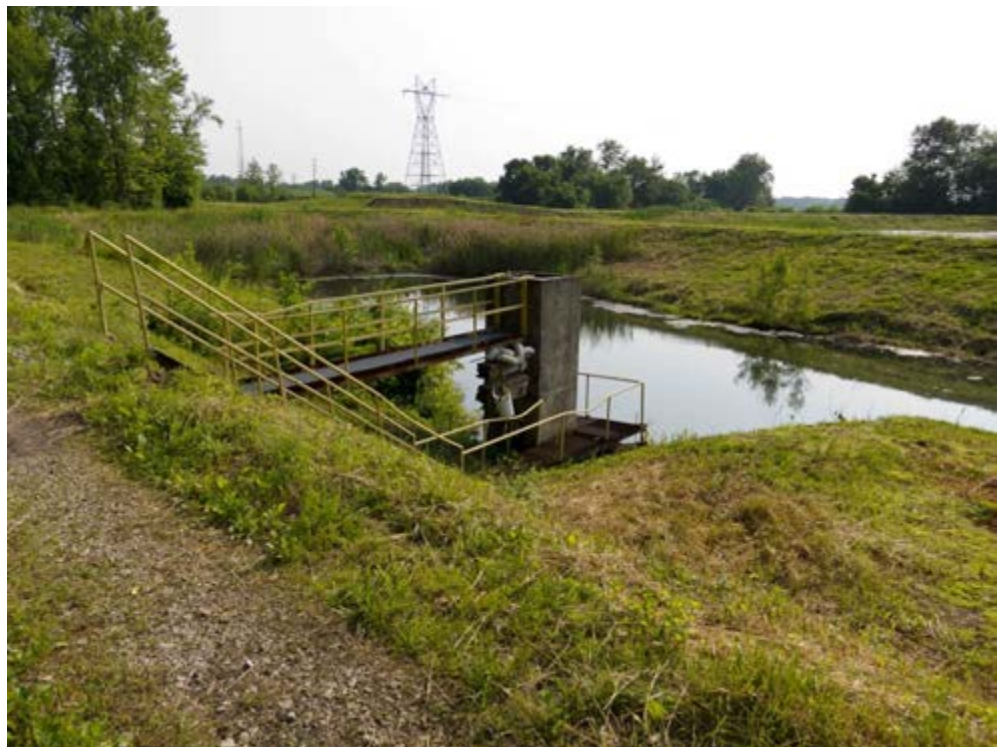
View of access ramp to concrete discharge structure in clearwater pond .

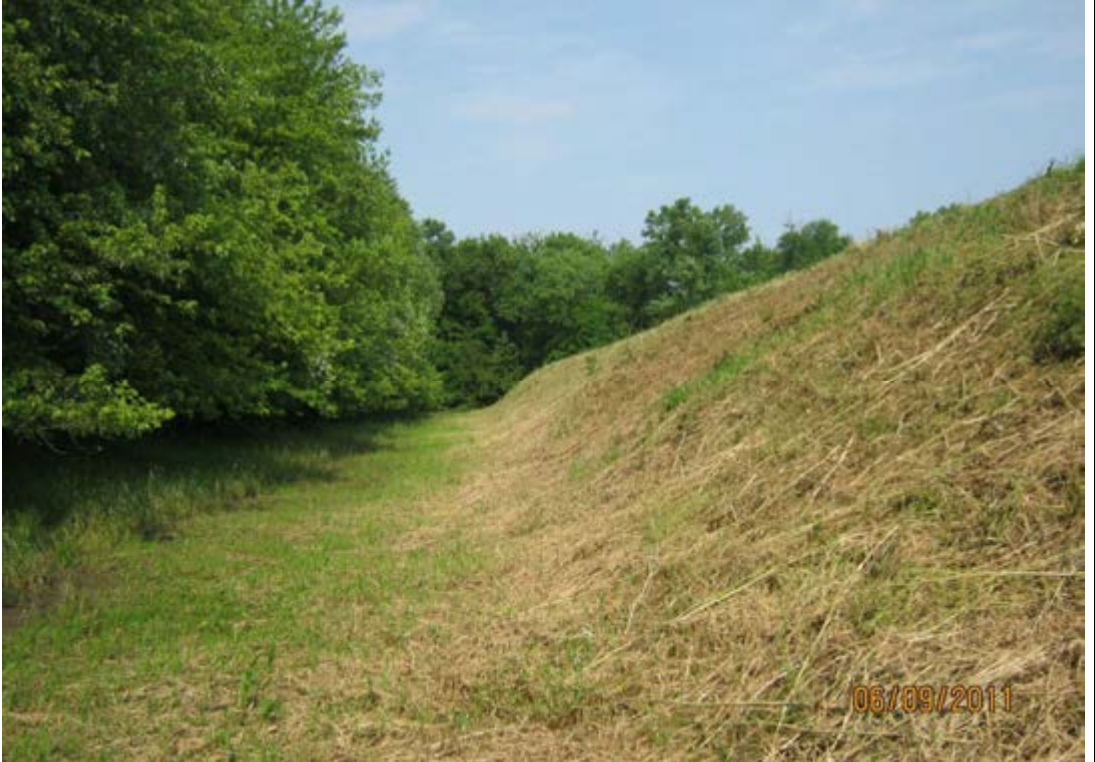
Client Name: U.S. Environmental Protection Agency		Site Location: American Electric Power (AEP) Picway Generating Station Lockbourne, Ohio	Project No. 01.0170142.30
Photo No. 19	Date: 06/09/11

Direction Photo Taken: West			
Description: View of outer south embankment of south pond. Photo taken near the southeast corner of the south pond.

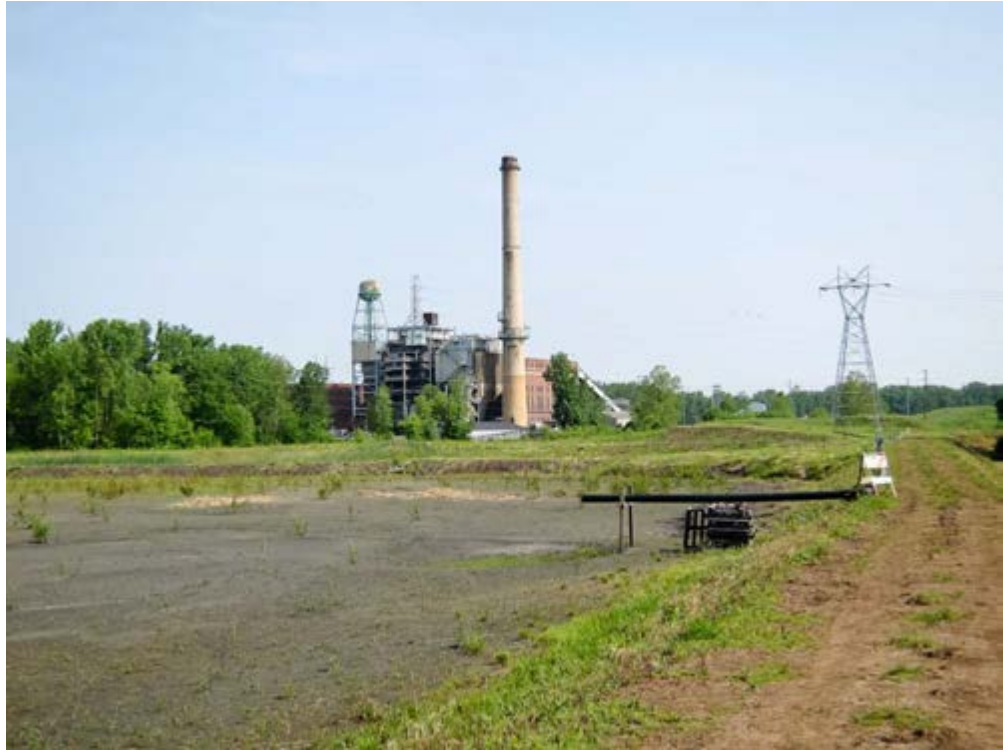
Photo No. 22

View of Cell S2 of the south pond and fly ash slurry pipeline. Picway Plant is shown in the background. Cell S2 was the active cell during the June 9, 2011 site visit.

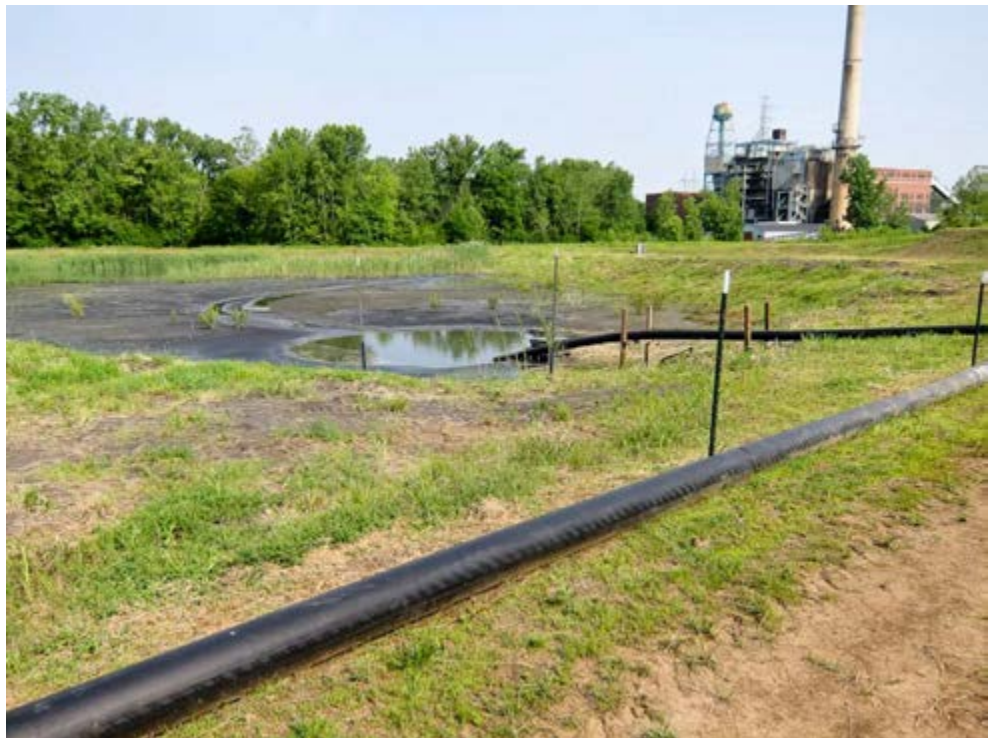
View of Cell S3 of the south pond. Picway Plant and outlet structure (circled) are shown in the background.

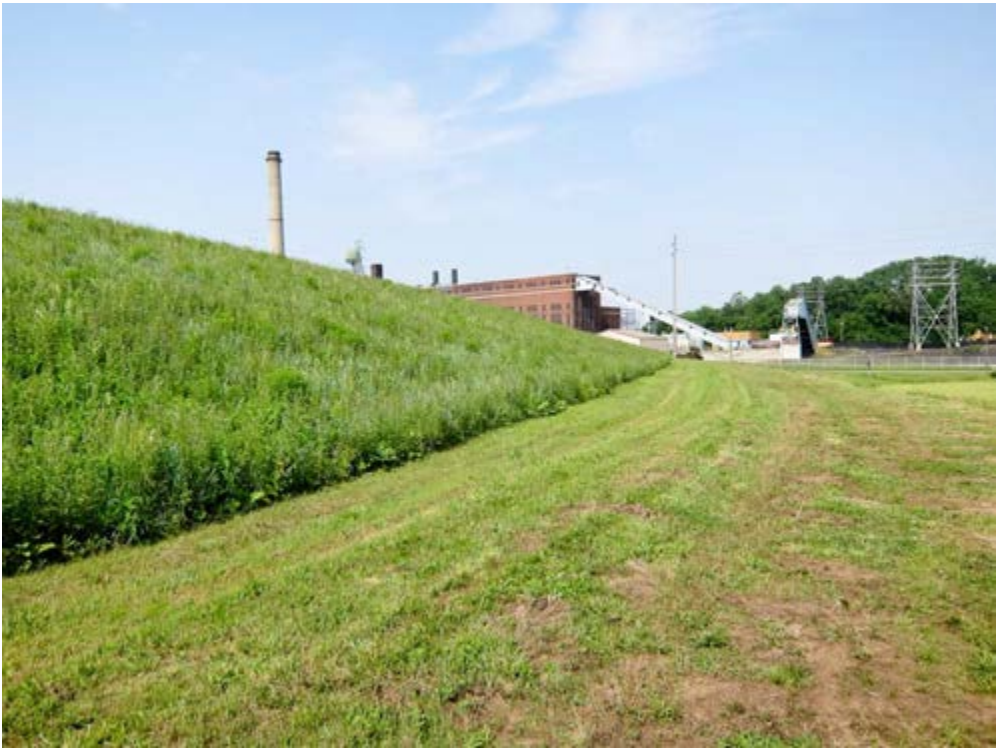
Client Name: U.S. Environmental Protection Agency		Site Location: American Electric Power (AEP) Picway Generating Station Lockbourne, Ohio	Project No. 01.0170142.30
Photo No. 29	Date: 06/09/11

Direction Photo Taken: West			
Description: View of crest of north embankment of the north pond. Note capped portion of north pond to left and Picway Plant in the background.
