Report of Dam Safety Assessment of Coal Combustion  
Surface Impoundments  
Interstate Power and Light Company  
M.L. Kapp Generating Station  
Clinton, IA

AMEC Project No. 3-2106-0183.0002

May 2011

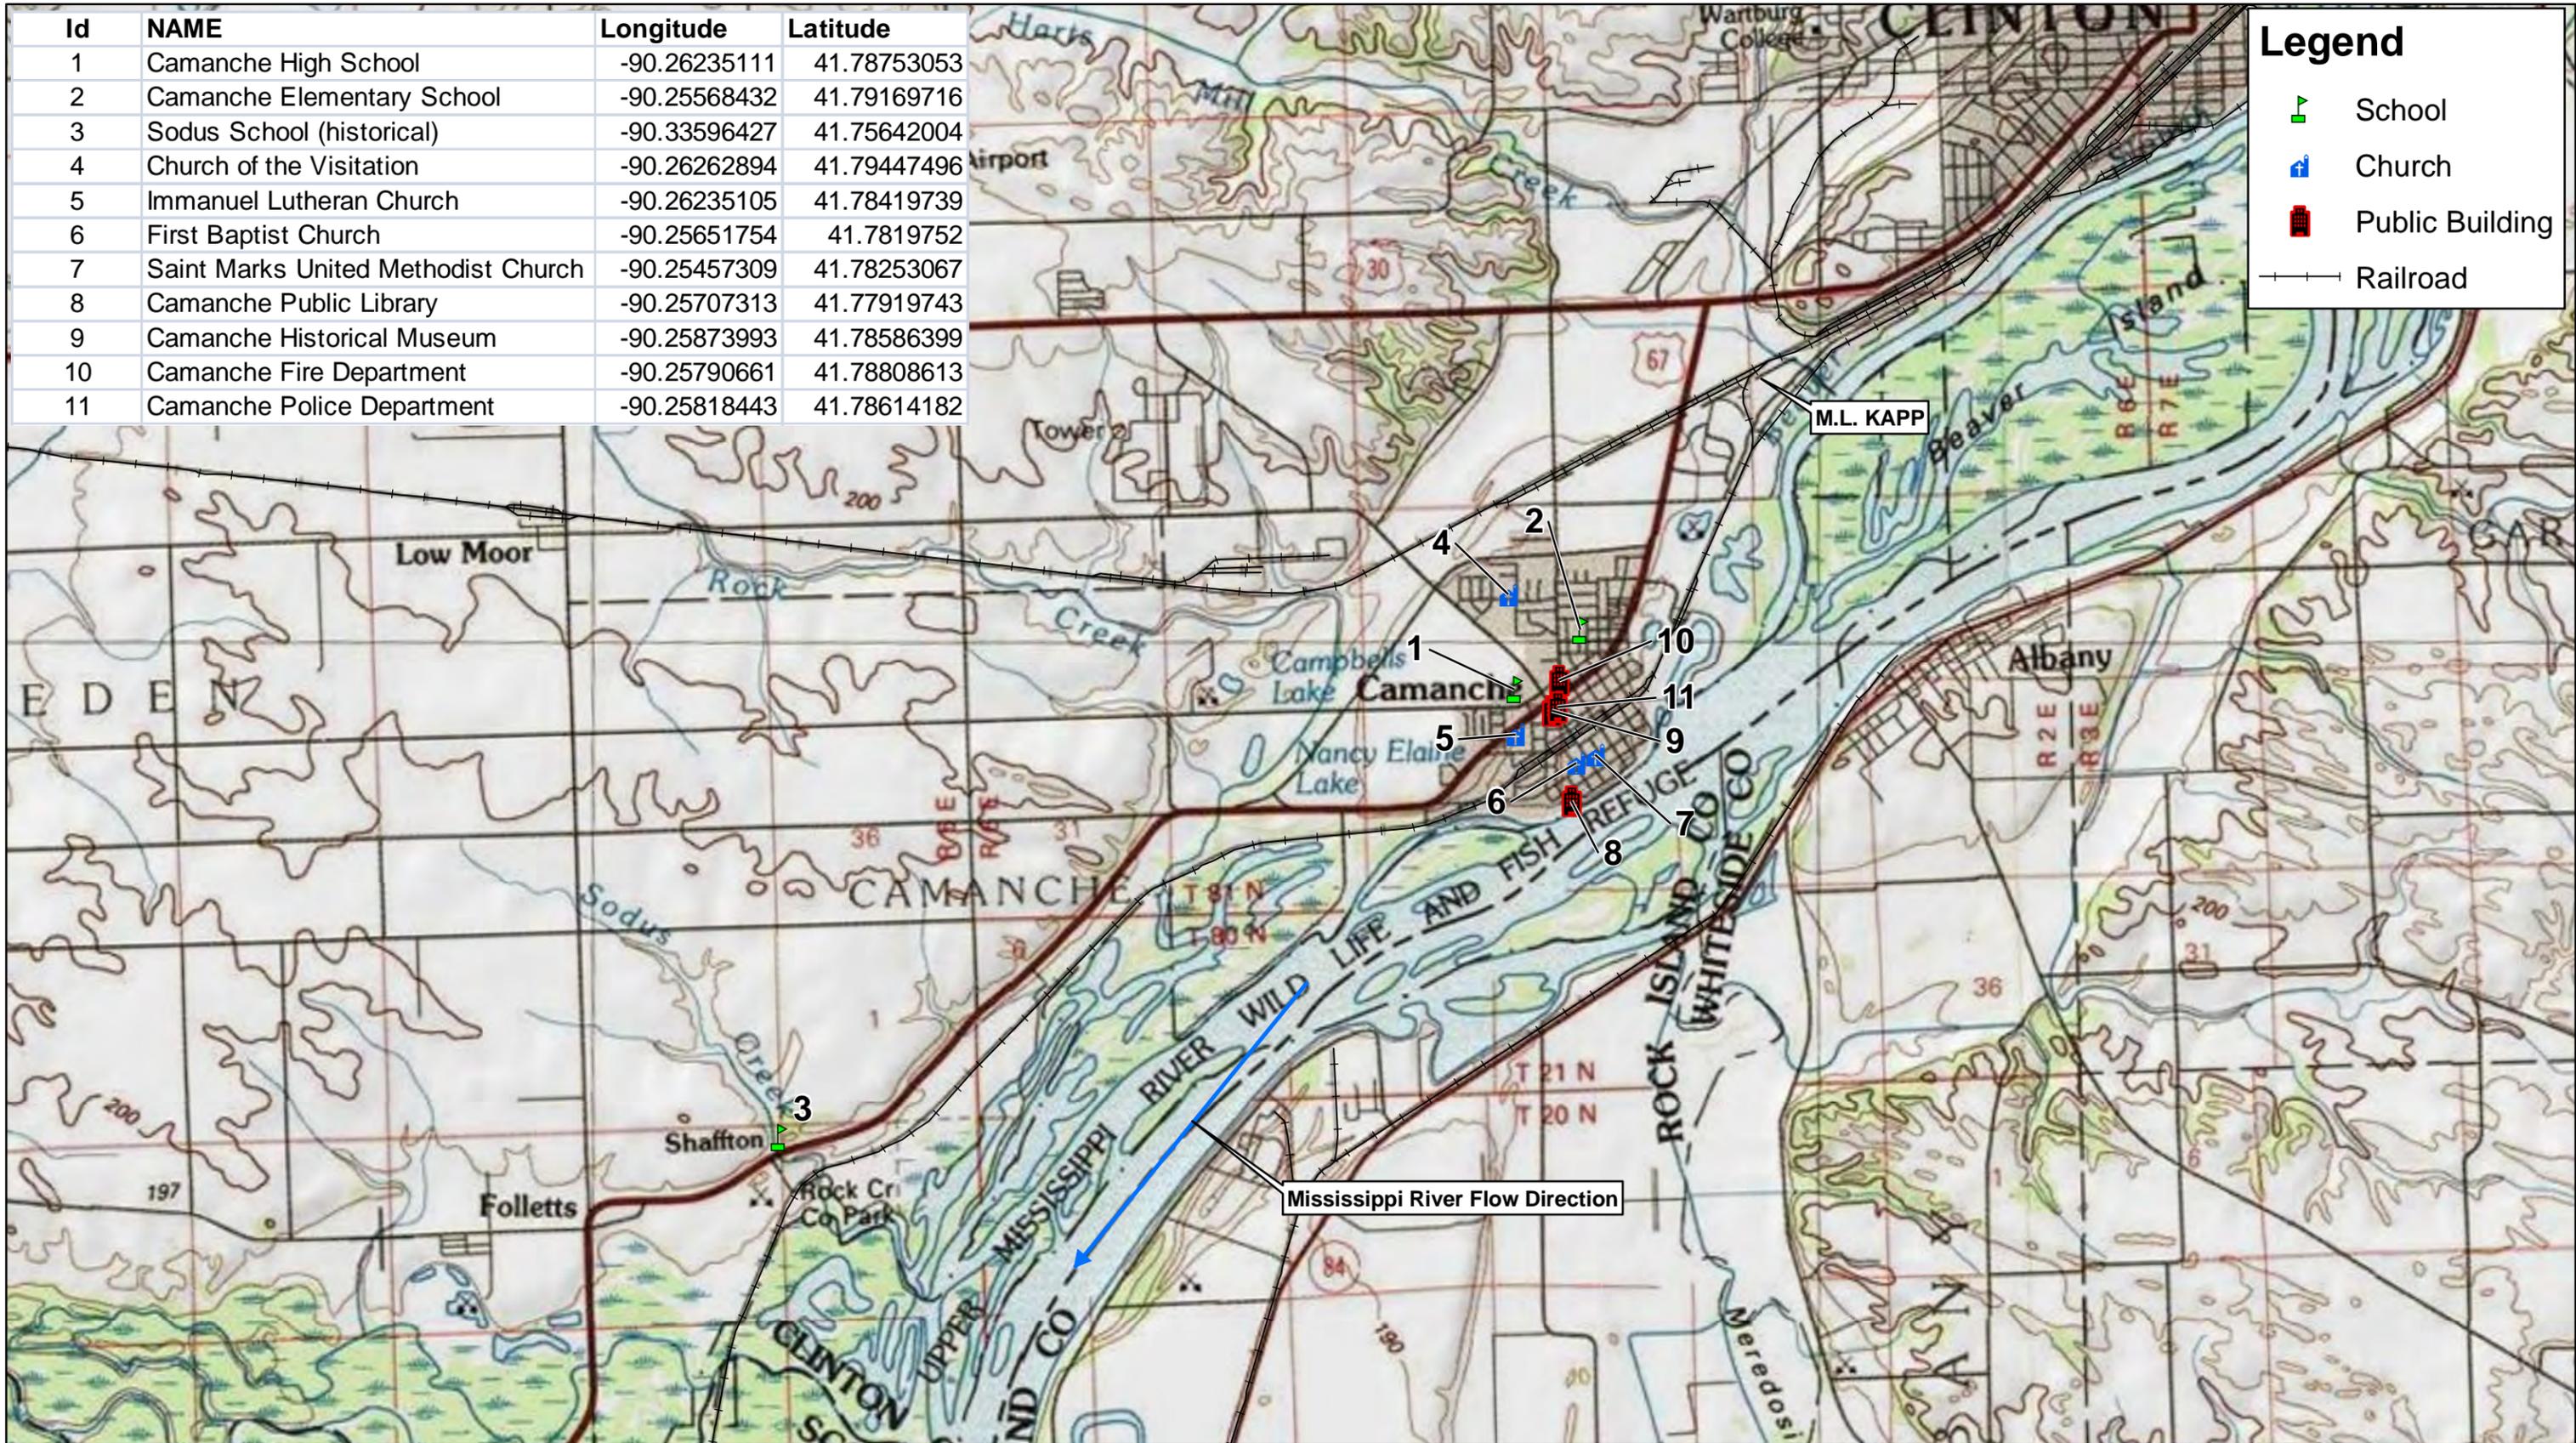
FIGURE  
3

Figure 3, the Critical Infrastructure Map, provides an aerial view of the region and indicates the location of the M.L. Kapp ash ponds in relation to schools, hospitals, and other critical infrastructure that is located within approximately 5 miles down gradient of the impoundments. A table that provides names and coordinate data for the infrastructure is included on the map. A Topographic Site Map is included as Figure 4.
