**COAL ASH IMPOUNDMENT
SITE ASSESSMENT DRAFT REPORT**

**Duck Creek Power Station
Ameren Energy Generating Company
Canton, Illinois**

KLEINFELDER PROJECT NUMBER 112618-5

September 16, 2010

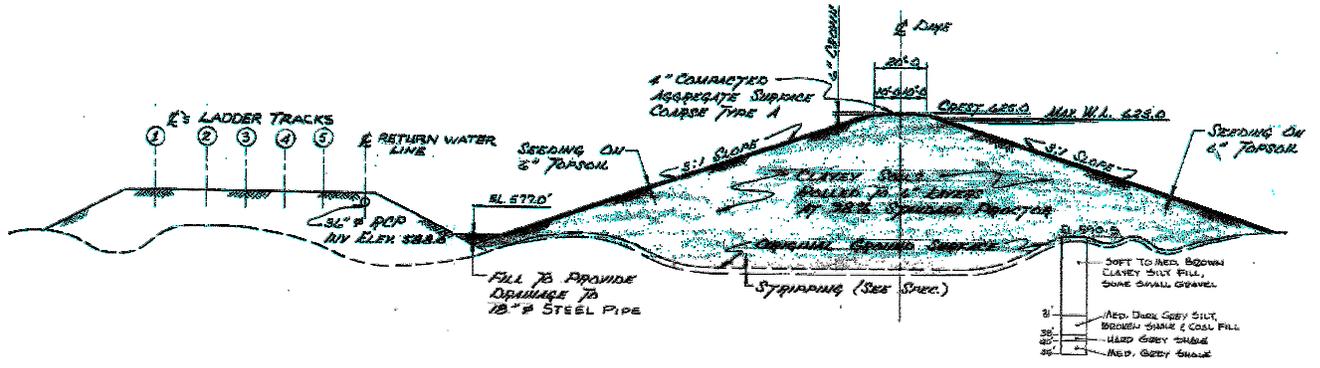
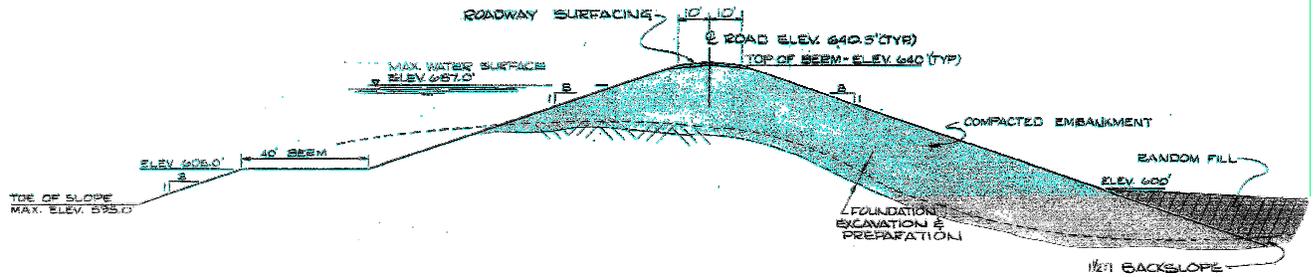
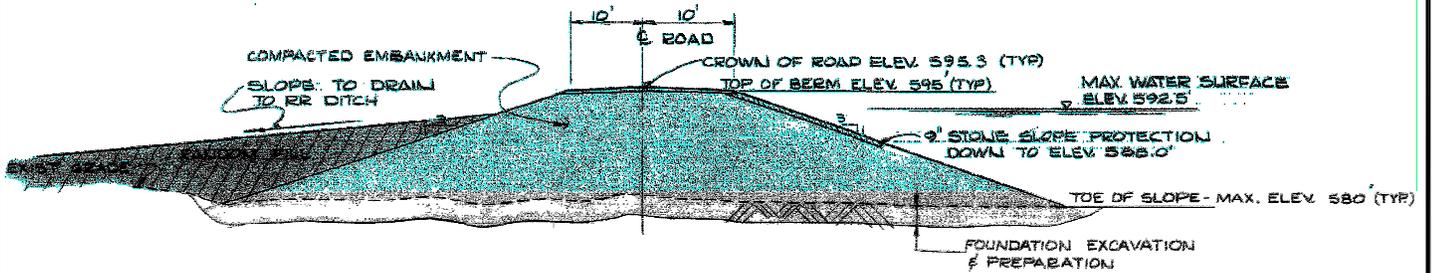
**TYPICAL CROSS SECTION
FLY ASH & RECYCLE PONDS**

TYPICAL EMBANKMENT SECTION - FLY ASH POND 1
NTS

TYPICAL EMBANKMENT SECTION - FLY ASH POND 2

TYPICAL EMBANKMENT SECTION - RECYCLE POND
NTS
