**Coal Combustion Waste Impoundment**

**Round 7 - Dam Assessment Report**

***Rush Island Power Station (Site #003)***

***AmerenUE***  
**Festus, Missouri**

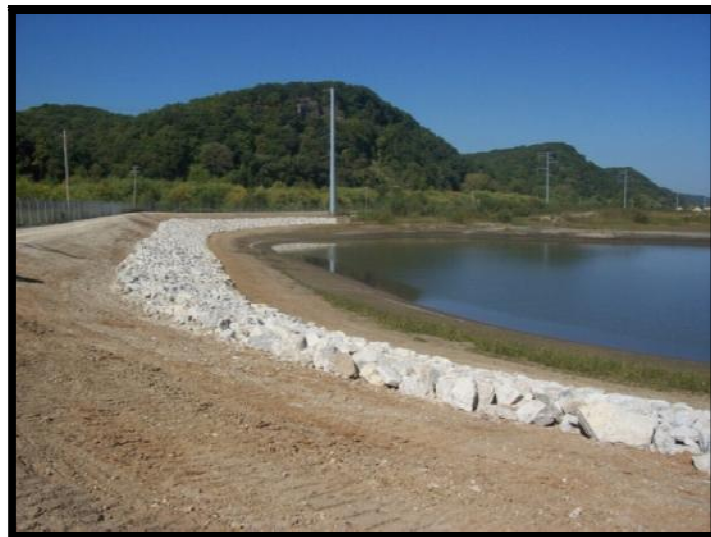
**Figure 5.2.2-2:** Riprap armored interior slope of ash pond.

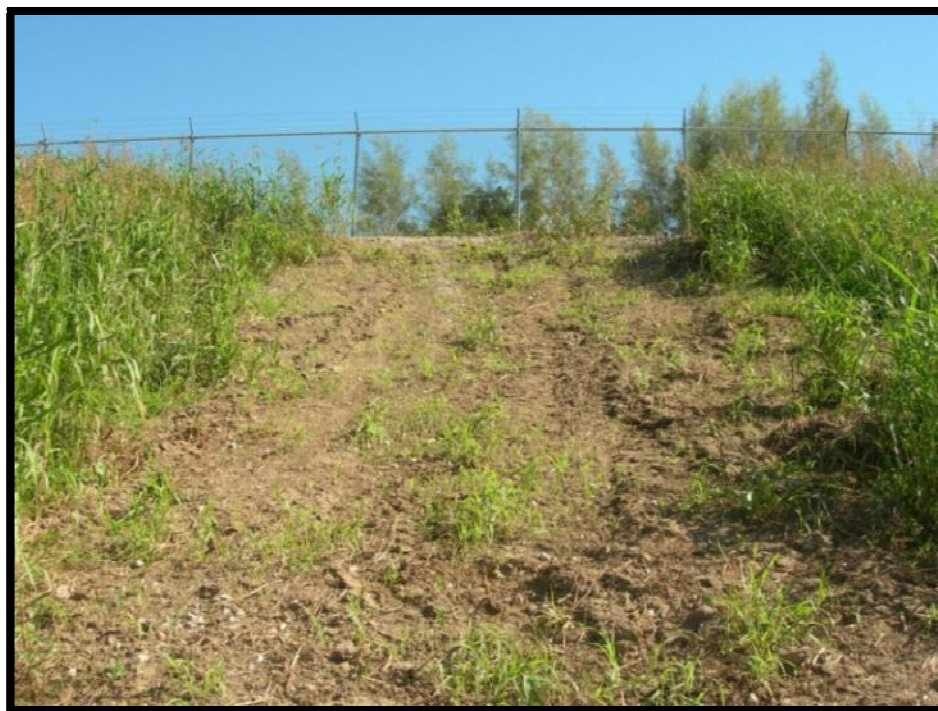
**Figure 13:** Ash pond exterior embankment erosion.
