**DAM SAFETY INSPECTION
REPORT**

**GORGAS STEAM PLANT
WALKER COUNTY,
ALABAMA**

**PROJECT No. 09-4157
JULY 2009**

**DAM SAFETY INSPECTION REPORT
WILLIAM CRAWFORD GORGAS ELECTRIC
GENERATING PLANT
WALKER COUNTY, ALABAMA
PROJECT NO. 09-4157**

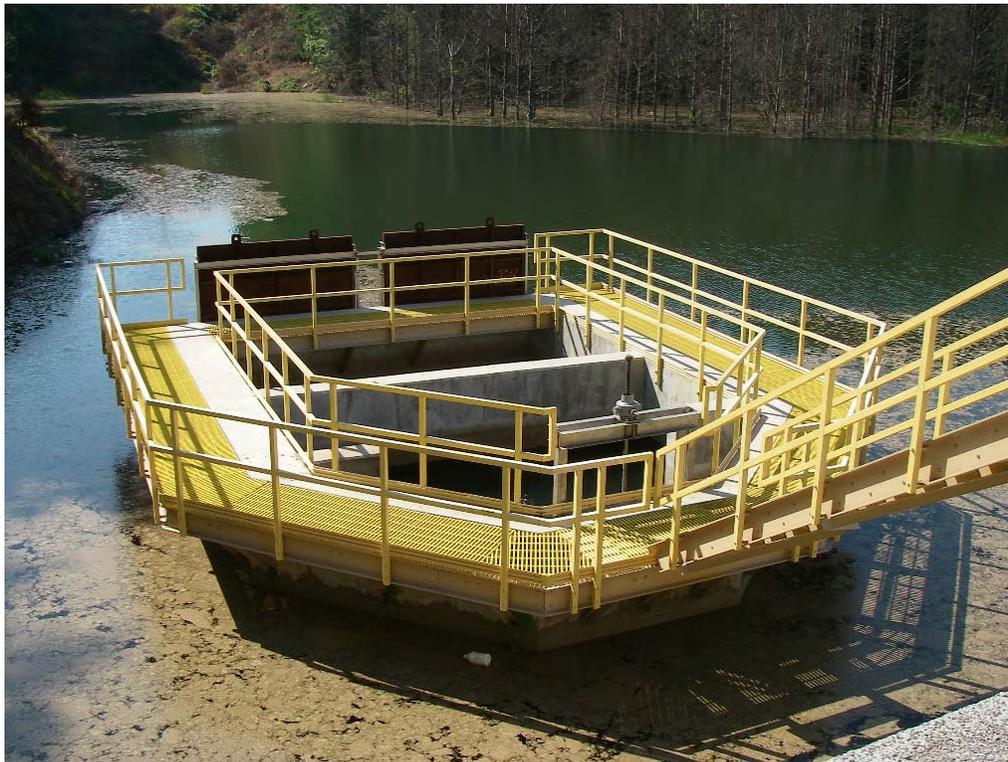
The weir intake structure is a new reinforced concrete structure in excellent condition. This structure outlets into a 48-inch diameter corrugated metal pipe that carries decant water down the hill to the NPDES permitted release point. The release point is under water, therefore observation of the water at the point of discharge was not visible. Water at the point of entry was clear water. (See Photo 2).

PHOTO 1: RATTLESNAKE DAM WEIR FLOW INTAKE STRUCTURE

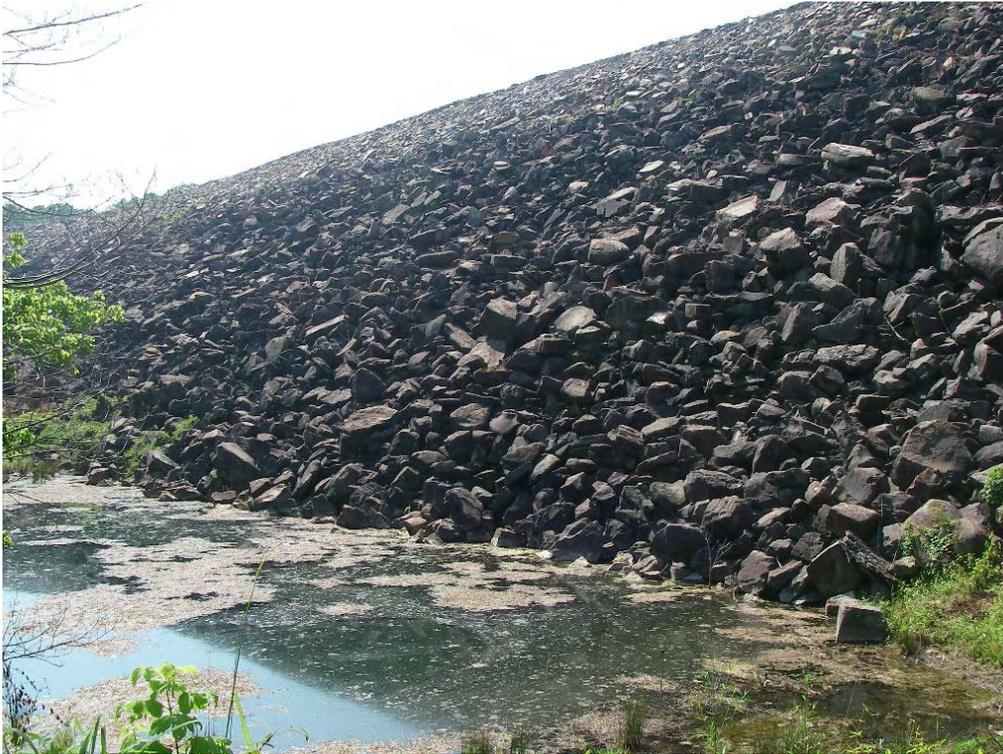
PHOTO 17: RATTLESNAKE DAM DOWNSTREAM SLOPE AND POOL AT TOE

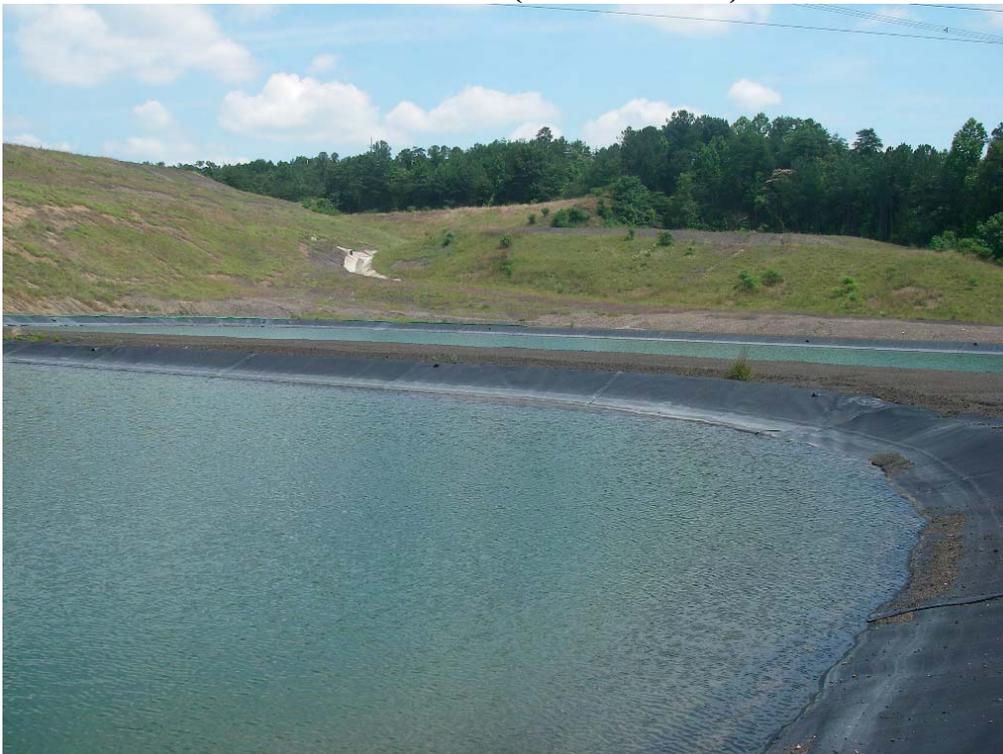
The ponds were found to have smooth, even, well graded slopes with spotty vegetation on the exterior slopes. The lack of grass cover is attributed to the recent regional drought since the slopes were seeded after construction. This has resulted in areas of surface erosion on the slopes as shown in Photos 34, 35, and 36. According to Alabama Power personnel, repairs to the slope erosion and vegetation is scheduled for the near future. The erosion is not an immediate threat to the embankments, but should be addressed before it becomes a problem. The planned slope and vegetation repairs should help solve the threat.

PHOTO 34: SEDIMENT POND, BACKGROUND, AND CLEAR POOL, FOREGROUND (LOOKING NE)

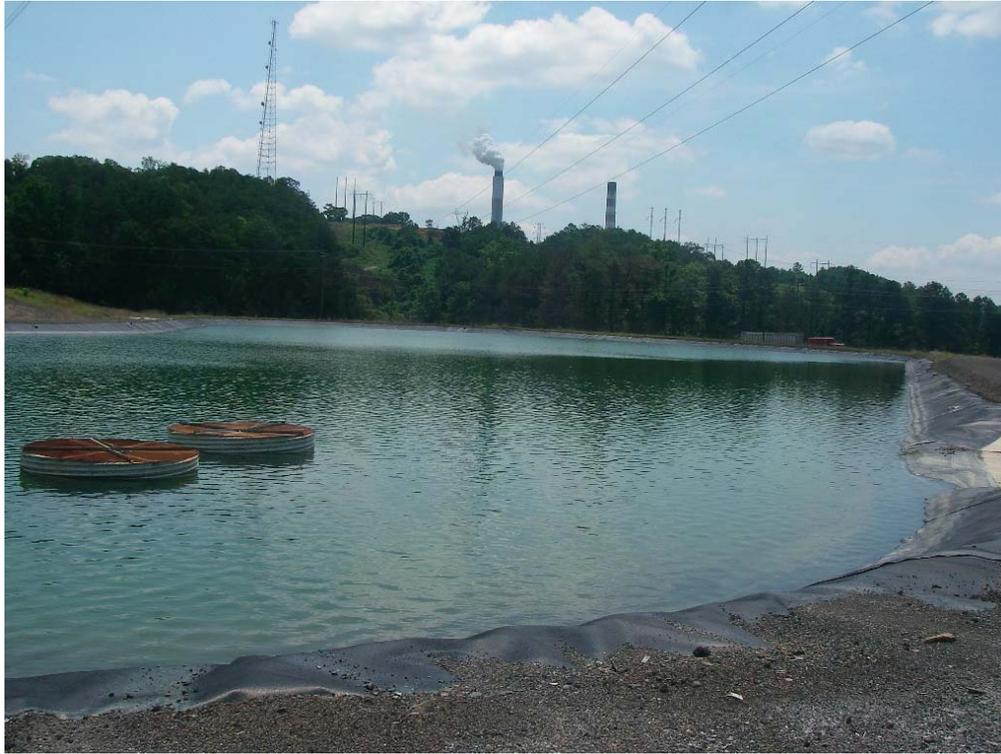
PHOTO 35: DECANT PIPES IN SEDIMENT BASIN

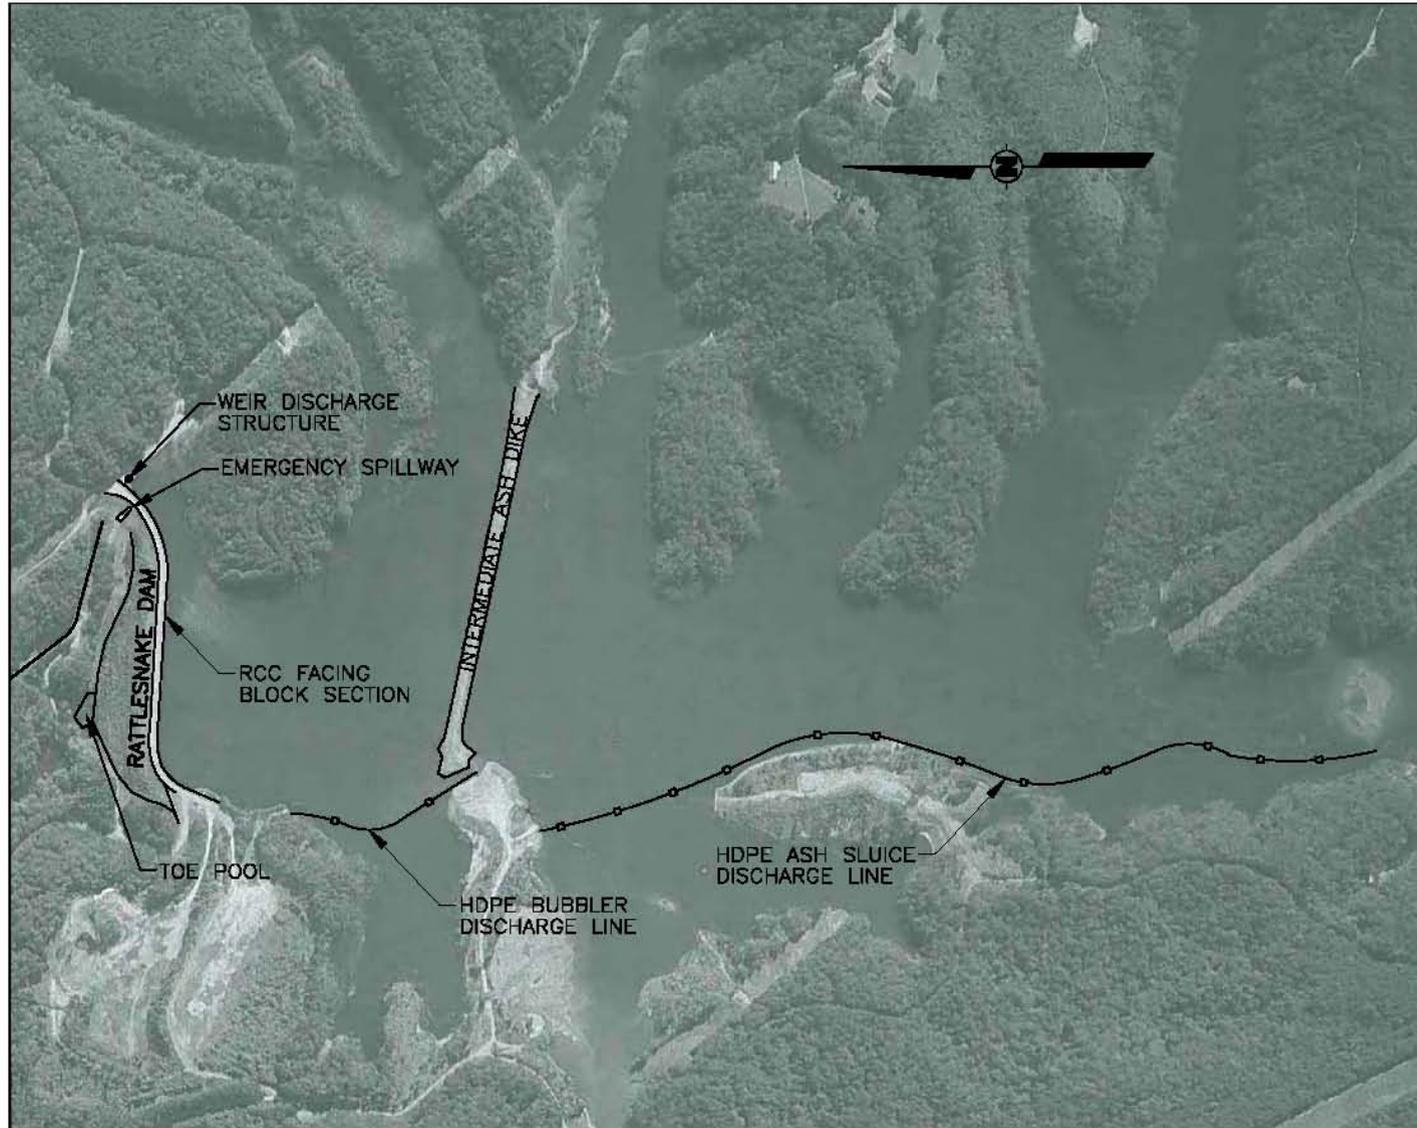
FIGURE 3
 RATTLESNAKE DAM
 AND FEATURES
 GORGAS PLANT
 DAM SAFETY INSPECTION
 PREPARED FOR
 USEPA
 WASHINGTON, D.C.

- ① APPROXIMATE LOCATION OF SEEPAGE FROM TOE.
- ② CRACKING IN RCC FACING BLOCK NOTED HERE.
