DRAFT FINAL
Coal Ash Impoundment
Specific Site Assessment
Report
Arizona Public Service
Cholla Power Plant

Submitted by:
GEI Consultants, Inc.
6950 South Potomac Street, Suite 300
Centennial, CO 80112

October 2009
Project 091330

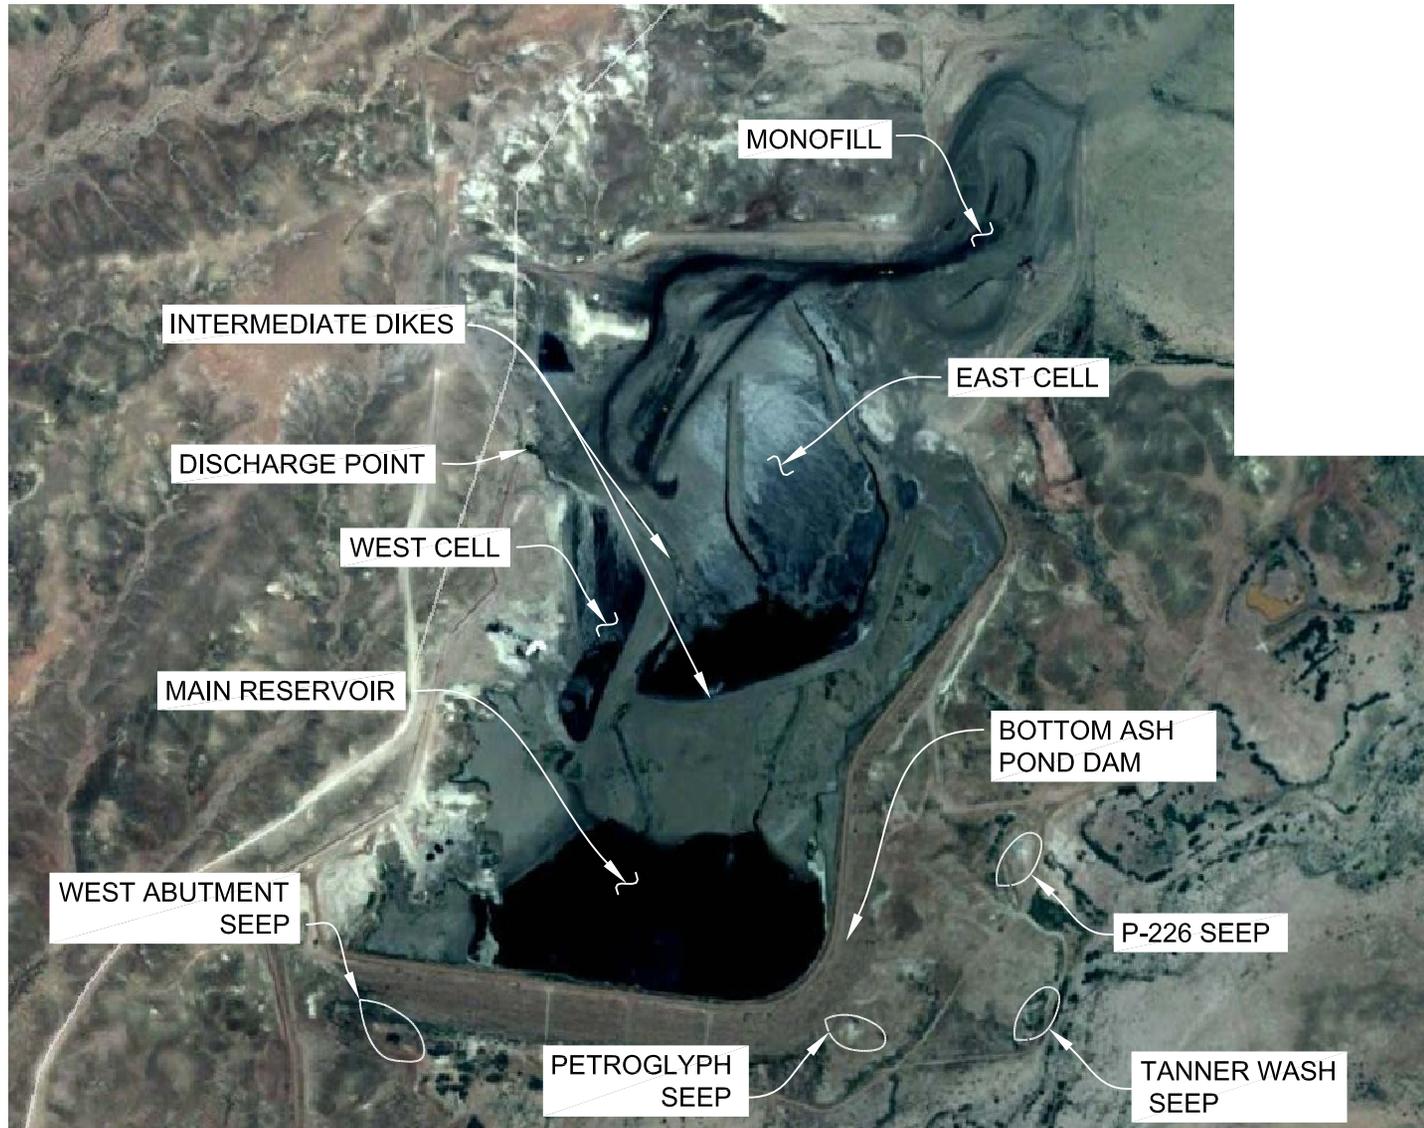
Project 091330 October 2009 Figure 4

constructed to collect surface water and groundwater and return it to the ponds. An aerial photograph of the Bottom Ash Pond is shown in Figure 4. Drawings including a plan, profile and sections of the Bottom Ash Pond Dam are attached in Exhibit 4. A plan for the siphon system for the Bottom Ash Pond is attached in Exhibit 5. A profile of the Bottom Ash Pond Dam is attached in Exhibit 6.

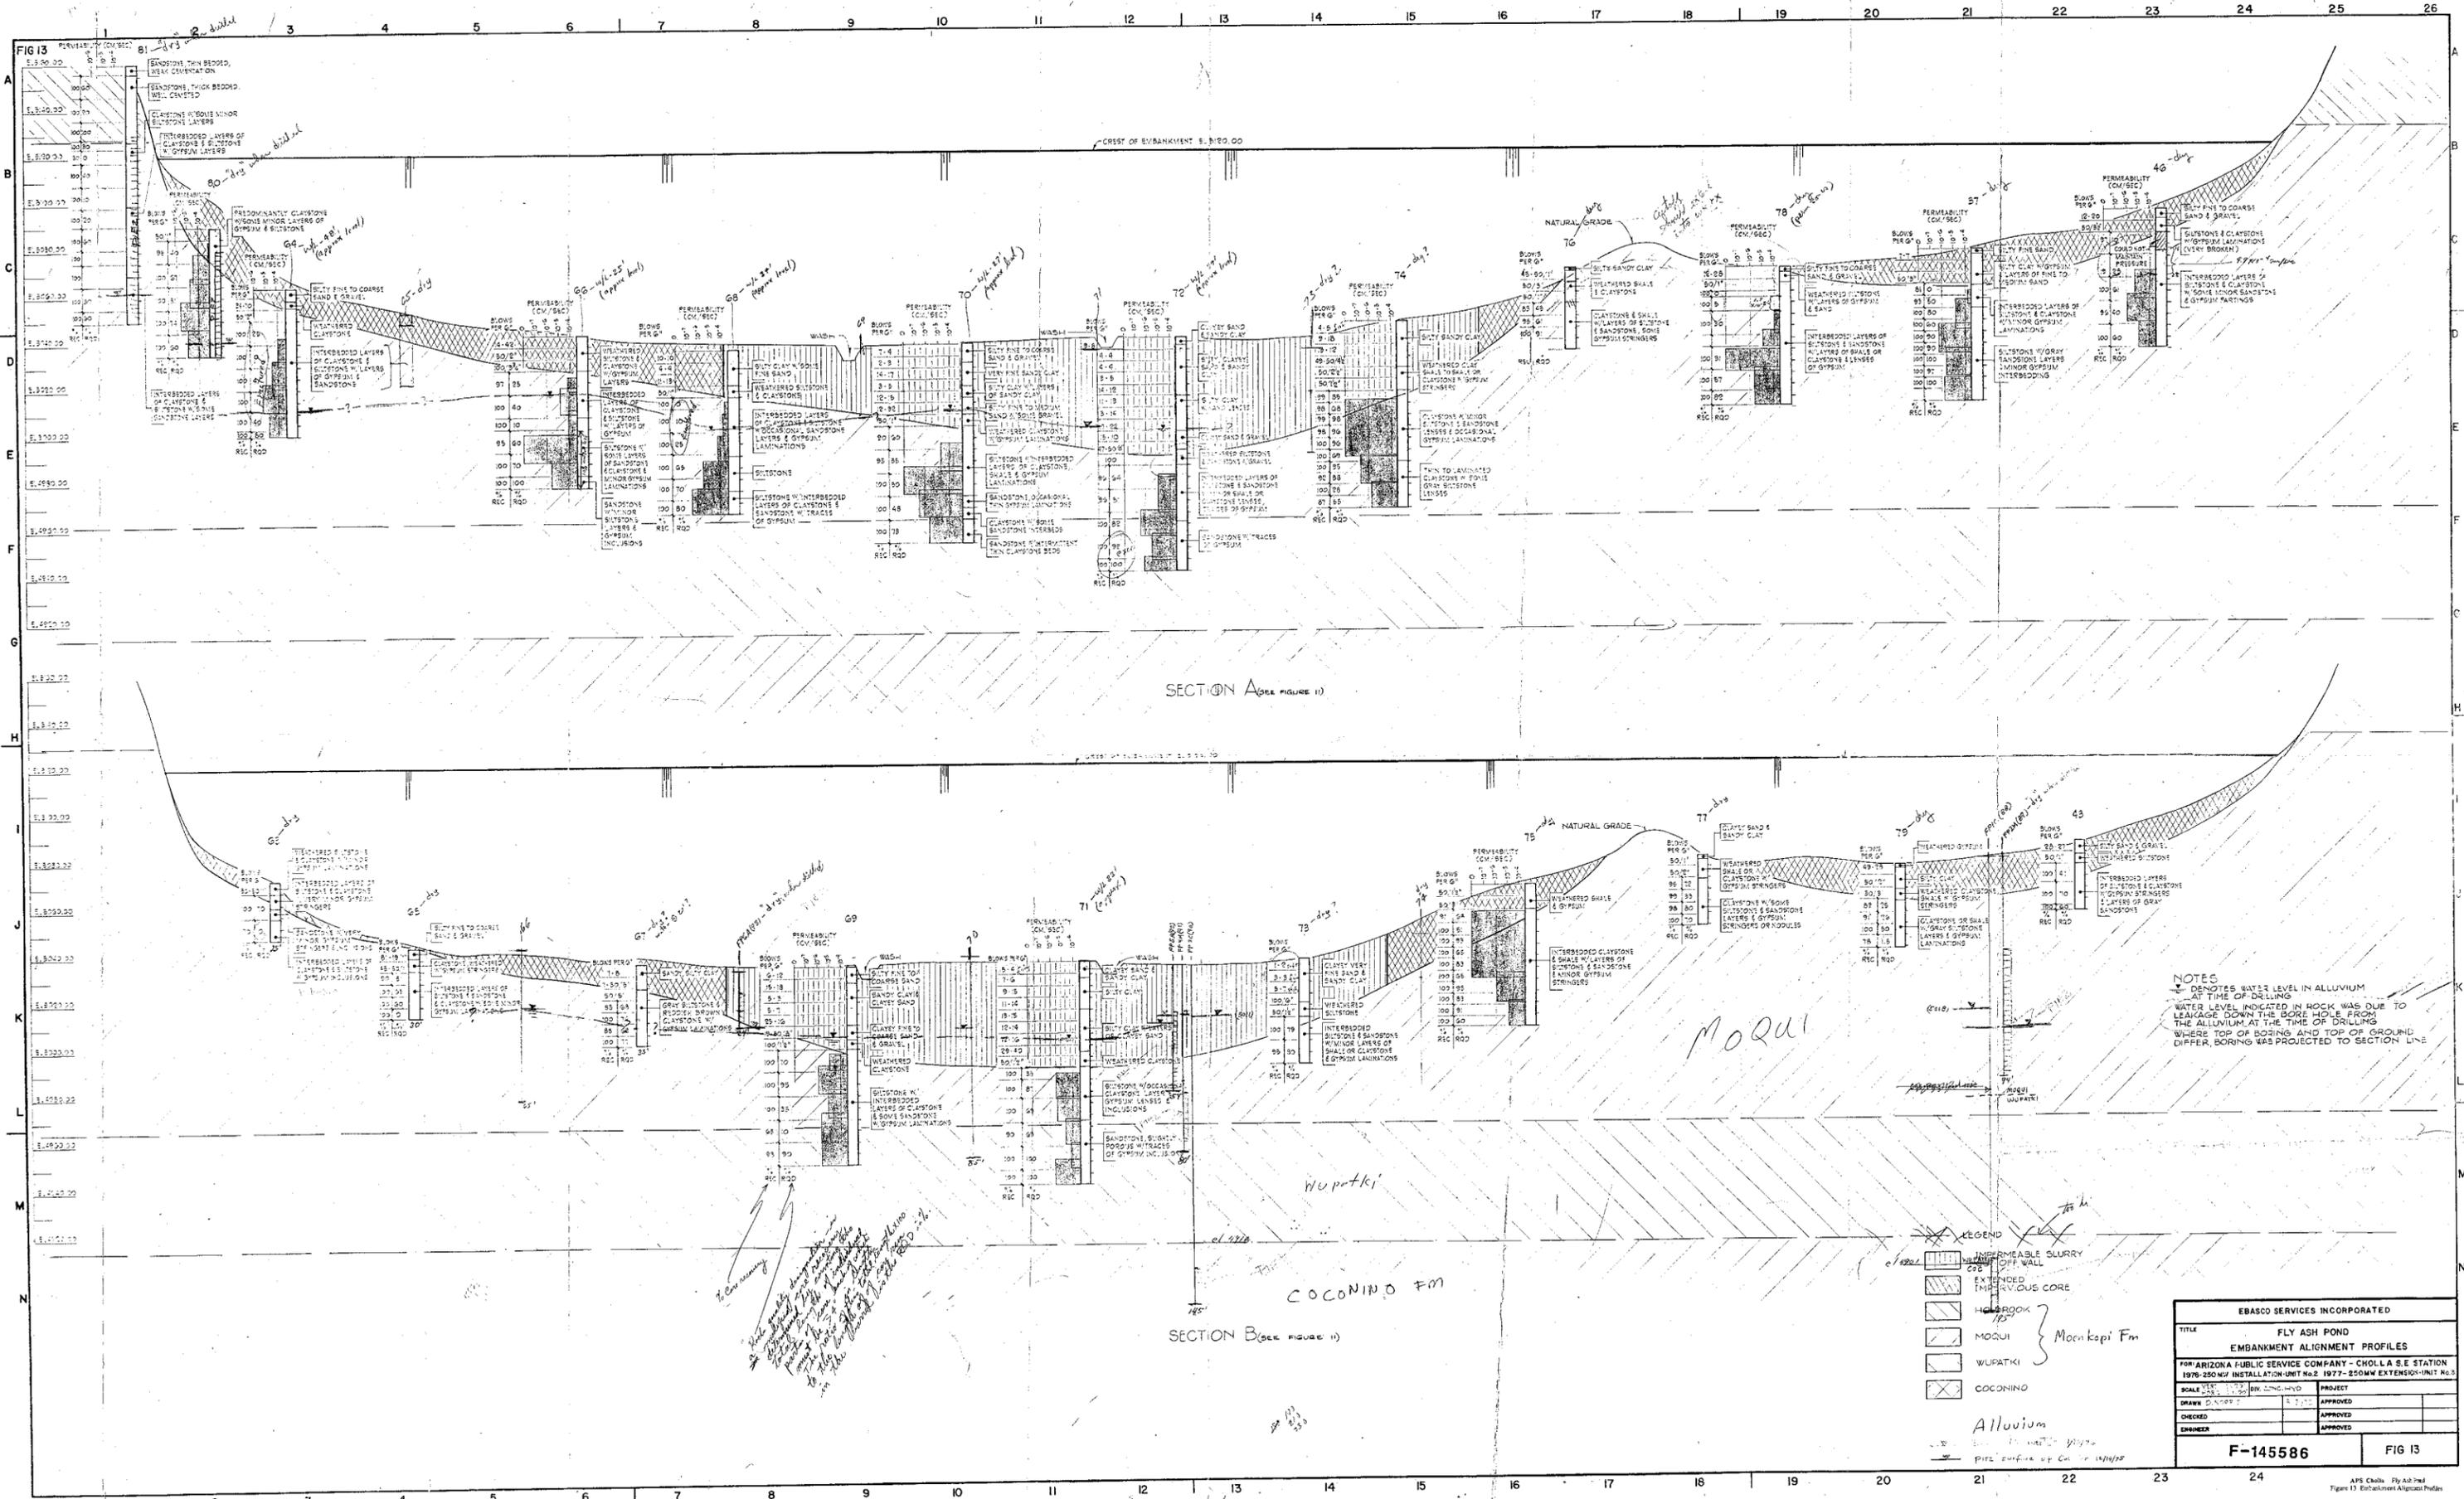
Exhibit 3

The dam is constructed of earth fill and has a zoned cross section with a central clay core. The clay core extends to bedrock where bedrock is relatively shallow. In the central portion of the dam, where bedrock is relatively deep (greater than about 20 feet below the original ground surface), a slurry cutoff wall extends 1 foot into bedrock or 2 feet into stiff clay. In addition, there is a clay blanket extending about 250 feet from the right (west) abutment. The Fly Ash Pond Dam has no internal drain system. Where seepage has been observed, valley drains have been constructed to collect surface water and groundwater and return it to the ponds. An aerial photograph of the Fly Ash Pond is shown in Figure 3. Drawings including a plan, profile and sections of the Fly Ash Pond Dam are attached in Exhibits 1 and 2. A profile of the Fly Ash Pond Dam is attached in Exhibit 3.

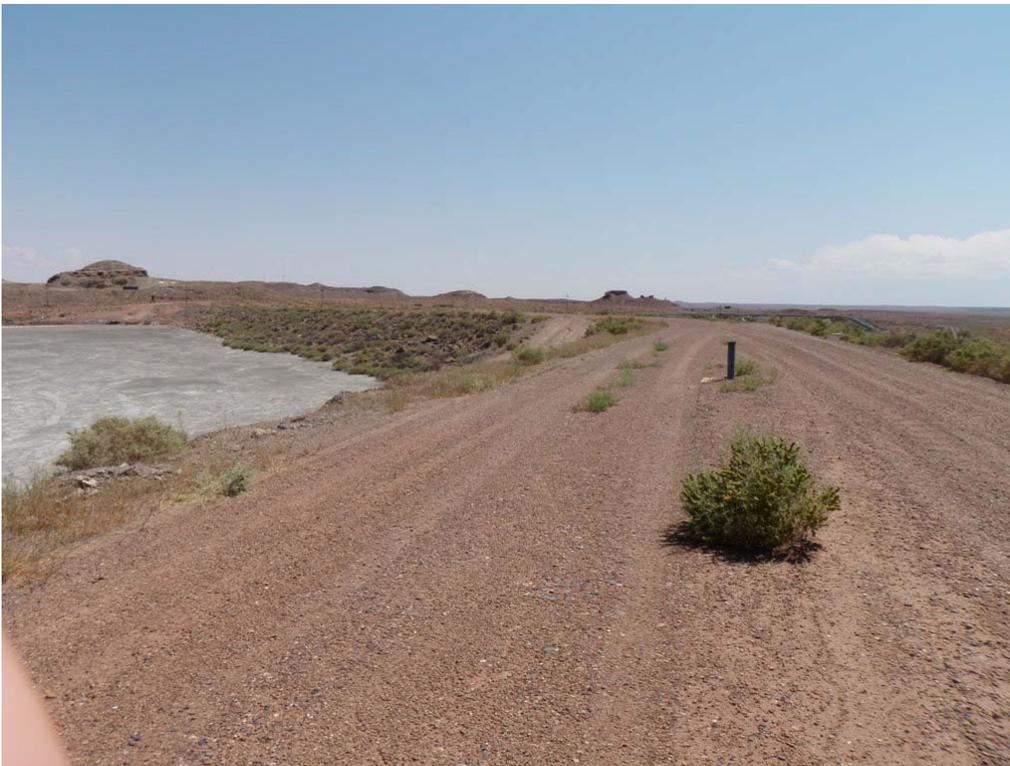
Photo 4 –Crest of Fly Ash Pond Dam with piezometer, looking east at bend in embankment.

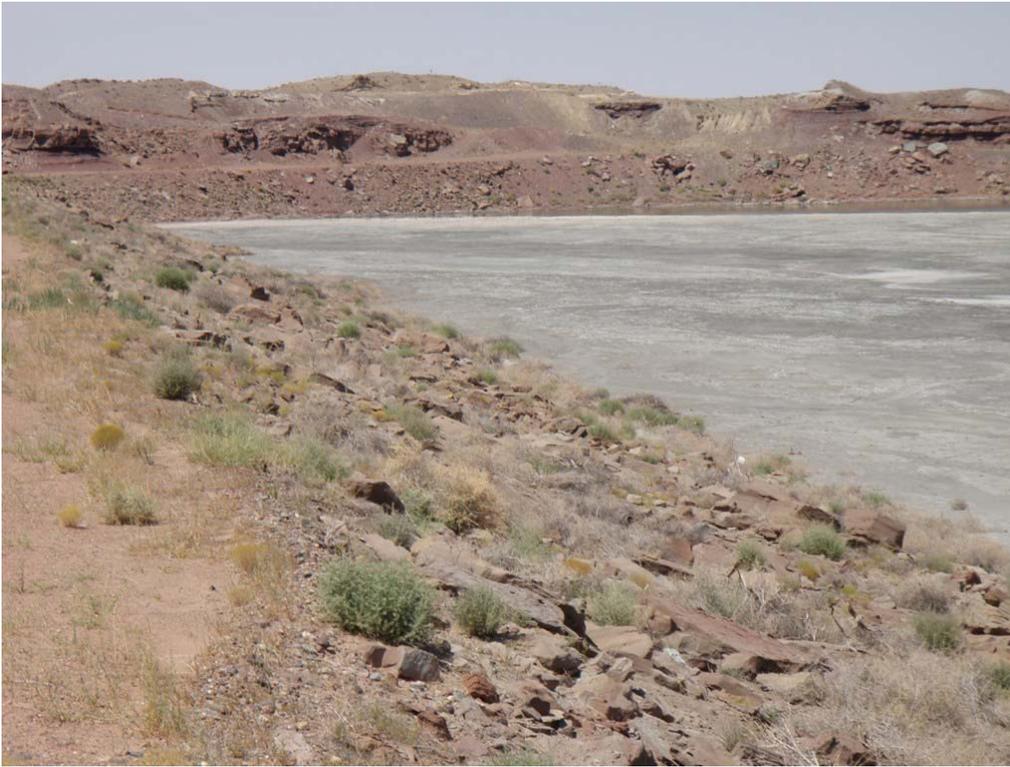
Photo 5 – Fly Ash Pond Dam: Upstream slope, looking west. Note vegetation.

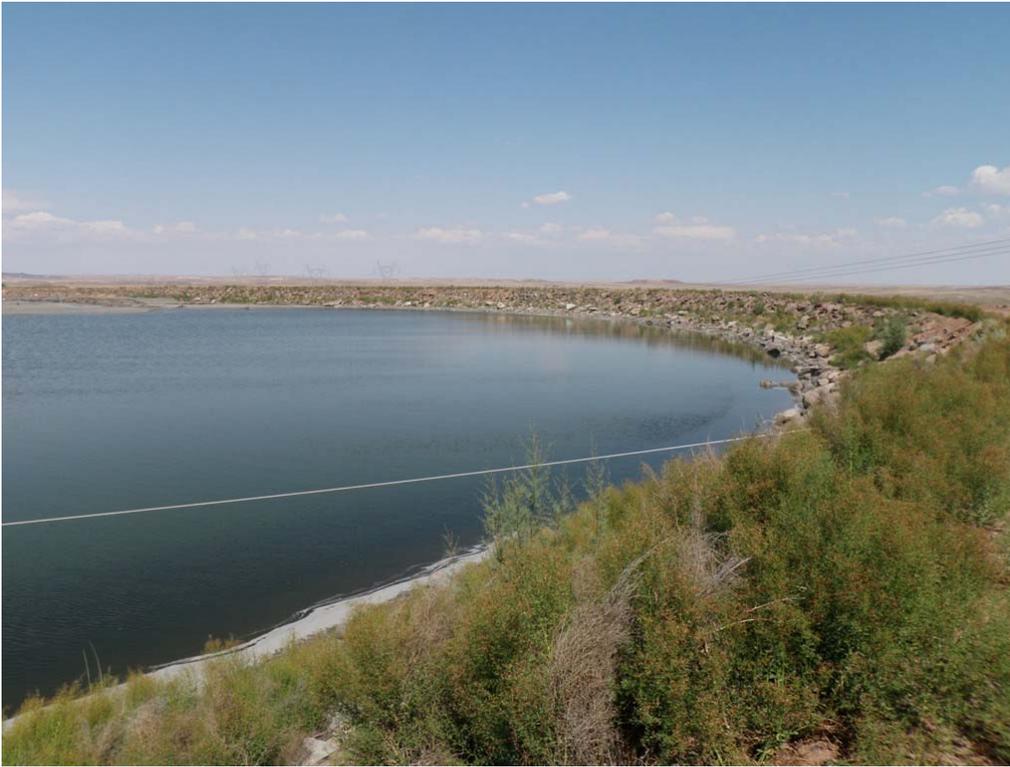
The upstream slope of the embankment is protected from erosion by riprap and appeared to be in good condition (Photo 17). Some vegetation is present on the upstream slope.

Photo 17 – Bottom Ash Pond Dam: Upstream slope, looking east. Note vegetation.

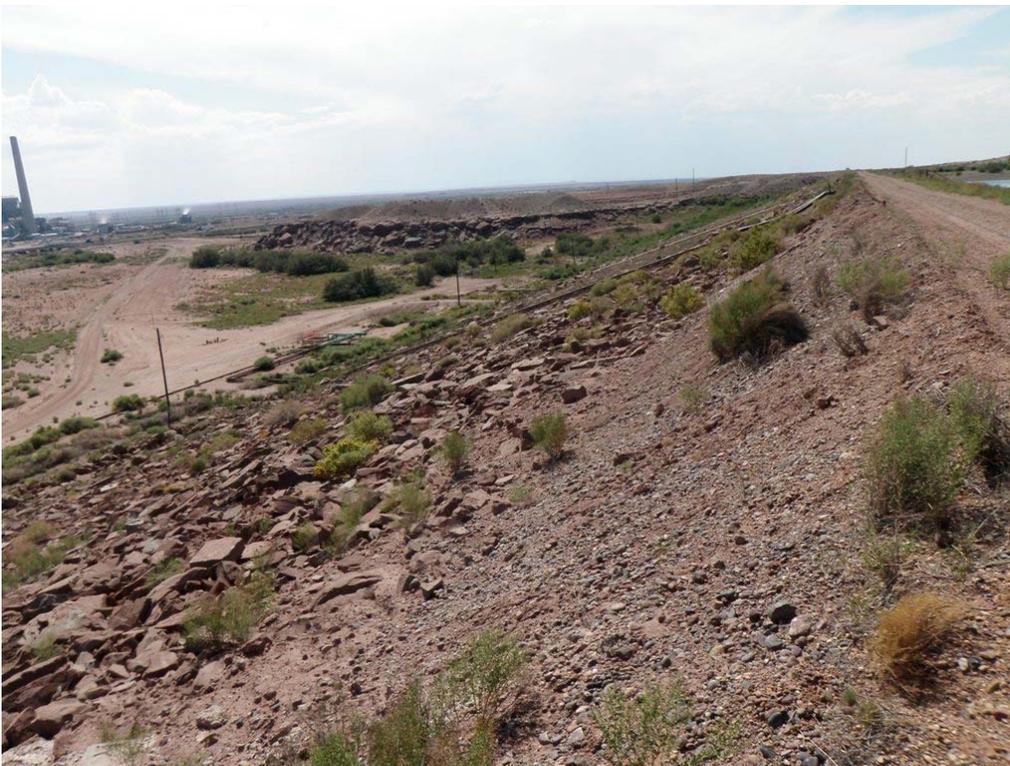
The downstream slope of the embankment is protected from erosion by riprap and appeared to be in good condition, though the riprap is eroding in some areas (Photo 18). Some vegetation (brush) is present on the downstream slope.

Photo 18 – Bottom Ash Pond: Downstream slope looking west. Note vegetation and riprap erosion

There was no significant erosion of the dams or abutments noted during the assessment. Some minor erosion of riprap was observed (e.g. Photo 7 of Fly Ash Pond downstream slope). Eroded riprap should be replaced.

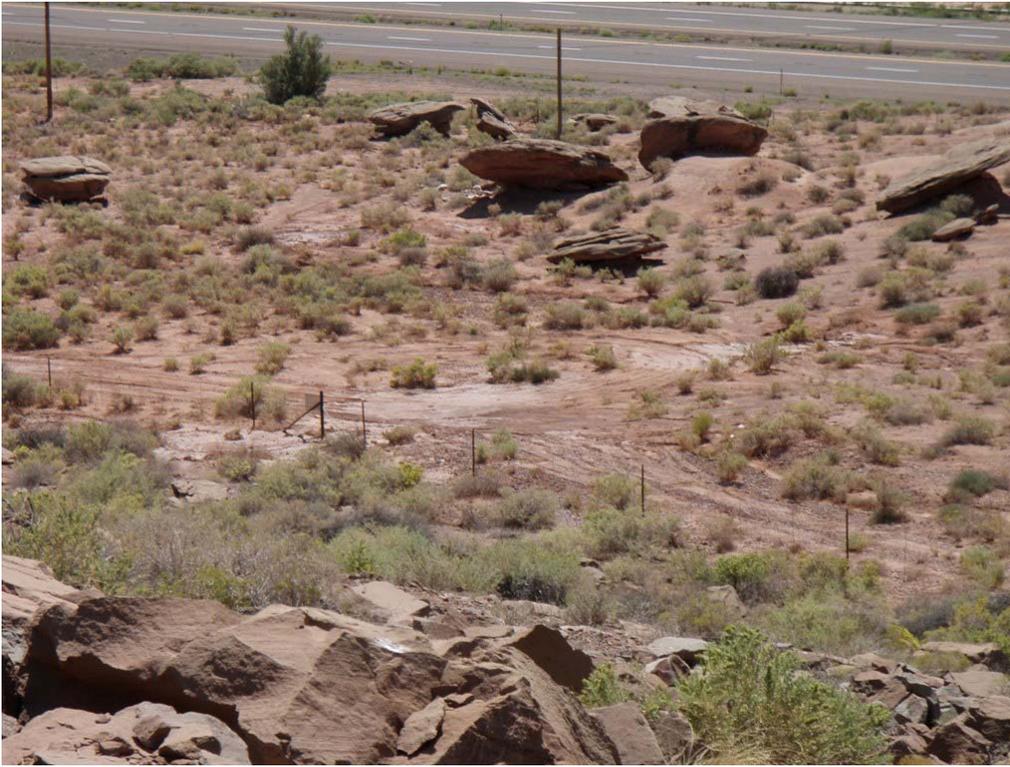
Photo 19 – Fly Ash Pond: Salt patch associated with seepage near right abutment toe (known as the “Hoodoo Salt Patch”).

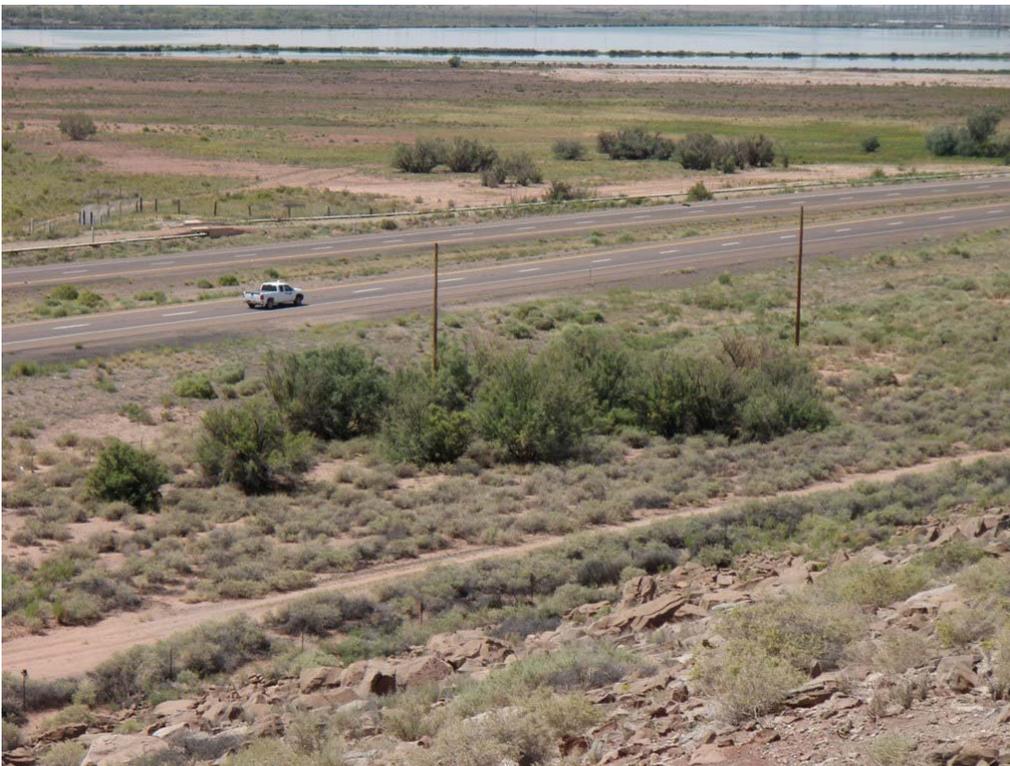
Photo 20 – Fly Ash Pond: Tamarisks near downstream toe indicating seepage.

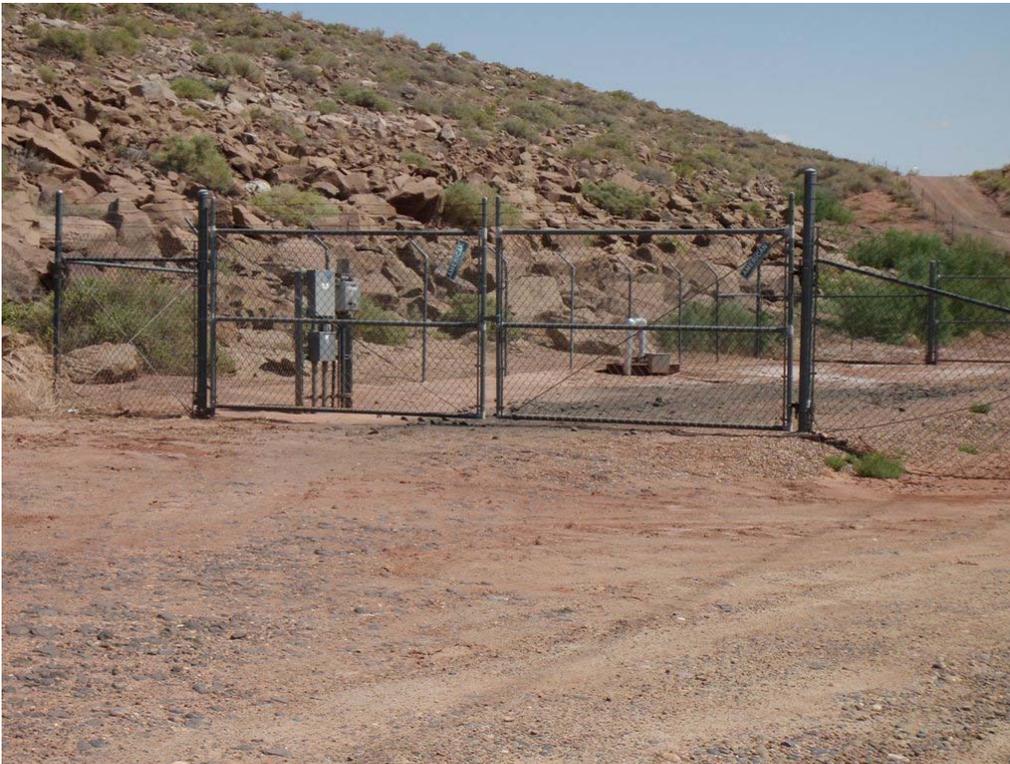
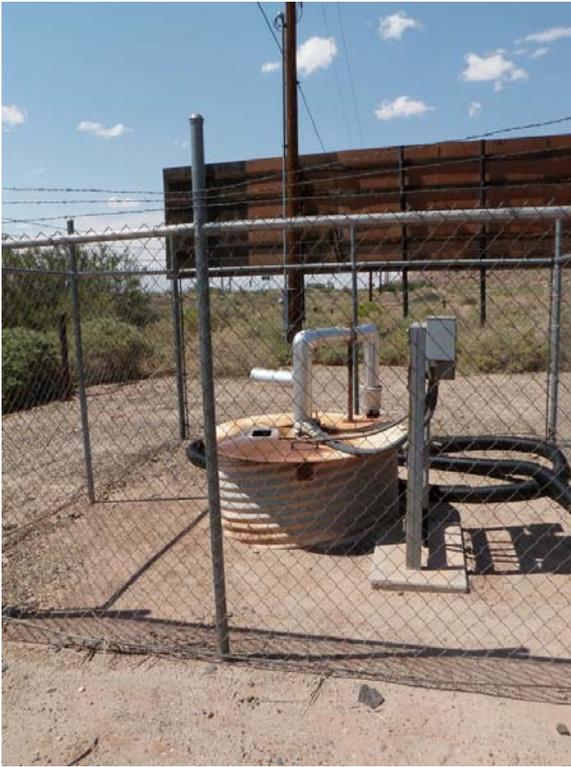
Geronimo Seep: The Geronimo Seep is located less than 50 feet beyond the downstream toe of the Fly Ash Pond Dam, about 2,000 feet from the right abutment. An underground french drain system and wellpoints have been installed to monitor and collect the seepage in this area (Photos 22 and 23). Relatively large flows (up to about 47 gpm) have been measured at this location, but APS indicates that the totalizer at this location has malfunctioned recently and readings may not be accurate. No flowing surface water was observed at this seep location at the time of our assessment.

Photo 22 – Fly Ash Pond: Seepage collection system for Gironimo Seep.

Photo 23 – Fly Ash Pond: Seepage collection system for Gironimo Seep.

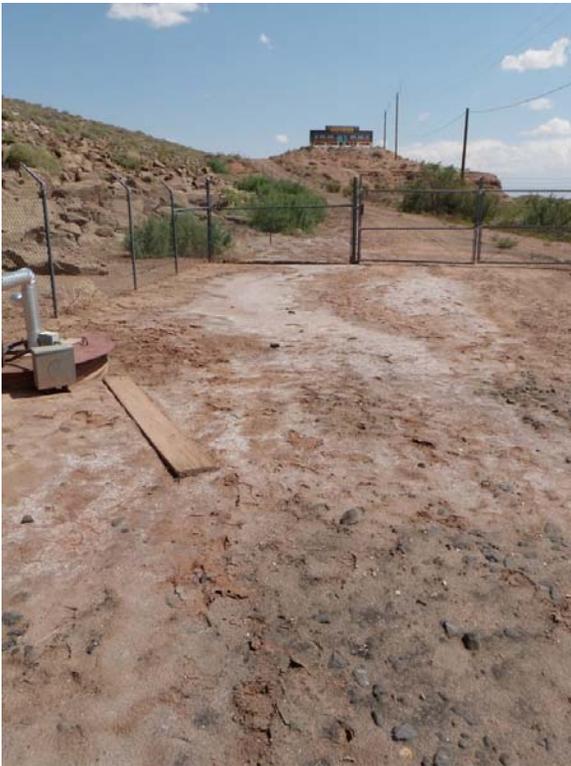
Hunt Seep: The Hunt Seep is located more than 1,500 feet beyond the downstream toe of the Fly Ash Pond Dam. The previously-damp soil indicating the seep in this area is shown in Photo 24. An underground french drain system is used to monitor and collect seepage in this area. No flowing water was observed at the time of the dam assessment at this location. The

Photo 24 – Fly Ash Pond: Hunt Seep area. Note seepage collection system on left.

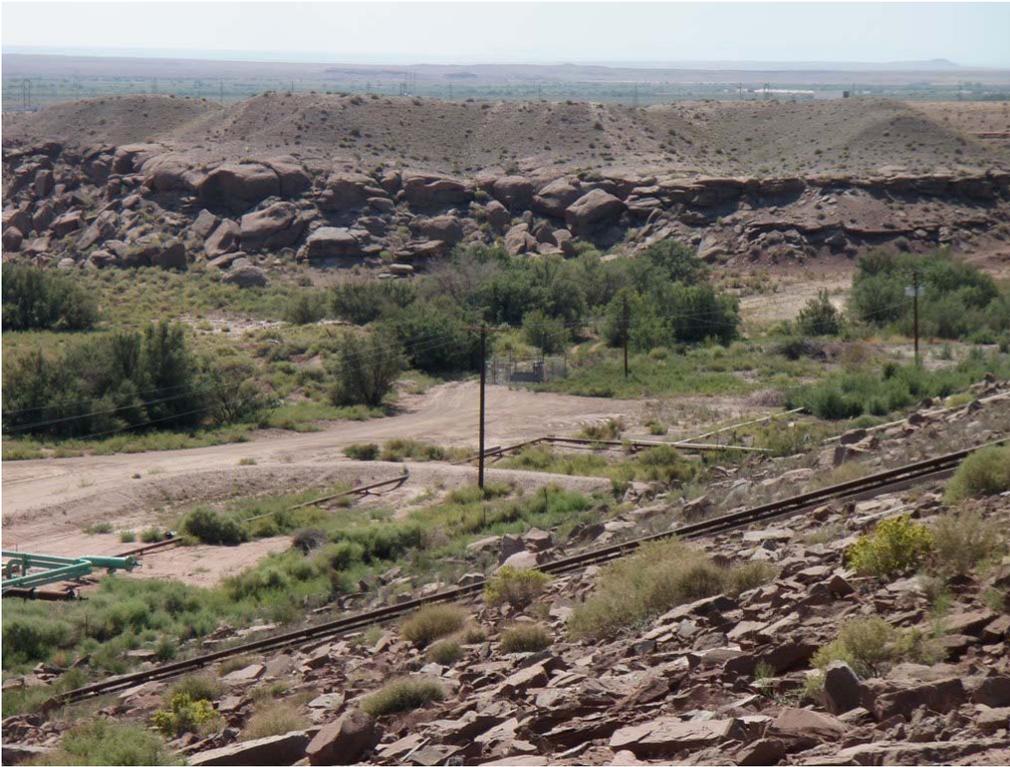
West Abutment Seep: The West Abutment Seep is located about 100 feet downstream of the Bottom Ash Pond Dam toe (Photo 25). APS monitors the flow that daylight in this area by means of a weir (Photo 26), in addition to an underground french drain system several hundred feet east along the face (Photo 27). The general West Abutment Seep area is shown in Photo 28. We observed water flowing through the weir at the time of our site visit, and a rough measurement indicated that the flow at this time was less than 2 gpm. Flows in the weir are typically 4 gpm or less, and the totalizer at this location has measured a maximum of about 16 gpm since 1996.

Photo 25 – Bottom Ash Pond: West Abutment Seep from embankment crest. Siphon pipes (center) and siphon collection system (lower left) are also visible.

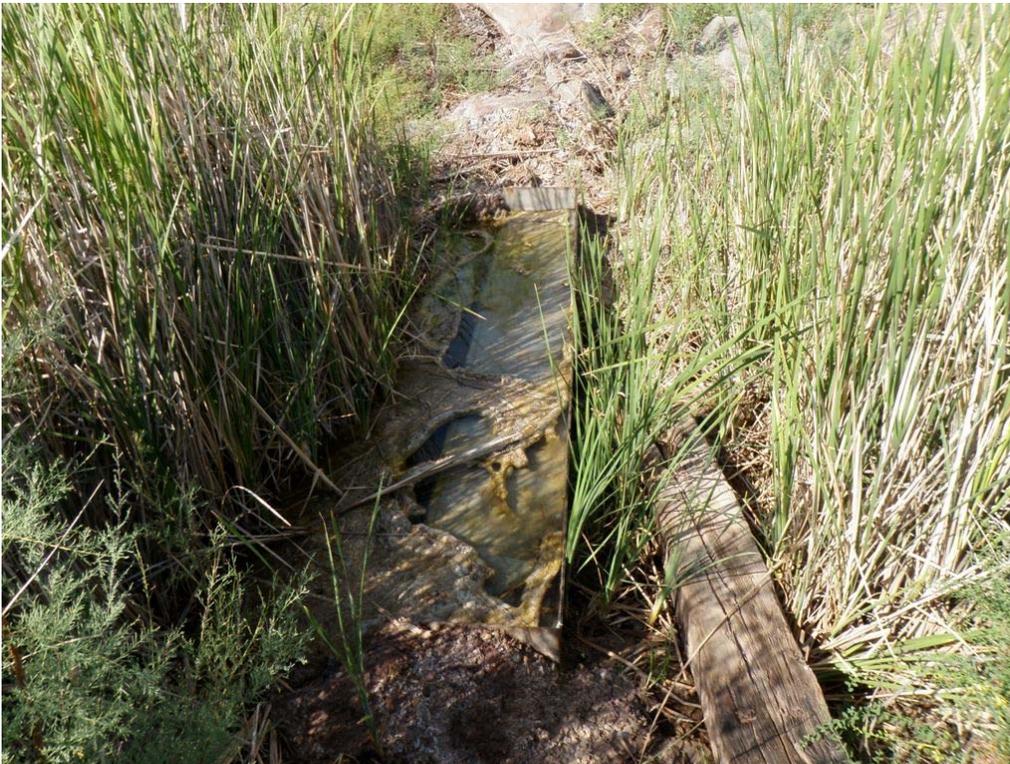
Photo 26 – Bottom Ash Pond: Weir at West Abutment Seep.

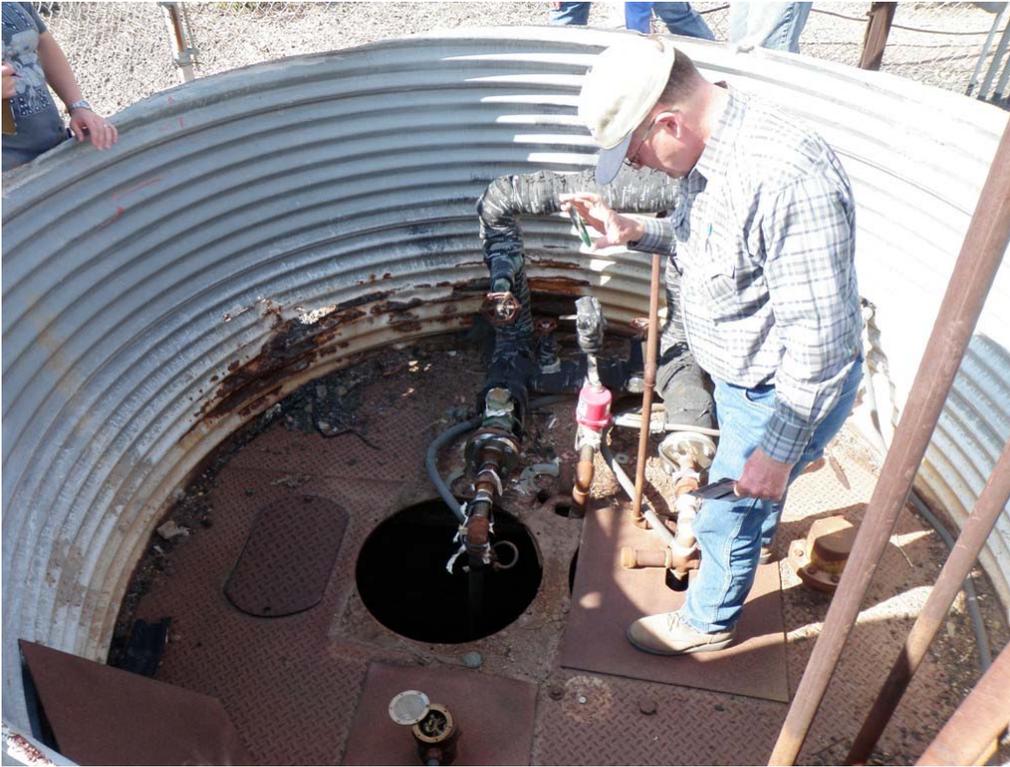
Photo 27 – Bottom Ash Pond: Seepage collection system at West Abutment Seep.

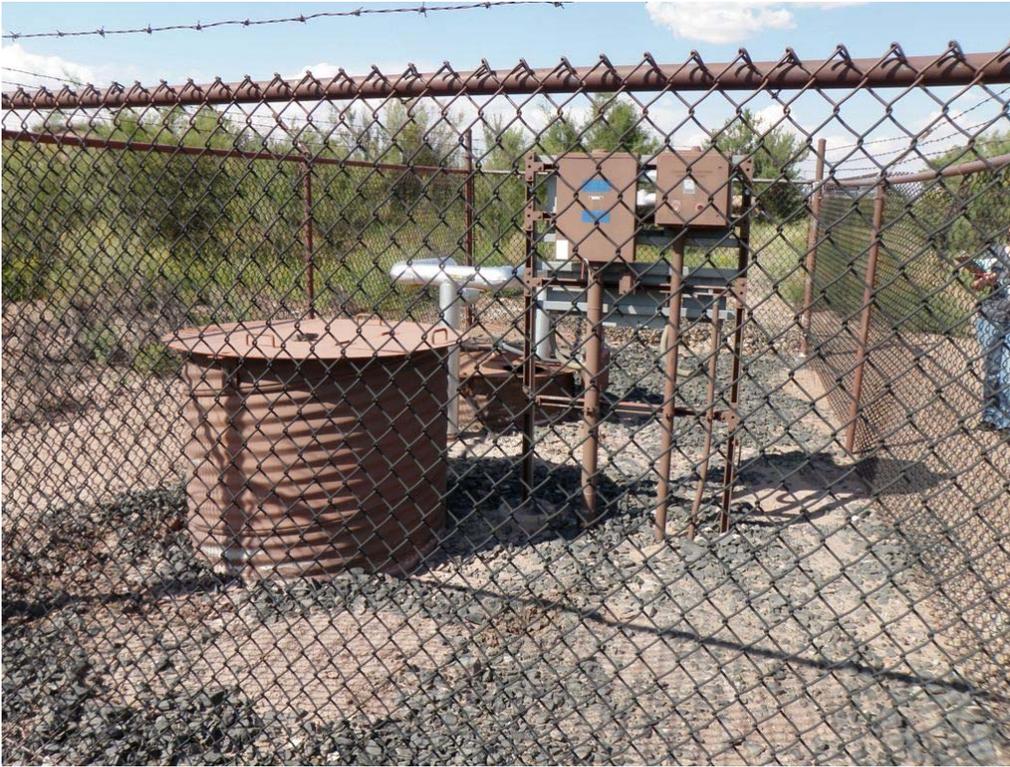
Tanner Wash Seep: The Tanner Wash Seep is located about 350 feet beyond the toe of the Bottom Ash Pond Dam near the left abutment. Seepage is collected and measured via an underground french drain system with a totalizer (Photo 29). Both salt patches (Photo 30) and flowing surface water (Photo 31) were observed at this seep at the time of our assessment. A maximum flow of about 15 gpm has been measured at this location since 1995. This seep is far enough from the dam that it is not considered a dam safety concern. This seep is of more environmental concern than others due to its vicinity to Tanner Wash (Photo 32).

Photo 29 – Bottom Ash Pond: Seepage collection system for Tanner Wash Seep.

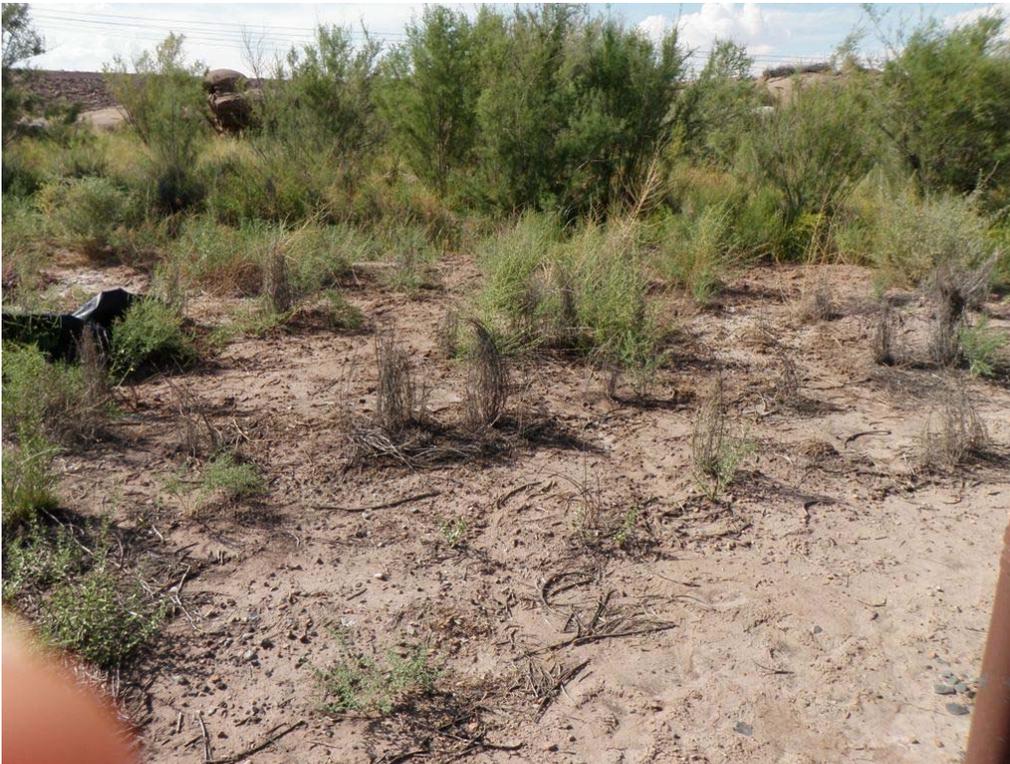
Photo 30 – Bottom Ash Pond: Salt patches at Tanner Wash Seep.

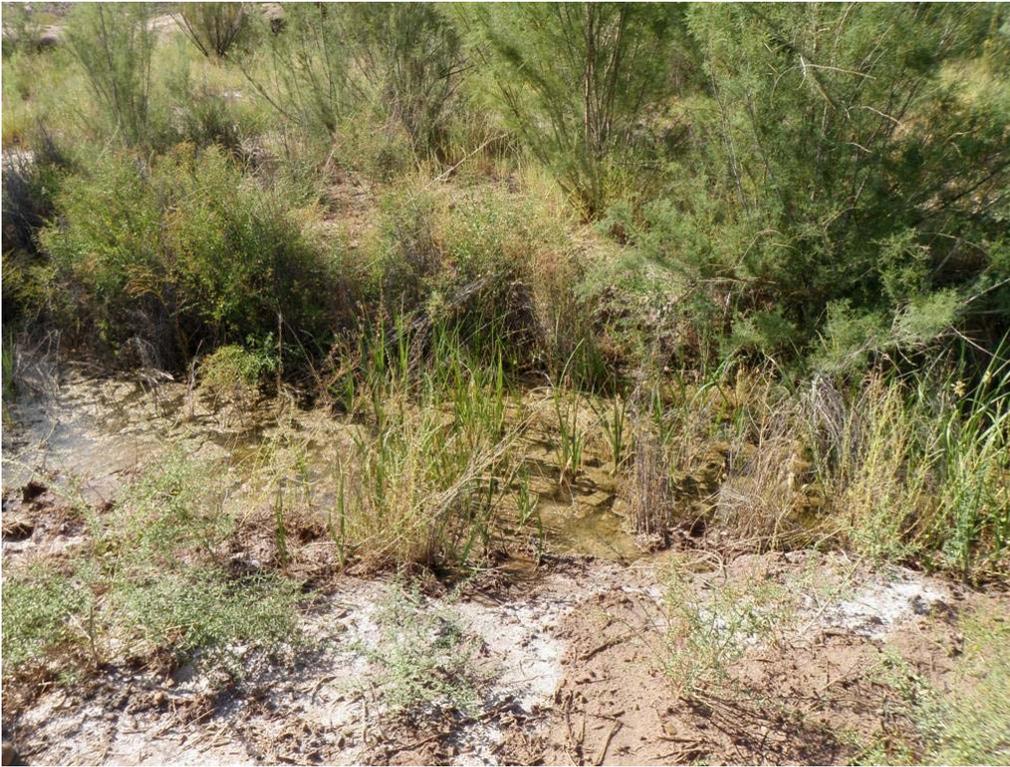
Photo 31 – Bottom Ash Pond: Flowing surface water at Tanner Wash Seep.

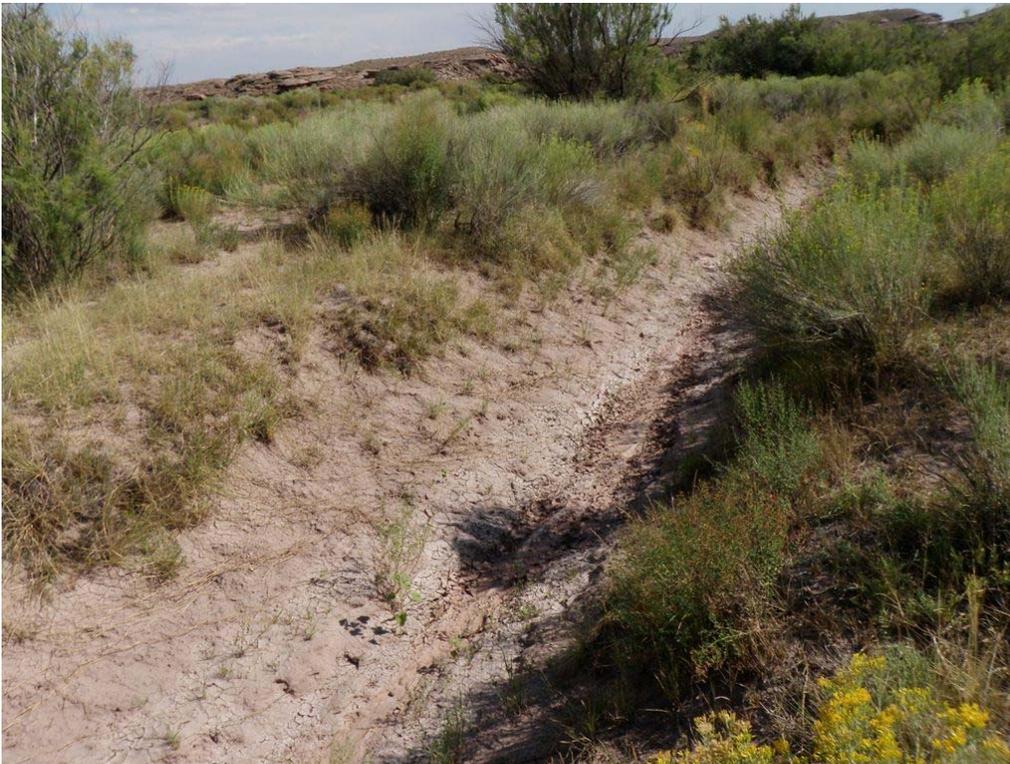
Photo 32 – Bottom Ash Pond: Tanner Wash.

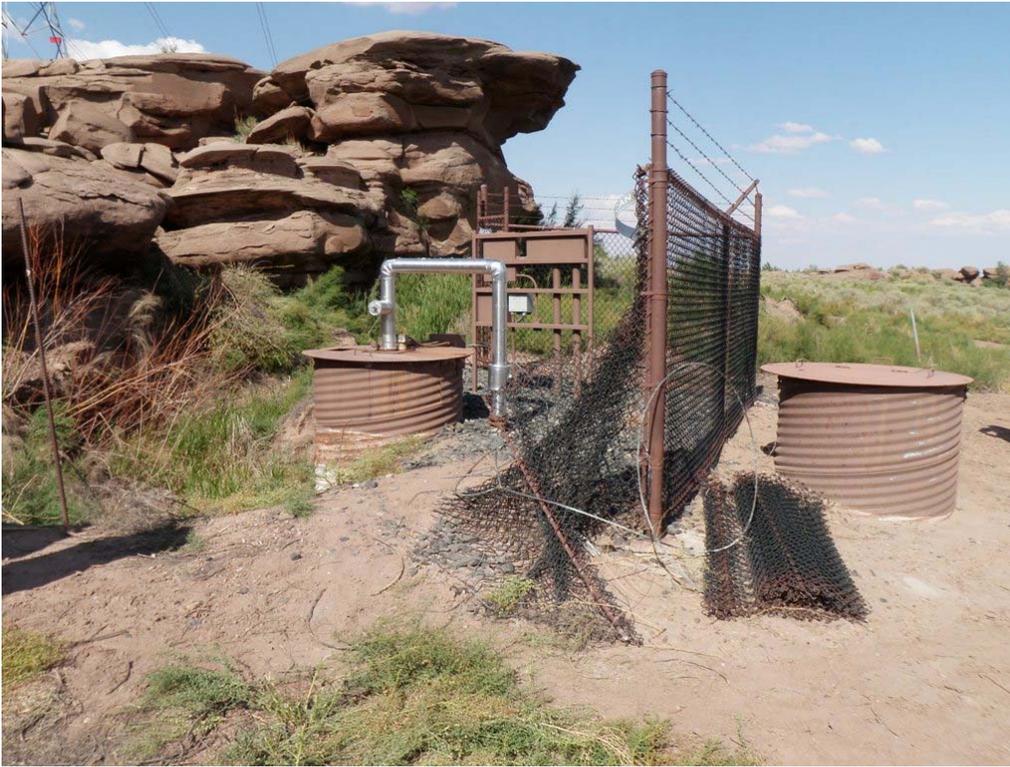
Petroglyph Seep: The Petroglyph Seep is located about 150 feet beyond the dam toe on the east side of the dam, south of the Tanner Wash Seep. Seepage is collected and measured via an underground french drain system with a totalizer (Photo 33). Flowing surface water was observed at this seep at the time of our assessment (Photo 34). A maximum flow of about 13 gpm has been measured at this location since 1993. This seep is far enough from the dam that it is not considered a dam safety concern.

Photo 33 – Bottom Ash Pond: Seepage collection system for Petroglyph Seep.

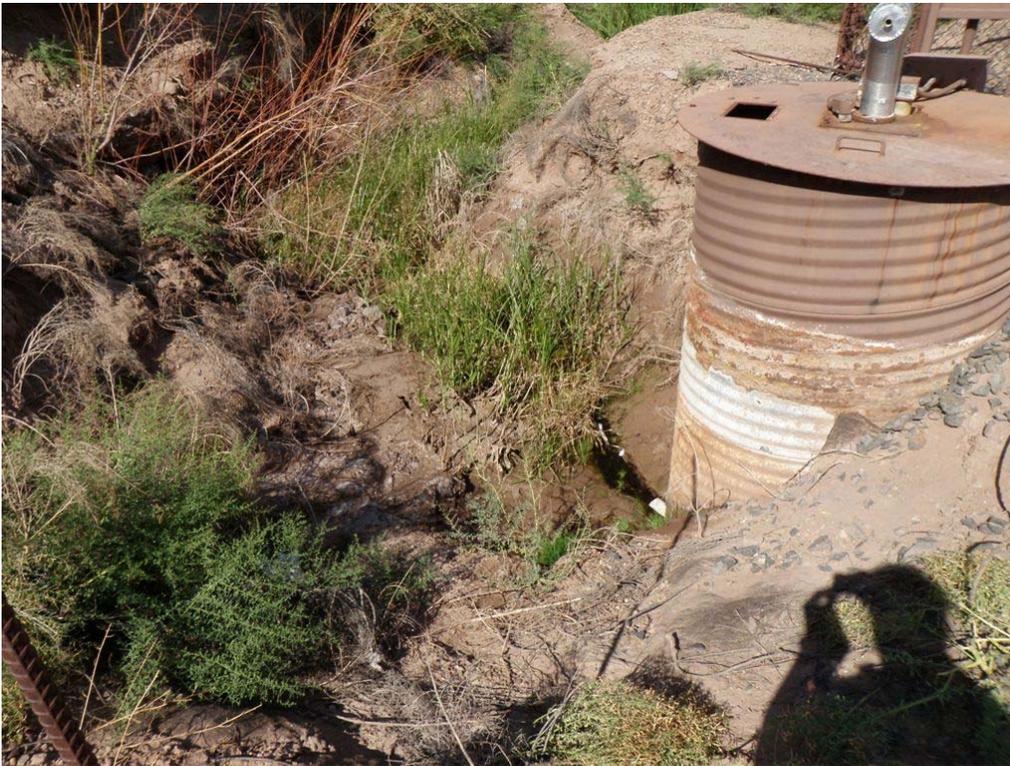
feet beyond the dam toe. It is also collected by an underground French drain system. Flowing surface water was observed at the location of this seep at the time of our assessment. A maximum flow of 12.6 gpm has been measured at this seep since measurements began in December 1993.

Photo 34 – Bottom Ash Pond: Flowing surface water at Petroglyph Seep.

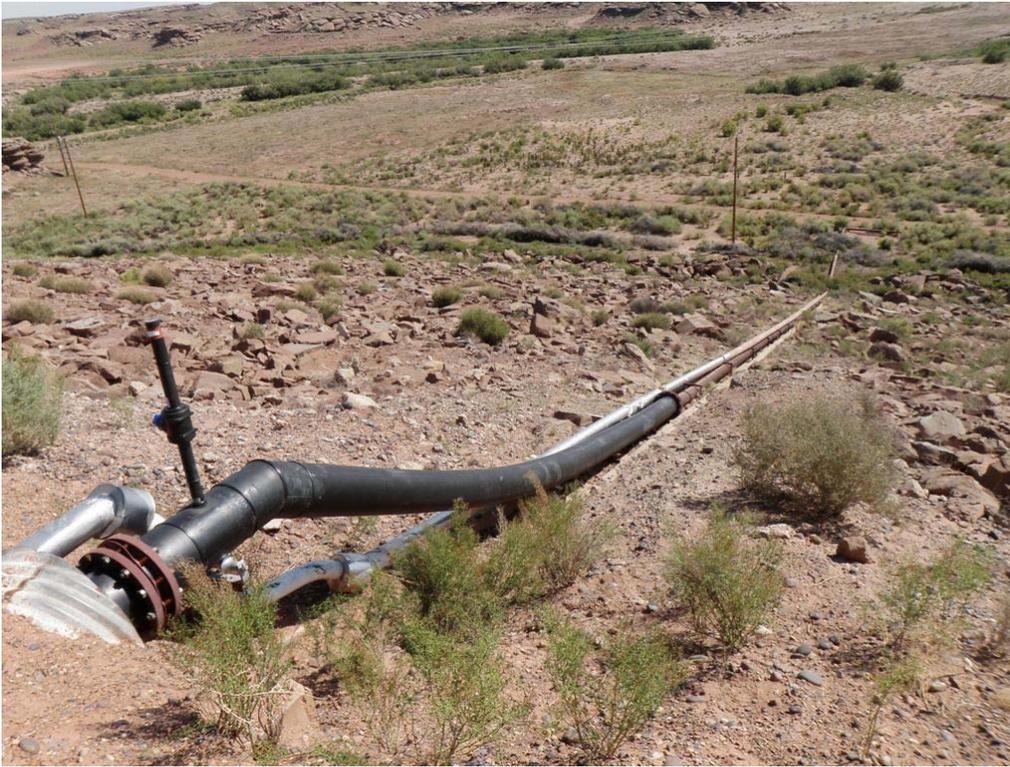
There are no spillways at either dam, and the Fly Ash Pond has no outlet. Four siphon pipes are the only outlet for the Bottom Ash Pond, and they appear to be in good condition. The siphon pipes are shown in Photos 36 (upstream side) and 37 (downstream side). The siphon

Photo 37 – Bottom Ash Pond: Siphon pipes extending along downstream slope of dam.

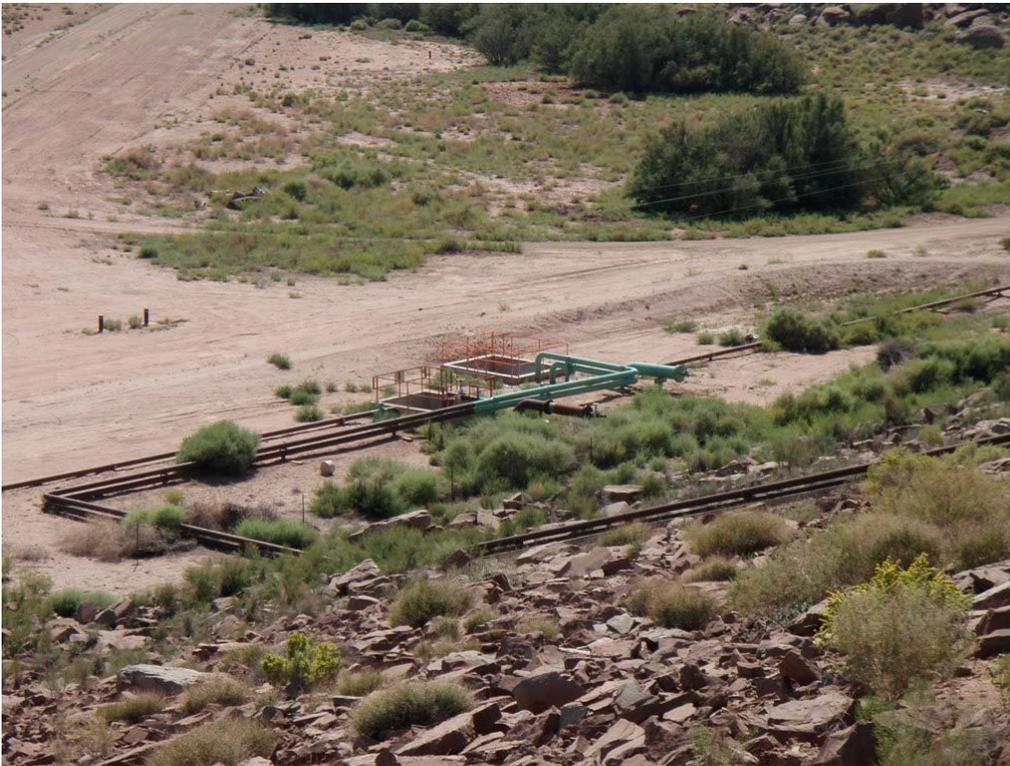
collection point, where water from the siphon pipes is combined and routed to the plant, is shown in Photos 38 and 39.

Photo 38 – Bottom Ash Pond: Siphon collection station at toe of dam.

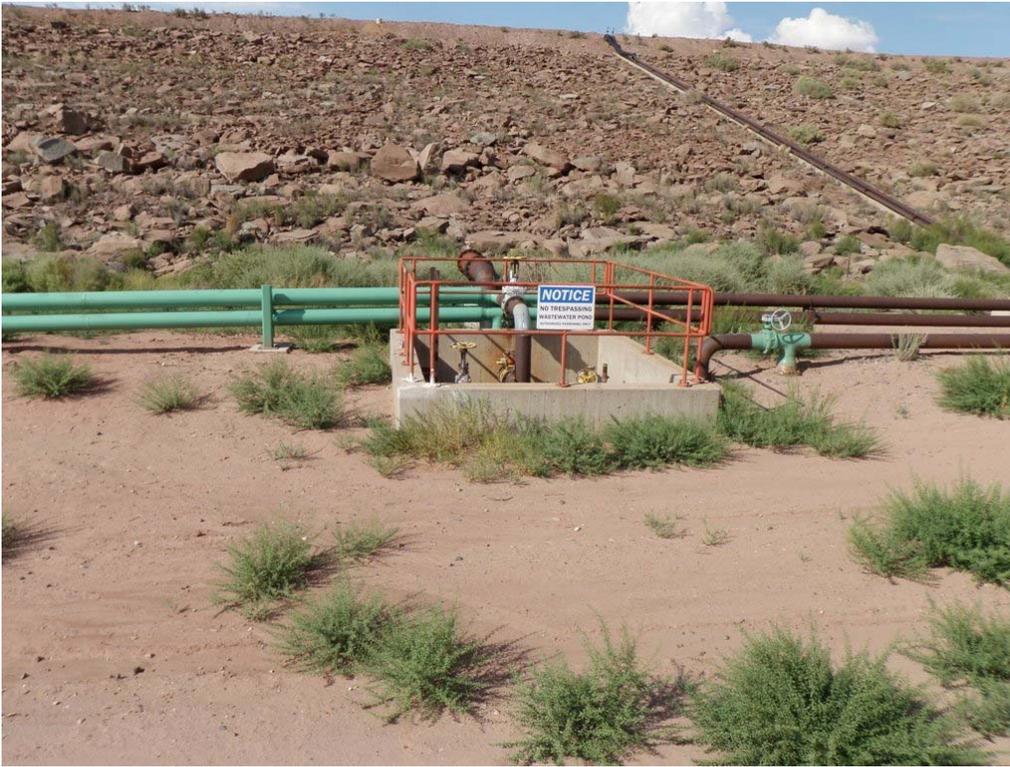
Photo 39 – Bottom Ash Pond: Siphon pipes extending along downstream slope, and siphon collection station.
