DRAFT FINAL
Coal Ash Impoundment
Specific Site Assessment
Report
Arizona Public Service
Cholla Power Plant

Submitted by:
GEI Consultants, Inc.
6950 South Potomac Street, Suite 300
Centennial, CO 80112

October 2009
Project 091330

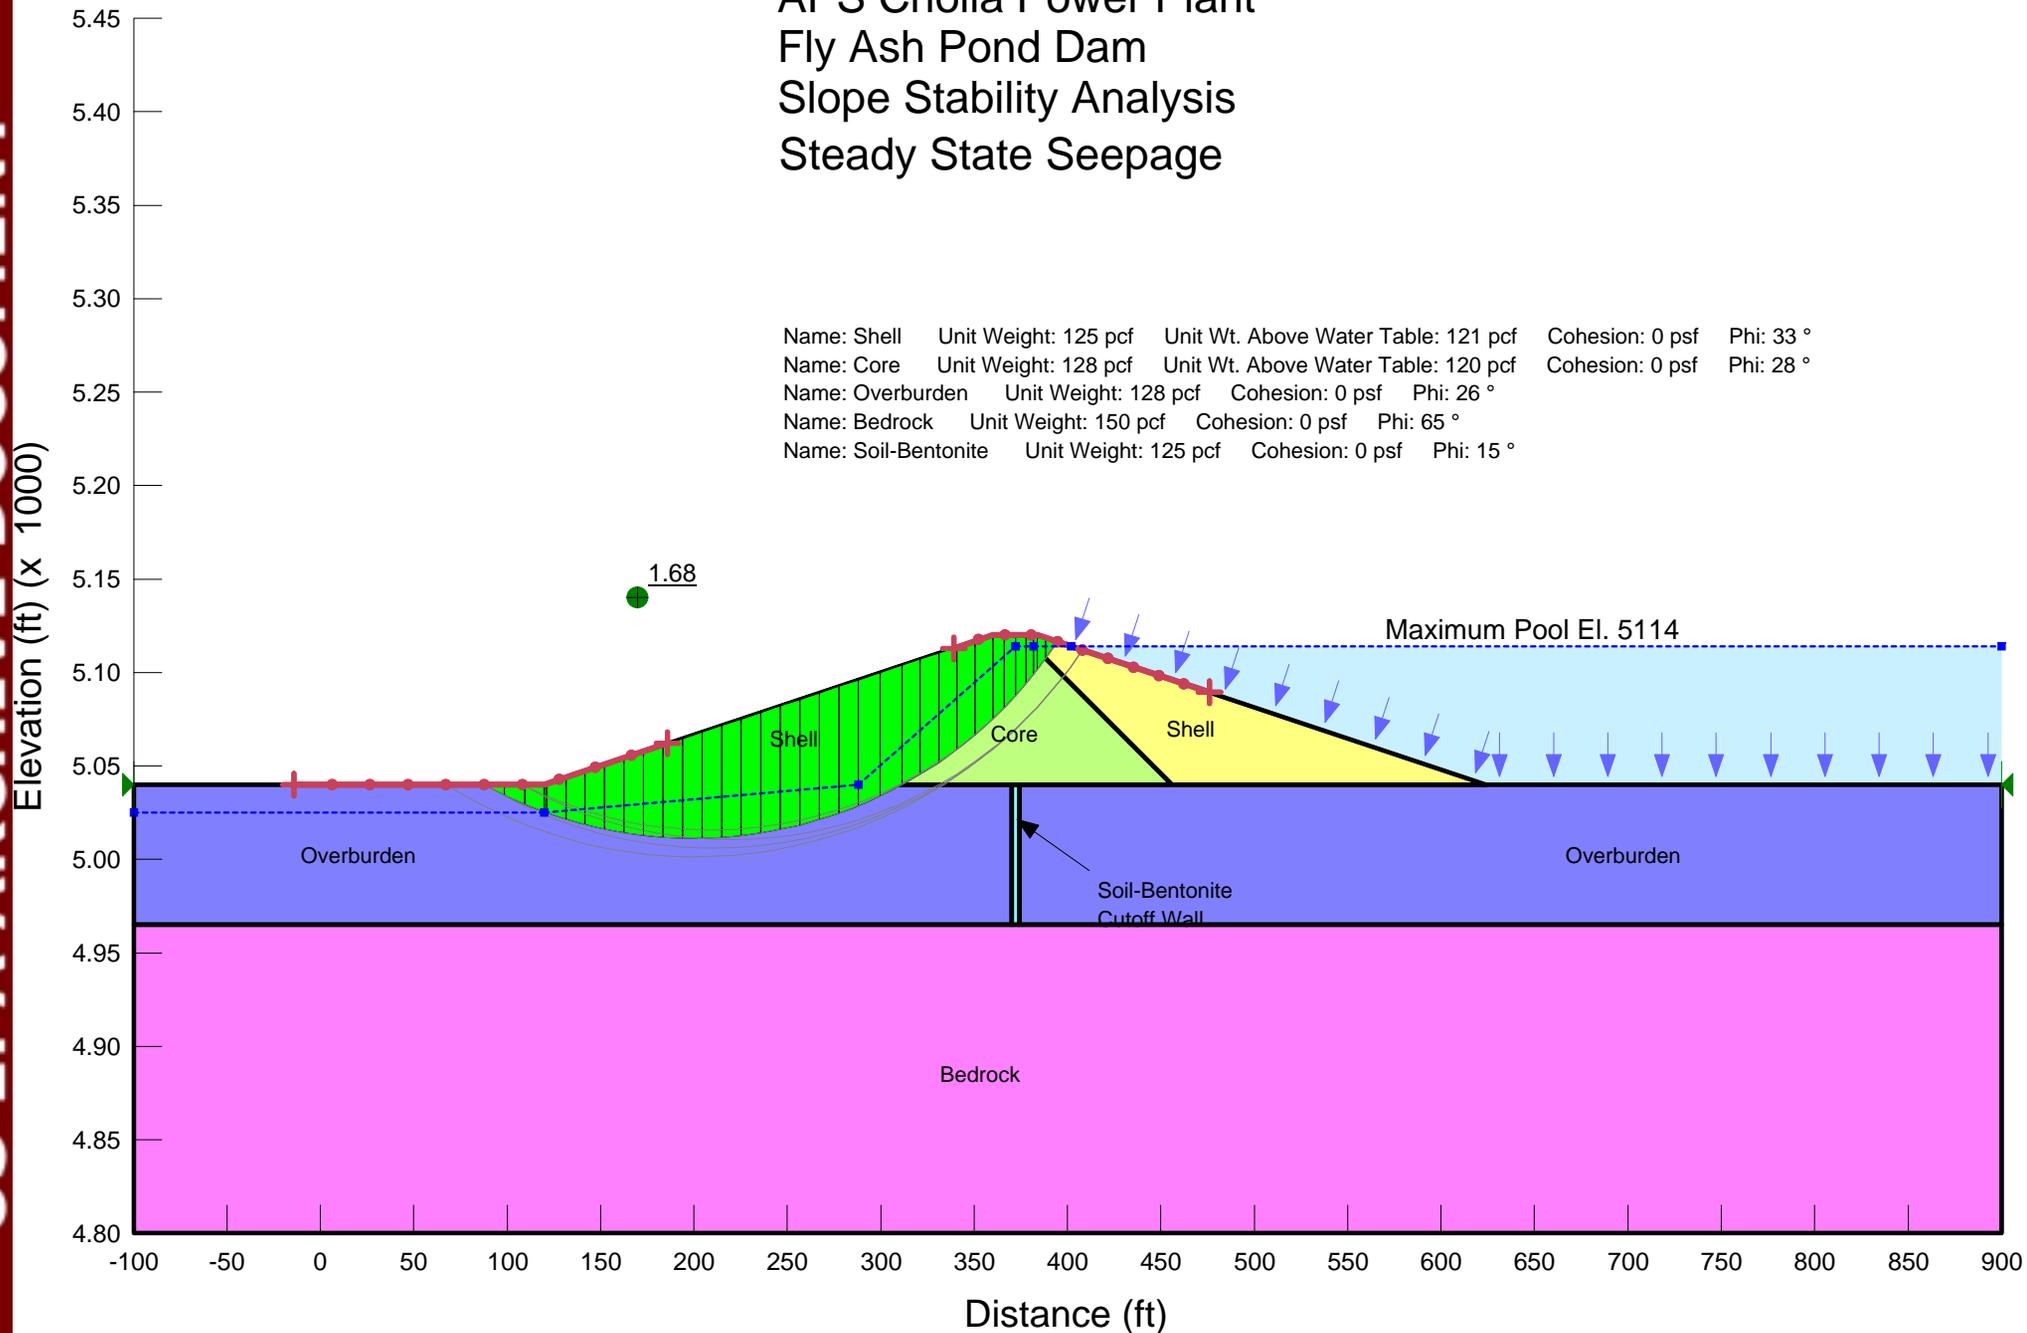
APS Cholla Power Plant Fly Ash Pond Dam Slope Stability Analysis Steady State Seepage

Name: Shell	Unit Weight: 125 pcf	Unit Wt. Above Water Table: 121 pcf	Cohesion: 0 psf	Phi: 33 °
Name: Core	Unit Weight: 128 pcf	Unit Wt. Above Water Table: 120 pcf	Cohesion: 0 psf	Phi: 28 °
Name: Overburden	Unit Weight: 128 pcf	Cohesion: 0 psf	Phi: 26 °	
Name: Bedrock	Unit Weight: 150 pcf	Cohesion: 0 psf	Phi: 65 °	
Name: Soil-Bentonite	Unit Weight: 125 pcf	Cohesion: 0 psf	Phi: 15 °

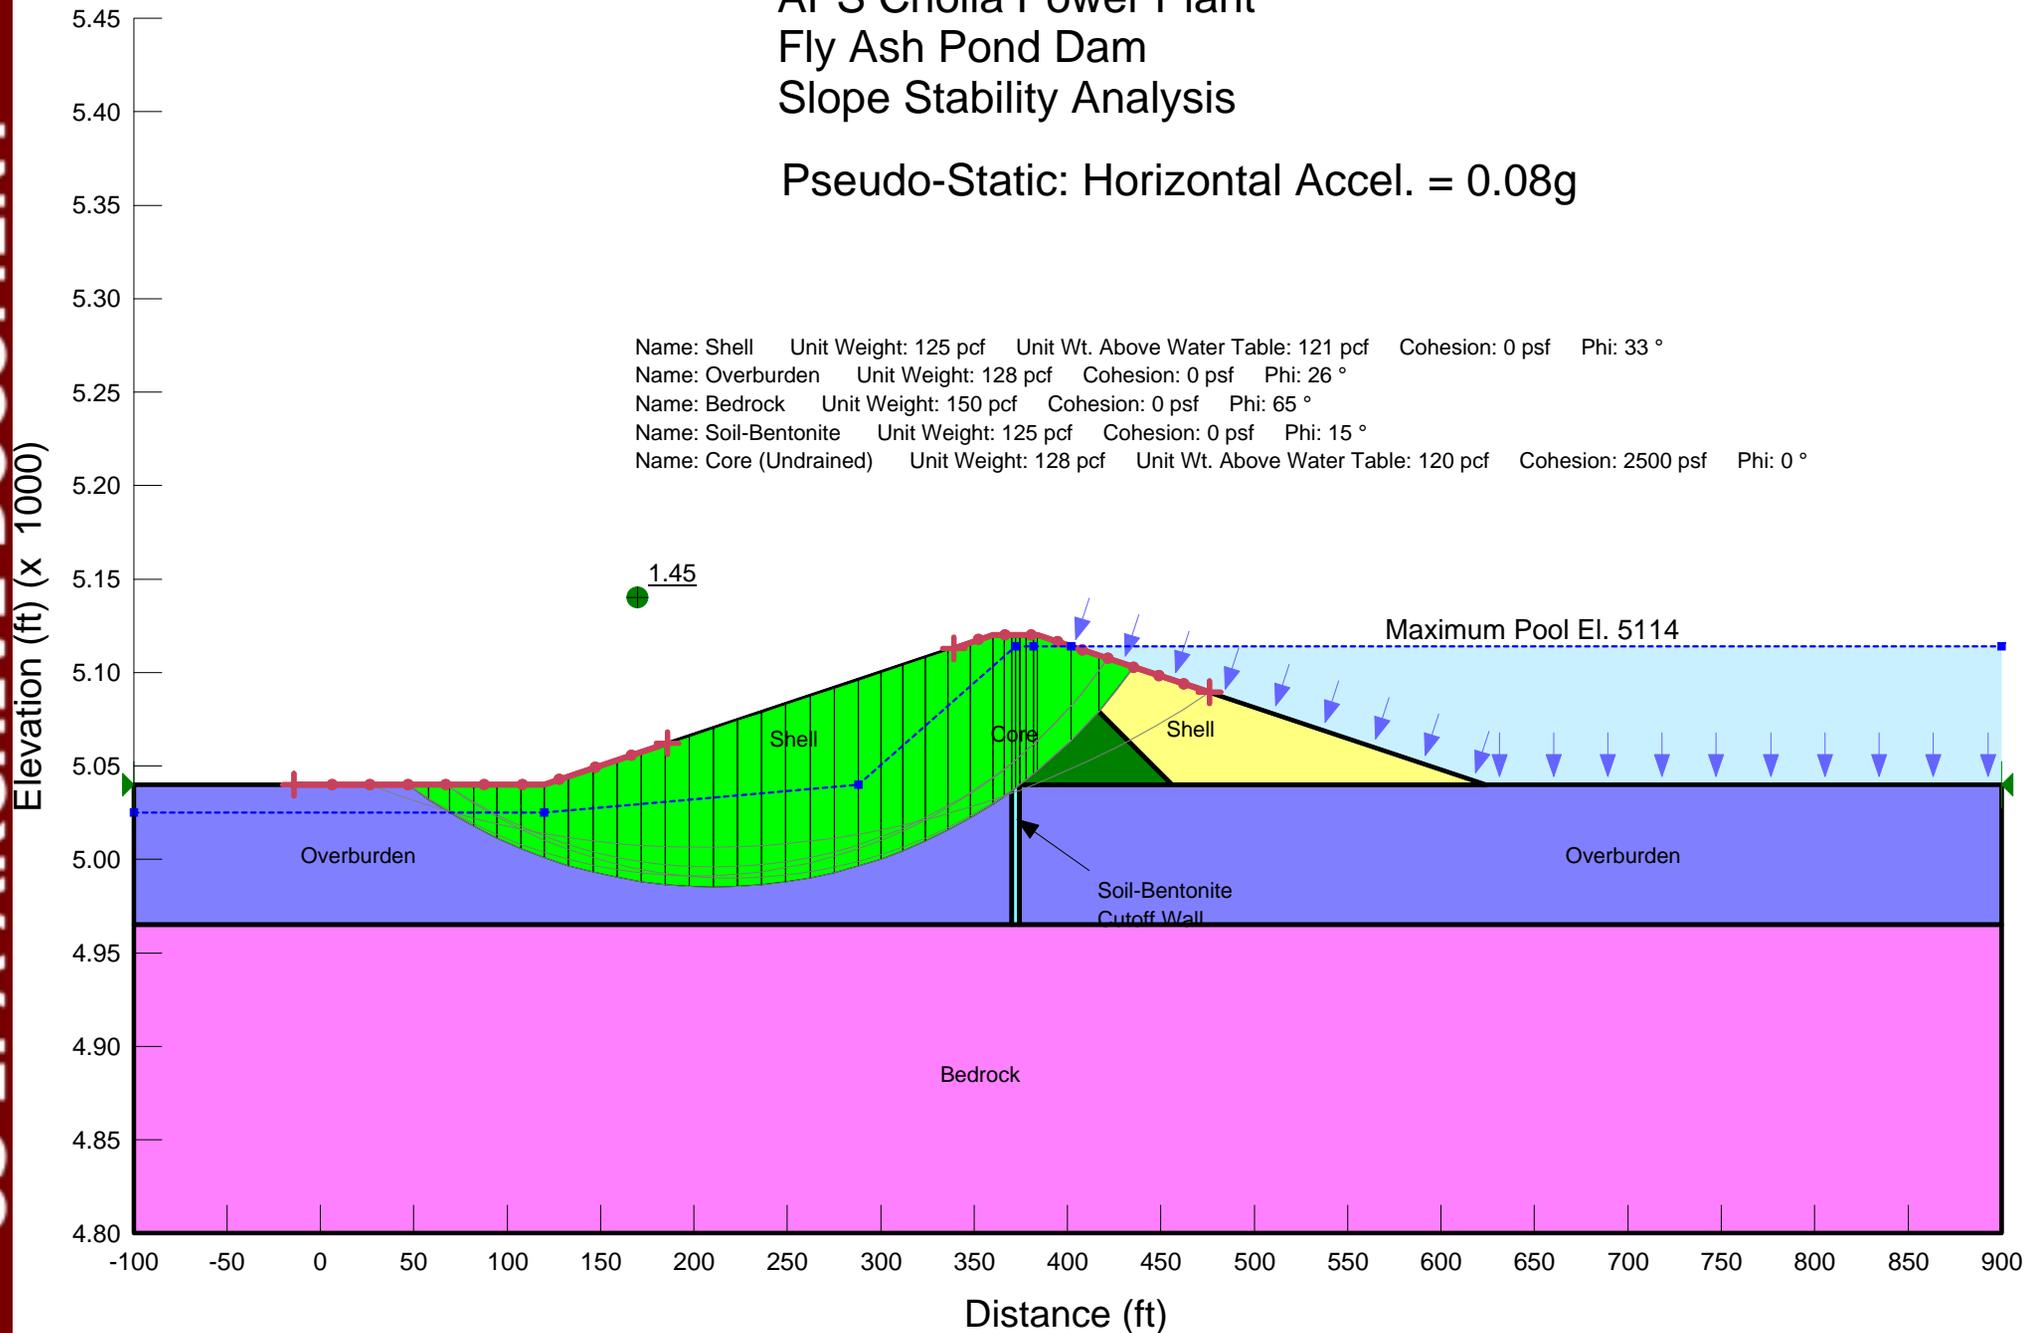
APS Cholla Power Plant Fly Ash Pond Dam Slope Stability Analysis

Pseudo-Static: Horizontal Accel. = 0.08g

Name: Shell Unit Weight: 125 pcf Unit Wt. Above Water Table: 121 pcf Cohesion: 0 psf Phi: 33 °
 Name: Overburden Unit Weight: 128 pcf Cohesion: 0 psf Phi: 26 °
 Name: Bedrock Unit Weight: 150 pcf Cohesion: 0 psf Phi: 65 °
 Name: Soil-Bentonite Unit Weight: 125 pcf Cohesion: 0 psf Phi: 15 °
 Name: Core (Undrained) Unit Weight: 128 pcf Unit Wt. Above Water Table: 120 pcf Cohesion: 2500 psf Phi: 0 °

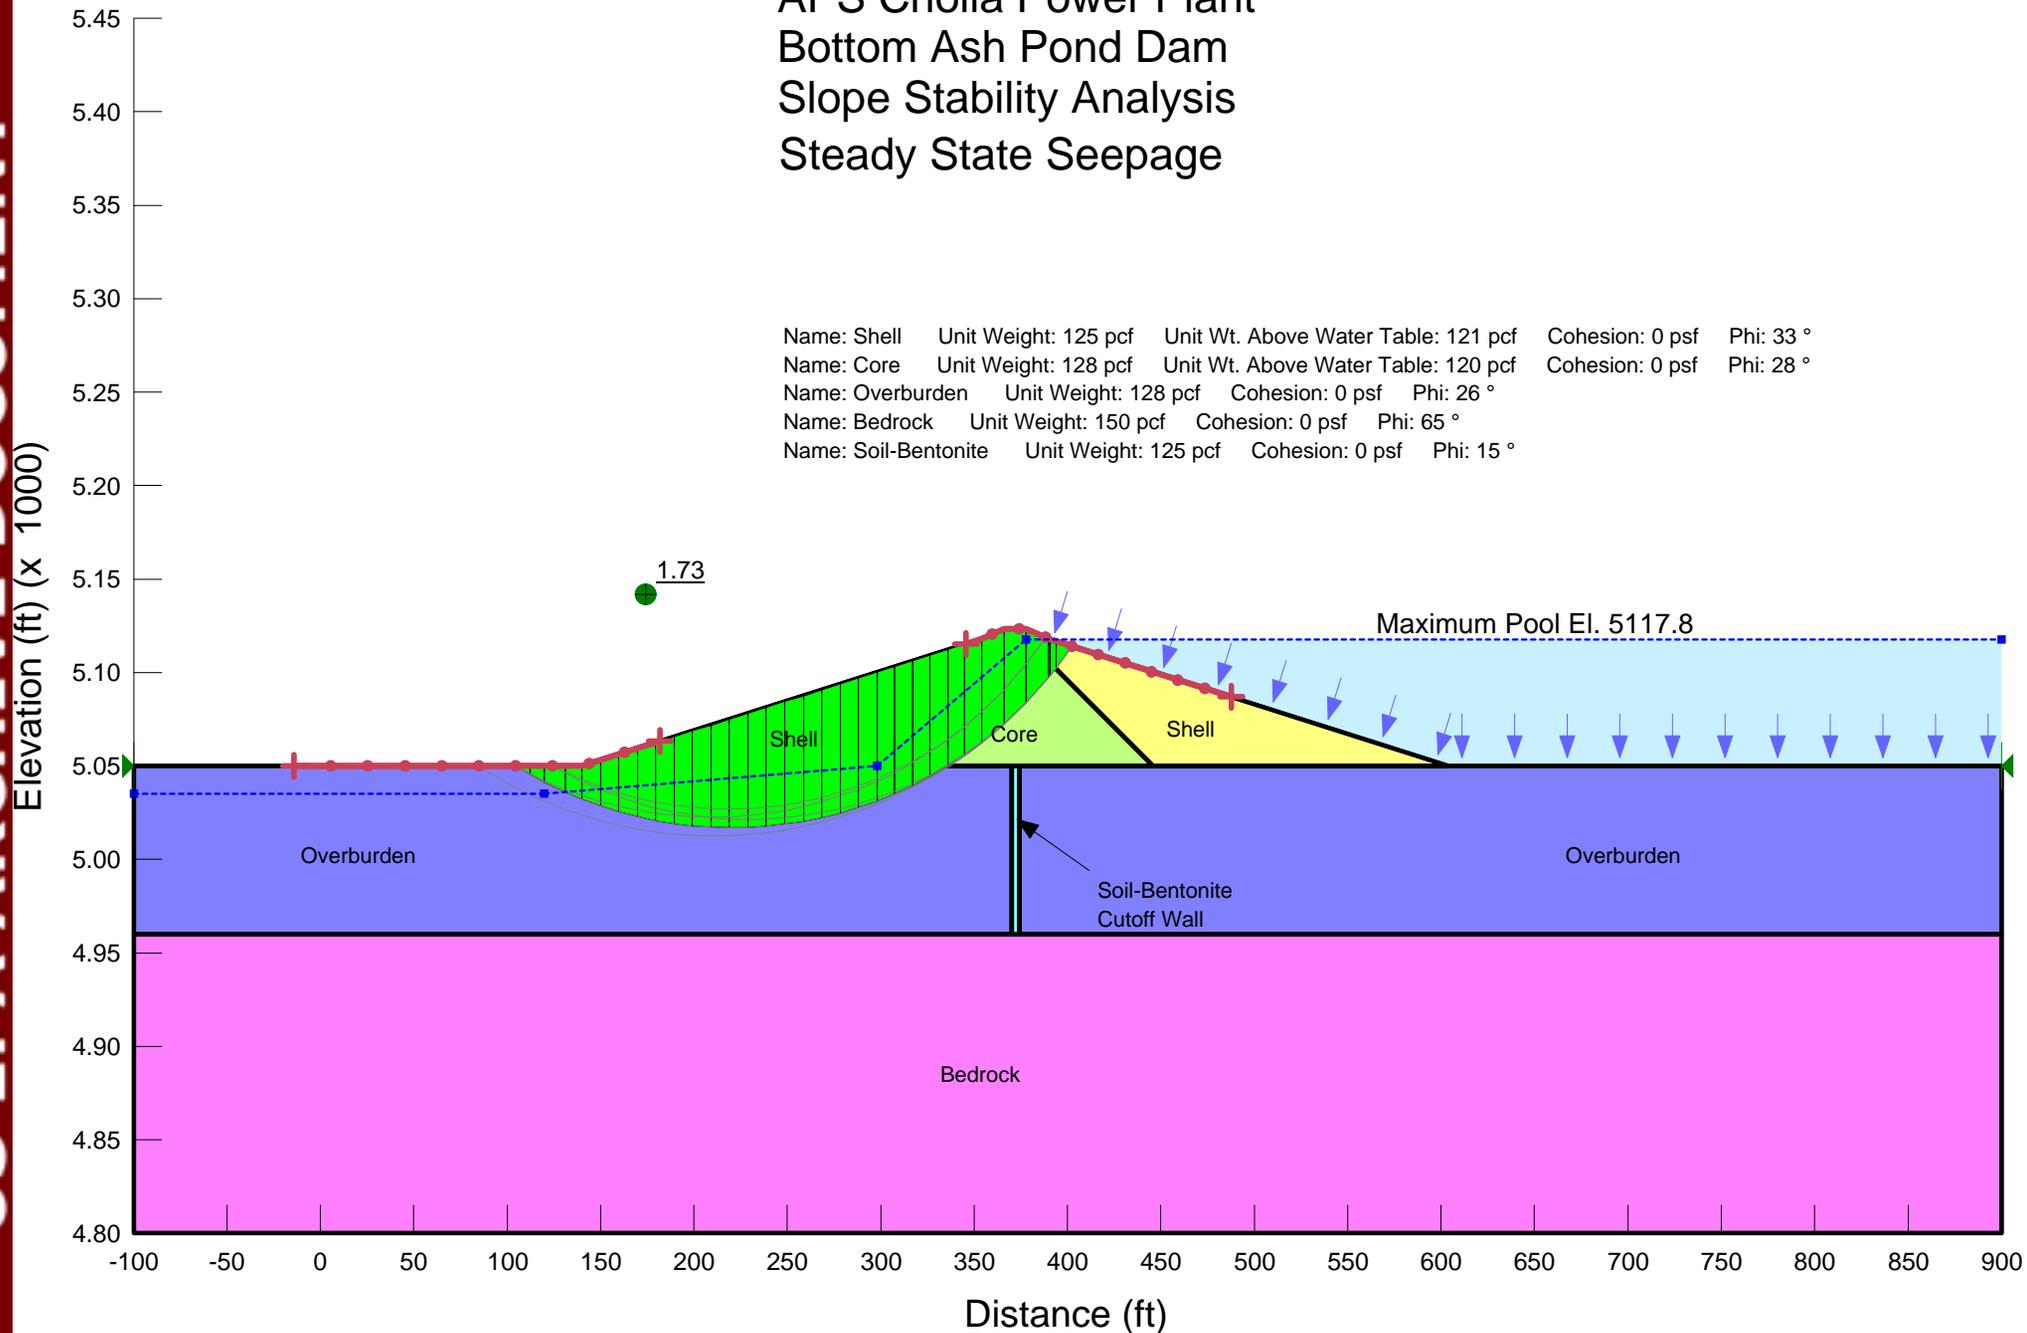
APS Cholla Power Plant Bottom Ash Pond Dam Slope Stability Analysis Steady State Seepage

Name: Shell	Unit Weight: 125 pcf	Unit Wt. Above Water Table: 121 pcf	Cohesion: 0 psf	Phi: 33 °
Name: Core	Unit Weight: 128 pcf	Unit Wt. Above Water Table: 120 pcf	Cohesion: 0 psf	Phi: 28 °
Name: Overburden	Unit Weight: 128 pcf	Cohesion: 0 psf	Phi: 26 °	
Name: Bedrock	Unit Weight: 150 pcf	Cohesion: 0 psf	Phi: 65 °	
Name: Soil-Bentonite	Unit Weight: 125 pcf	Cohesion: 0 psf	Phi: 15 °

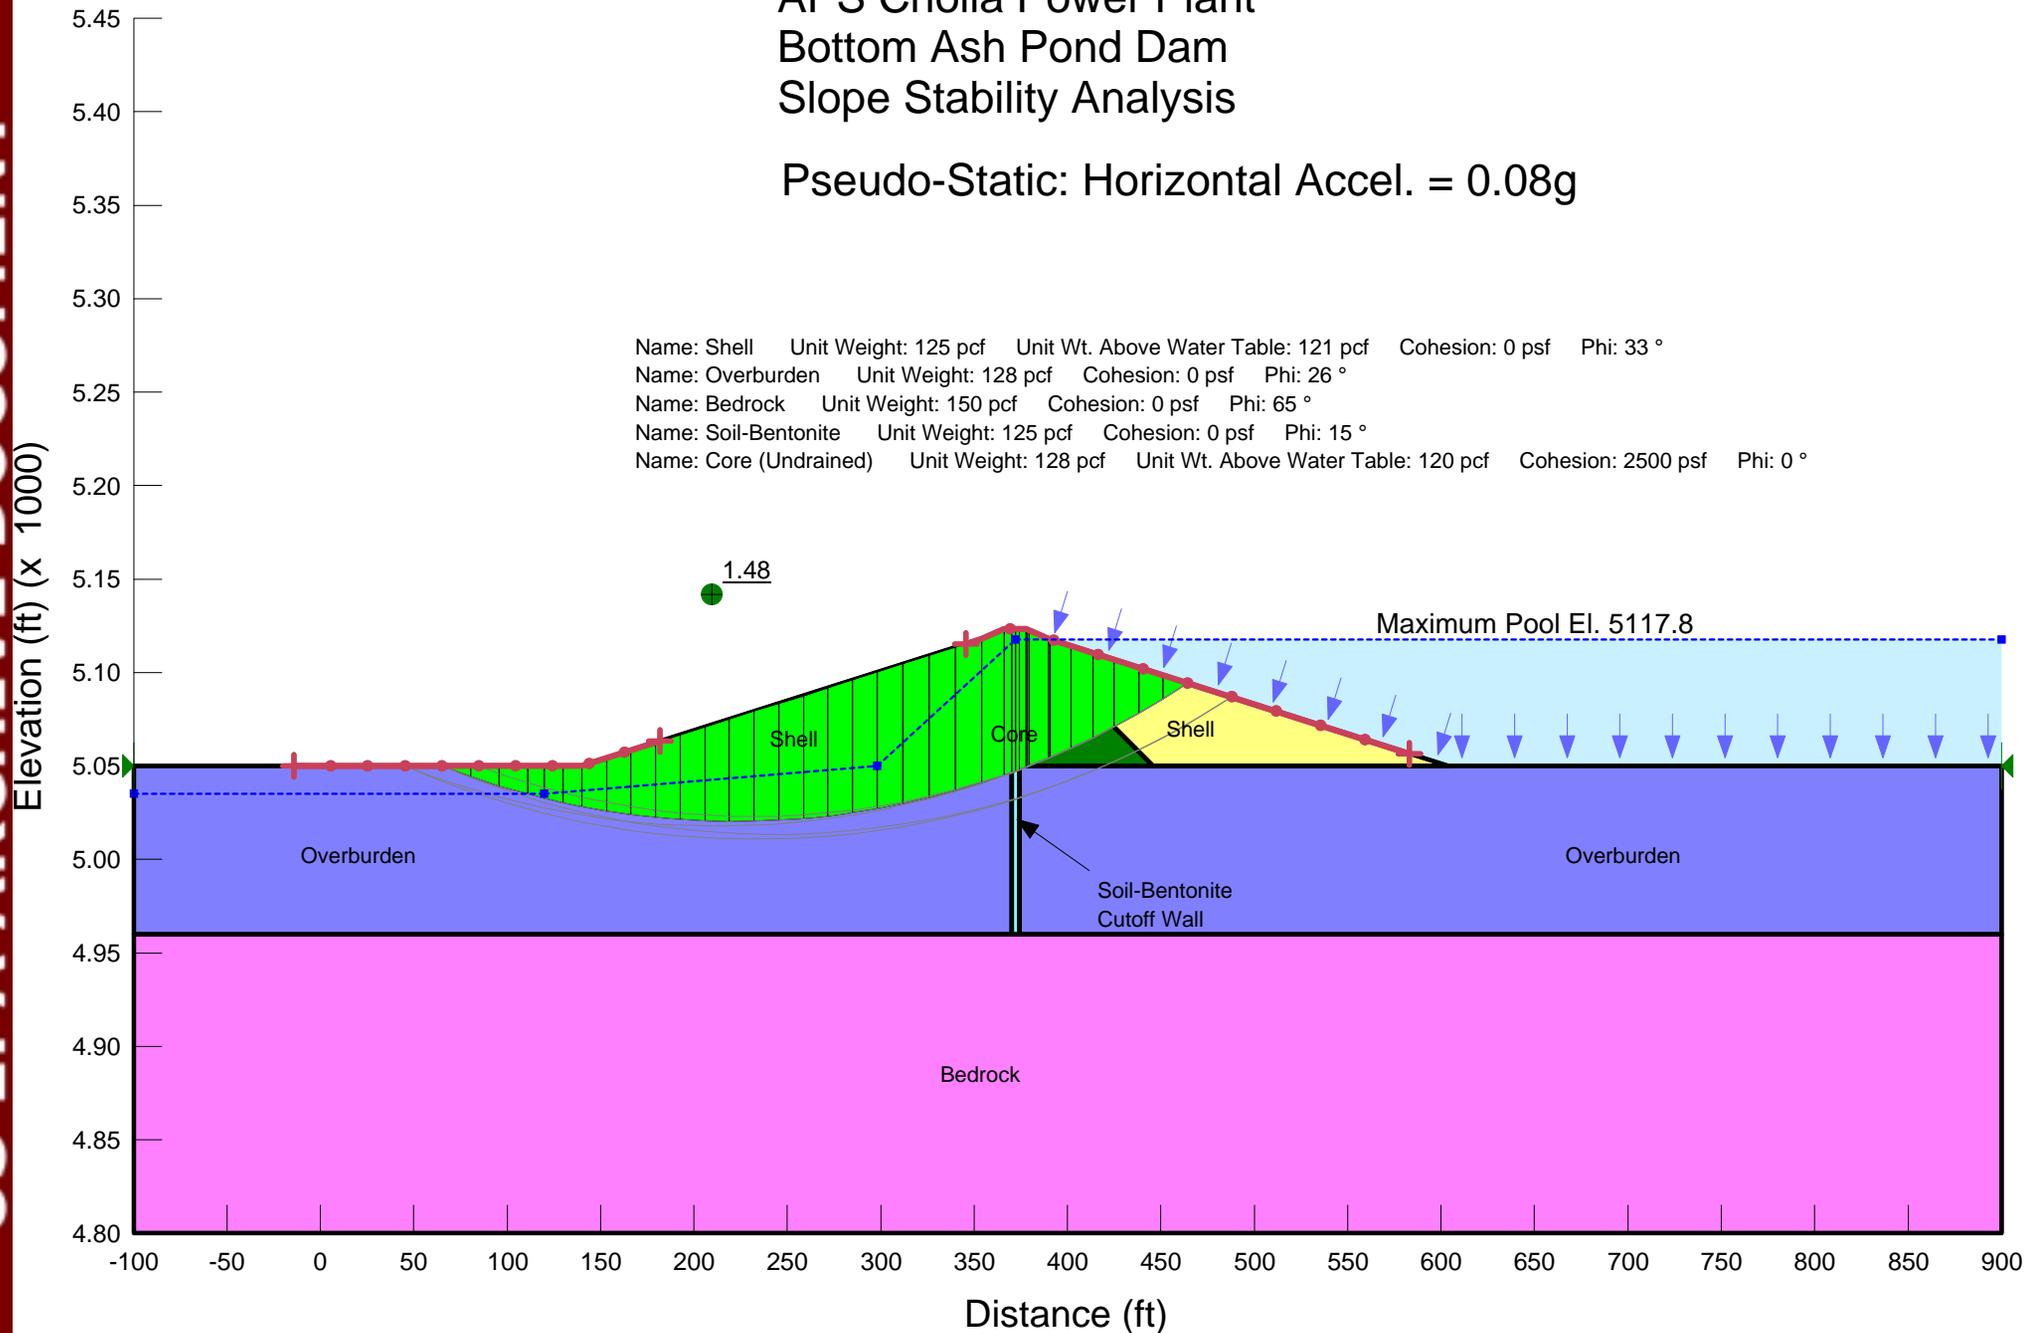
APS Cholla Power Plant Bottom Ash Pond Dam Slope Stability Analysis

Pseudo-Static: Horizontal Accel. = 0.08g

Name: Shell Unit Weight: 125 pcf Unit Wt. Above Water Table: 121 pcf Cohesion: 0 psf Phi: 33 °
 Name: Overburden Unit Weight: 128 pcf Cohesion: 0 psf Phi: 26 °
 Name: Bedrock Unit Weight: 150 pcf Cohesion: 0 psf Phi: 65 °
 Name: Soil-Bentonite Unit Weight: 125 pcf Cohesion: 0 psf Phi: 15 °
 Name: Core (Undrained) Unit Weight: 128 pcf Unit Wt. Above Water Table: 120 pcf Cohesion: 2500 psf Phi: 0 °
