**Dam Safety Assessment of CCW
Impoundments**

**Reid/Green/HMP&L Station II
Report**

**Lockheed Martin
Contractor for the USEPA**

December 2009

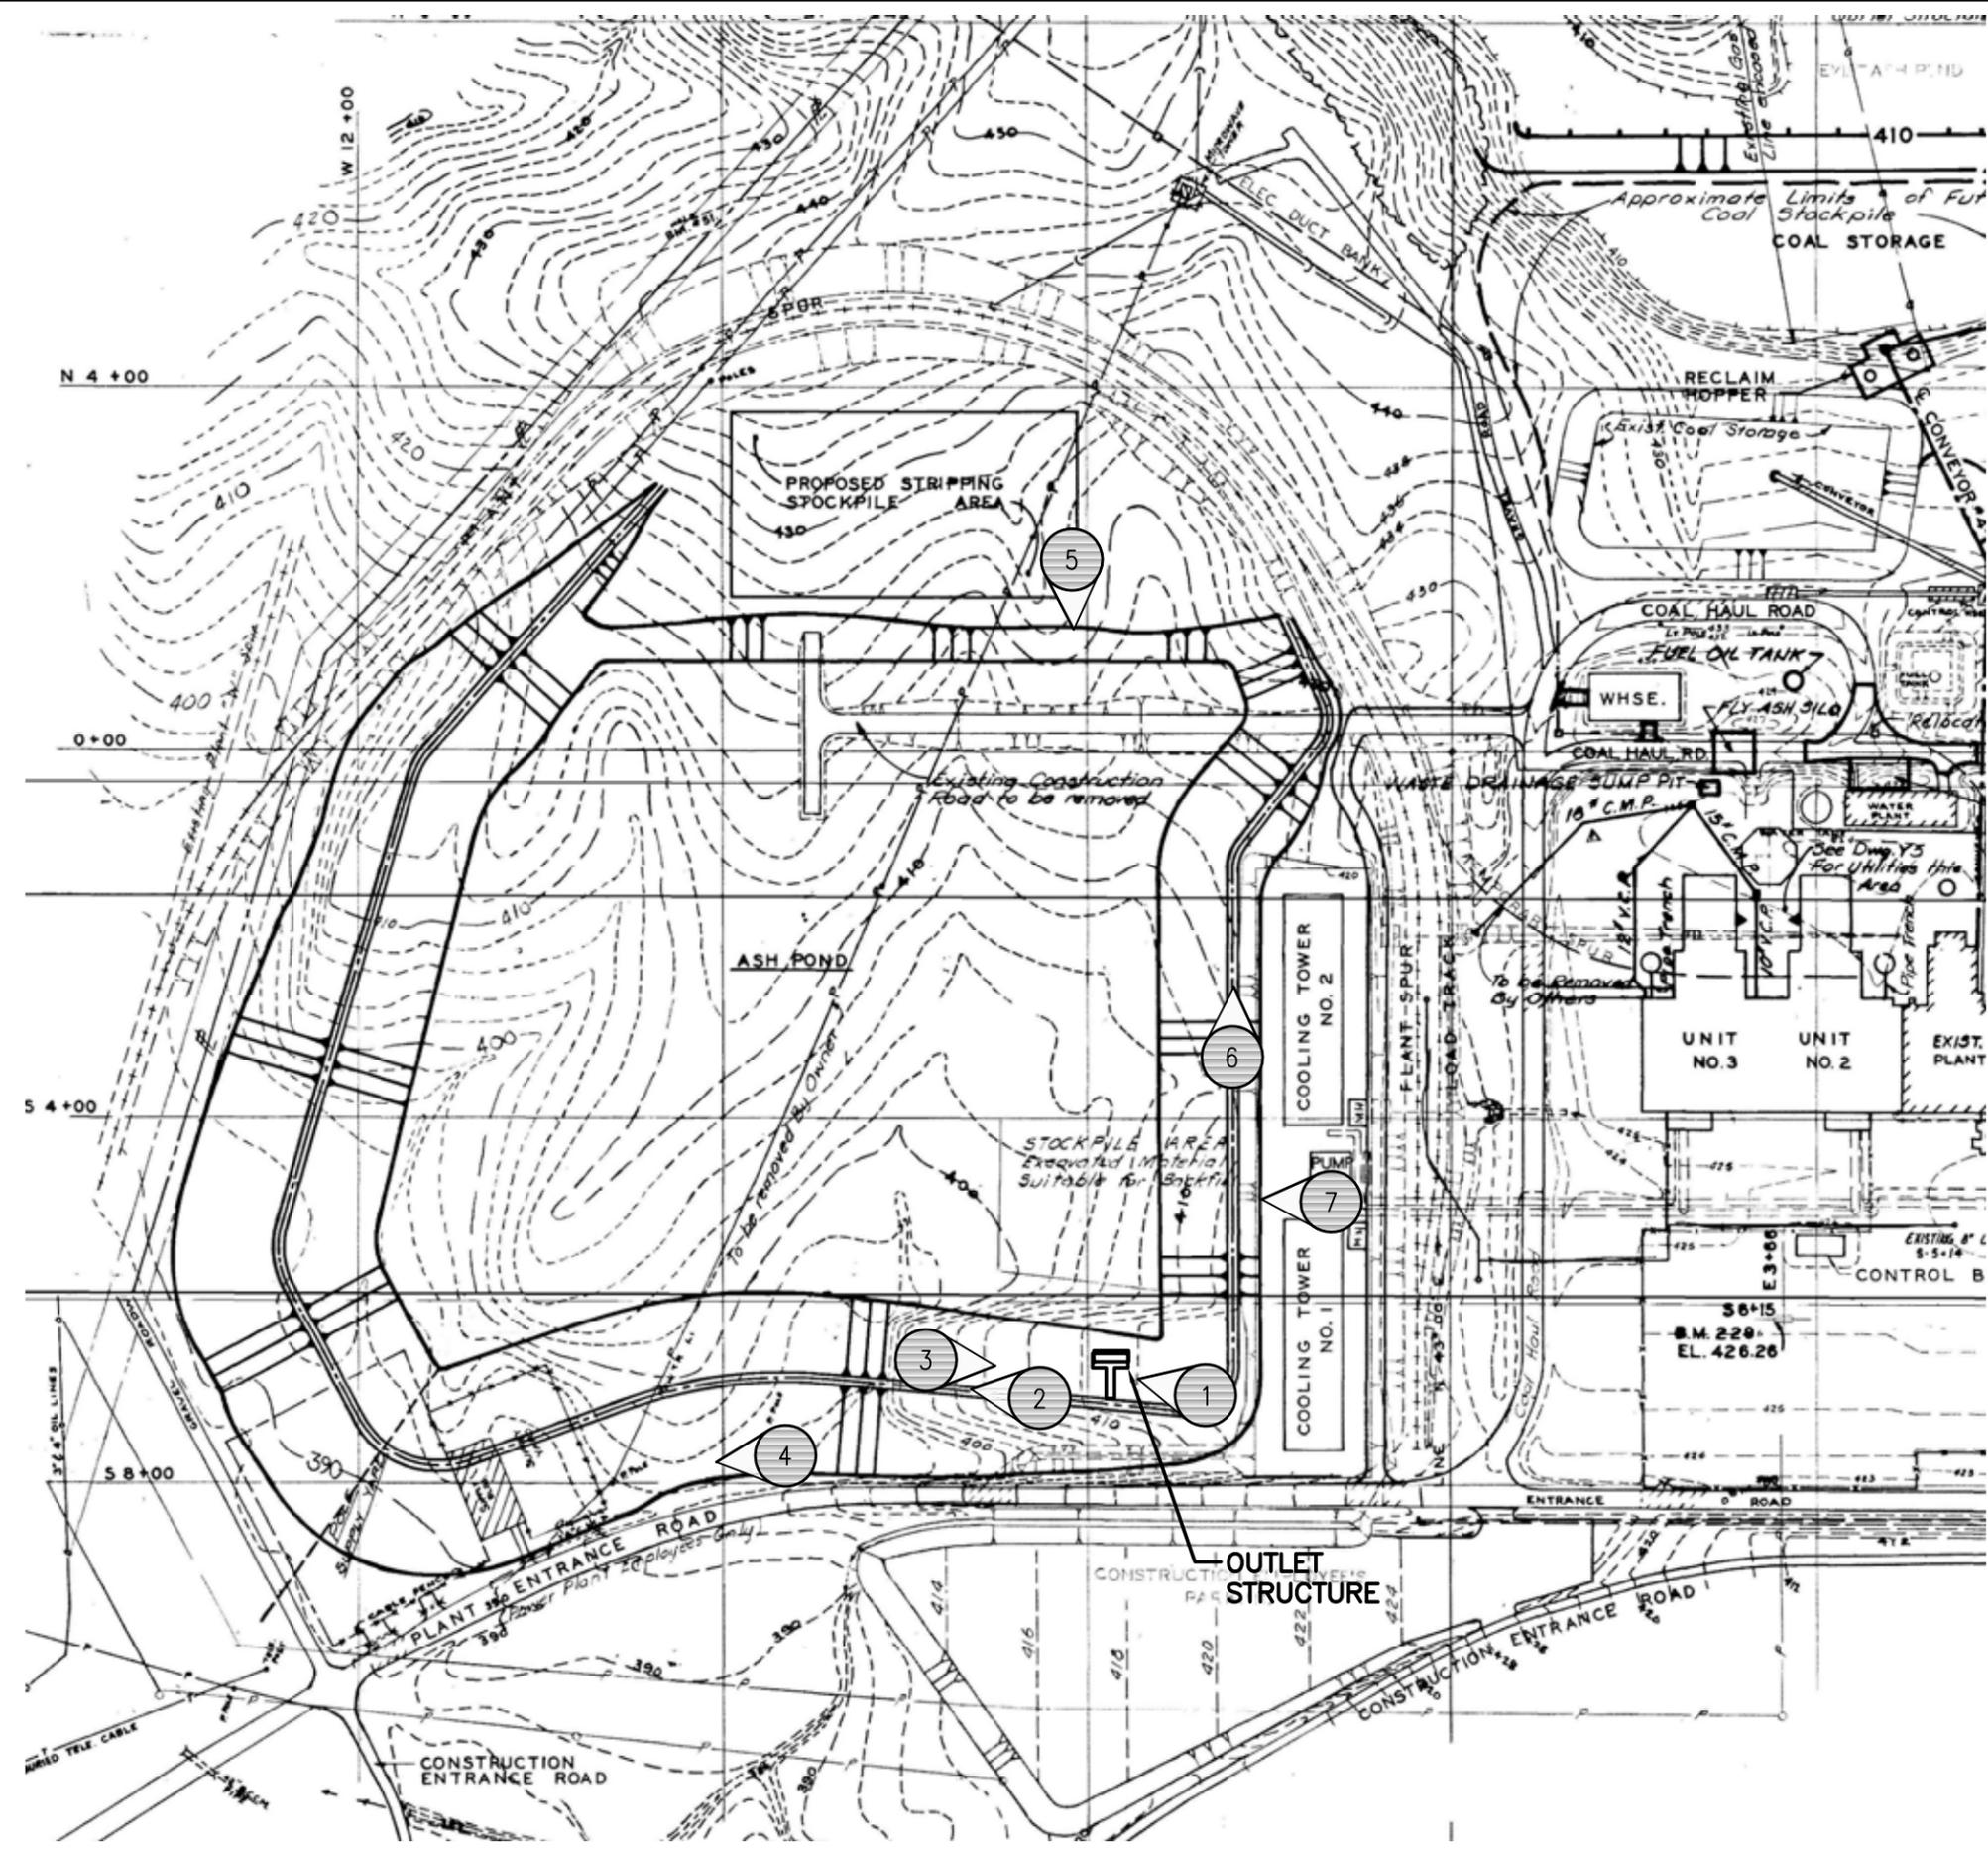
FIGURE 3

Photos of relevant features and conditions observed during the inspection were taken by O'Brien & Gere and are provided in Appendix B and C for the Reid/HMPL Ash Pond and the Green Ash Pond, respectively. Site Plans of the Reid/HMPL Ash Pond and the Green Ash Pond are presented as Figure 3 and 4, respectively, which provide photograph locations and directions.
