**Coal Combustion Waste Impoundment
Round 6 - Dam Assessment Report**

East Bend Station (Site # 002)

Fly Ash Dike
Duke Energy
Boone County, KY

August 2010

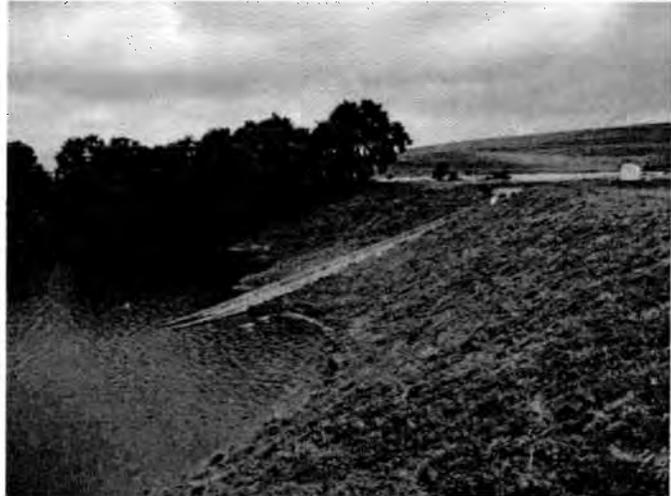
<p>Photo 1</p> <p>South slope of north abutment with landfill runoff inlet structure, photo facing west.</p>

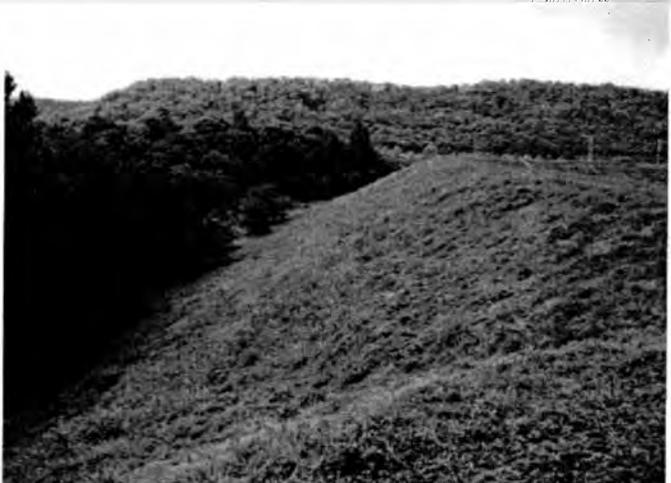
<p>Photo 2</p> <p>Downstream slope of east embankment, photo facing south.</p>

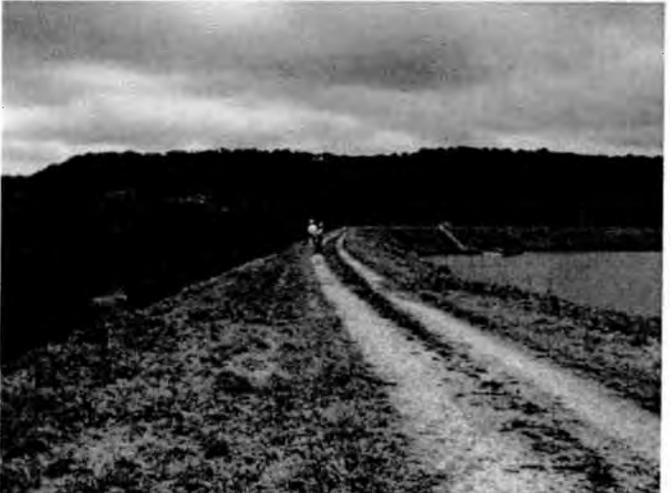
<p>Photo 3</p> <p>Crest of east embankment, photo facing south.</p>

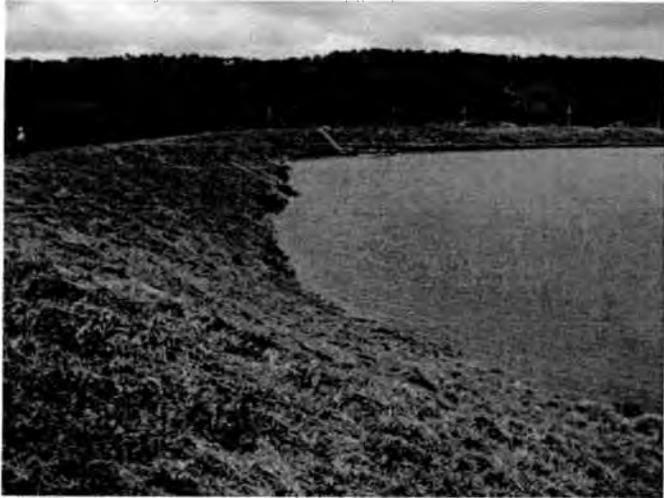
1. Light poles on downstream slope along the crest of south and west embankments;
2. Minor to excessive erosion from wave action was observed along the east and south embankment upstream slopes (see Photos 4, 14 and 18);

<p>Photo 4 Inboard slope of east embankment, photo facing south.</p>

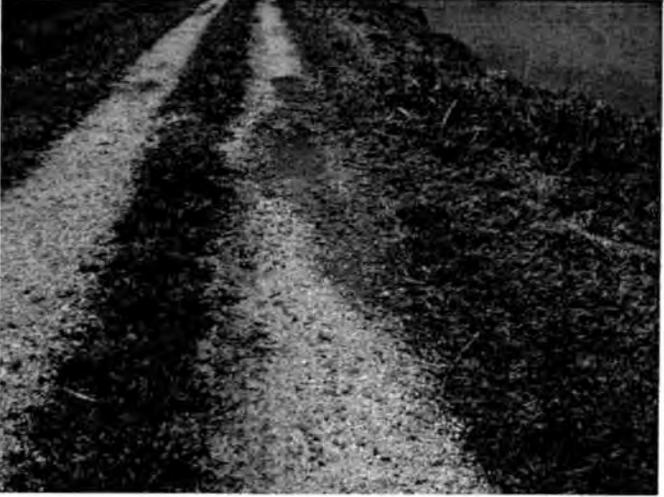
3. Minor low areas observed in gravel areas on the embankment crest (see Photo 5);
4. Approximately 350 linear feet of rip rap placed as wave action armor on upstream slope of the east embankment (see Photo 6);

<p>Photo 5 Low area along crest of east embankment.</p>

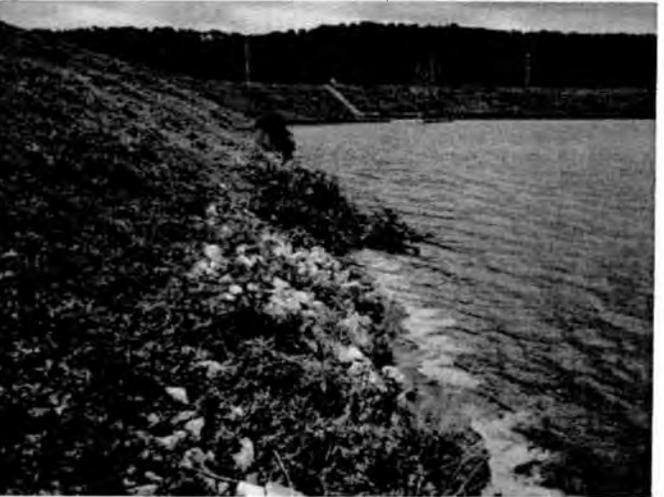
<p>Photo 6 Rip rap placed to remediate wave action erosion on the inboard slope of the east embankment, photo facing south.</p>

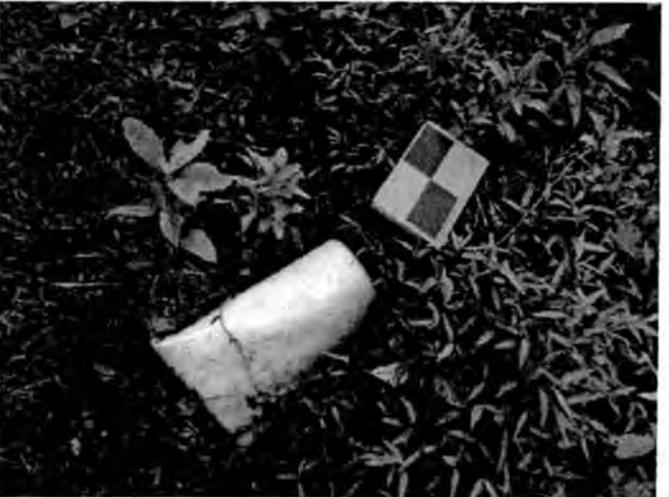
6. Marsh area was observed beyond the toe of the east embankment (see Photo 8);
7. Scrap pipe located along the toe of the east embankment (see Photo 9);

<p>Photo 9 Existing scrap pipe located near toe of the east embankment.</p>

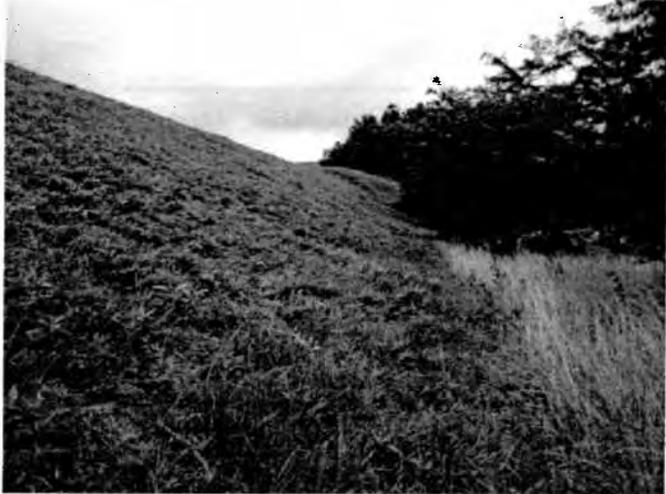
<p>Photo 10</p> <p>Toe of east embankment, photo facing north.</p>

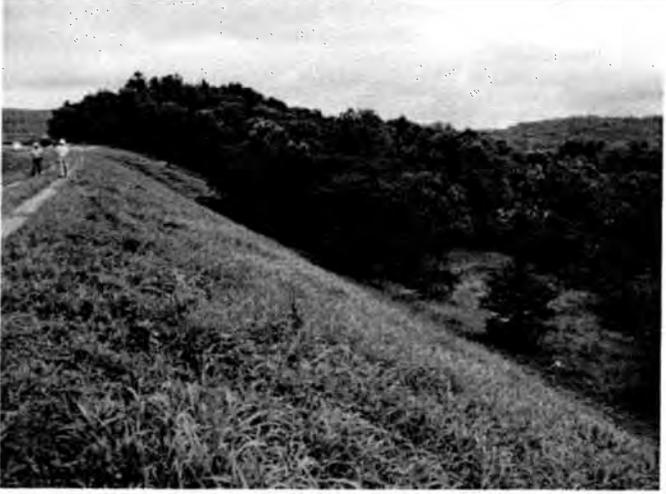
<p>Photo 11</p> <p>Downstream slope of east embankment, photo facing north.</p>

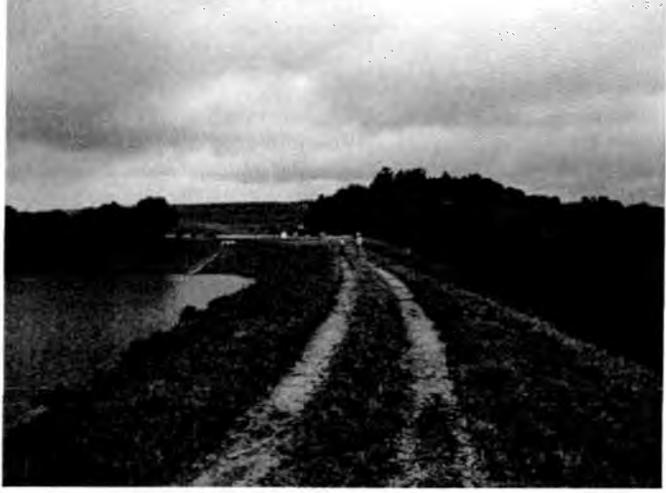
<p>Photo 12</p> <p>Crest of embankment, south photo facing east.</p>

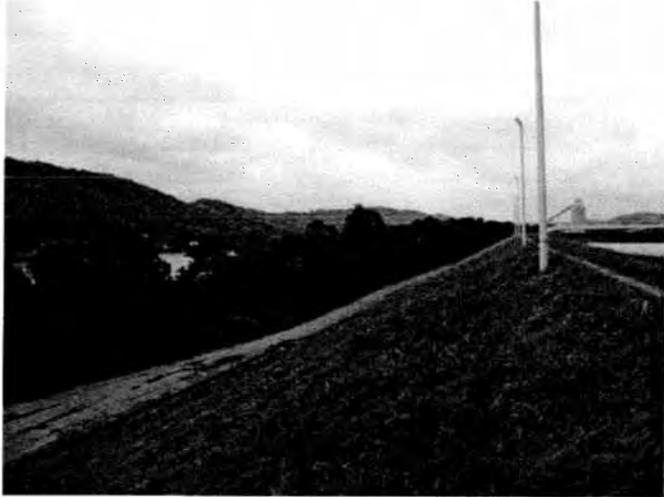
5. Excessive vegetation beyond the toe of the east embankment (see Photo 7) and on the downstream slope below the access road running along the toe of the south embankment (see Photos 16 and 17);

<p>Photo 16</p> <p>Downstream slope of south embankment, photo facing west.</p>

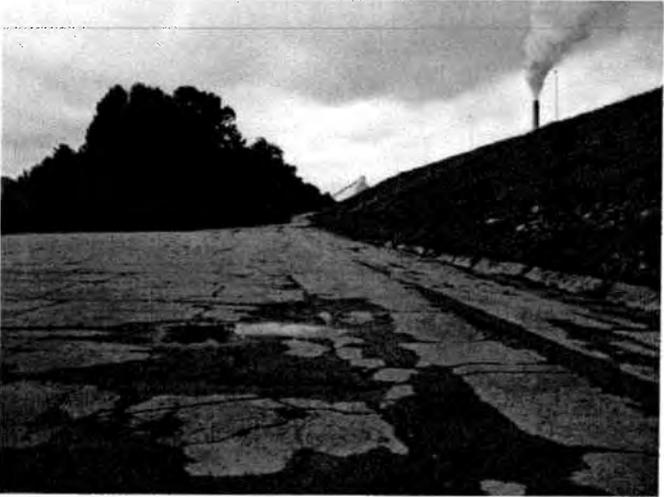
A black and white photograph showing a grassy embankment sloping downwards from the right towards the left. In the background, there are trees and a utility pole.
<p>Photo 17</p> <p>Toe of south embankment, photo facing west.</p>

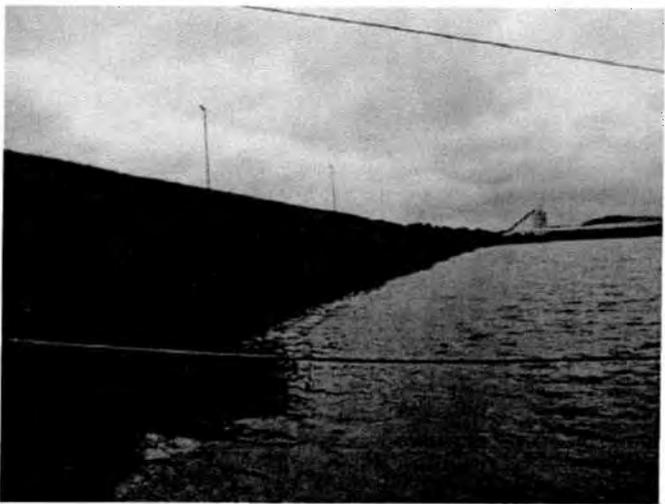
A black and white photograph of a paved road or path leading towards a large, dark embankment on the right. A smokestack is visible in the distance against a cloudy sky.
<p>Photo 18</p> <p>Wave action erosion on the upstream slope of the south embankment, photo facing west.</p>

Impoundment:				
Pool level	()	(X)	()	Normal pool levels observed to be greater than 10 feet below embankment crest(s)
Wave action protection	()	()	(X)	Observed toe erosion along east and south embankments
Inlet Structure:				Type: Multiple inlets from the plant and landfill
Structure condition	()	(X)	()	
Debris	(X)	()	()	None observed
Valves	()	(X)	()	Appear to be operating
Outlet Structure:				
Structure condition	()	()	()	Could not observe, structure was below the level of the Ohio River
Debris	()	(X)	()	None observed, portions under water
Erosion or slides in the outlet channel	()	(X)	()	None observed, portions under water
Armor around outlet	()	()	()	Could not observe
Drains:				No internal drains observed
Condition of drains	()	()	()	
Primary Spillway Structure:				Type: Pipe and riser structure
Spillway condition	()	(X)	()	No obstructions observed around inlet pipe. Observed flowing water in downstream riser pipes

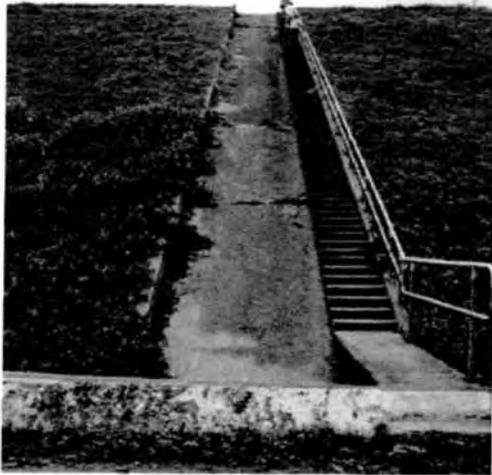
8. Minor vegetation within the concrete drainage channel and emergency spillway (see Photos 24 and 26);
9. Excessive vegetation at the mouth of the concrete channel located along the toe of the south embankment (see Photo 27);

<p>Photo 24</p> <p>Emergency spillway channel on south embankment, photo facing north.</p>

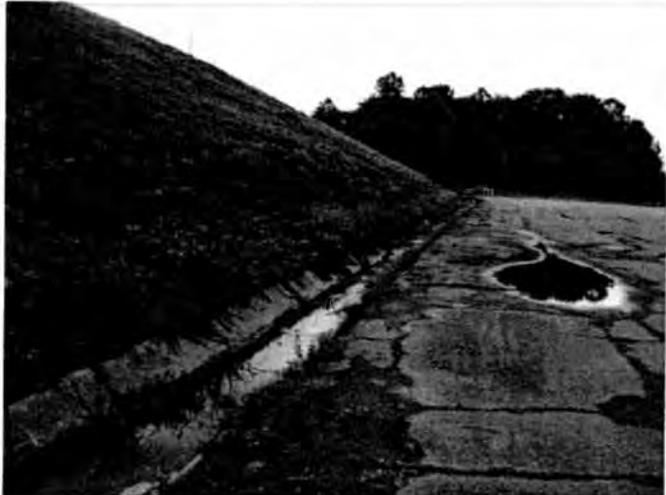
<p>Photo 26</p> <p>Emergency spillway channel along toe of south embankment, photo facing east.</p>

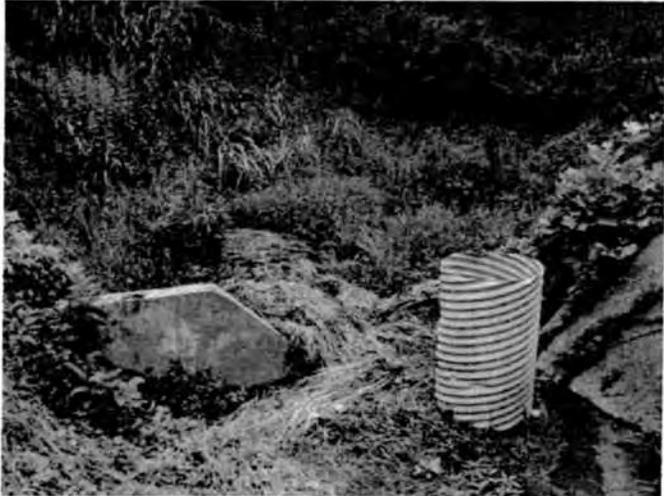
<p>Photo 27</p> <p>Emergency spillway channel mouth and vertical riser for the outlet pipe along toe of south embankment, photo facing east.</p>

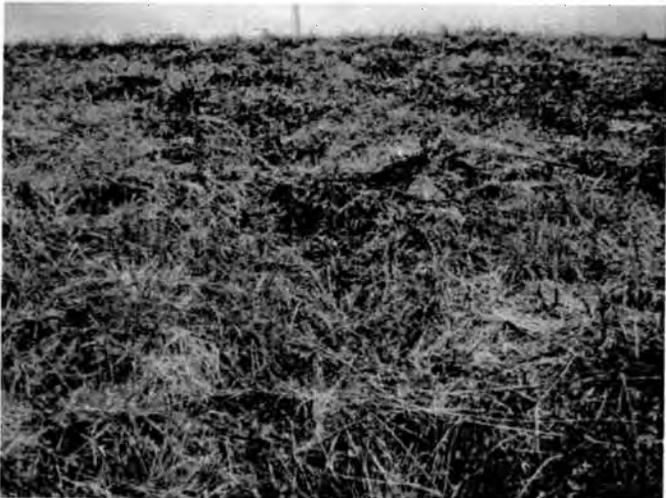
10. Minor erosion channels were observed on the upstream slopes of the east and south embankments (see Photo 31);
11. Inlet channel flowing adjacent to the south embankment (see Photo 33);
12. Rip rap placed on upstream slope of the west embankment (see Photos 40, 42 and 45);
13. Low area on the downstream slope of the west embankment, adjacent to the crest (see Photo 44).

<p>Photo 31</p> <p>Erosion channel on the upstream slope of the south embankment, photo facing south.</p>

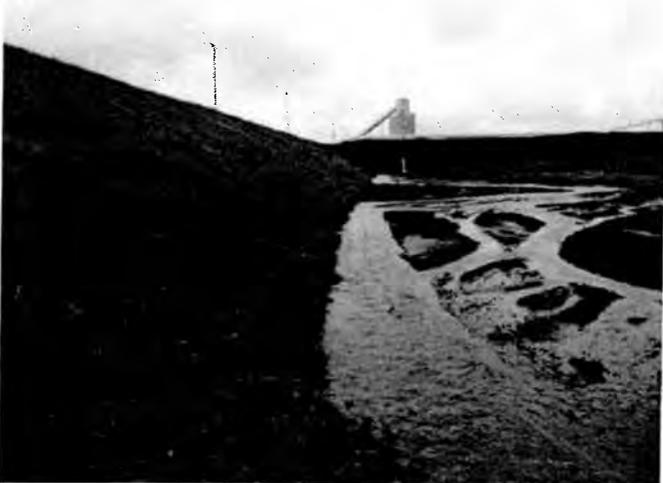
<p>Photo 33</p> <p>Inlet channel flowing through the ash along the south embankment, photo facing west.</p>

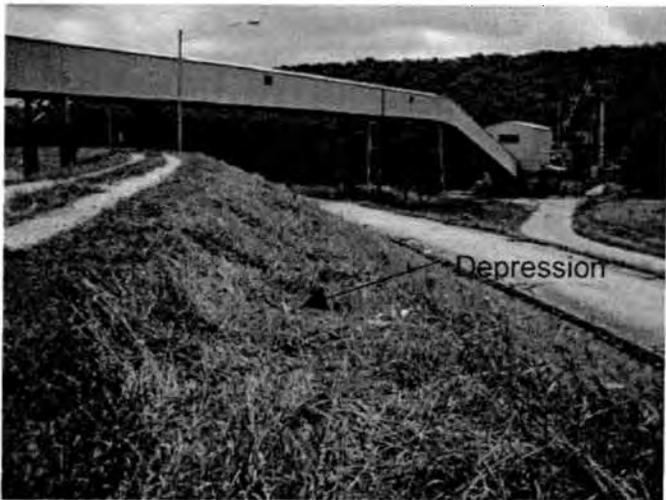
<p>Photo 41</p> <p>Depression on the downstream slope of the west embankment, photo facing southeast.</p>

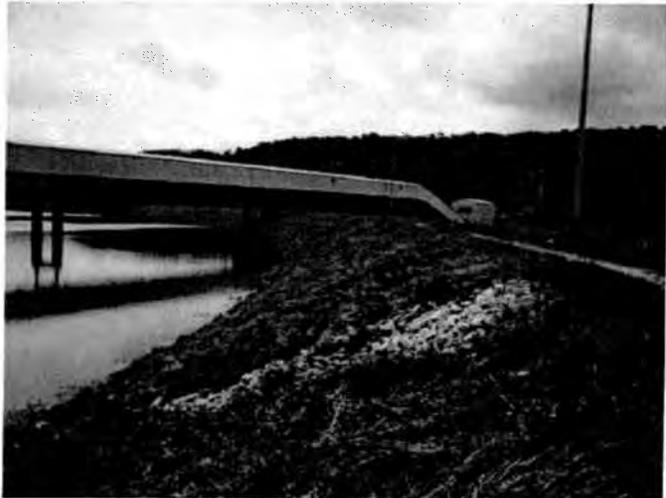
<p>Photo 42</p> <p>Upstream slope of west embankment, photo facing southeast.</p>

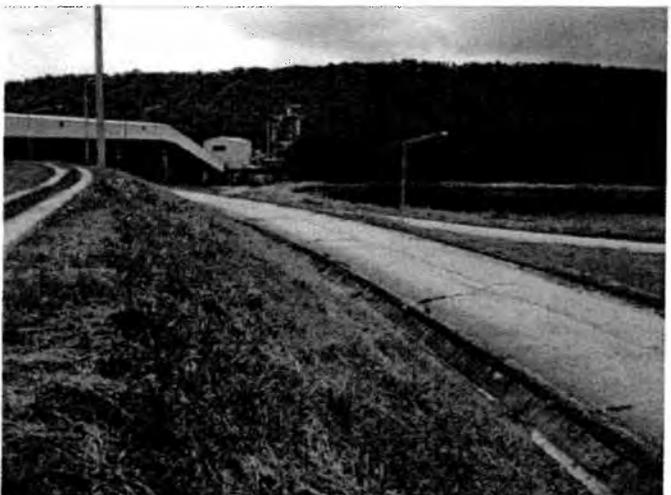
<p>Photo 44 Low area on the downstream slope of west embankment, photo facing southeast.</p>

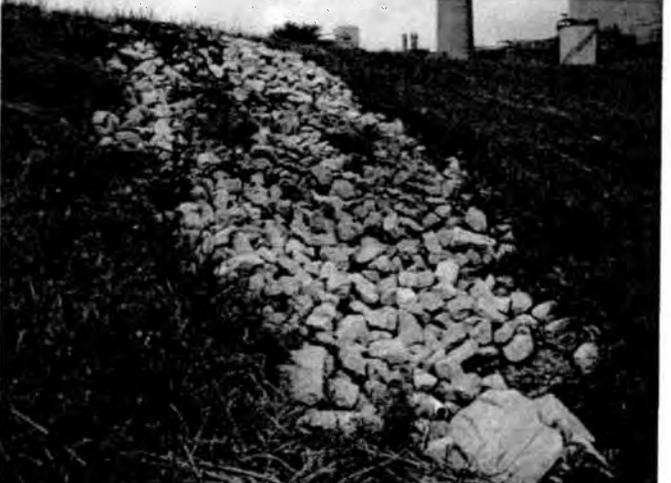
<p>Photo 45 Rip rap placed on the upstream slope of the west embankment at the inlet from the wastewater structure, photo facing west.</p>
