Assessment of Dam Safety Coal Combustion Surface Impoundments (Task 3) Final Report

Louisville Gas &
Electric Company
(A subsidiary of E.ON U.S.)

Cane Run Power Station
Louisville, Kentucky

April 16, 2010

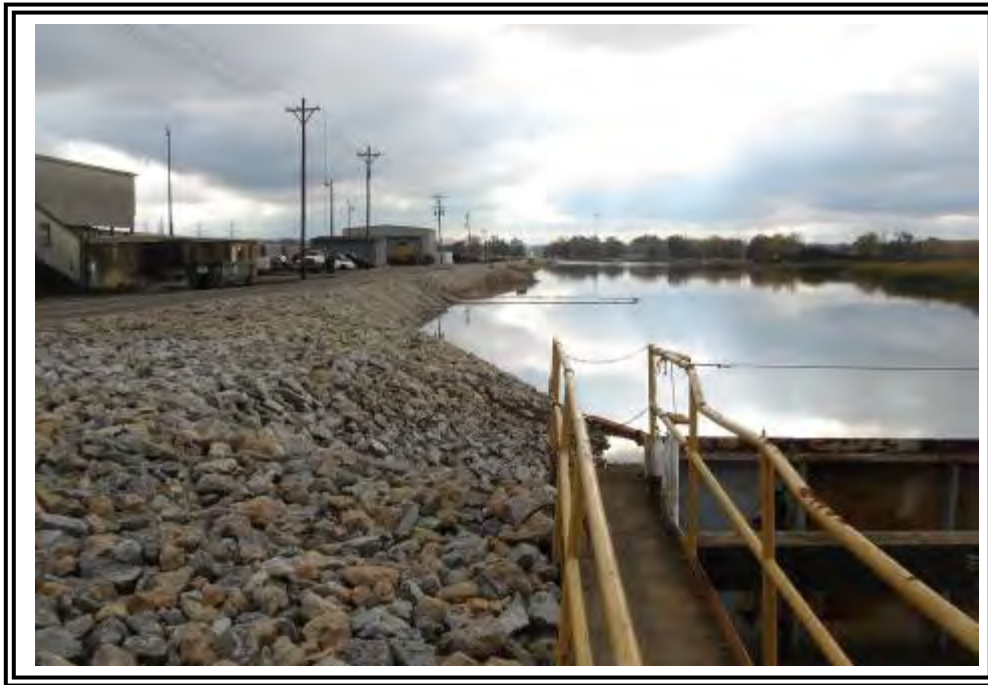
9

Upstream slope of ATB north dike looking east from outlet structure.

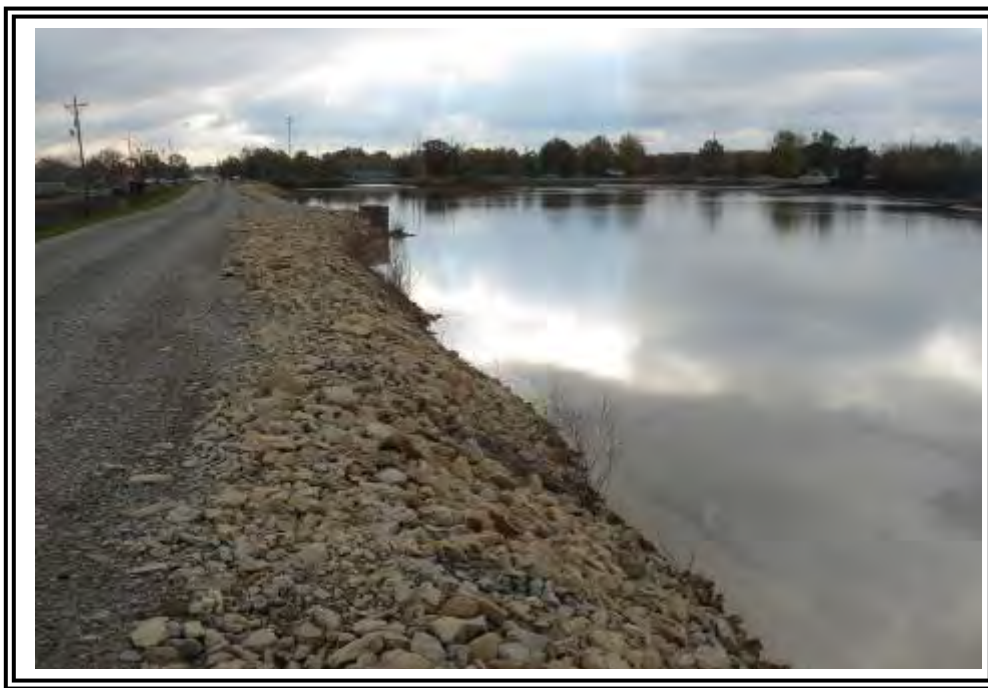
10

Upstream slope and crest of ATB north dike looking east.

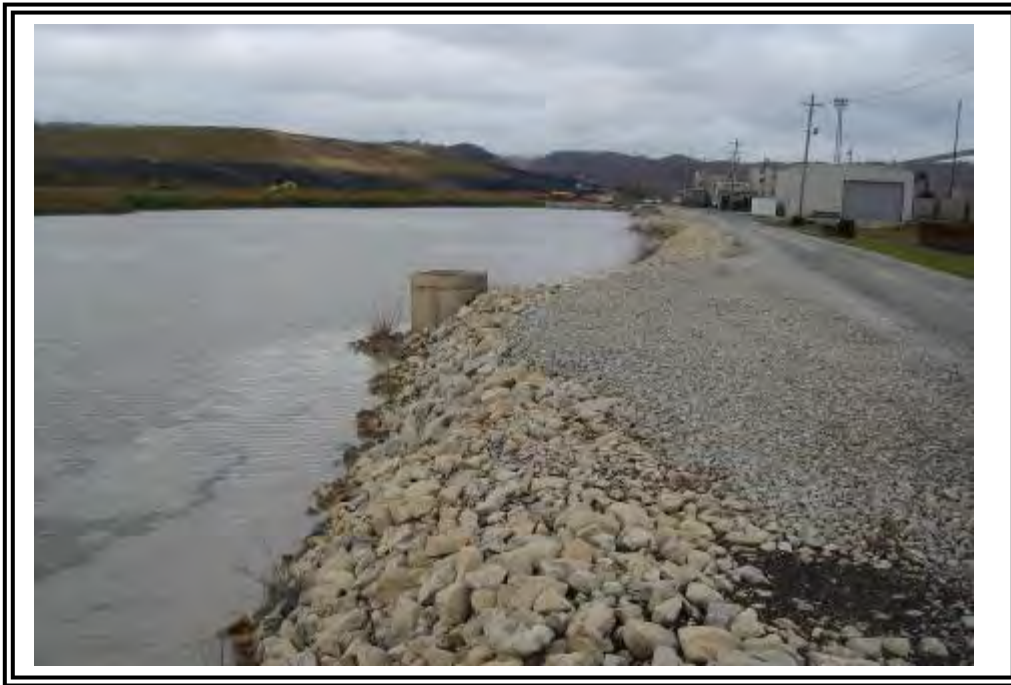
11

Upstream slope and crest of ATB north dike looking west.

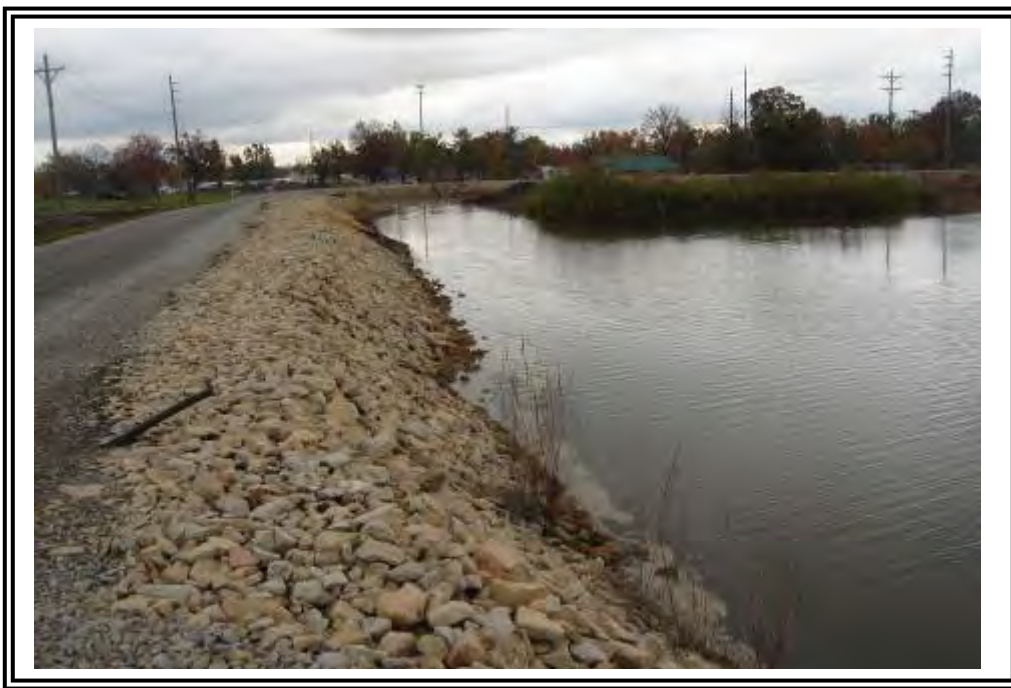
12

Upstream slope and crest of ATB north dike looking east near east corner.

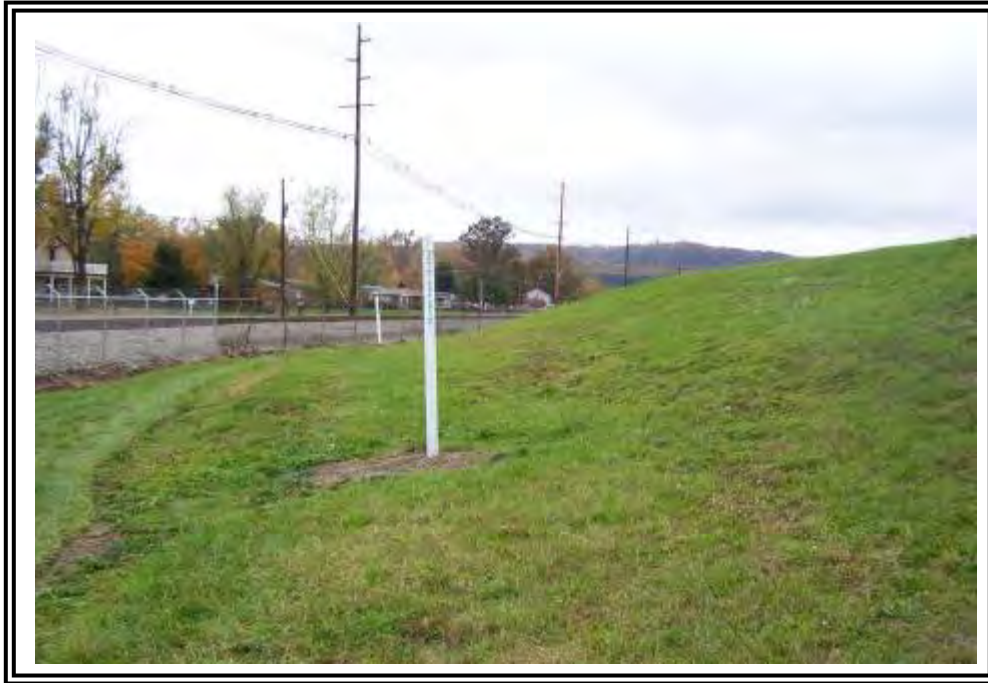
15

Downstream slope of ATB east dike at southwest corner.
White markers indicate the location of a high pressure gas line installed in 2005.

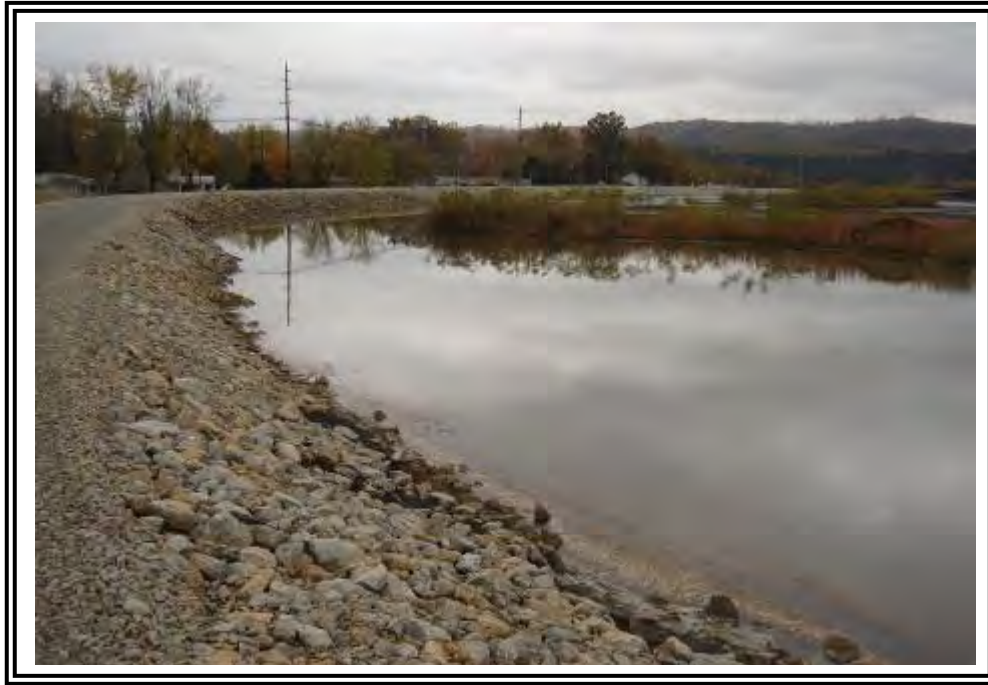
17

Upstream slope of ATB east dike looking south.

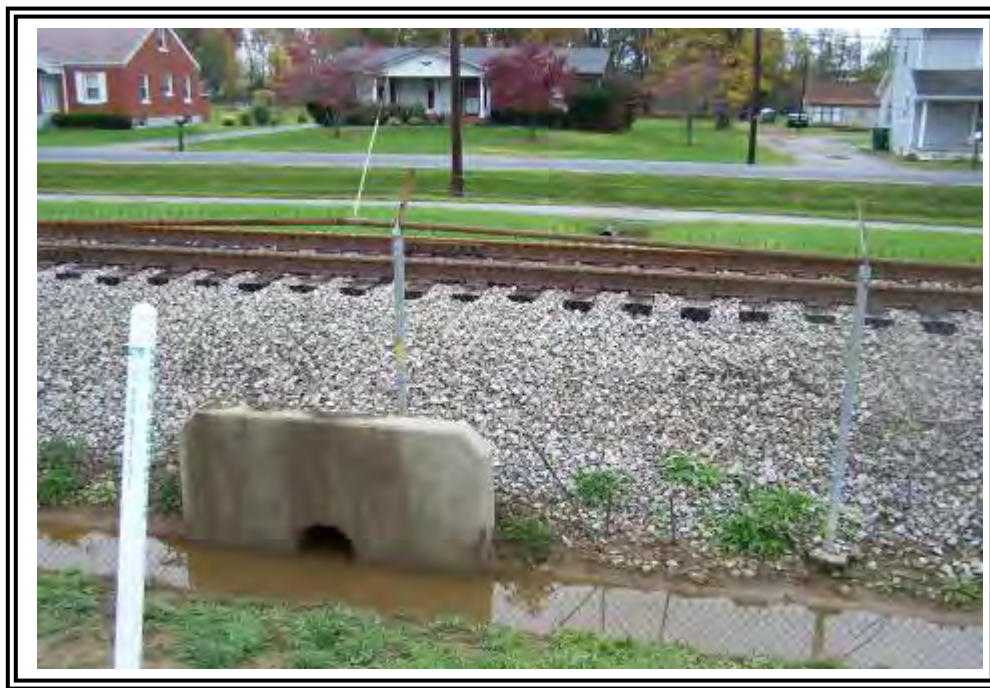
20

The gas line continues along the downstream toe of the south dike as shown in Photo 18. Photo 21 shows slight settlement which has occurred over the gas line in this area. Photo 19 shows a concrete lined swale running along the toe, which intercepts storm water and carries it to a culvert running under the adjacent railroad embankment (Photo 20). Photos 21 to 24 show the surface treatment and condition of both the upstream and downstream slopes are similar to the east dike, except for the west end, where soil material for use at the landfill has been stockpiled on the upstream side of the embankment (Photo 25).

Drainage swale outlet along ATB south dike looking south.

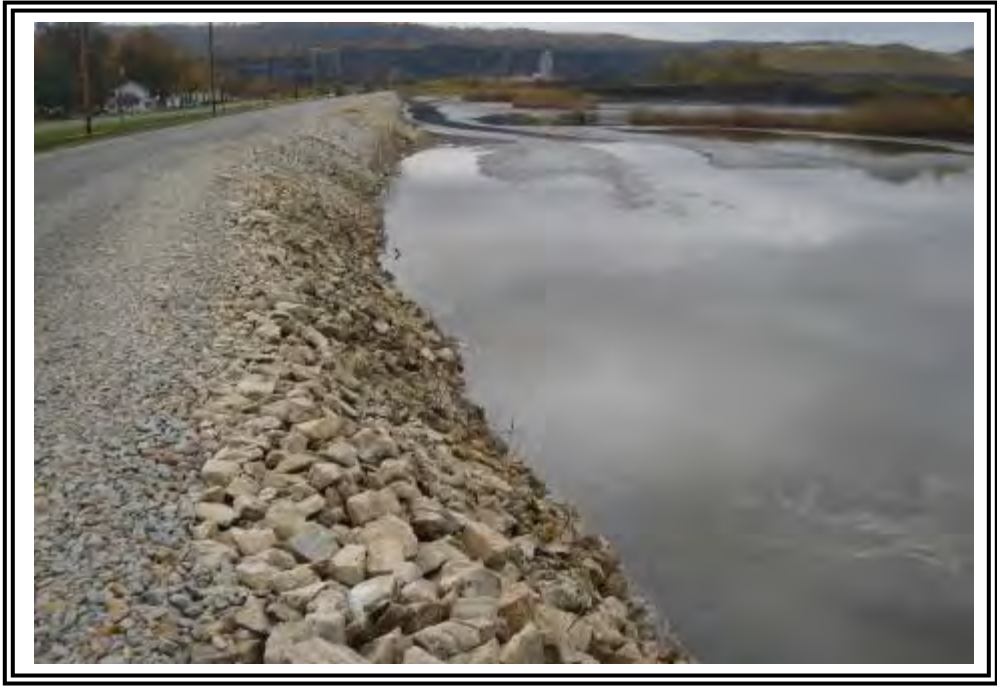
23

Upstream slope of ATB south dike looking west.

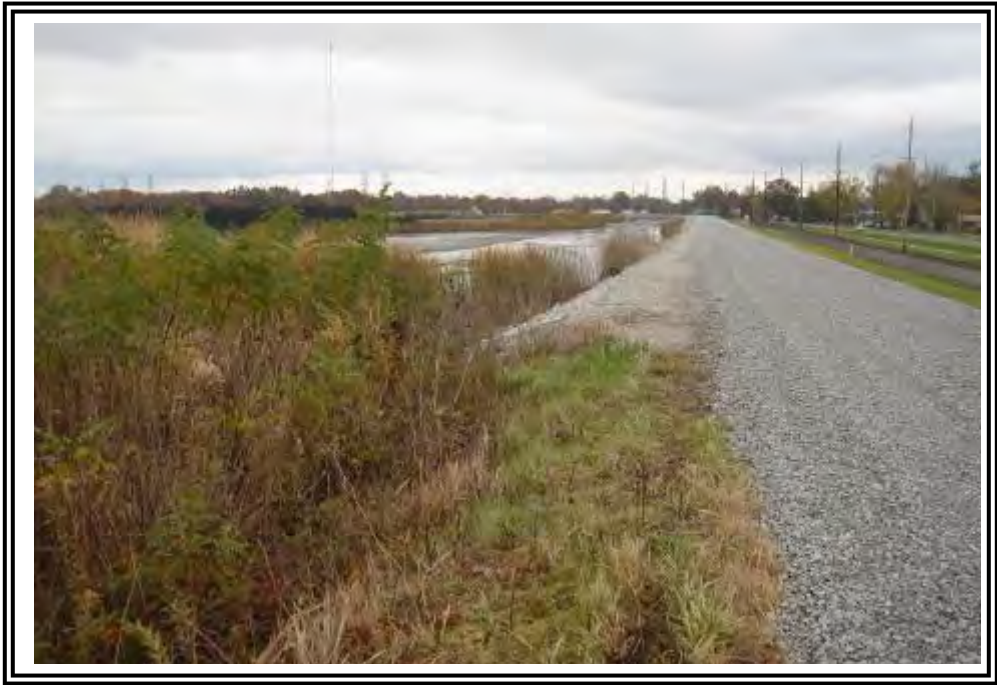
24

Crest of ATB south dike looking east.

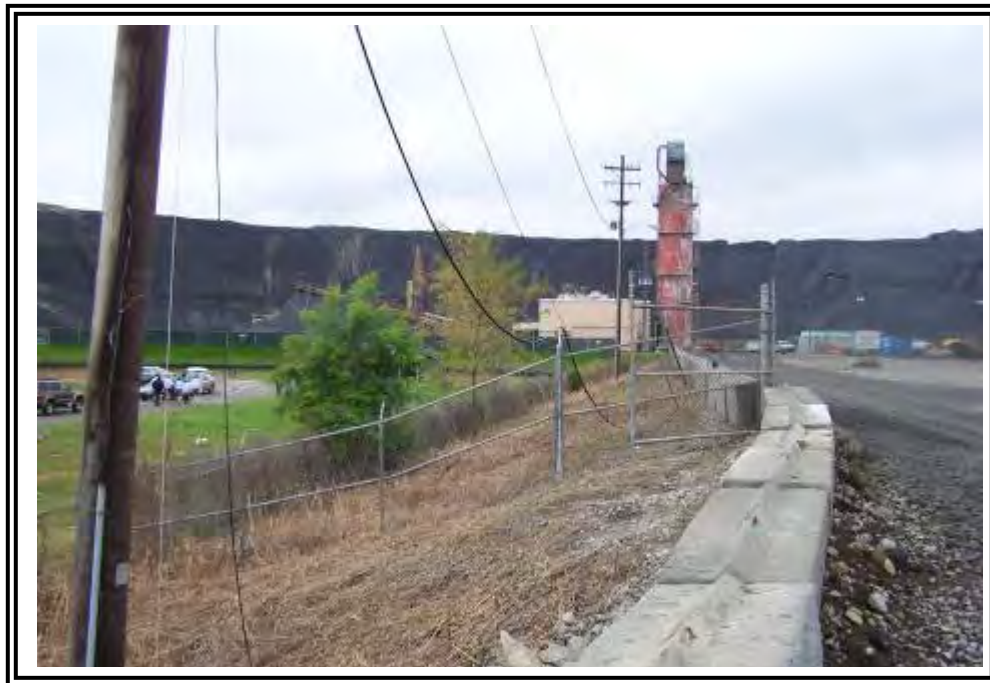
The ATB south dike continues along the E-Pond. The downstream embankment of the western 420 feet of the south dike, as shown in Photos 26 through 30, becomes over-steepened and irregular, and vegetation appears predominantly weedy. Surface probing indicated soft conditions, with up to 18" of penetration observed. A concrete barrier runs between the crest and the downstream face. Photo 29 shows several erosion rills which have developed under this barrier. Photo 31 shows the E-Pond which was excavated within previously deposited ash slightly to the northeast of the E-Pond location indicated on a 1972 proposed site plan. Storm

Downstream slope and crest of west end of ATB south dike where adjacent to the E-Pond, looking west.

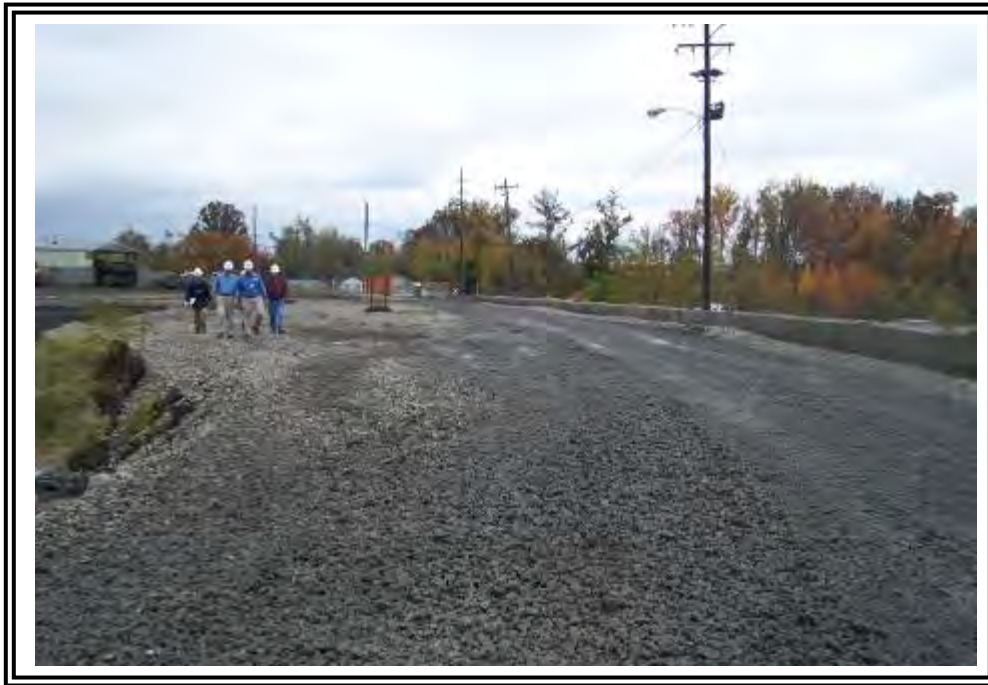
31

E-Pond (left of people) is excavated within previously deposited ash. Original ATB south dike and ash create south side of the impoundment.

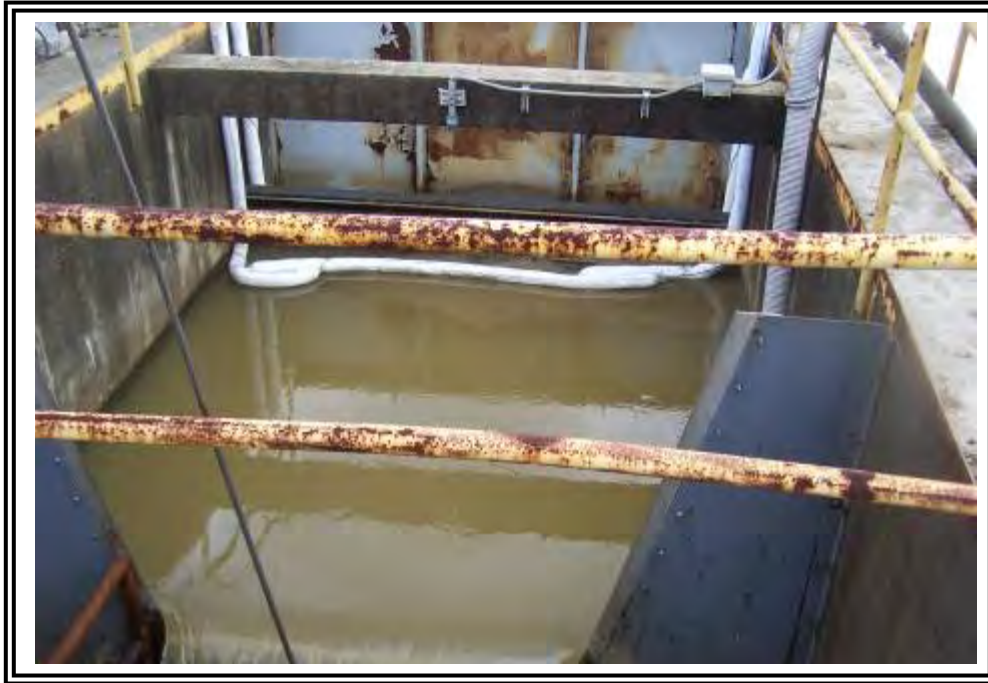
33

ATB discharge structure.

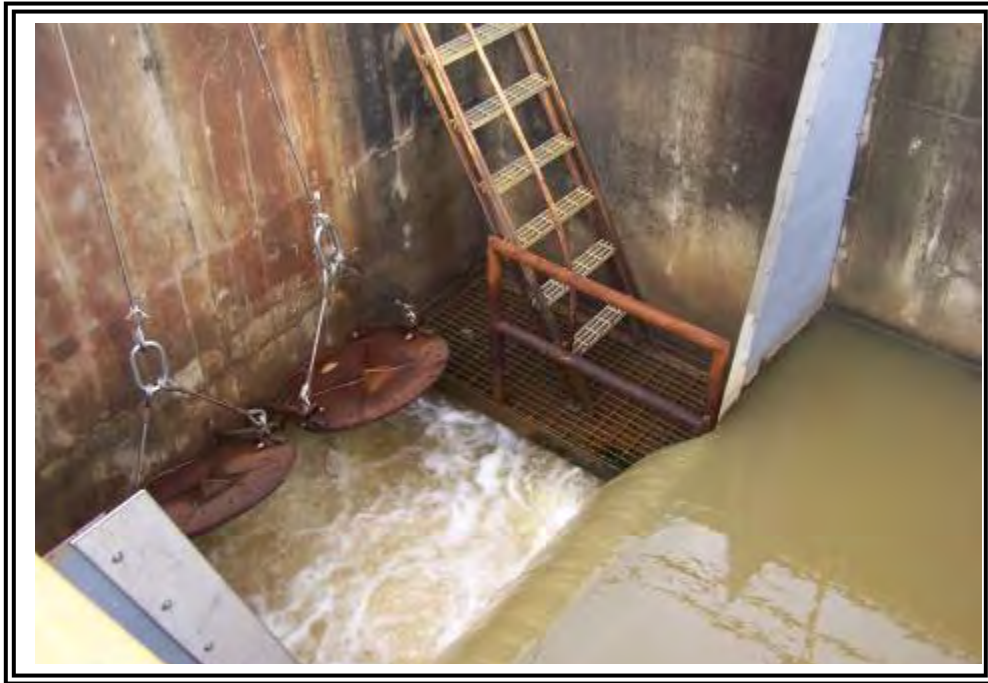
34

ATB discharge to KYPDES permitted outfall. Pipes (beyond flap gates) discharges at Ohio River.

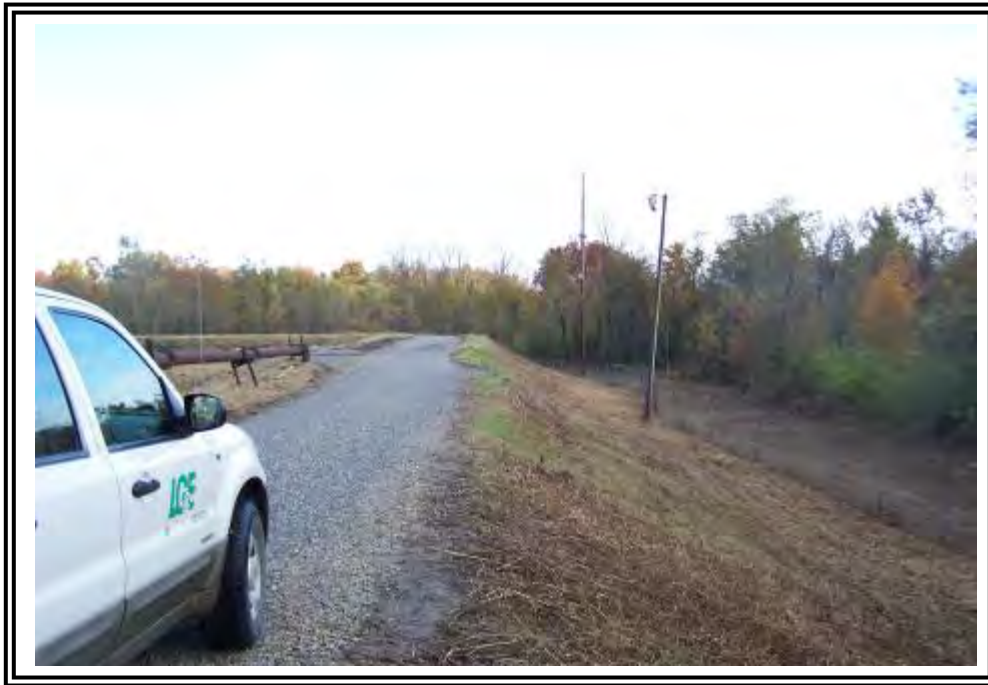
35

Crest and downstream slope of east dike at Basin/ Dead Storage Pond looking north.

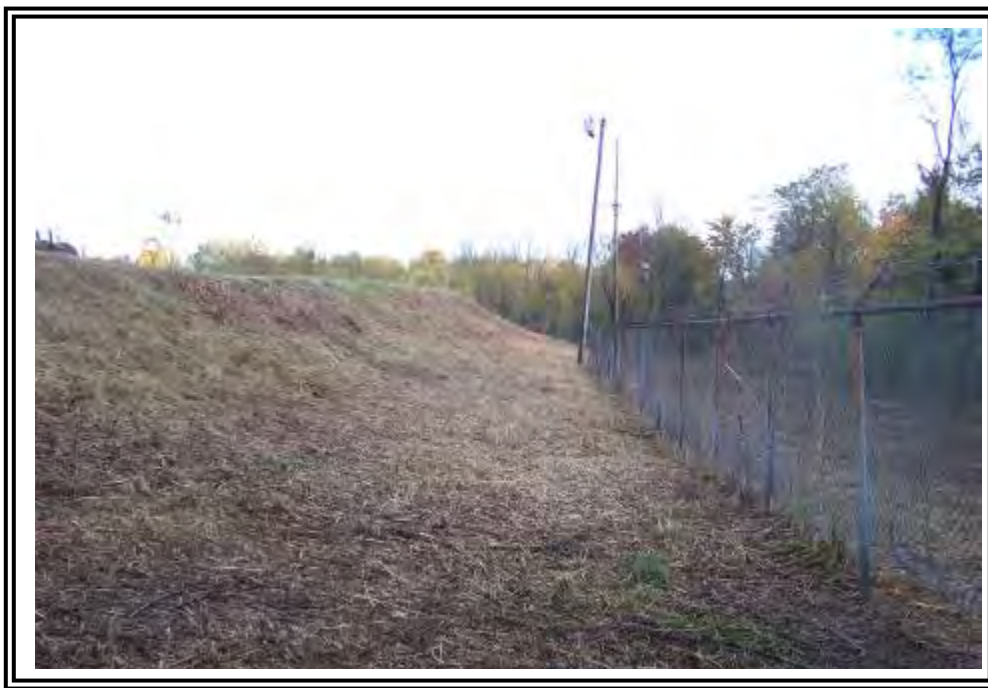
36

Downstream slope of east dike at Basin/ Dead Storage Pond at toe looking north.

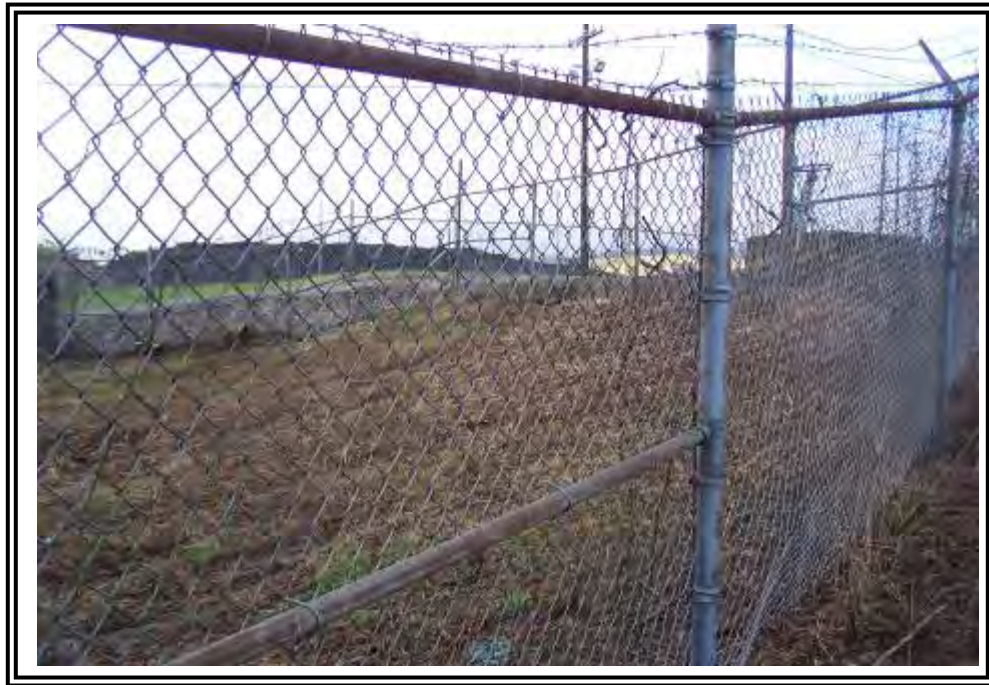
37

Looking towards south abutment at Basin/ Dead Storage Pond.

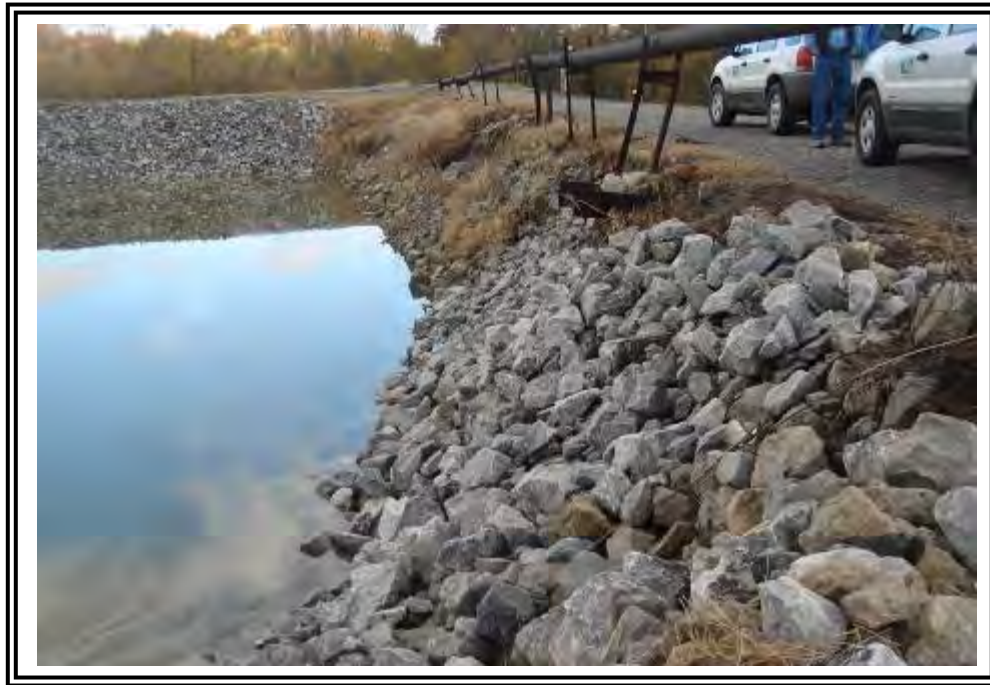
43

Upstream slope of east dike at Basin/ Dead Storage Pond looking north along south cell.

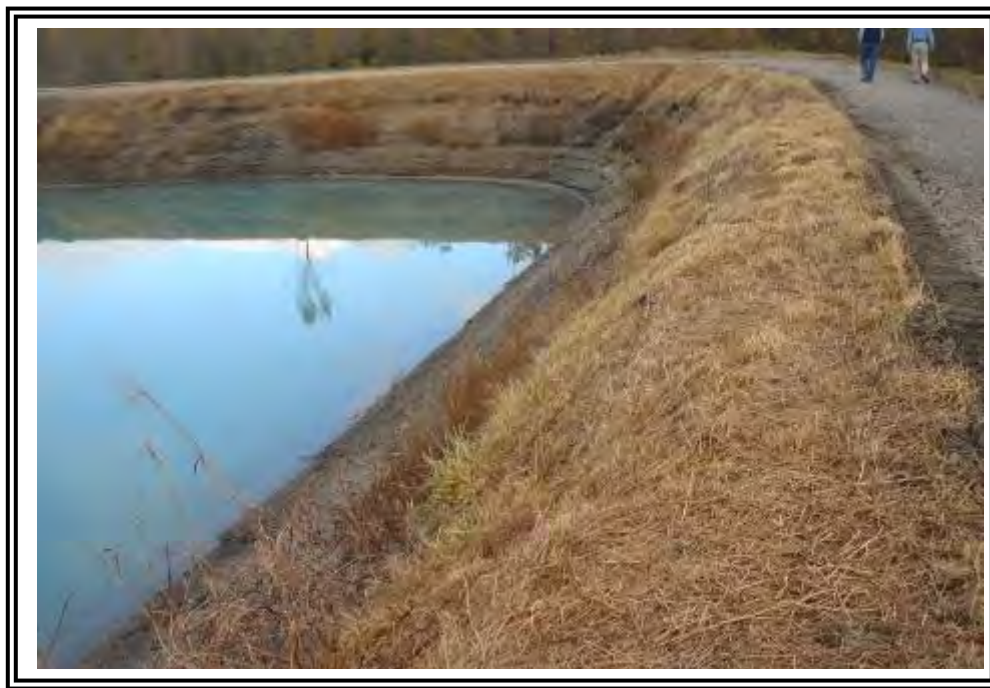
44

Upstream slope of east dike at Basin/ Dead Storage Pond looking north along north cell.

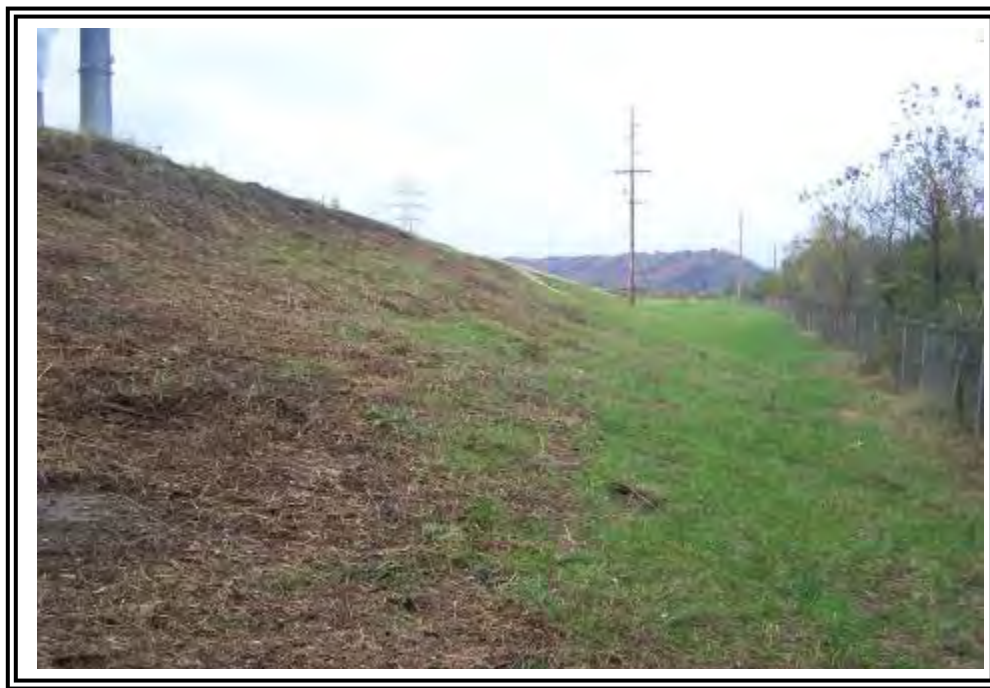
46

Surface irregularities as shown in Photos 46, 47, 50, and 51 are typical along the downstream slope of the north dike, consisting of surface slumps, erosion rills and tire ruts. Surface probing indicated firm soils approximately 9 inches below the surface. Photos 48, 49, 52, 54, and 55 show recent repairs near the north dike crest which have not yet established vegetation. Surface irregularities are also apparent on the upstream slope as shown in Photo 53.

Downstream slope of north dike at Basin/ Dead Storage Pond looking west.

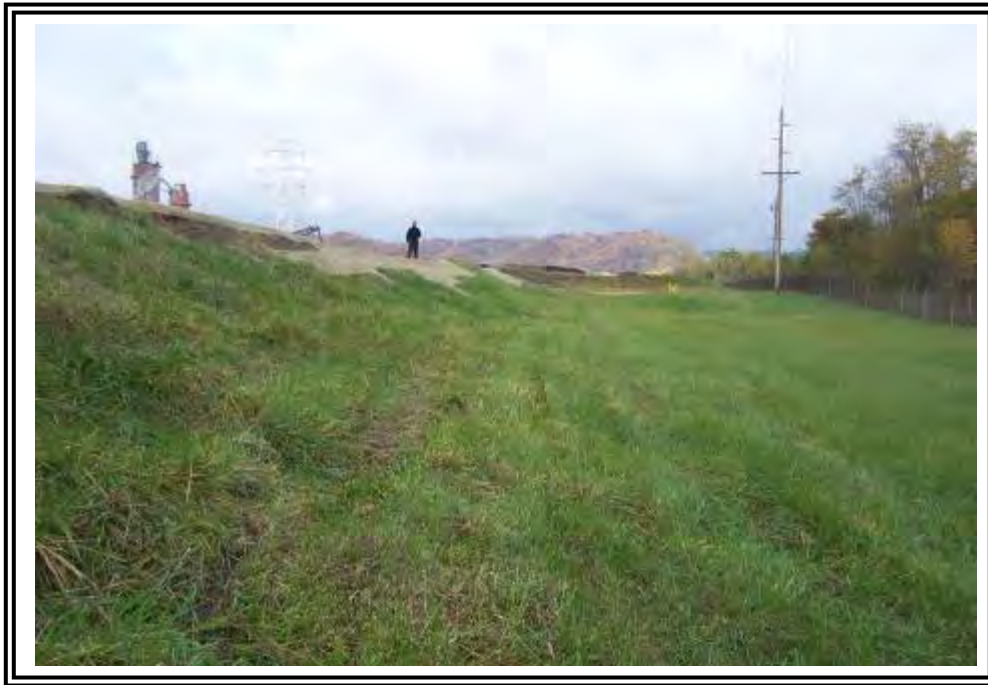
51

Downstream slope of north dike at Basin/ Dead Storage Pond looking west.

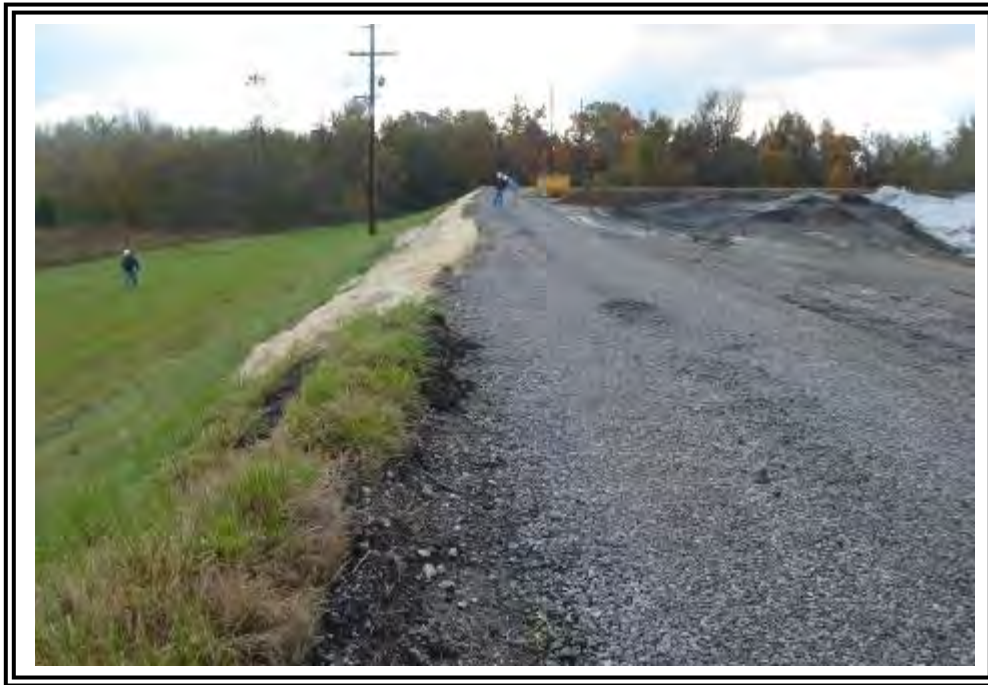
55

Crest of Basin/ Dead Storage Pond north dike looking east.
