Assessment of Dam Safety Coal Combustion Surface Impoundments (Task 3) Final Report

Kentucky Utilities

Ghent Generating Station

February 25, 2010

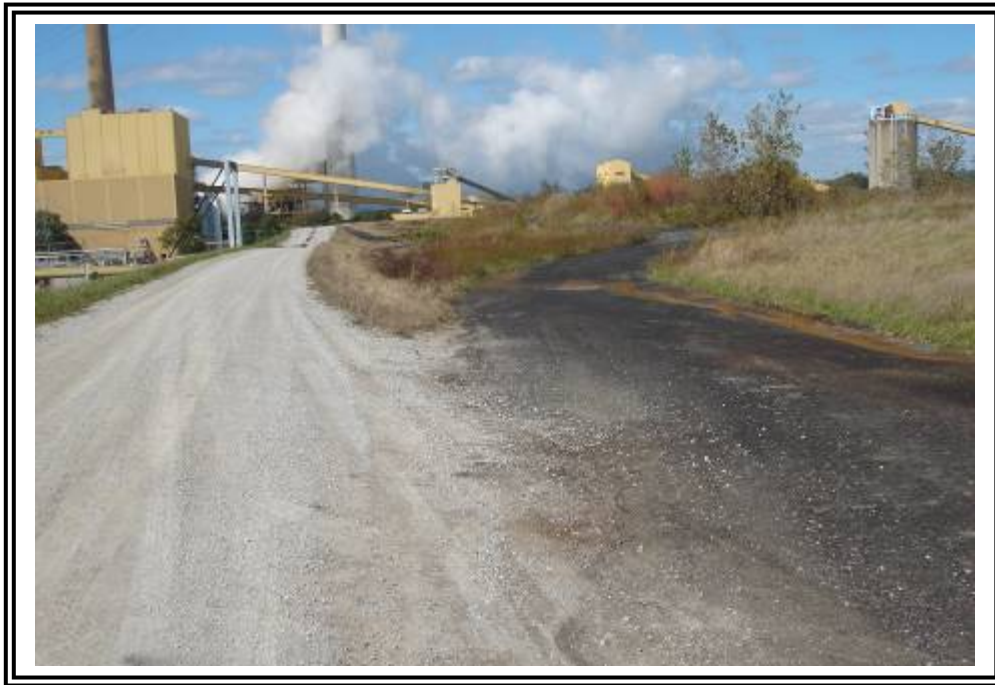
3

“Upstream” end of ATB #1 at west dike/abutment, looking north.

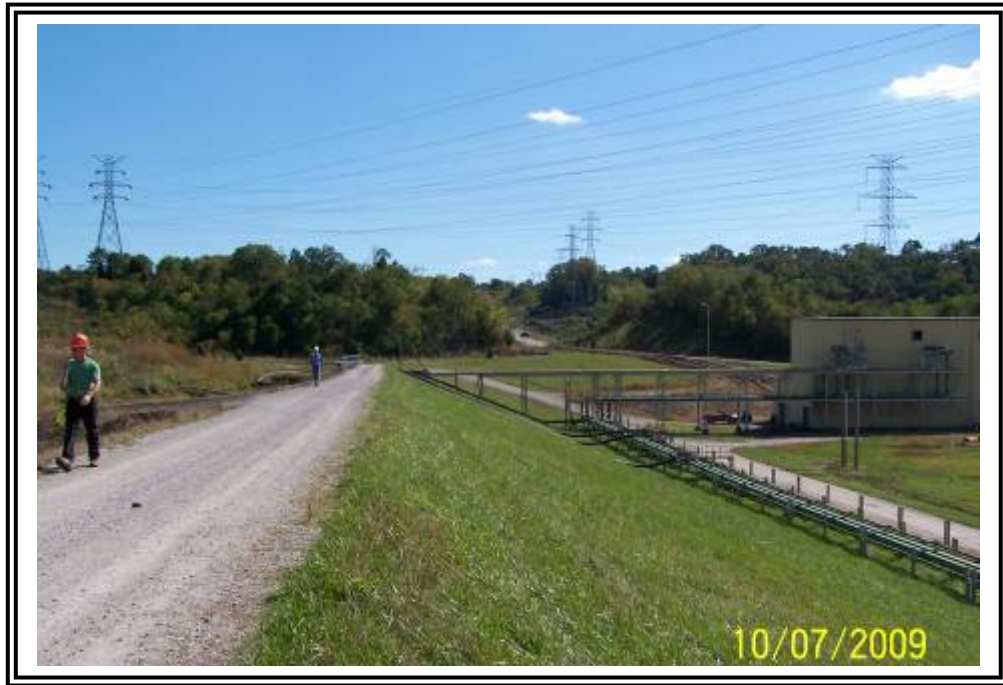
5

Downstream slope ATB #1 west dike looking south.

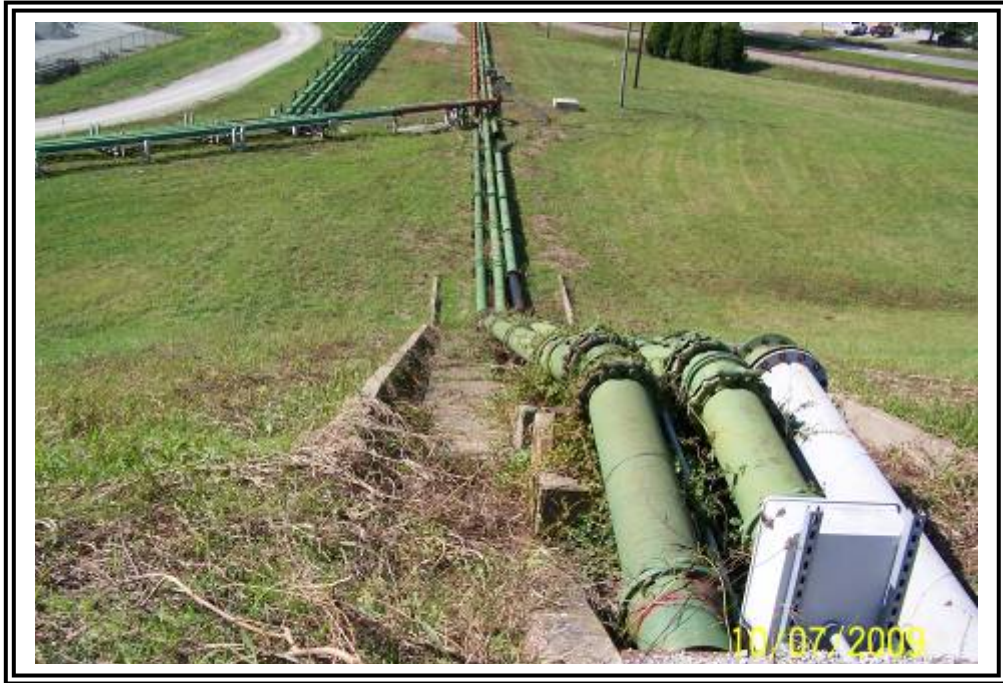
7

Utility corridor at northwest corner of ATB #1.

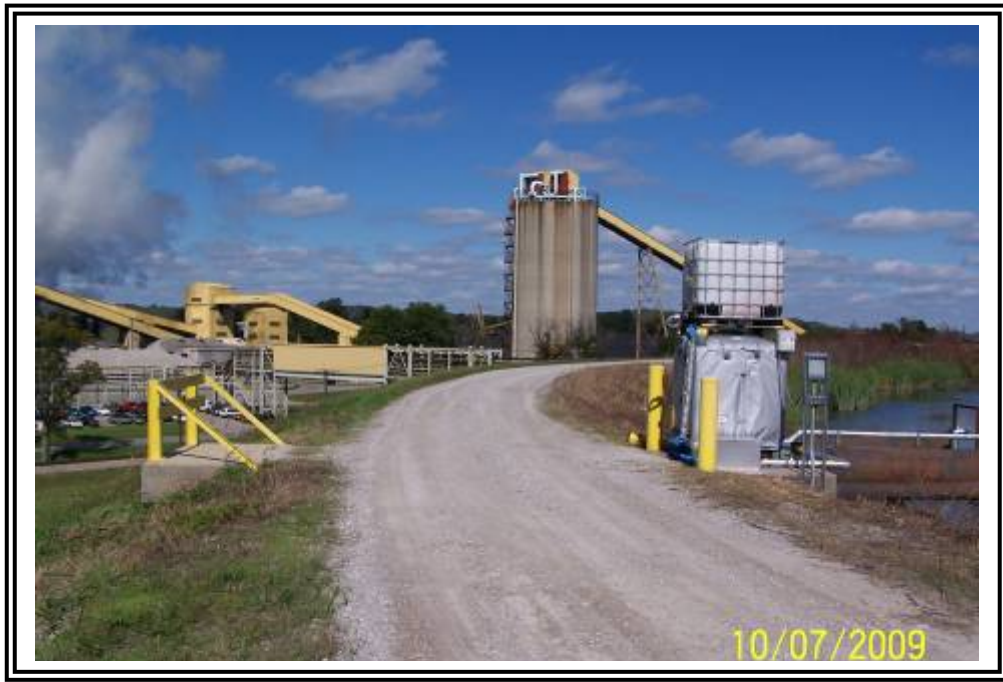
8

Crest at northwest corner of ATB #1. Station in right of photo is chemical treatment, pad at left is forklift turn around.

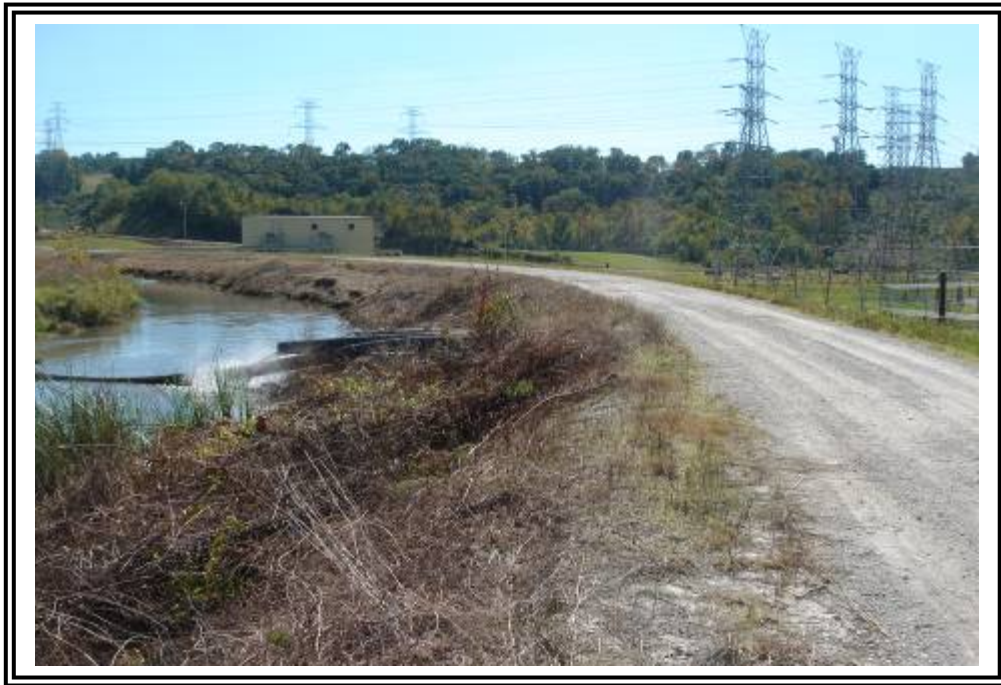
9

Upstream slope at northwest corner of ATB #1 looking southwest.

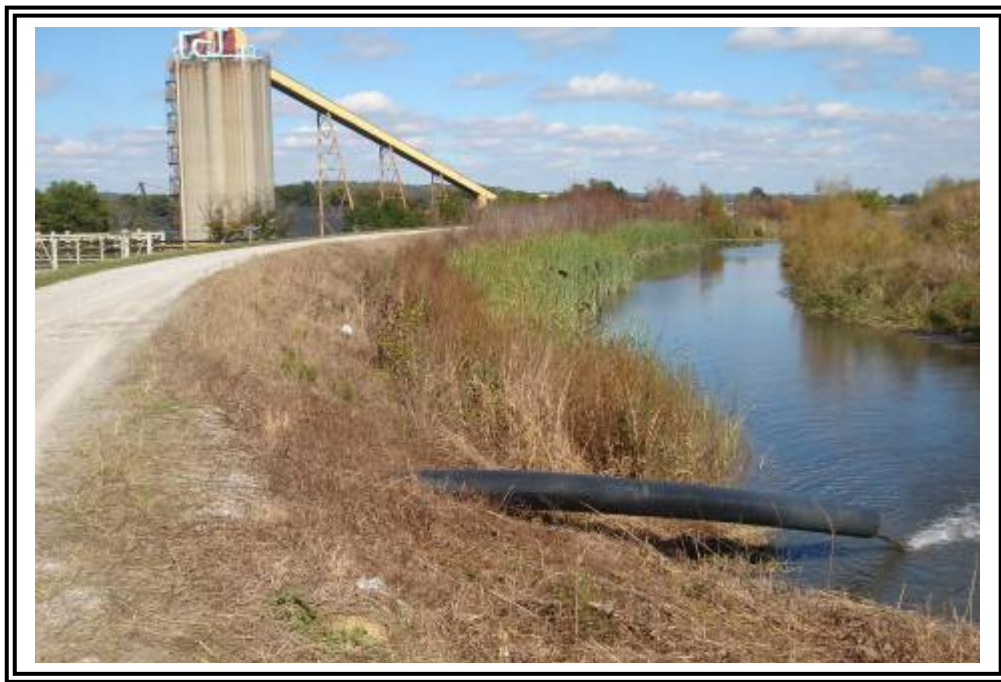
10

Upstream slope at northwest corner of ATB #1 looking northeast.

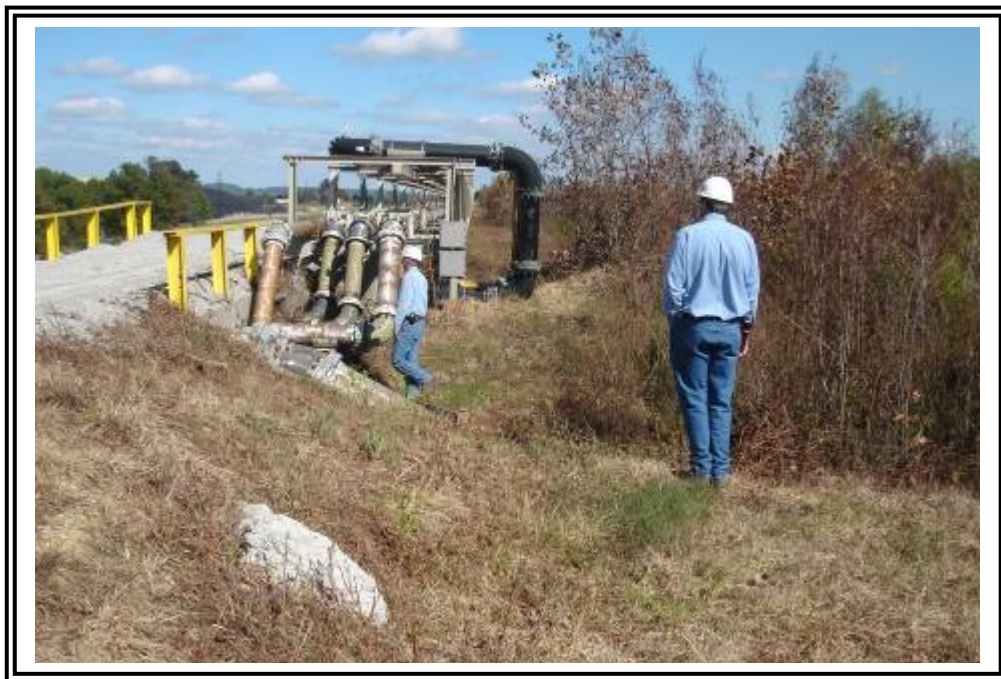
12

Upstream slope of ATB #1 north dike pipe racks for gypsum stacking facility. Note trees are growing on ash "not" dike.

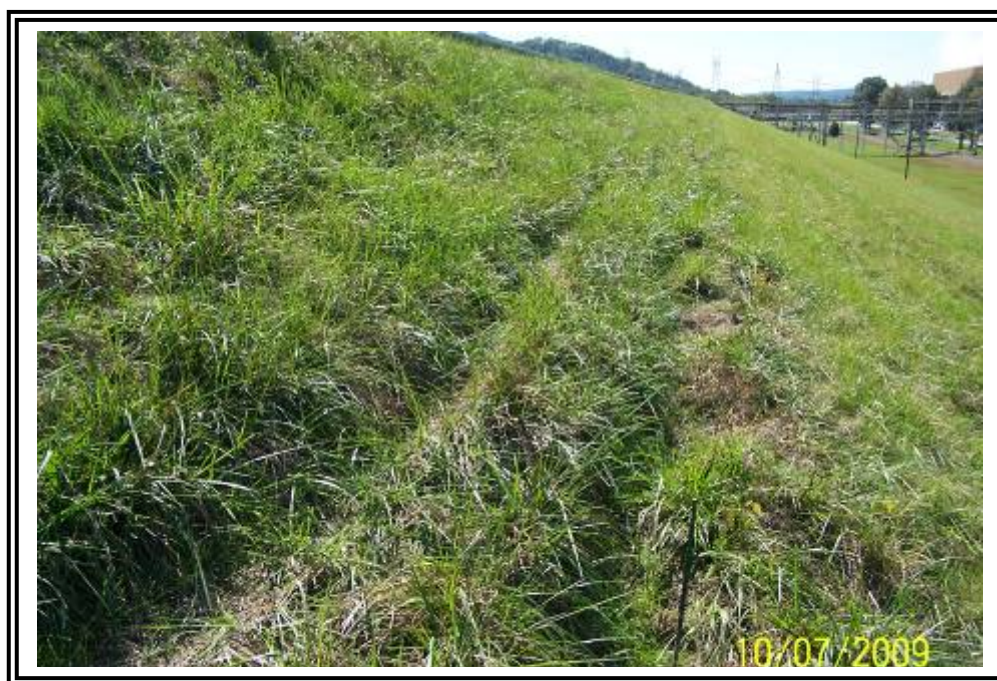
14

Tire ruts from mower on over steepened area.

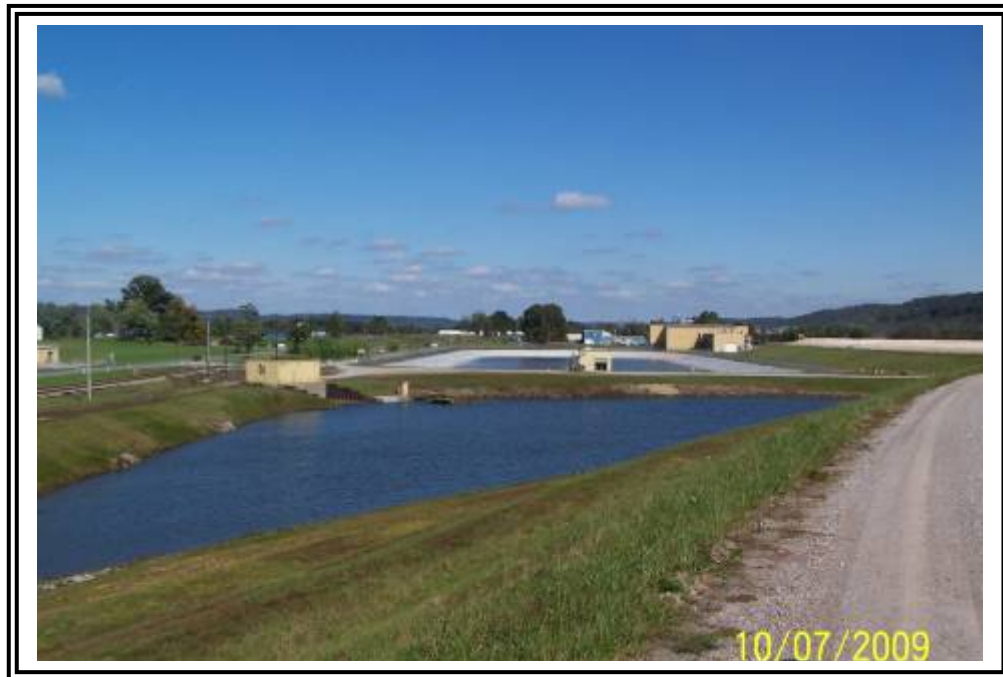
18

Secondary Ash Treatment basin (foreground) and gypsum stack surge pond (beyond) are incised ponds.

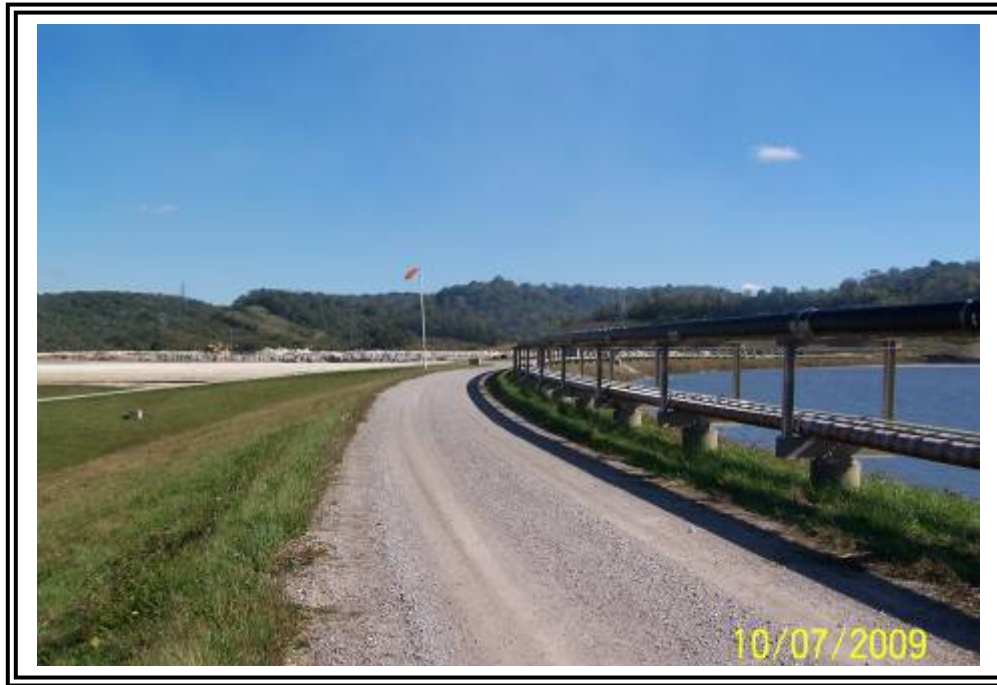
19

ATB #1 dike crest at northeast corner, looking southeast.

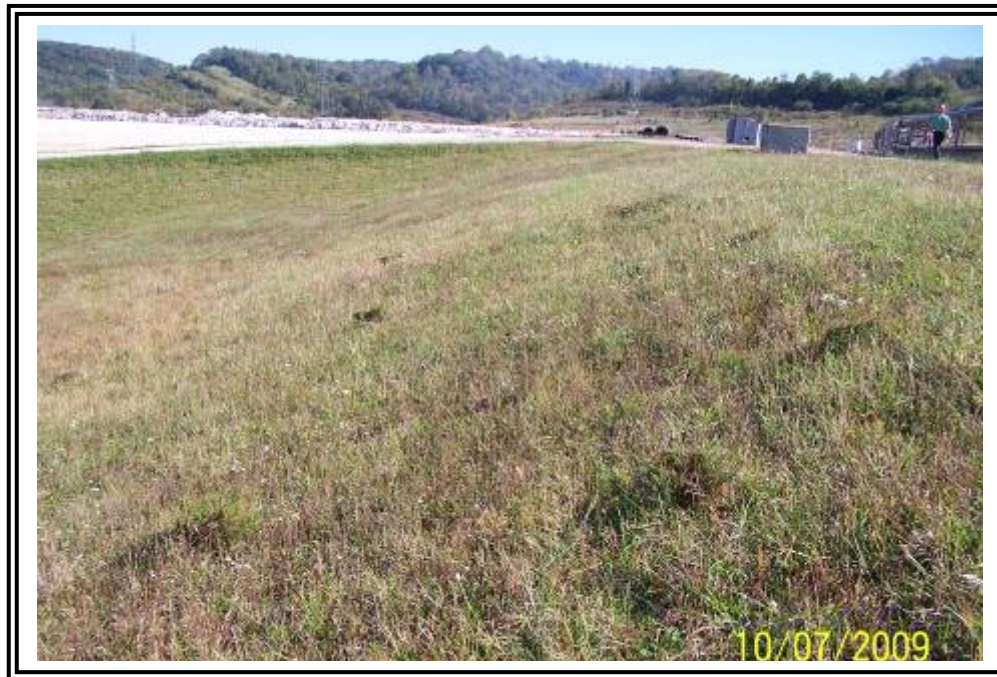
20

Downstream slope at north end of ATB #1 east dike. The east dike is now shared with the gypsum stacking facility.

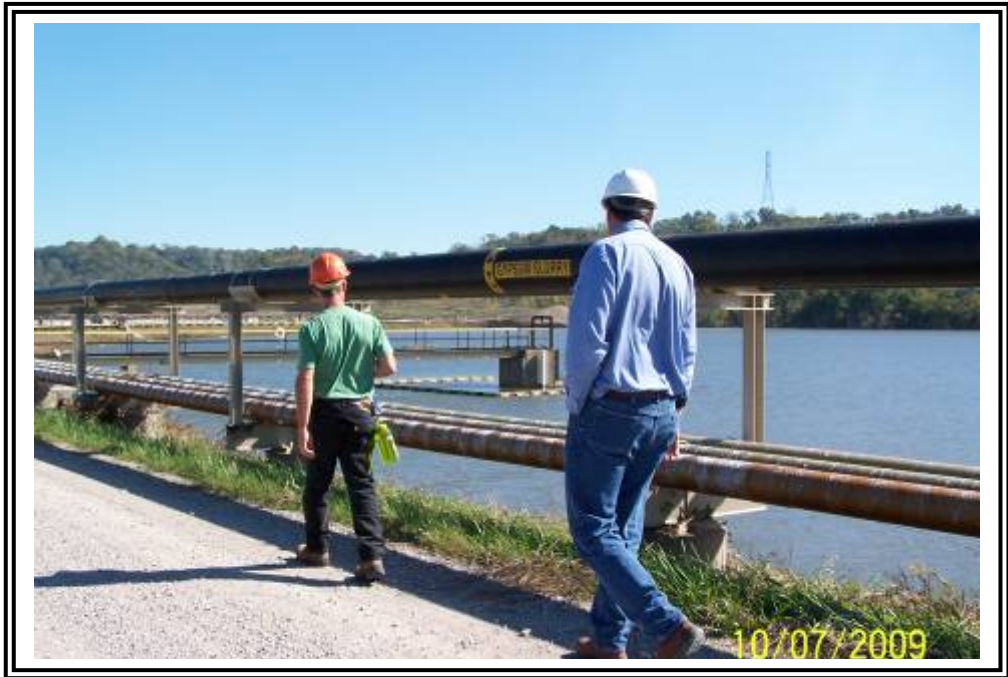
24

Outlet structure in ATB #1.

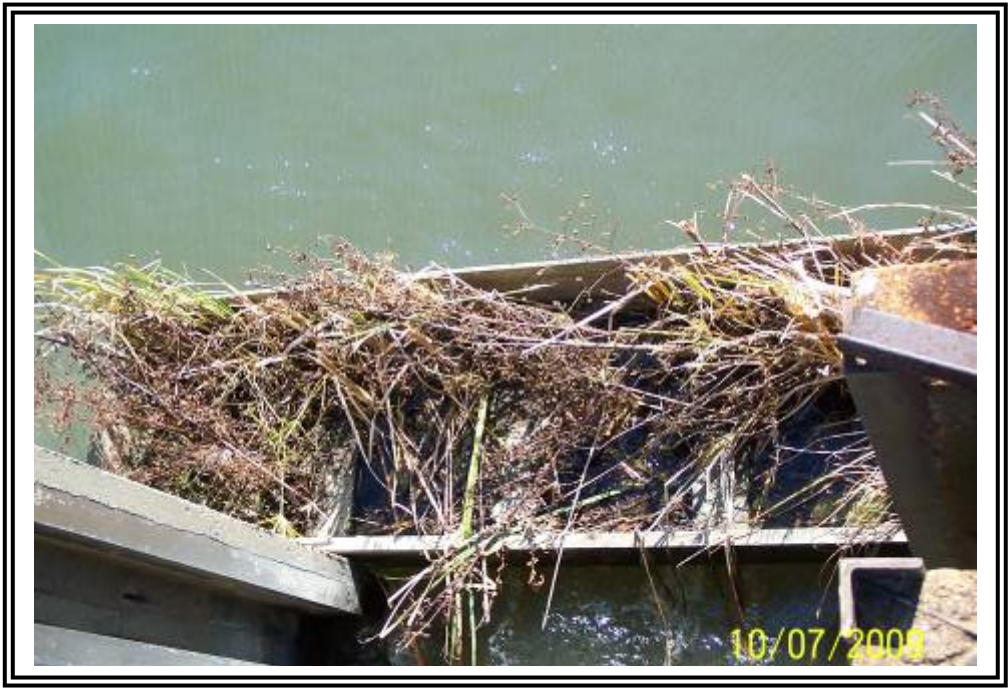
25

Decant structure in ATB #1.

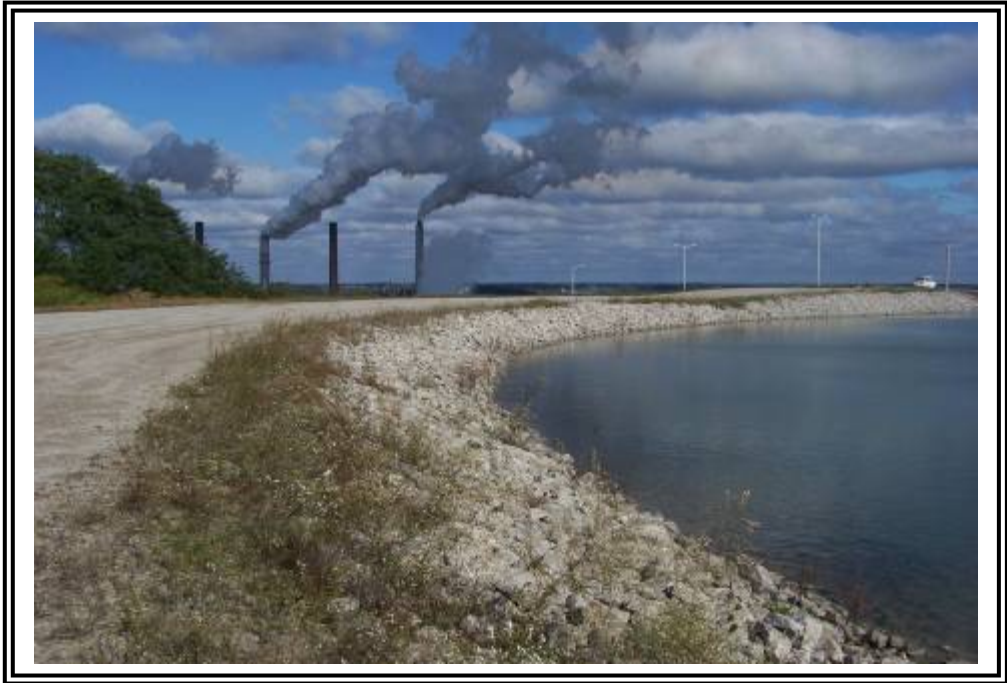
27

Upstream slope of ATB #2 looking north.

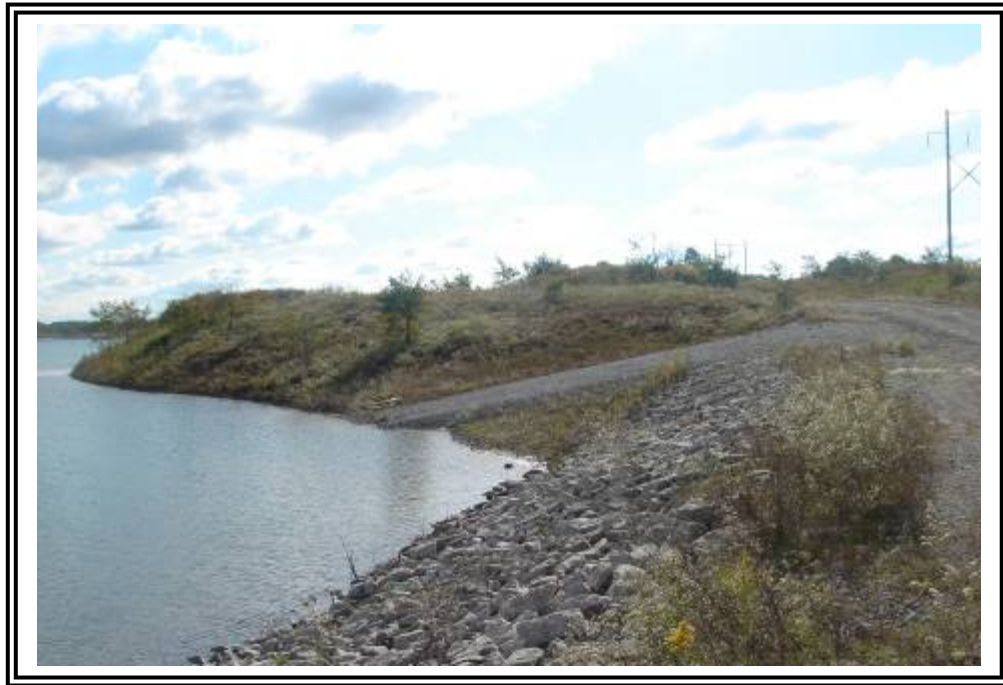
29

Upstream slope of ATB #2 looking south at west abutment and boat ramp.

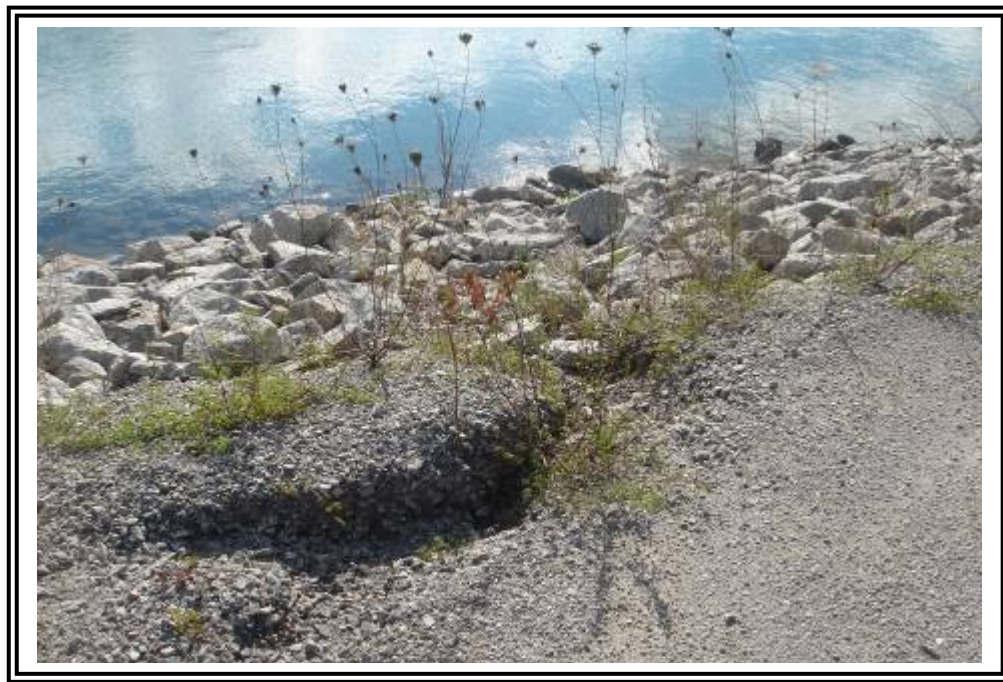
The upstream slope of the ATB #2 was covered with rip rap, which appeared uniformly placed. Photos 27 through 34 show the general conditions of the upstream slope. Occasional erosion rills, such as that noted in Photo 30 were observed.

Erosion rill on upstream slope.

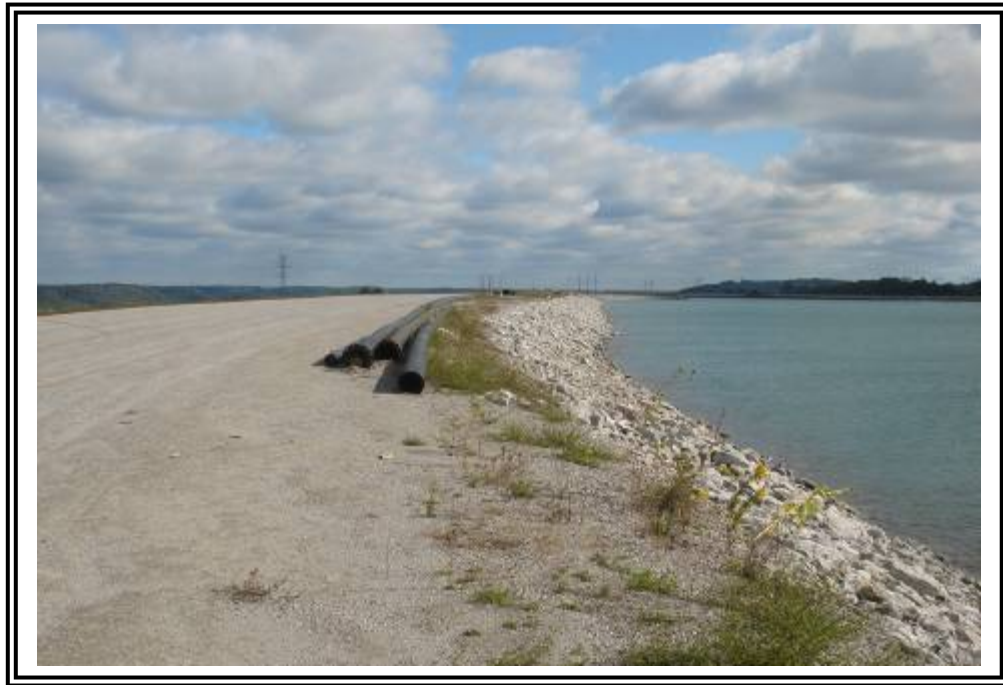
31

Upstream slope of ATB #2 looking east.

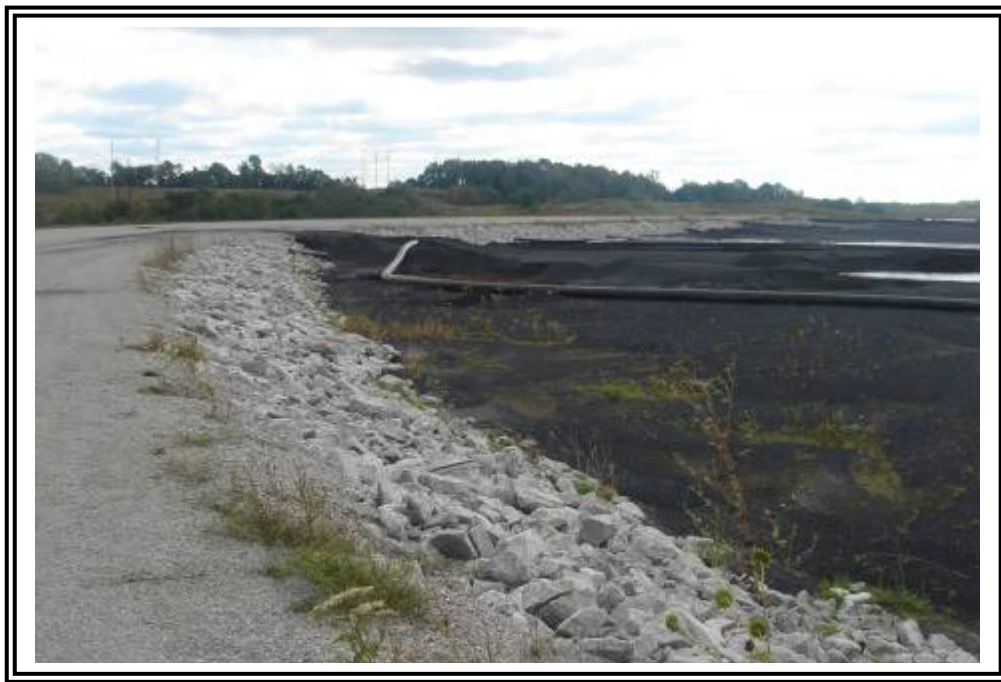
34

Upstream slope of ATB #2 looking southeast towards east abutment.

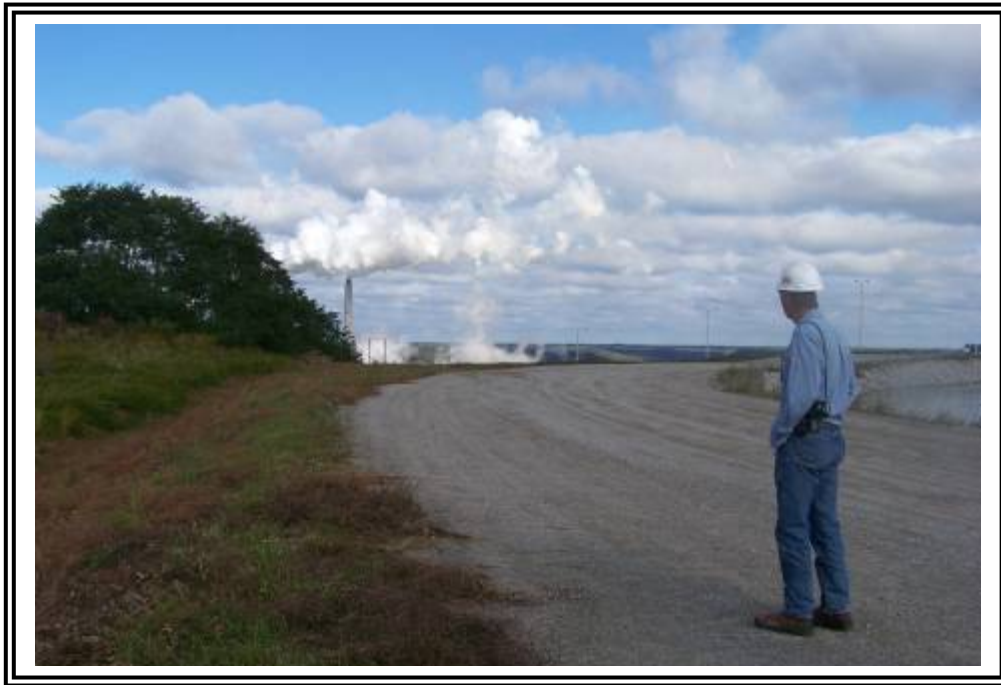
35

Crest of ATB #2 at west end looking northeast.

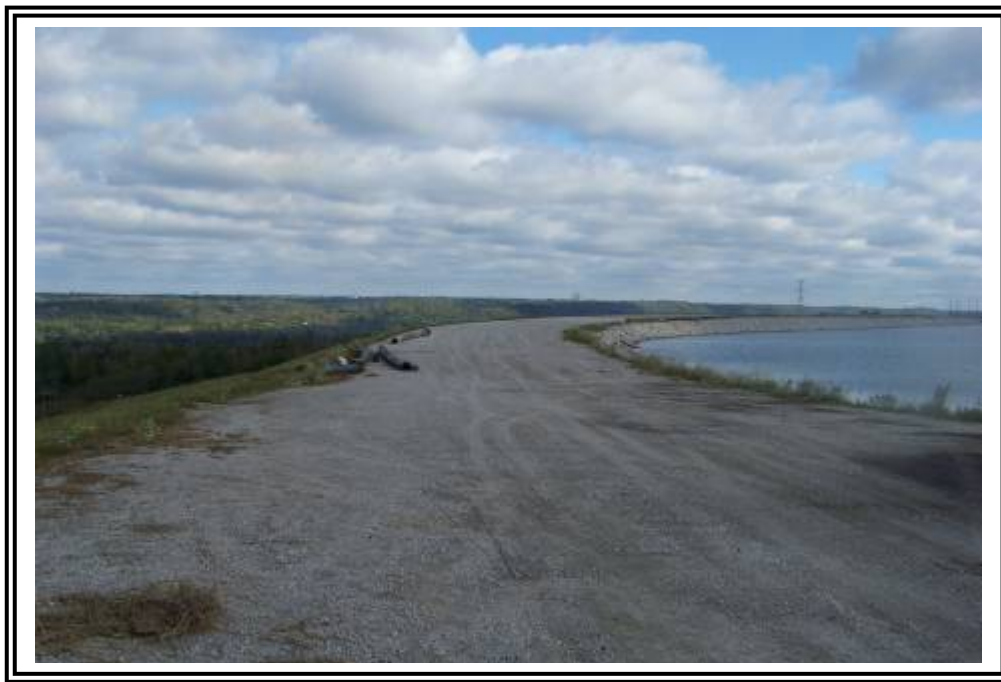
36

Crest of ATB #2 from access to decant structure looking east.

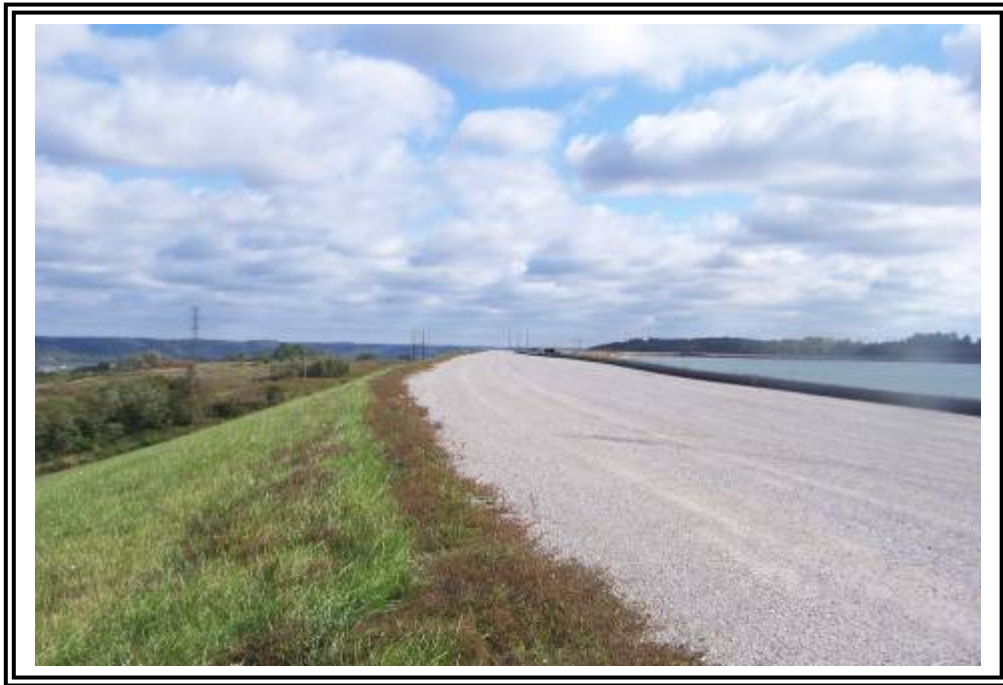
37

Crest of ATB #2 looking east.

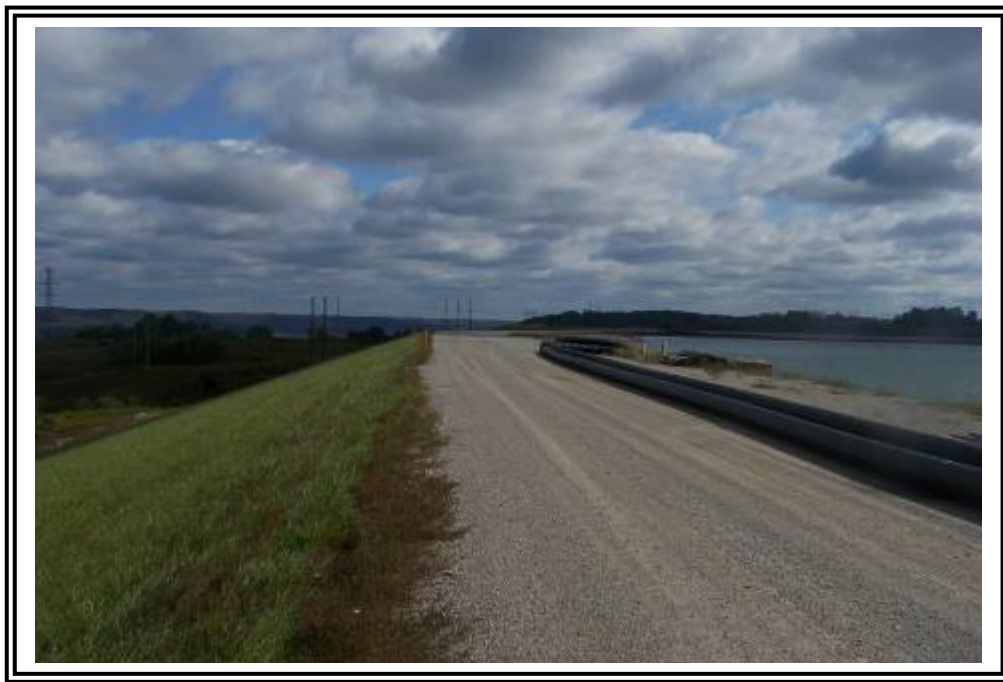
38

Crest of ATB #2 looking east.

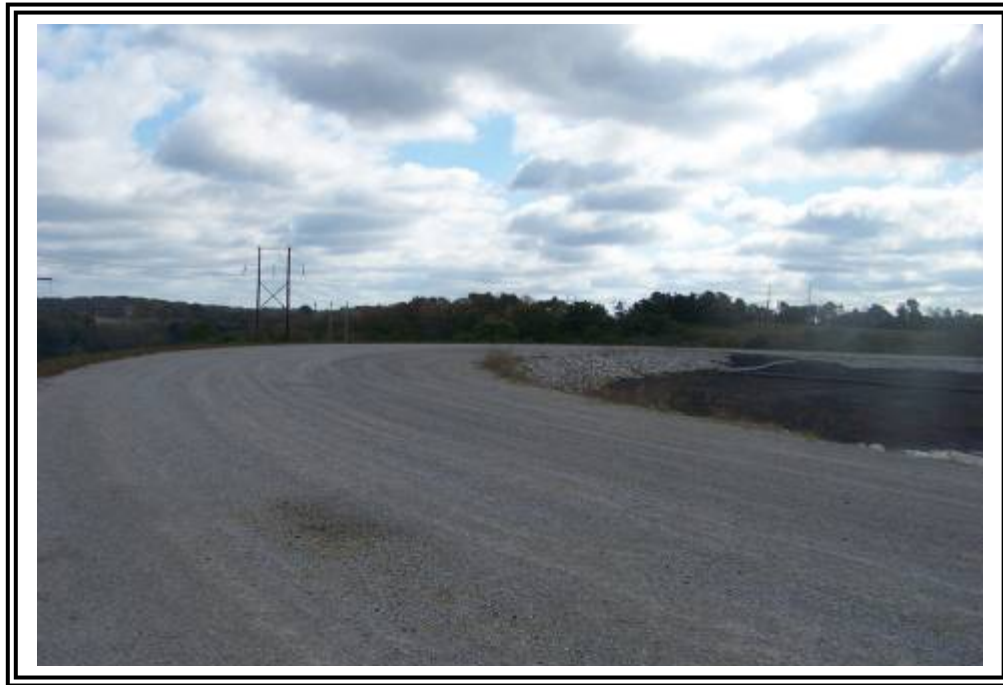
39

Crest of ATB #2 looking southeast.

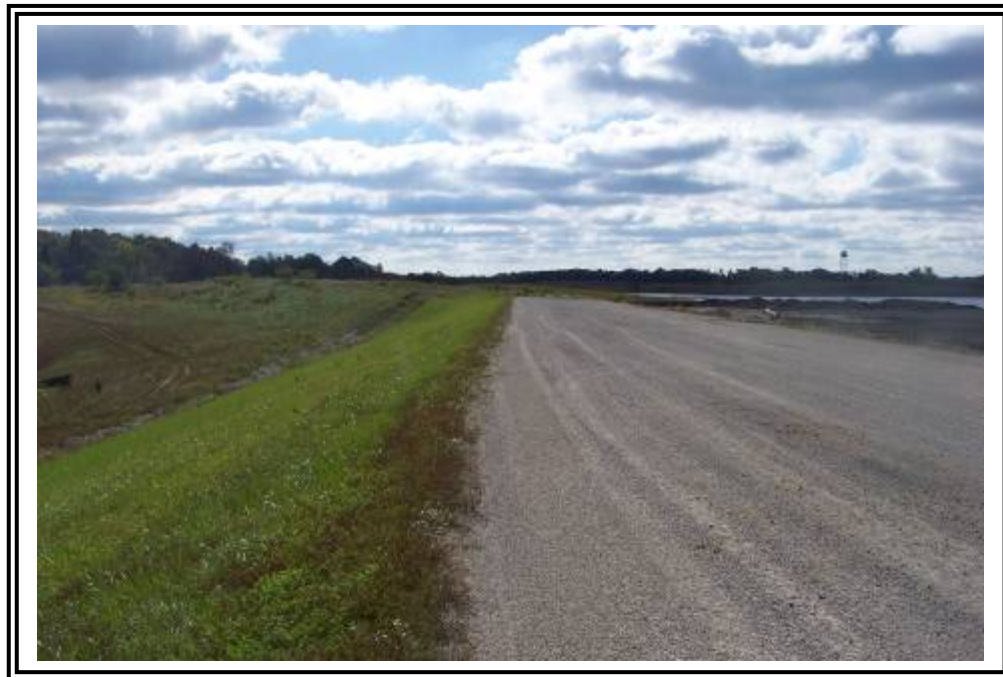
40

Crest of ATB #2 looking south toward the east abutment.

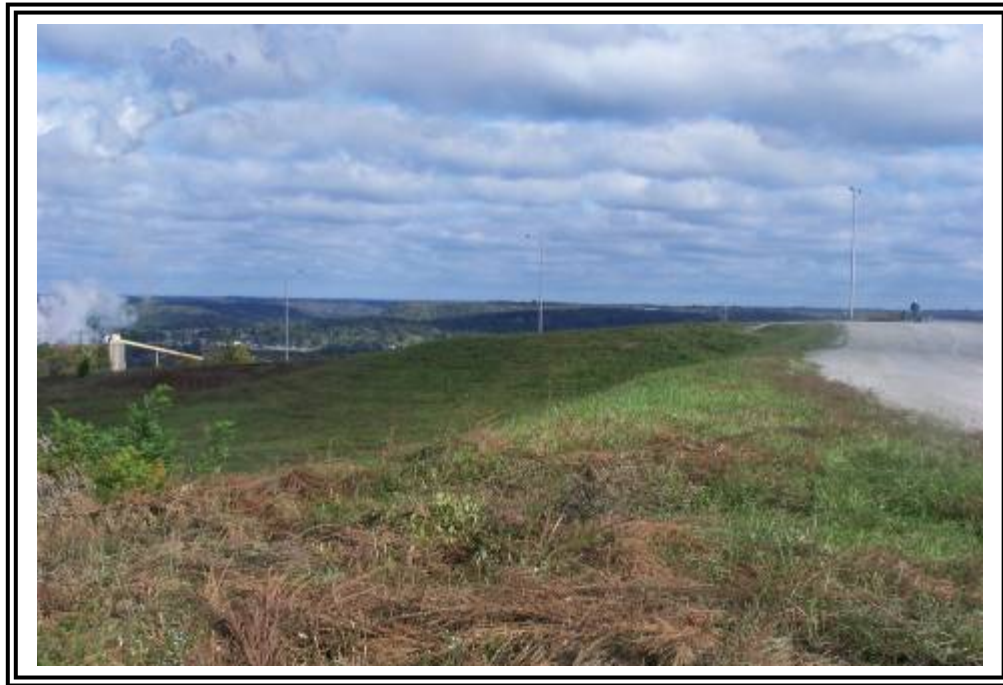
43

Western knoll looking east toward access road at downstream slope.

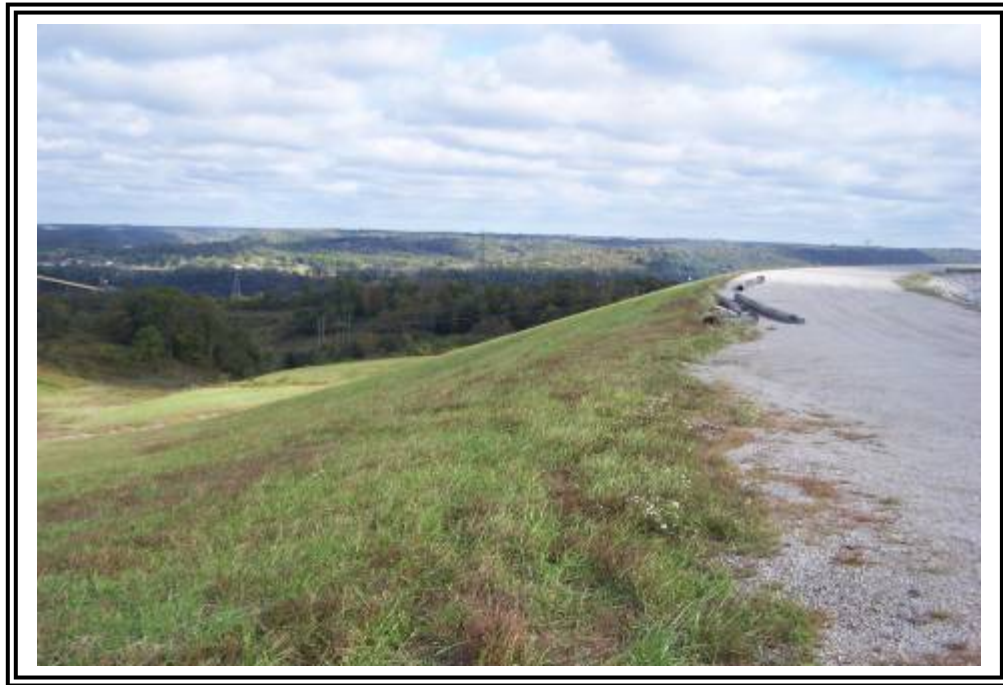
45

Downstream slope from access road looking northeast.

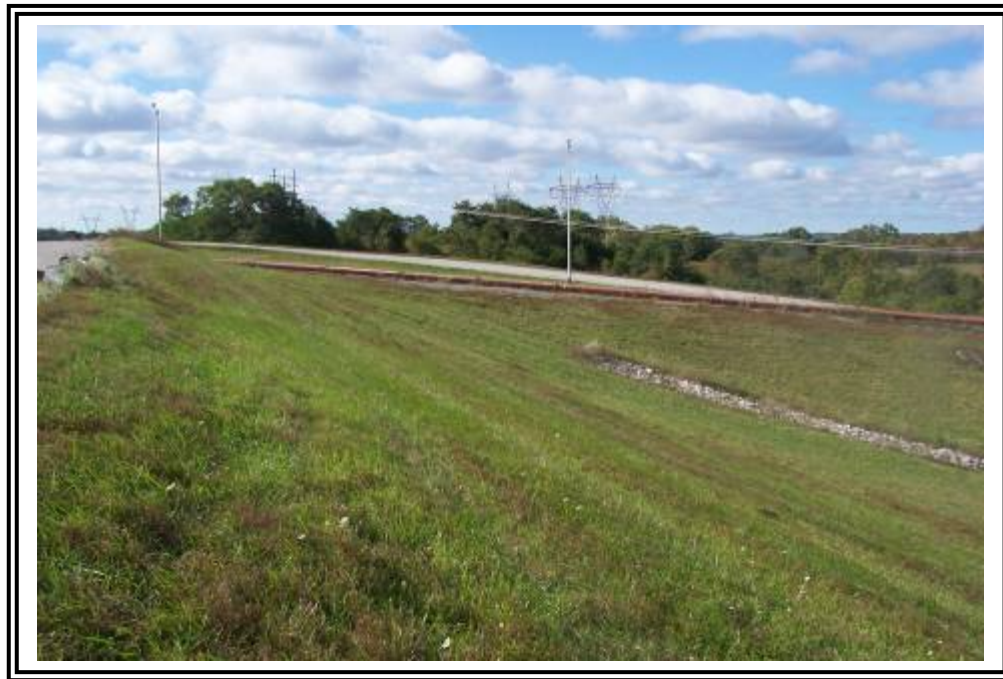
46

Downstream slope looking west toward access road.

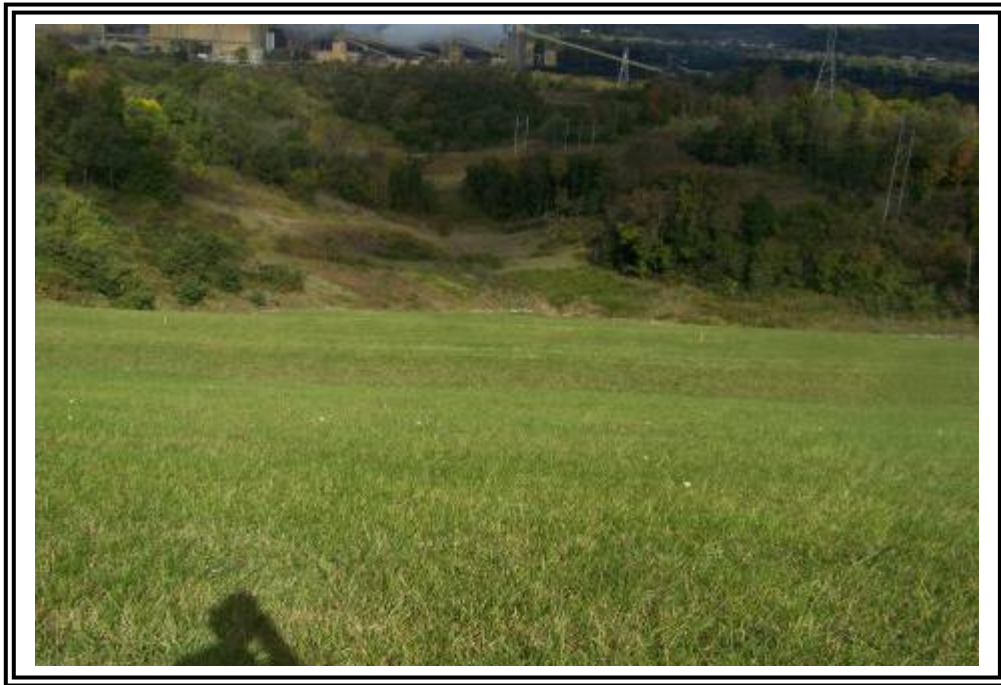
49

Downstream slope of ATB #2 at the maximum height section looking north.

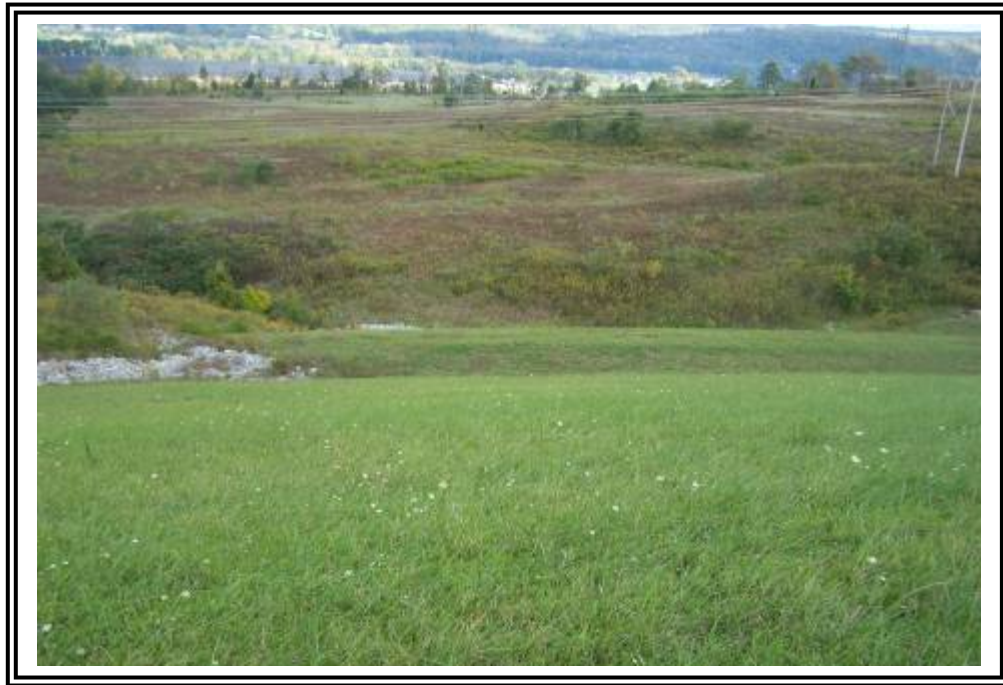
51

Downstream slope of ATB #2 just east of eastern knoll looking northeast.

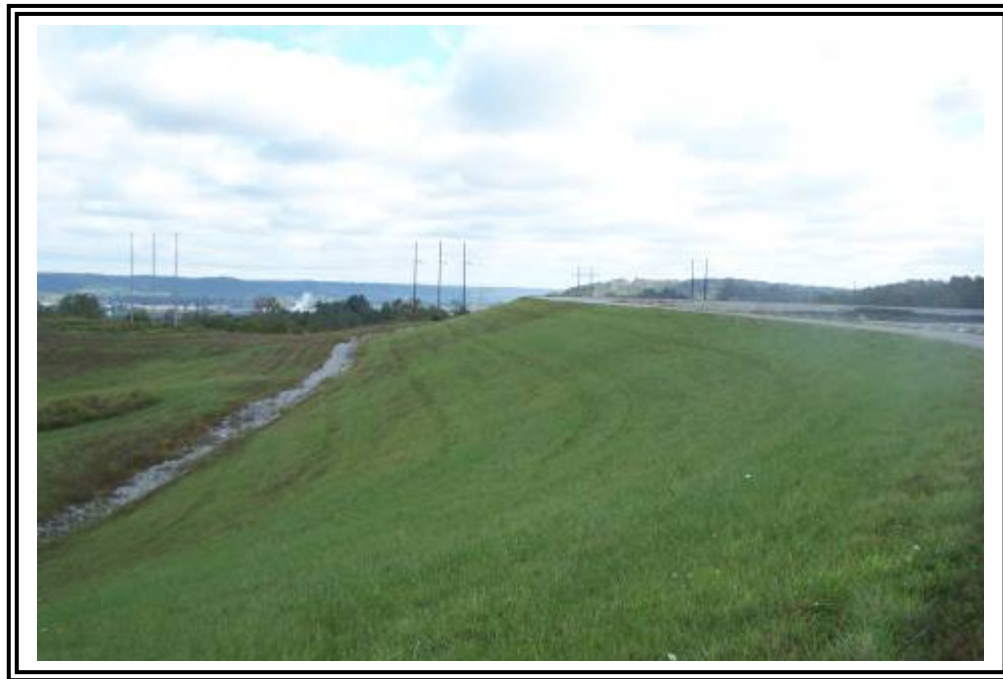
52

Downstream slope of ATB #2 looking east.

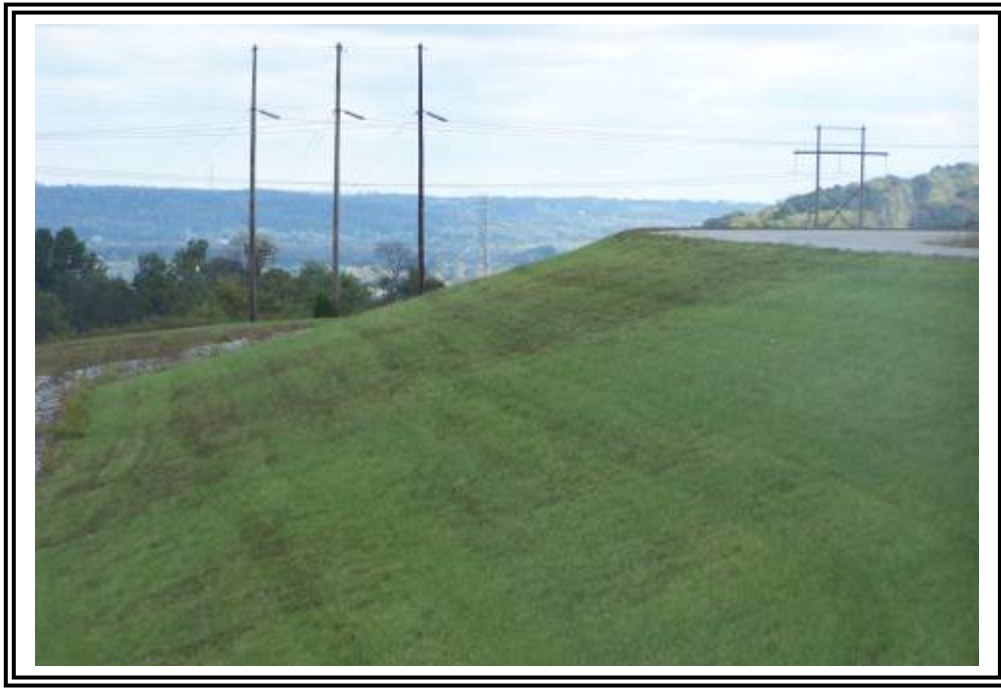
53

Downstream slope of east end of ATB #2 dike looking northeast.

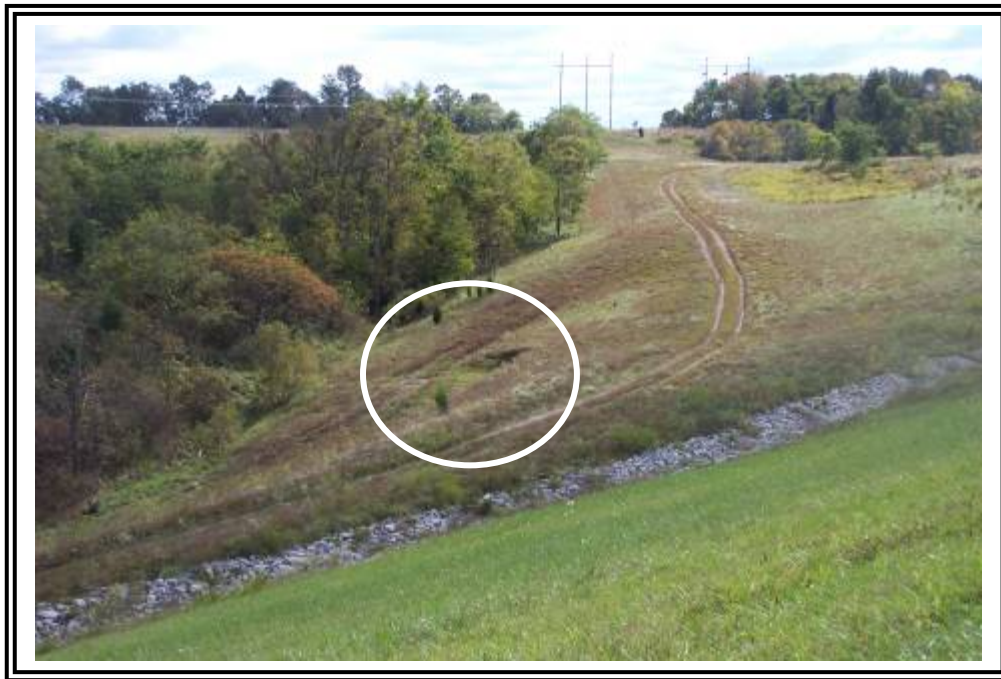
54

Slump in natural slope near the east abutment of ATB #2.

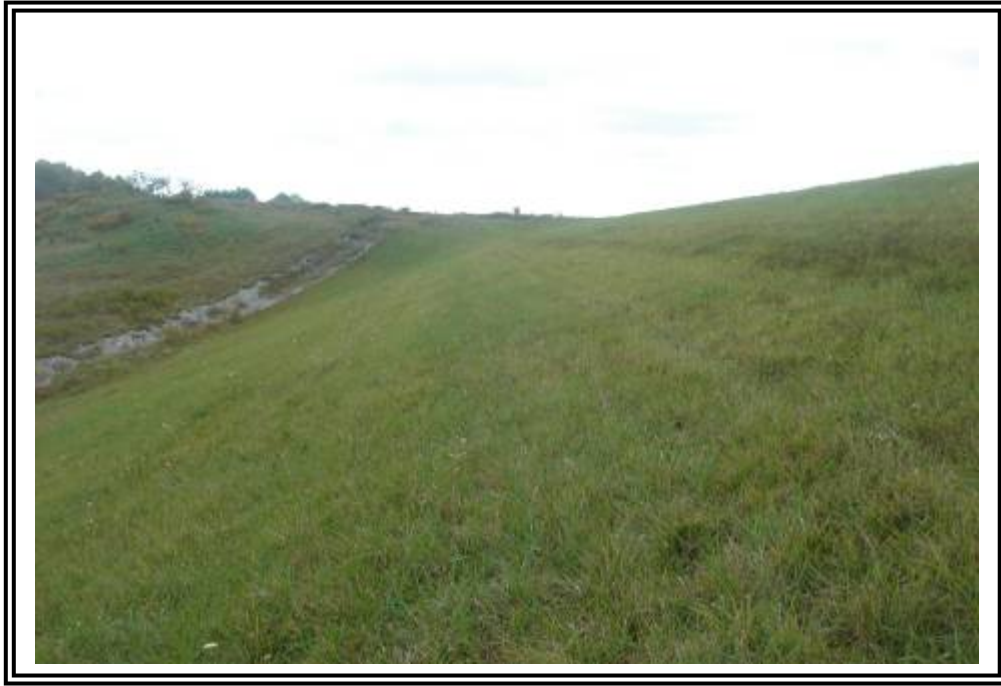
55

East abutment of ATB #2 looking south.
