Assessment of Dam Safety Coal Combustion Surface Impoundments (Task 3) Final Report

Kentucky Utilities

Ghent Generating Station

February 25, 2010

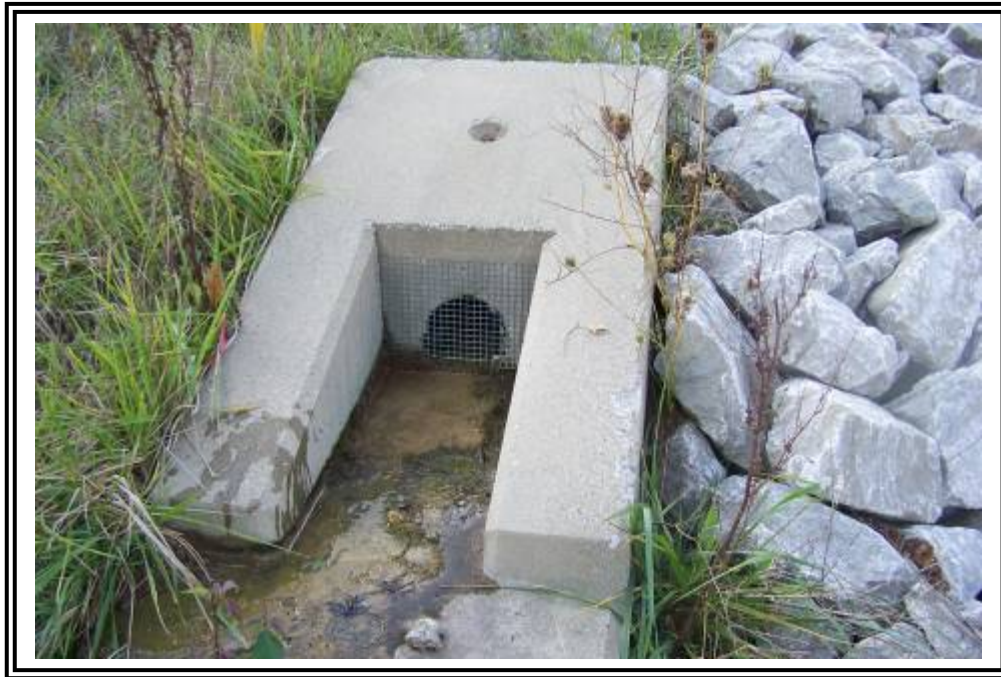
56

Toe drain on east of ATB #2. Flow clear/immeasurable.

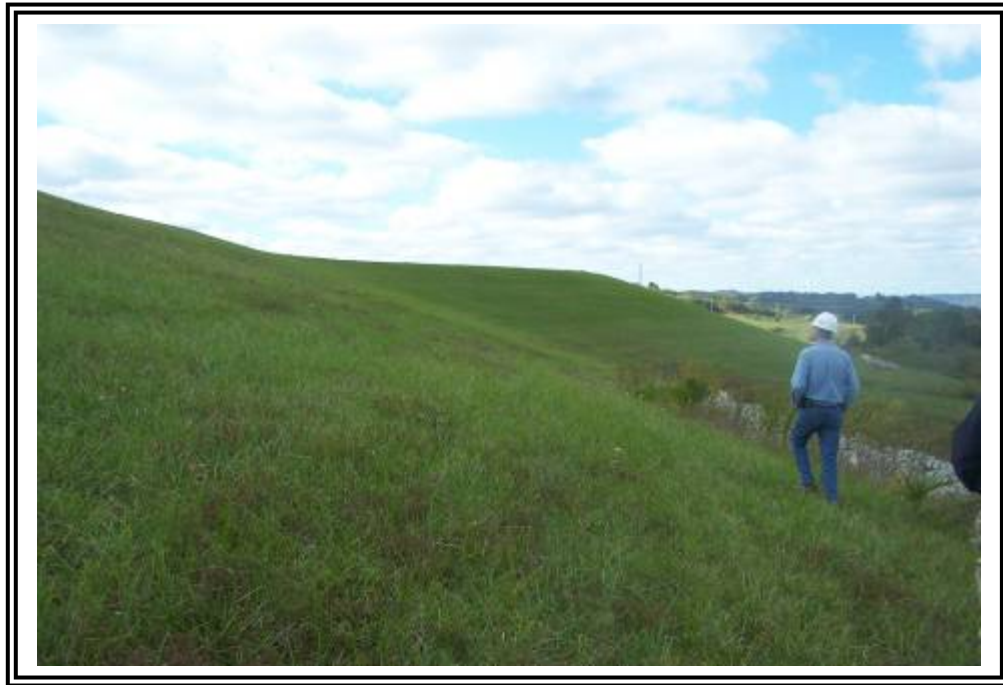
57

Downstream slope of ATB #2 looking west from northeast corner of dike.

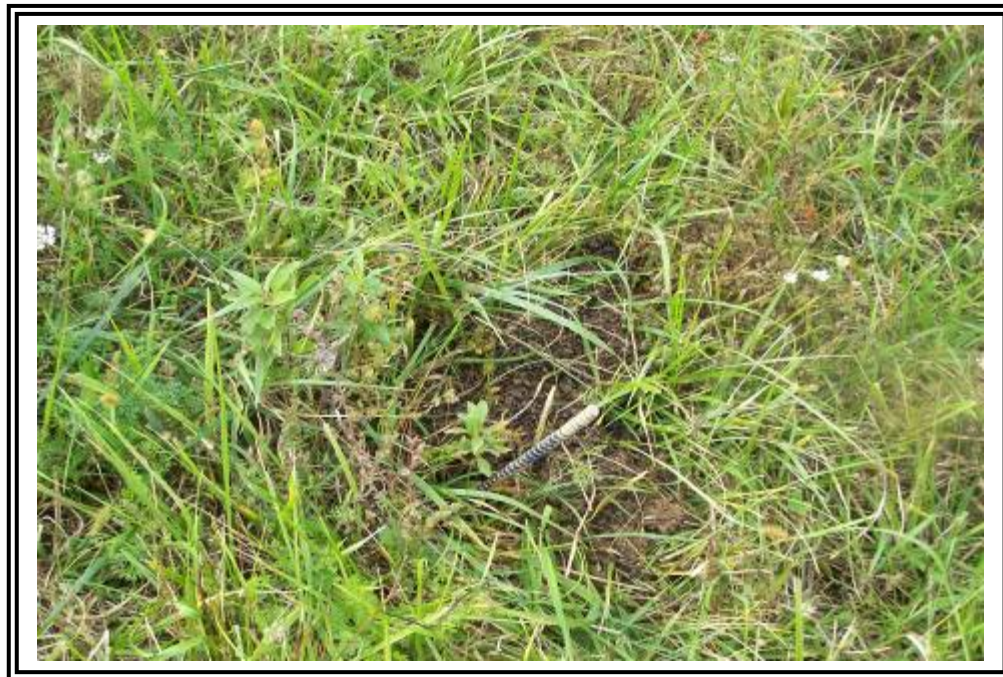
58

Small rodent hole on bench in secondary drainage fill section about 18 inches deep.

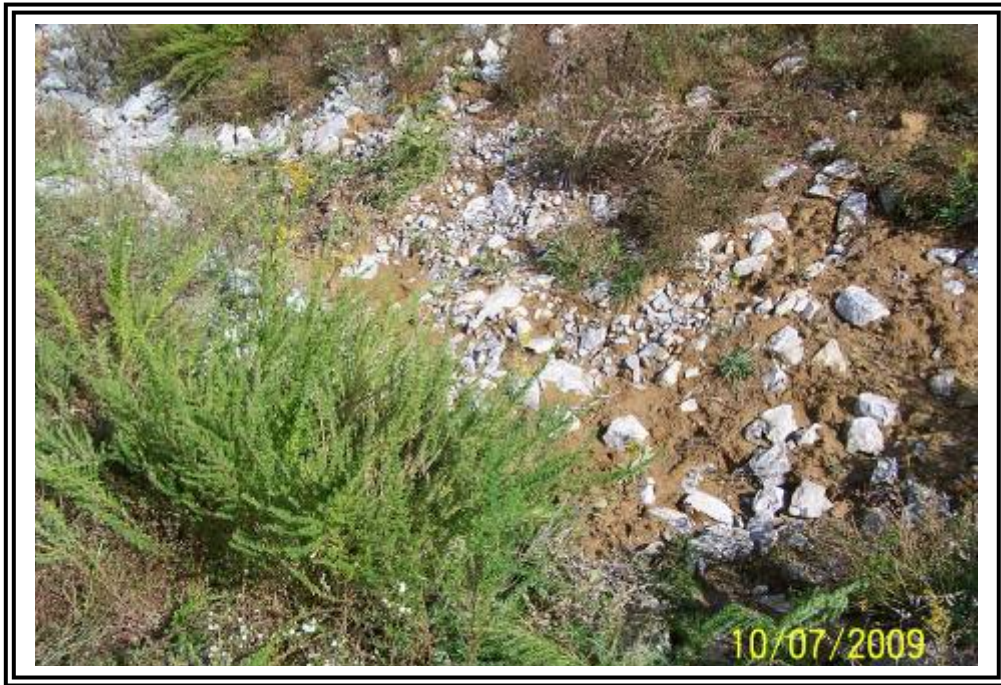
59

Area around toe drain shown in next photo.

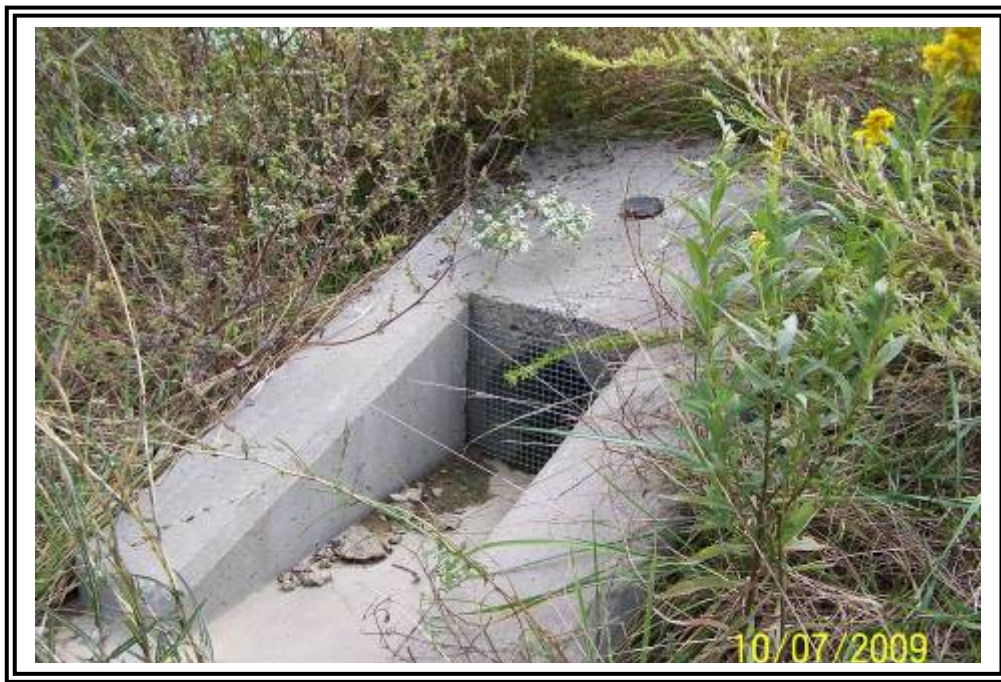
62

Upper toe drain at east side of main drainage fill (dry).

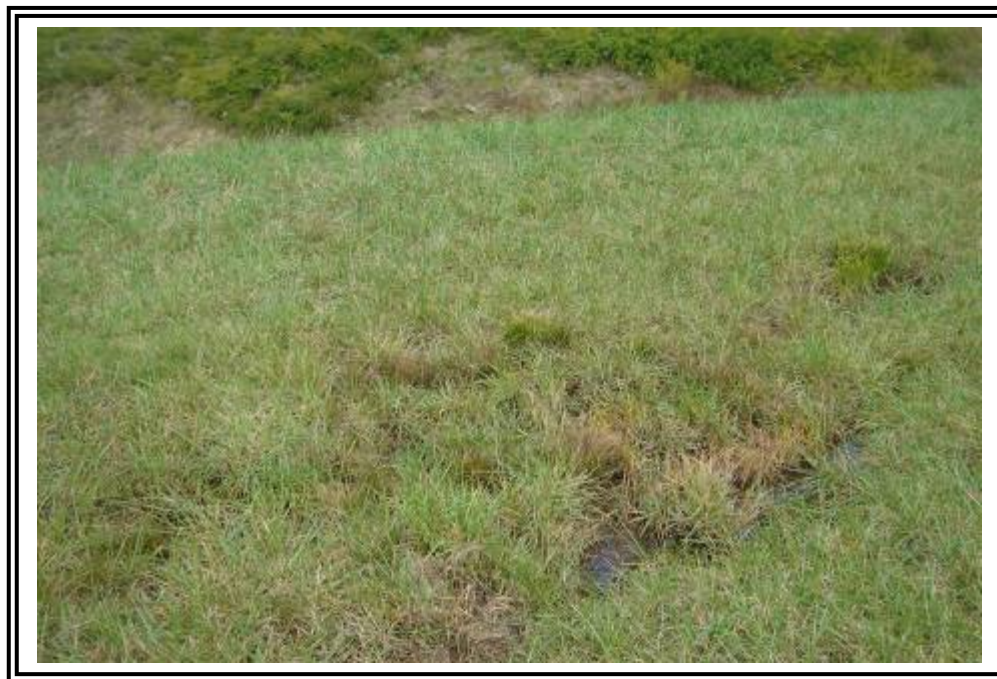
64

Close up of standing water on upper bench. Soil firm when probed.

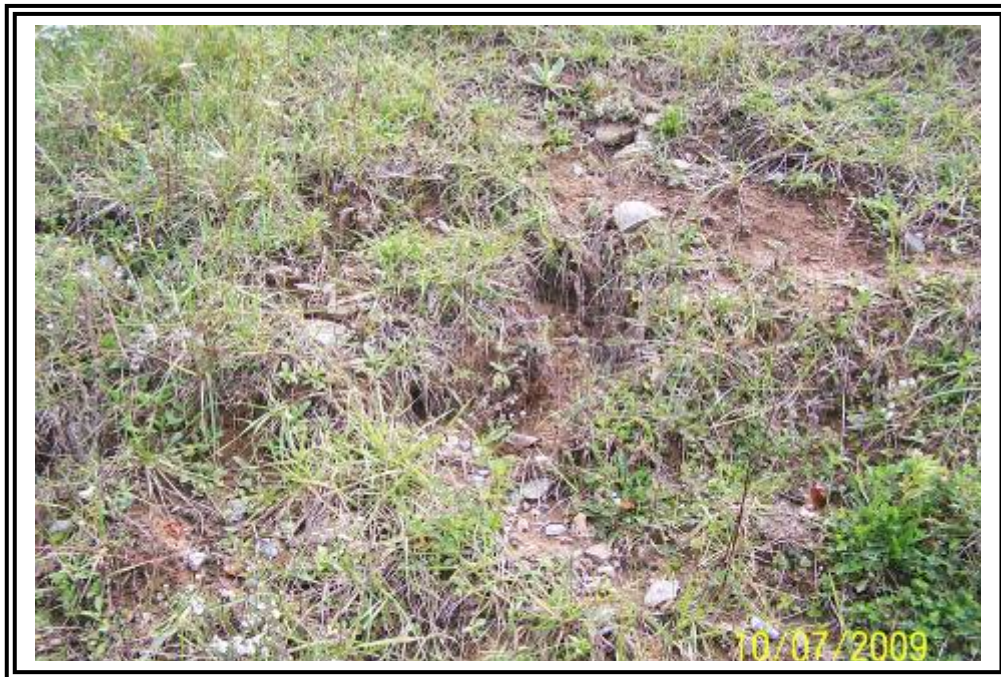
66

Erosion at occasional locations appears related to turning mowers.

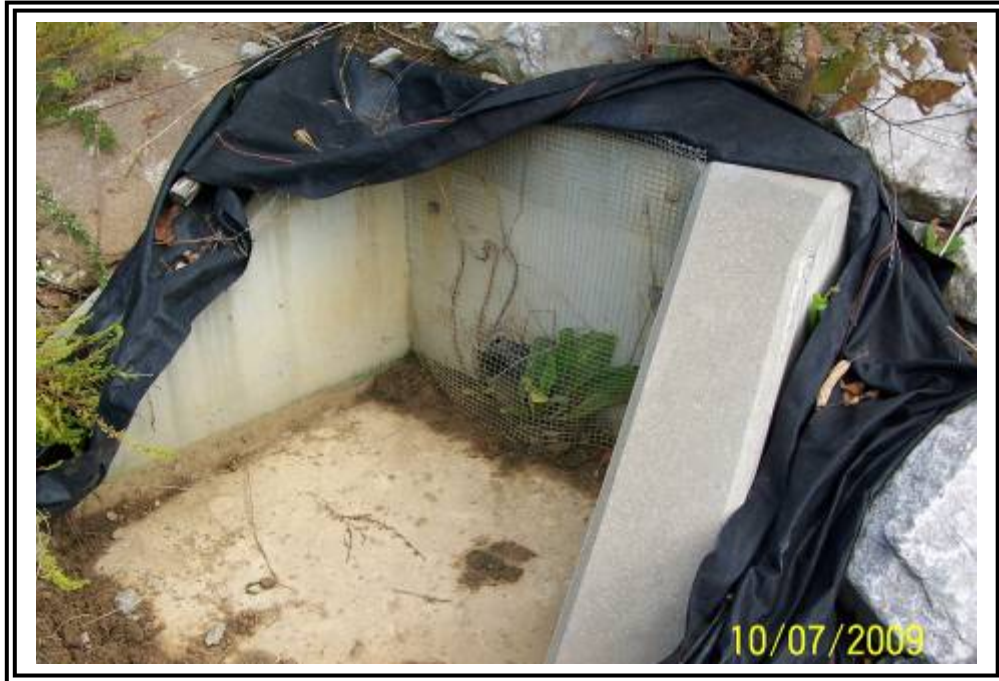
67

Toe drain above lowest bench of main fill.

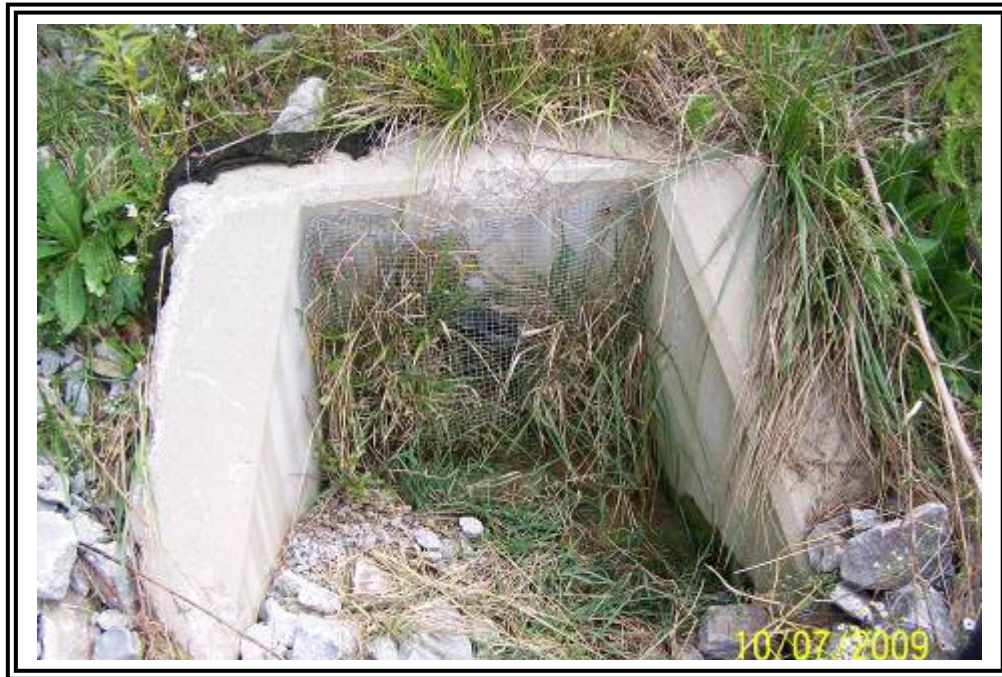
68

Toe drain at base of main fill.

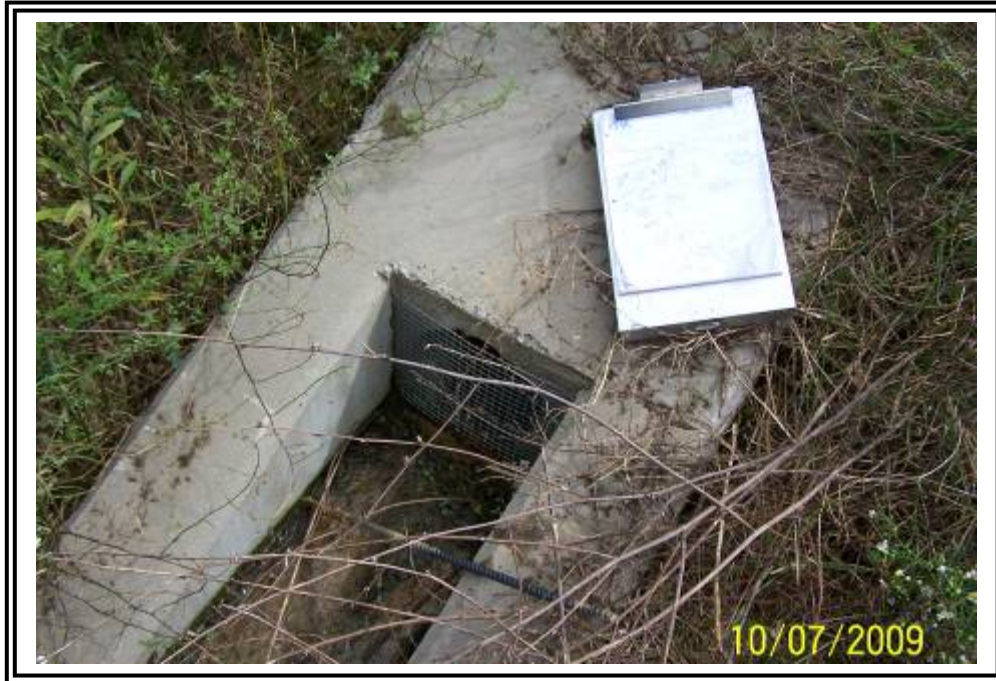
71

East toe drain at west of main fill.

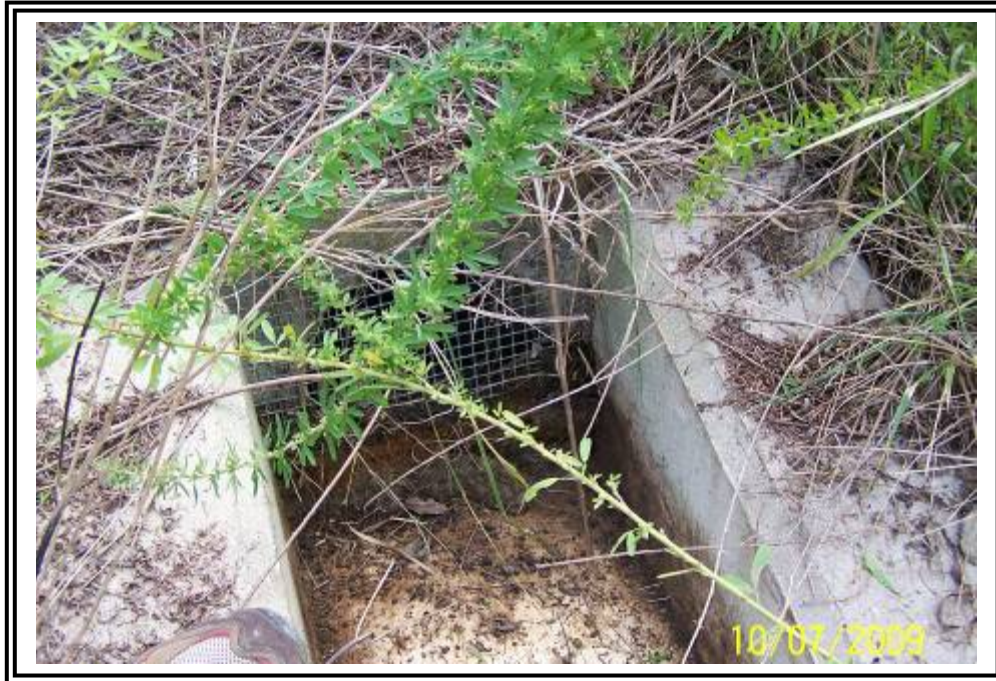
73

West toe drain at west of main fill.

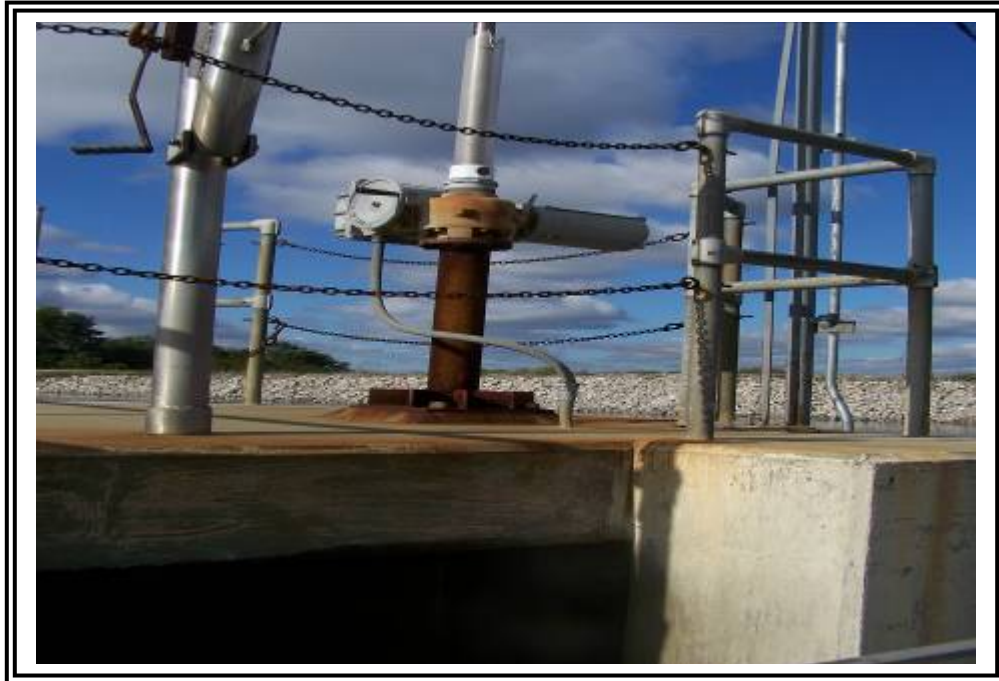
77

Outlet structure equipped with gates to close outlet flow from discharge pipe.

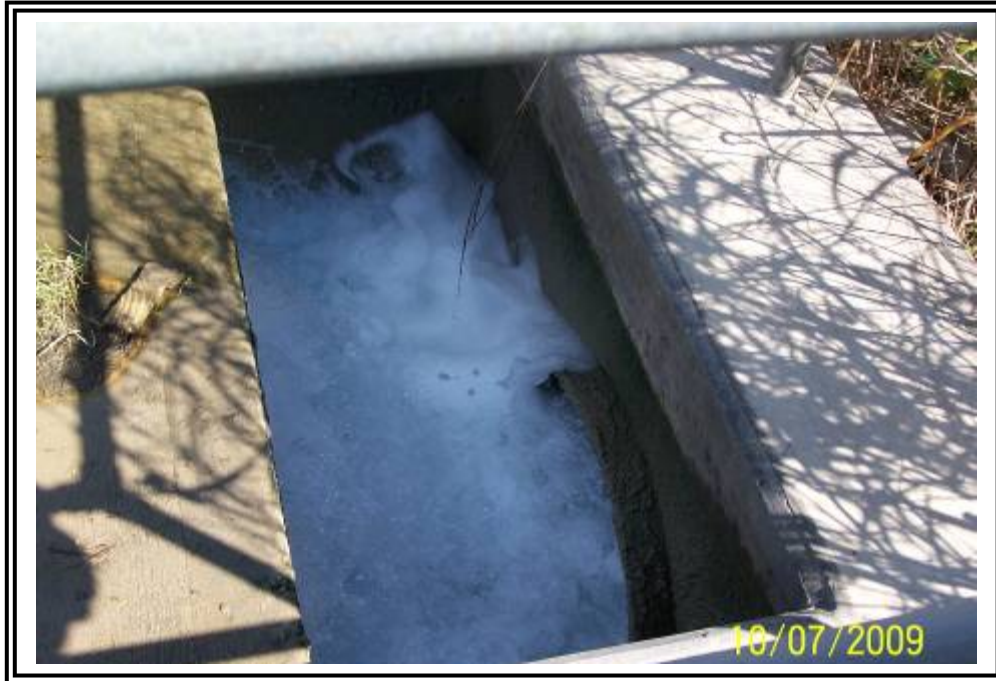
79

Discharge from ATB #2 near ATB #1. Discharges into structure with impact baffle.

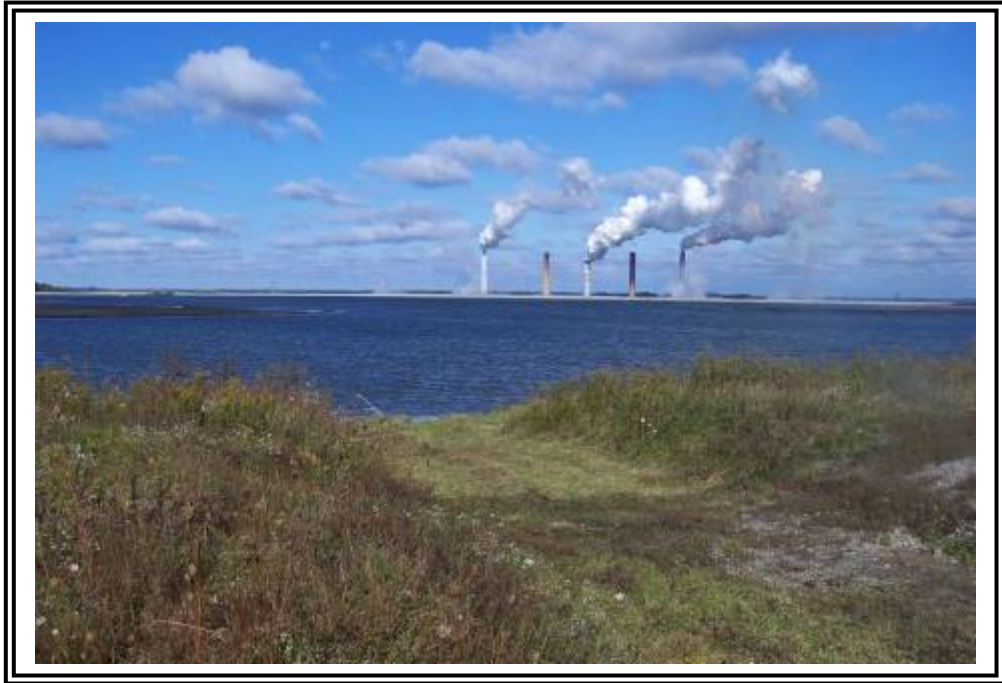
81

Emergency spillway from south side of ATB #2 looking north.

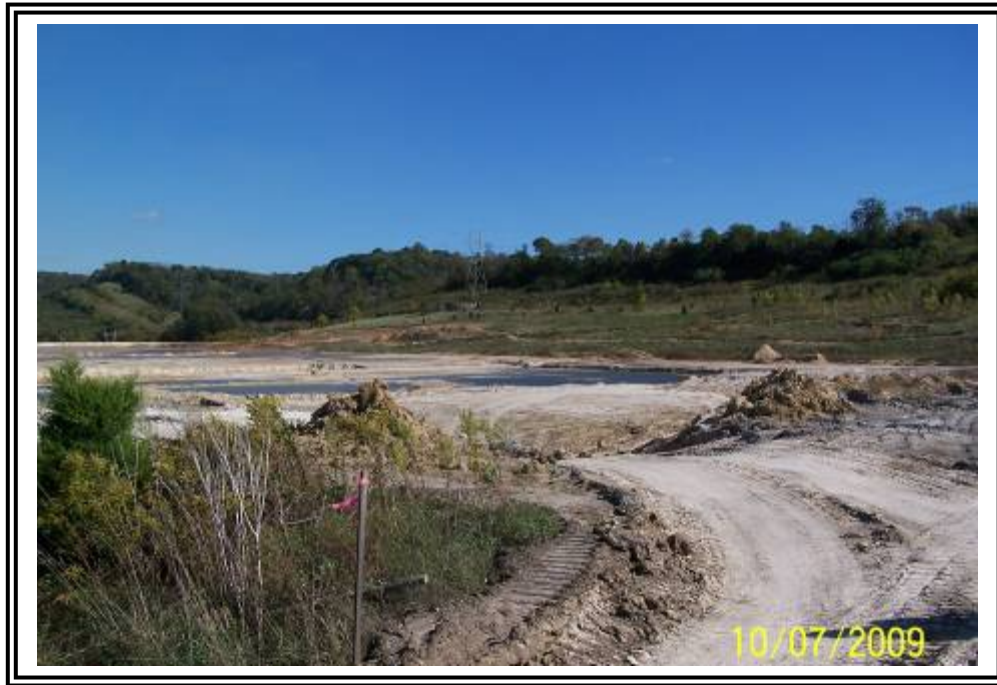
83

South end of gypsum stacking facility looking southeast.

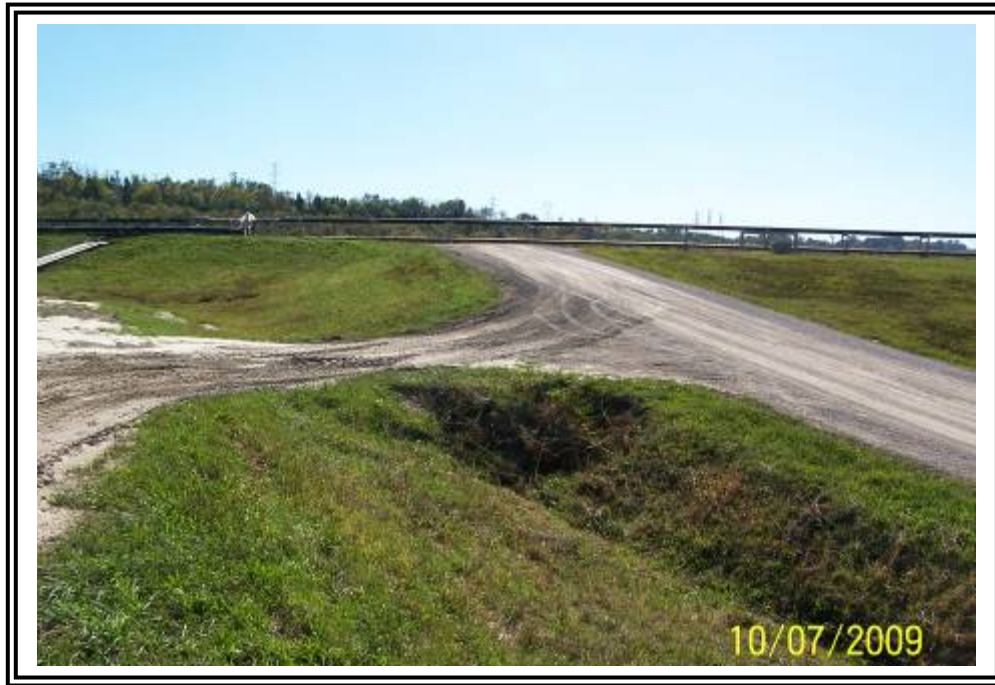
85

Drainage swale at northwest corner of gypsum stacking facility dike, looking southwest. ATB#1 dike beyond.

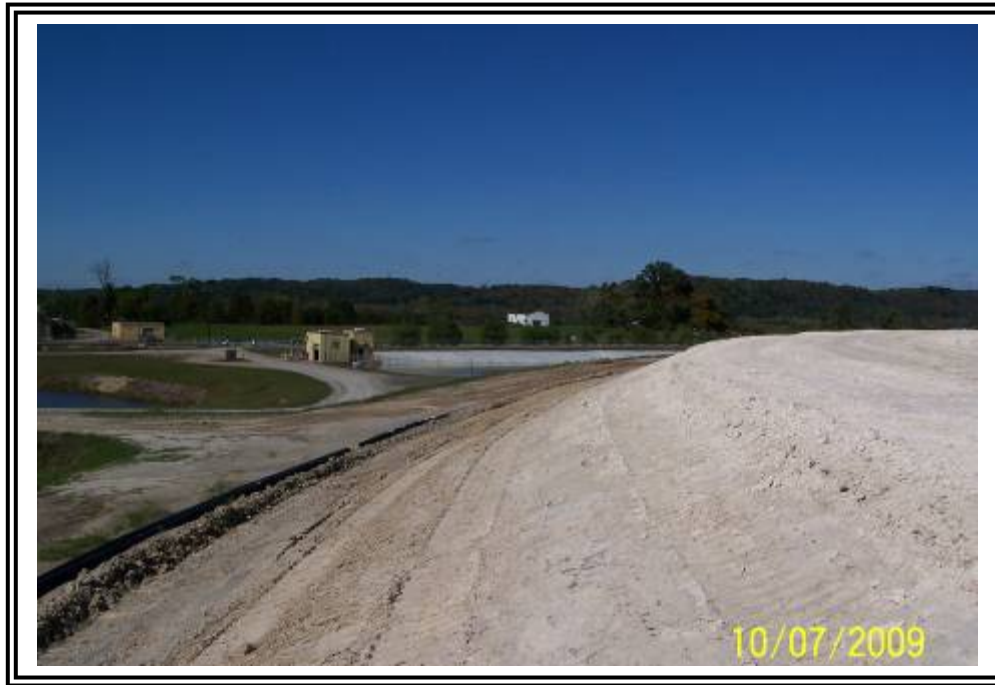
87

Downstream slope of northwest corner of gypsum stacking facility dike above starter dike (under construction from dewatered gypsum).

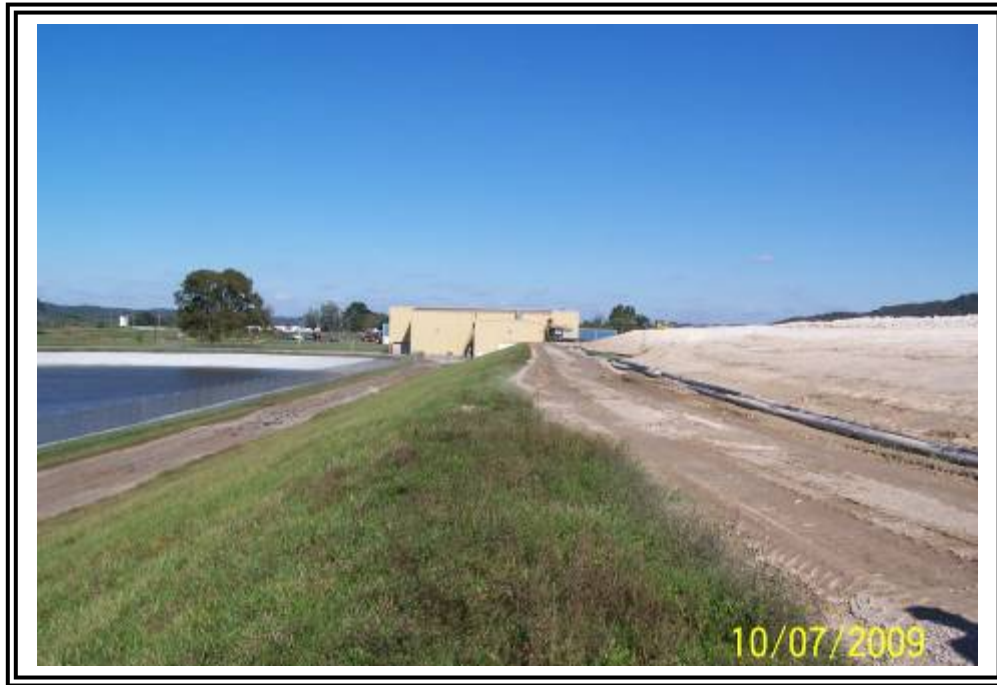
89

Crest of starter dike, north side of gypsum stacking facility, looking east.

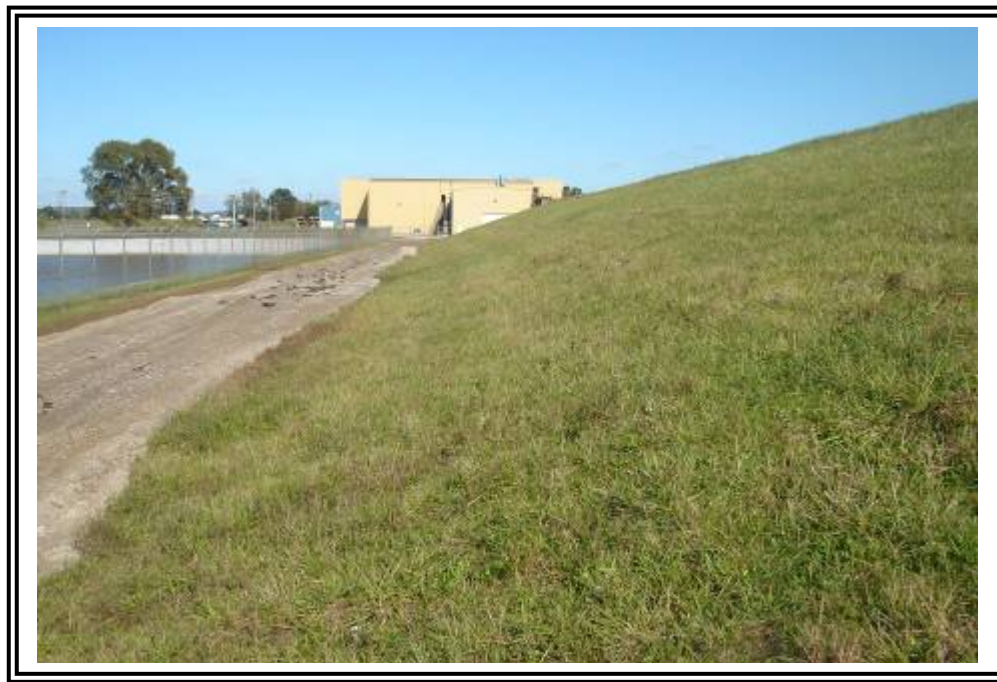
90

Downstream slope of north side of gypsum stacking facility starter dike (compacted soil), looking east.

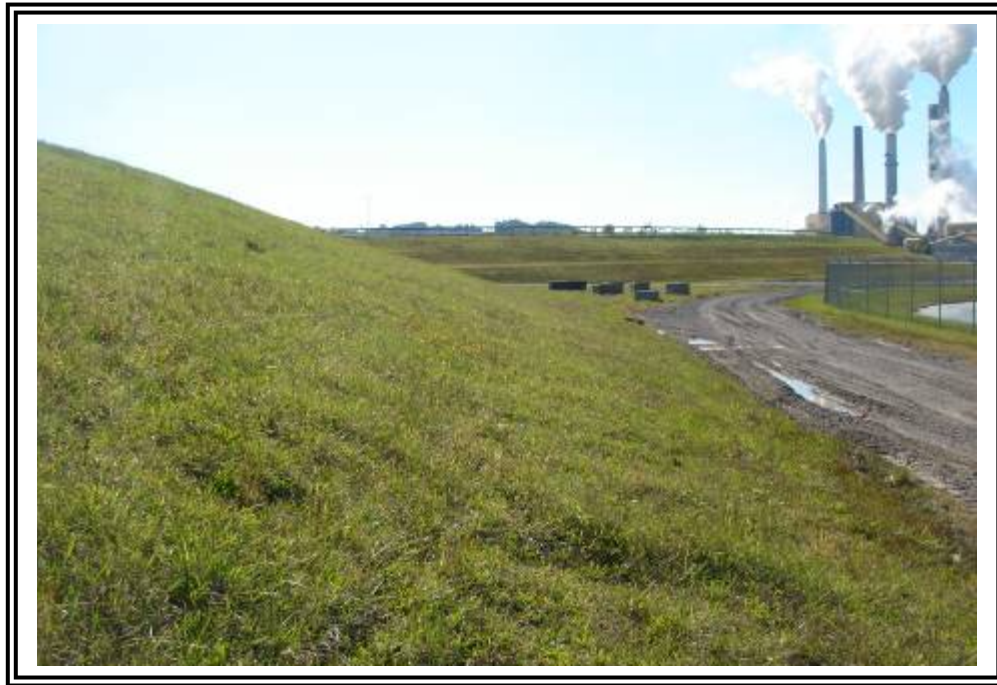
91

Depressions at toe of north side of starter dike of gypsum stacking facility, looking west.

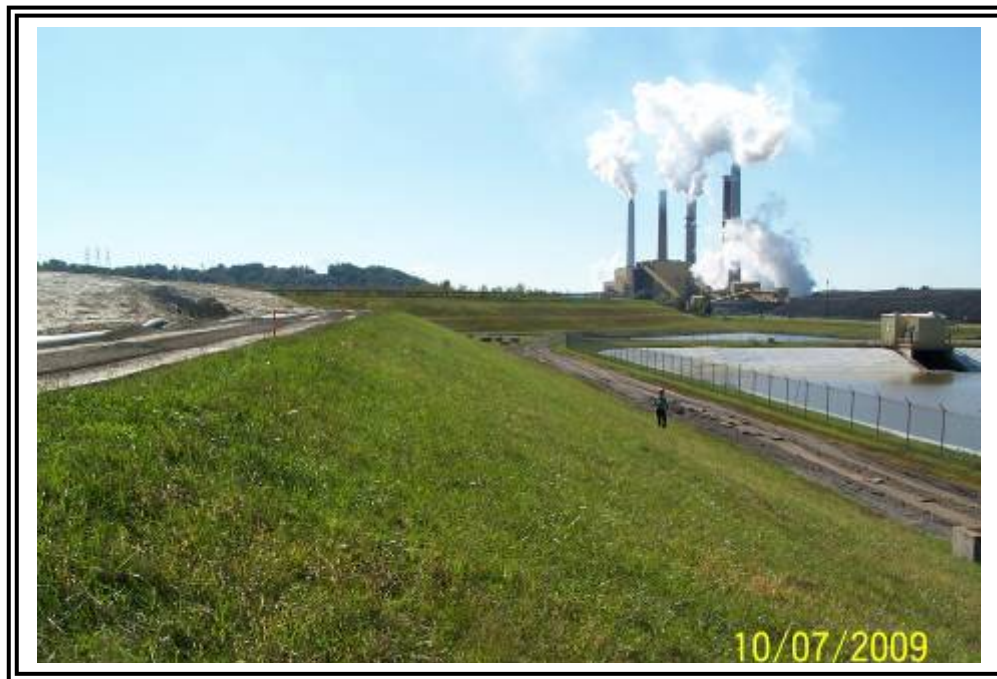
92

Downstream slope of gypsum stacking facility starter dike at the northeast corner looking west.

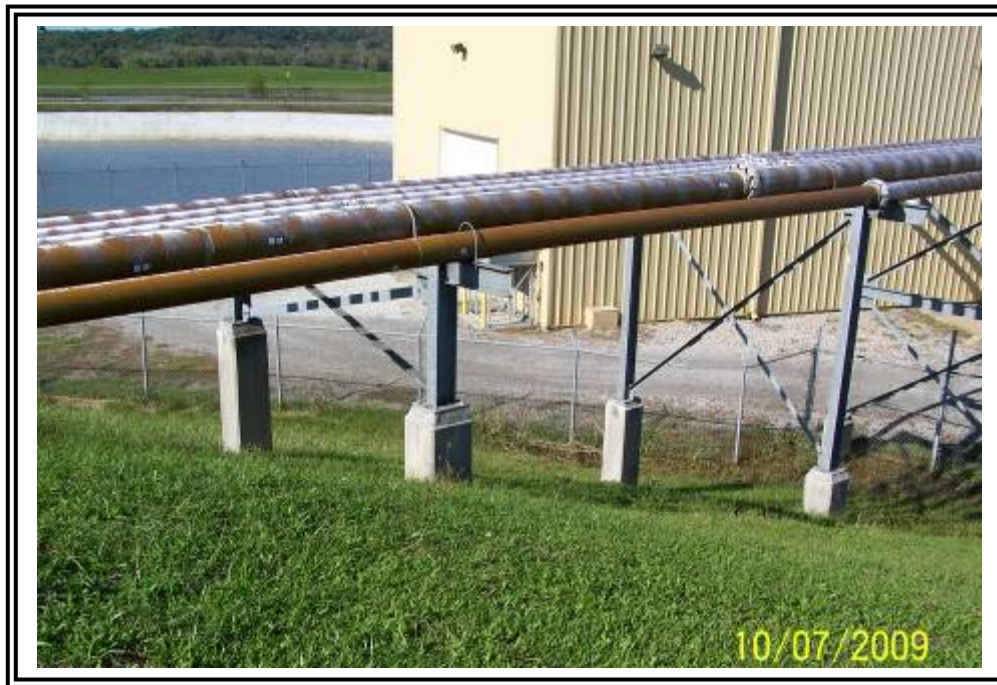
93

Pipe rack diverting gypsum to reuse facility on northeast corner of the gypsum stacking facility starter dike.

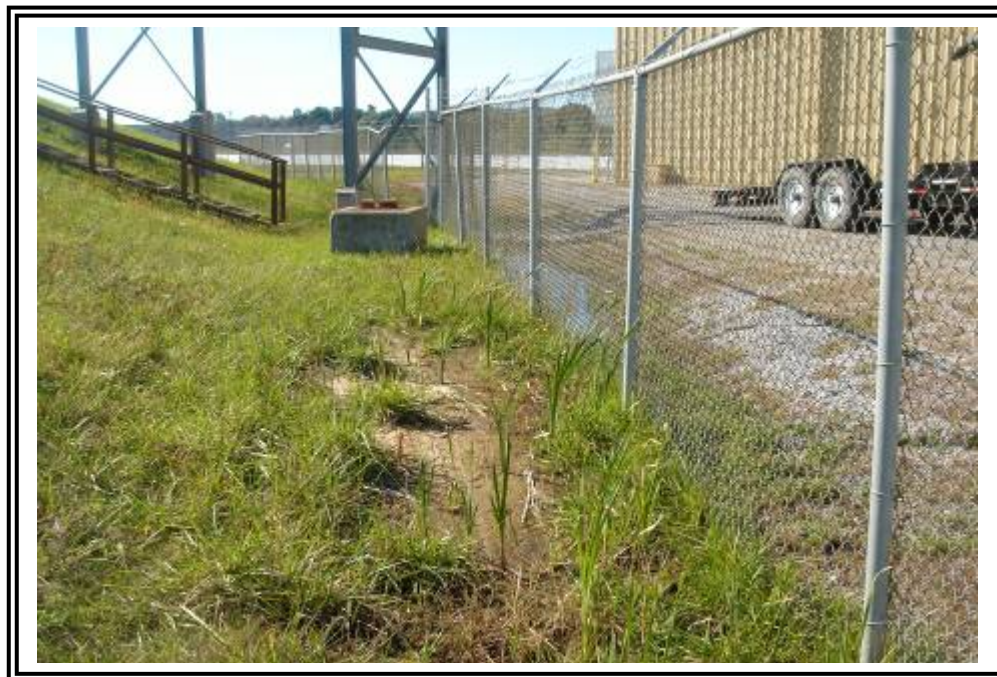
94

Standing water at toe at northeast corner of gypsum stacking facility starter dike. Appears to be surface drainage water.

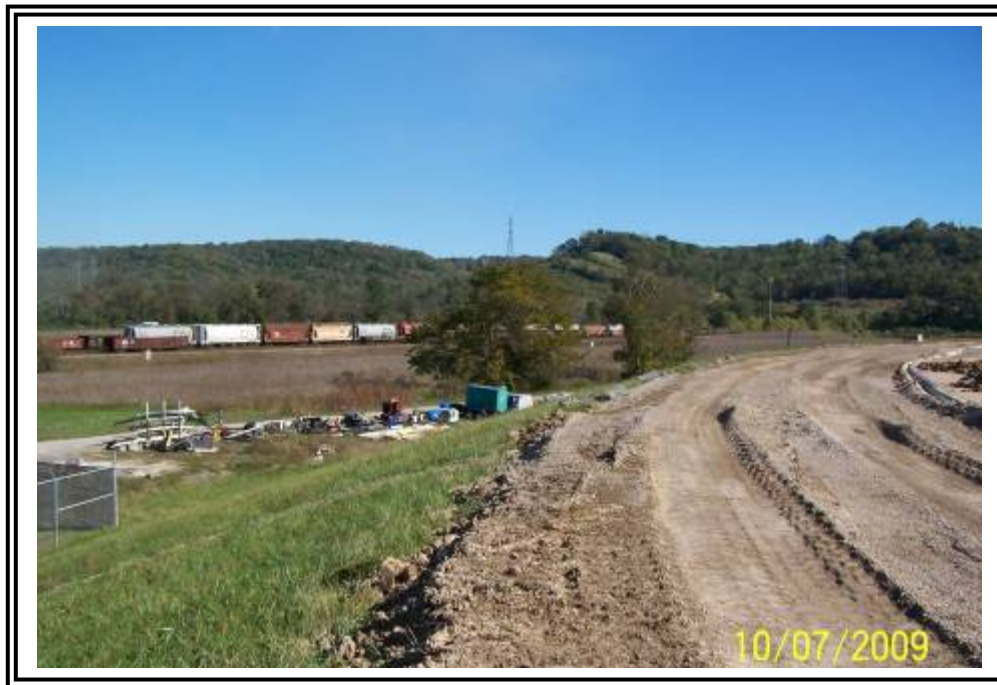
95

Crest of starter dike at northeast corner of gypsum stacking facility (under construction).

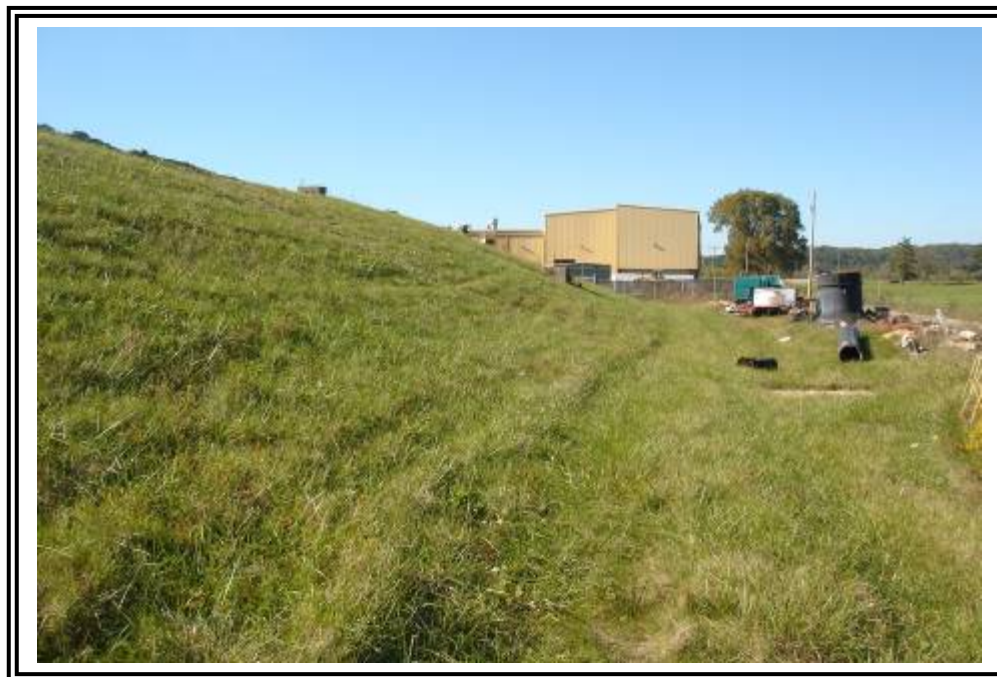
96

Downstream slope of east side of gypsum stacking facility starter dike, looking north.

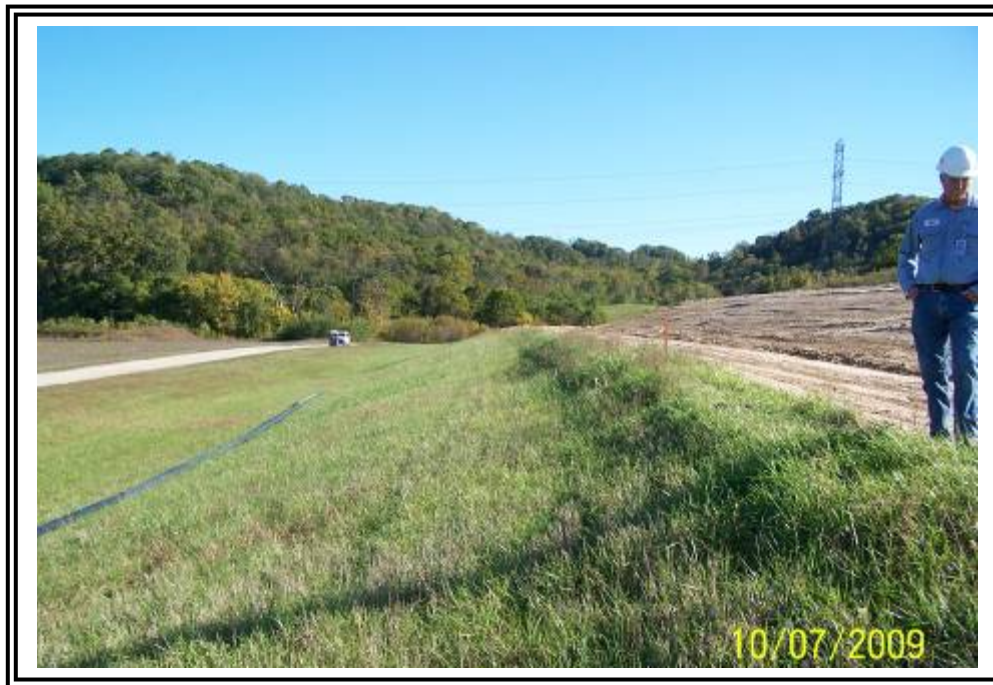
97

Over steepening at crest of east side of gypsum stacking facility starter dike, looking south.

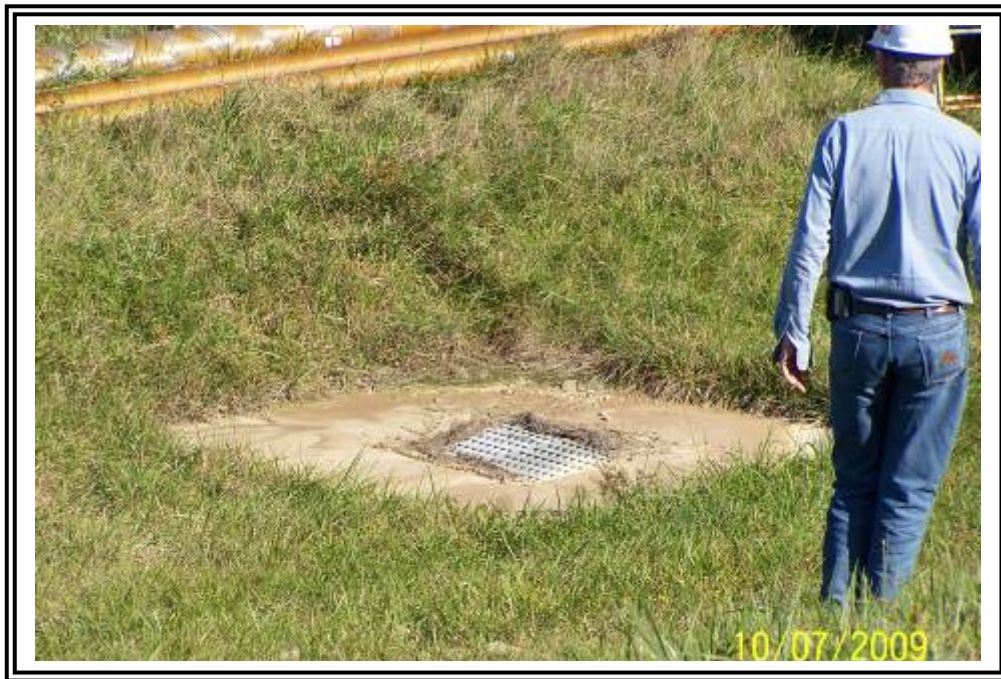
100

Surface drainage system on east side of gypsum stacking facility starter dike.

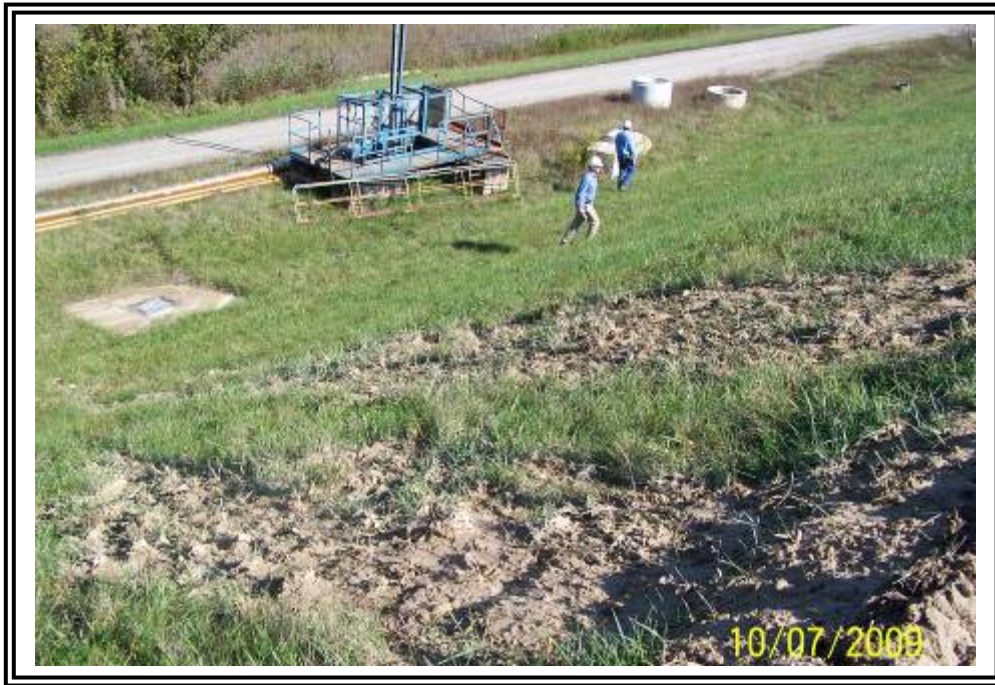
101

Runoff from gypsum stacking facility east dike under construction.

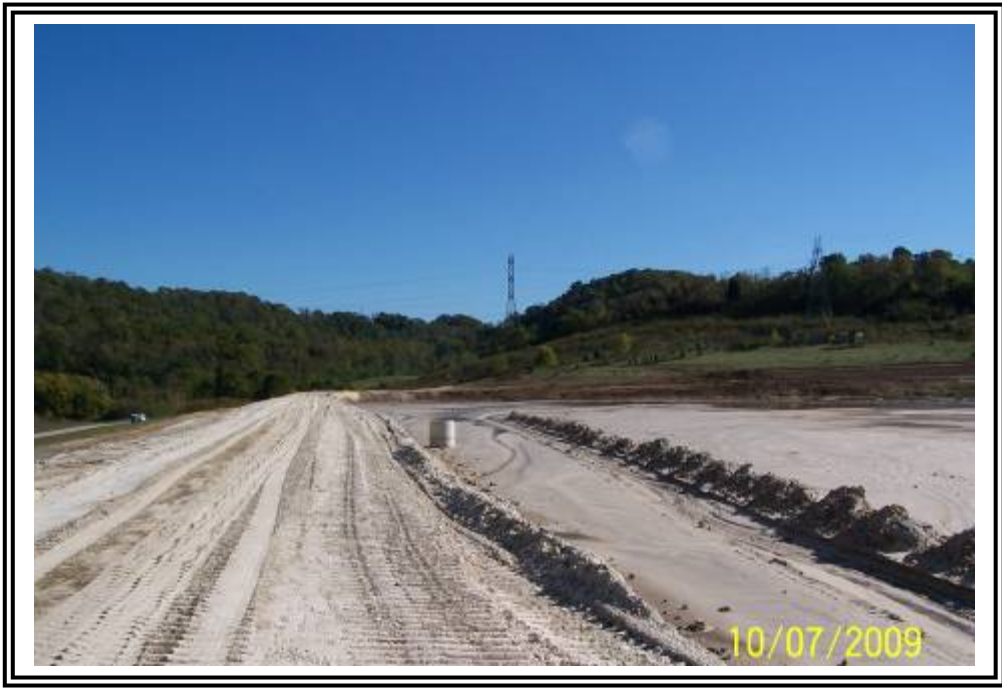
103

Crest of gypsum stacking facility dike east side, looking south.

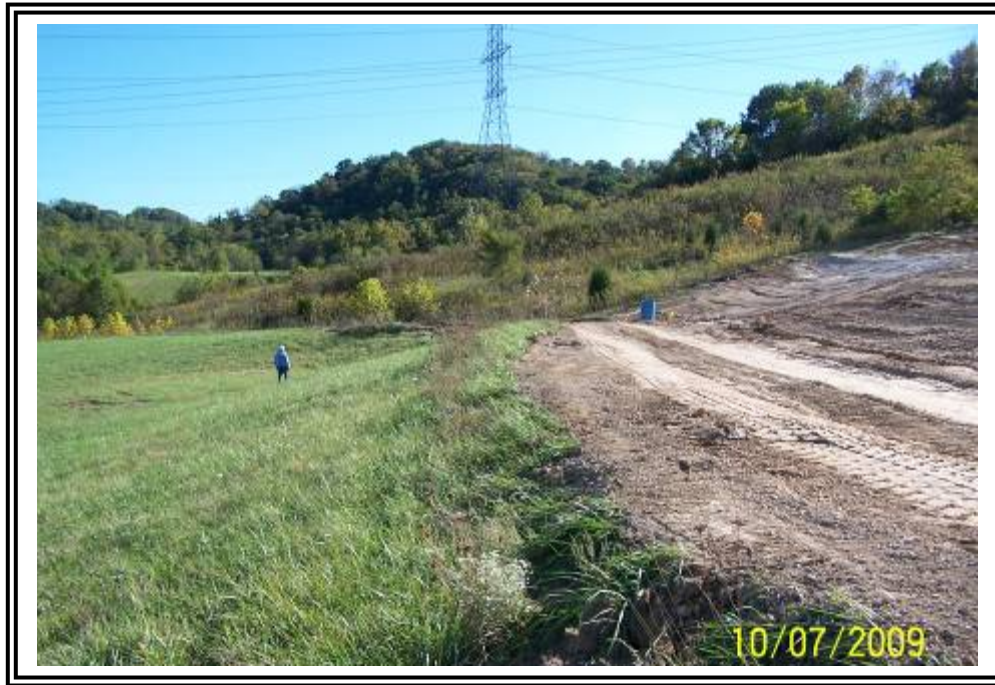
105

East abutment of gypsum starter dike, looking south.
