Report of Dam Safety Assessment
of Coal Combustion Surface Impoundments
Georgia Power
Plant Scherer, Juliette, GA

AMEC Project No. 3-2106-0174.0200

December 2010

Southern Company, Georgia Power, Plant Scherer Ash Pond and Settling Pond
were assessed on May 12, 2010.

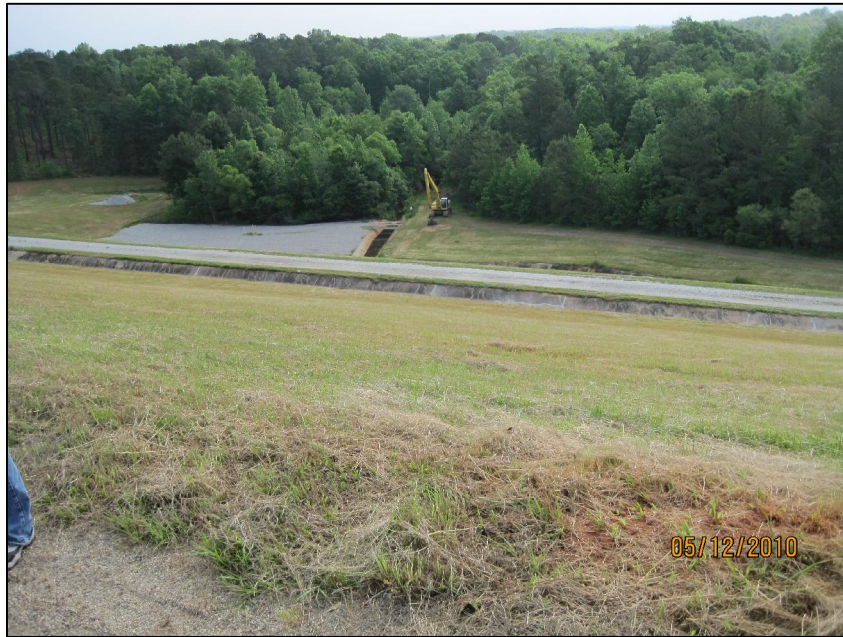
AP-3
CREST OF EAST DIKE, LOOKING EAST AT TOE DRAIN OUTLET

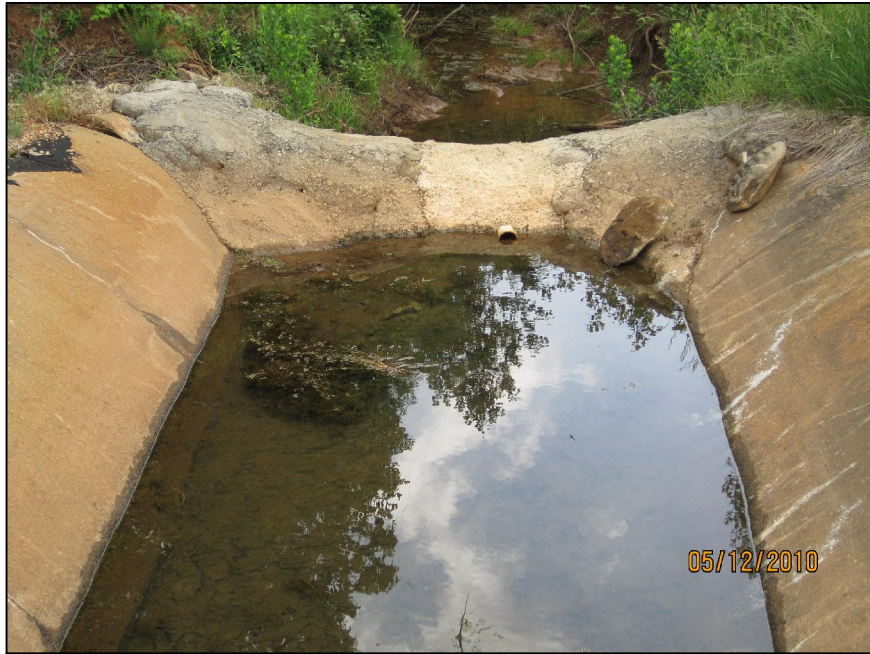
AP-31
 DOWNSTREAM TOE OF EAST DIKE, LOOKING EAST AT BLANKET DRAIN OUTLET WITH 4-INCH
 DIAMETER PIPE

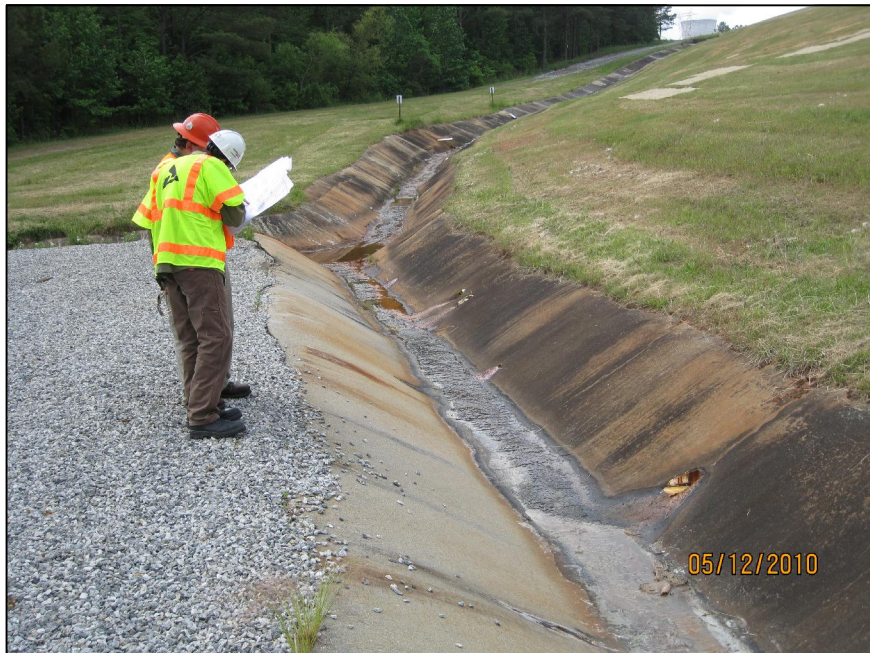
AP-32
 DOWNSTREAM TOE OF EAST DIKE, LOOKING SOUTH AT FLOWING BLANKET DRAIN ON NORTH
 SIDE OF BLANKET DRAIN OUTLET

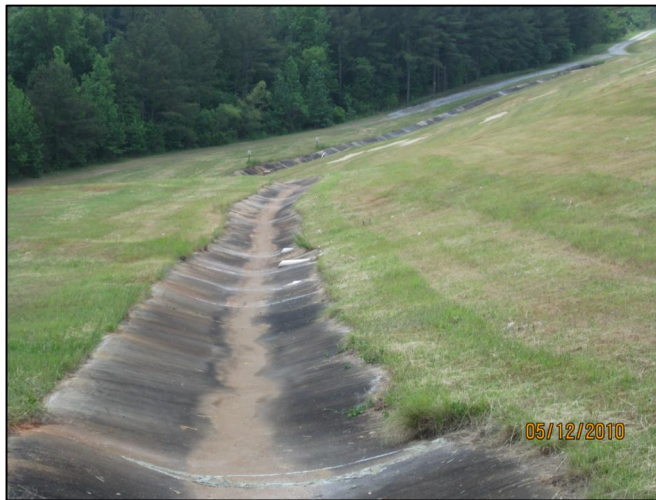
AP-34
 DOWNSTREAM SLOPE OF EAST DIKE, LOOKING SOUTHEAST, TOP OF NORTH END OF ROAD AND BLANKET DRAIN CONCRETE DITCH

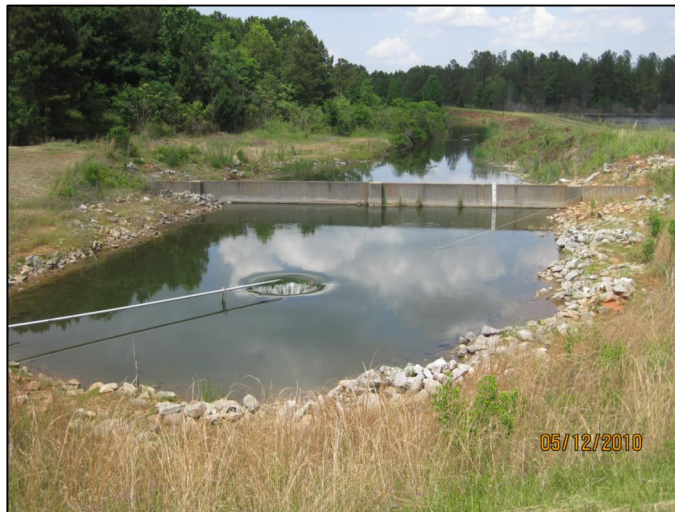
AP-36
 ASH POND OUTLET WEIR AND DECANT PIPE (TREATMENT PIPE ABOVE DECANT)

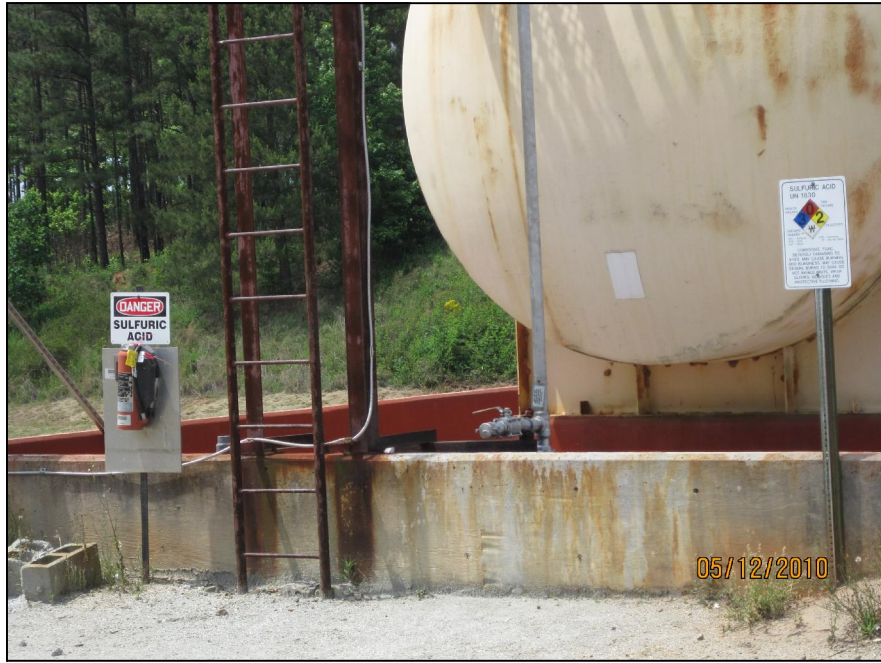
AP-37
SULFURIC ACID TANK FOR OUTLET TREATMENT

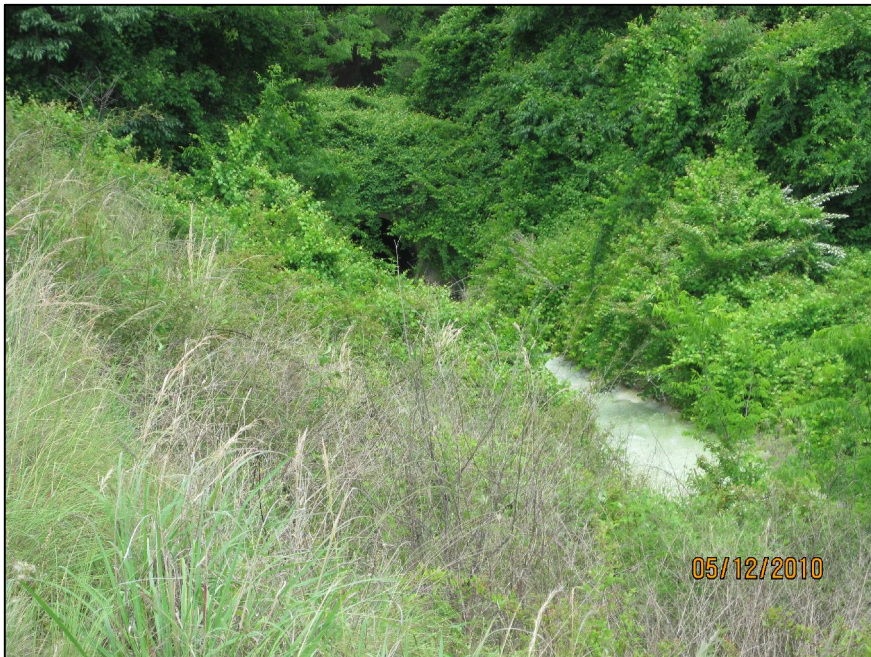
AP-40
LOOKING NORTHEAST AT DECANT PIPE OUTLET TO CONCRETE DITCH

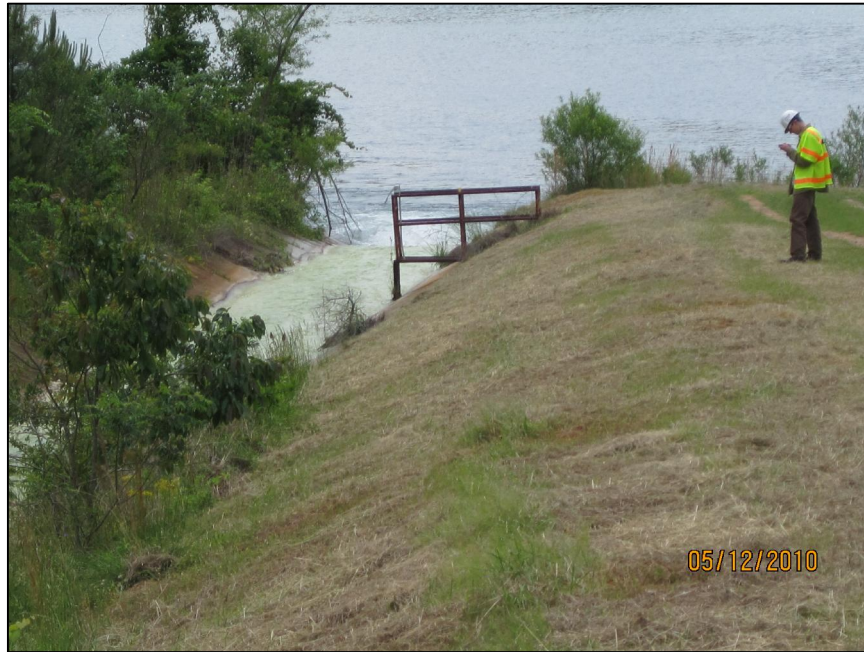
AP-41
LOOKING SOUTH AT ASH POND OUTLET TO SETTLING BASIN

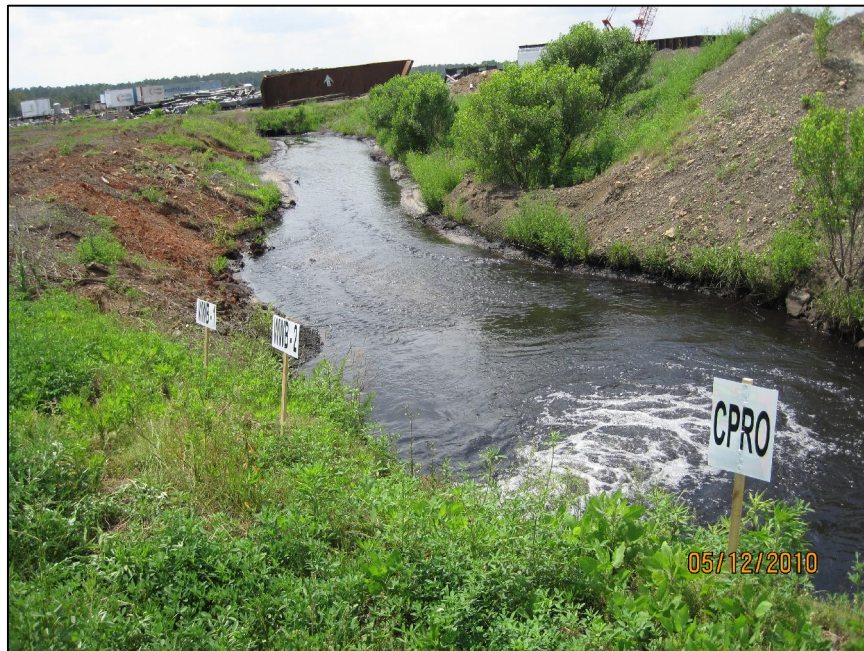
AP-42
SOUTH DIKE, WASTEWATER BASIN (WWB1 AND WWB2) AND COAL PILE RUNOFF OUTLET PIPES

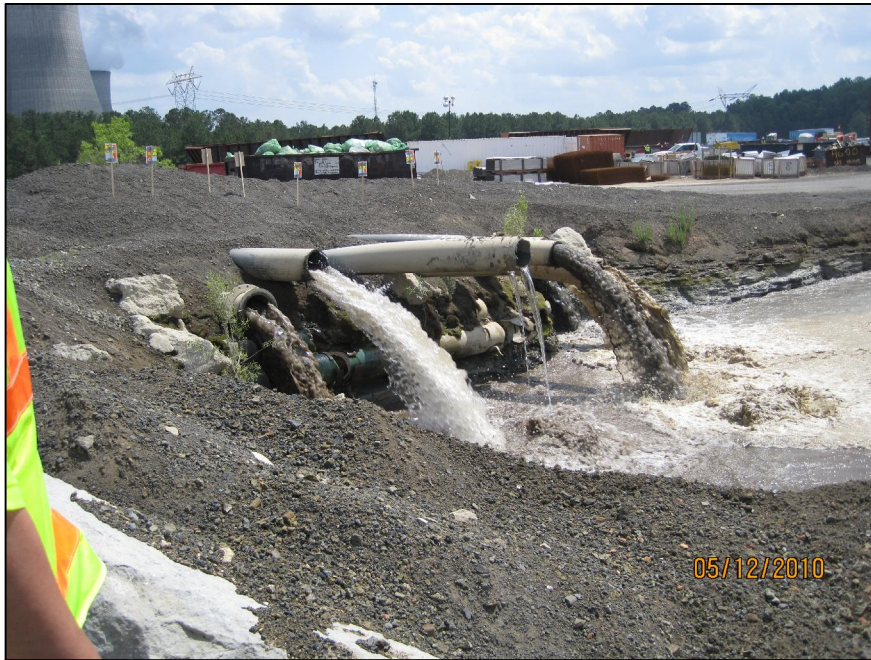
AP-43
SOUTH DIKE, BOTTOM AND TOP ASH SLURRY LINE OUTLET PIPES

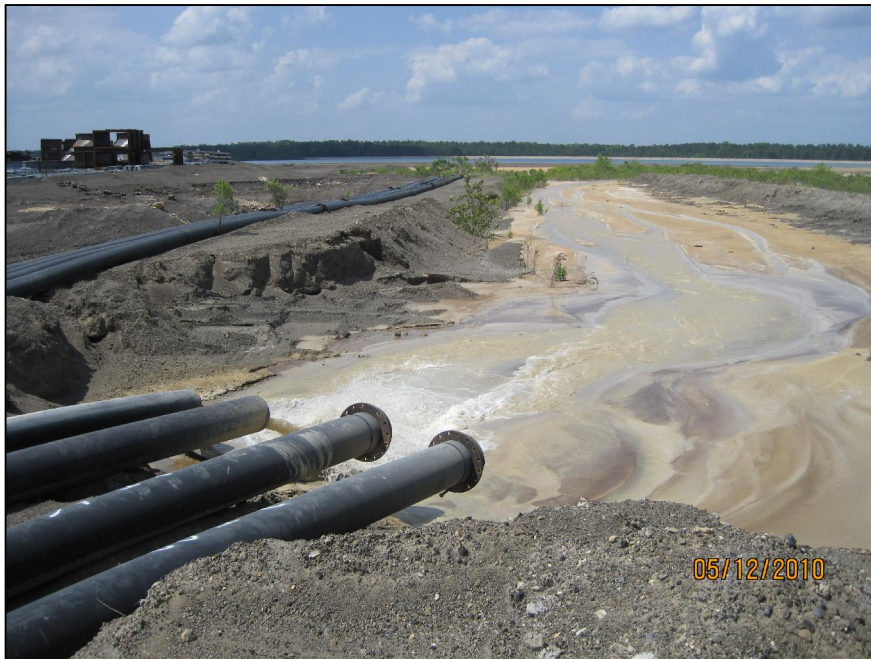
AP-44
SOUTH DIKE, UNITS 1 AND 2 TOP ASH SLURRY LINE OUTLET PIPES

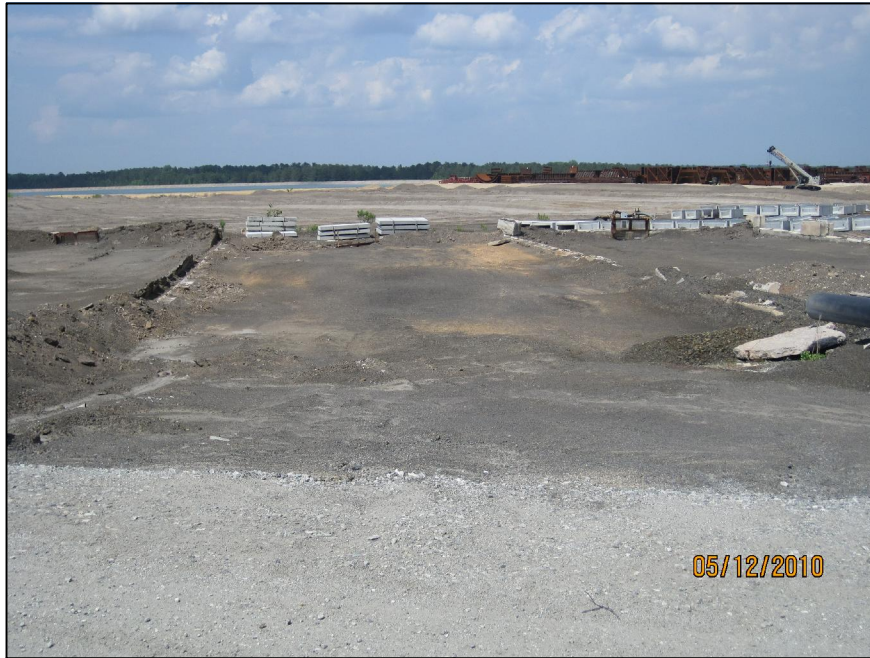
AP-45
SOUTH DIKE, LOOKING NORTH AT ASH POND

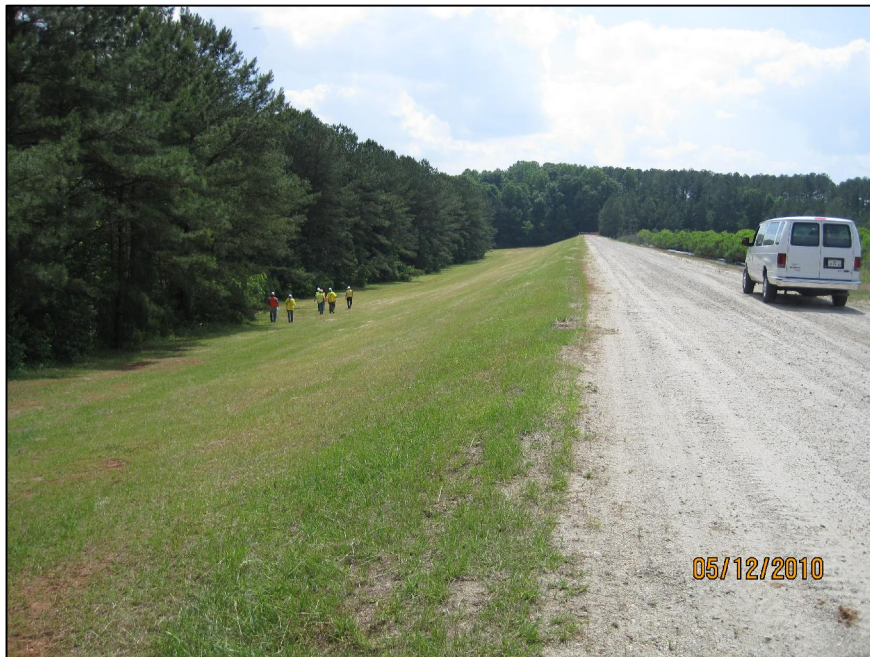
AP-46
CREST OF SOUTH DIKE, LOOKING WEST AT DOWNSTREAM SLOPE AND CREST

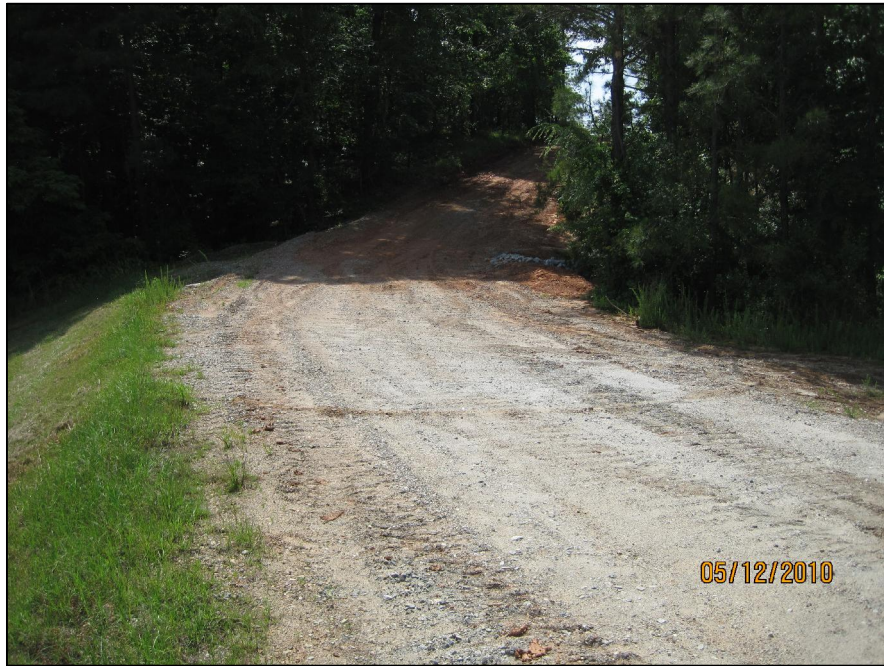
AP-49
SOUTH DIKE, TIE-IN OF RIGHT ABUTMENT

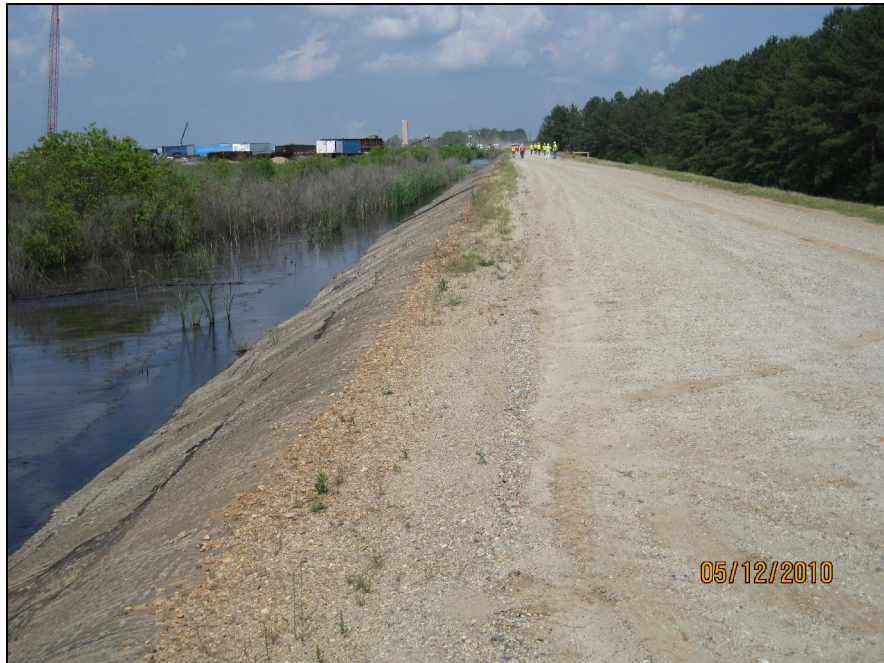
AP-50
SOUTH DIKE, UPSTREAM FABRIFORM SLOPE OF SOUTH DIKE
