# **Assessment of Dam Safety of Coal Combustion Surface Impoundments**

**Indianapolis Power & Light Company**

**Petersburg Generating Station**

**June 8, 2010**

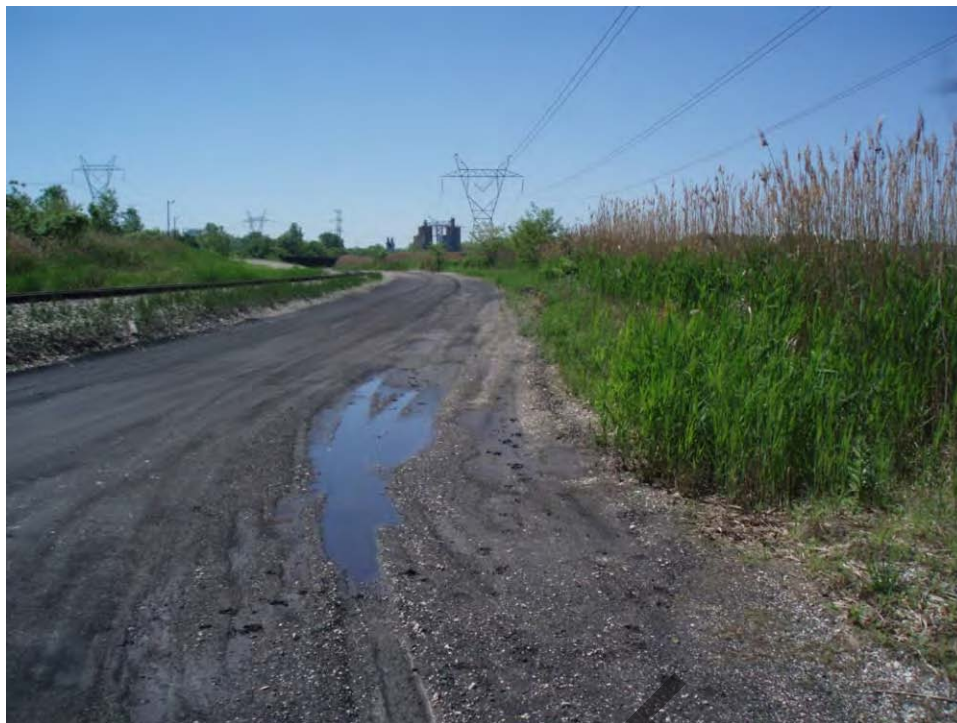
1. Pond A - East embankment crest, looking south.

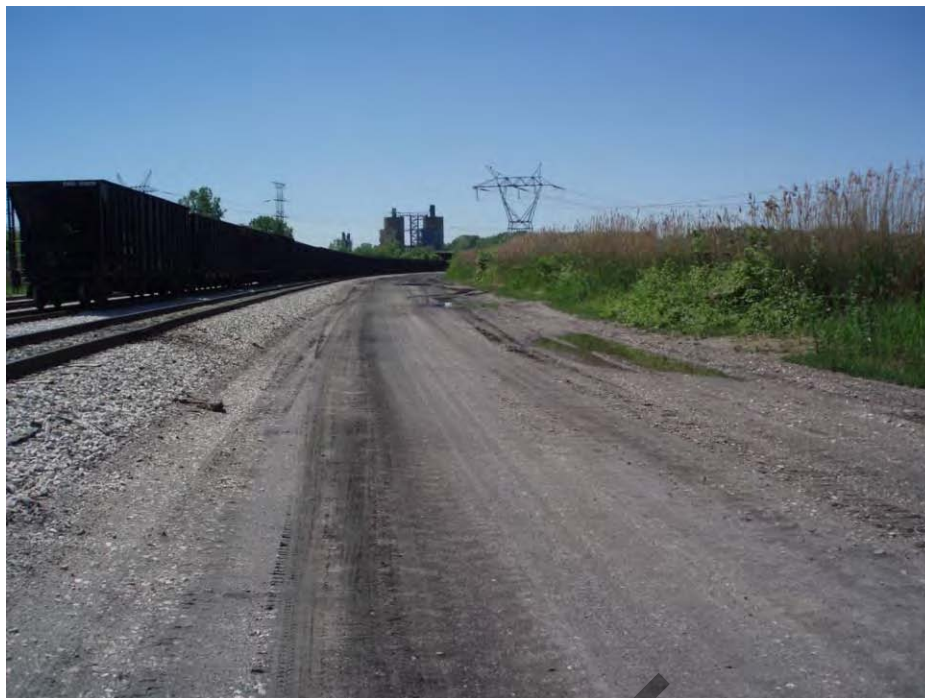
3. Pond A – East embankment crest, looking south.

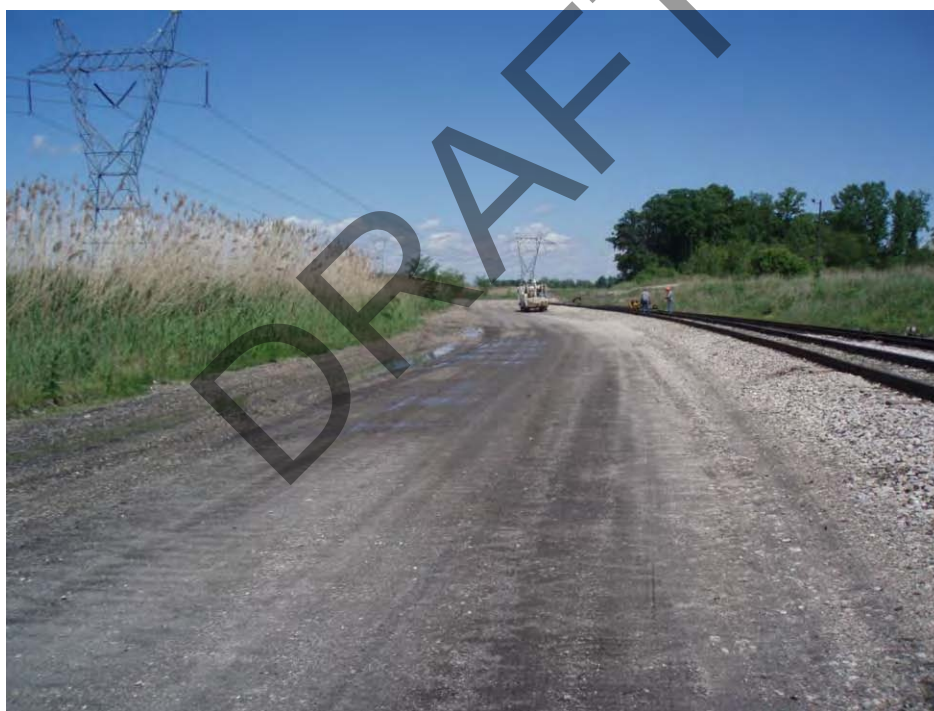
4. Pond A – East embankment crest, looking north

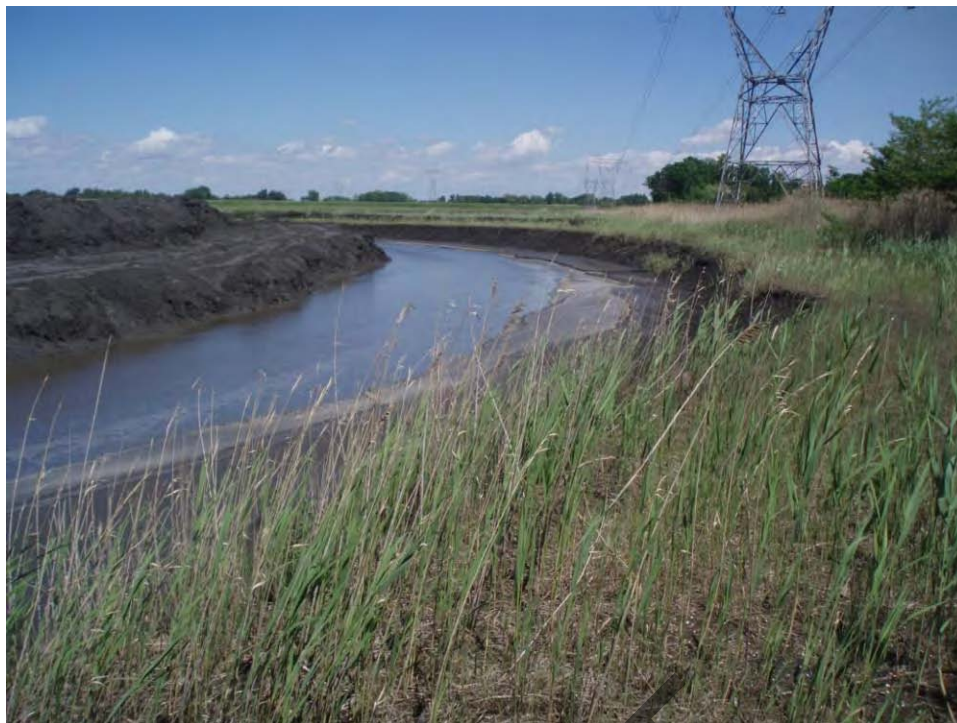
5. Pond A rim ditch, looking north.

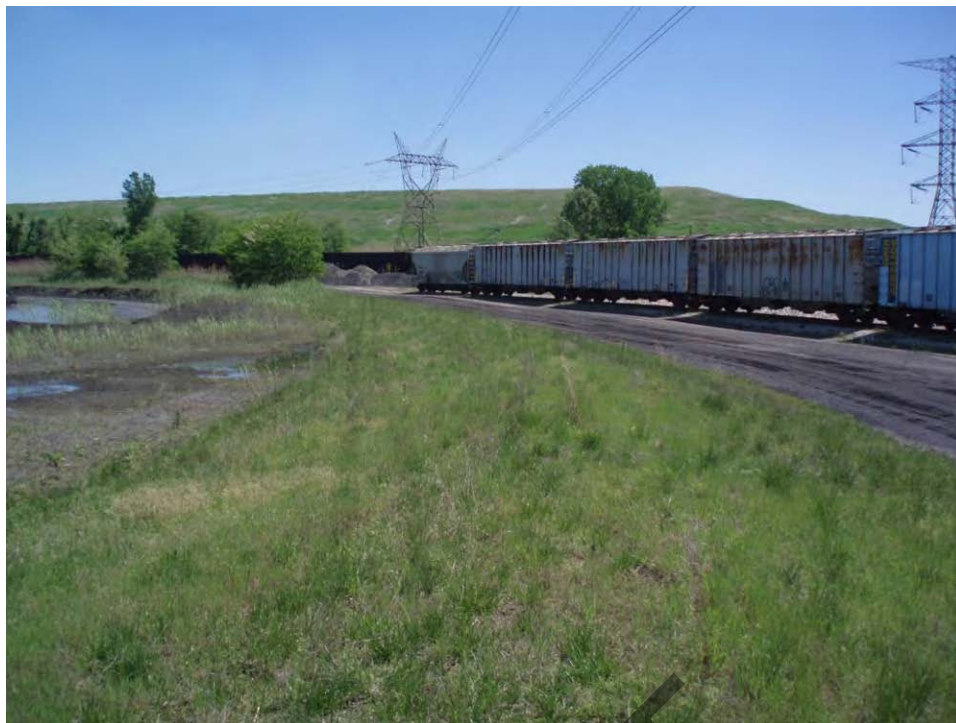
9. Pond A - South embankment crest, looking east.

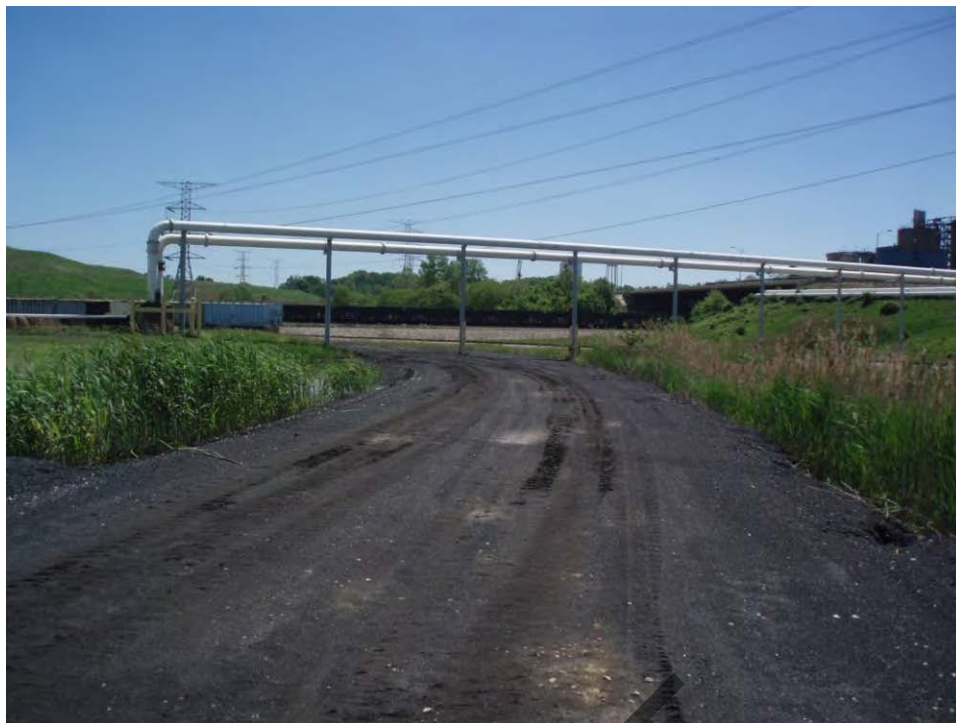
11. Pond A - South embankment looking southeast.

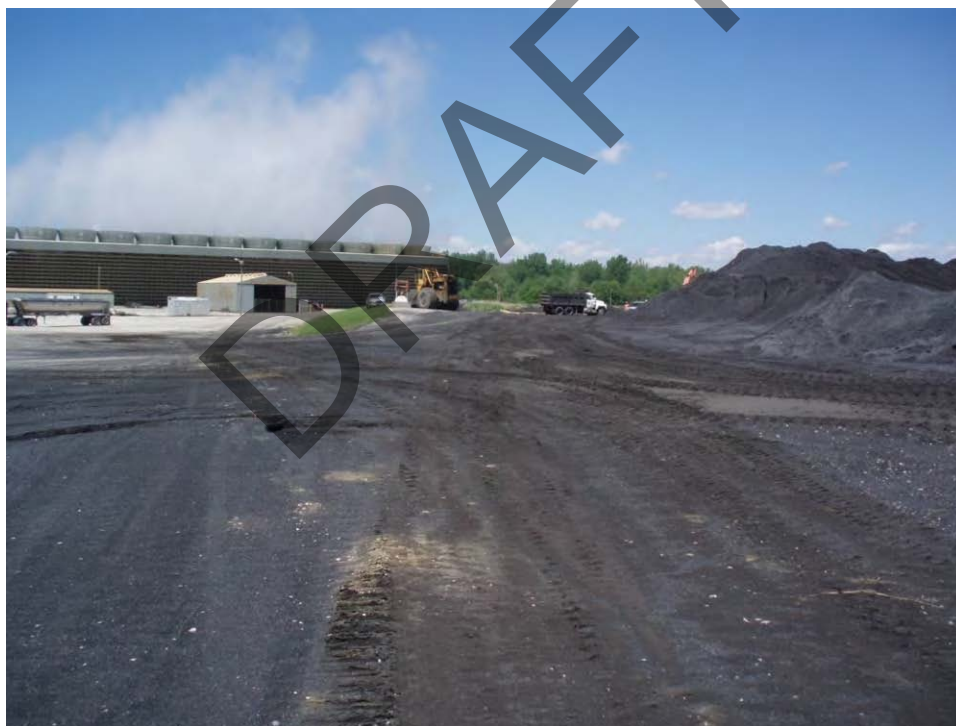
12. Pond A - South embankment crest, looking northwest.

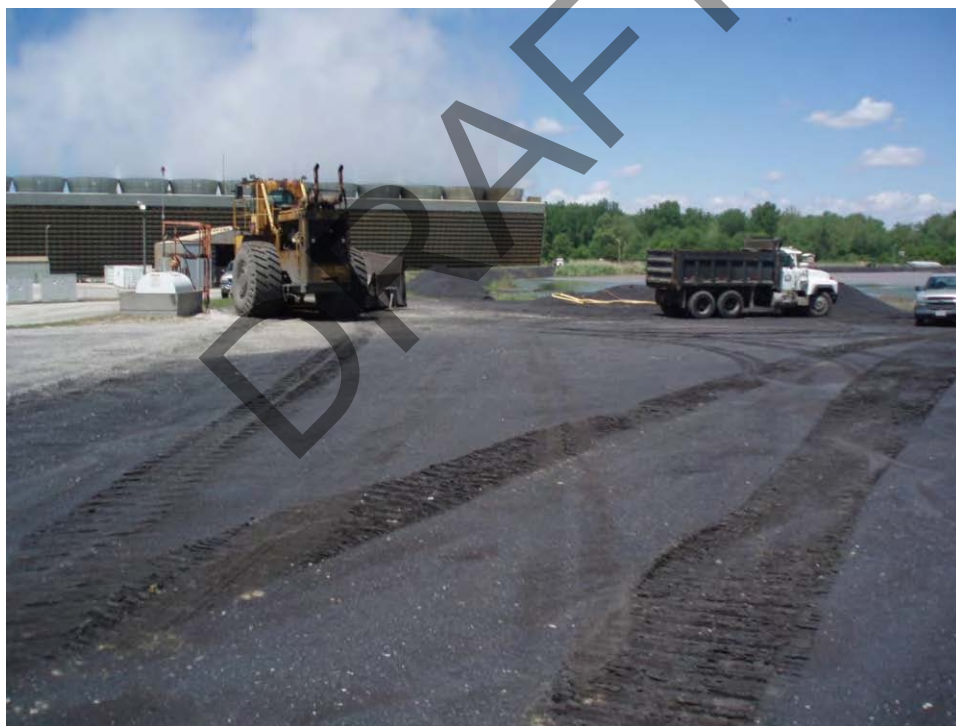
14. Pond A - South embankment crest, looking northwest.

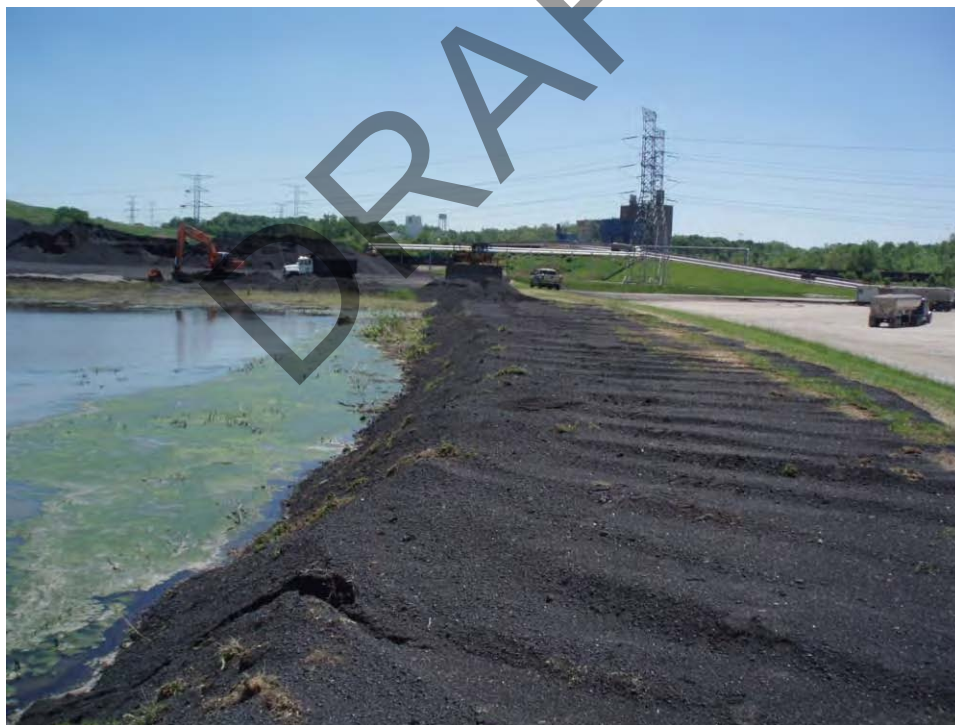
16. Pond A - South embankment crest, looking southeast at recently placed ash material. Note existing embankment was not cleared or grubbed before placing material.

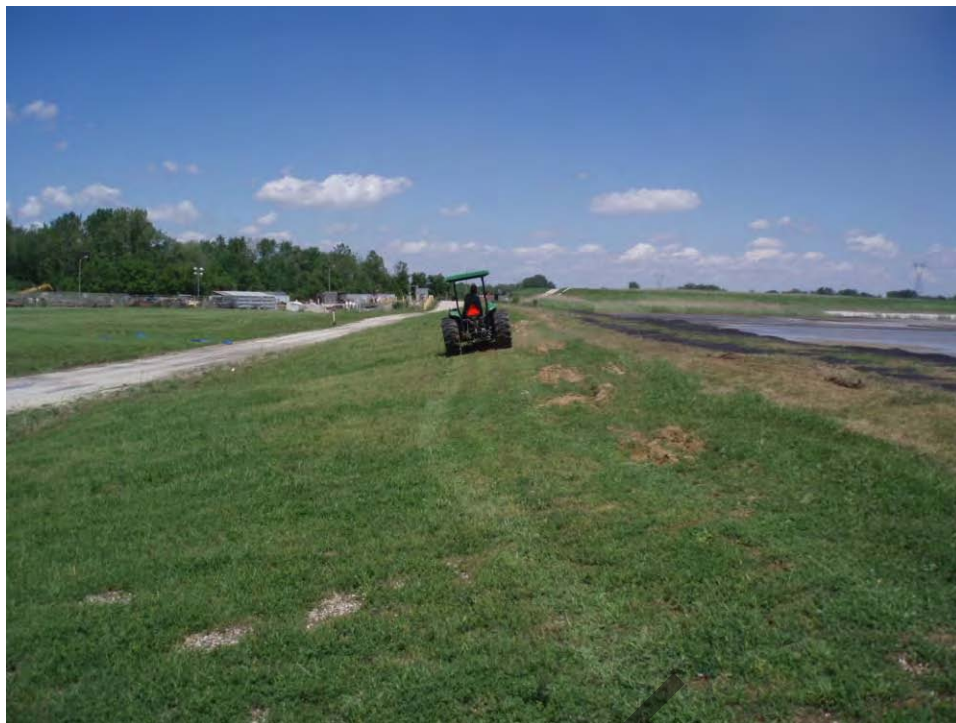
19. Pond A - West embankment exterior slope, looking north at mowing operation.

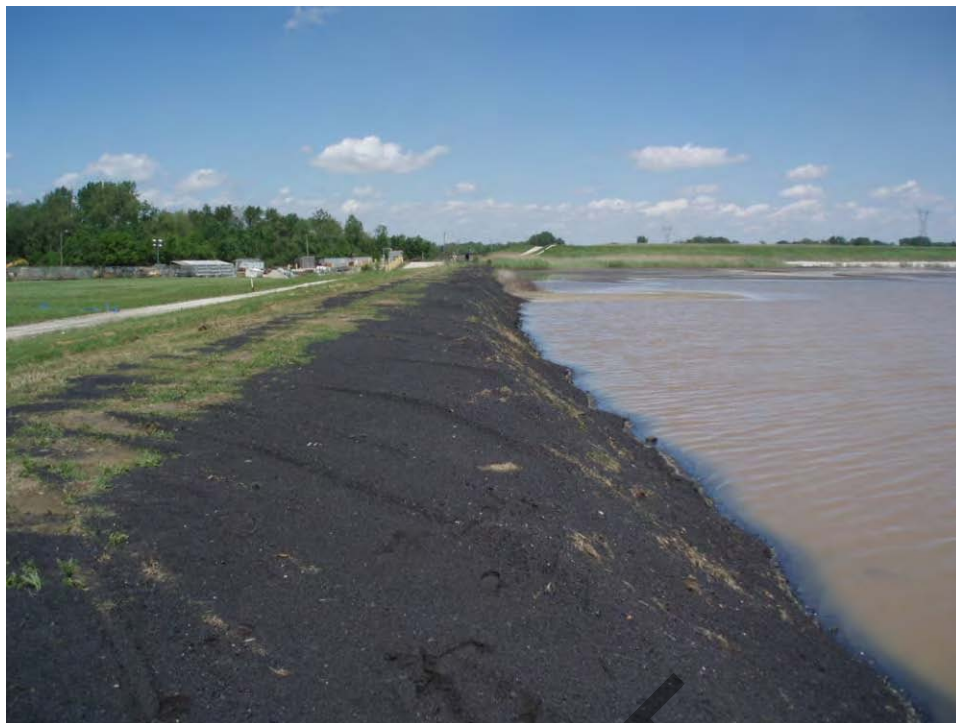
21. Pond A - West embankment interior slope and crest, looking north

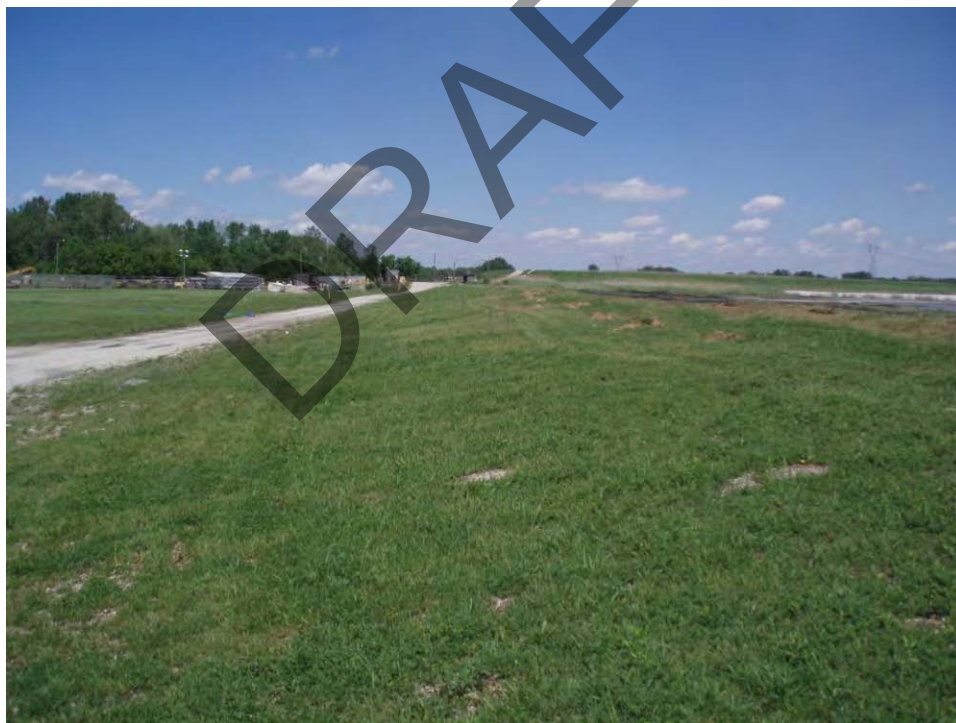
22. Pond A - West embankment exterior slope, looking north.

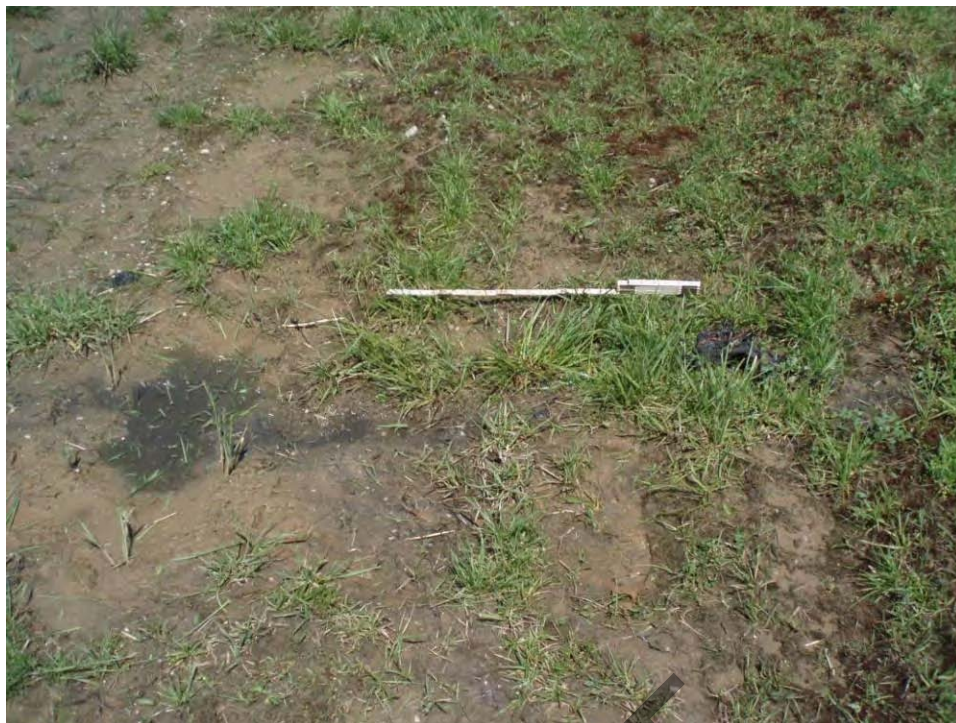
A possible seepage area was observed on the west embankment exterior slope (Photo 25).

25. Pond A - Saturated area on west embankment exterior slope.

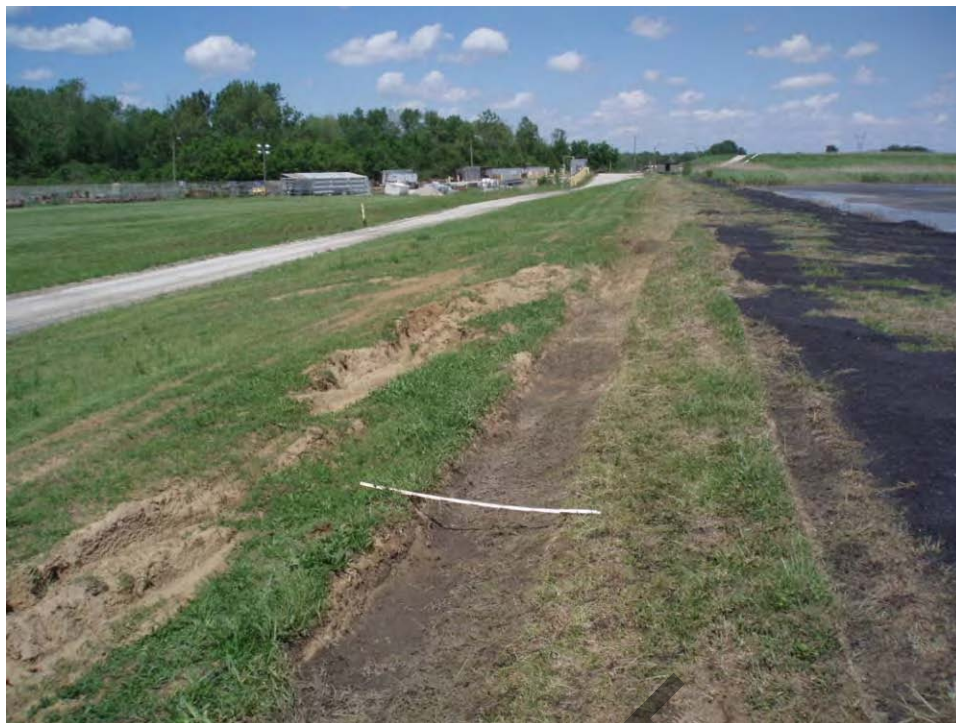
27. Pond A - West embankment exterior slope, looking north at large tractor ruts and excavator tracks.

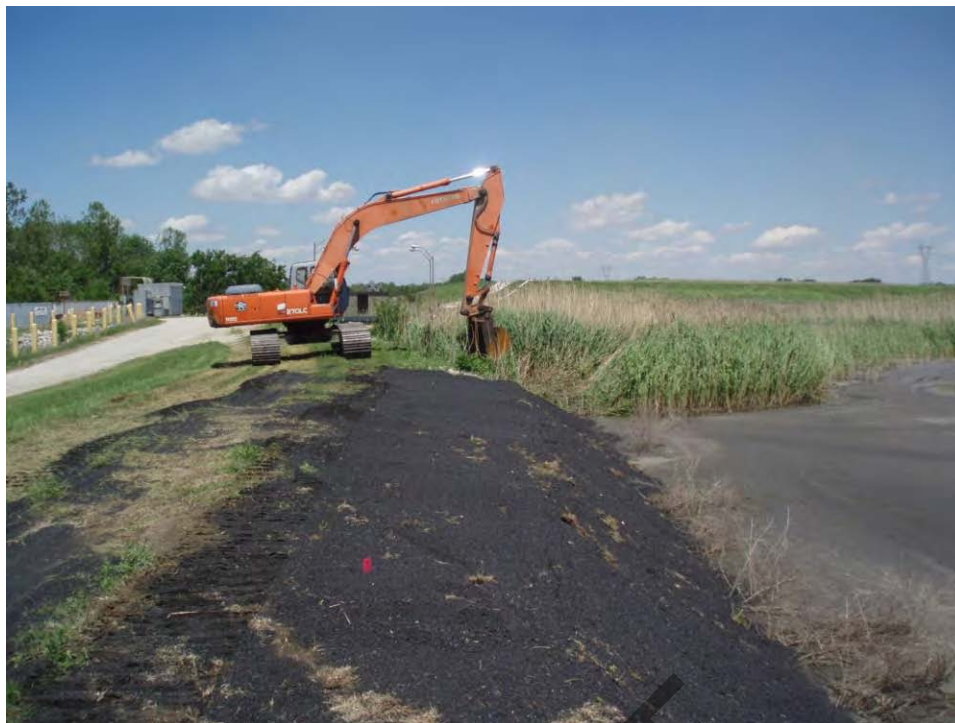
29. Pond A - West embankment interior slope looking north at embankment work.

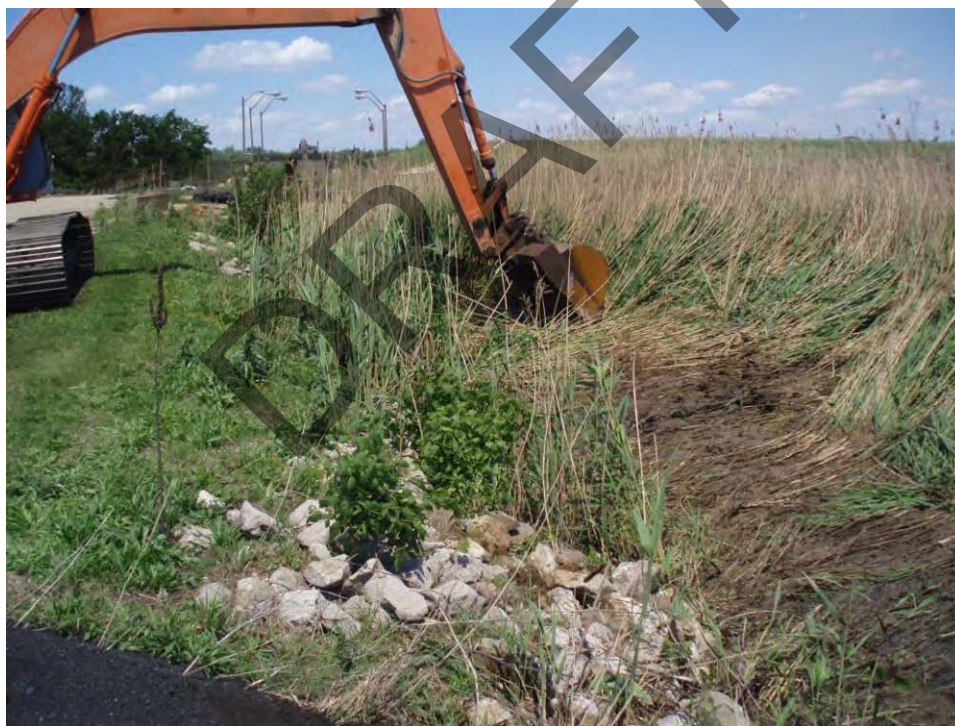
30. Pond A - West embankment interior slope, looking north at excavator flattening vegetation before placing ash material. Note an unknown 24-inch-diameter RC pipe in the embankment was being covered with ash.

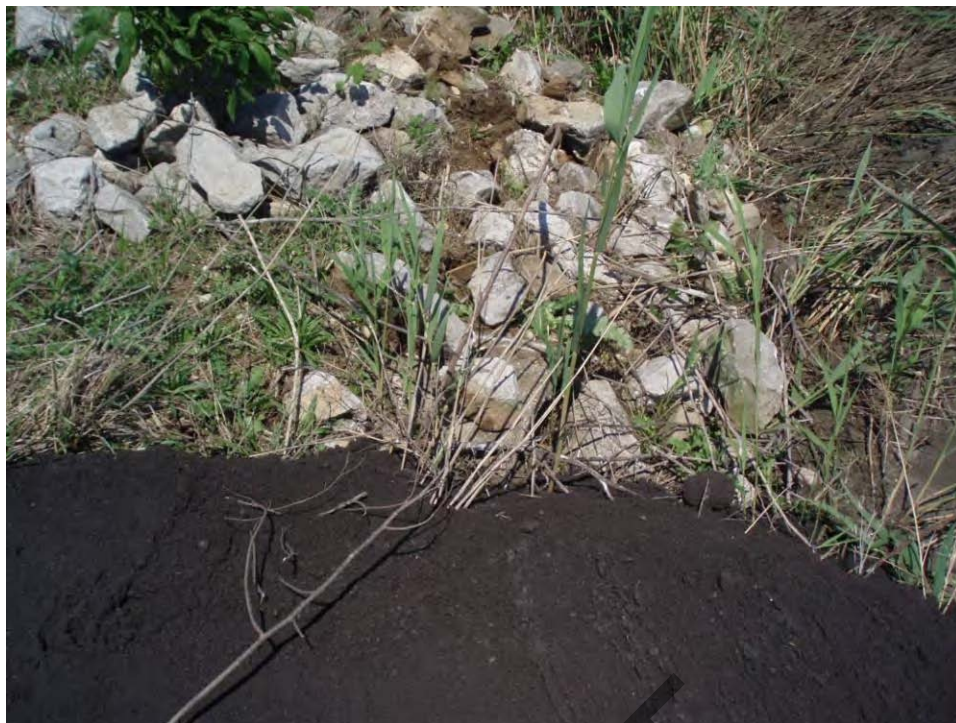
33. Pond A - 24-inch-diameter RC pipe being covered by ash.

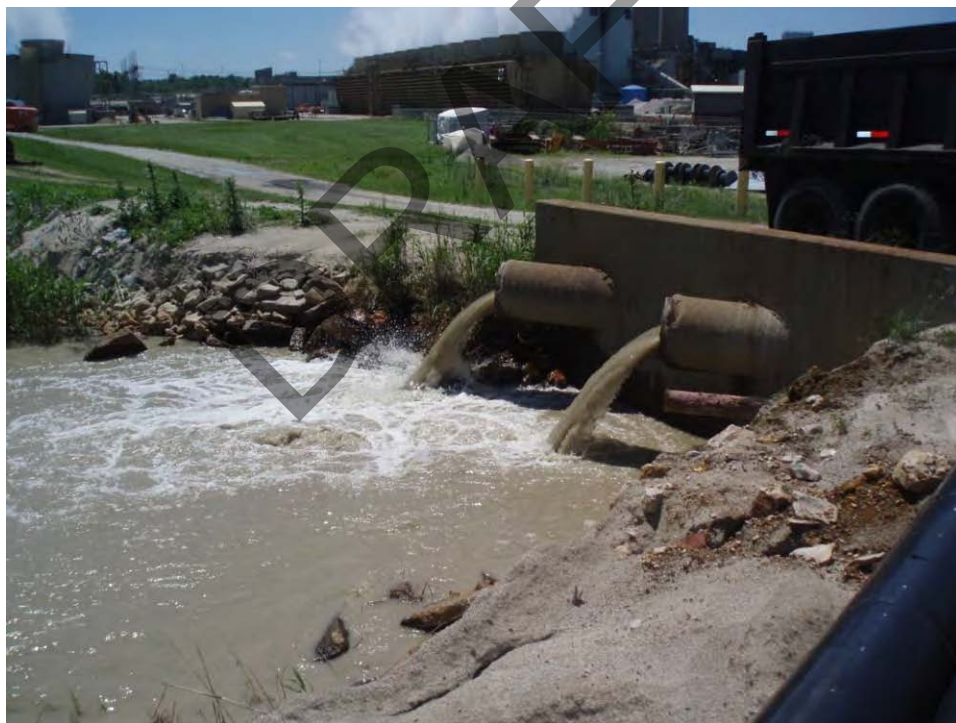
36. Pond A - West embankment interior slope, looking southeast at two (2) 24-inch-diameter RCP from plant super sumps and one (1) 4-inch-diameter DI pipe from unknown origin.

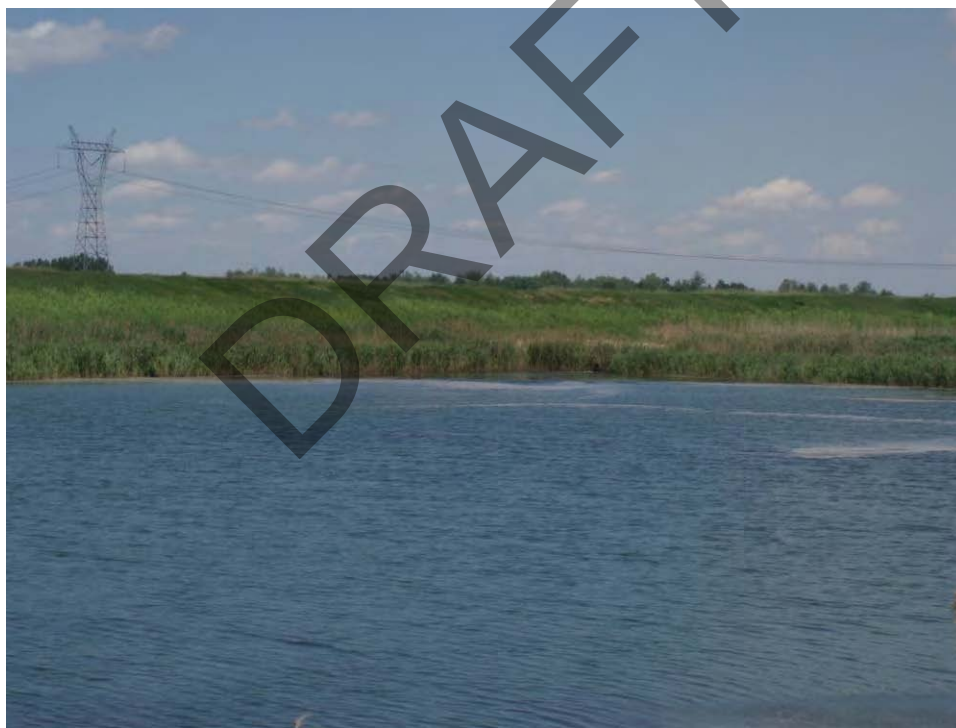
42. Overview of Pond A - Discharge, looking northeast at inlet pipes from Pond A.

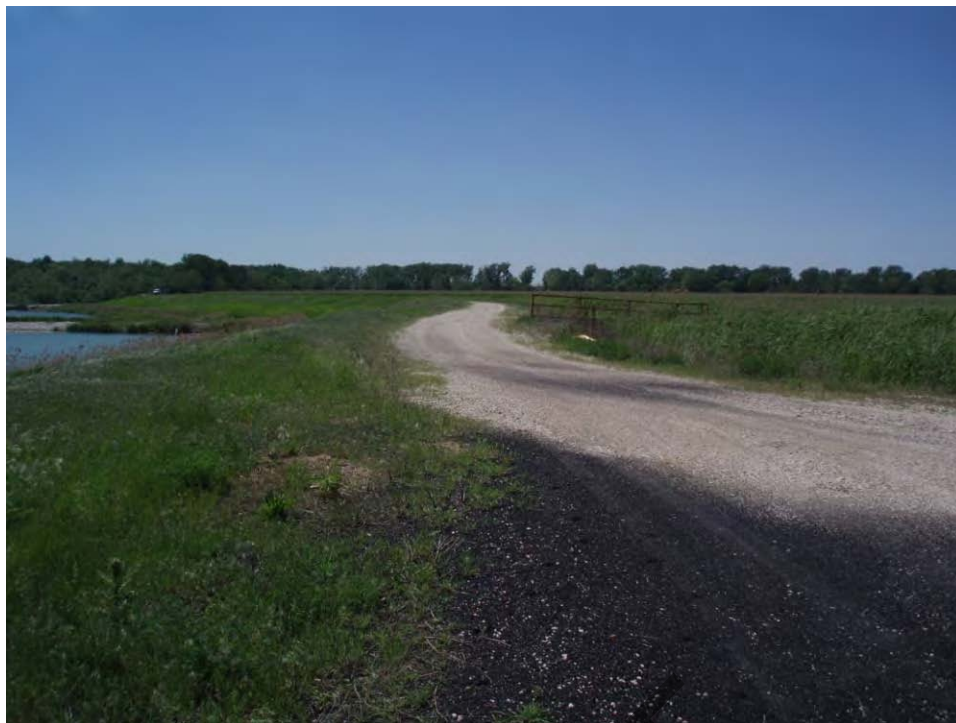
53. Pond B - South embankment crest, looking west.

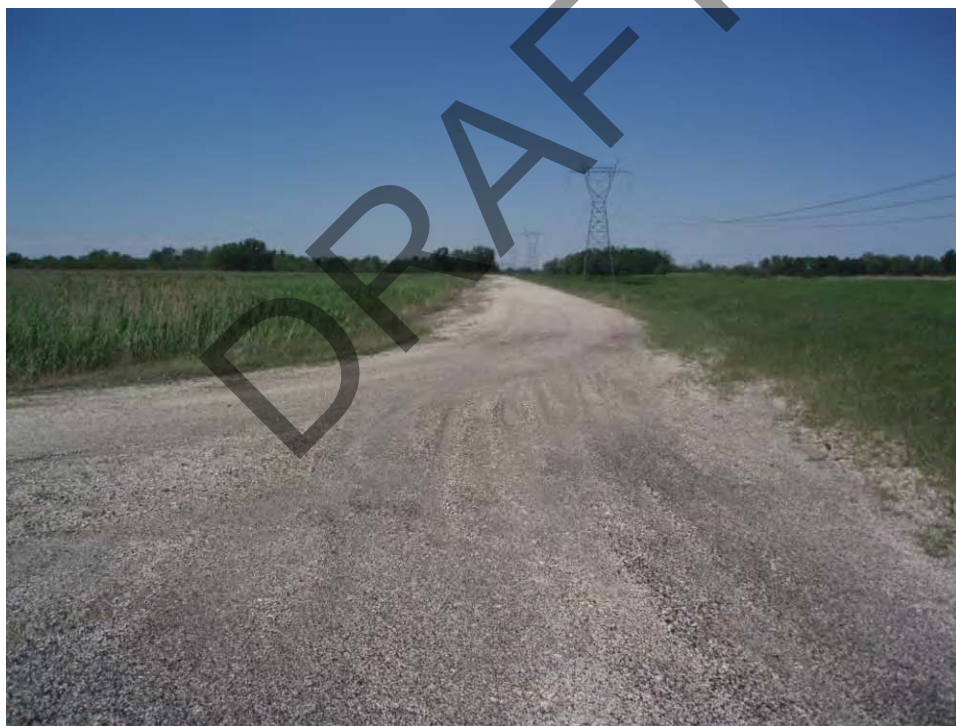
54. Pond B - East embankment crest, looking north.

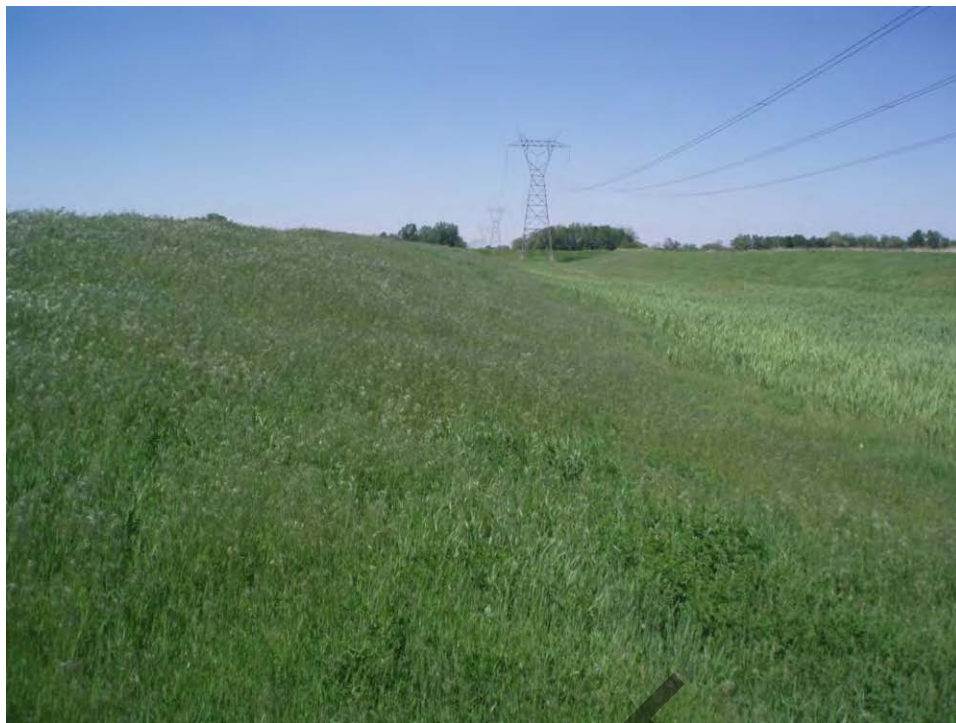
55. Pond B - East embankment exterior slope, looking north.

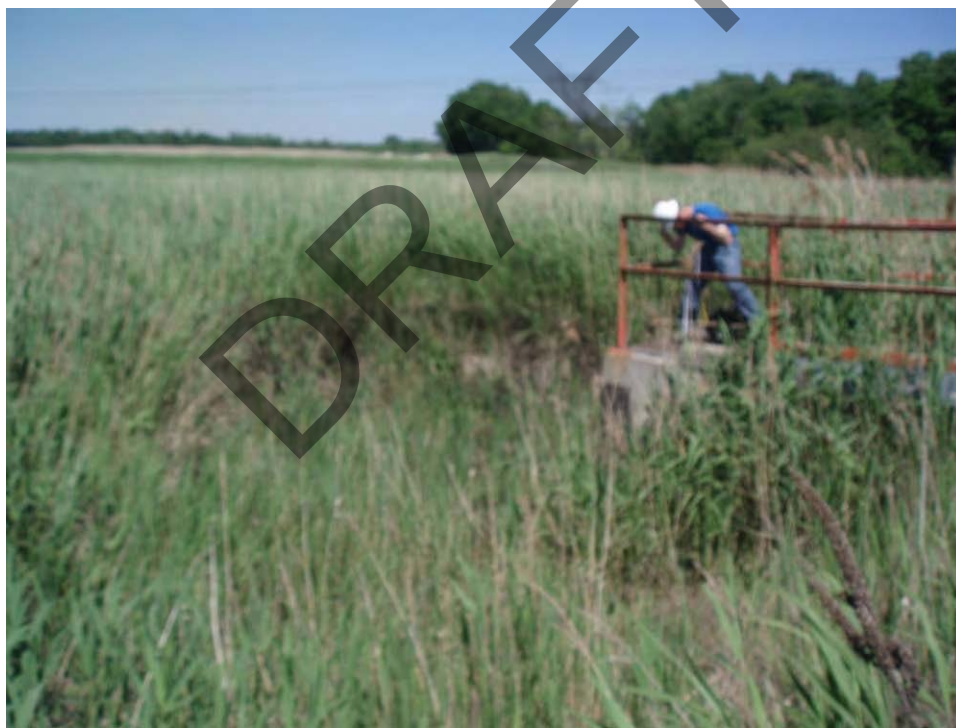
56. Pond B - Overview of outlet control structure with stoplogs, looking east.

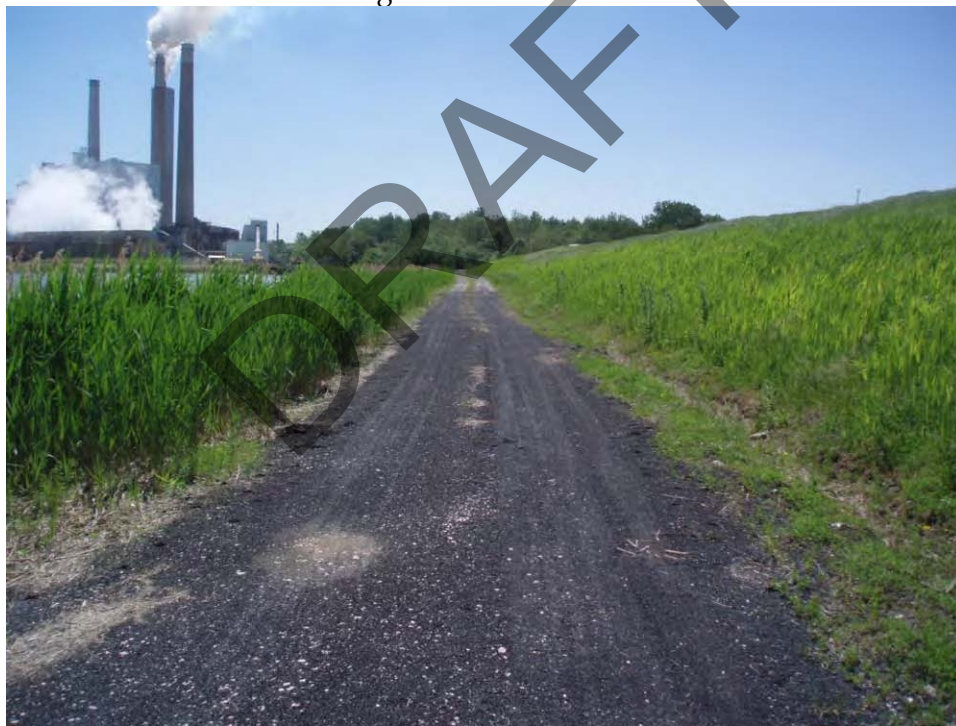
62. Pond A - Discharge north crest and Pond B south embankment toe, looking west.

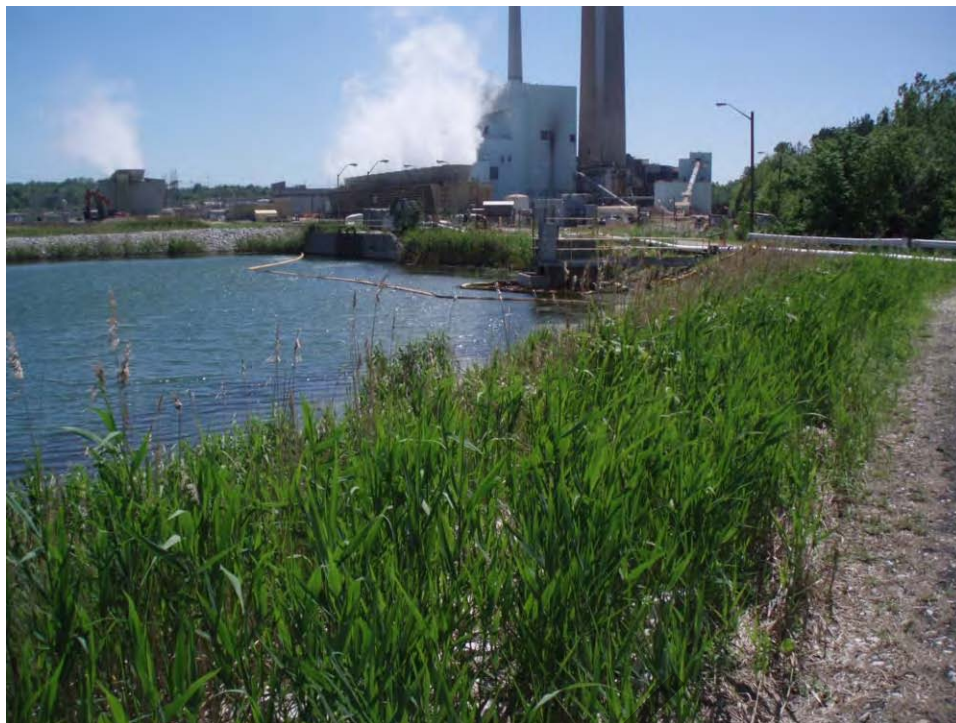
65. Pond A - Discharge, looking southwest at outlet structure and recycle pump station.

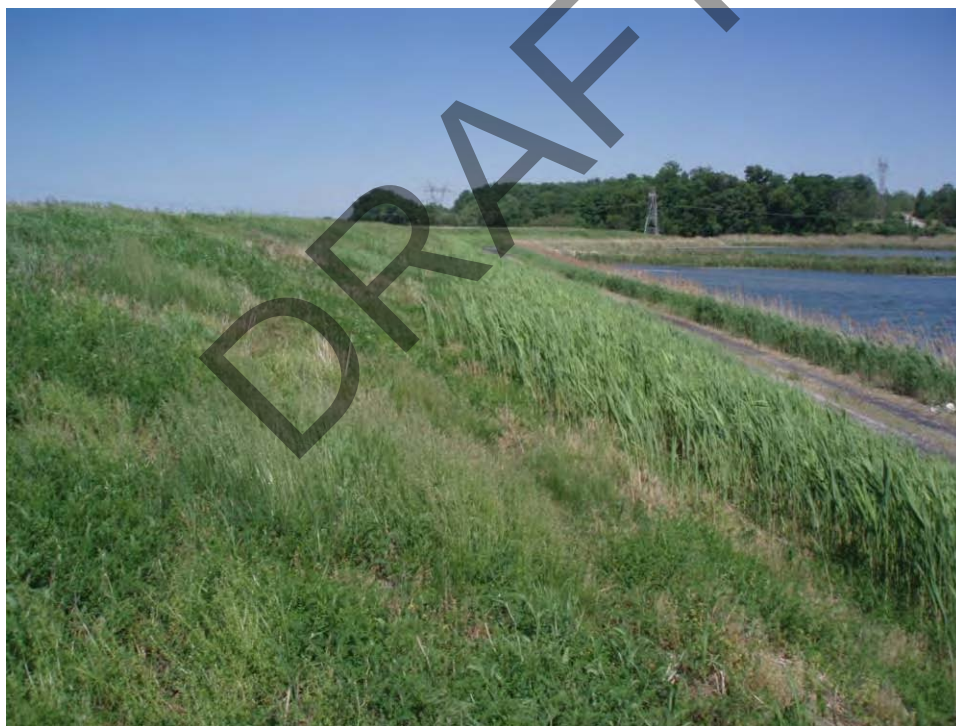
66. Pond B - South embankment exterior slope, looking northeast.

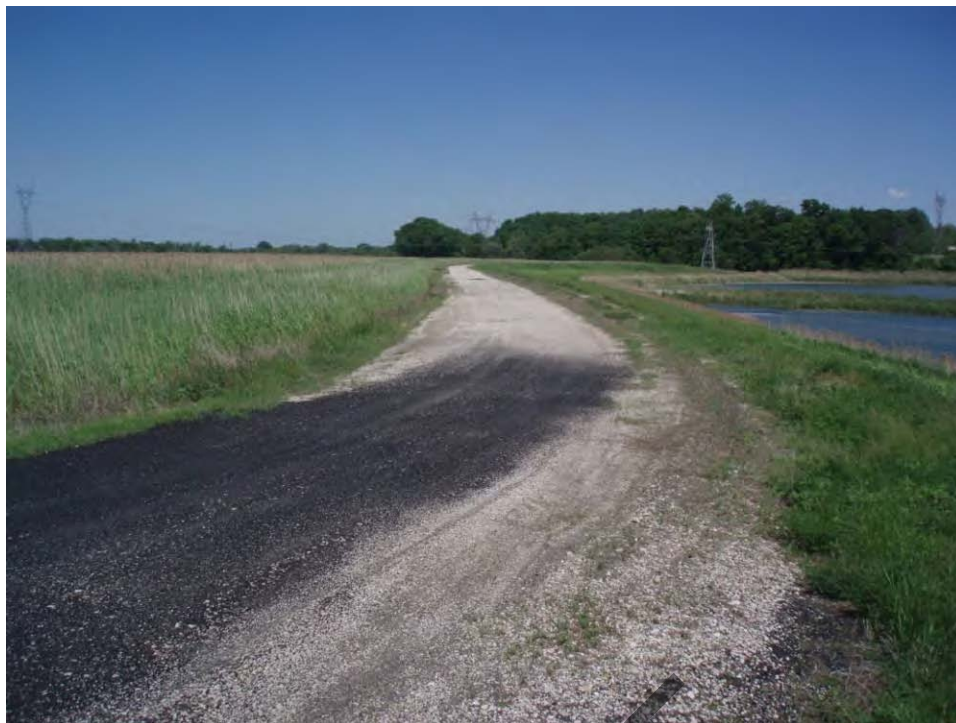
67. Pond B - South embankment crest, looking northeast.

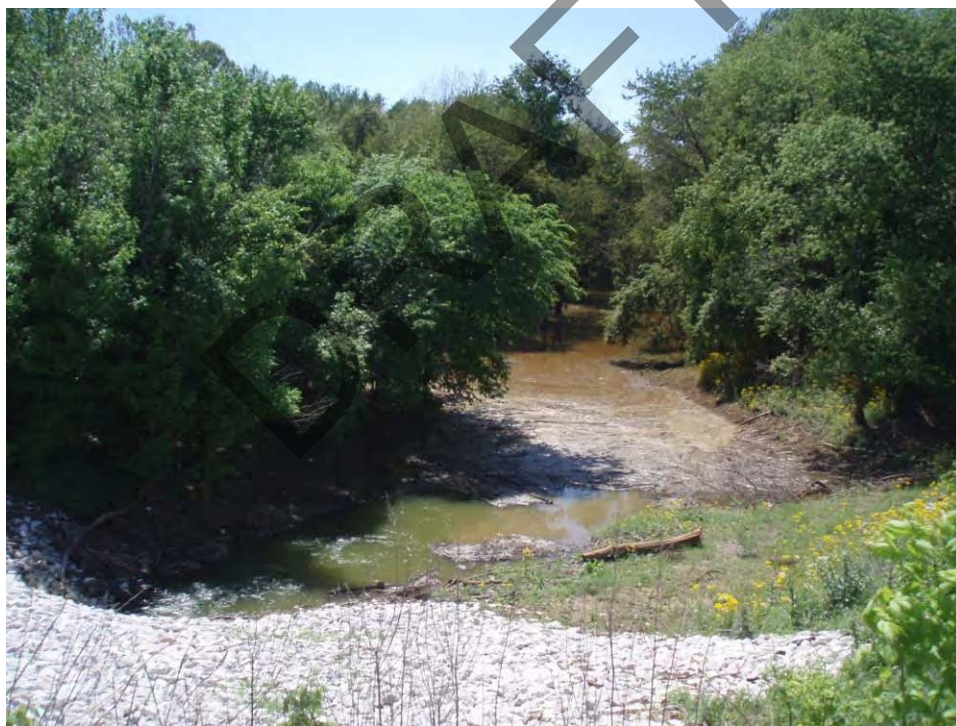
68. Pond A - Discharge, looking west at discharge canal to the White River.

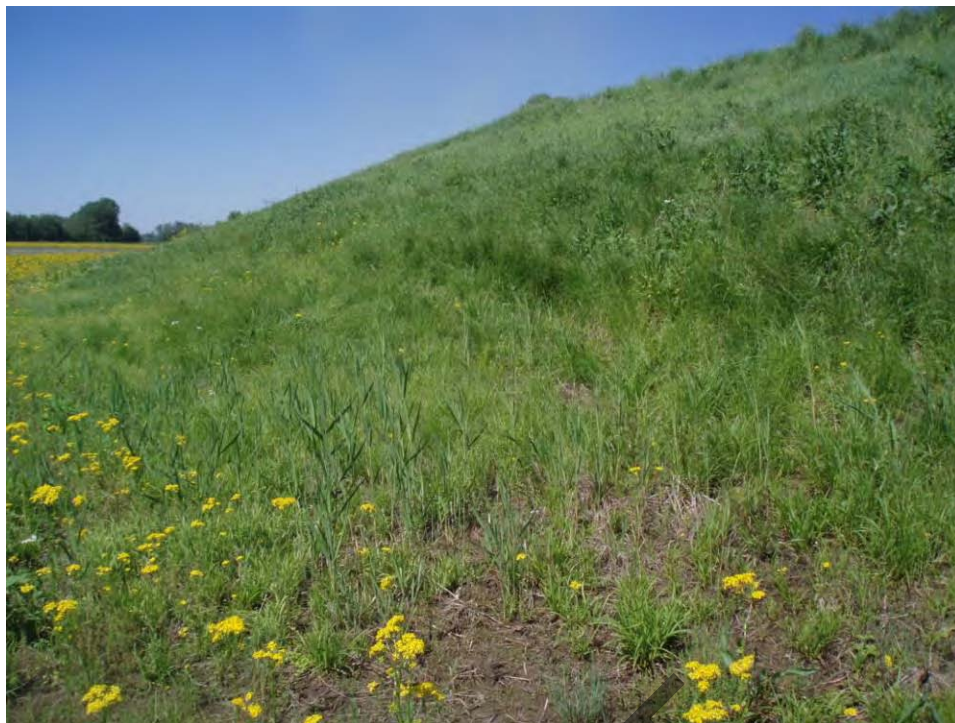
73. Pond B - West embankment lower exterior slope, looking north at saturated area at toe of slope.

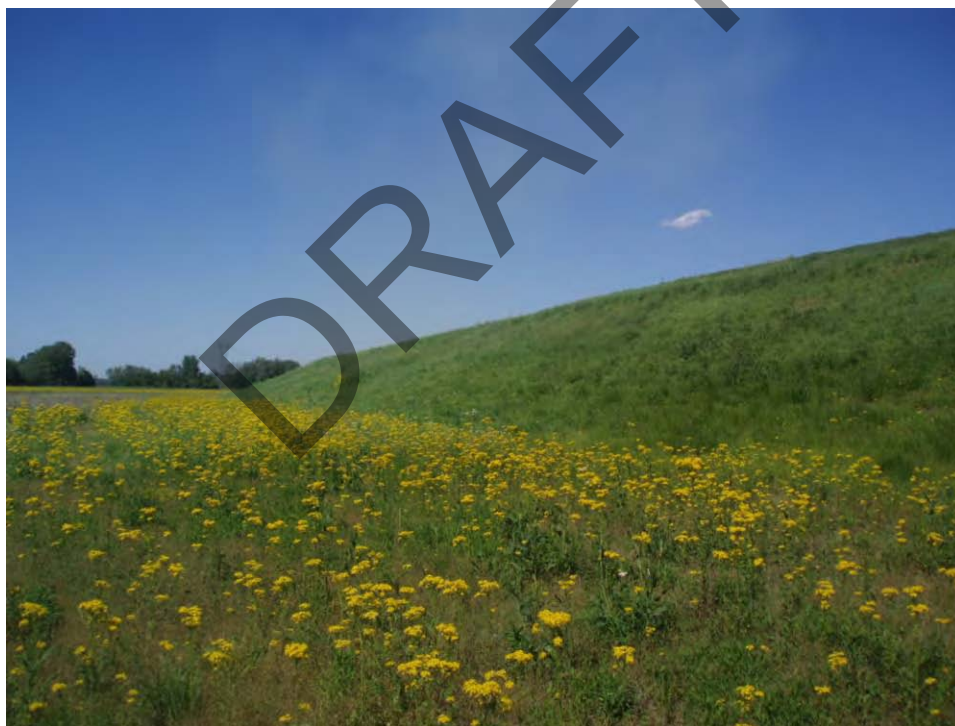
74. Pond B - West embankment, looking north at downstream area in flood plain. Note field area is saturated and wet from recent storm events.

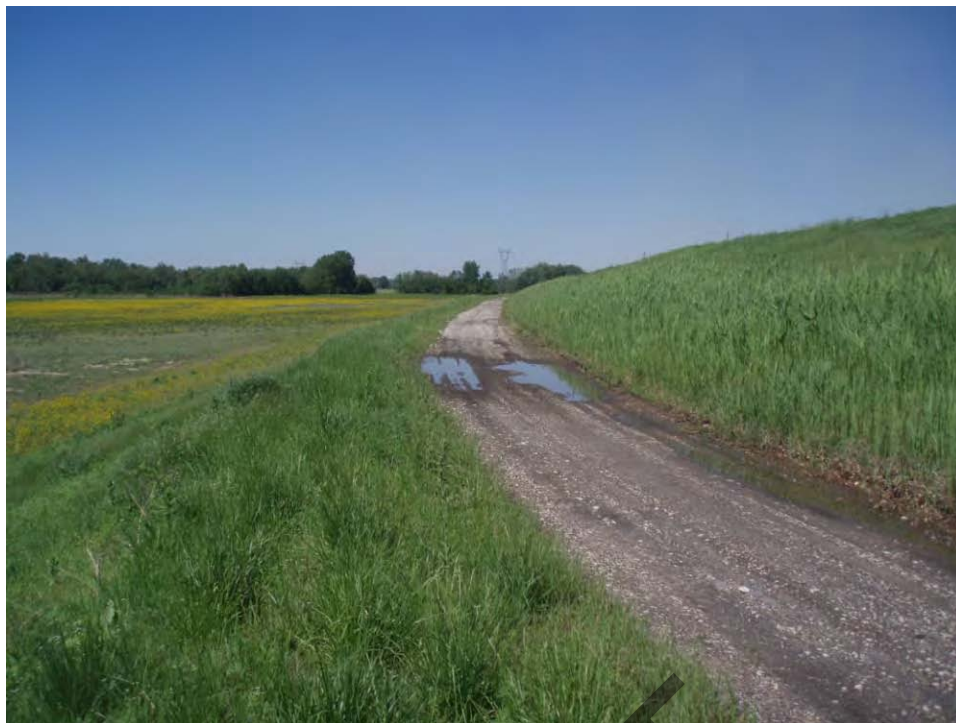
75. Pond B - West embankment bench, looking north. Note inside of bench is wet from recent storm events.

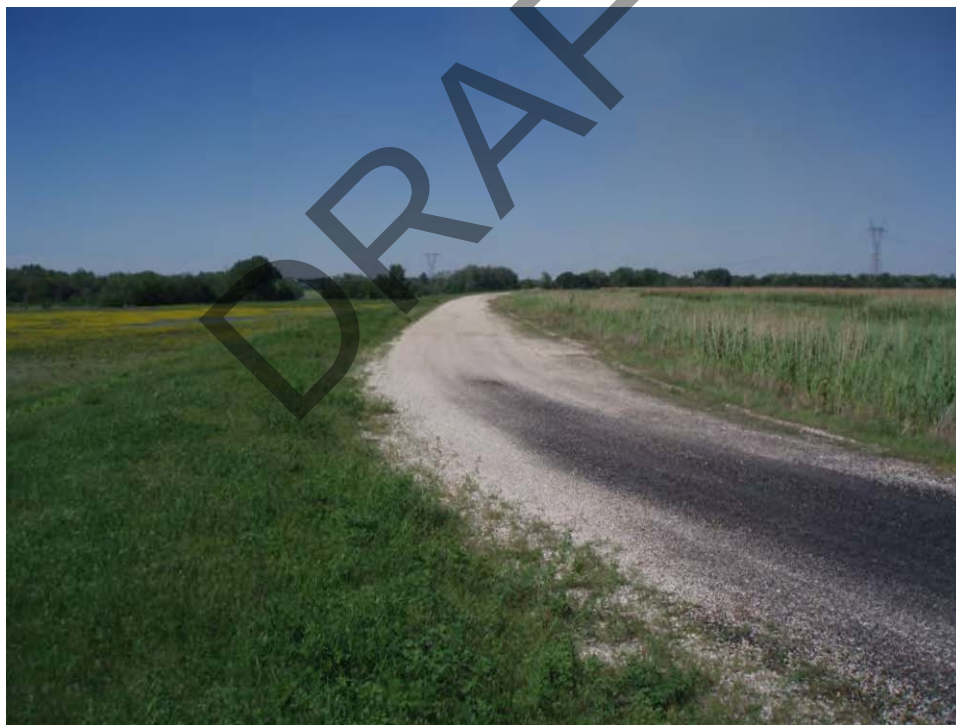
76. Pond B - West embankment crest, looking north.
