# **Assessment of Dam Safety of Coal Combustion Surface Impoundments**

**Indianapolis Power & Light Company**

**Petersburg Generating Station**

**June 8, 2010**

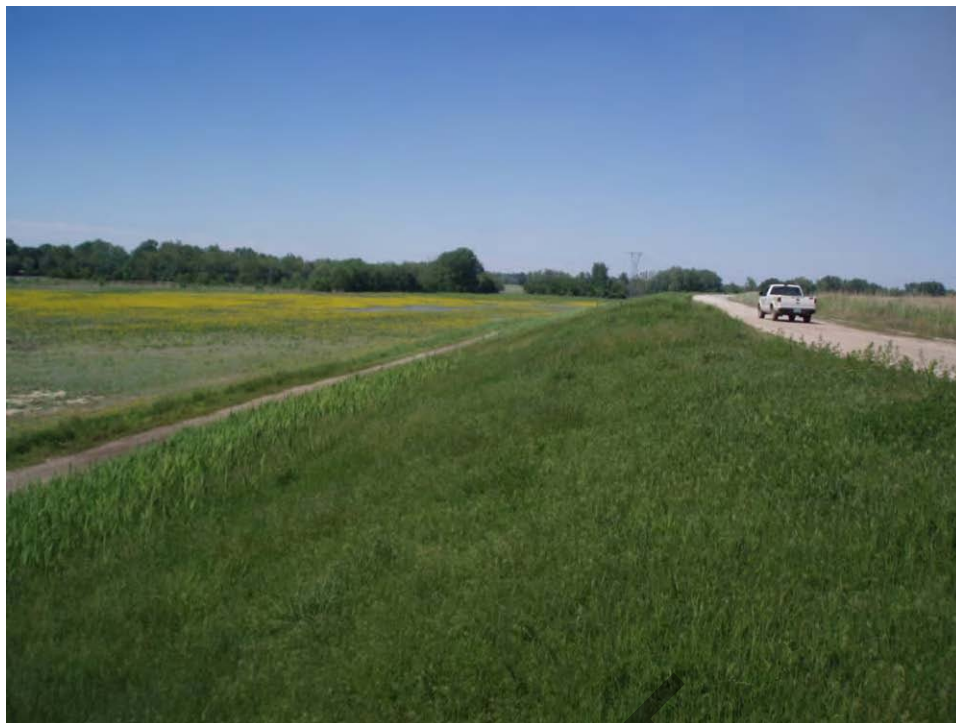
77. Pond B - West embankment upper exterior slope, looking north.

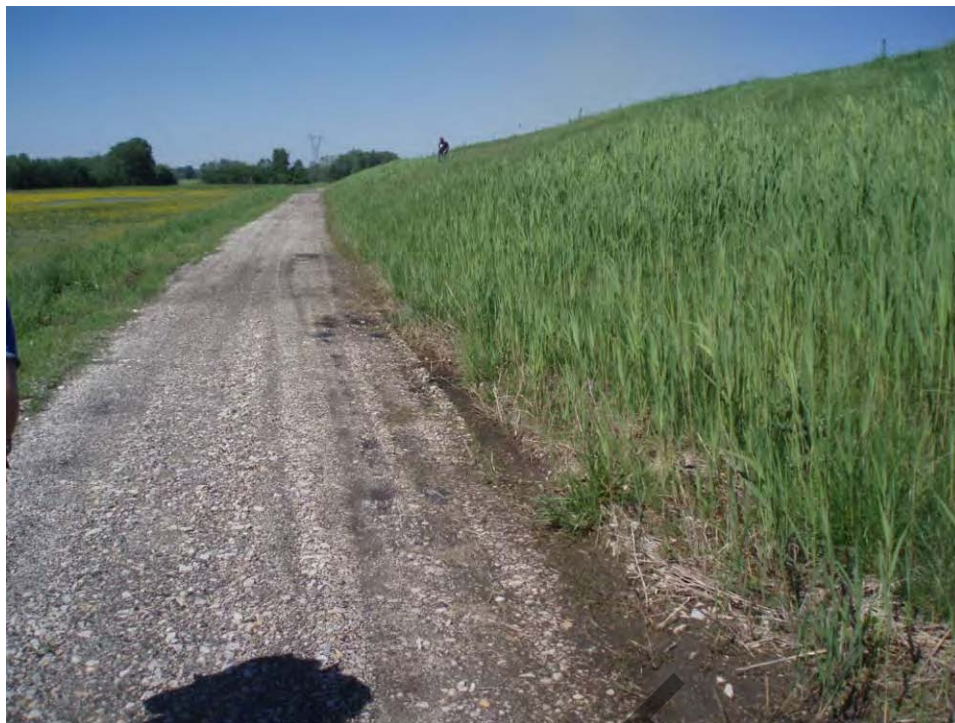
79. Pond B - West embankment bench, looking north at possible seep. Note area is soft and saturated.

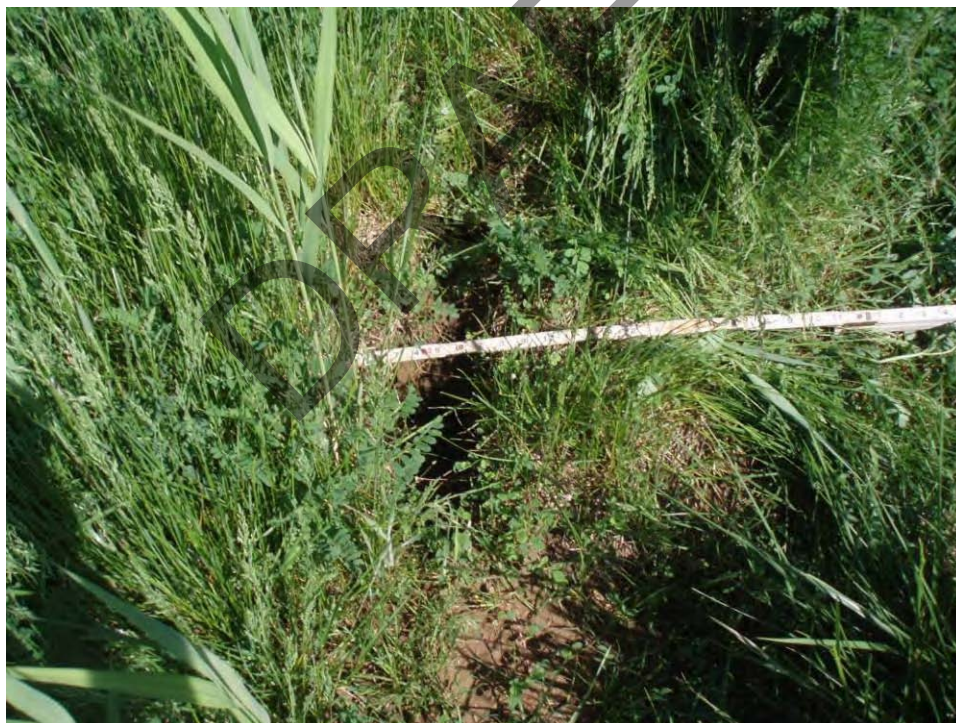
86. Pond B - West embankment upper exterior slope, looking at an 8-inch-diameter rodent hole.

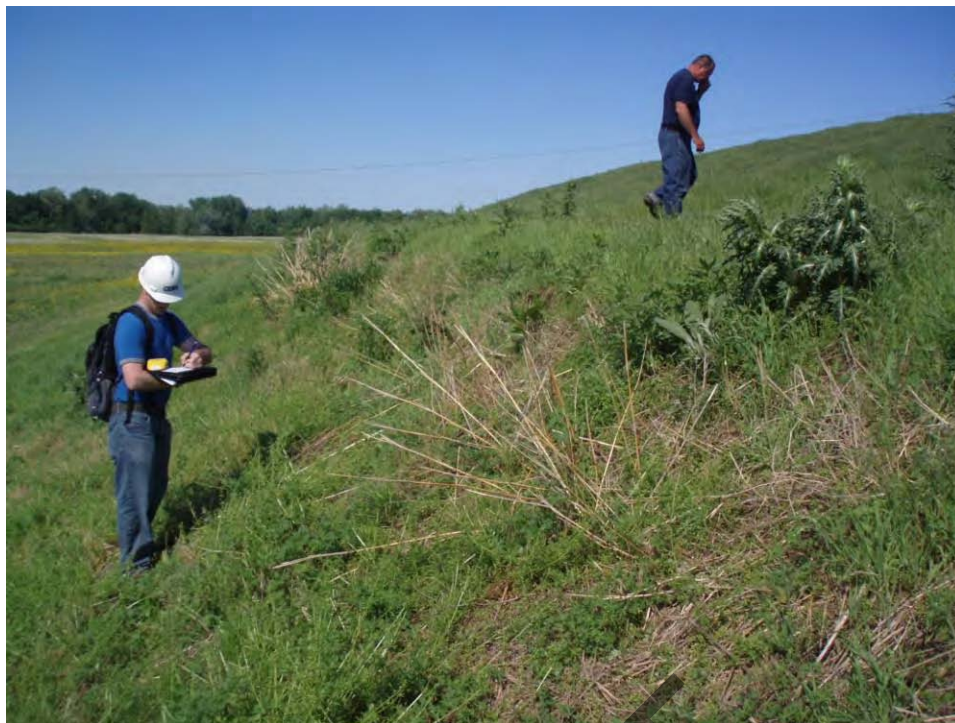
87. Pond B - West embankment lower exterior slope, looking north at over-steep slope and tractor ruts near bench.

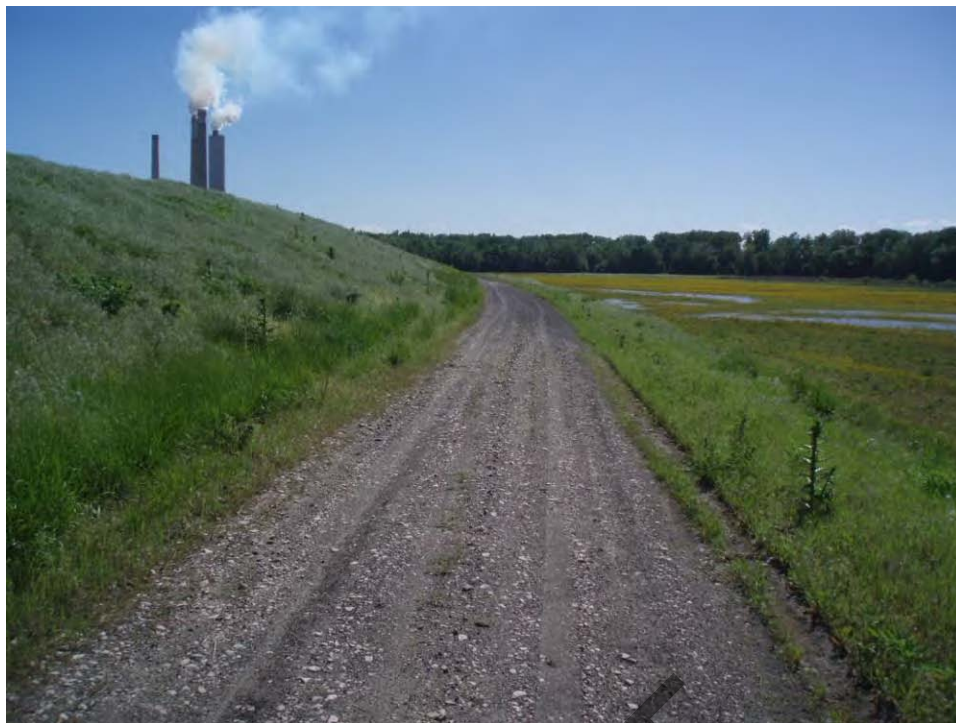
89. Pond B - West embankment bench, looking southwest.

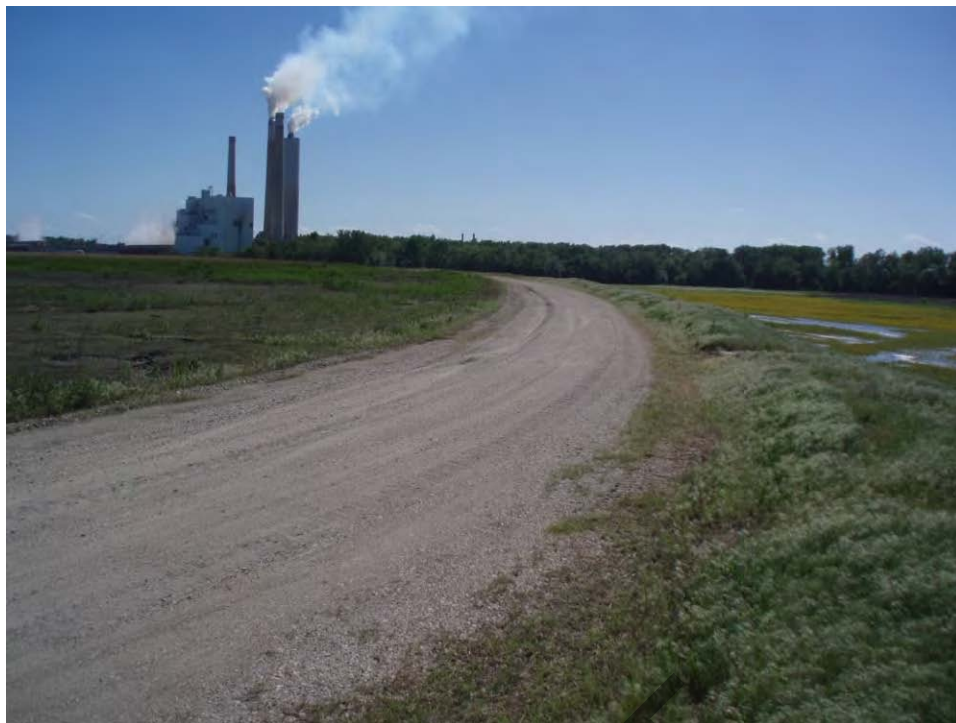
91. Pond B - West embankment crest, looking southwest.

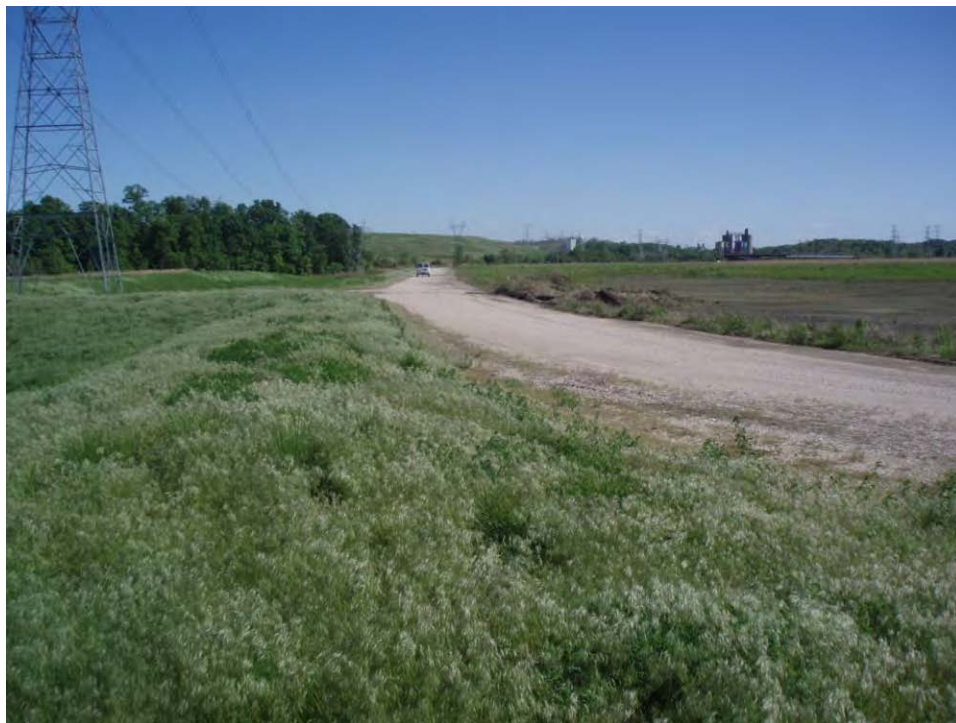
93. Pond B - North embankment crest, looking southeast.

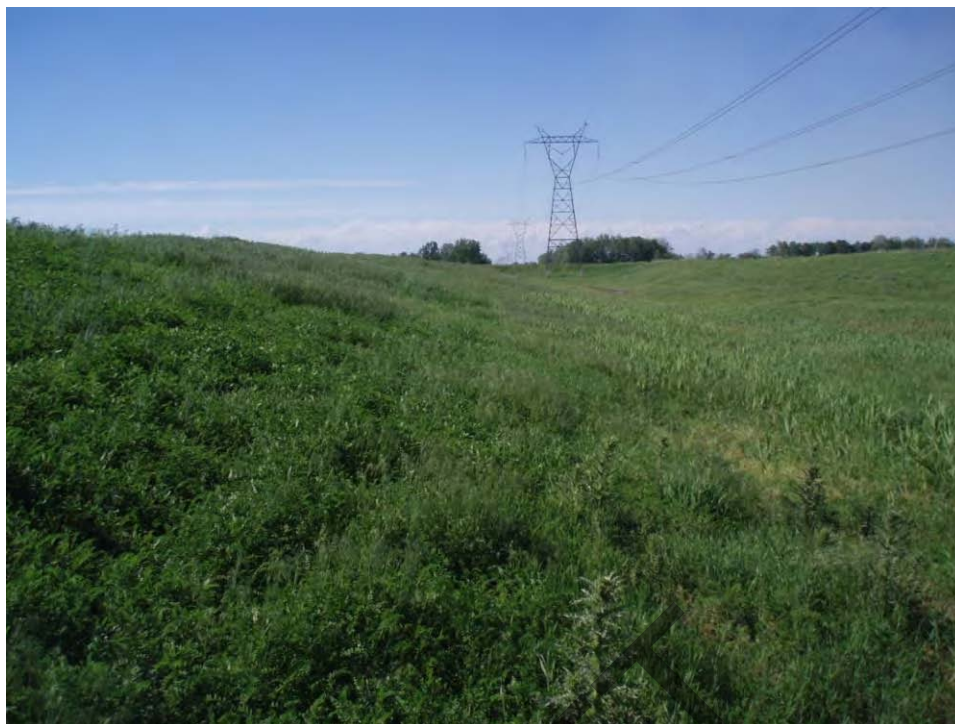
97. Pond B - North embankment exterior slope, looking northwest.

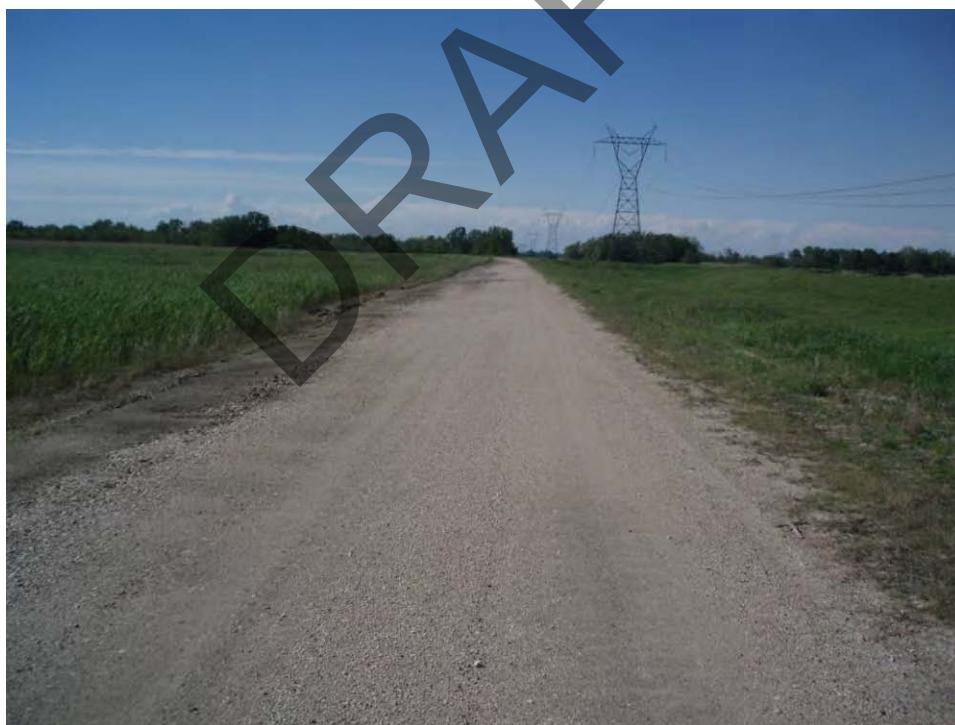
98. Pond B - North embankment crest, looking northwest.

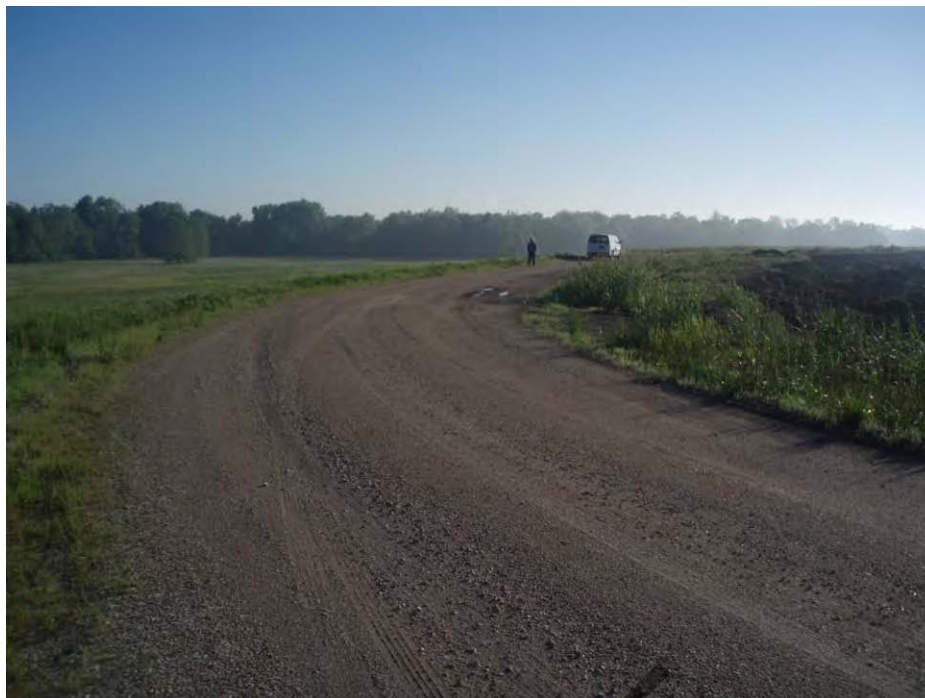
99. Pond C - West embankment crest, looking northeast.

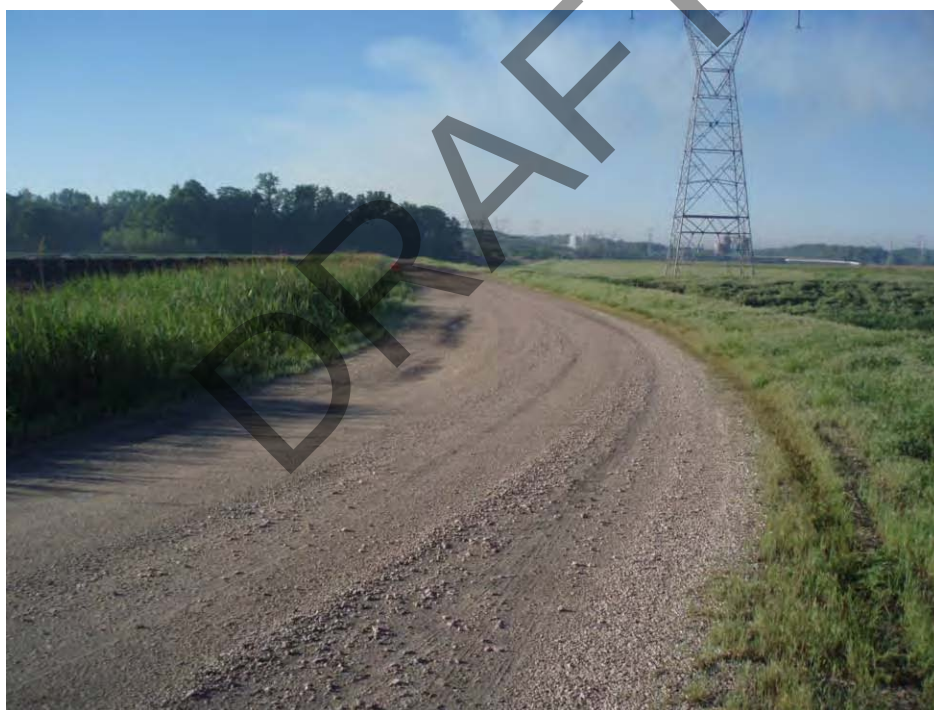
100. Pond C - South embankment crest, looking southeast.

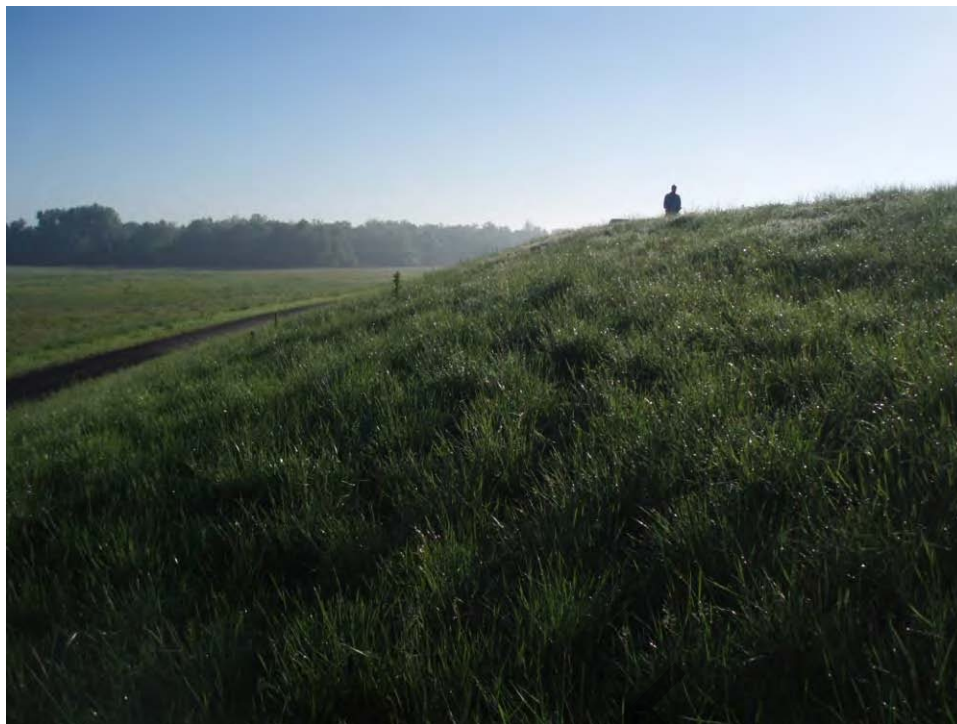
101. Pond C - West embankment upper exterior slope, looking northeast.

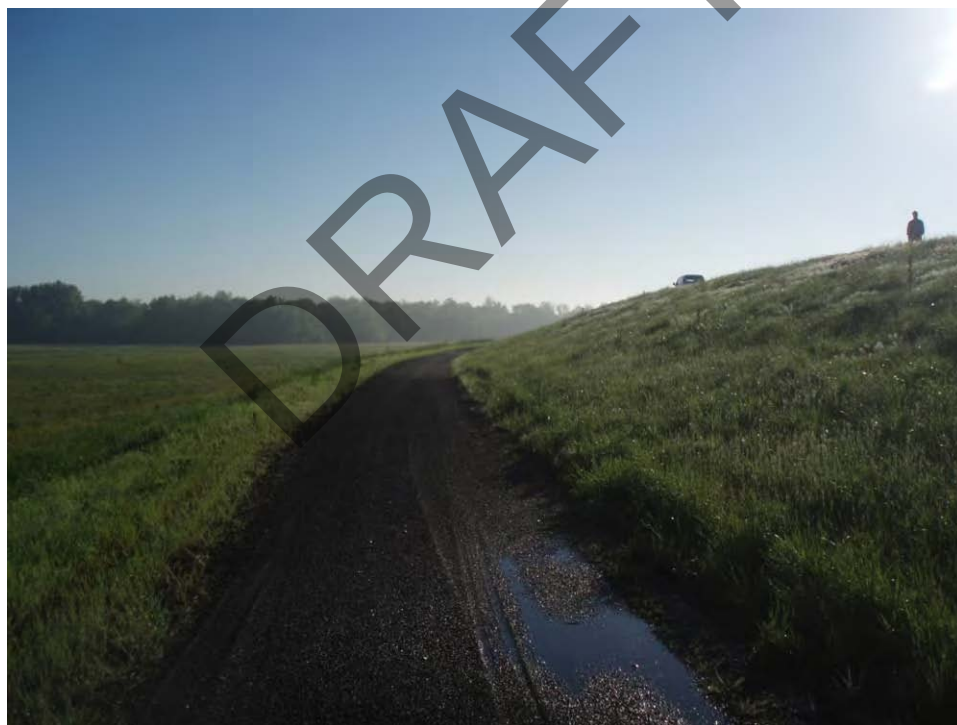
102. Pond C - West embankment bench, looking northeast.

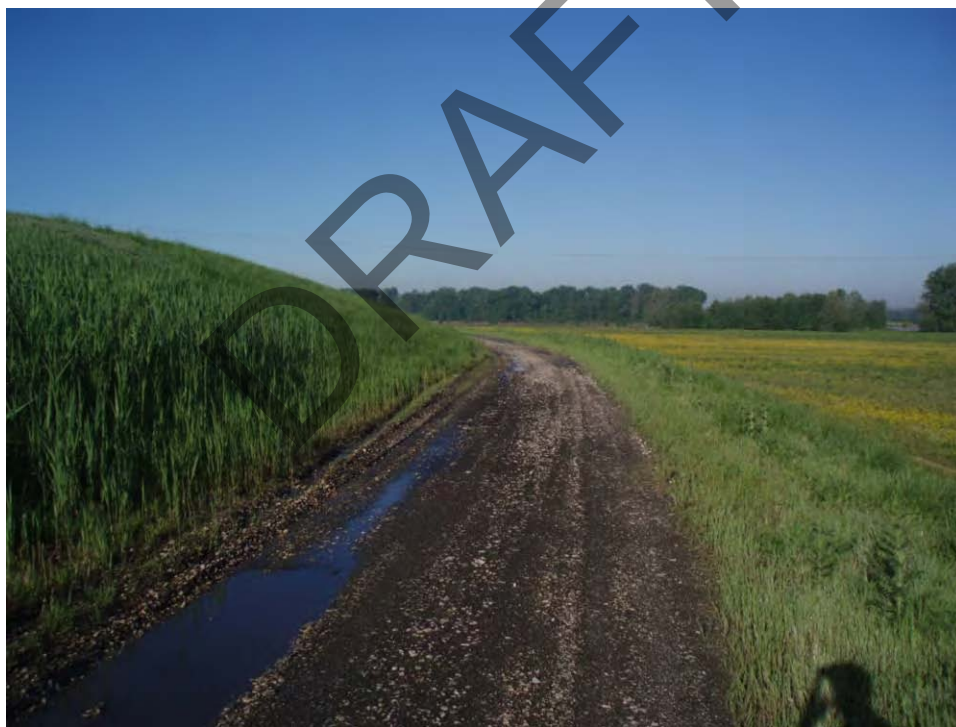
108. Pond C - West embankment bench, looking southwest.

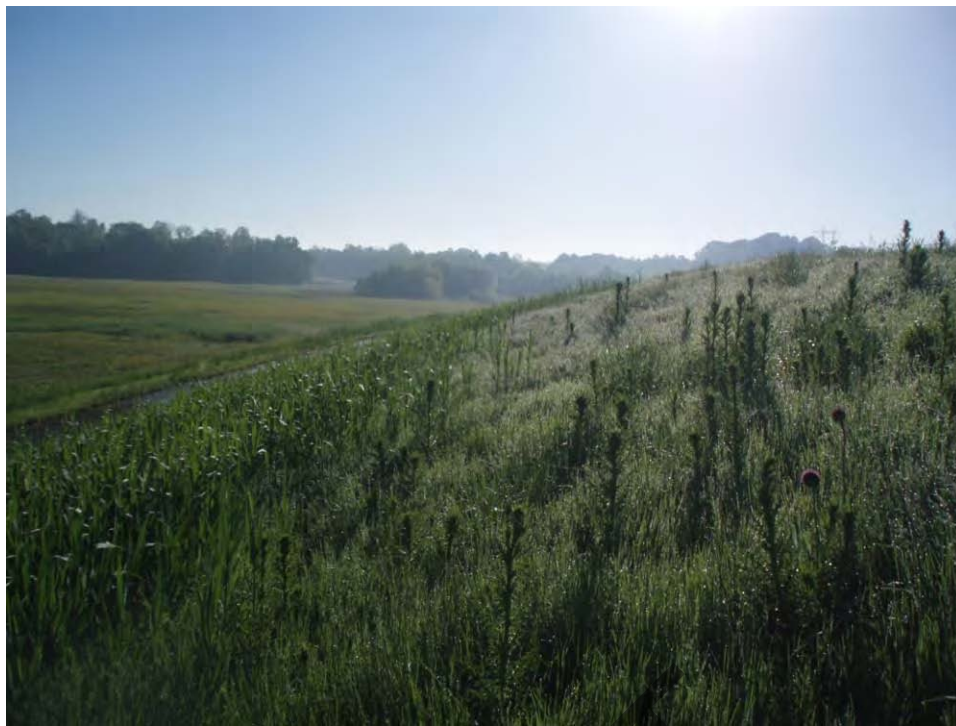
109. Pond C - West embankment upper exterior slope, looking northeast.

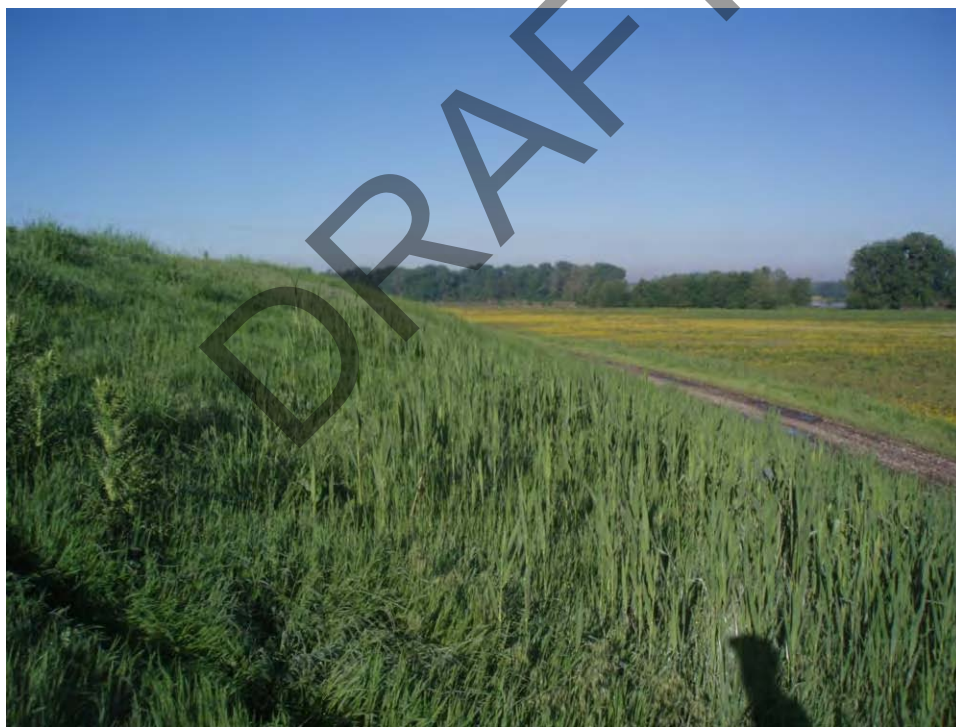
110. Pond C - West embankment upper exterior slope, looking southwest.

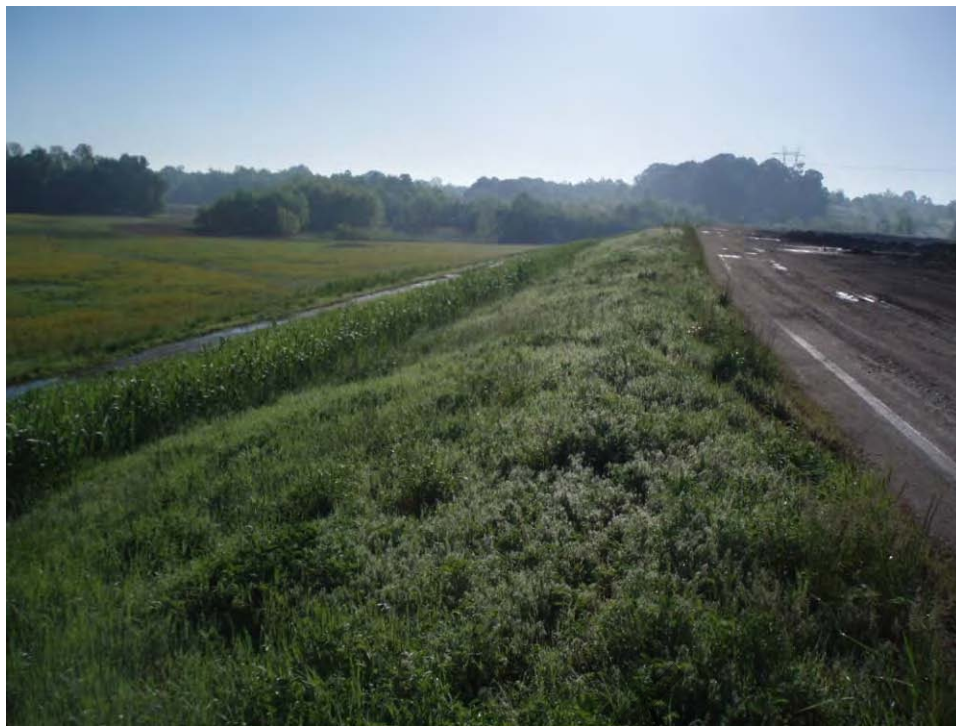
111. Pond C - West embankment crest, looking east.

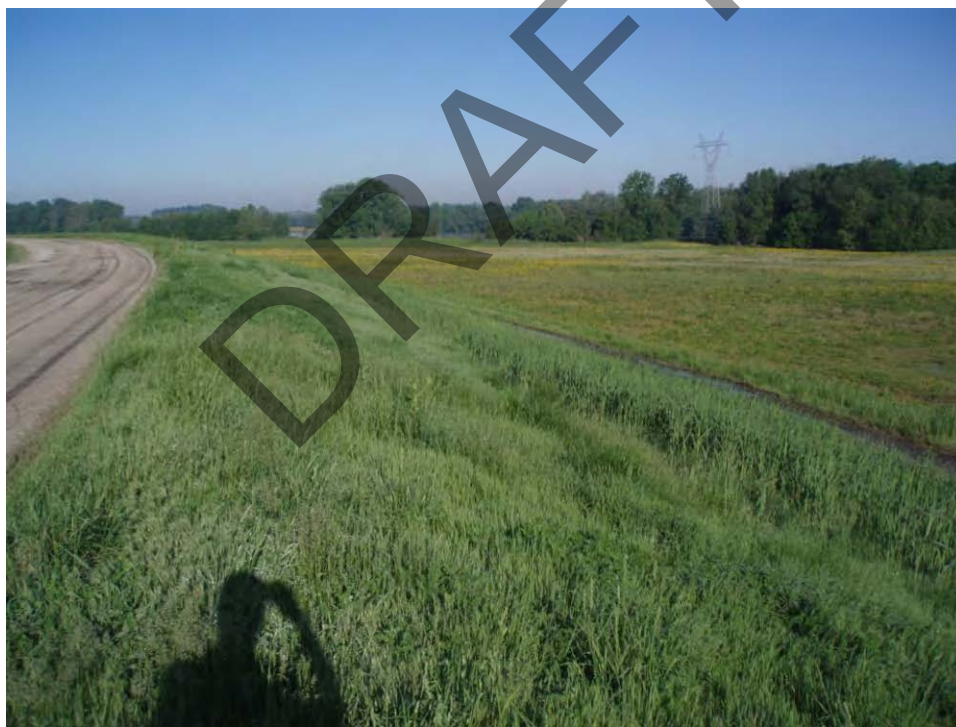
112. Pond C - West embankment crest, looking west.

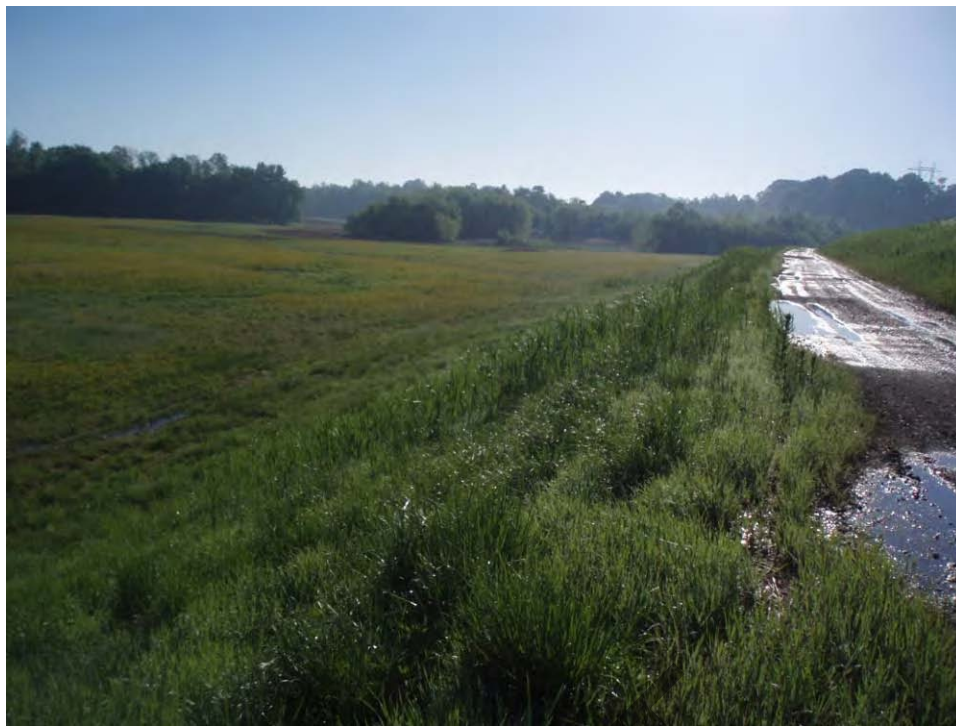
113. Pond C - West embankment bench, looking east.

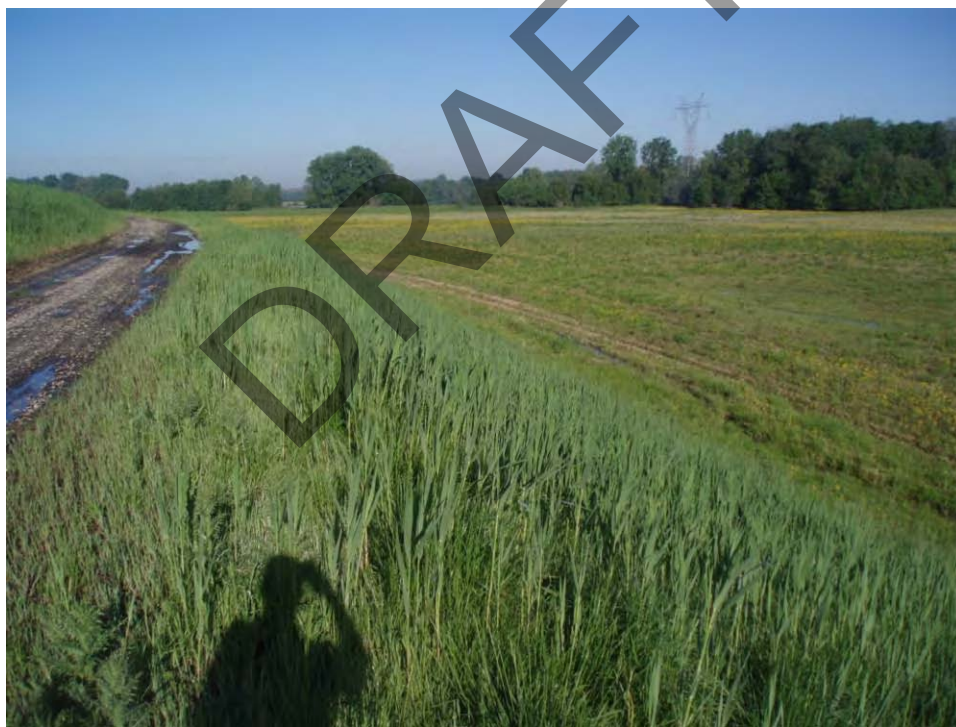
114. Pond C - West embankment bench, looking west.

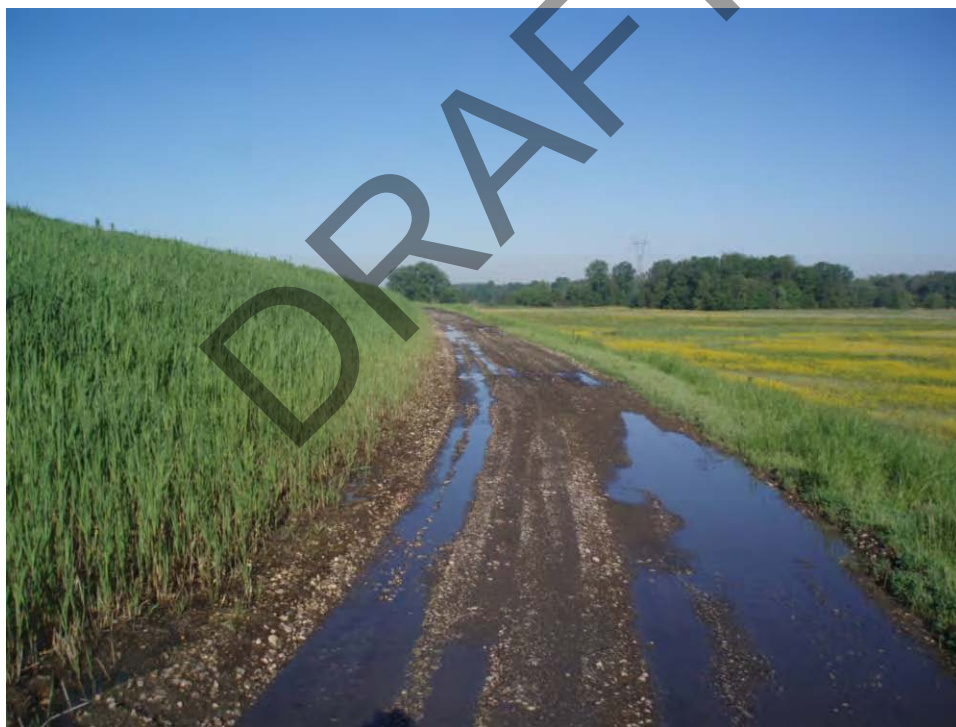
118. Pond C - West embankment bench, looking west.

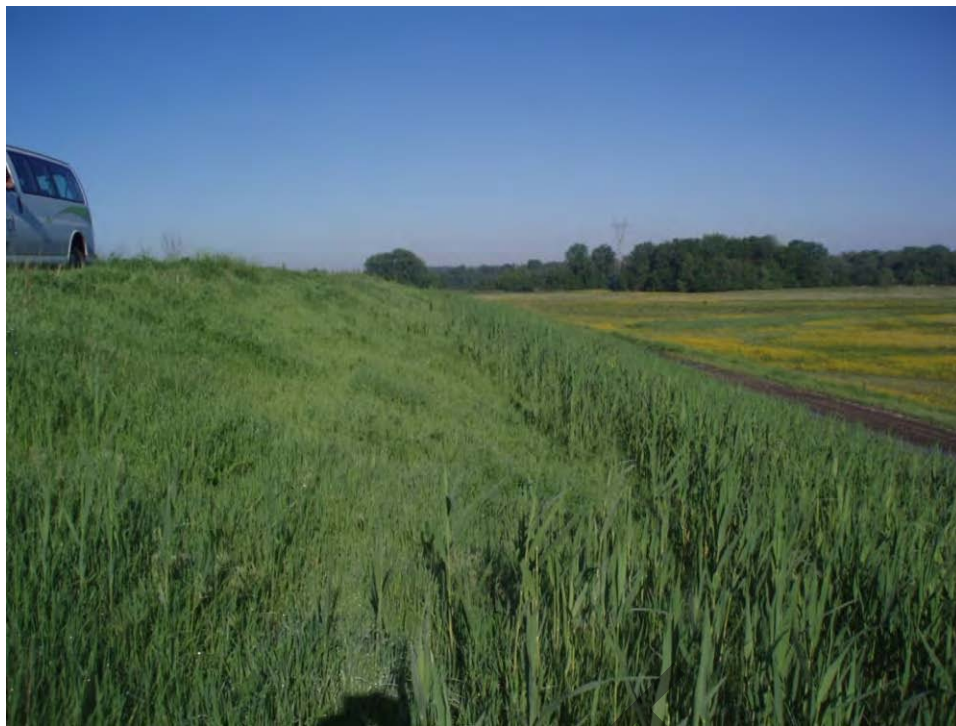
119. Pond C - West embankment upper exterior slope, looking west.

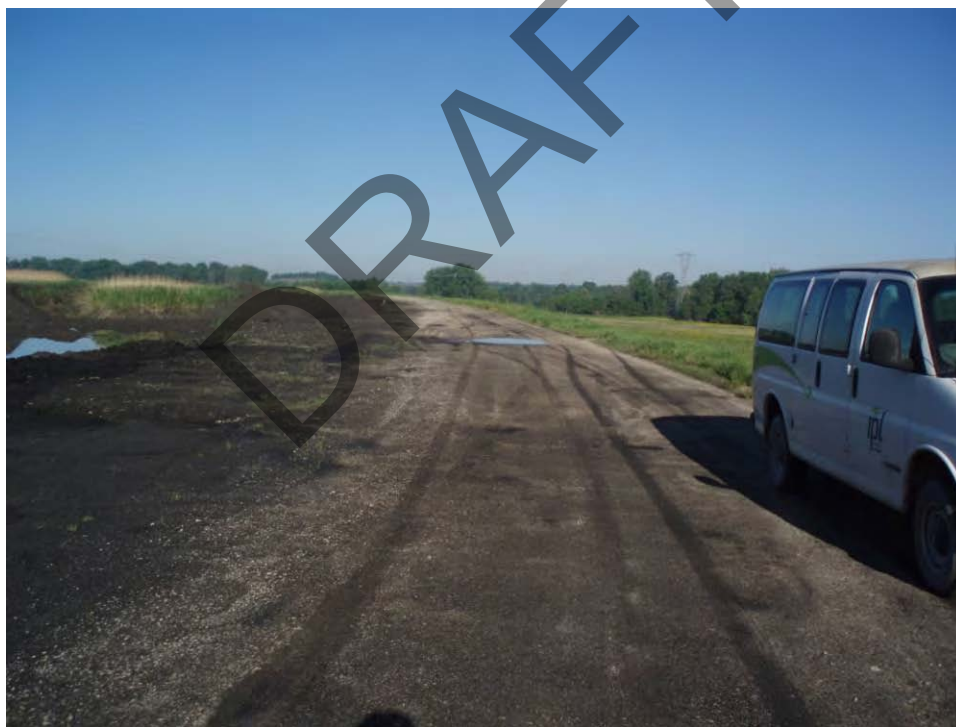
120. Pond C - West embankment crest, looking west.

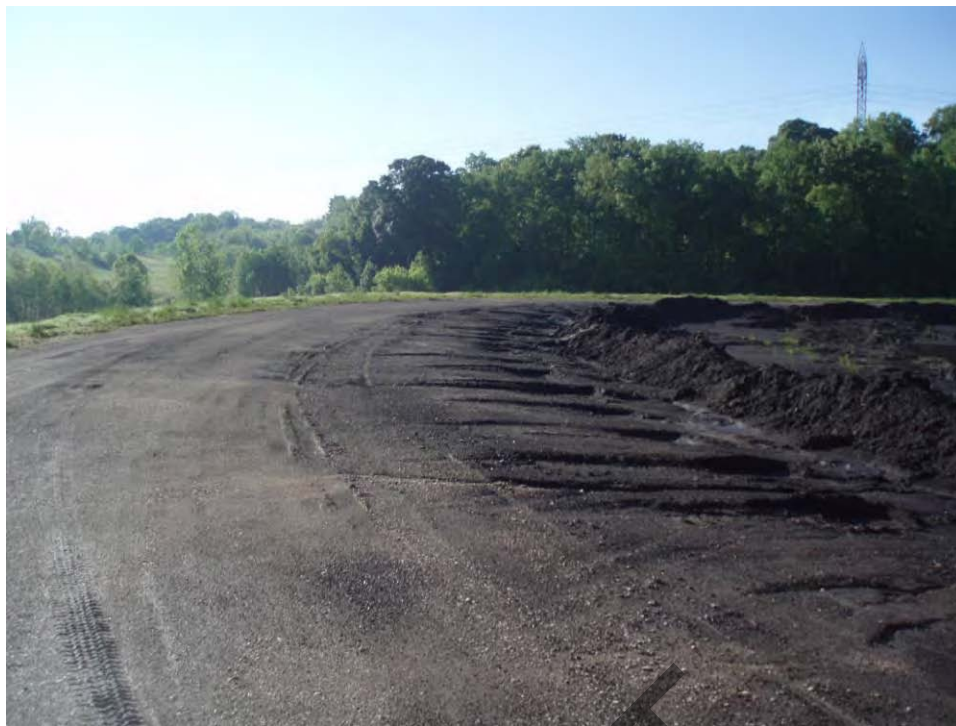
121. Pond C - North embankment crest, looking southeast.

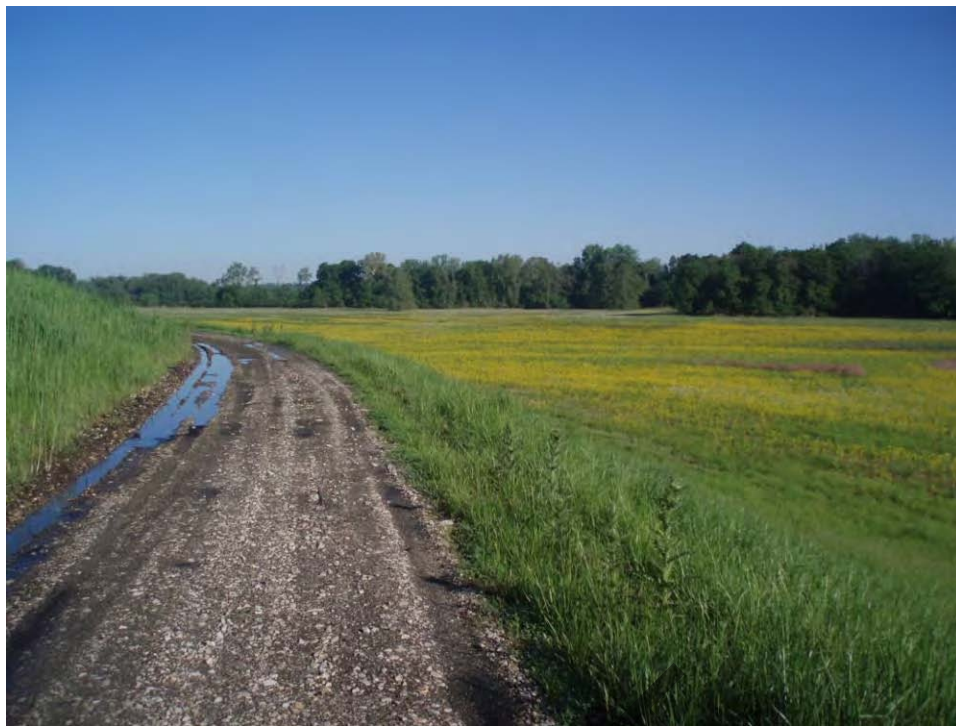
123. Pond C - North embankment bench, looking northwest.

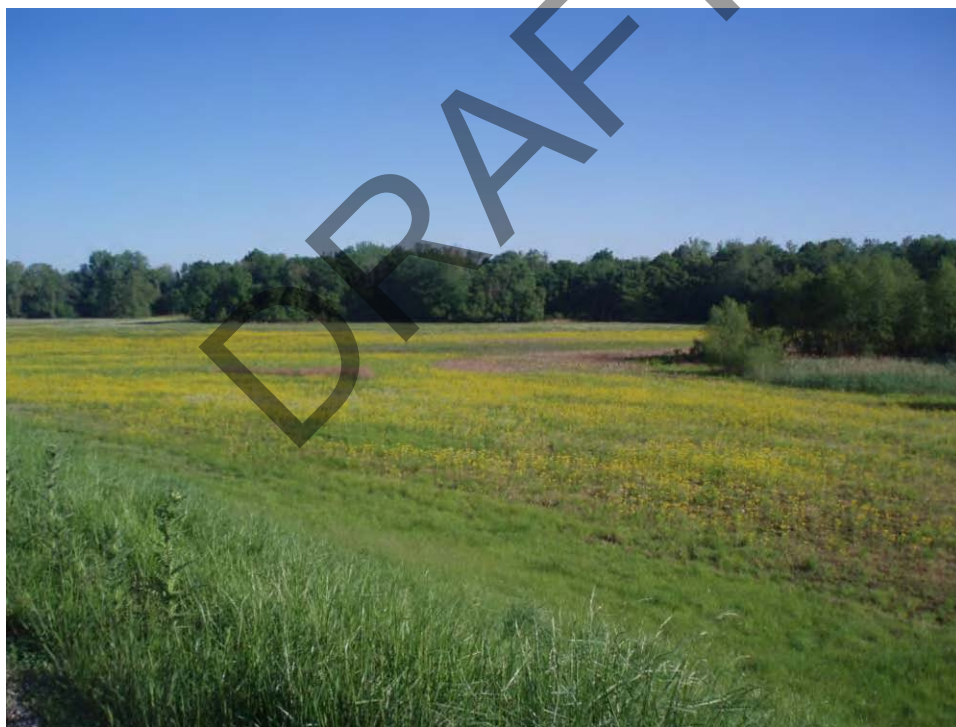
124. Pond C - North embankment, looking north at downstream area.

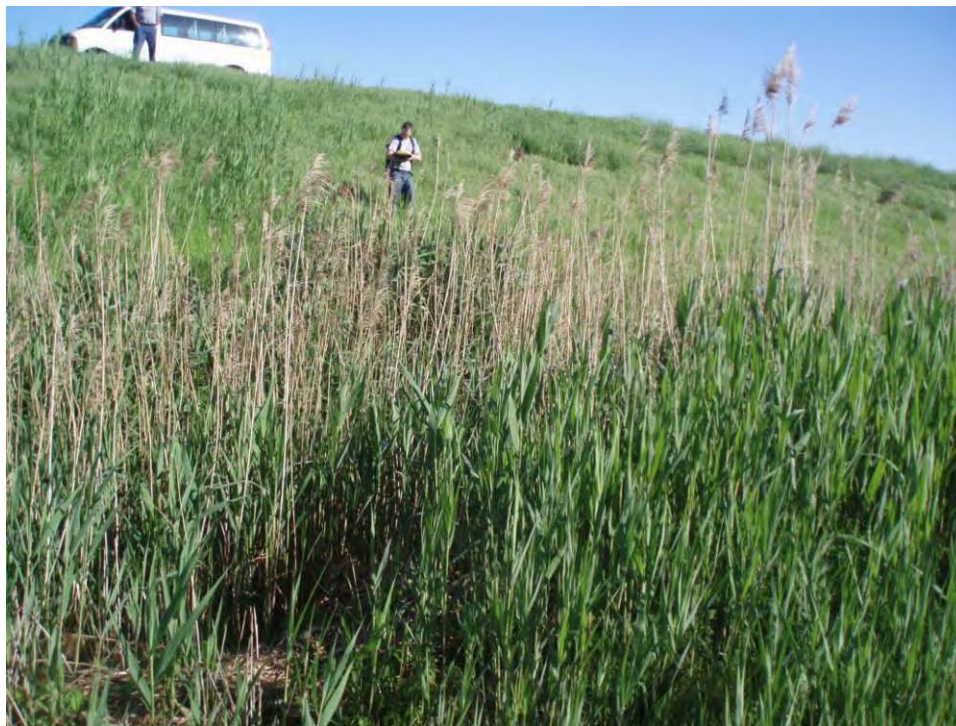
129. Pond C - East embankment exterior slope, looking at area of outlet pipe from outlet structure. Note water was flowing from outlet pipe into drainage ditch.

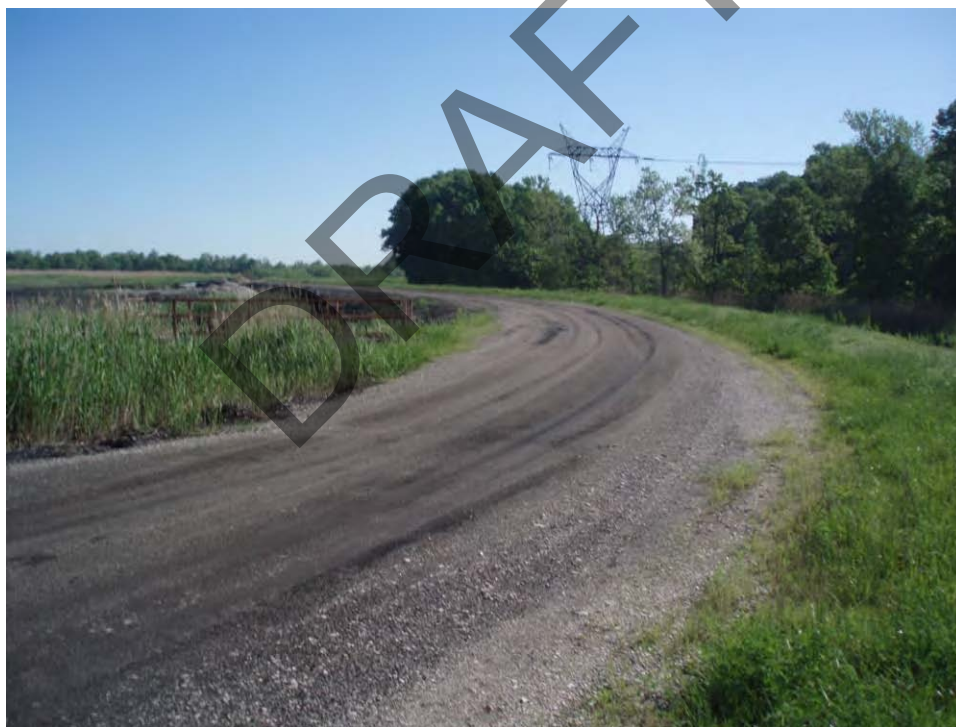
136. Pond C - East embankment crest, looking northeast.

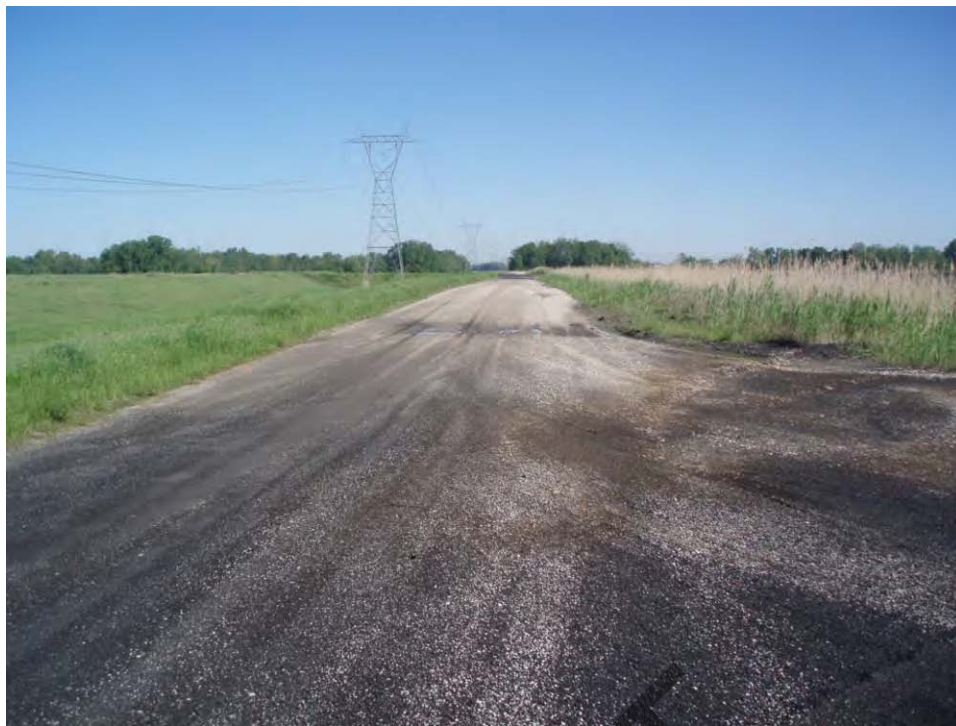
137. Pond C - South embankment crest, looking northwest.

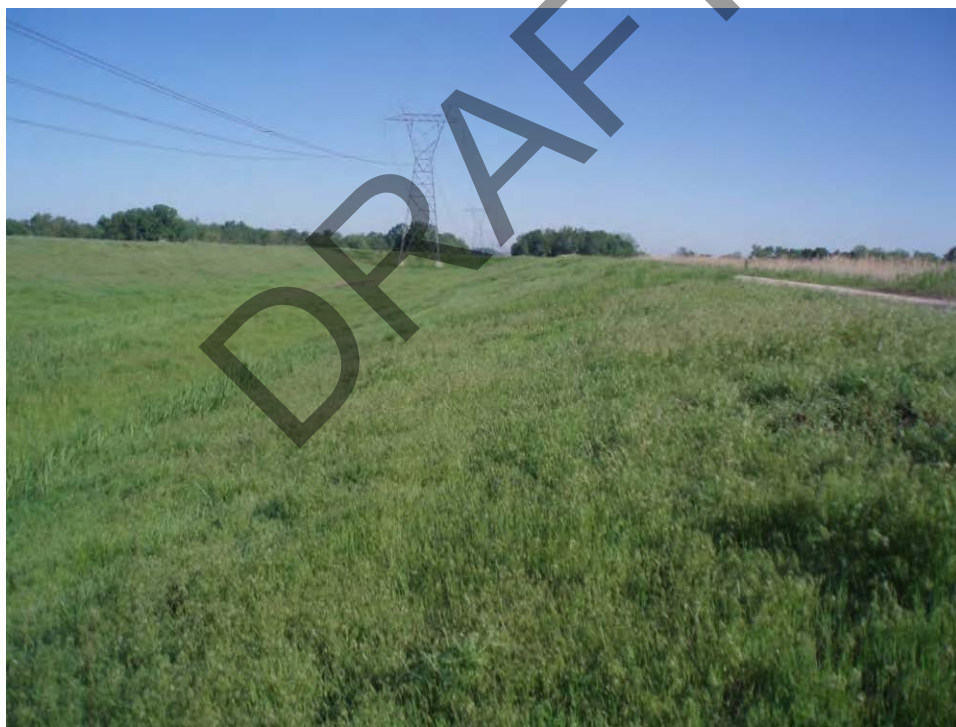
138. Pond C - South embankment exterior slope, looking northwest at area between Pond B and Pond C.

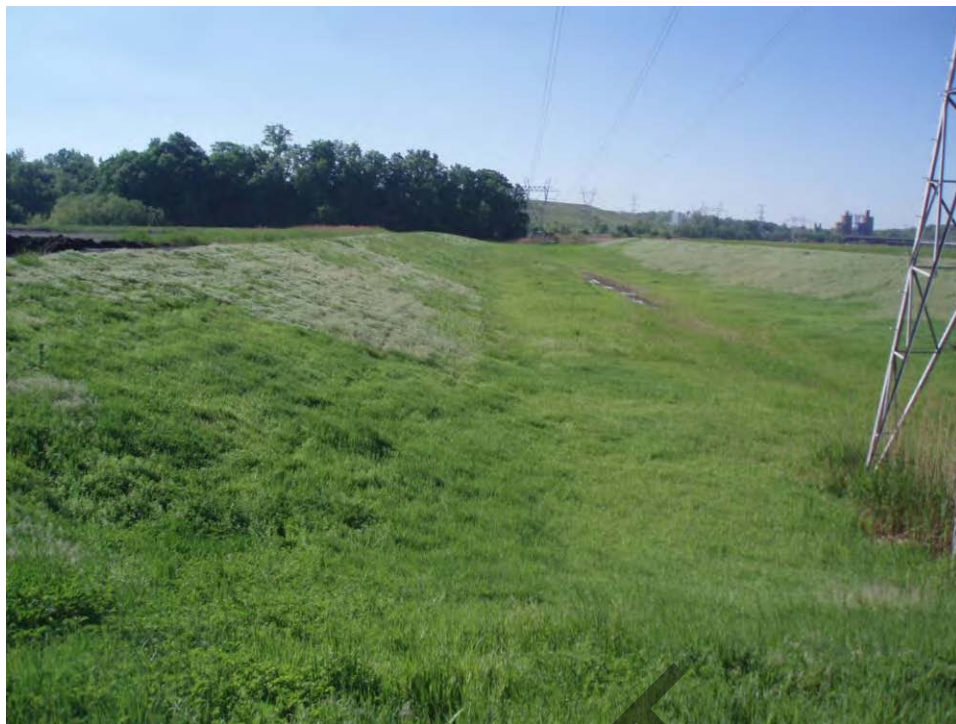
139. Pond C - South embankment exterior slope, looking southeast at area between Pond B and Pond C.

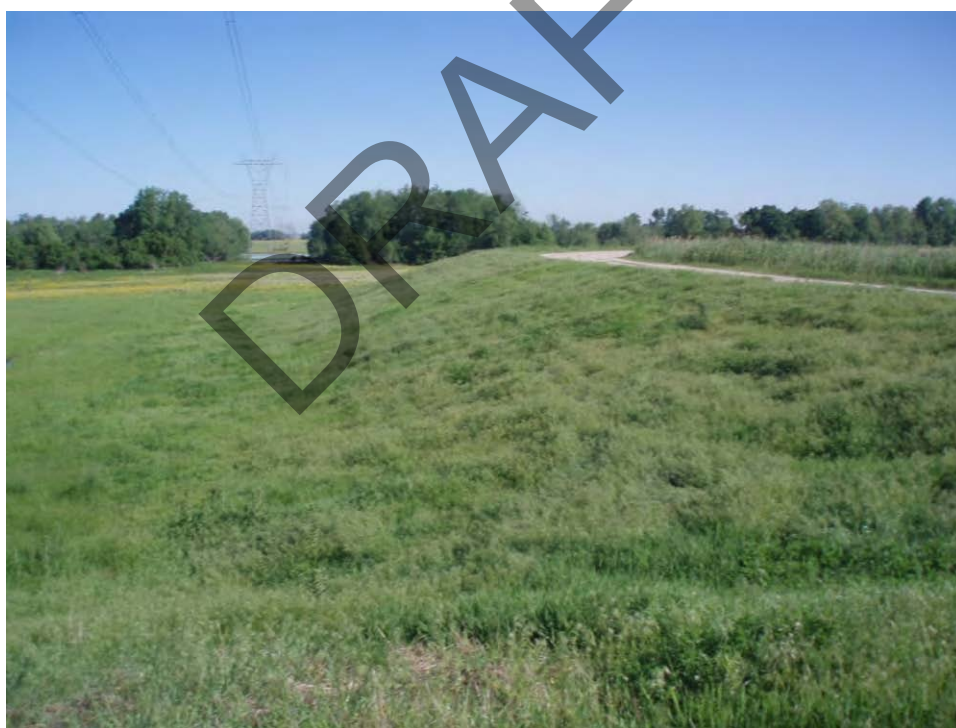
140. Pond C - South embankment exterior slope, looking northwest.
