Comments on Draft Report on Kentucky Utilities – Green River Station

**Re: Kentucky Utilities' Comments on  
*DRAFT Report of Geotechnical Investigation Dam Safety Assessment of Coal Combustion Surface  
Impoundments Kentucky Utilities, a Subsidiary of E.ON U.S. Green River Station, Central City, Kentucky***

***Report of Geotechnical Exploration and Slope Stability Analyses  
Kentucky Utilities (KU) Green River Power Station  
No. 2 Pond/Coal Pile Runoff Pond and Scrubber Pond  
South Carrollton, Muhlenberg County, Kentucky***

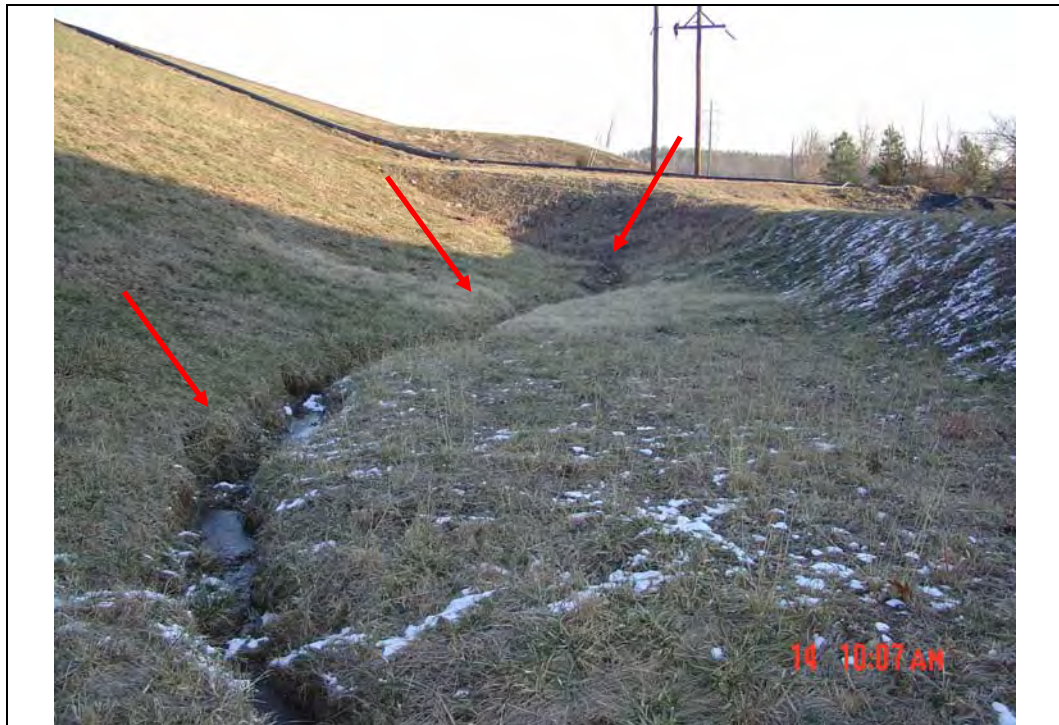
Photo #3: South embankment toe, exterior slope, looking NE  
Note: Groin ditch along toe, clogged culvert

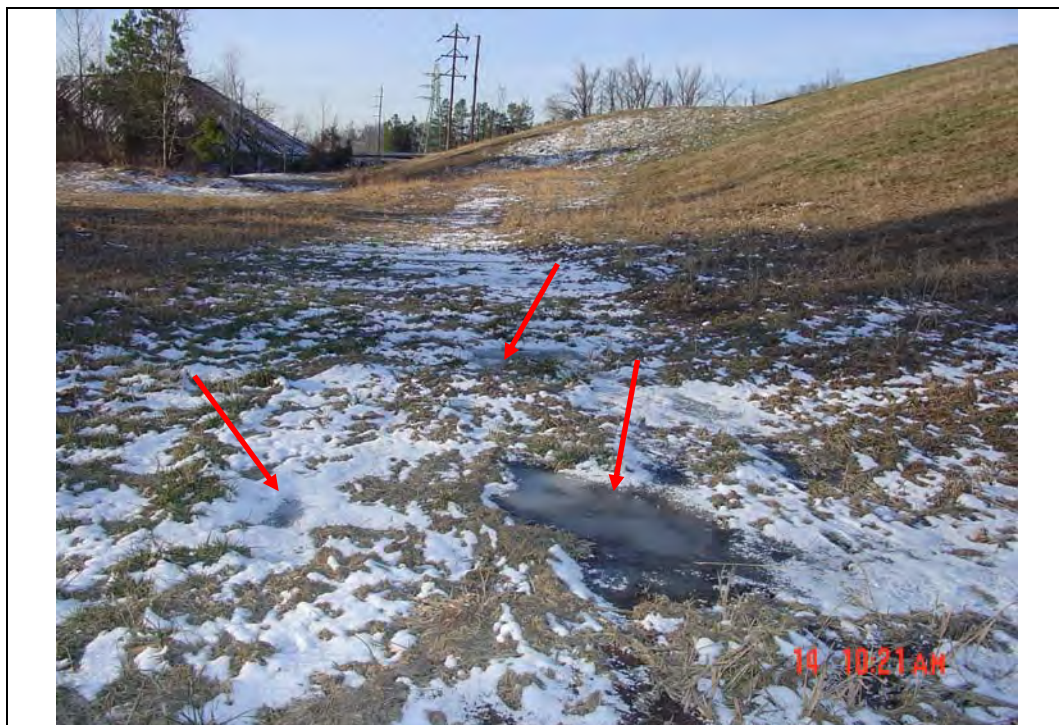
Photo #4: South embankment toe, looking SW  
Note: Ponded water along exterior slope toe

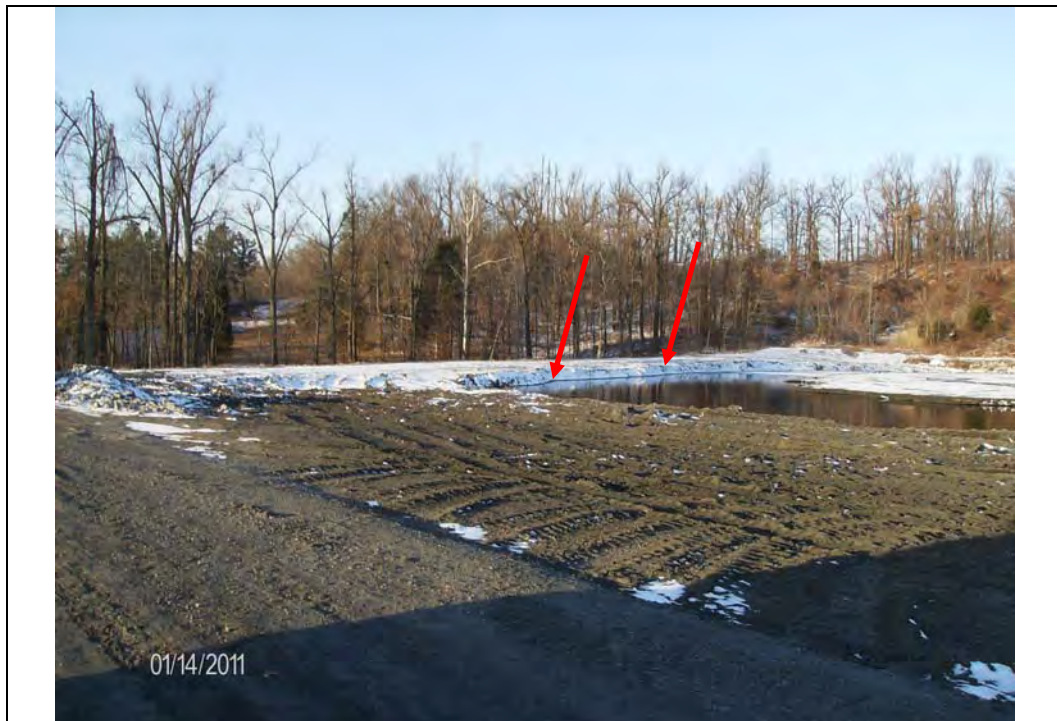
Photo #5: Interior slope of west embankment, looking west

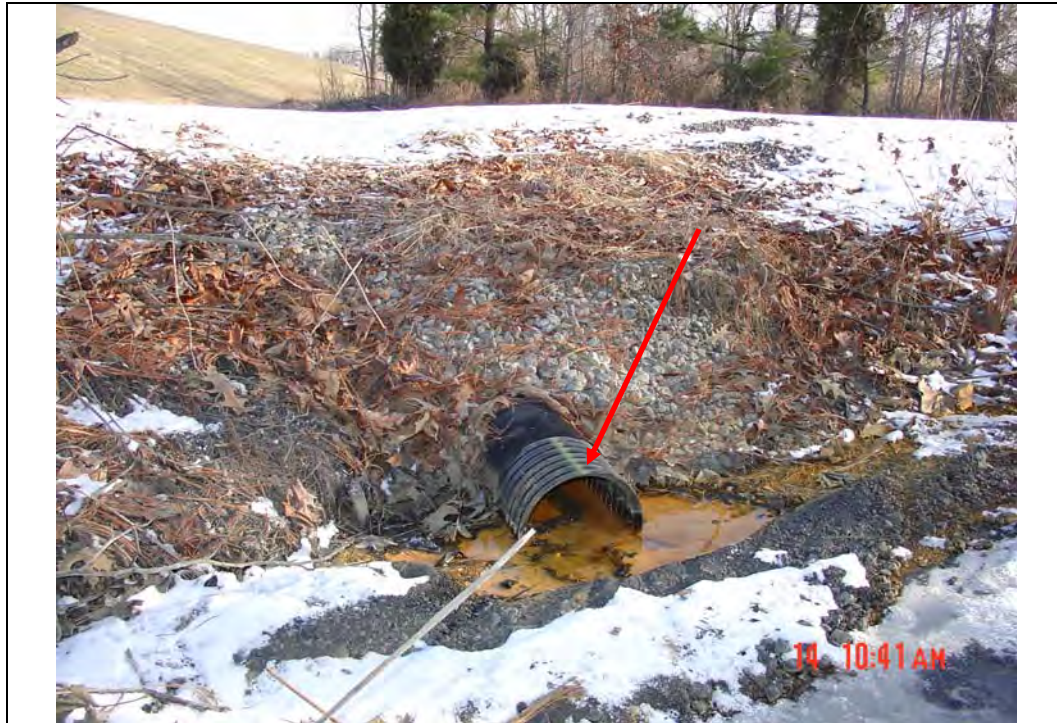
Photo #6: Drainage pipe at west end of south embankment, looking NE  
Note: Ponded water in outlet pipe

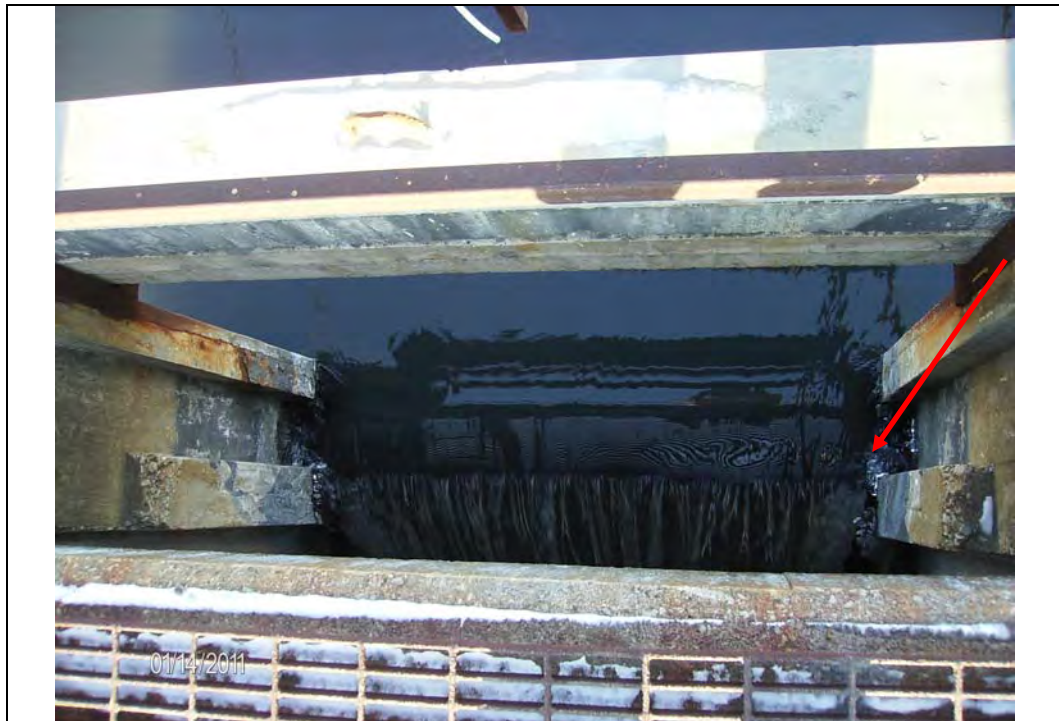
Photo #7: Principal Spillway inlet  
Note: Top of stop logs just below water surface

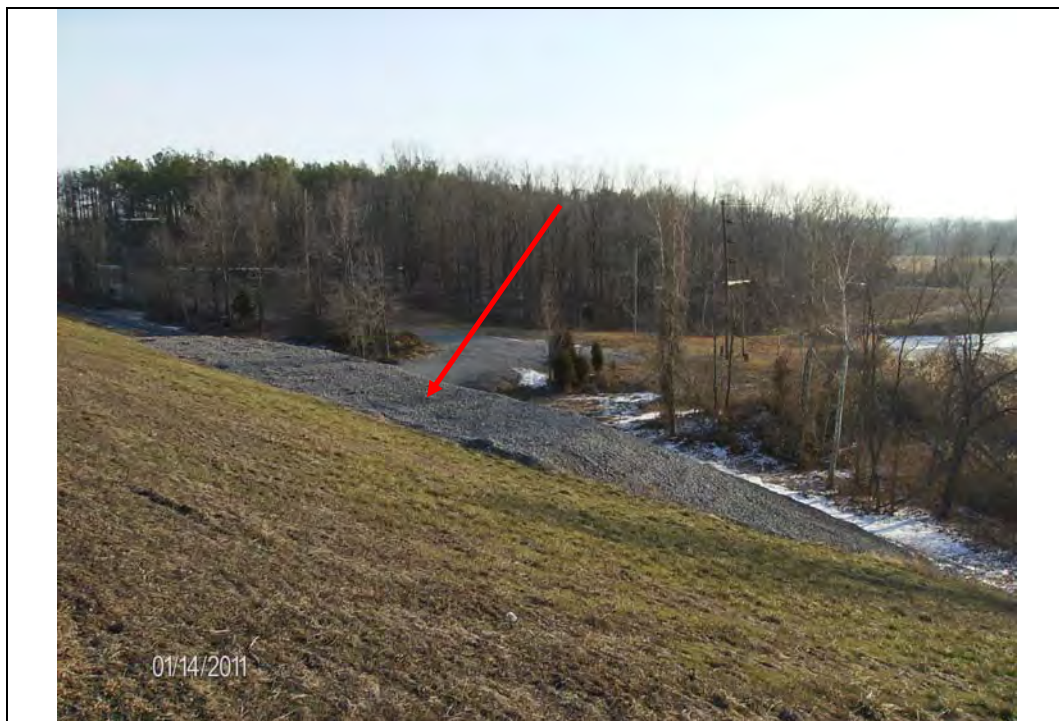
Photo #8: East end of south embankment, exterior slope, looking east  
Note: Rock toe berm

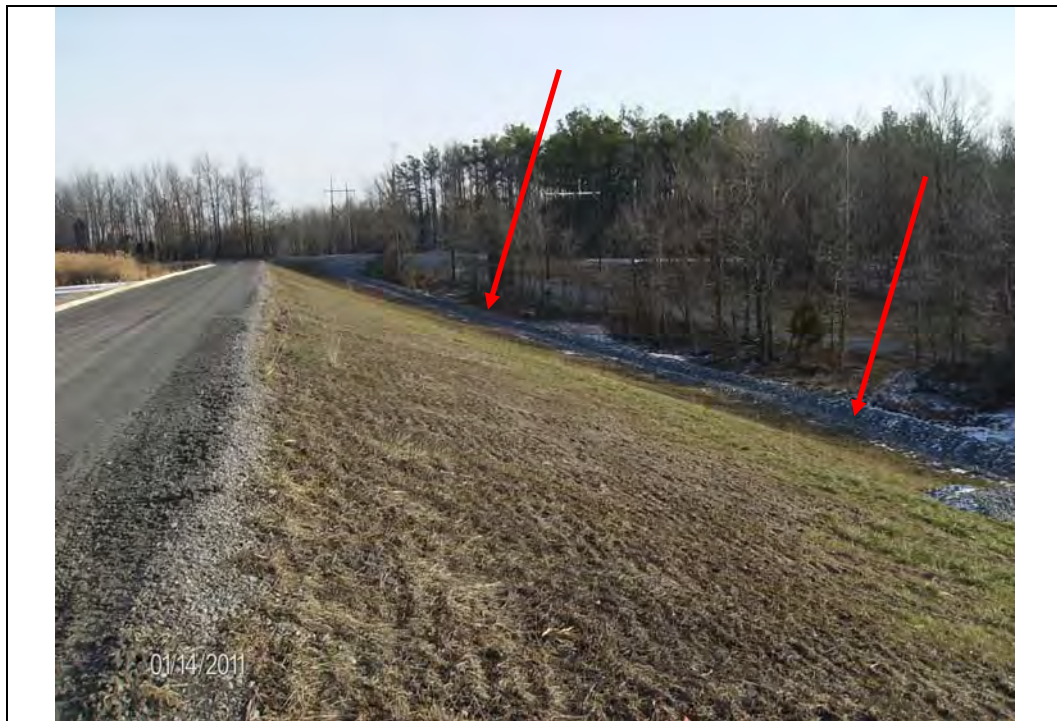
Photo #9: East end of south embankment, exterior slope, looking NE  
Note: Rock groin ditch recently installed along toe

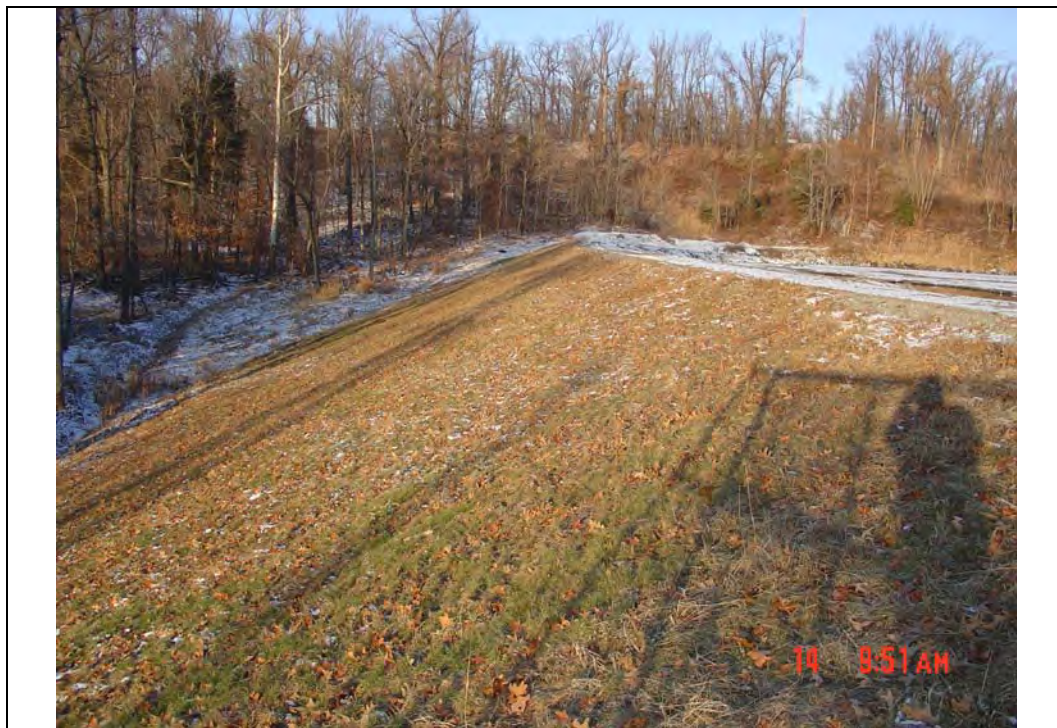
Photo #10: Exterior slope of west embankment, east

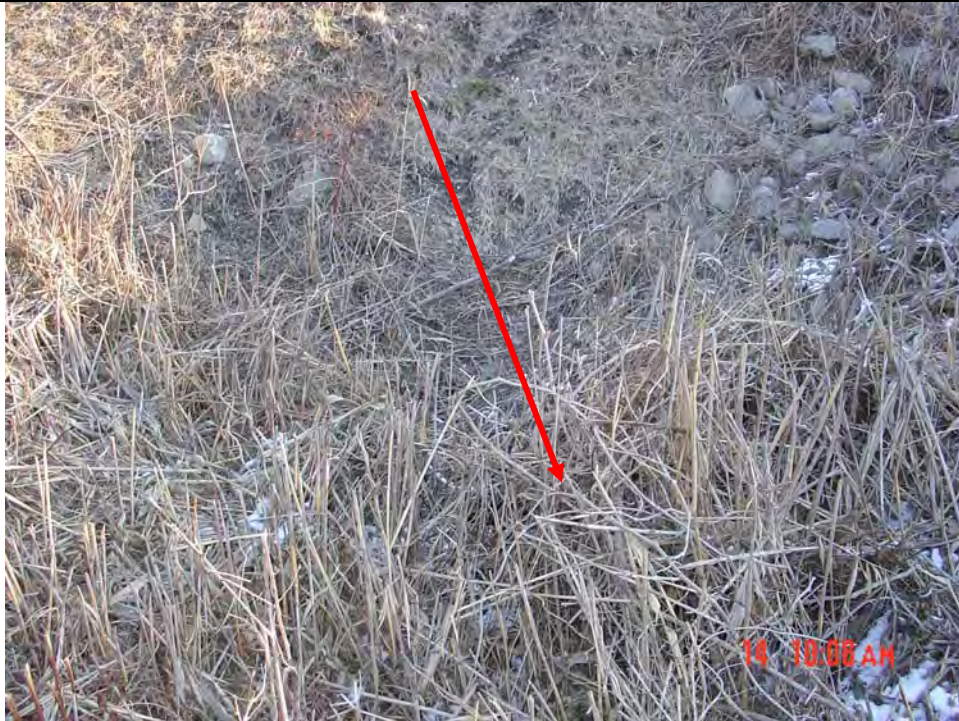
Photo #13: Culvert inlet clogged with vegetation, west side of south embankment, looking NE

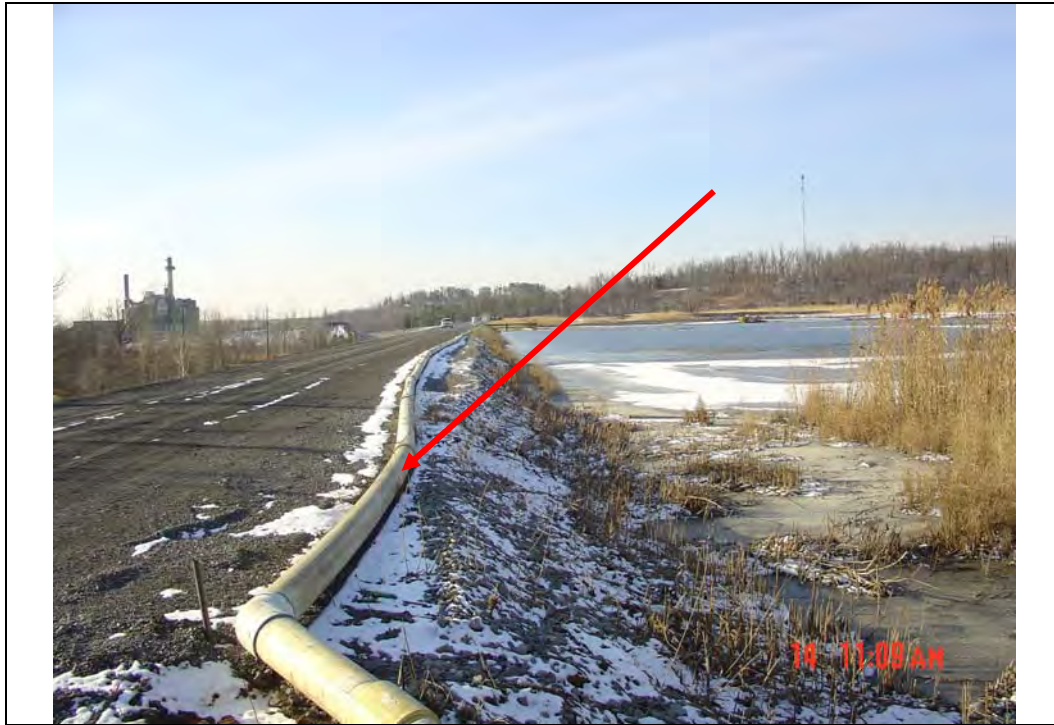
Photo #15: East end of south embankment, interior slope and crest,  
looking west  
Note: Ash discharge line

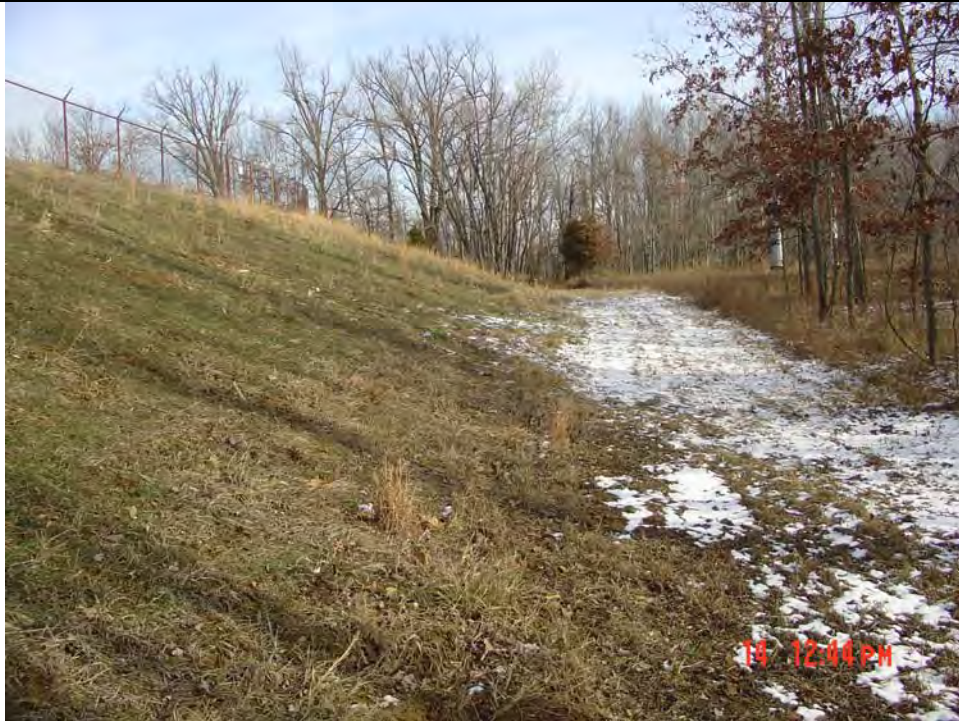
Photo #1: Exterior slope toe, south embankment east side, looking NW

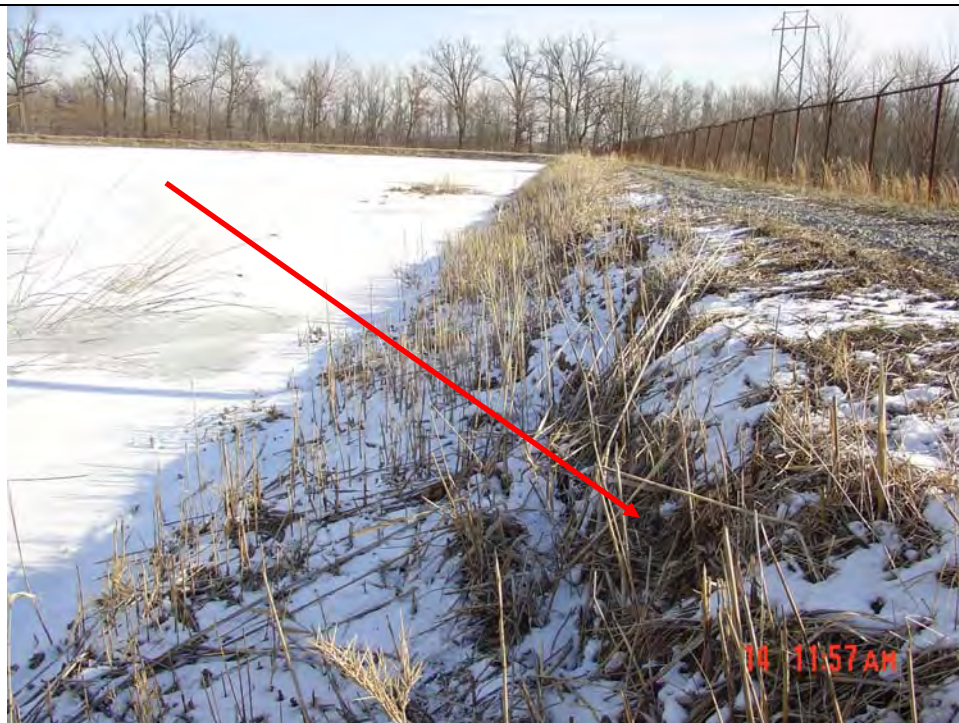
Photo #2: Interior slope of south embankment, looking east  
Note: Note wave erosion encroaching on edge of dam crest

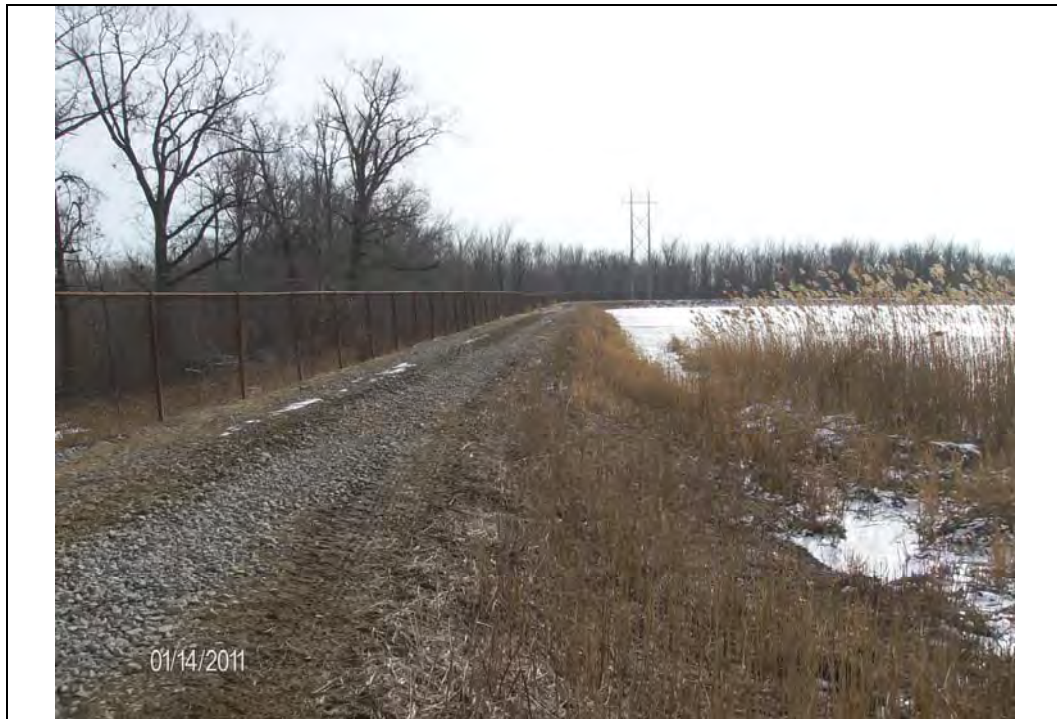
Photo #3: East embankment, interior slope, looking south

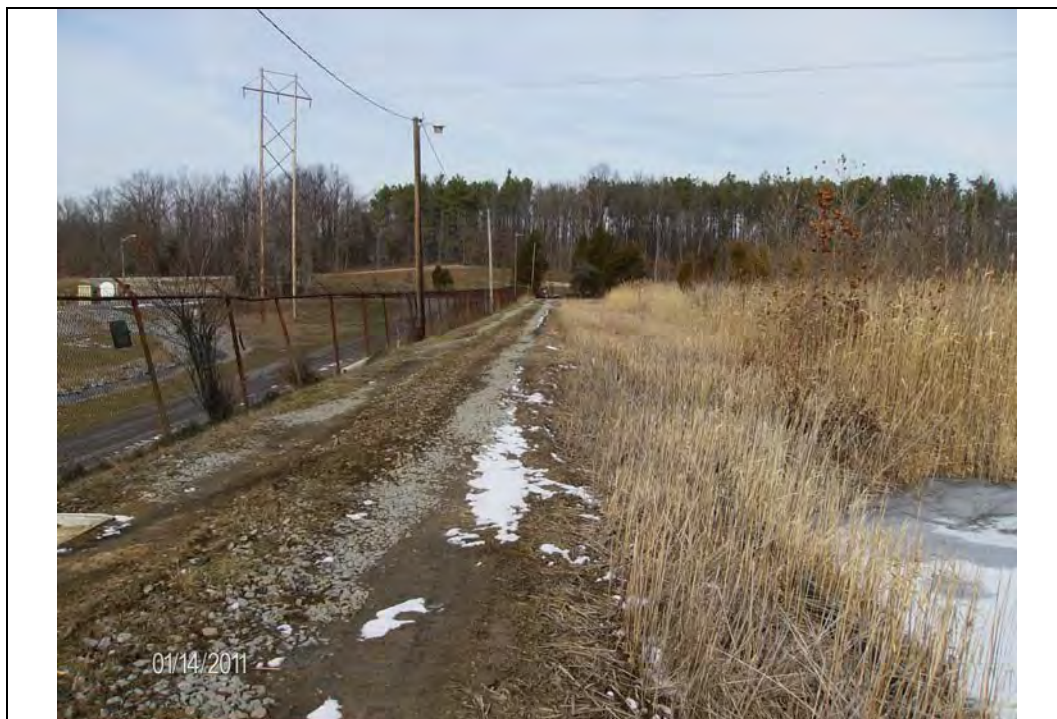
Photo #4: West embankment, crest and interior slope,  
looking north

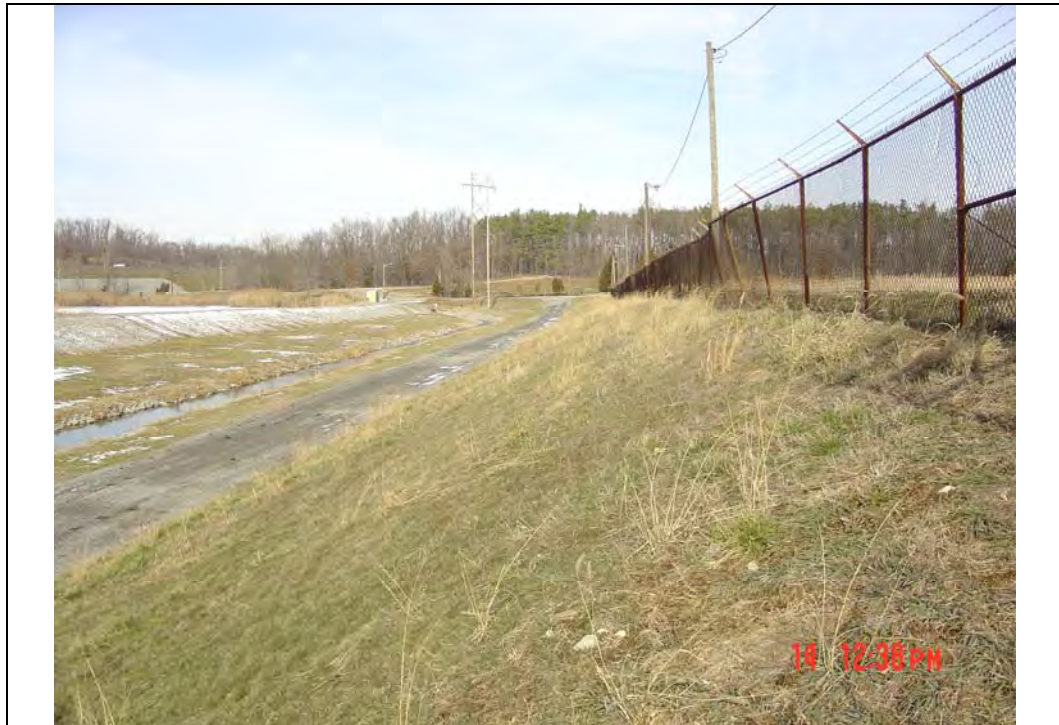
Photo #5: West embankment, exterior slope,  
looking north

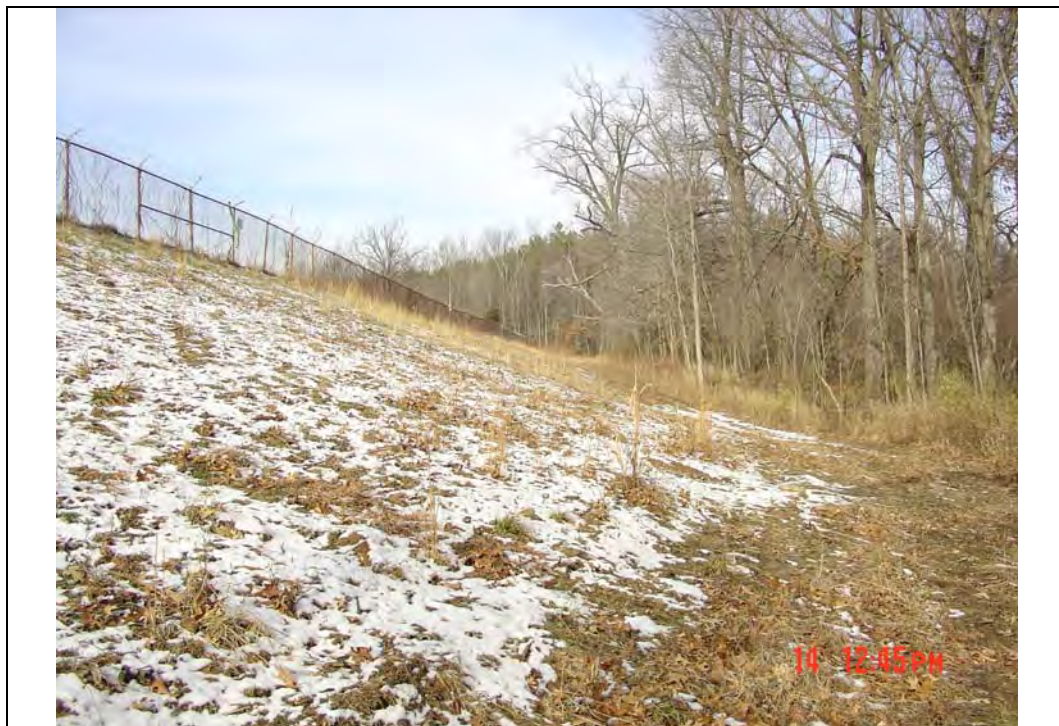
Photo #6: East embankment, exterior slope and toe, looking north

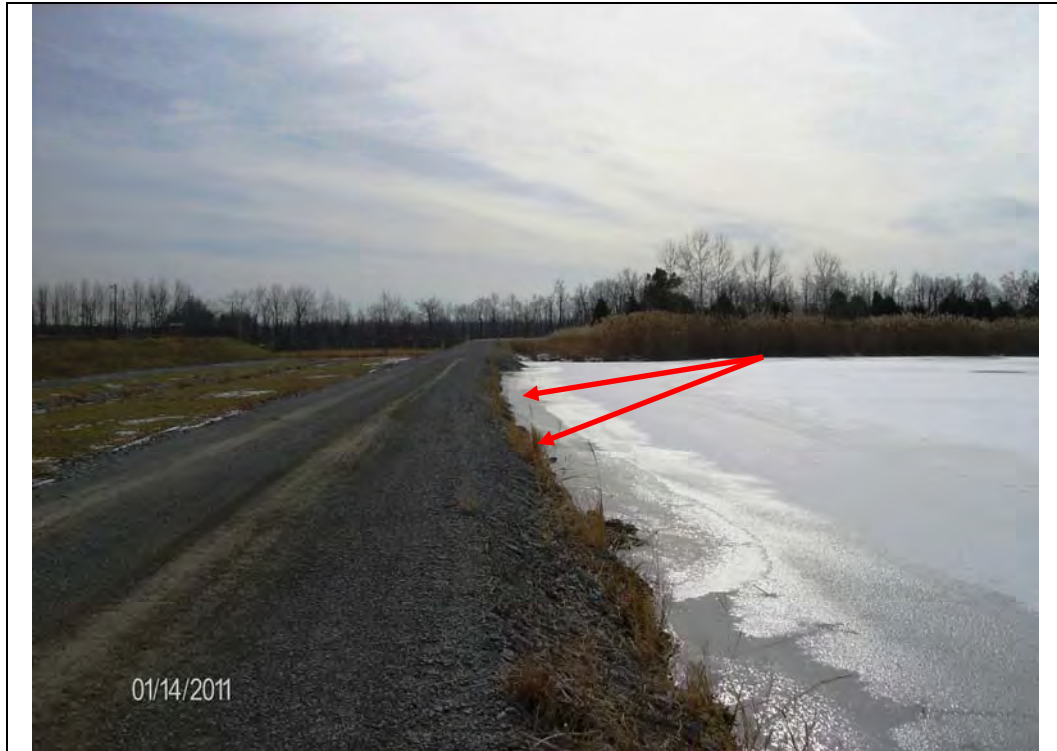
Photo #1: East embankment crest and upstream slope, looking south  
Note: steep slopes with sparse rip rap erosion protection.

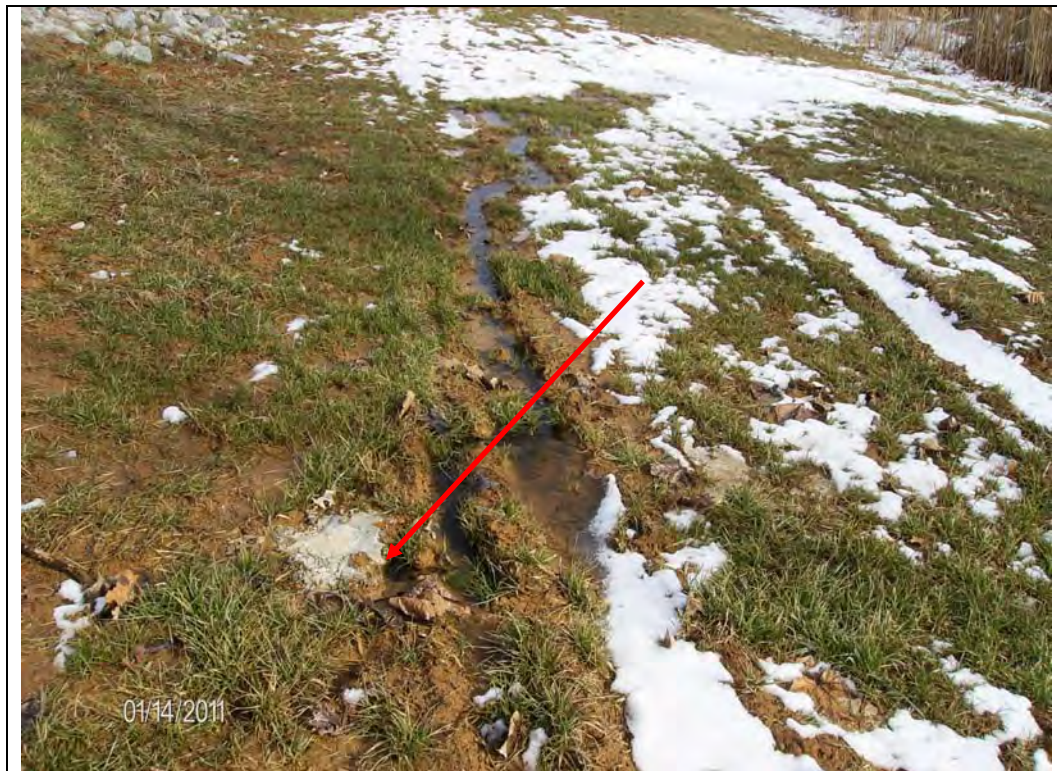
Photo #2: Seep at toe of south embankment, looking east  
Note: Source of flow adjacent to grouted hole

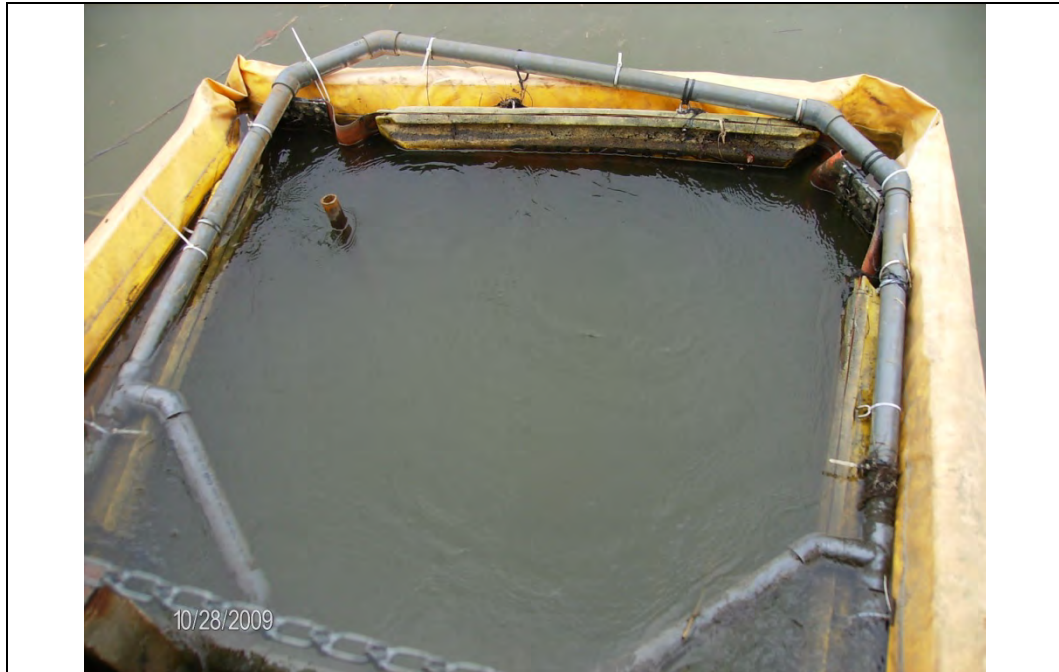
Photo #3: Principal Spillway Inlet

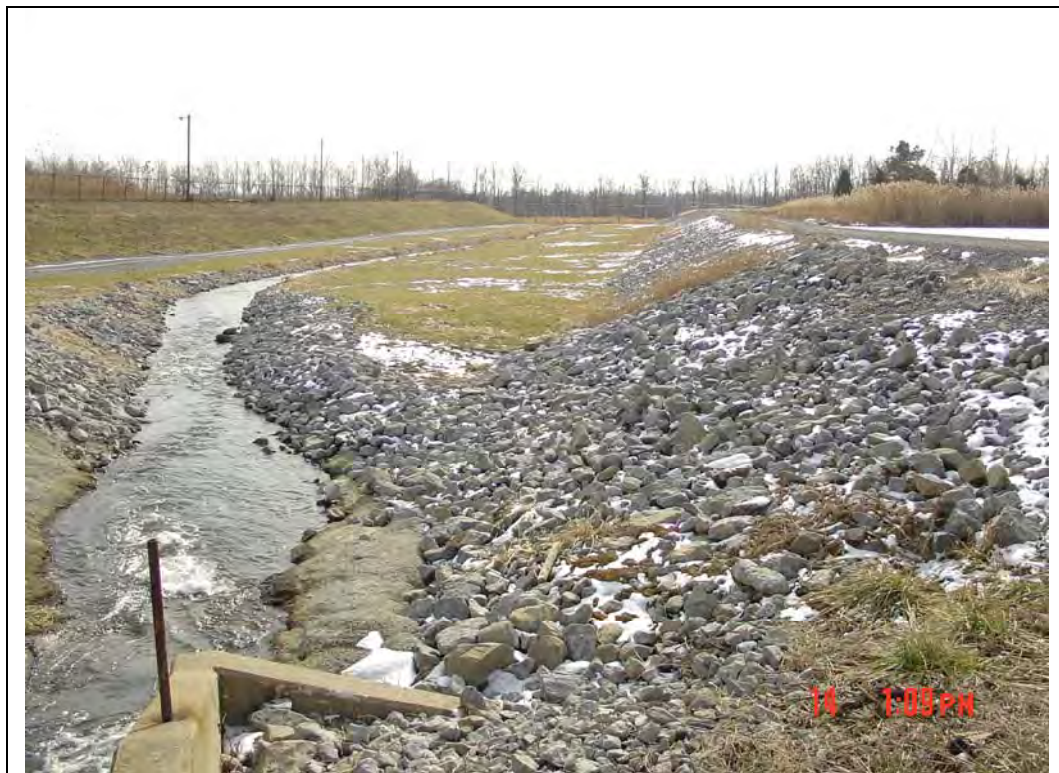
Photo #4: East embankment, downstream slope, toe, and principal spillway outlet, looking south

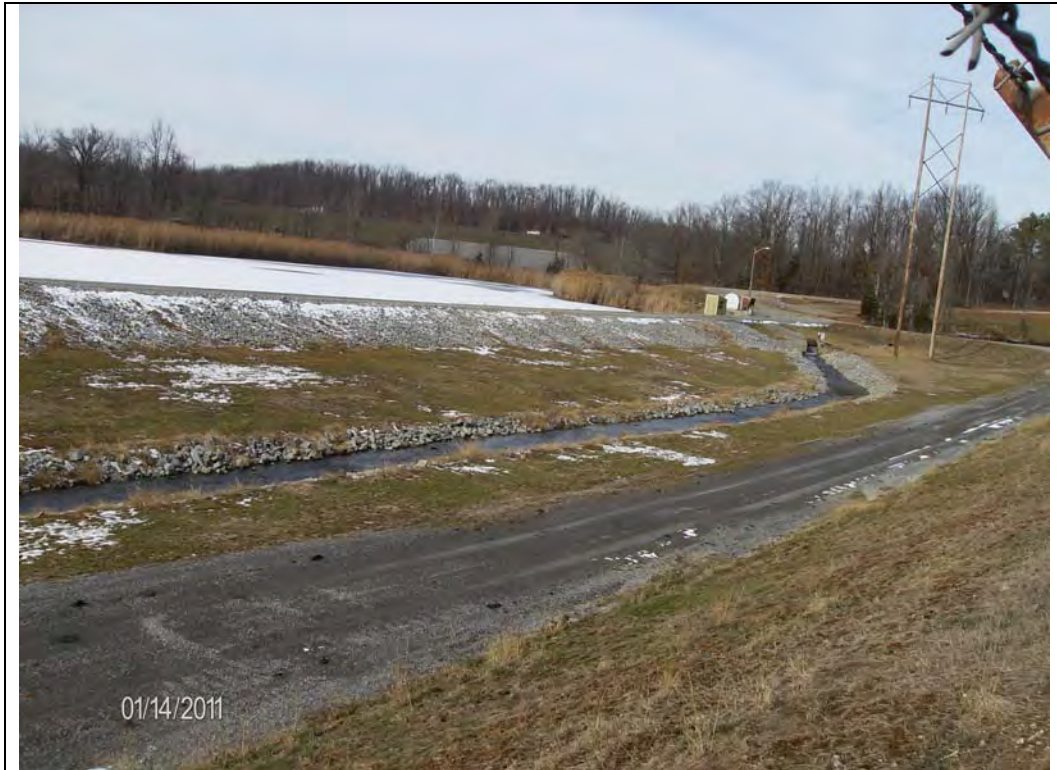
Photo #5: East embankment, downstream slope and toe,  
looking northwest

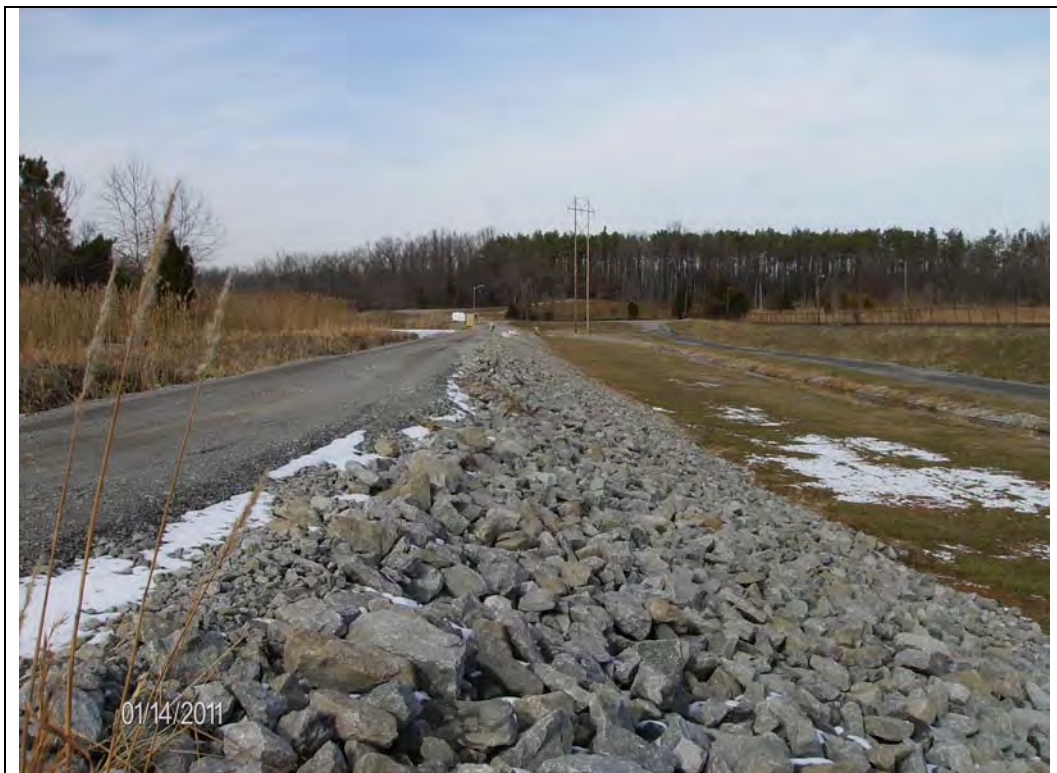
Photo #6: East embankment crest and downstream slope, looking north

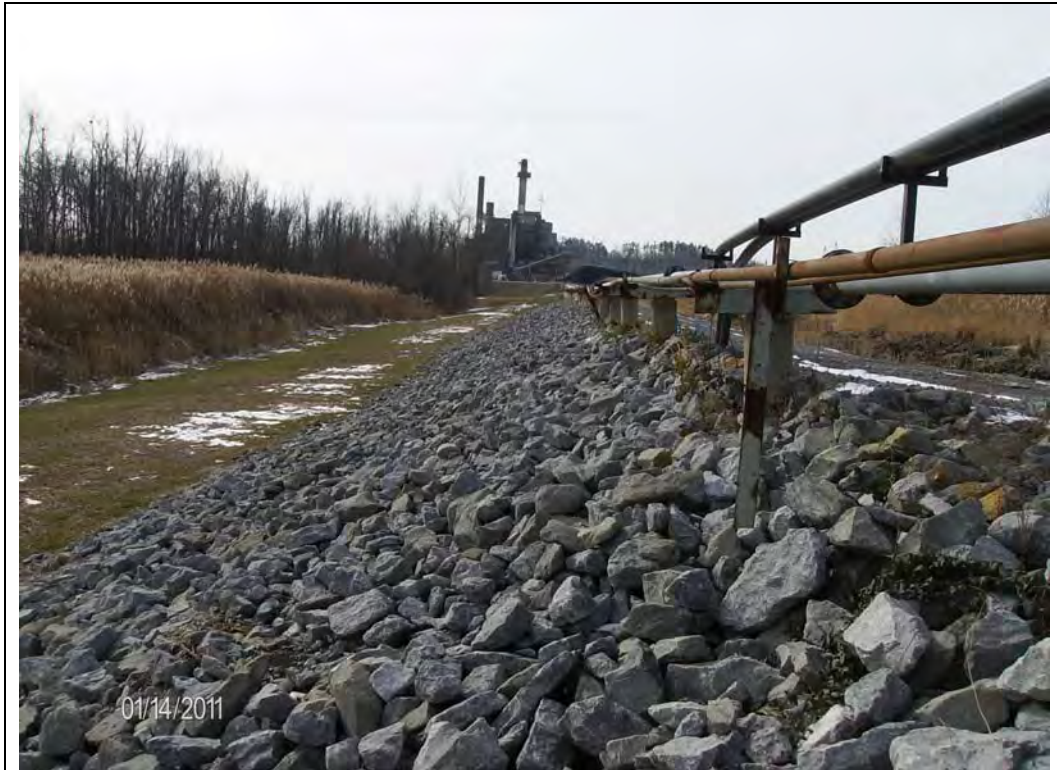
Photo #7: South embankment, downstream slope, southwest

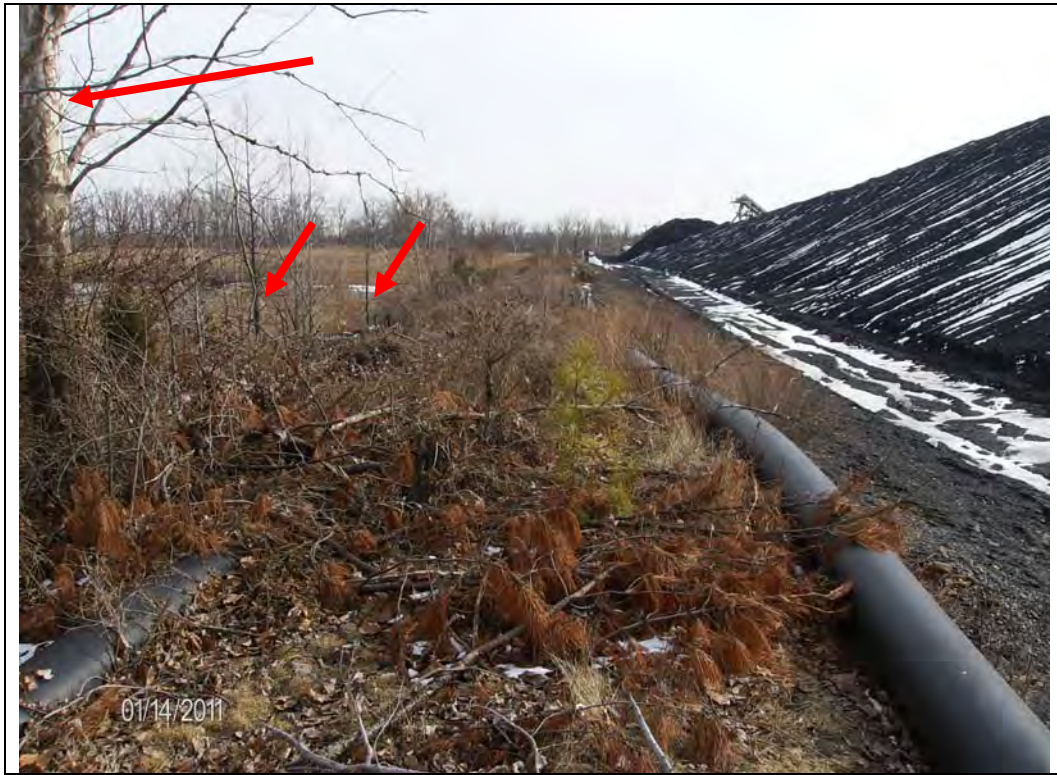
Photo #1: West embankment at NW corner, looking south  
Note: Sparse vegetation and trees along interior of embankment

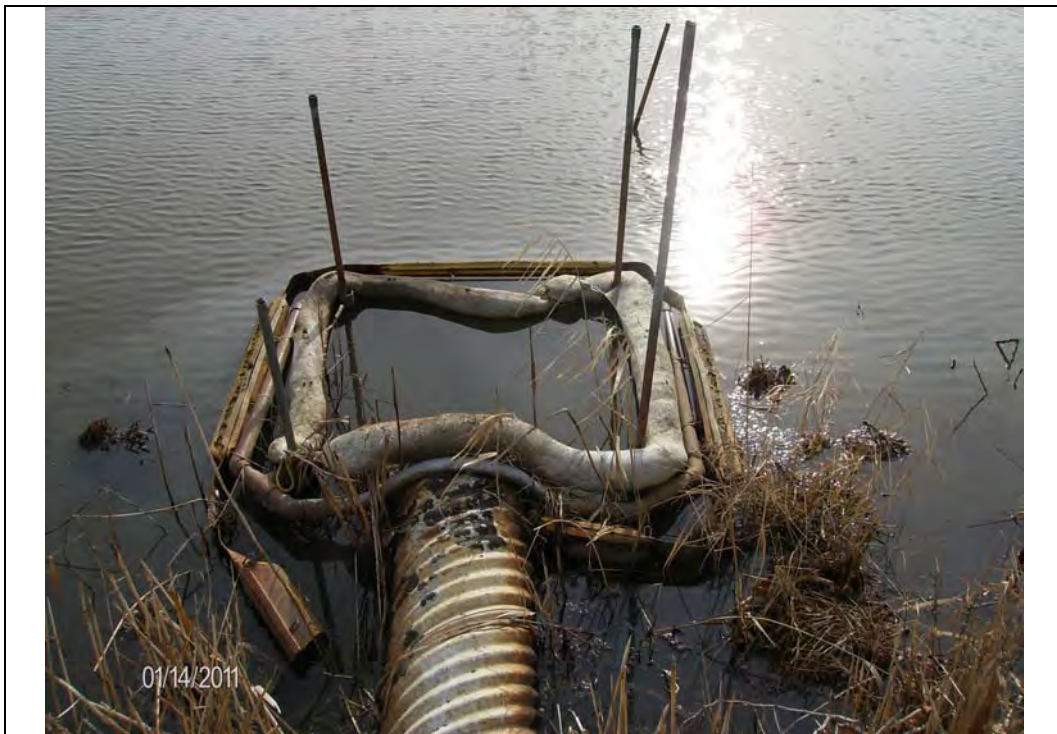
Photo #2: Principal Spillway inlet

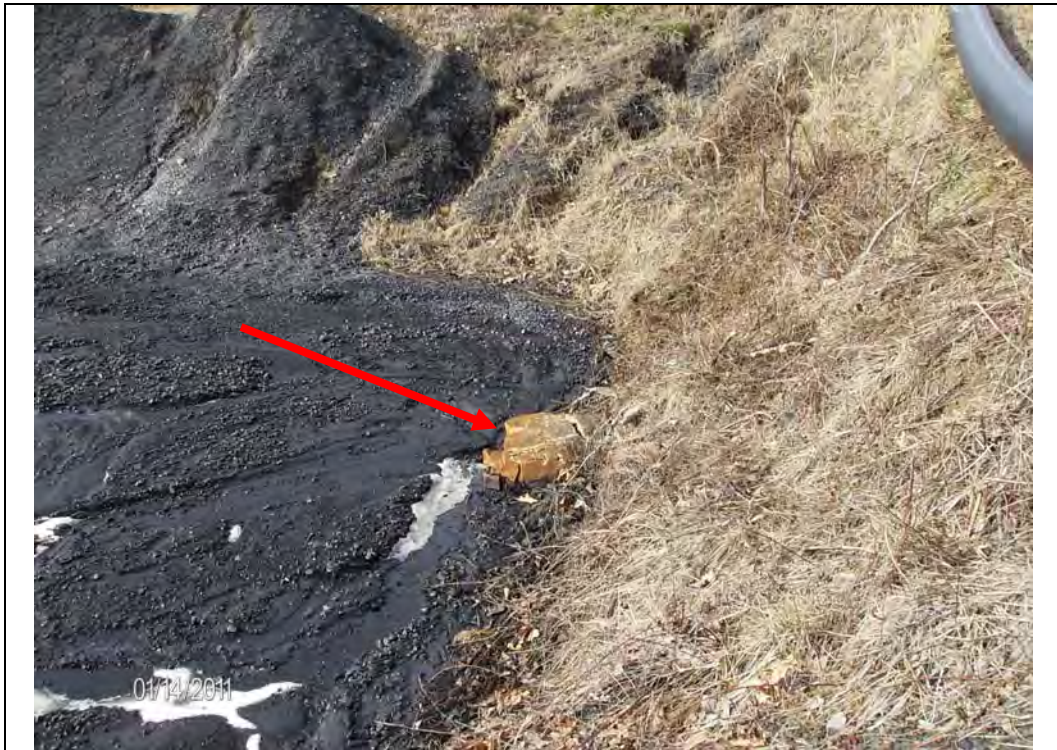
Photo #3: Inlet pipe from coal storage yard to coal runoff pond crushed, partially filled with coal, looking north

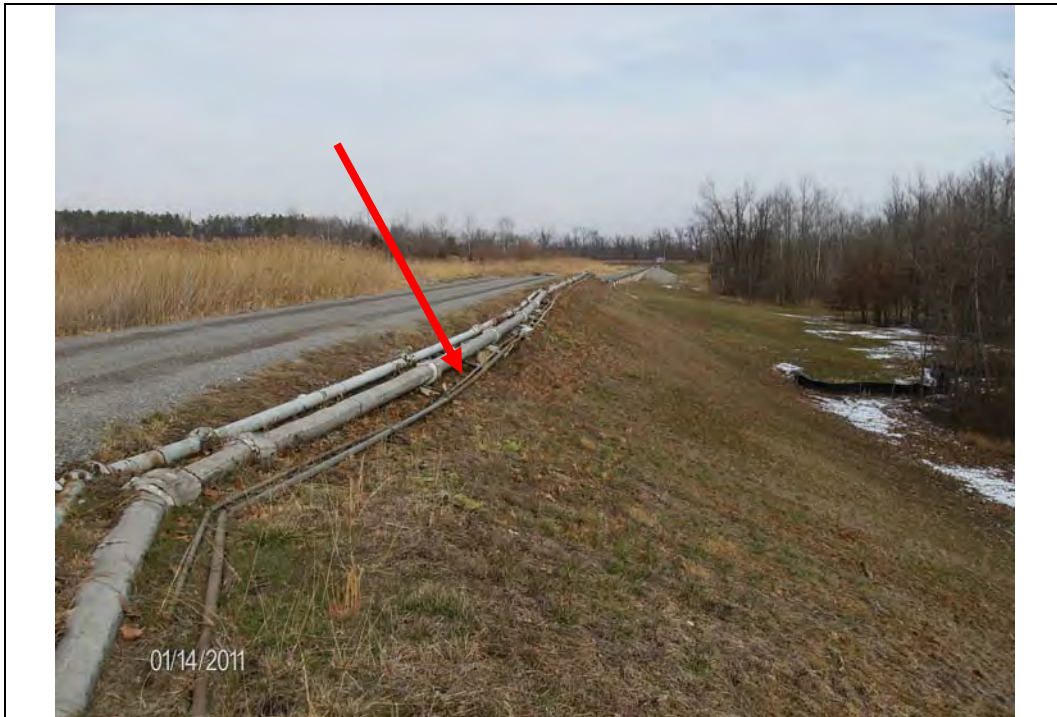
Photo #4: South embankment, exterior slope, looking east  
Note: Low spot in crest

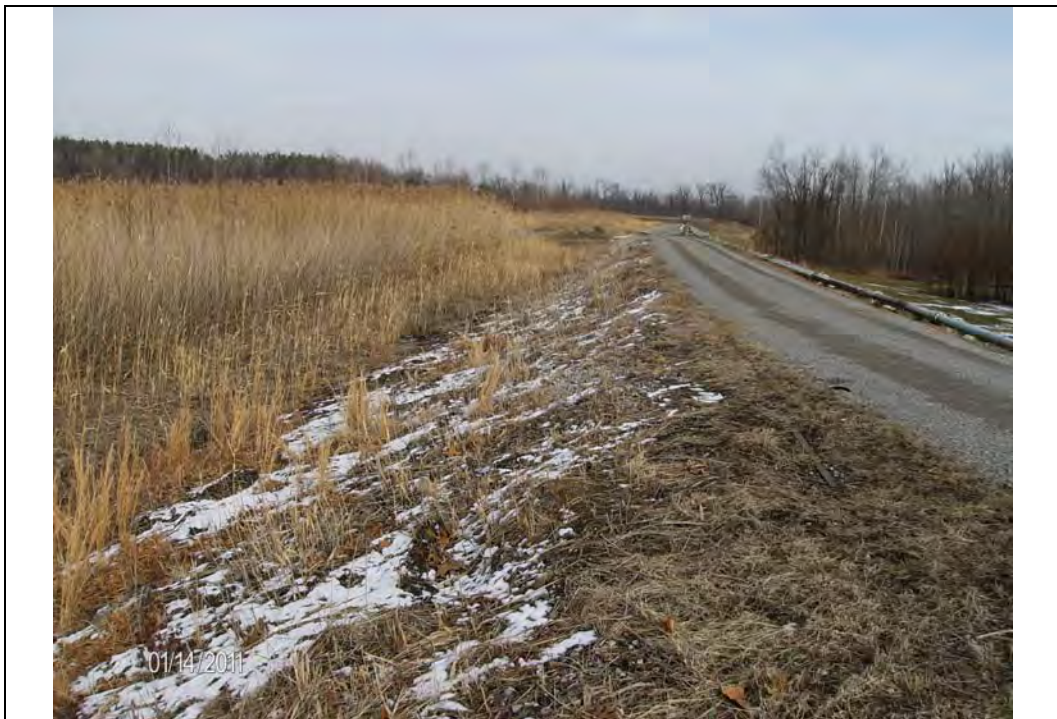
Photo #5: South embankment, interior slope, looking east  
Note: Sparse vegetation

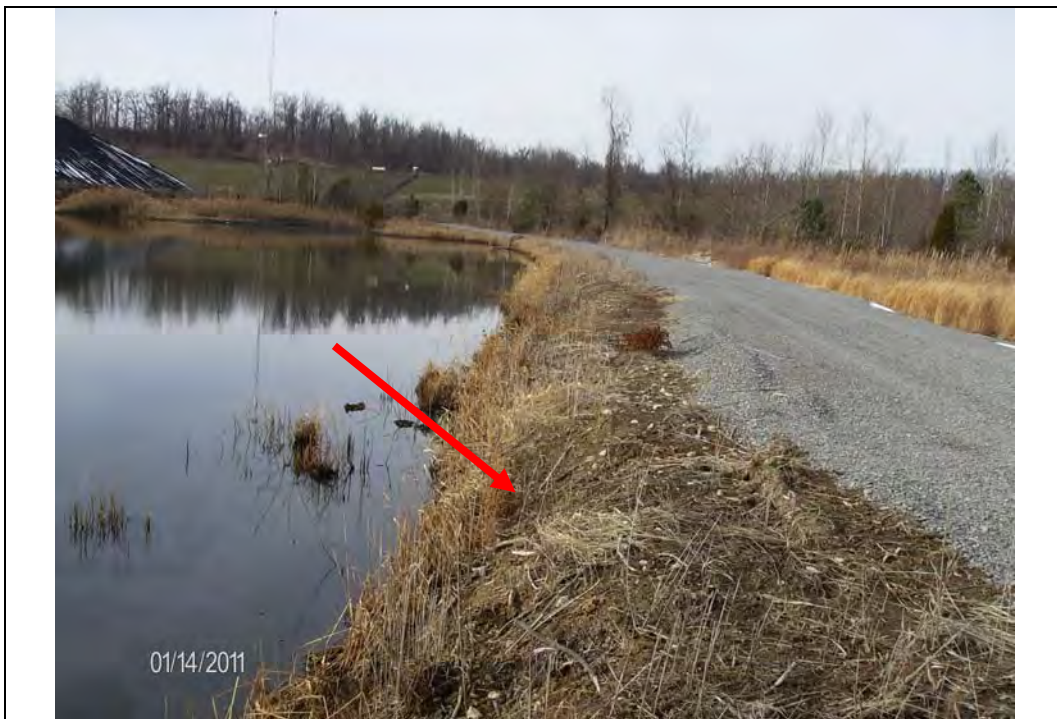
Photo #6: East embankment, interior slope, looking north  
Note: Animal burrows

GPS PT.	COORDINATES	DESCRIPTION
G60	N37°21'54.2" W87°7'9.8"	REPAIR TOP OF OLD SCARP ON SOUTH EMBANKMENT
G61	N37°21'59.0" W87°7'15.0"	DREDGE SEDIMENT FROM AROUND INTAKE AT SPILLWAY
G62	N37°21'57.9" W87°7'17.7"	2 HOPE ASH LINES UNDERMINED, WEST CREST
G63	N37°21'59.1" W87°7'19.1"	DAMAGE CONCRETE PIPE INLET FROM COAL YARD
G64	N37°21'57.5" W87°7'11.6"	ANIMAL BURROWS, INTERIOR SLOPE OF EAST EMB.
G65	N37°21'58.2" W87°7'12.9"	ANIMAL BURROWS, INTERIOR SLOPE OF EAST EMB.
