Coal Combustion Residue Impoundment

Round 12 - Dam Assessment Report

Big Brown Steam Electric Station

Bottom Ash Pond

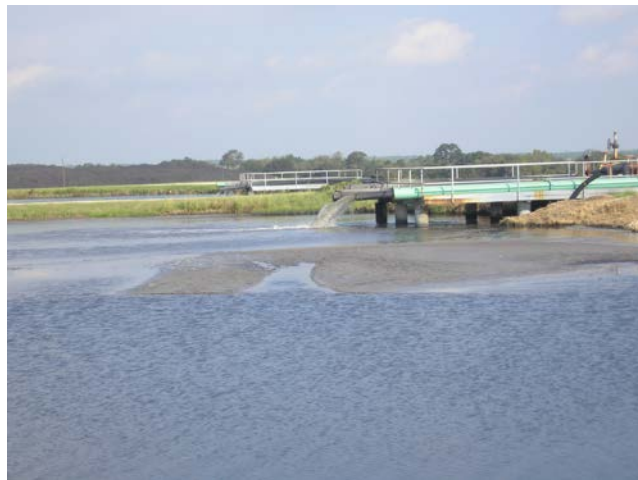
Photograph 2.2.2-1: Ash sluice water return pipes from dewatering bins to Bottom Ash Pond

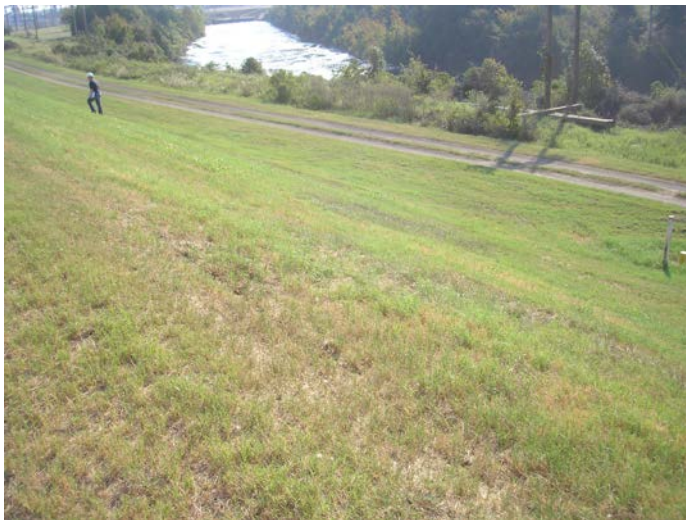
The plant cooling water discharge canal passes near the center of the north embankment on its path to the main lake (See Figure 5.2.3-2)

Figure 5.2.3-2 Plant Cooling Water Discharge Canal near Bottom Ash Pond North Embankment

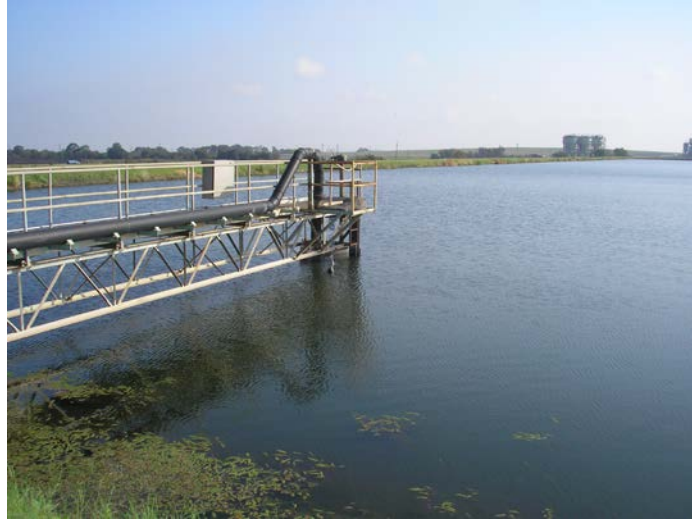
Figure 5.3.3-1: Access Bridge to Riser Structure; Bottom Ash Pond South Cell

The pipe along the top of the access bridge is the HDPE pipe that can be connected to a mobile pump for transferring water between pond cells.

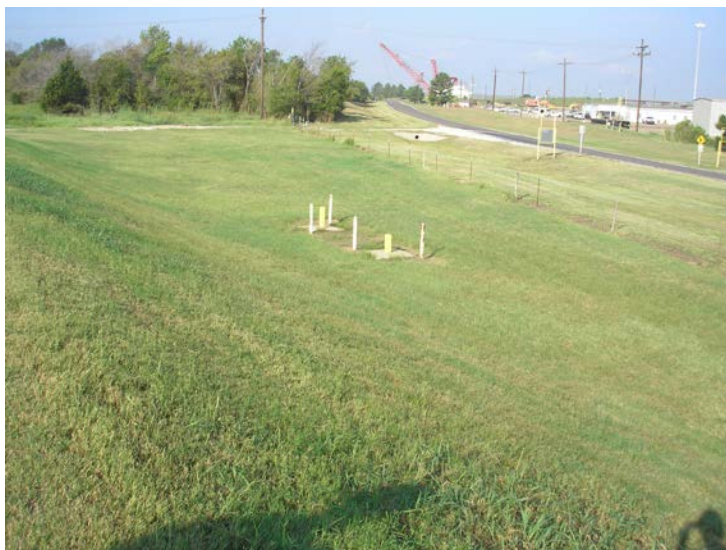
Instrumentation of the embankment consists of groundwater piezometers located outside the toe of the perimeter embankment (See Figure 9.2-1). The piezometers are read semi-annually and results reported to plant management.

**Figure 9.2-1: Piezometer near Embankment Toe
– Northwest Groin**

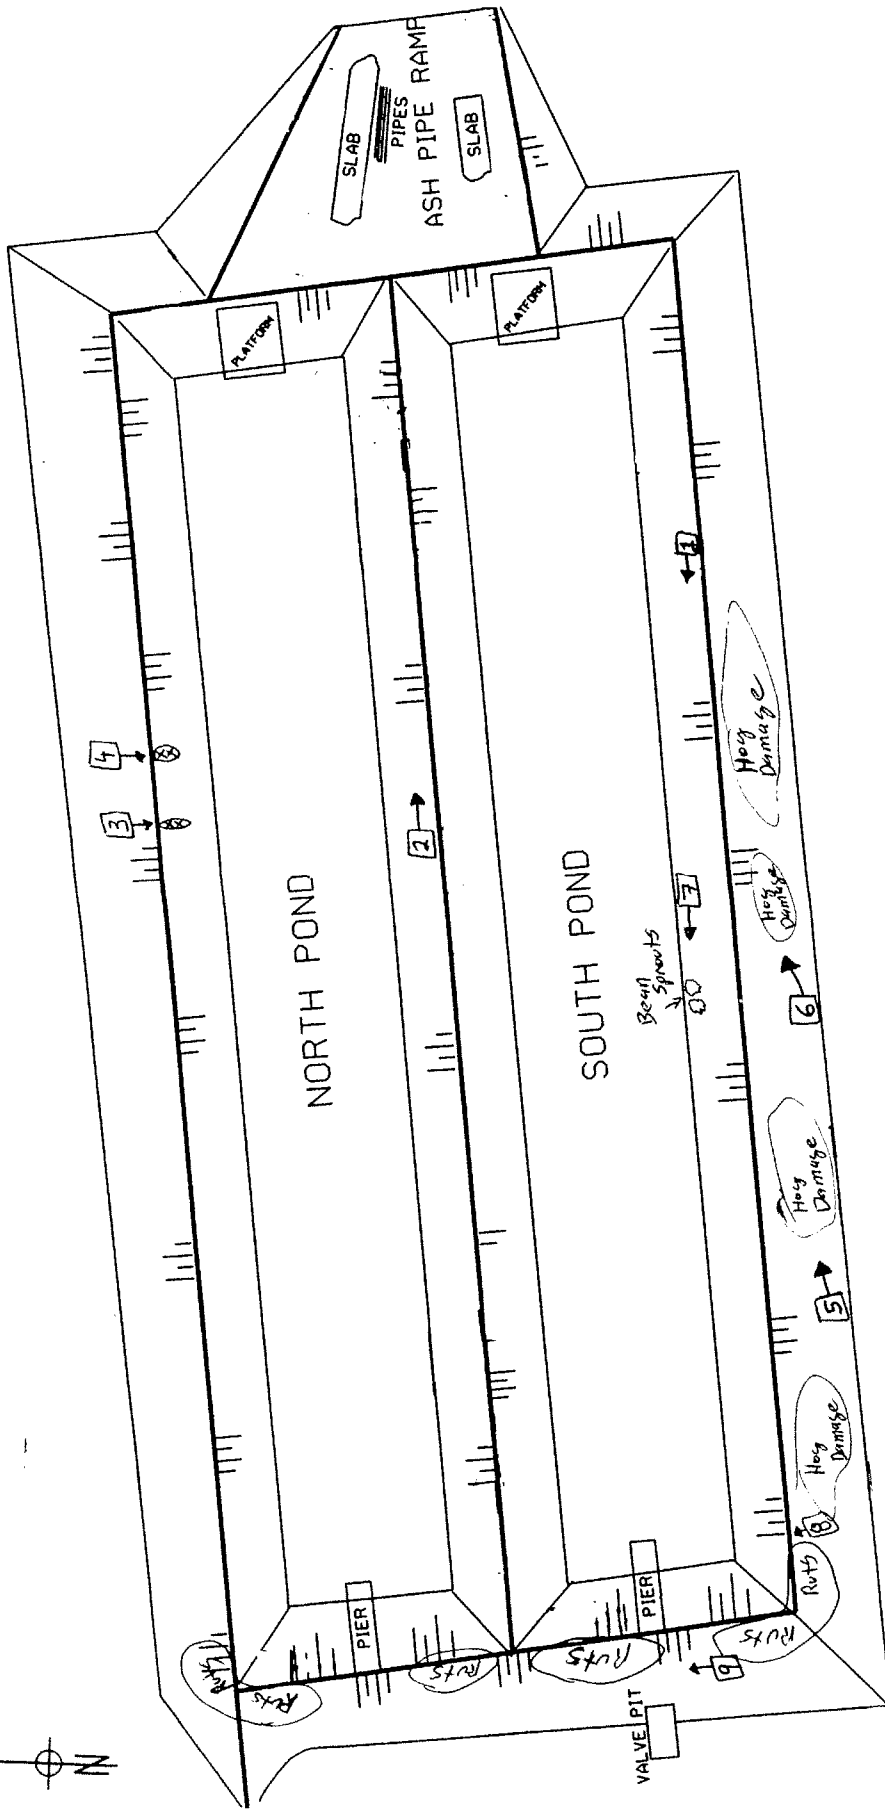
BIG BROWN SES
SK-1 "BOTTOM ASH POND"
INSPECTION DATE: JANUARY 17, 2011

Photos 8 and 9 are rutting along the crest. The ruts allow rainwater to collect, penetrate and potentially weaken the embankment. These should be repaired and care should be taken to avoid driving on the crest when the embankment has been softened by wet conditions. See SK-1 for the locations of the ruts.

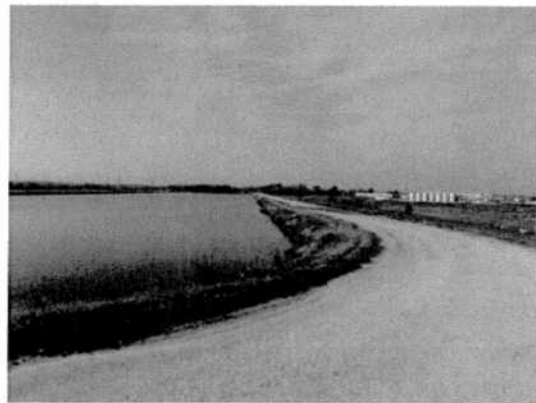
In general, the crest of the impoundment was in good condition (Figures 2 and 3).

Figure 3: Crest of North Impoundment

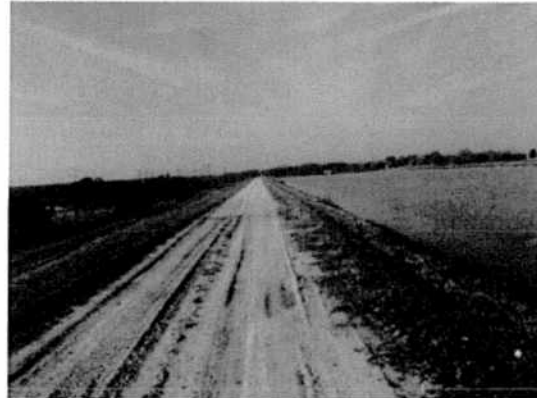
MODERATE ITEM: The crest of the impoundment had areas with rutting from vehicular traffic (Figures 4 and 5) in localized areas around the entire pond.

Figure 5: Crest Rutting South Pond

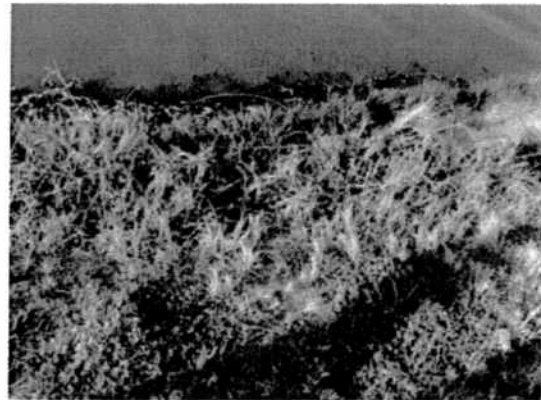
MODERATE ITEM: Wave erosion was observed on the North Pond (Figure 6). Erosion matting was installed to mitigate the erosion along the upstream embankments of both ponds. The matting installed in the North Pond did not appear to be functioning as well as the matting installed on the South Pond (Figure 7). The North Pond was emptied in 2011 and repairs were made to the liner and protective cover. The South Pond was emptied and repaired in 2009.

Figure 7: South Pond Upstream Embankment (Note geotextile well placed and functioning as intended)

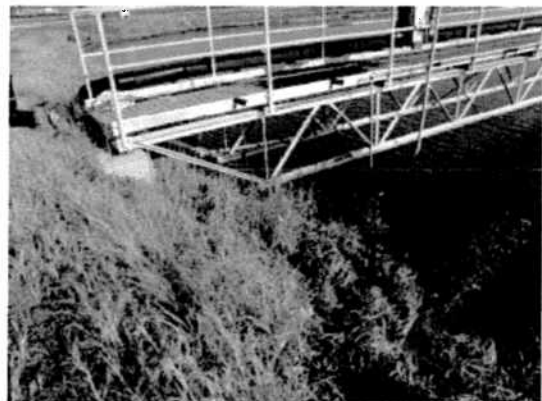
MODERATE ITEM: The South Bottom Ash Pond had isolated areas of cattails and other vegetation growing on the upstream embankment (Figures: 8 and 9).

Figure 9: Bush Growing South Pond Embankment

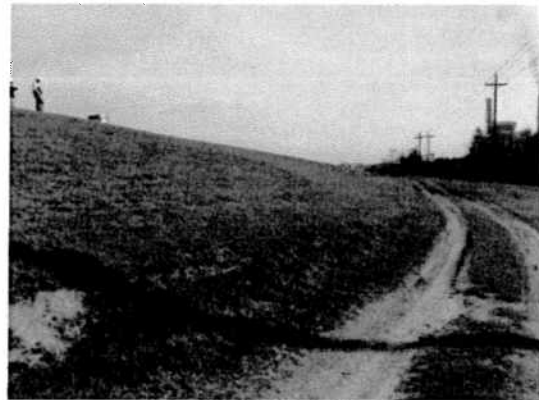
MODERATE ITEM: Bare areas were found at a couple of areas along the downstream face of the embankment around both ponds (Figures: 14 and 15).

Figure 15: Bare Area South Pond

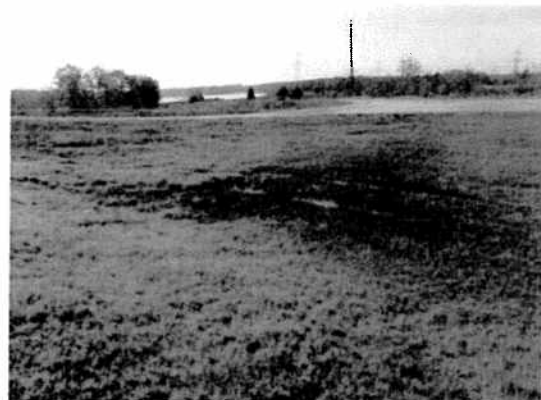
MODERATE ITEM: Water is ponding at the toe of both ponds in isolated areas (Figures 16 and 17). It is assumed the water was from recent storm activities, but this could also represent seepage from the impoundment.

Figure 17: South Pond Standing Water at Toe

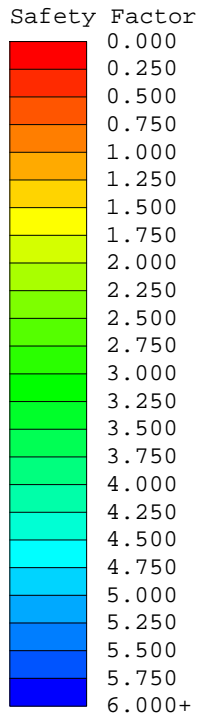
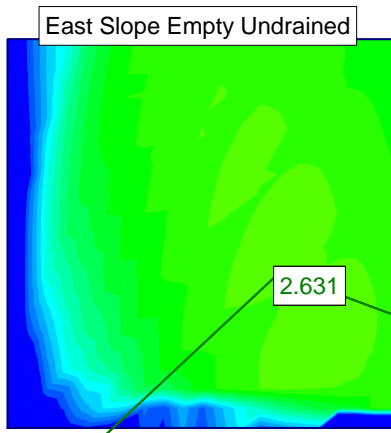
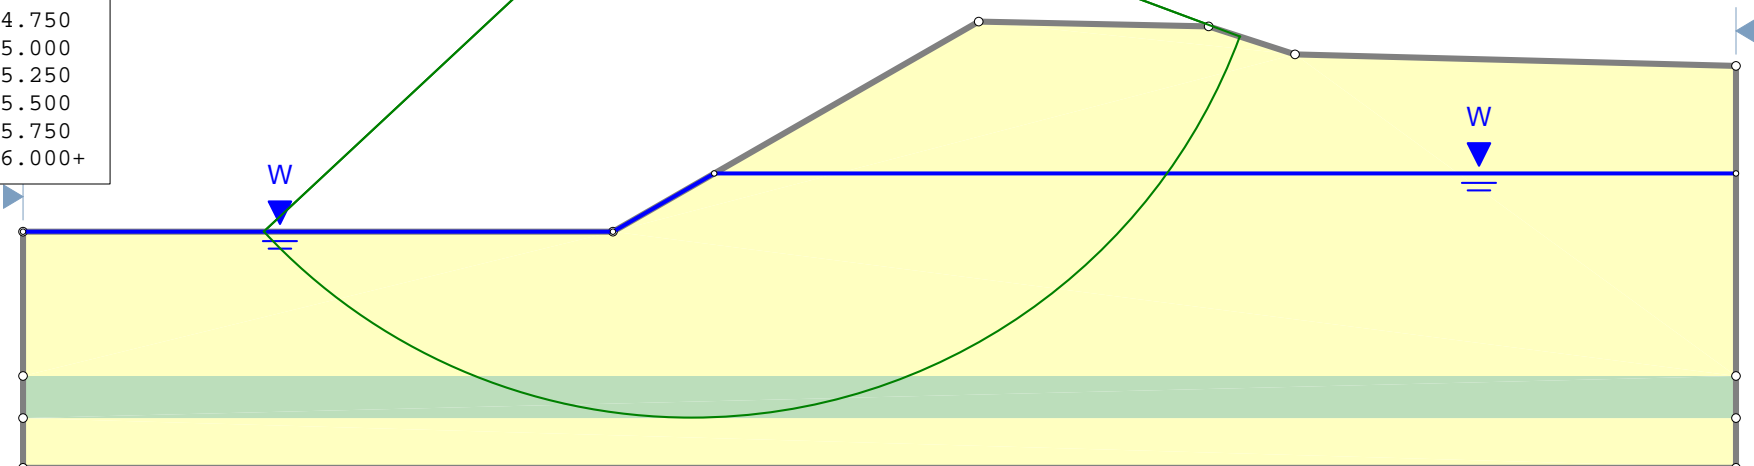
Case 1

Results
 bishop simplified
 Surface Type: Circular
 Search Method: Grid Search
 Radius Increment: 10
 Composite Surfaces: Disabled
 Reverse Curvature: Create Tension Crack
 Minimum Elevation: Not Defined
 Minimum Depth: Not Defined
 Every available surface
 2.631
 Factor of Safety: 2.631
 Center: -61.281, 375.327
 Radius: 69.391
 Left Slip Surface Endpoint: -112.028, 328.000
 Right Slip Surface Endpoint: 3.752, 351.123

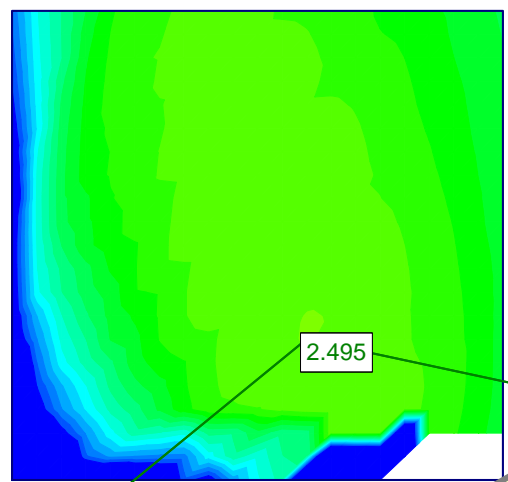
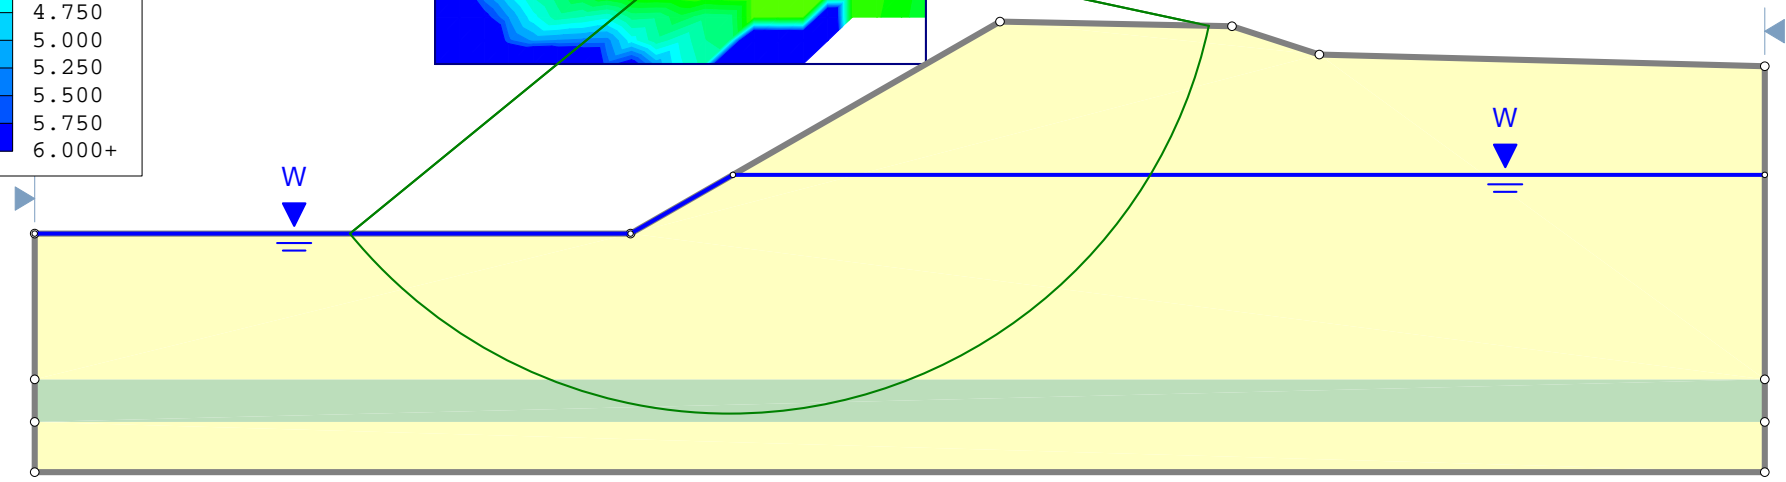
Document
East Slope Empty Drained.sli

Results
 bishop simplified
 Surface Type: Circular
 Search Method: Grid Search
 Radius Increment: 10
 Composite Surfaces: Disabled
 Reverse Curvature: Create Tension Crack
 Minimum Elevation: Not Defined
 Minimum Depth: Not Defined
 Every available surface
 2.495
 Factor of Safety: 2.495
 Center: -58.985, 364.435
 Radius: 57.569
 Left Slip Surface Endpoint: -103.556, 328.000
 Right Slip Surface Endpoint: -2.689, 352.395

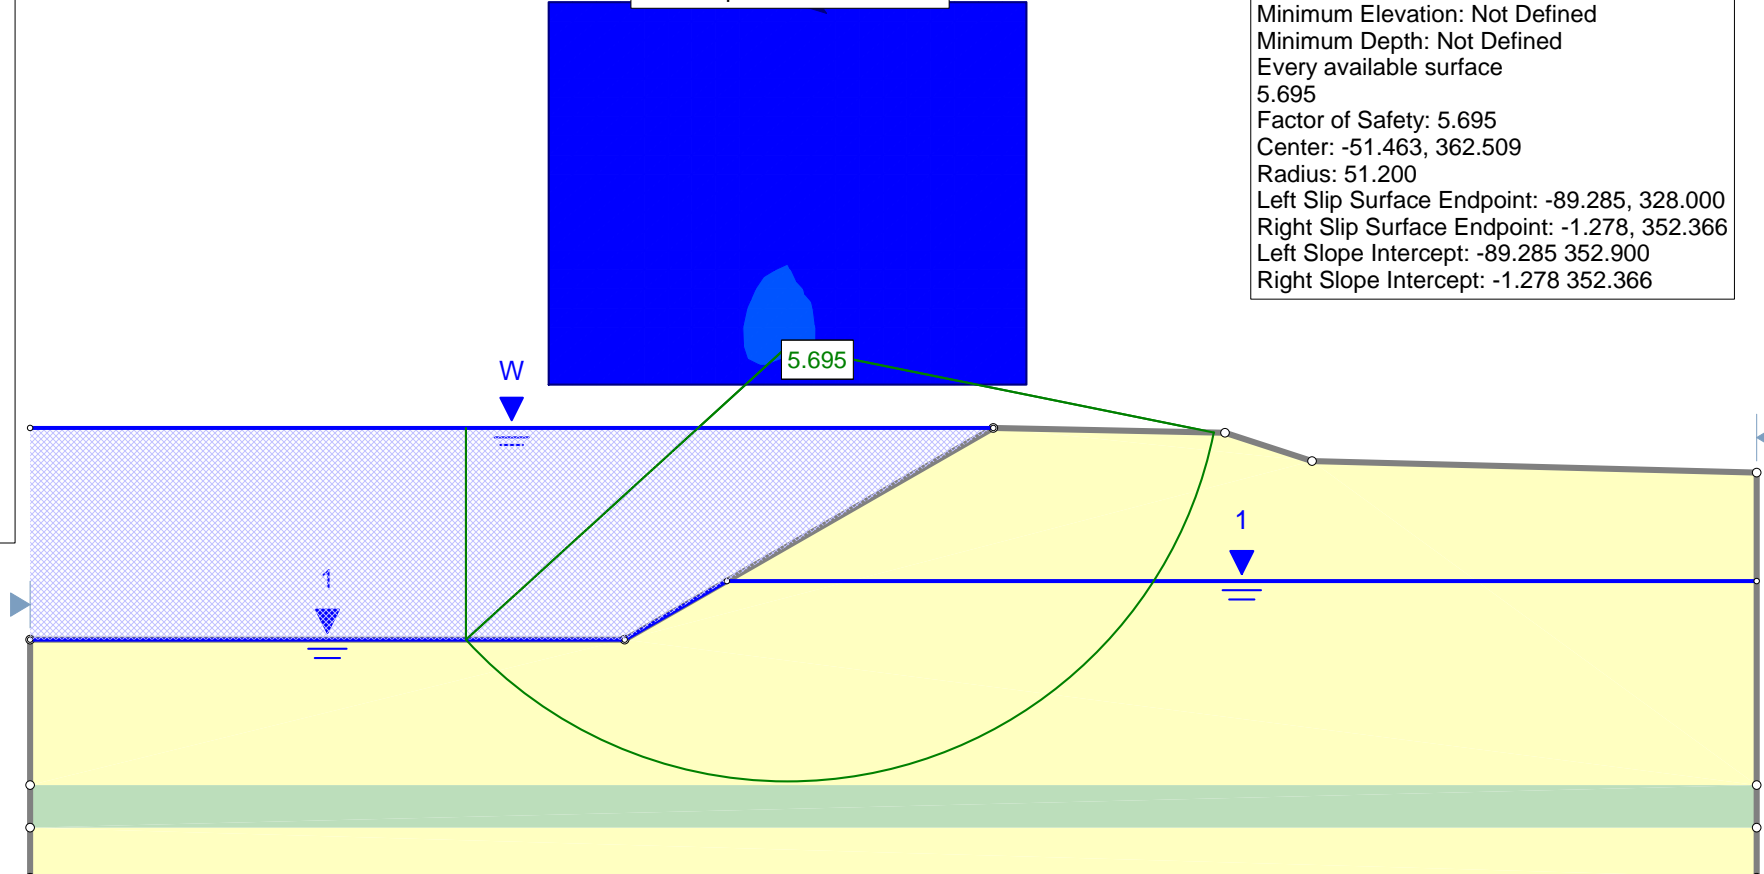
Document
 East Slope Full Undrained.sli

Results
 bishop simplified
 Surface Type: Circular
 Search Method: Grid Search
 Radius Increment: 10
 Composite Surfaces: Disabled
 Reverse Curvature: Create Tension Crack
 Minimum Elevation: Not Defined
 Minimum Depth: Not Defined
 Every available surface
 5.695
 Factor of Safety: 5.695
 Center: -51.463, 362.509
 Radius: 51.200
 Left Slip Surface Endpoint: -89.285, 328.000
 Right Slip Surface Endpoint: -1.278, 352.366
 Left Slope Intercept: -89.285 352.900
 Right Slope Intercept: -1.278 352.366

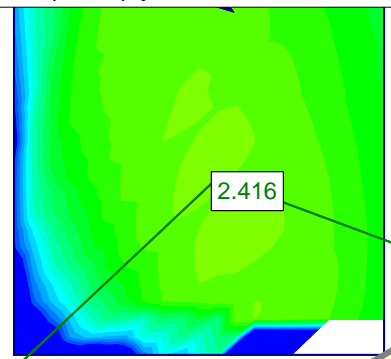
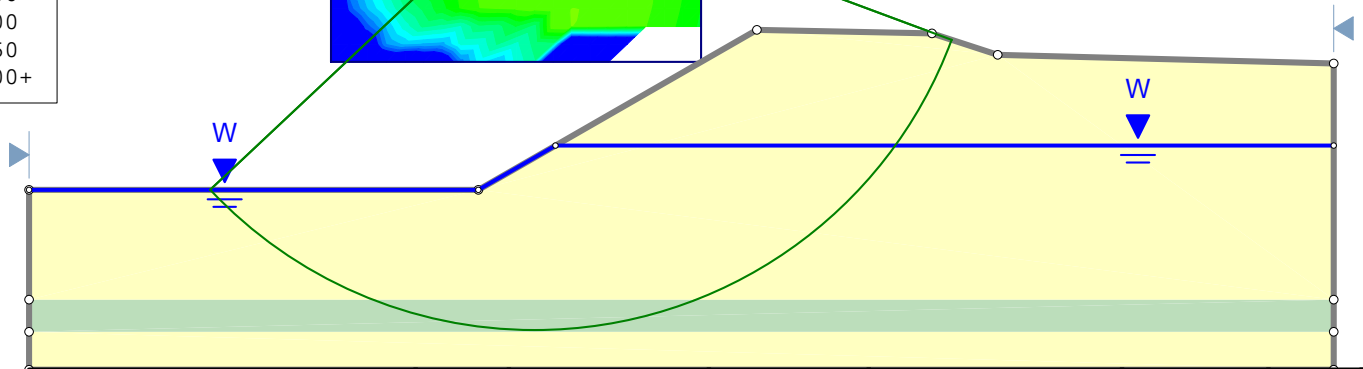
East Slope Empty Drained_seismic load.slim

Results
 bishop simplified
 Surface Type: Circular
 Search Method: Grid Search
 Radius Increment: 10
 Composite Surfaces: Disabled
 Reverse Curvature: Create Tension Crack
 Minimum Elevation: Not Defined
 Minimum Depth: Not Defined
 Every available surface
 2.416
 Factor of Safety: 2.416
 Center: -61.865, 375.451
 Radius: 69.296
 Left Slip Surface Endpoint: -112.367, 328.000
 Right Slip Surface Endpoint: 3.099, 351.335

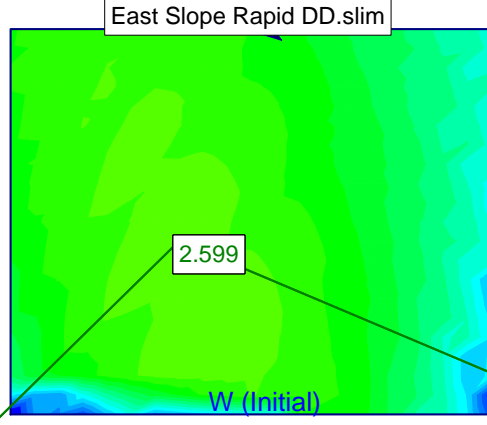
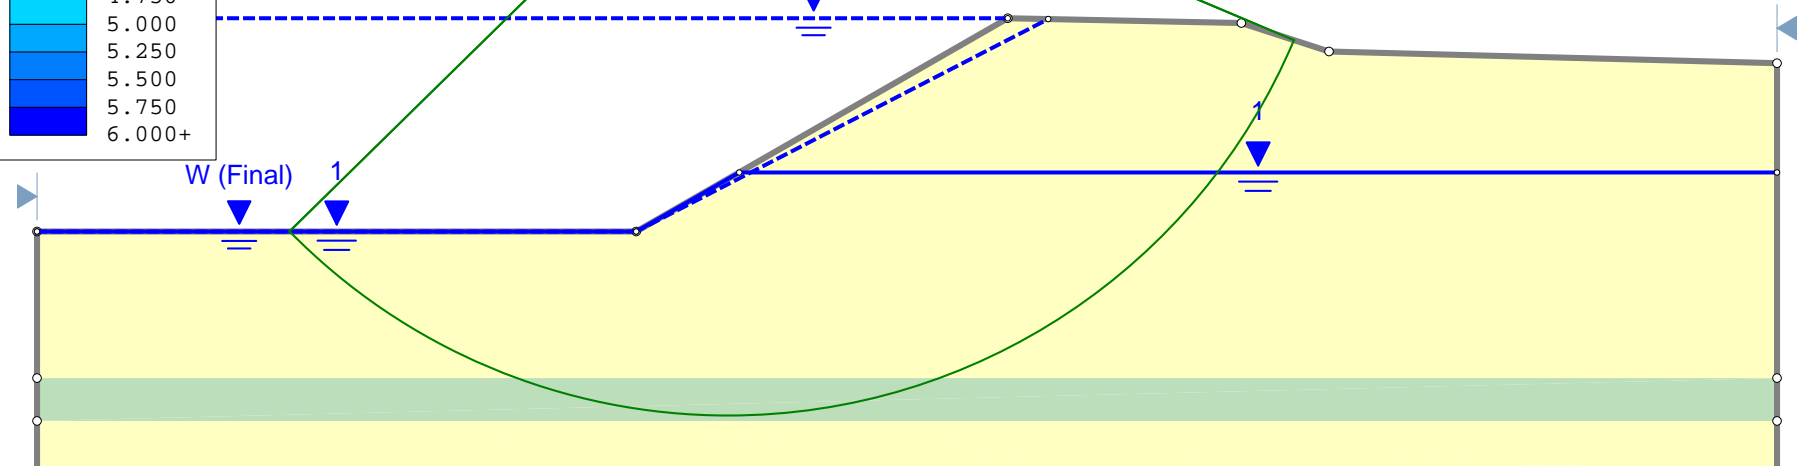
Case 6

Results
 bishop simplified
 Surface Type: Circular
 Search Method: Grid Search
 Radius Increment: 10
 Composite Surfaces: Disabled
 Reverse Curvature: Create Tension Crack
 Minimum Elevation: Not Defined
 Minimum Depth: Not Defined
 Every available surface
 2.599
 Factor of Safety: 2.599
 Center: -59.893, 378.252
 Radius: 71.745
 Left Slip Surface Endpoint: -111.100, 328.000
 Right Slip Surface Endpoint: 6.197, 350.331

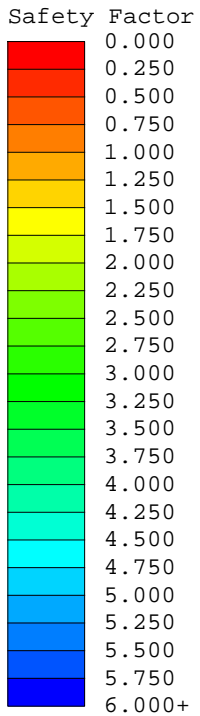
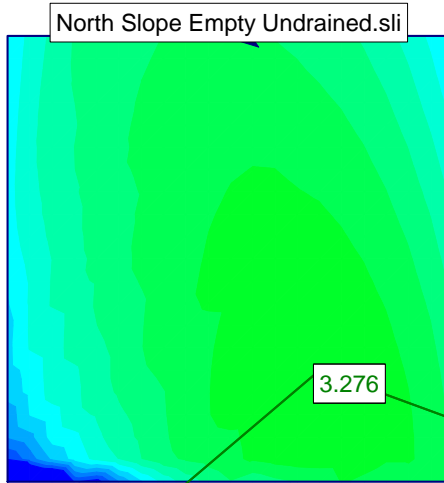
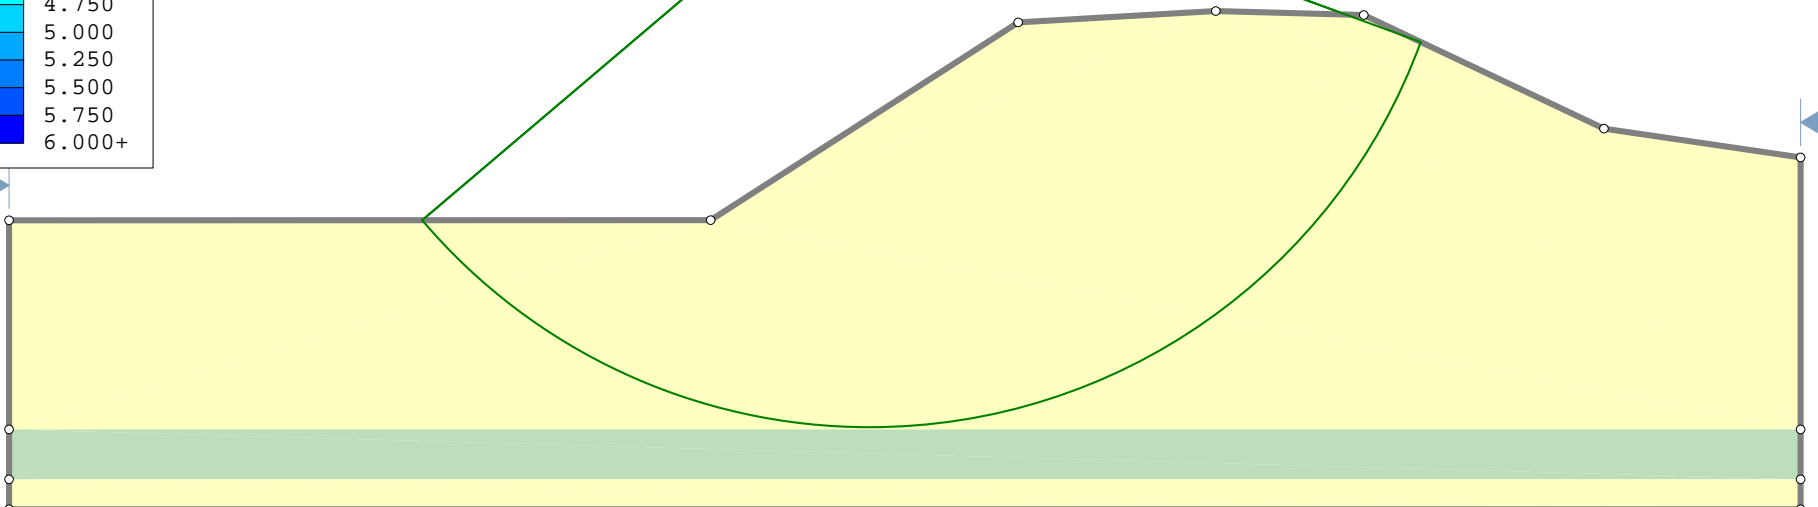
Case 7

Results
 bishop simplified
 Surface Type: Circular
 Search Method: Grid Search
 Radius Increment: 10
 Composite Surfaces: Disabled
 Reverse Curvature: Create Tension Crack
 Minimum Elevation: Not Defined
 Minimum Depth: Not Defined
 Every available surface
 3.276
 Factor of Safety: 3.276
 Center: 86.346, 366.662
 Radius: 58.920
 Left Slip Surface Endpoint: 41.434, 328.525
 Right Slip Surface Endpoint: 141.675, 346.409

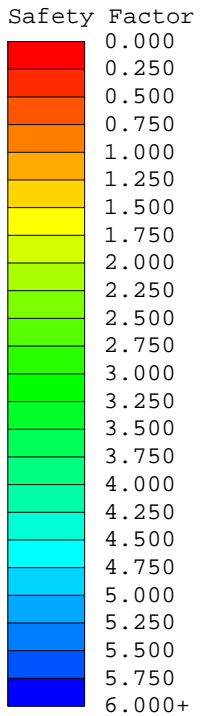
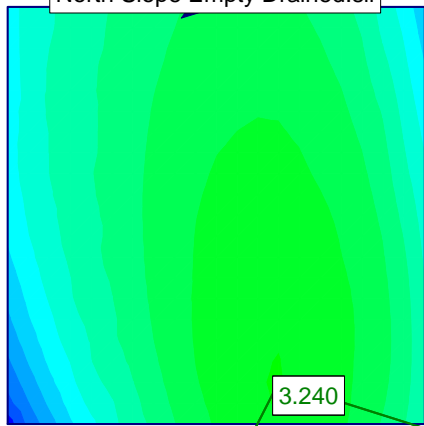
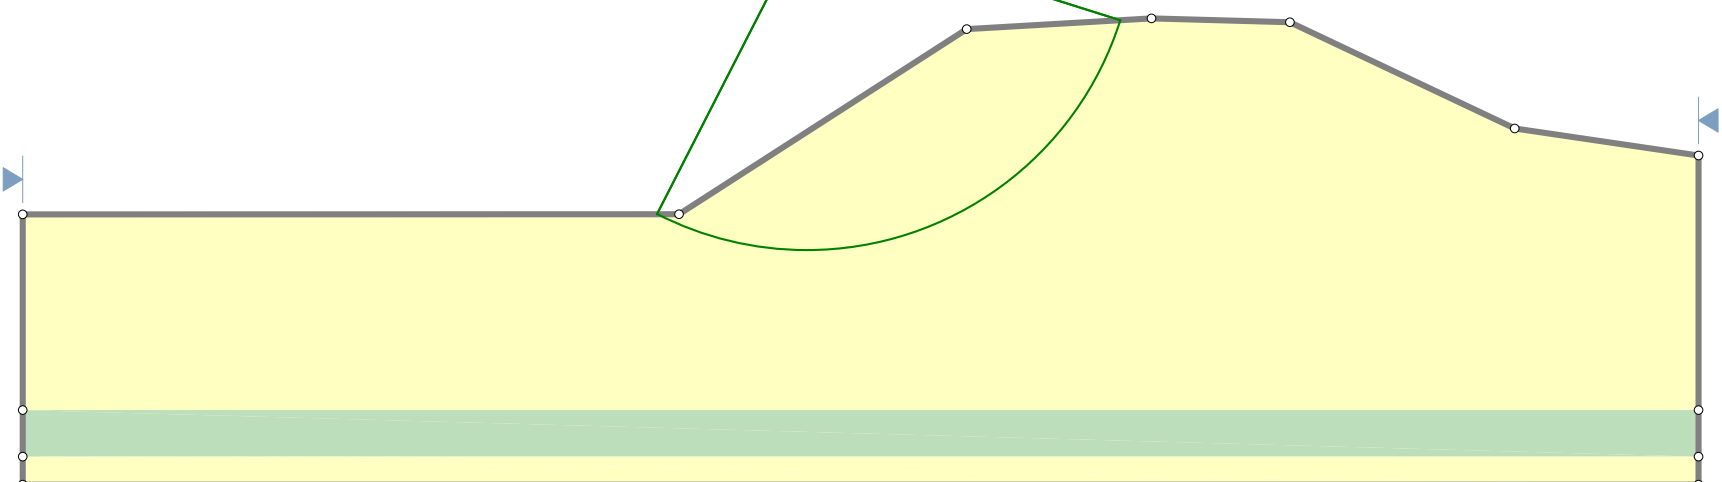
North Slope Empty Drained.sli

Results
 bishop simplified
 Surface Type: Circular
 Search Method: Grid Search
 Radius Increment: 10
 Composite Surfaces: Disabled
 Reverse Curvature: Create Tension Crack
 Minimum Elevation: Not Defined
 Minimum Depth: Not Defined
 Every available surface
 3.240
 Factor of Safety: 3.240
 Center: 84.109, 359.951
 Radius: 35.290
 Left Slip Surface Endpoint: 68.044, 328.530
 Right Slip Surface Endpoint: 117.765, 349.337

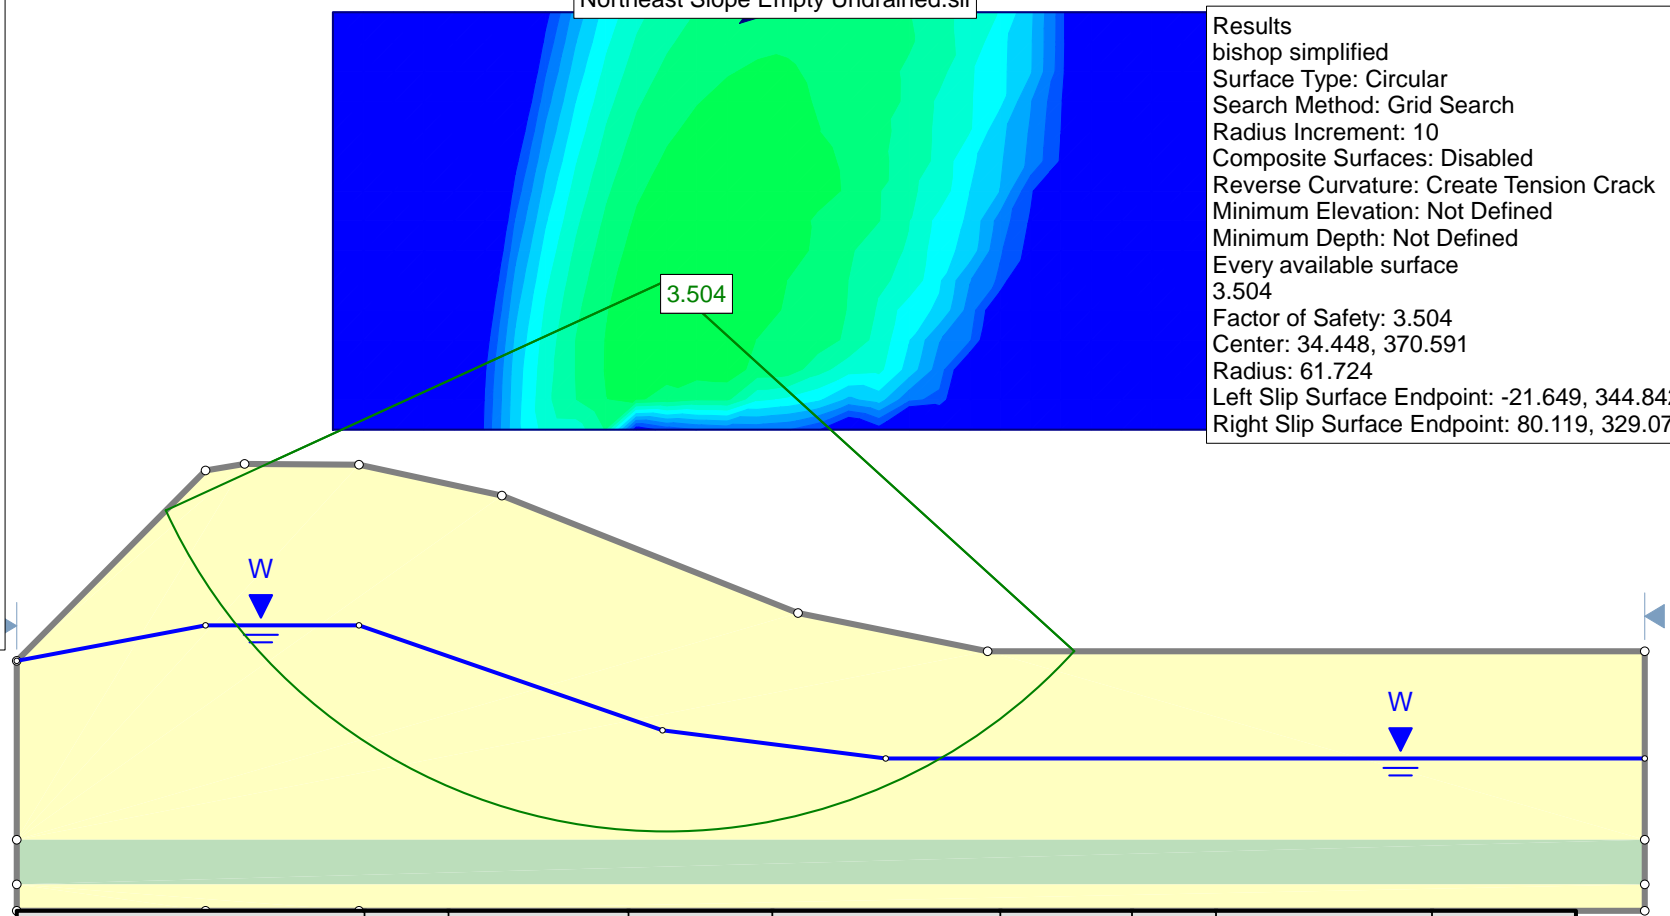
Results
 bishop simplified
 Surface Type: Circular
 Search Method: Grid Search
 Radius Increment: 10
 Composite Surfaces: Disabled
 Reverse Curvature: Create Tension Crack
 Minimum Elevation: Not Defined
 Minimum Depth: Not Defined
 Every available surface
 3.504
 Factor of Safety: 3.504
 Center: 34.448, 370.591
 Radius: 61.724
 Left Slip Surface Endpoint: -21.649, 344.842
 Right Slip Surface Endpoint: 80.119, 329.070

3.504

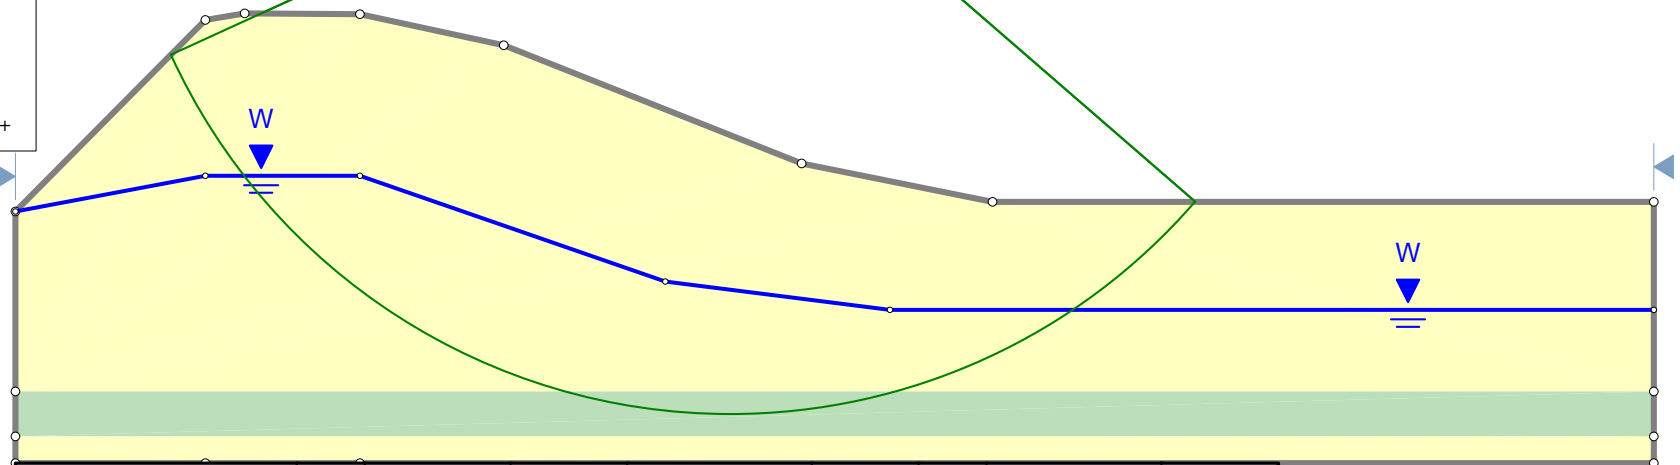
Results
 bishop simplified
 Surface Type: Circular
 Search Method: Grid Search
 Radius Increment: 10
 Composite Surfaces: Disabled
 Reverse Curvature: Create Tension Crack
 Minimum Elevation: Not Defined
 Minimum Depth: Not Defined
 Every available surface
 3.619
 Factor of Safety: 3.619
 Center: 41.243, 373.931
 Radius: 68.481
 Left Slip Surface Endpoint: -21.038, 345.458
 Right Slip Surface Endpoint: 92.983, 329.070

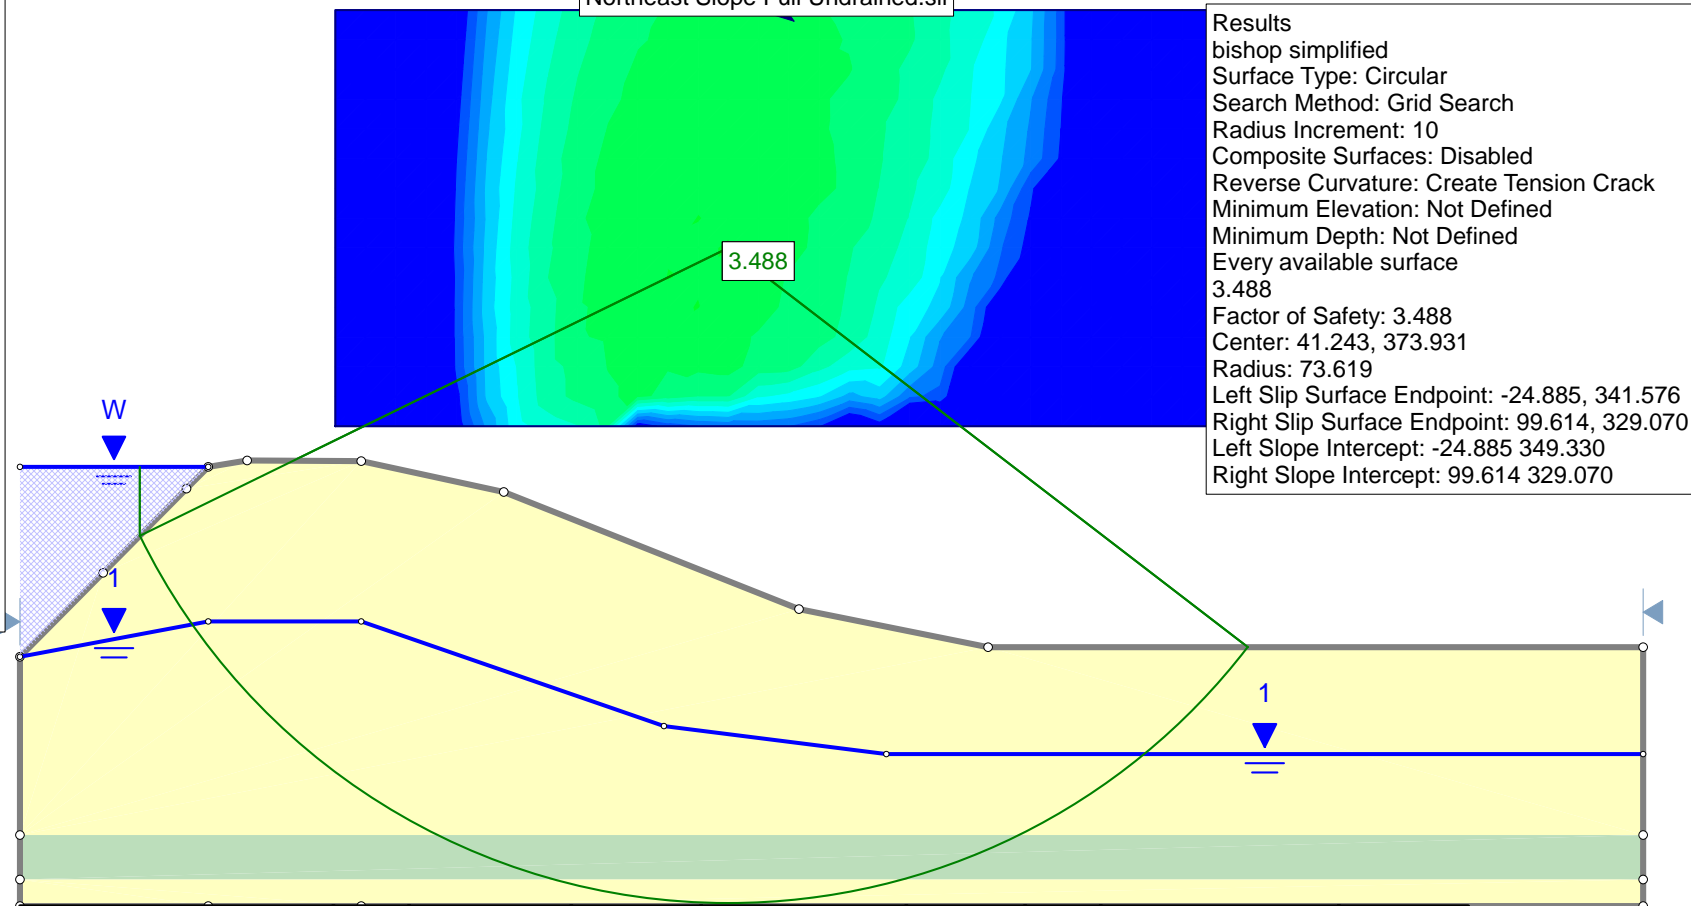
Results
 bishop simplified
 Surface Type: Circular
 Search Method: Grid Search
 Radius Increment: 10
 Composite Surfaces: Disabled
 Reverse Curvature: Create Tension Crack
 Minimum Elevation: Not Defined
 Minimum Depth: Not Defined
 Every available surface
 3.488
 Factor of Safety: 3.488
 Center: 41.243, 373.931
 Radius: 73.619
 Left Slip Surface Endpoint: -24.885, 341.576
 Right Slip Surface Endpoint: 99.614, 329.070
 Left Slope Intercept: -24.885 349.330
 Right Slope Intercept: 99.614 329.070

3.488

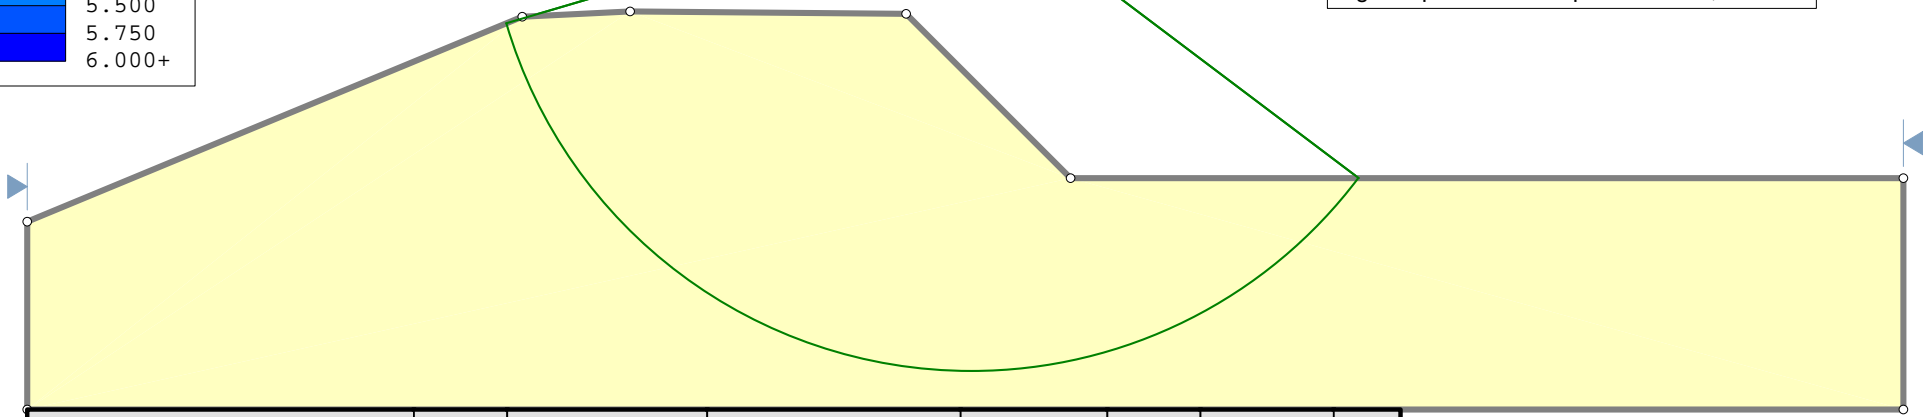
Results
 bishop simplified
 Surface Type: Circular
 Search Method: Grid Search
 Radius Increment: 10
 Composite Surfaces: Disabled
 Reverse Curvature: Create Tension Crack
 Minimum Elevation: Not Defined
 Minimum Depth: Not Defined
 Every available surface
 5.450
 Factor of Safety: 5.450
 Center: 25.067, 358.440
 Radius: 35.622
 Left Slip Surface Endpoint: -9.100, 348.362
 Right Slip Surface Endpoint: 53.507, 336.990

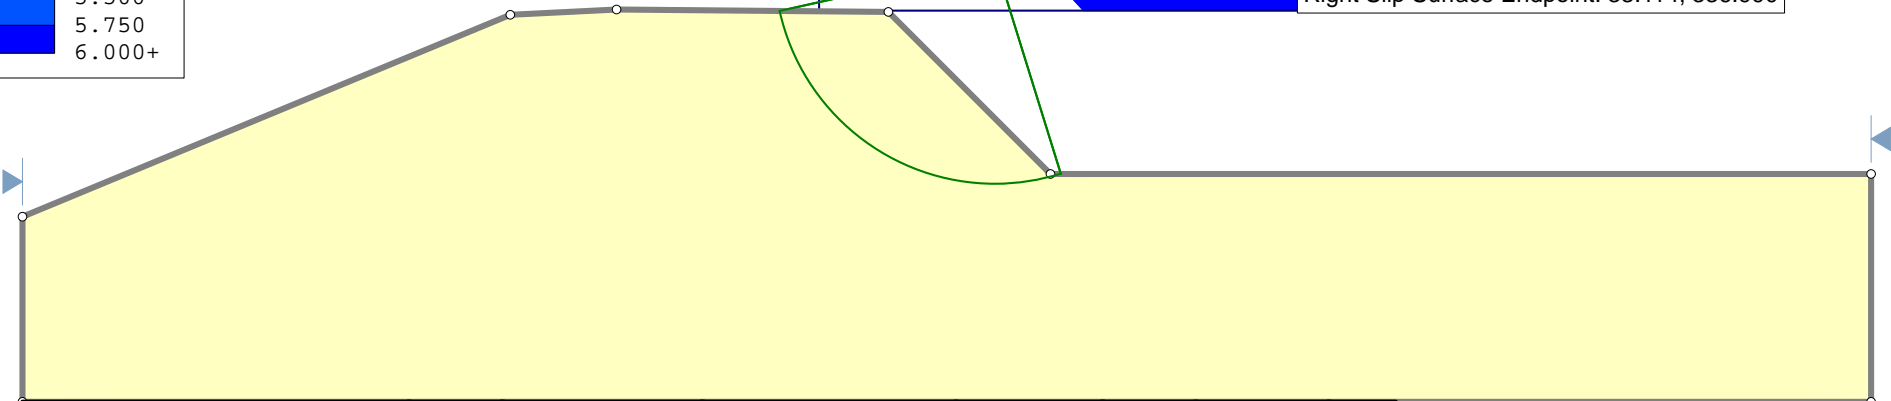
Results
 bishop simplified
 Surface Type: Circular
 Search Method: Grid Search
 Radius Increment: 10
 Composite Surfaces: Disabled
 Reverse Curvature: Create Tension Crack
 Minimum Elevation: Not Defined
 Minimum Depth: Not Defined
 Every available surface
 4.436
 Factor of Safety: 4.436
 Center: 28.226, 352.710
 Radius: 16.463
 Left Slip Surface Endpoint: 12.157, 349.132
 Right Slip Surface Endpoint: 33.114, 336.990

4.436

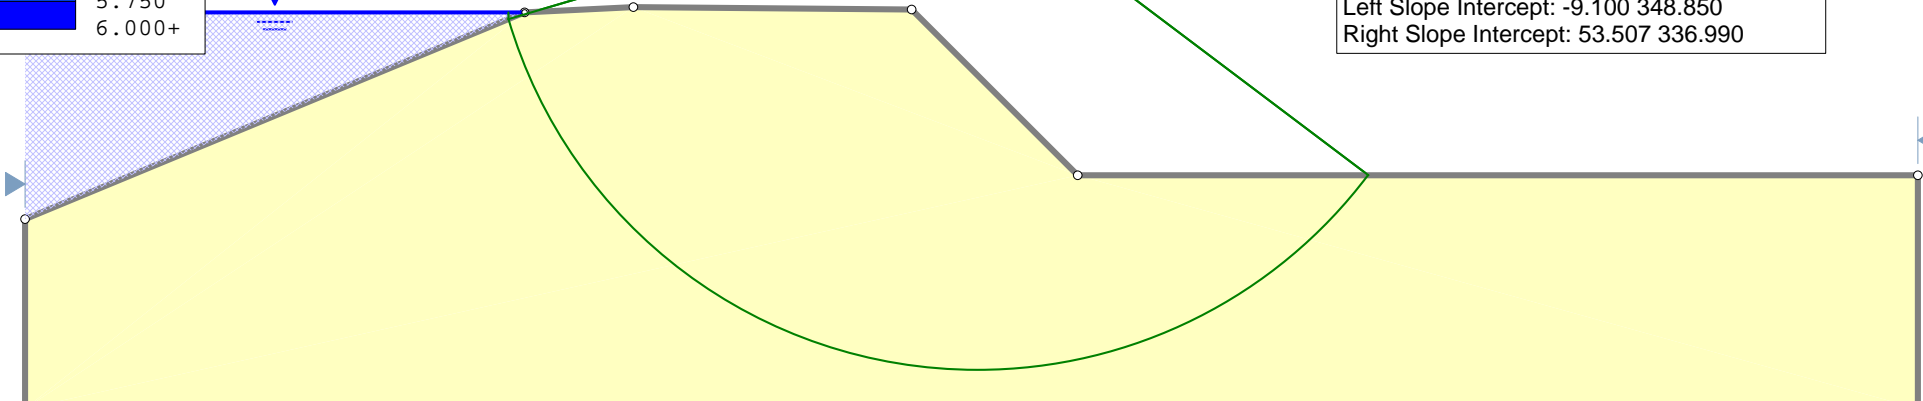
Results
 bishop simplified
 Surface Type: Circular
 Search Method: Grid Search
 Radius Increment: 10
 Composite Surfaces: Disabled
 Reverse Curvature: Create Tension Crack
 Minimum Elevation: Not Defined
 Minimum Depth: Not Defined
 Every available surface
 5.445
 Factor of Safety: 5.445
 Center: 25.067, 358.440
 Radius: 35.622
 Left Slip Surface Endpoint: -9.100, 348.362
 Right Slip Surface Endpoint: 53.507, 336.990
 Left Slope Intercept: -9.100 348.850
 Right Slope Intercept: 53.507 336.990
