# **Dam Safety Assessment of CCW Impoundments**

## **NRG ELRAMA POWER STATION**

**United States Environmental Protection Agency  
Washington, DC**

February 2014

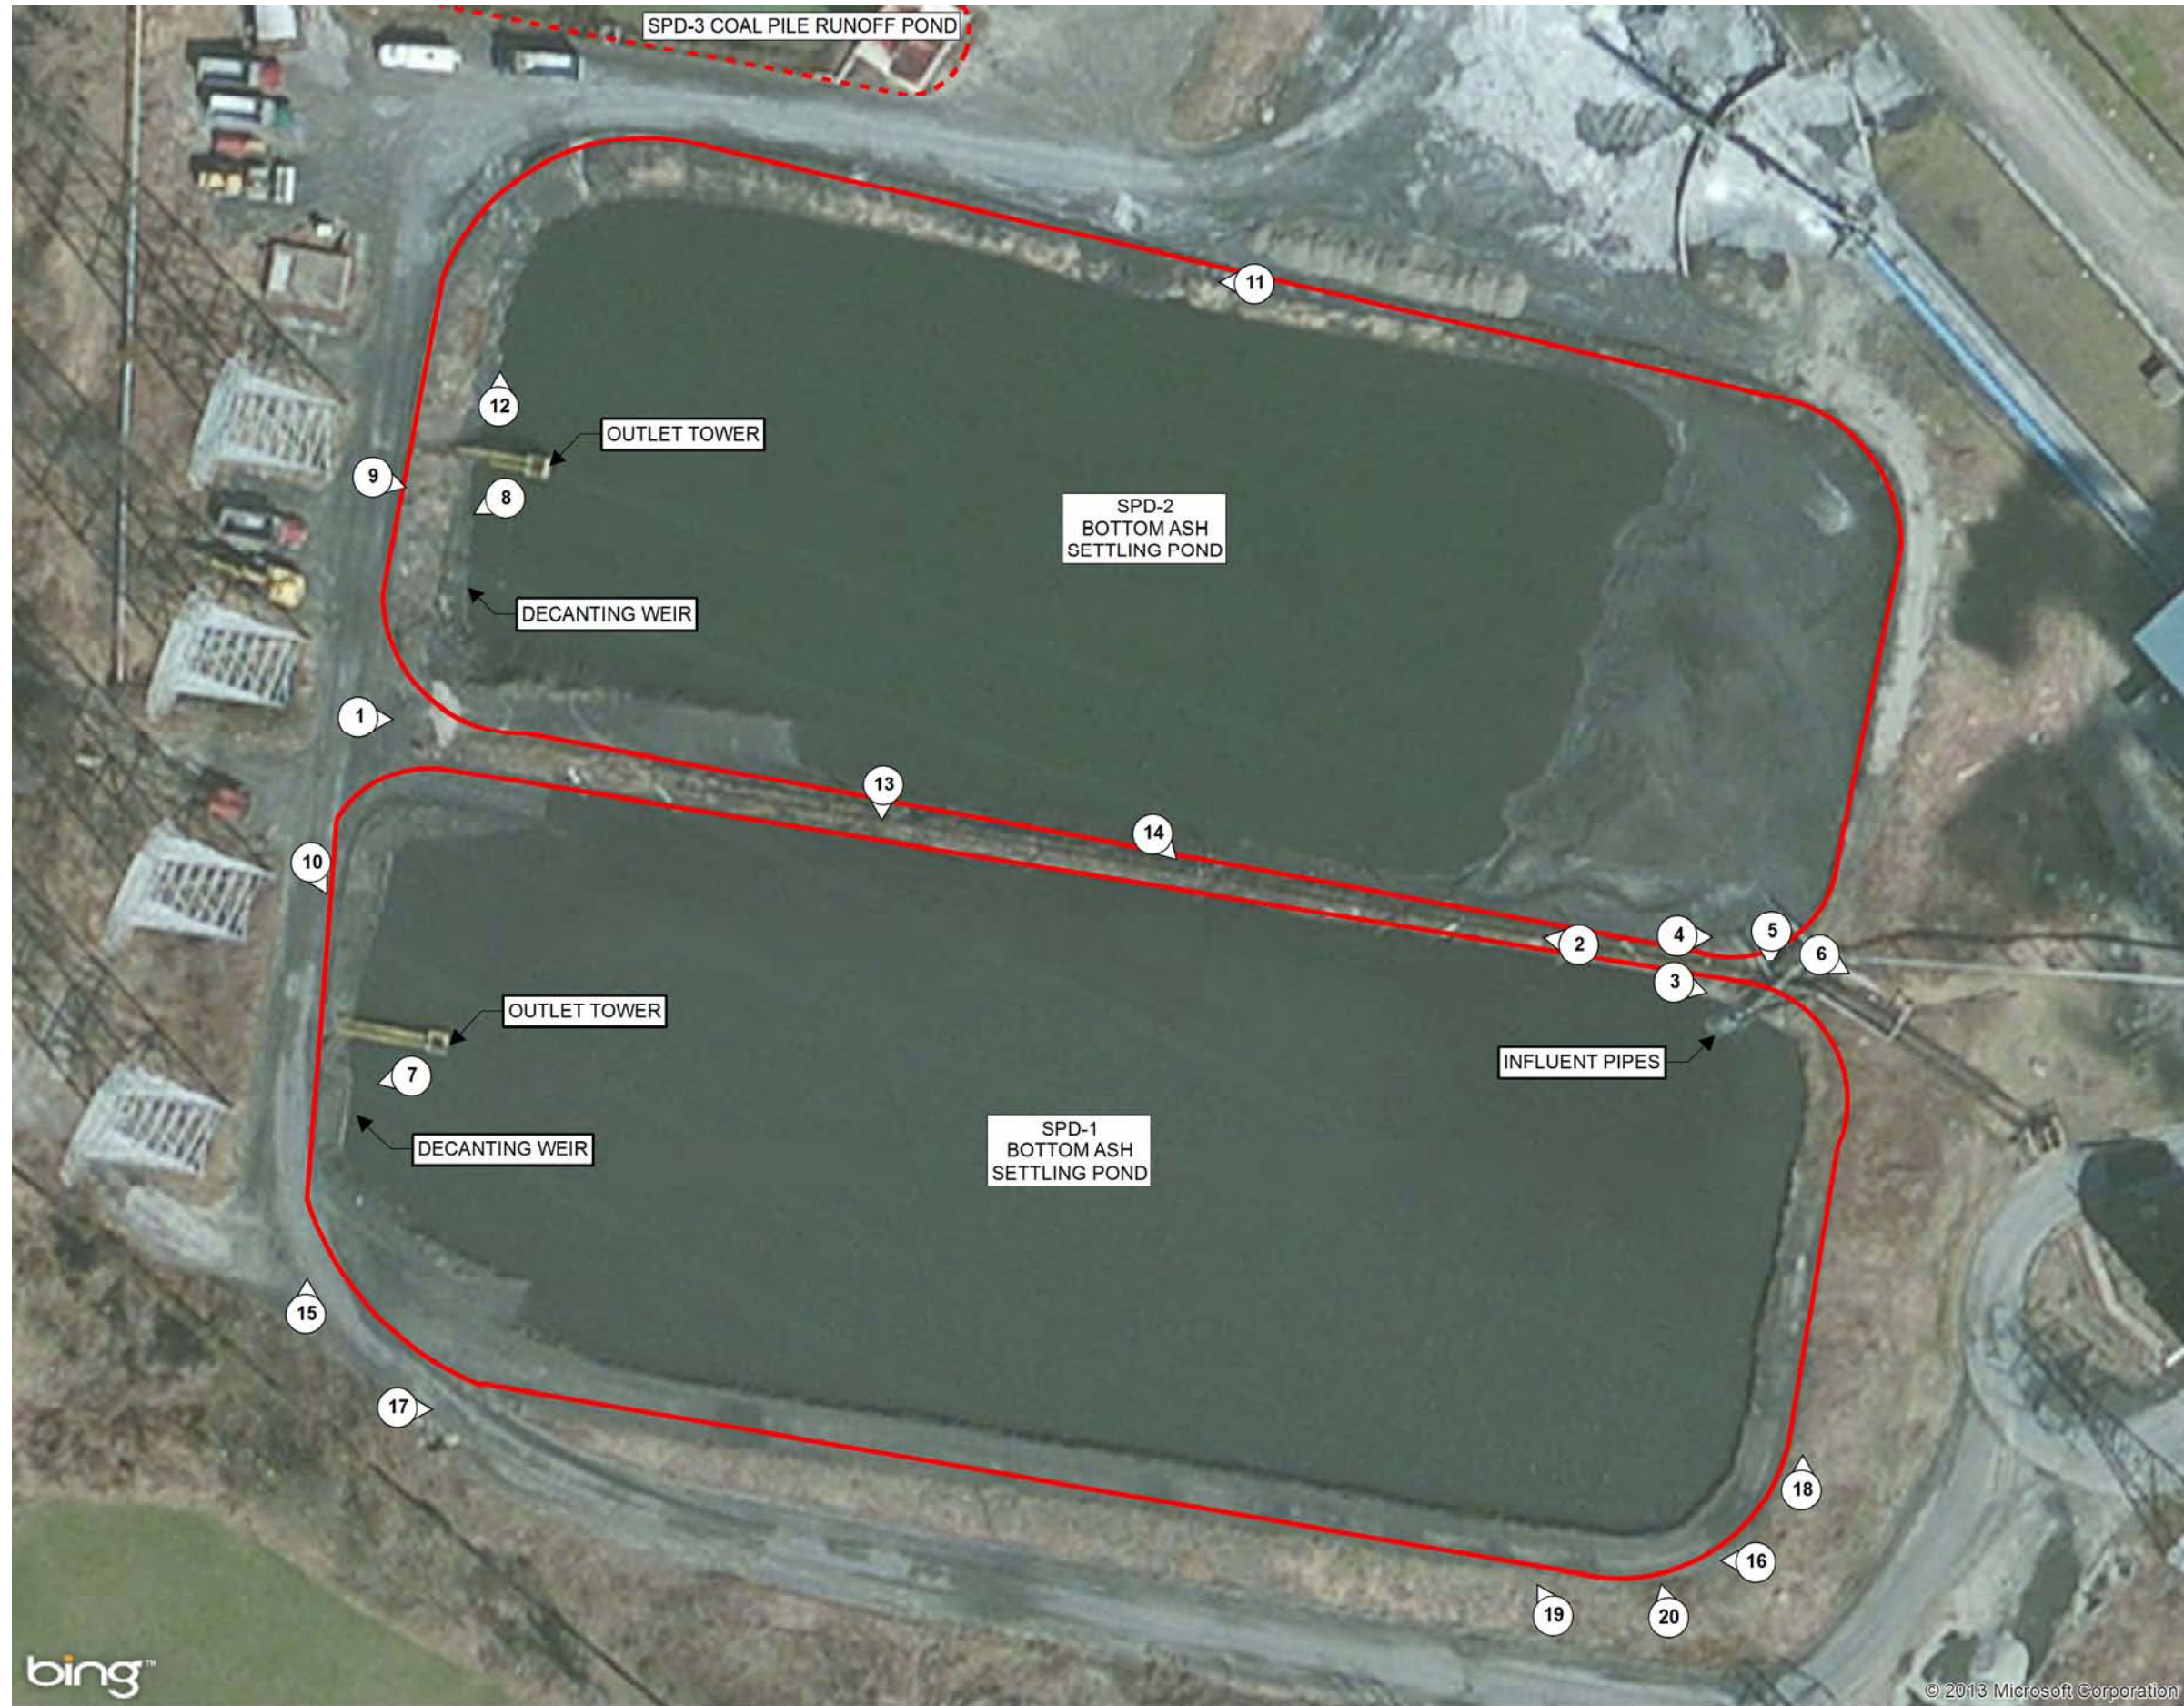
FIGURE 3A

Bottom Ash Settling Ponds SPD-1 and SPD-2 are located between Elrama Avenue and PA Route 837 (PA-837)/5<sup>th</sup> Street near Duquense Light Drive, as shown on Figure 2. Ponds SPD-1 and SPD-2 commenced operations in 1952. Each settling pond impounds a surface area of a little over 2 acres. The ponds are diked on all sides and separated by a dividing dike. Both ponds were assessed. A plan view and photo locations are shown on Figure 3A.

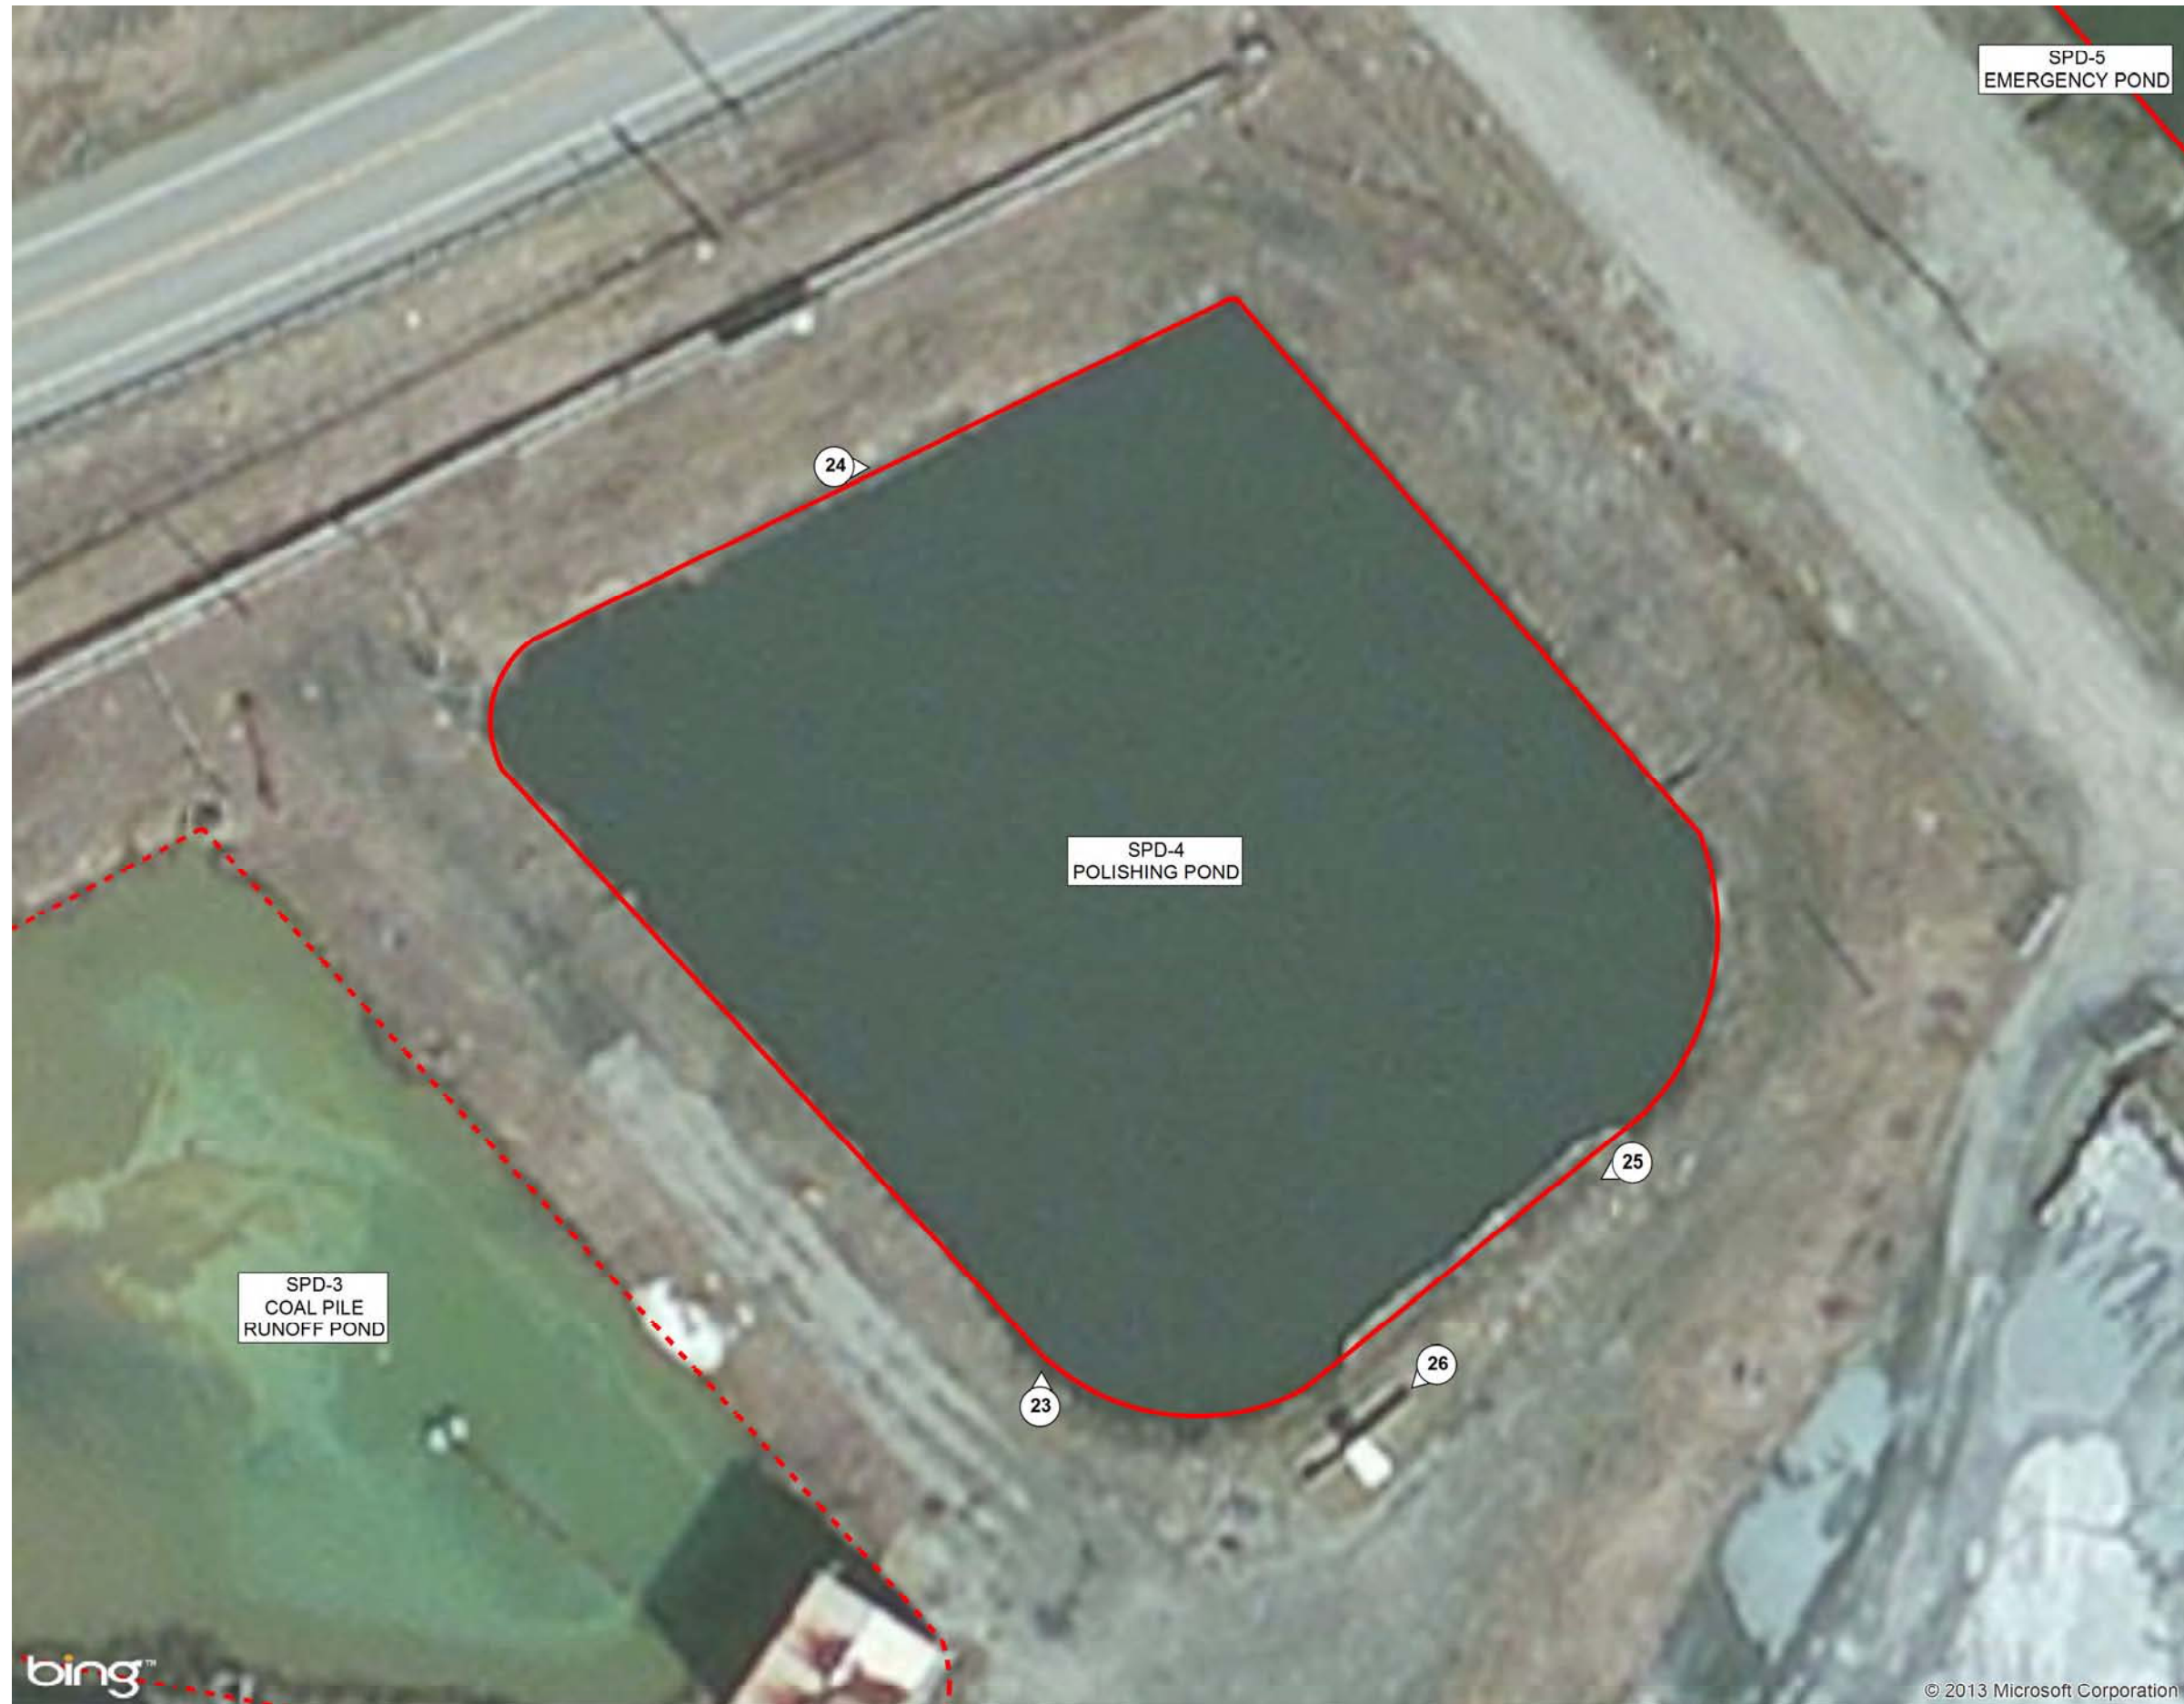
FIGURE 3B

Polishing Pond SPD-4 is located to the north of the Bottom Ash Ponds and Coal Pile Runoff Pond SPD-3, adjacent to PA-837/5<sup>th</sup> Street, as shown in Figure 2. It impounds a surface area of 0.4 acres and is completely incised on all sides. A plan view and photo locations are shown on Figure 3B.

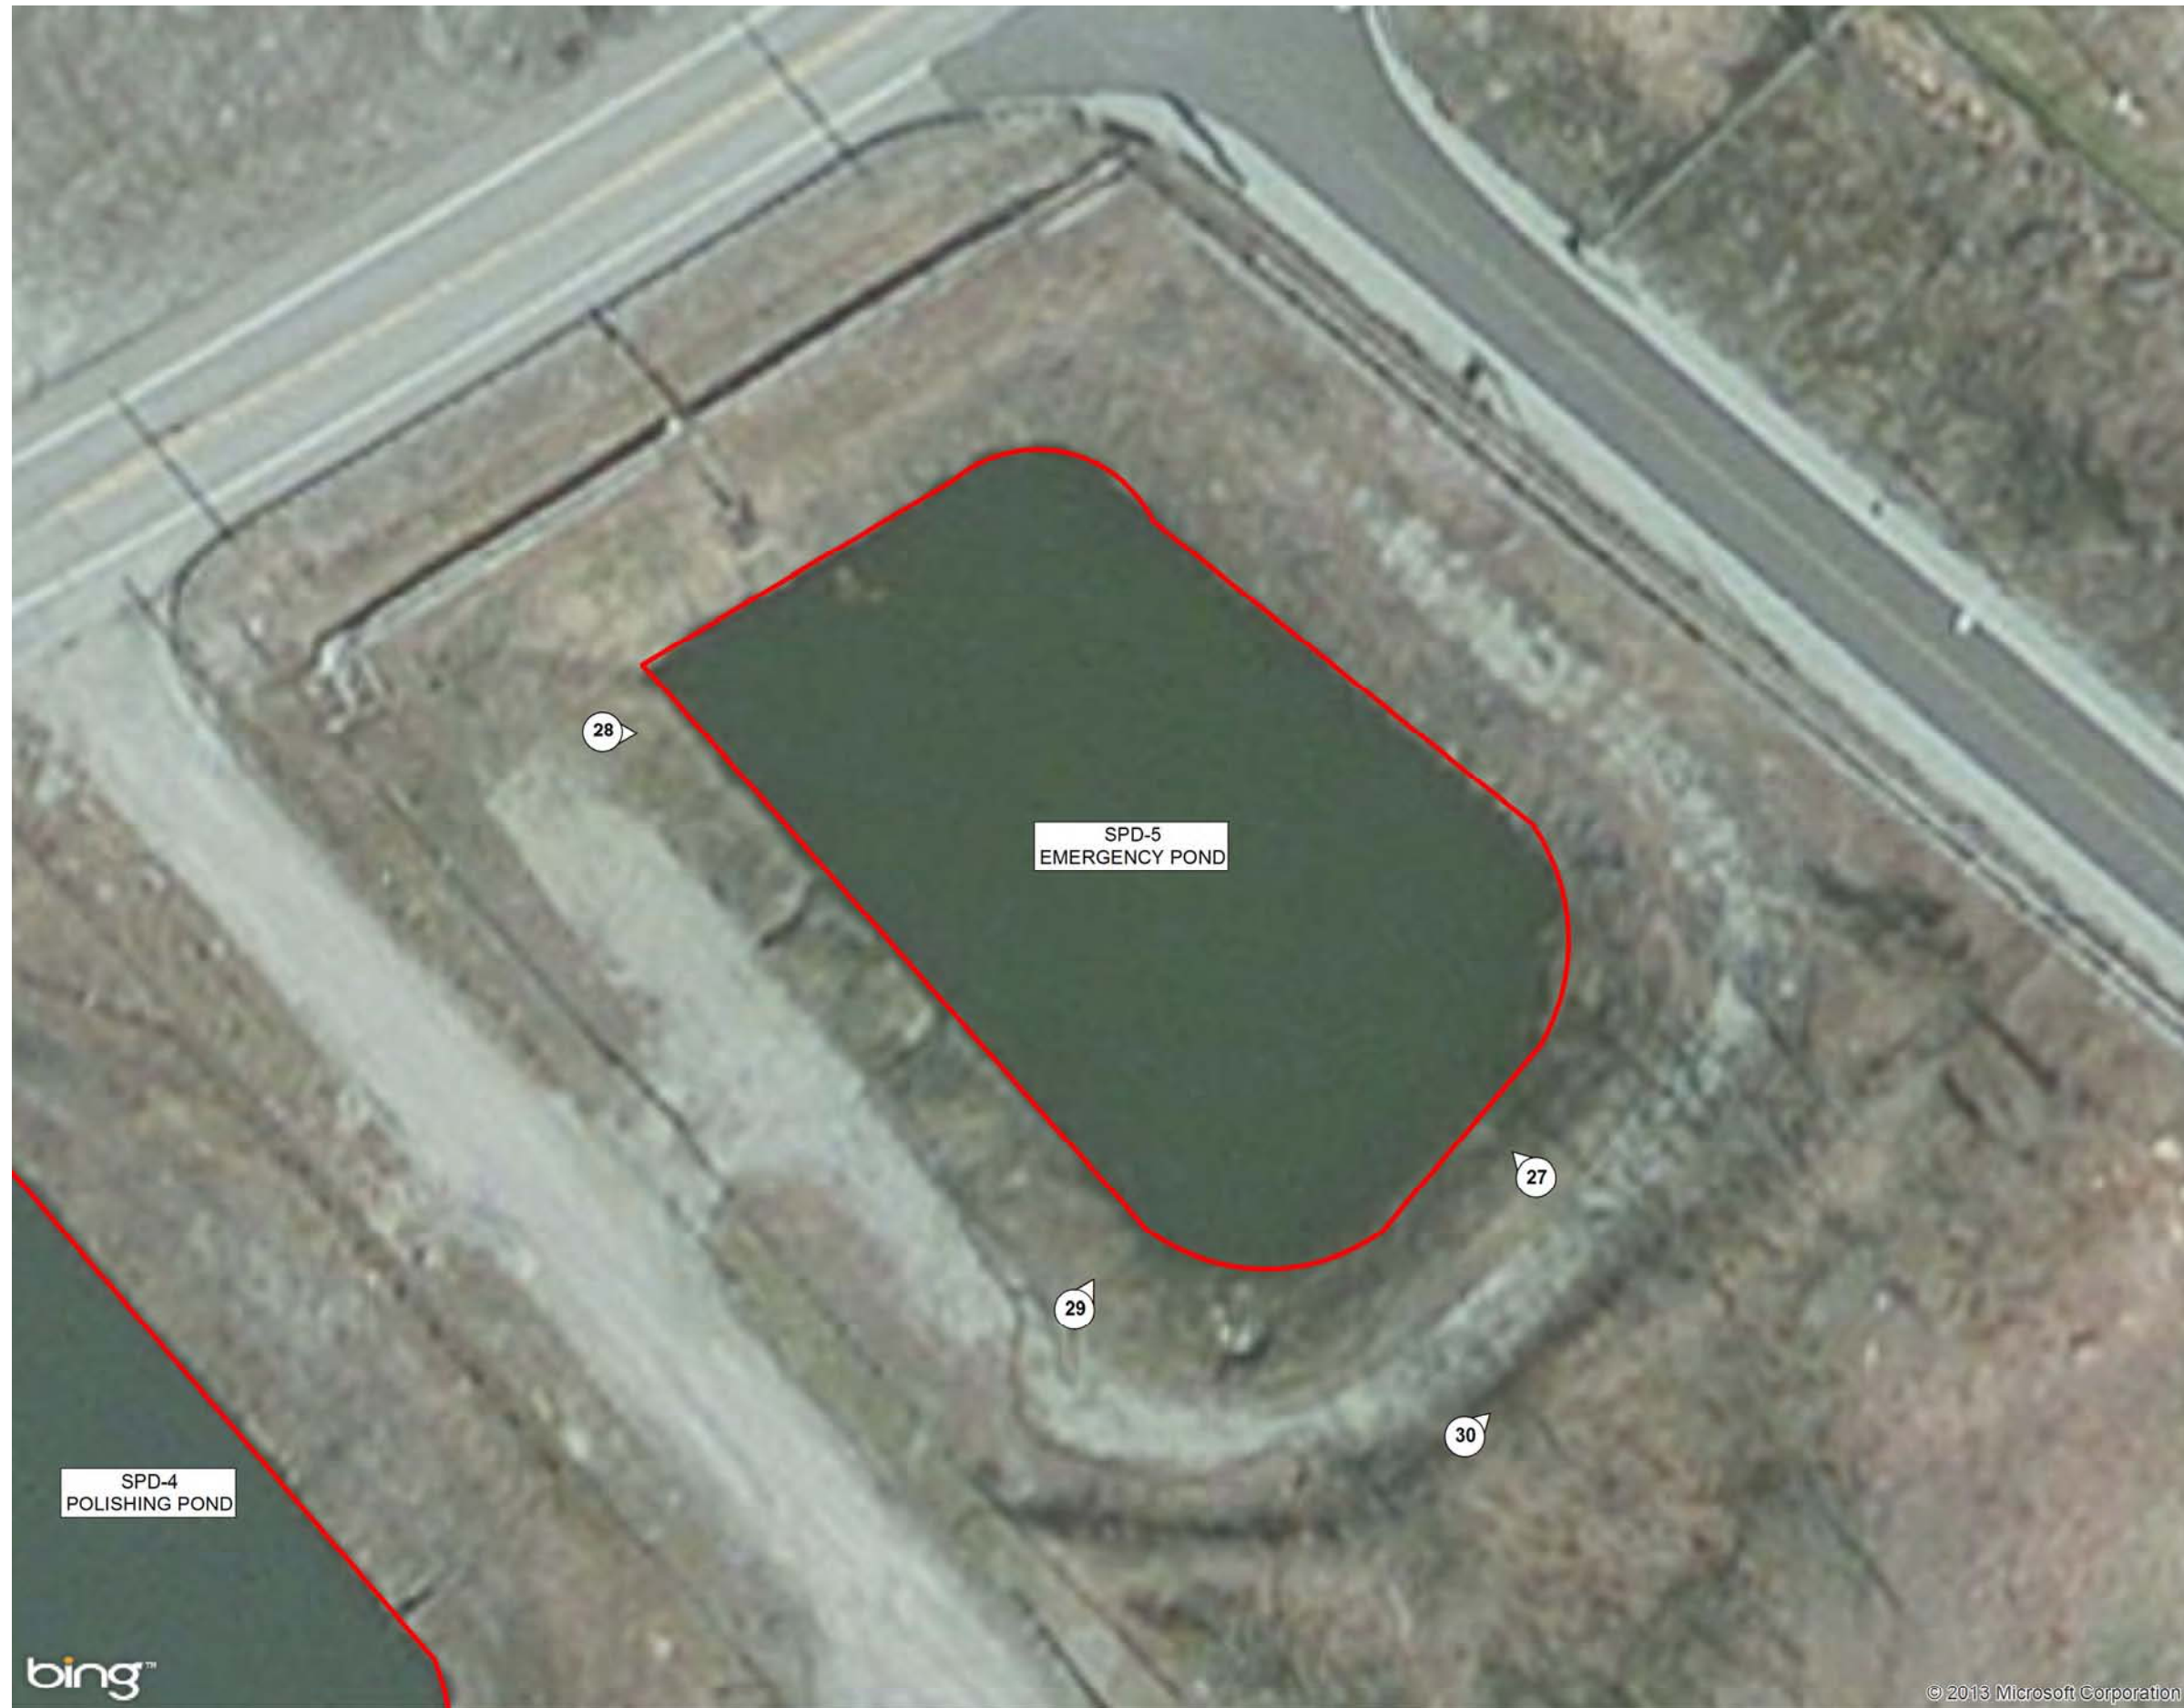
FIGURE 3C

Emergency Pond SPD-5 is located across a plant access road from Polishing Pond SPD-4, adjacent to PA-837/5<sup>th</sup> Street and Duquense Light Drive, as shown in Figure 2. It impounds a surface area of 0.3 acres and is incised on three (3) sides. The southeast side is impounded by an approximately six (6) feet high embankment. It receives water from thickeners and FGD residuals (scrubber sludge) only when normal operations are nonfunctional. A plan view and photo locations are shown on Figure 3C.

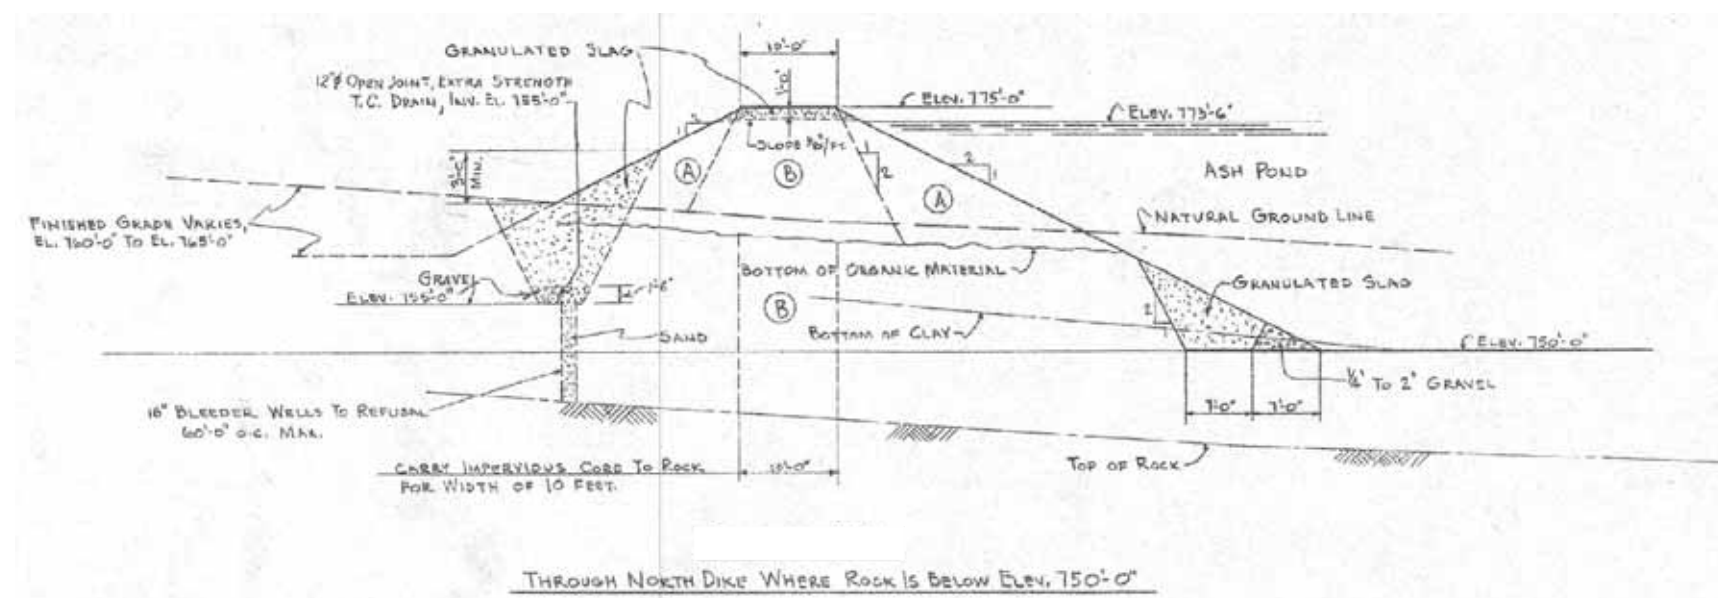
SECTION Y-Y  
SCALE: 1" = 20'-0"

As depicted in typical sections shown on Figures 4A through 4C, the granulated slag-covered crest is at approximately elevation (EL) 775 feet above mean sea level. The pond bottoms (as indicated by plant record drawings) are at approximately EL 750. All embankment slopes have an inclination of approximately 2H:1V. Each embankment was constructed with an “impervious” core (as shown on the design drawings) at 1H:2V to natural ground. Below natural ground, a 10-foot wide vertical “impervious” core was constructed to rock.

**BOTTOM ASH SETTLING POND SPD-2 (NORTHERN EMBANKMENT)**

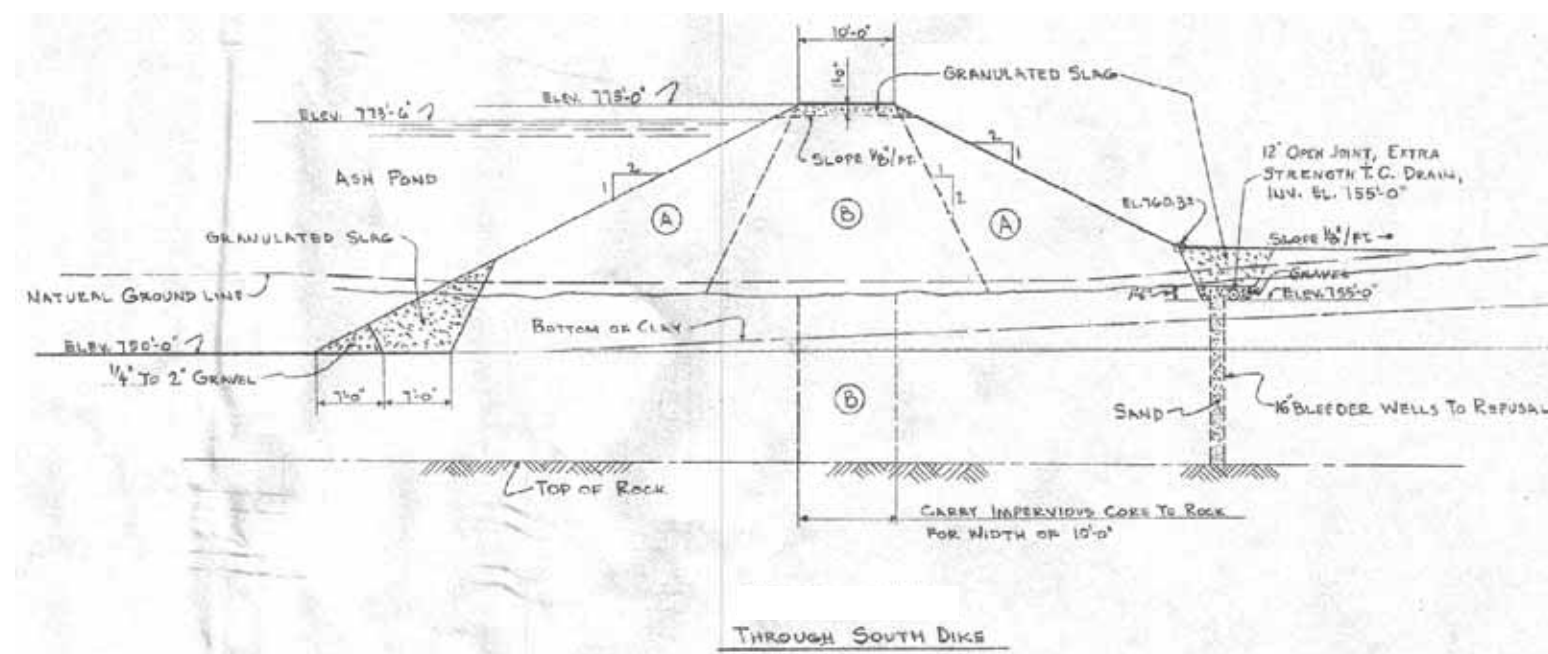
SECTION H-H  
SCALE: 1" = 20'-0"

**BOTTOM ASH SETTLING POND SPD-1 (SOUTHERN EMBANKMENT)**

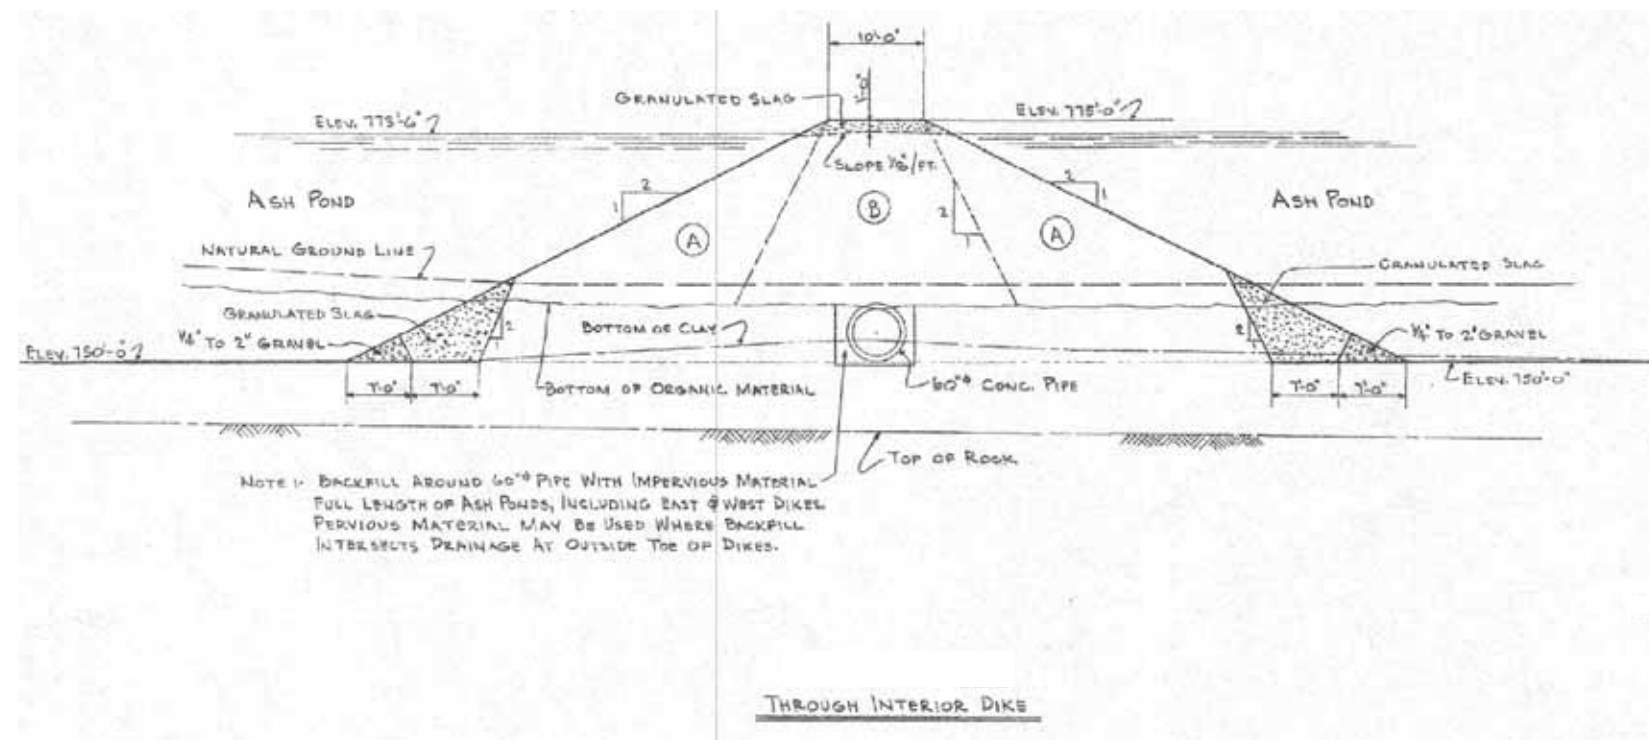
SECTION W-W  
SCALE: 1" = 20'-0"

## BOTTOM ASH SETTLING PONDS SPD-1 & SPD-2 (DIVIDING DIKE)

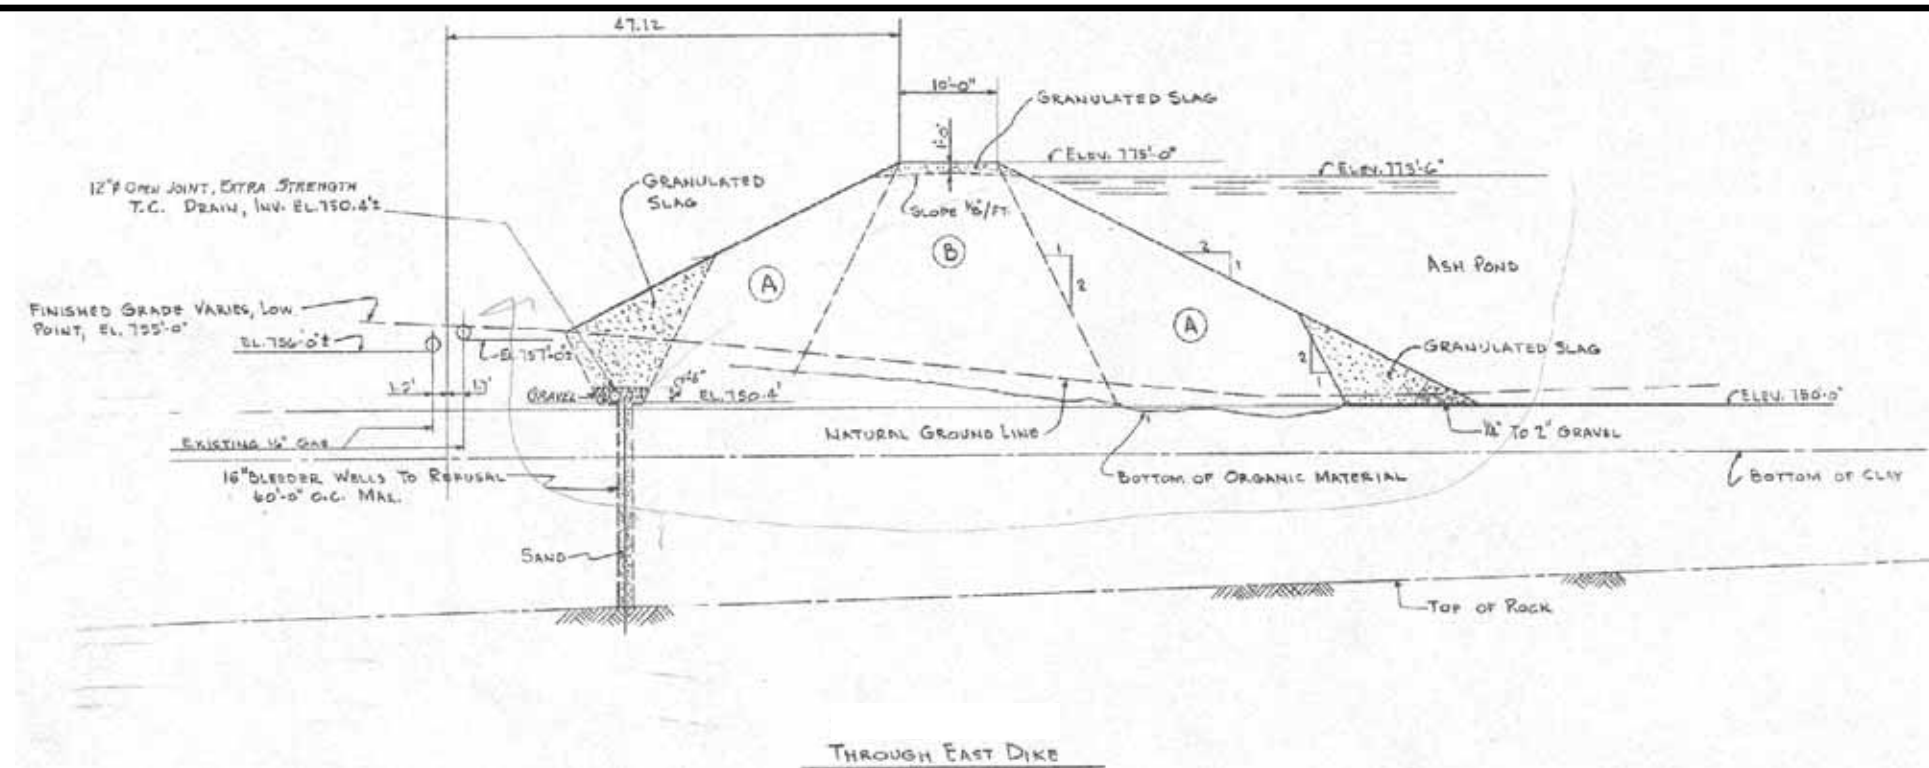
SECTION Z-Z  
SCALE: 1" = 20'-0"

### BOTTOM ASH SETTLING POND SPD-1 (EASTERN EMBANKMENT)

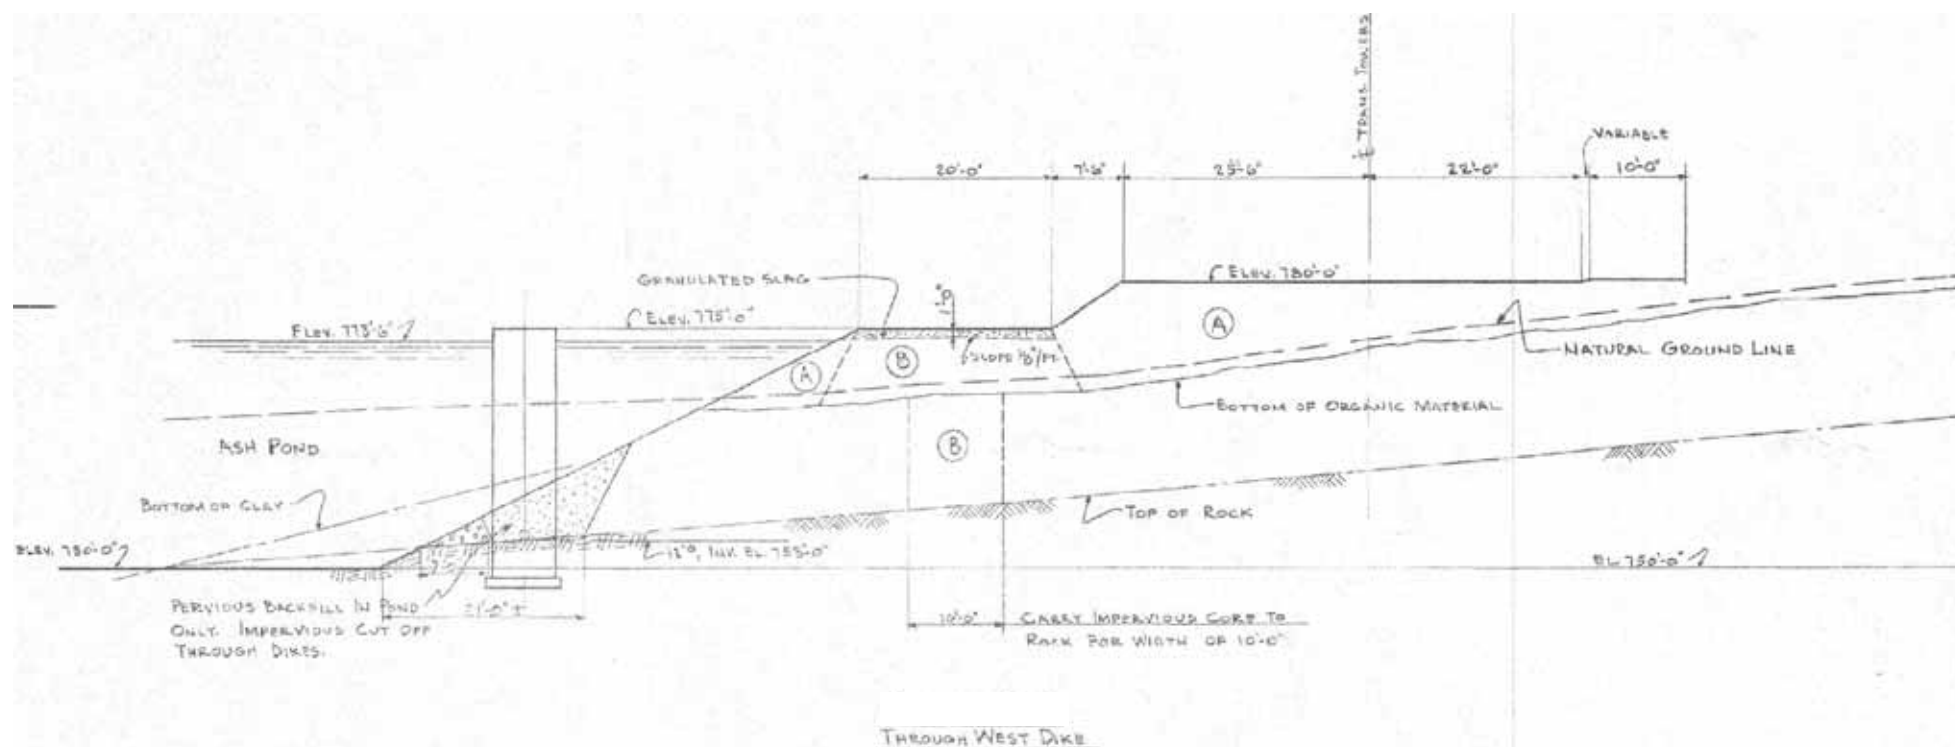
SECTION S-S  
SCALE: 1" = 20'-0"

### BOTTOM ASH SETTLING POND SPD-1 (WESTERN EMBANKMENT)
